EFFECT OF EPOXY COATING ON BOND AND ANCHORAGE OF
REINFORCEMENT IN CONCRETE STRUCTURES

Research Report 1181-1F

Research Project 3-5-88/90-1181
"Bond and Anchorage of Epoxy-Coated Reinforcement"

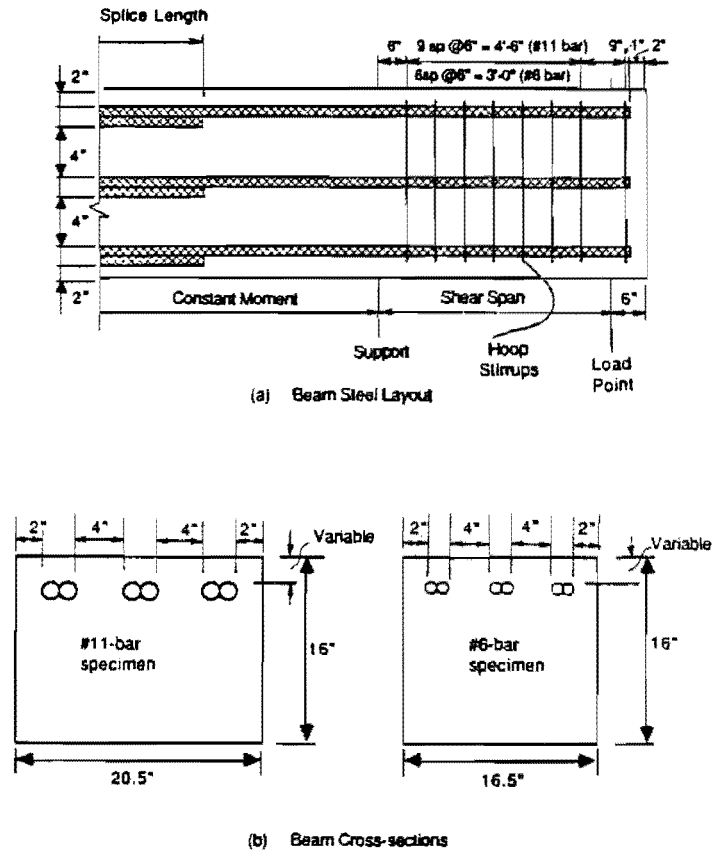
Figure 3.11 Beam reinforcement details, Treece [25].

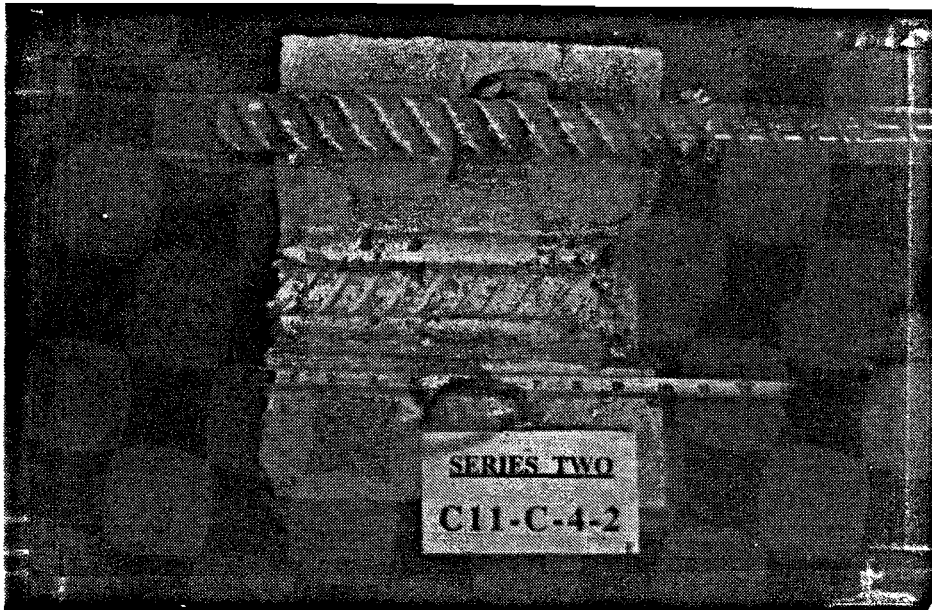
Figure 5.9 Epoxy-coated crescent deformation pattern #11 bar Type A pullout specimen after failure, top load = 10 kips, normal strength concrete.

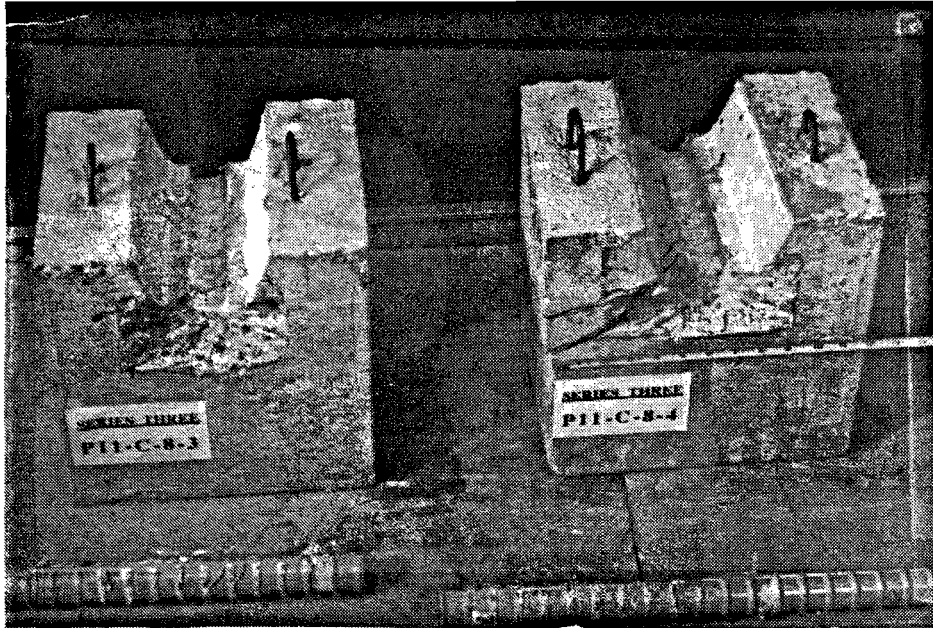
Figure 5.12 Different cracking patterns of parallel deformation pattern #11 bar Type A pullout specimens with high strength concrete.

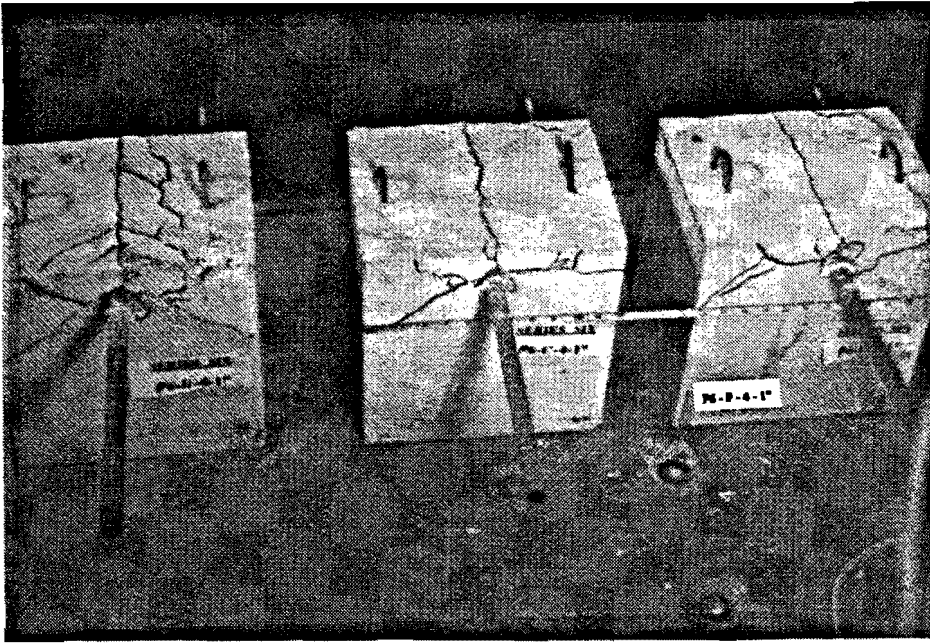
Figure 5.16 V-notch failure of #6 bar type B pullout specimens with 1-in. clear cover, series SIX, $f'_c = 4500$ psi.

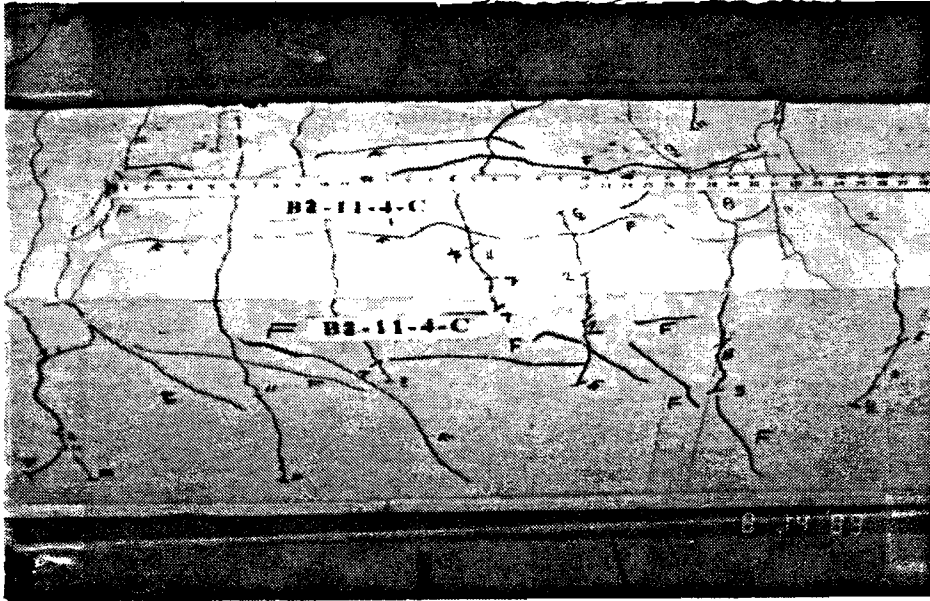
Figure 7.1 Face-and-side split failure of the epoxy-coated bar Specimen B2-11-4-C.

a face-and-side split failure. The failure was sudden. After failure, the beams carried virtually no load. The crack pattern in the splice region of beam B2, is shown in Figure 7.1. Numbers along each crack indicate the load levels at which extensions were observed. Cracks marked with the letter "F" formed at failure.

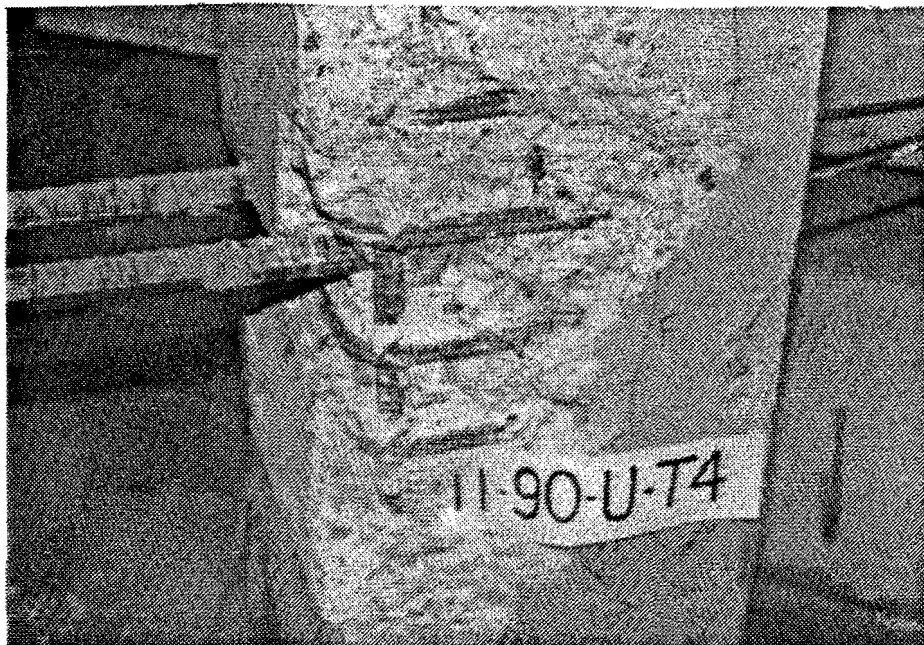
Figure 8.18 Joint region of the #11 uncoated hooked bar specimen of the fifth series, #3 at 4 in., $f'_c = 4225$ psi.

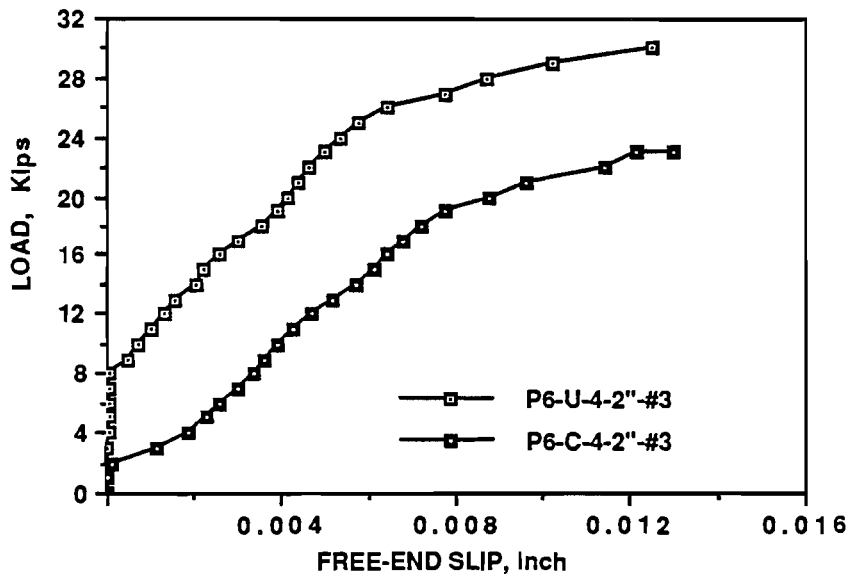
Figure A28 Load-slip curves for series EIGHT of pullout specimens, concrete cover = 2 in., #3 @ 10 in.
