1. Report No. FHWA/TX-92+1208-1F		2. Government Accession No.		3. Recipient's Catalog No.	
4. Title and Subtitle EFFECT OF ENVIRONMENTAL CYCLING ON THE STRENGTH OF SHORT RETROFIT ANCHOR BOLTS			5. Report Date July 1991

**EFFECT OF ENVIRONMENTAL CYCLING ON THE STRENGTH
OF SHORT RETROFIT ANCHOR BOLTS**

Research Report No. 1208-1F

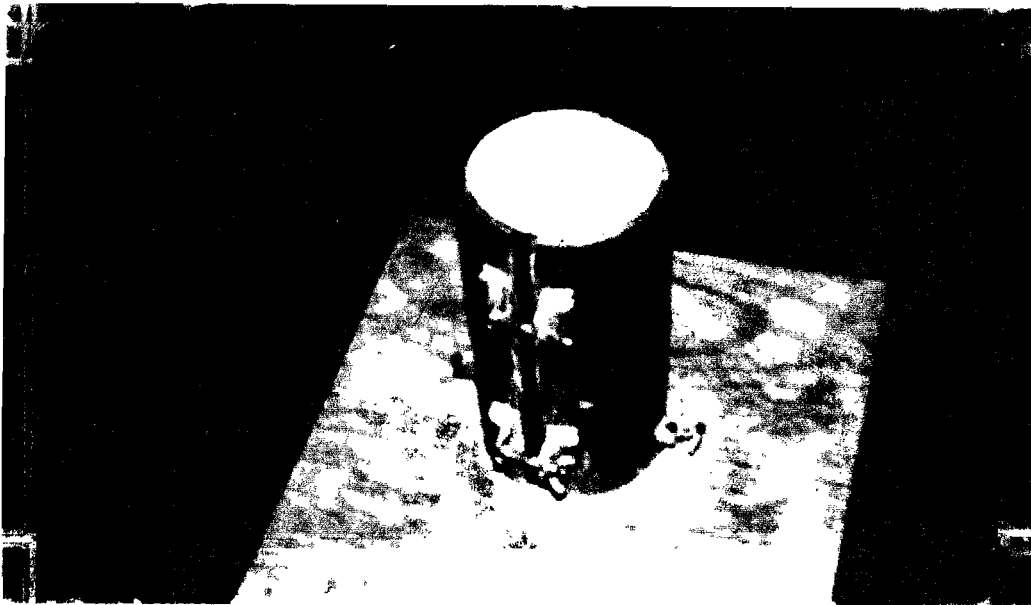
Figure 4.2 Steel collar used during drilling operation (closed).

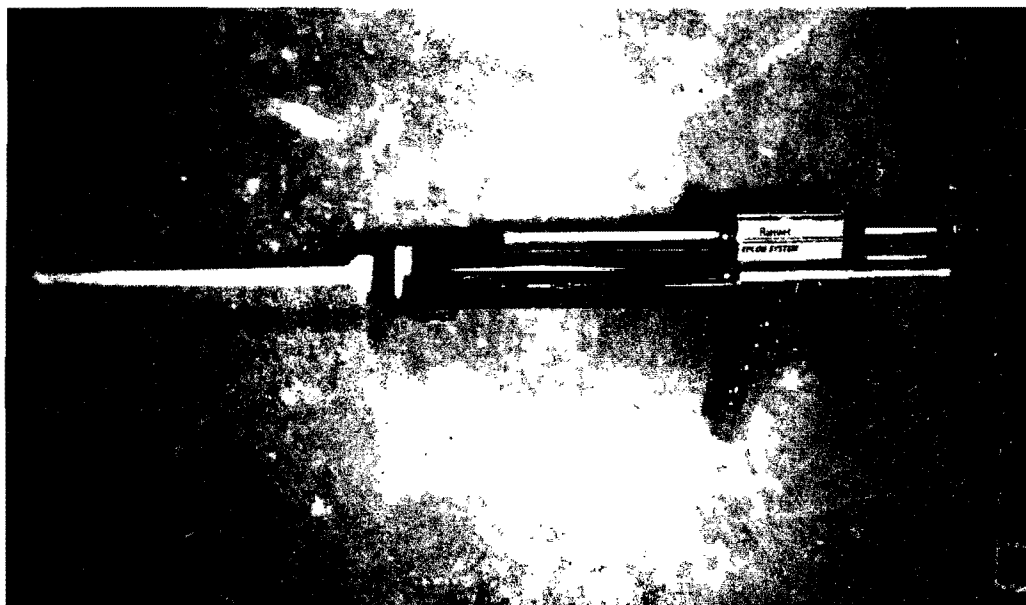
Figure 4.6 Two-component cartridge in applicator.

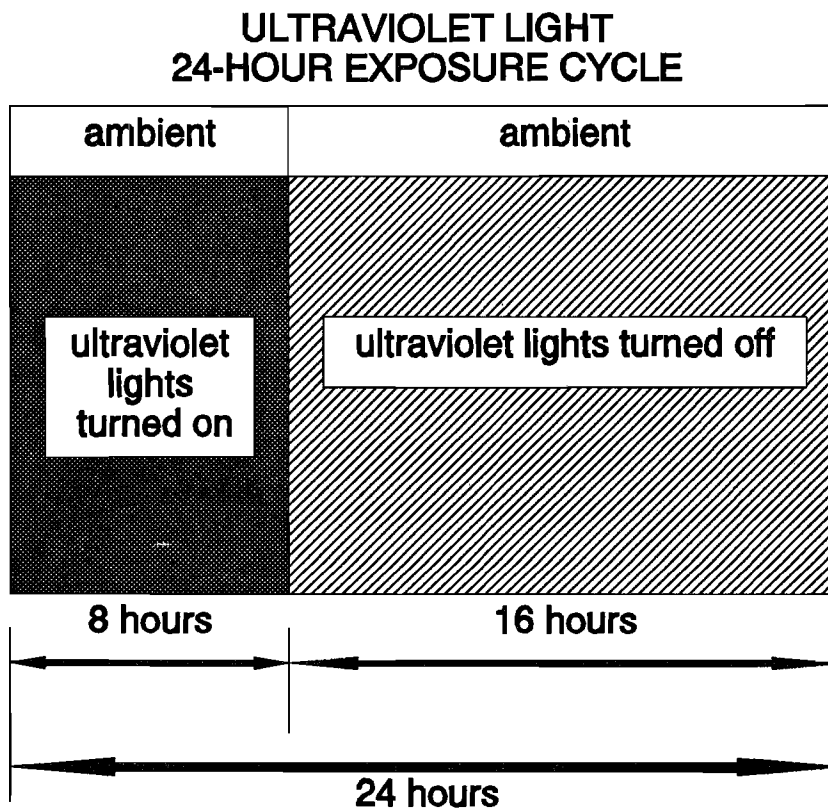
Figure 5.1 Schematic of ultraviolet light exposure.

According to Philips, 30 minutes of exposure under those conditions is equivalent to two hours of severe summer exposure; that is, the box is about four times as severe as natural UV exposure. The box involved a total of 8 hours/day x 30 days x 4 (factor), or the equivalent of 960 hours of intense UV exposure. Assuming the equivalent of four hours/day of intense exposure, one month in the box would be equivalent to about 240 days of normal exposure.

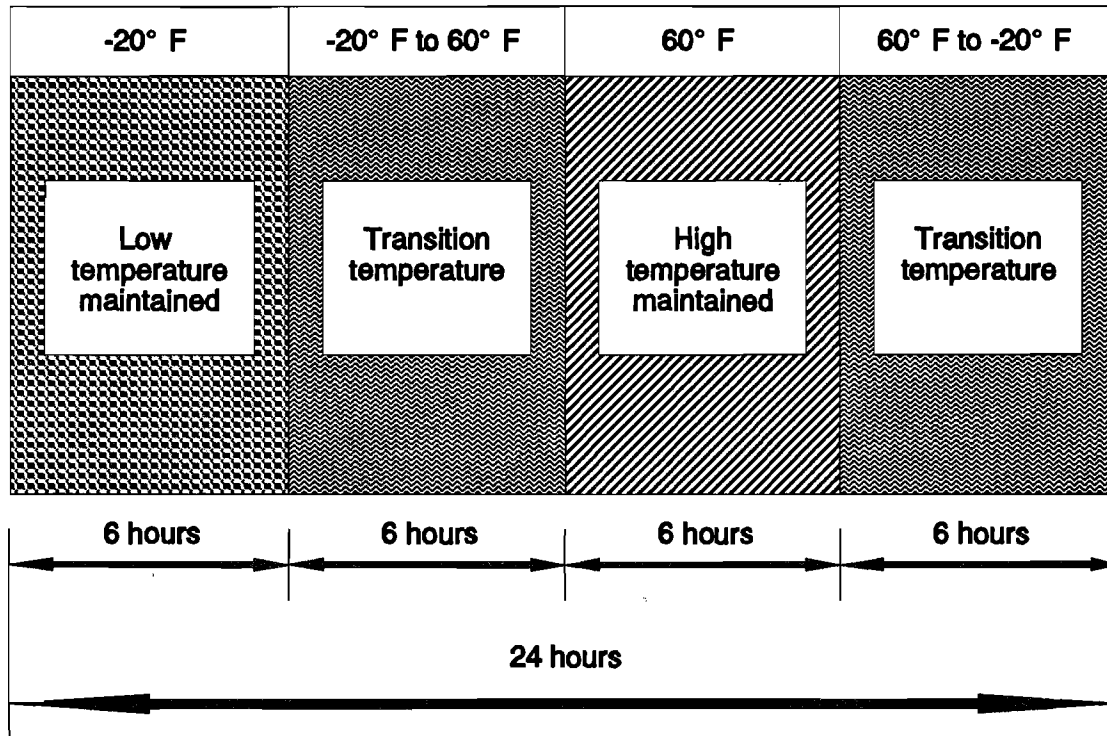
FREEZING and THAWING 24-HOUR EXPOSURE CYCLE

Figure 5.4 Schematic of freezing and thawing exposure.

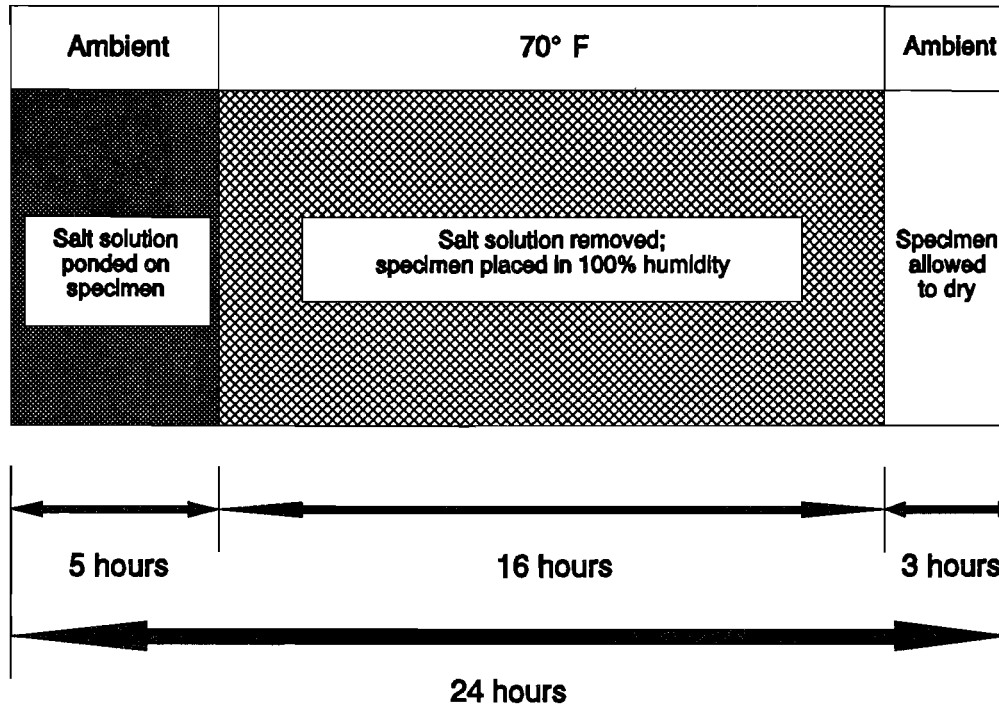
SALT (CORROSION) 24-HOUR EXPOSURE CYCLE

Figure 5.5 Schematic of salt (corrosion) exposure.

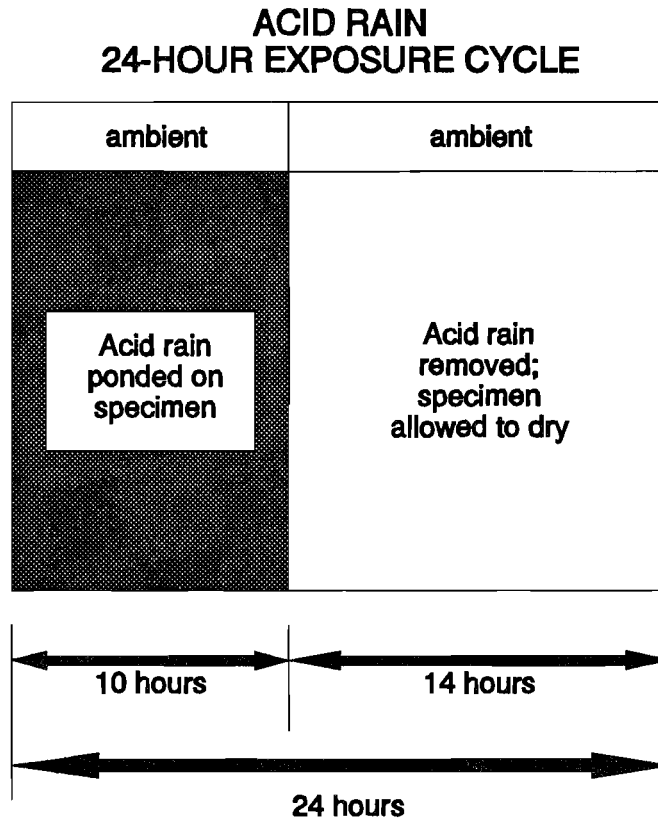
Figure 5.6 Schematic of acid rain wetting and drying exposure.

As shown schematically in Fig. 5.6, the solution was ponded on the test specimens for a period of 10 hours at ambient temperature. At the end of the 10 hours, the solution was poured off and the test specimen was allowed to dry for 14 hours at ambient temperature. Each wetting and drying cycle took 24 hours, and was repeated 50 times.

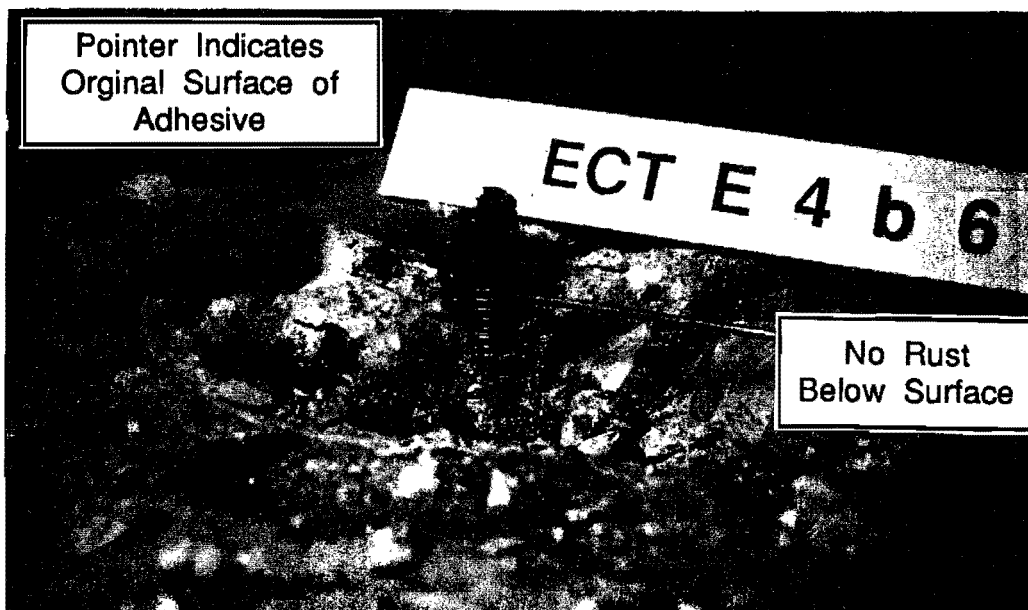
Figure 7.3 Adhesive exhibiting no rust penetration below surface.

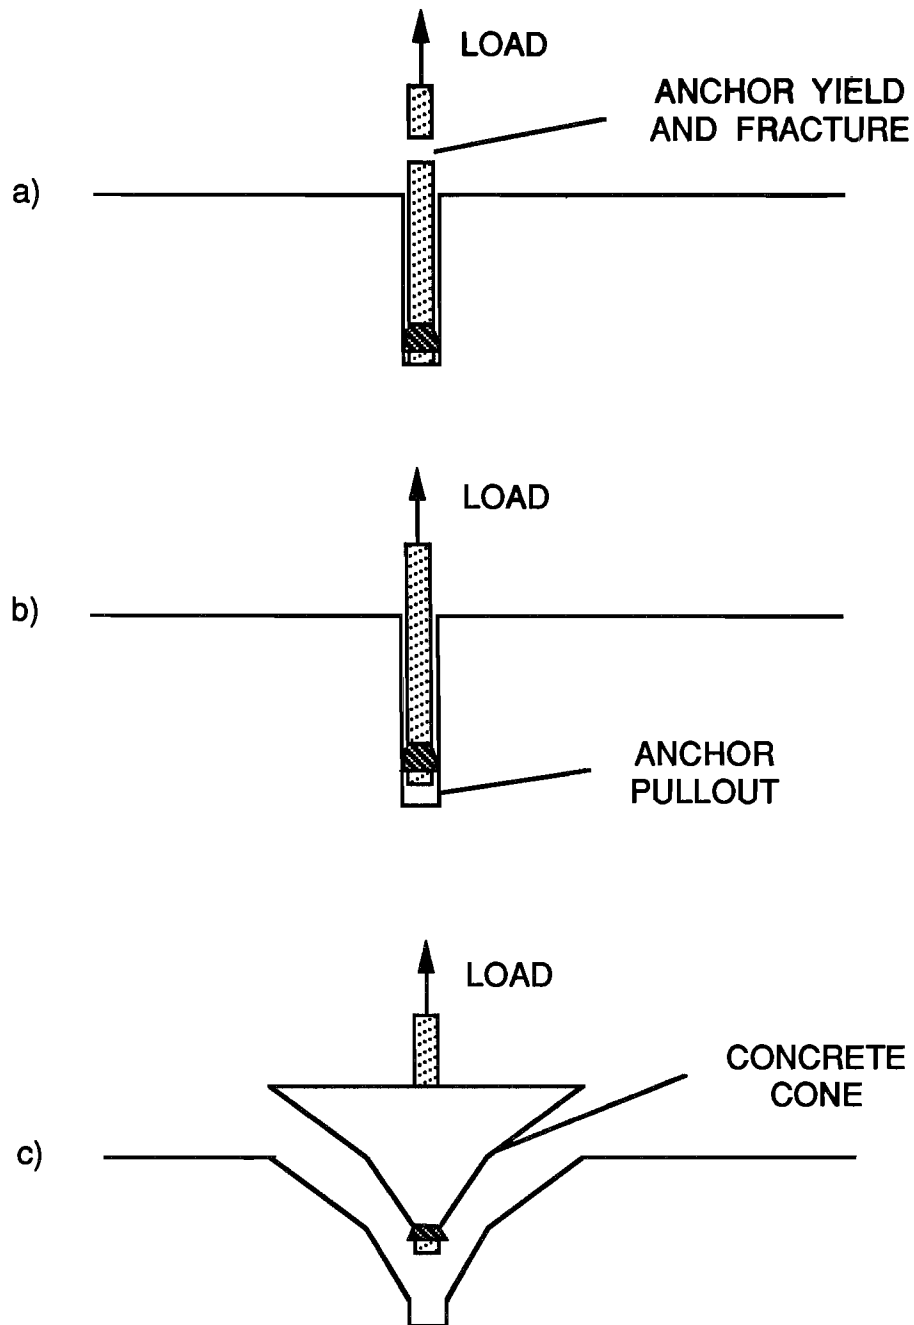
Figure 7.5 Failure modes for expansion anchors

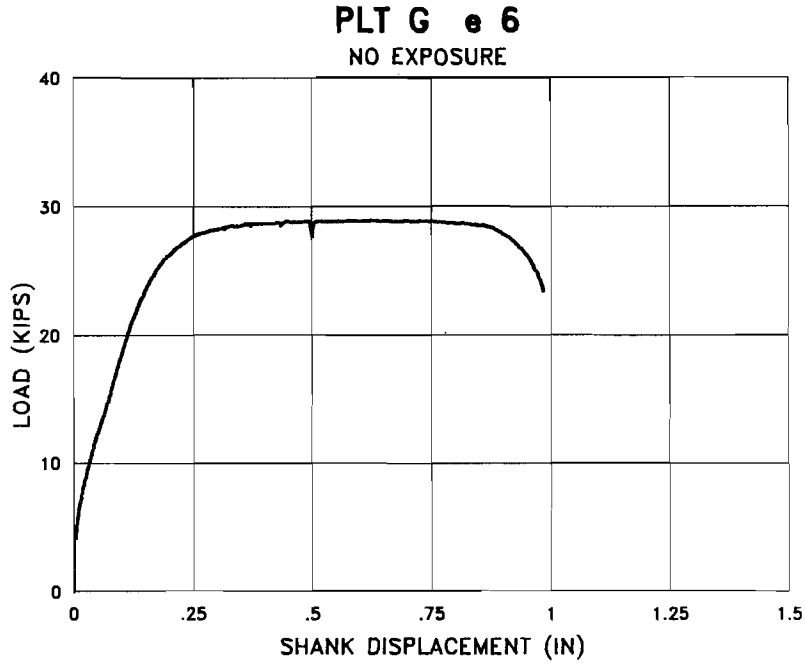
Figure 7.6a Typical load-deflection plot for PLT G anchors.

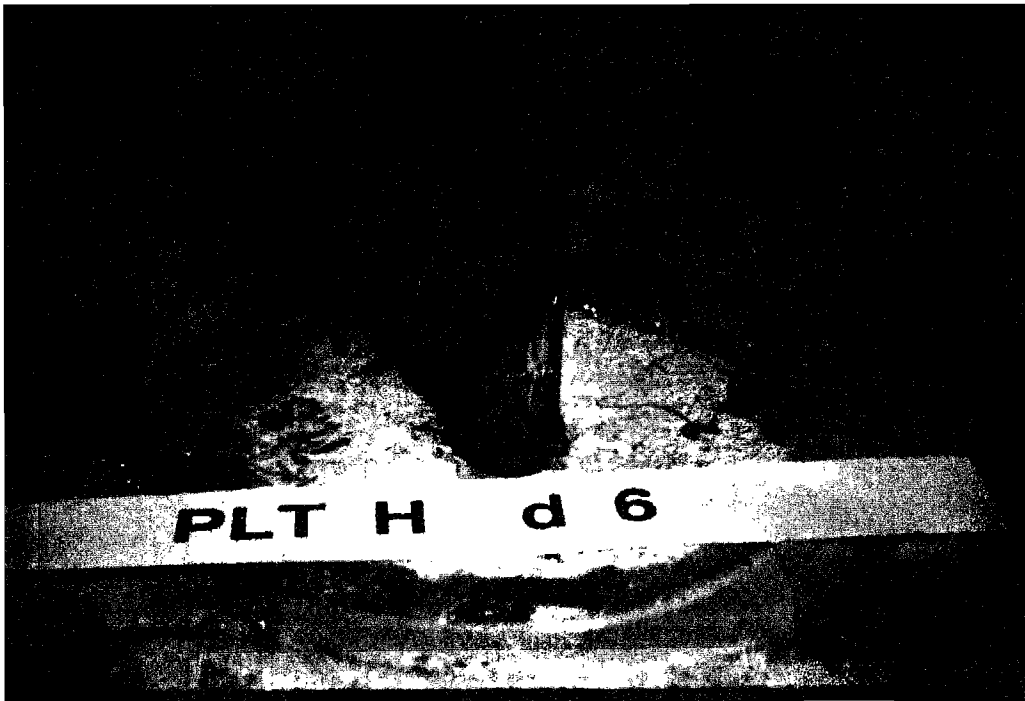
Figure 7.7 Pullout failure of PLT H anchor.

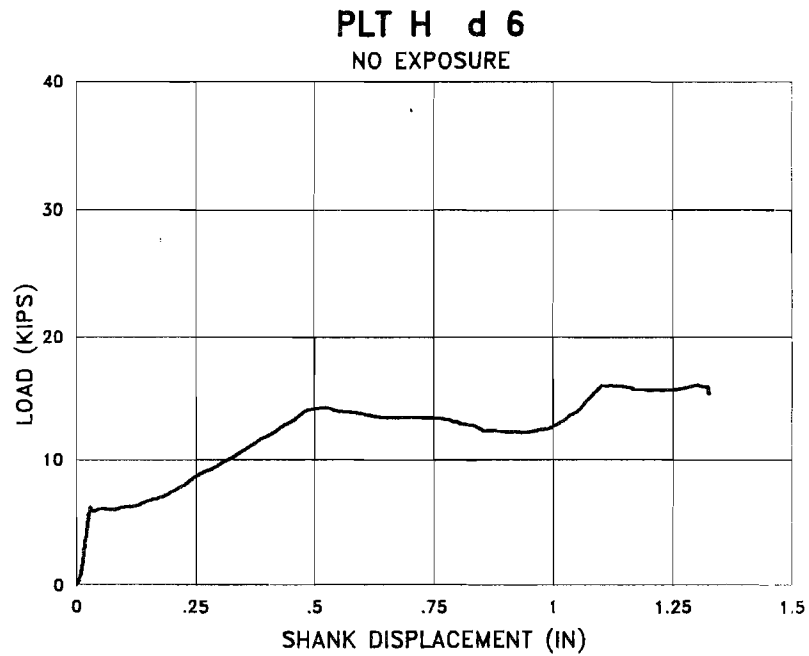
Figure 7.8 Load-deflection plot for pullout of PLT H anchor.

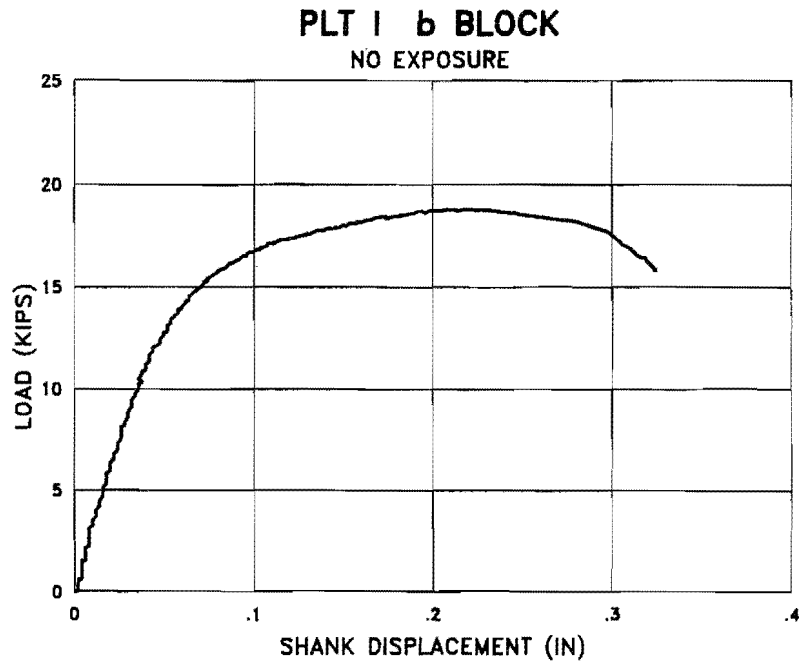
Figure 7.10a Typical load-deflection plot for PLT I anchors.

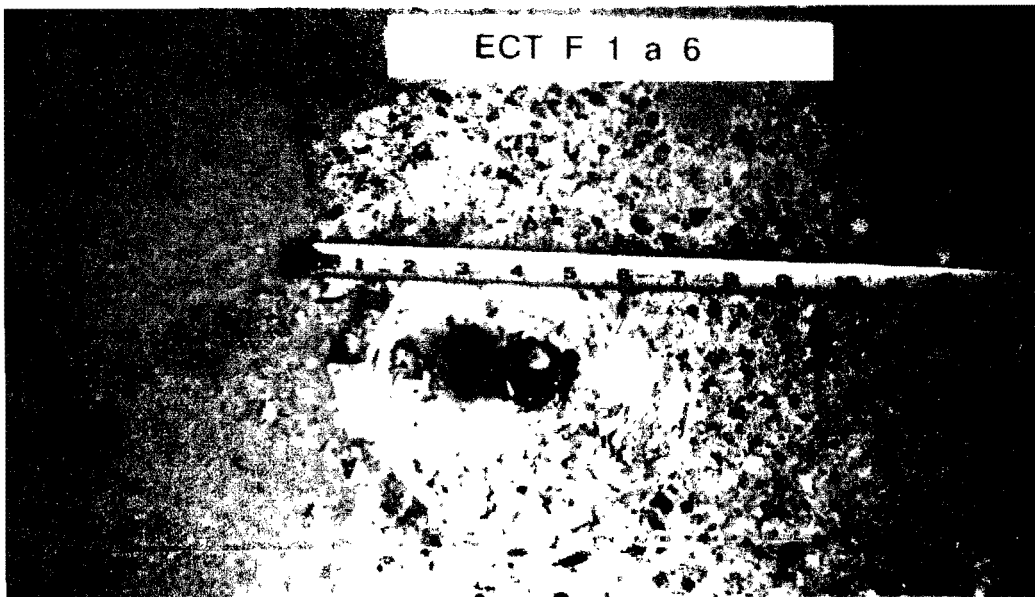
Figure 7.12 Cone failure of adhesive anchor subjected to ultraviolet light exposure.

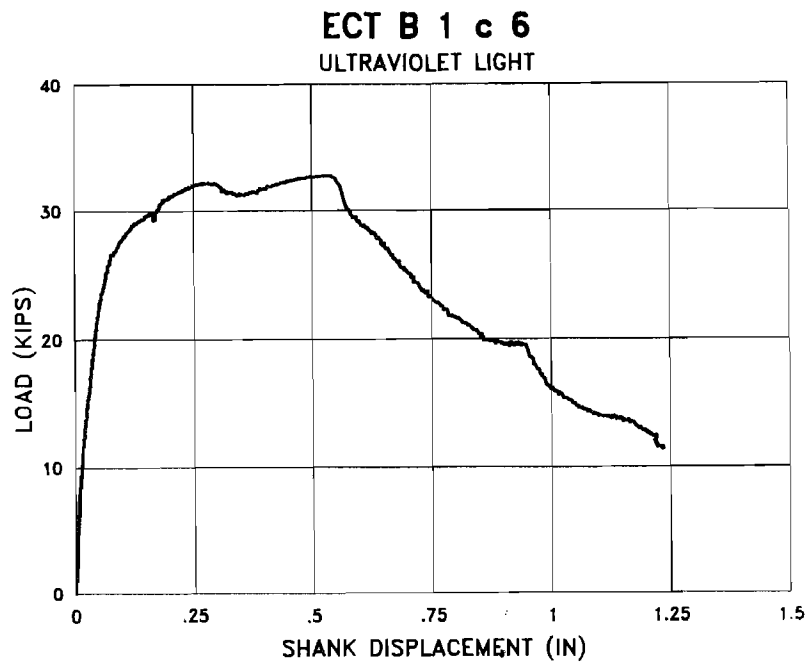
Figure 7.13 Load-deflection plot of cone failure for adhesive anchor subjected to ultraviolet light.

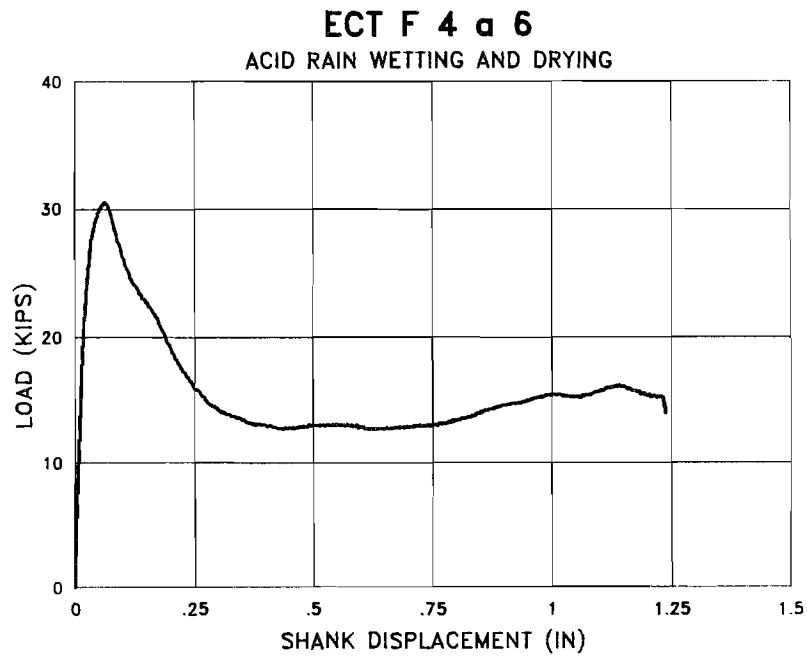
Figure 7.16 Load-deflection plot of cone failure for adhesive anchor subjected to acid rain wetting and drying.

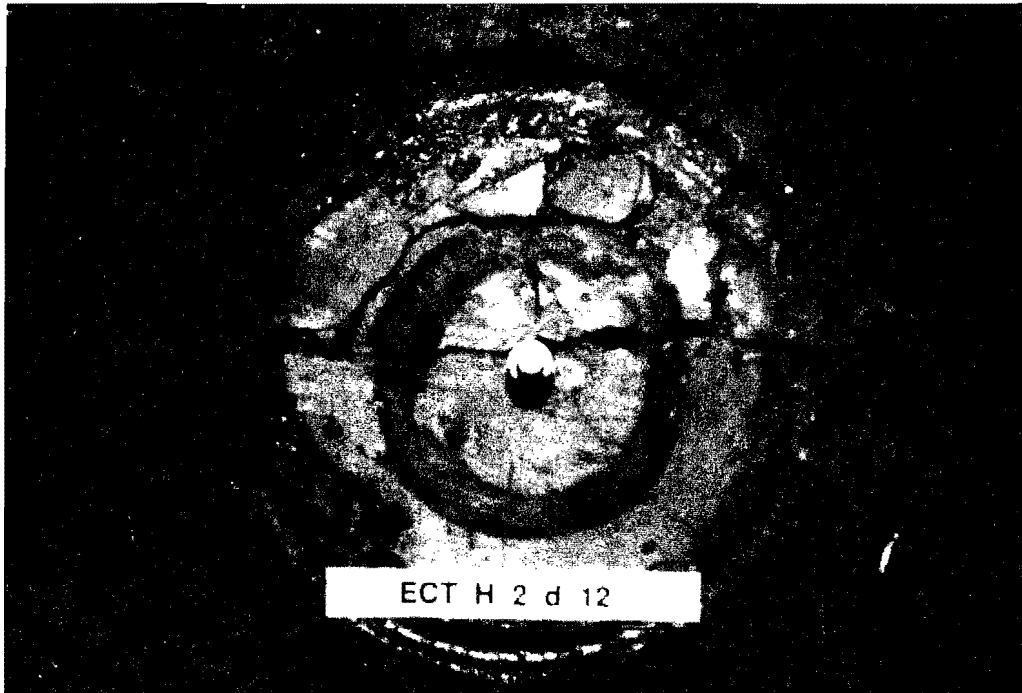
Figure 7.18 Cone failure of ECT H specimen subjected to freezing and thawing (concrete uncracked before testing)

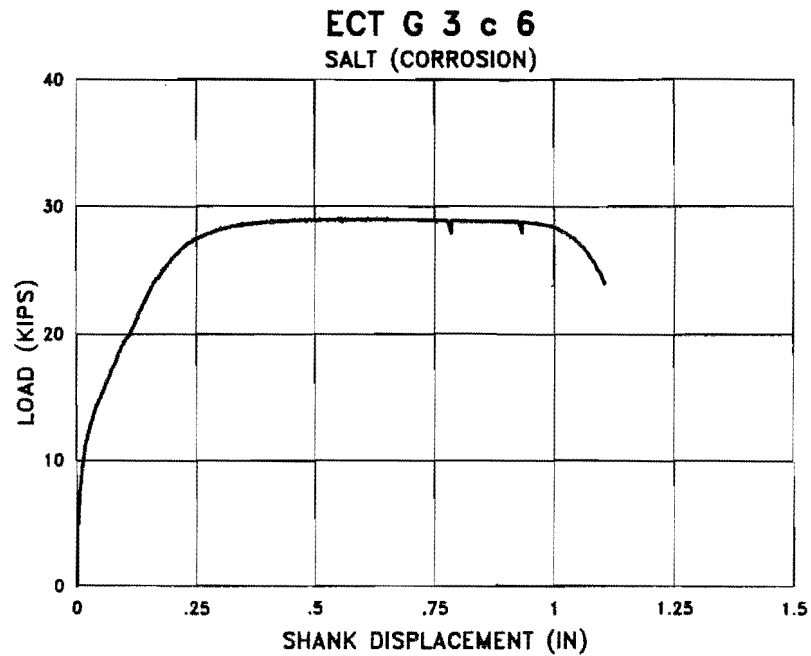
Figure 7.20a Typical load-deflection plot for designation G anchors subjected to salt (corrosion) exposure.

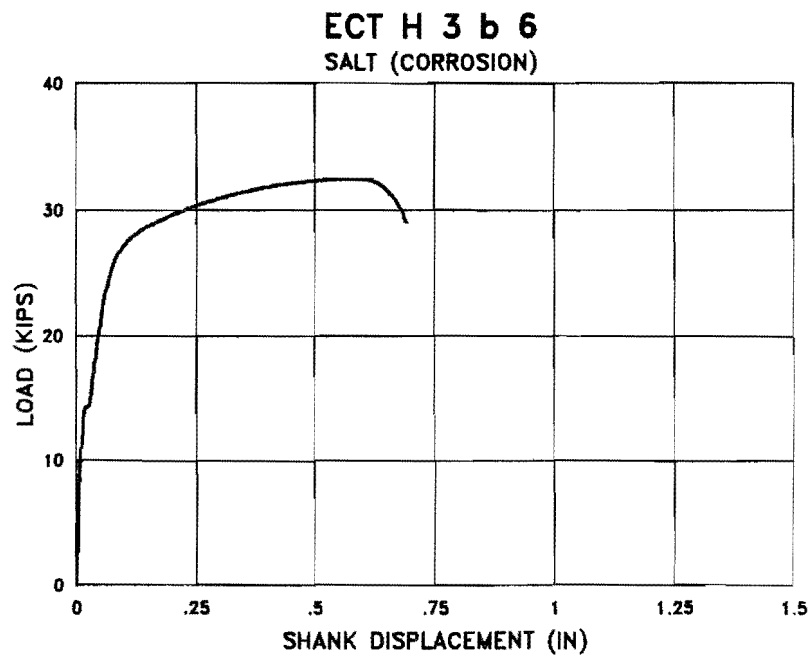
Figure 7.20b Typical load-deflection plot for Designation H anchors subjected to salt (corrosion) exposure.

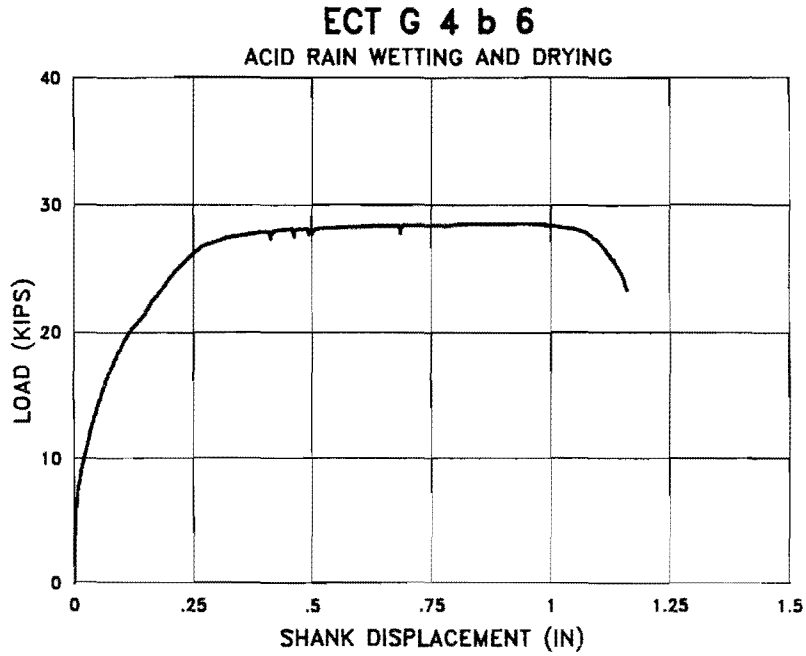
Figure 7.21a Typical load-deflection plot for Designation G anchors subjected to acid rain wetting and drying.

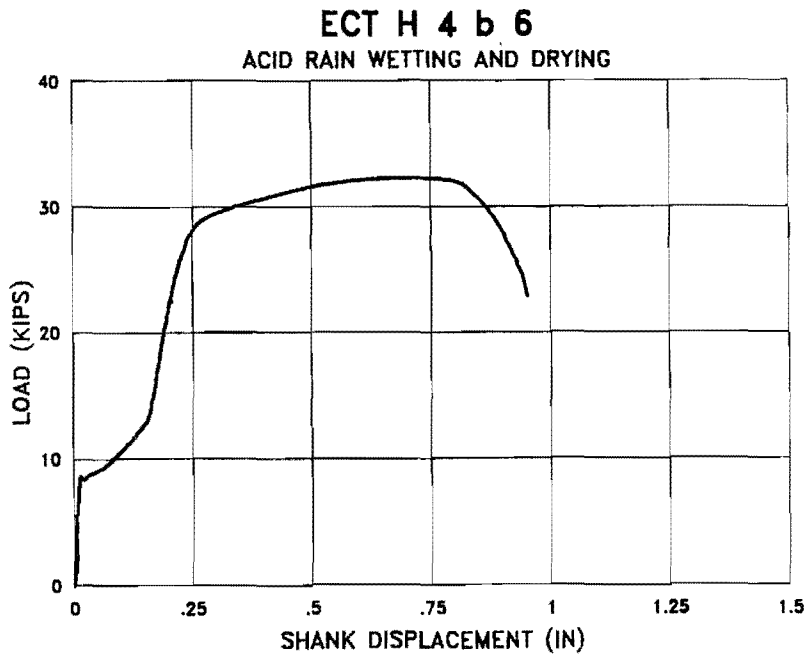
Figure 7.21b Typical load-deflection plot for Designation H anchors subjected to acid rain wetting and drying.

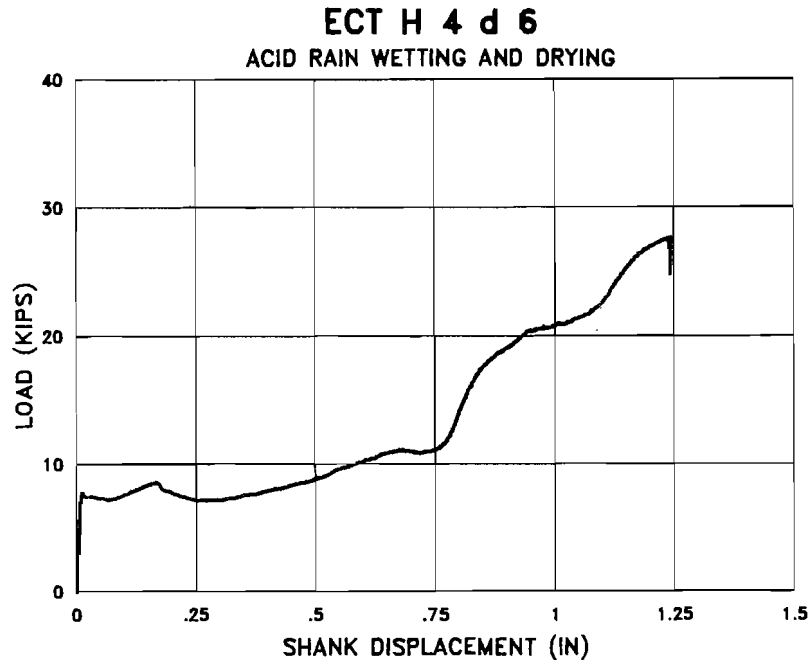
Figure 7.22 Load-deflection plots of pullout failure for Designation H anchors subjected to acid rain wetting and drying.

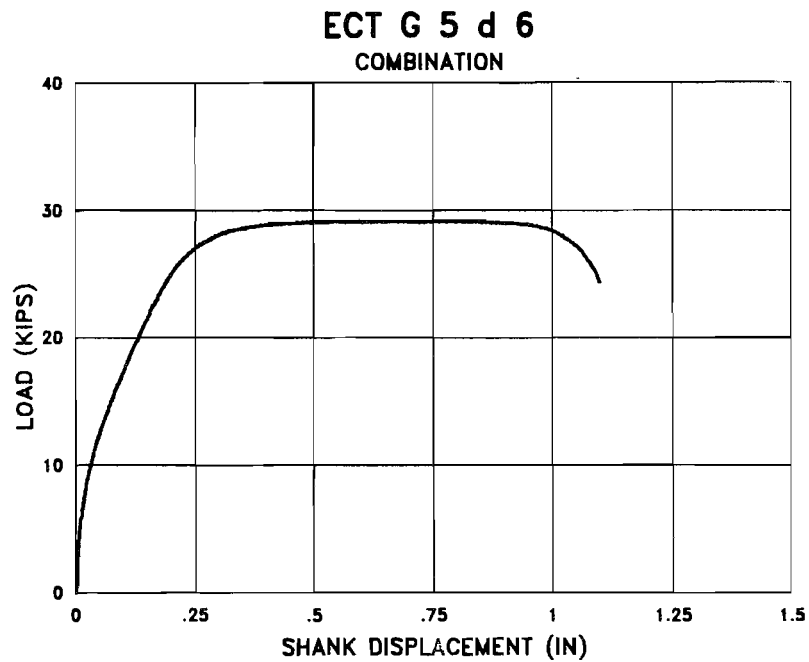
Figure 7.23a Typical load-deflection plot for Designation G anchors subjected to combination exposure.

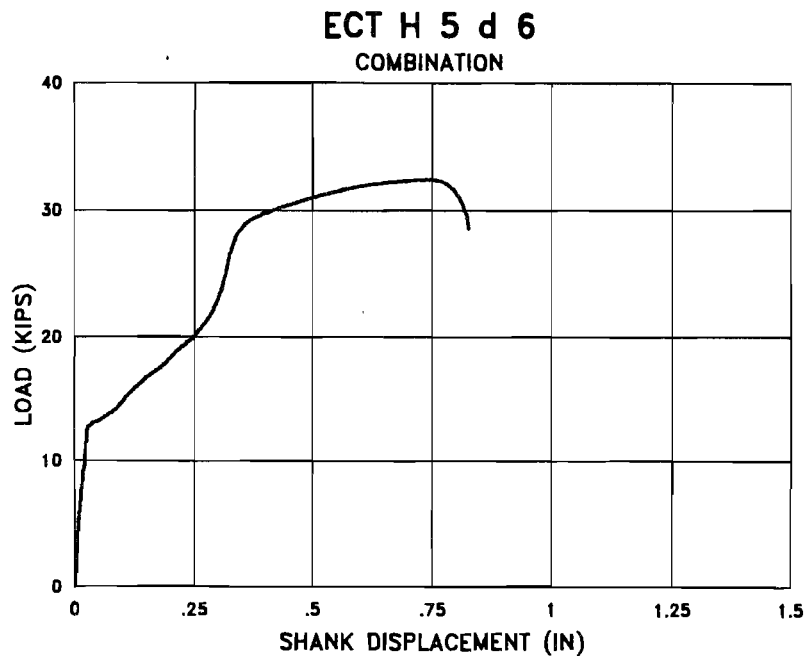
Figure 7.23b Typical load-deflection plot for Designation H anchors subjected to combination exposure.

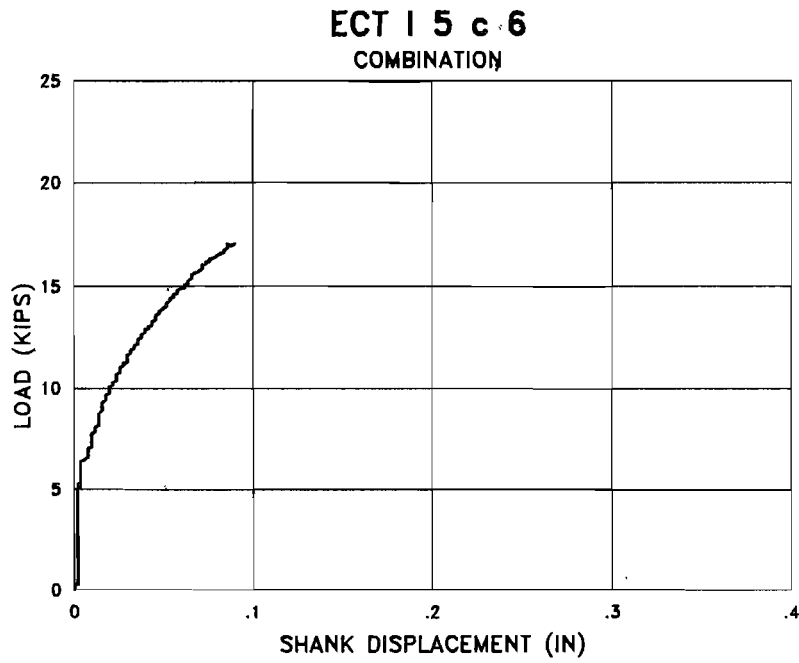
Figure 7.26 Load-deflection plot for Designation I anchor which failed by stripped lower threads.

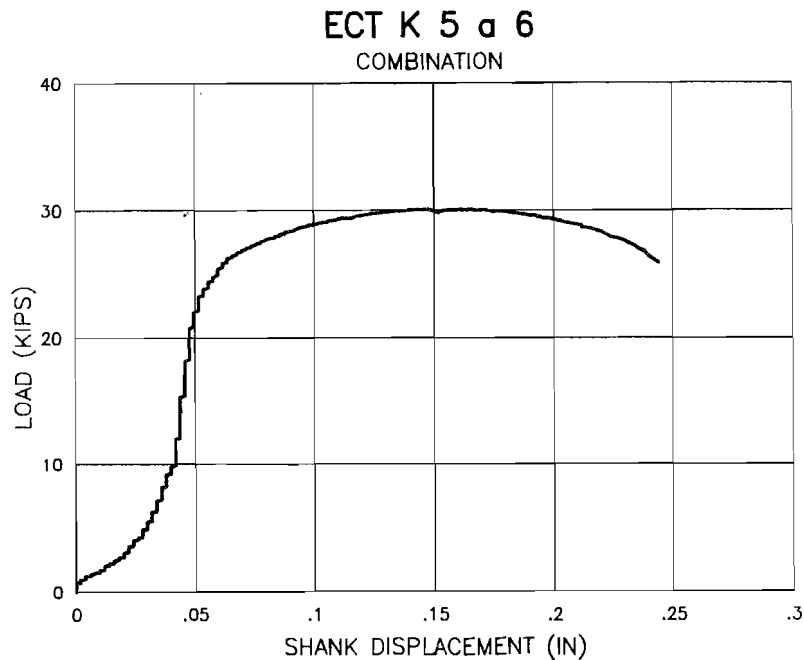
Figure 7.28 Typical load-deflection plot for designation K anchors subjected to combination exposure.

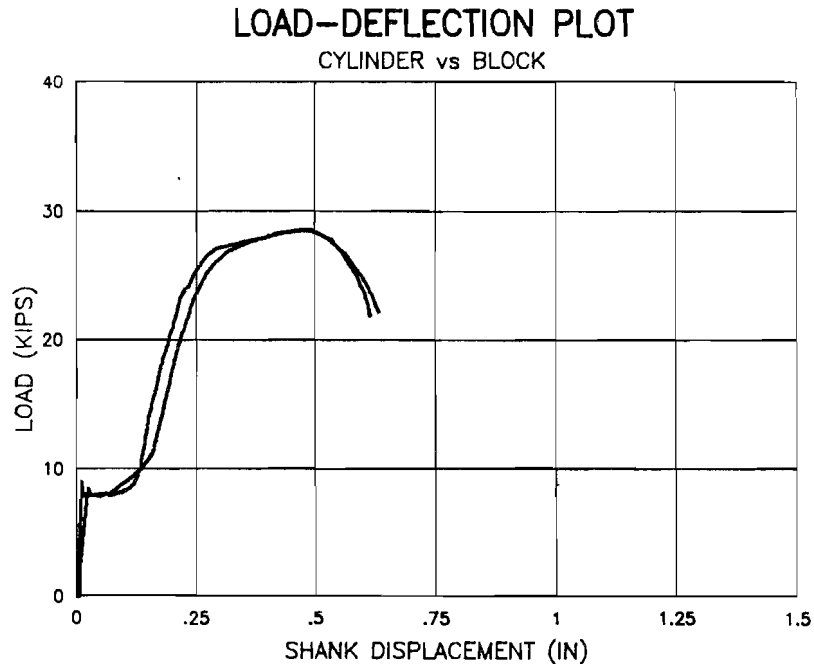
Figure 9.1 Comparison load-deflection plot of expansion anchors installed in blocks and in cylinders.

stiffness, failure mode, maximum load, maximum displacement, secant stiffness to 90% of maximum load, and load-deflection characteristics (Fig 9.1).

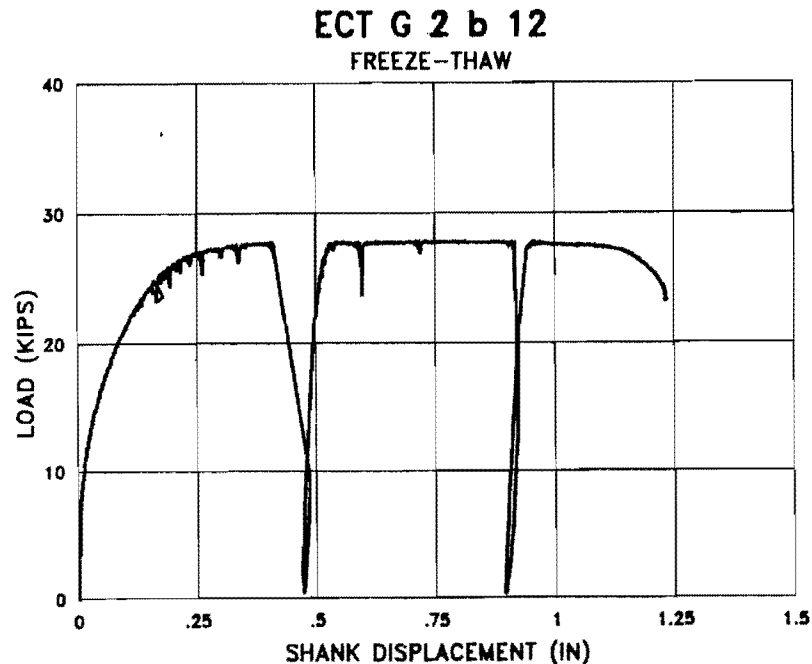
Figure 9.2 Load-deflection characteristics for exposed anchor demonstrating more slip than unexposed anchor.

Two differences exist between the behavior of exposed and unexposed ECT H anchors:

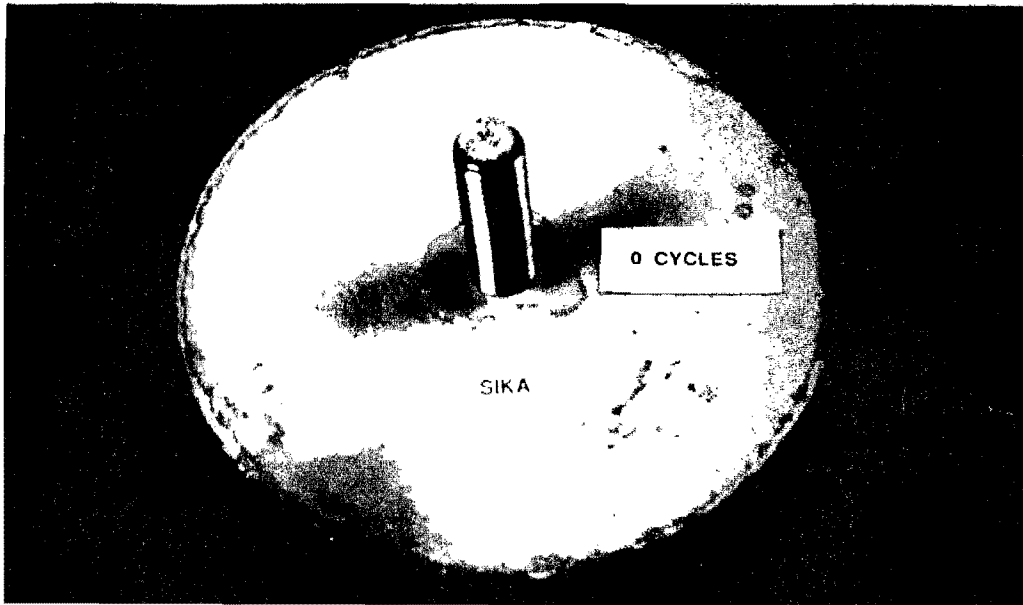
Figure A.7 Typical condition of adhesive anchor before ultraviolet light exposure.

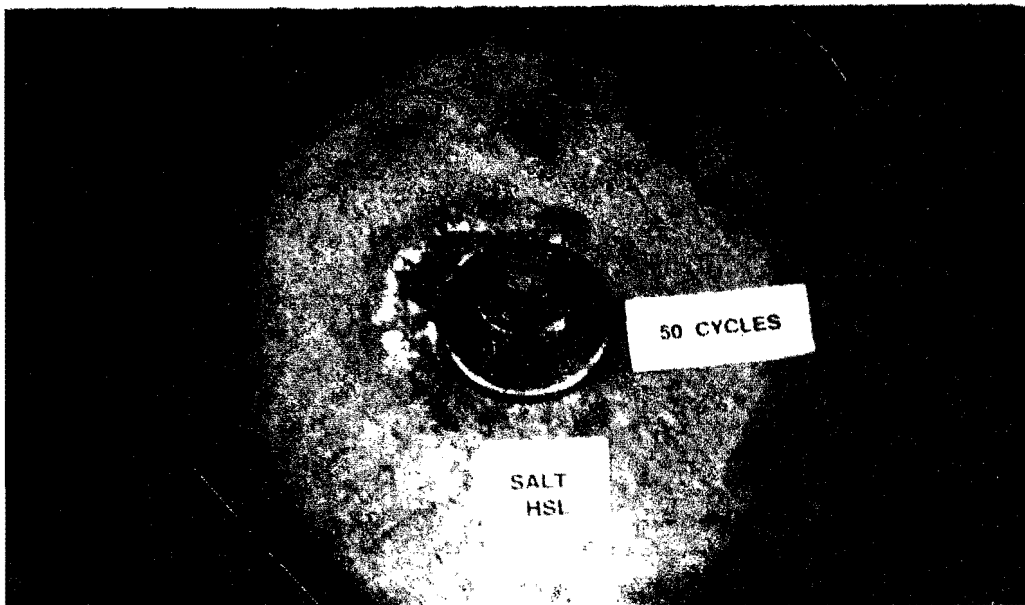
Figure A.14a Condition of Designation G anchors after 50 cycles of salt (corrosion exposure).

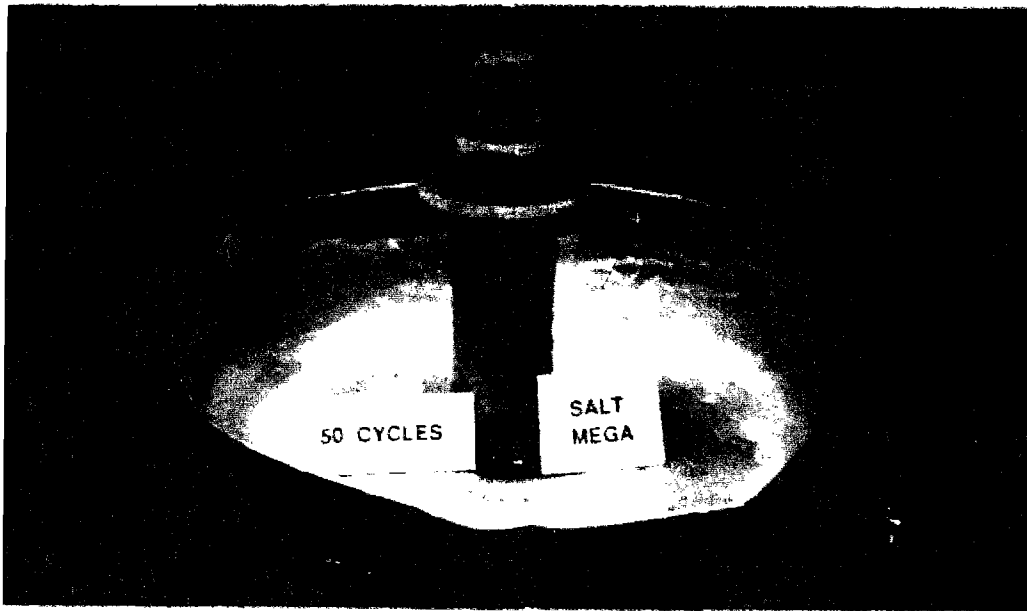
Figure A.15a Condition of Designation H anchors after 50 cycles of salt (corrosion) exposure.

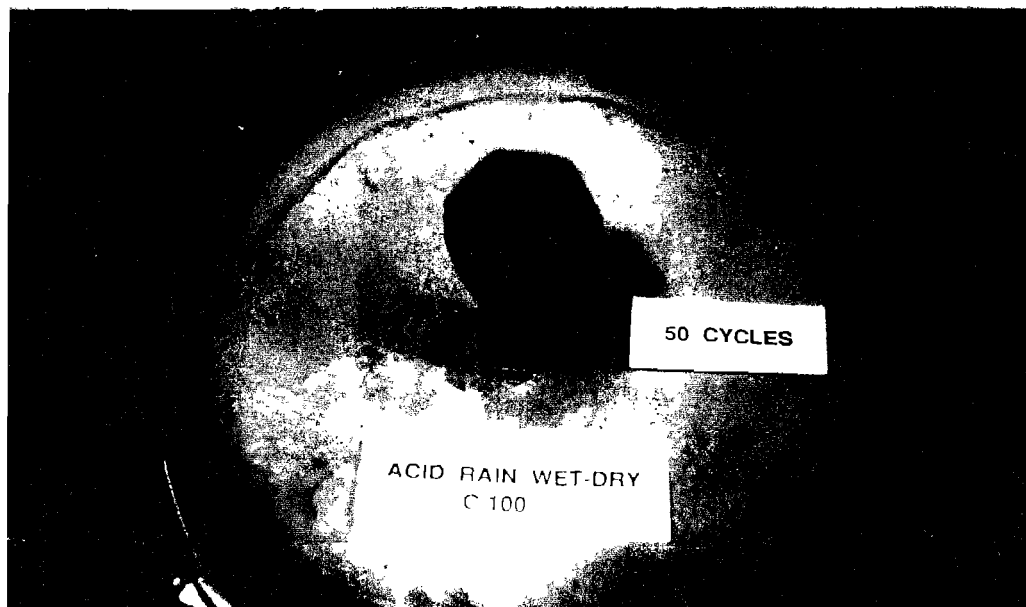
Figure A.17a Condition of Designation B anchors after 50 cycles of acid rain wetting and drying.

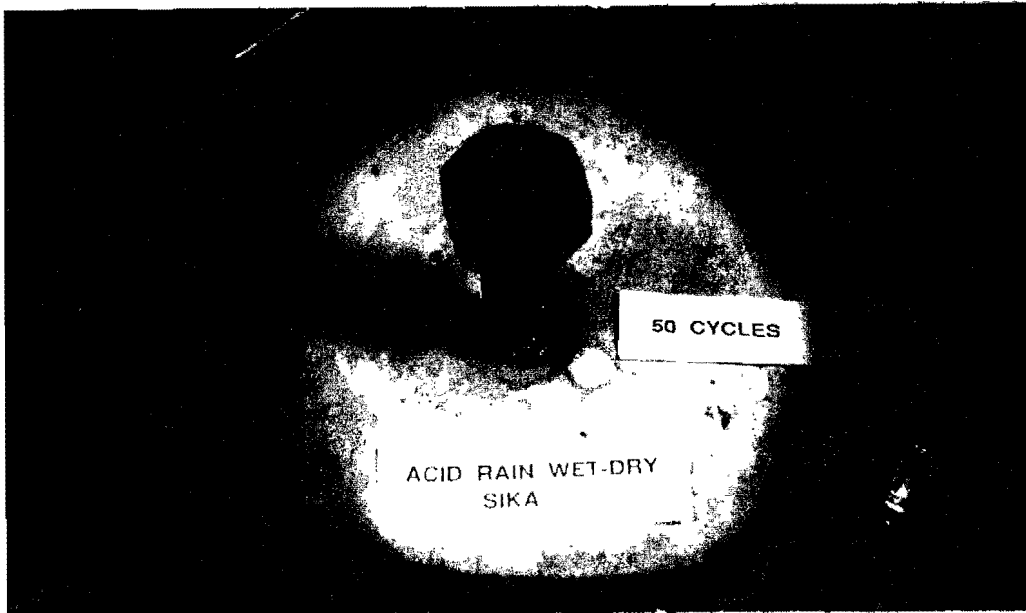
Figure A.18a Condition of Designation C anchors after 50 cycles of acid rain wetting and drying.

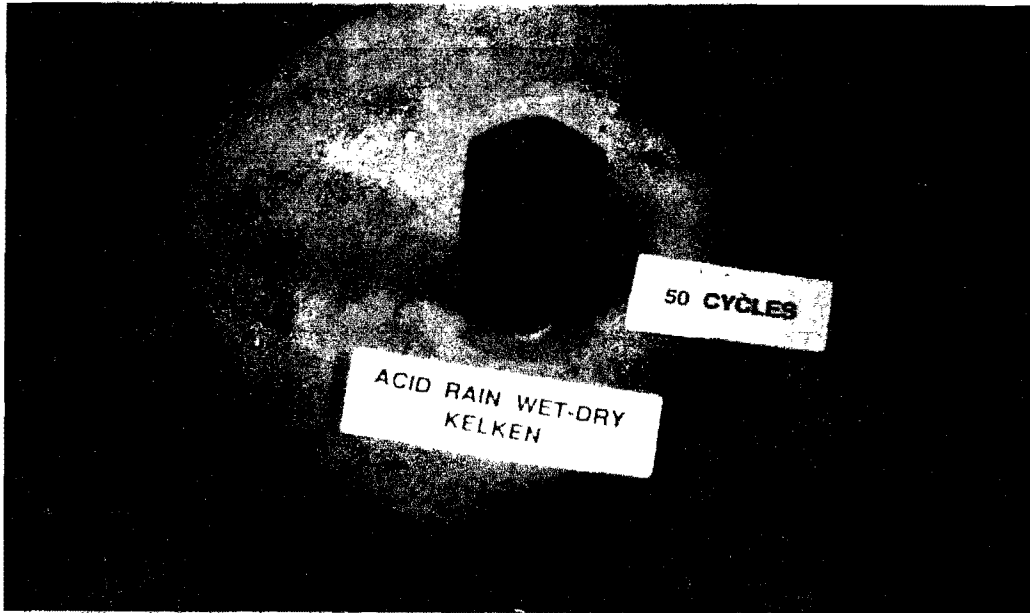
Figure A.19a Condition of Designation D anchors after 50 cycles of acid rain wetting and drying.

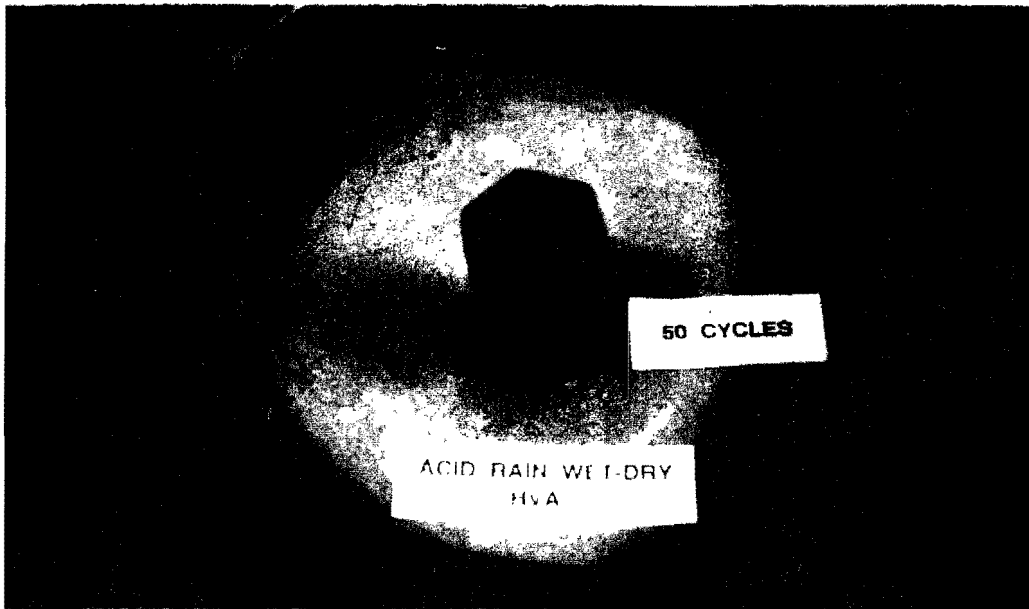
Figure A.20a Condition of Designation E anchors after 50 cycles of acid rain wetting and drying.

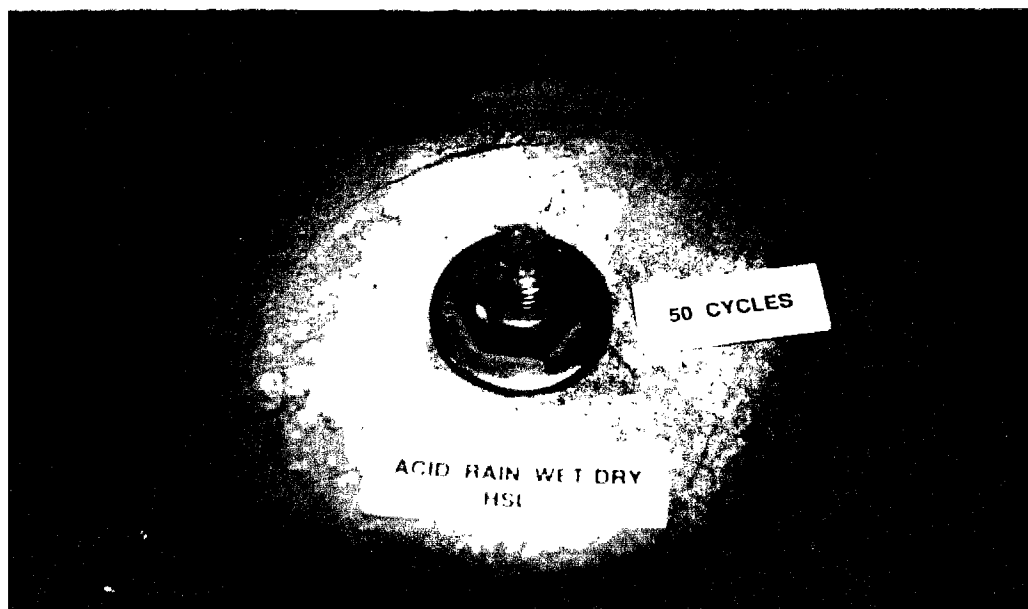
Figure A.22a Condition of Designation G anchors after 50 cycles of acid rain wetting and drying.

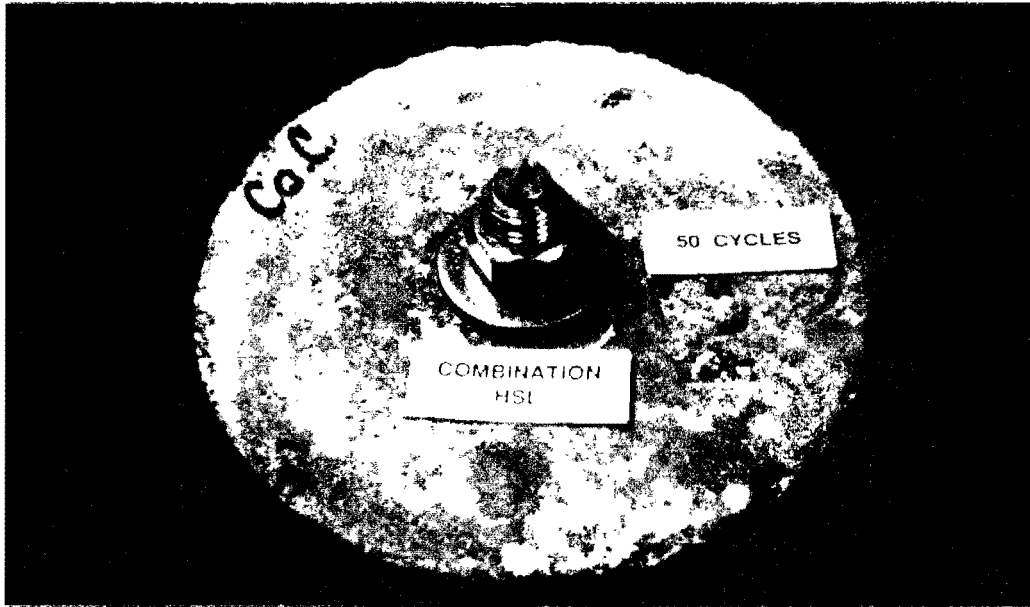
Figure A.24a Condition of Designation G anchors after 50 cycles of combination exposure.
