1. Report No. FHWA/TX-92+1208-1F		2. Government Accession No.		3. Recipient's Catalog No.	
4. Title and Subtitle EFFECT OF ENVIRONMENTAL CYCLING ON THE STRENGTH OF SHORT RETROFIT ANCHOR BOLTS			5. Report Date July 1991

**EFFECT OF ENVIRONMENTAL CYCLING ON THE STRENGTH
OF SHORT RETROFIT ANCHOR BOLTS**

Research Report No. 1208-1F

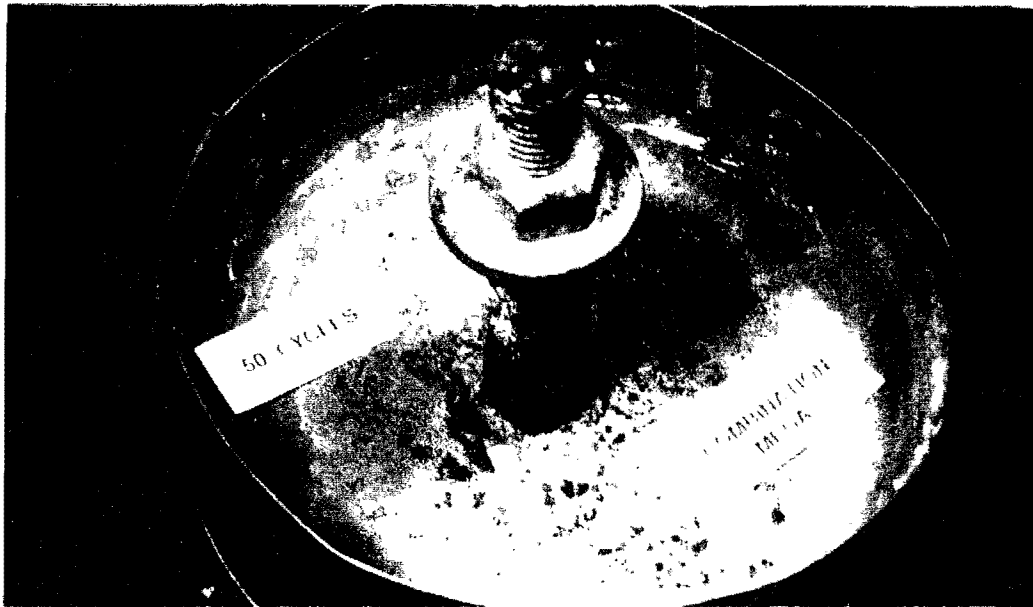
Figure A.25a Condition of Designation H anchors after 50 cycles of combination exposure.

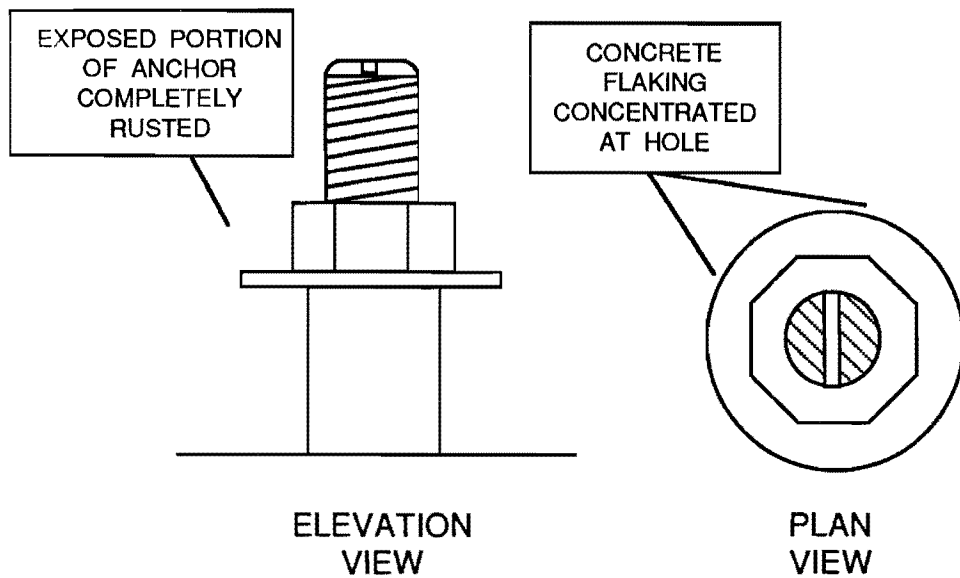
Figure A.25a Schematic of condition of Designation H anchors after 50 cycles of combination exposure.

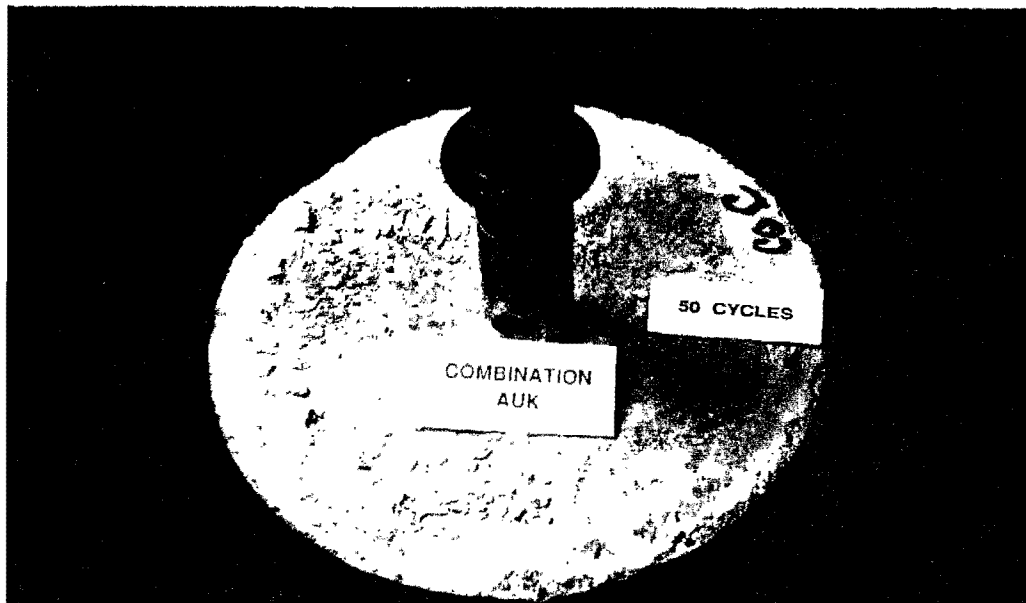
Figure A.26a Condition of Designation I anchors after 50 cycles of combination exposure.

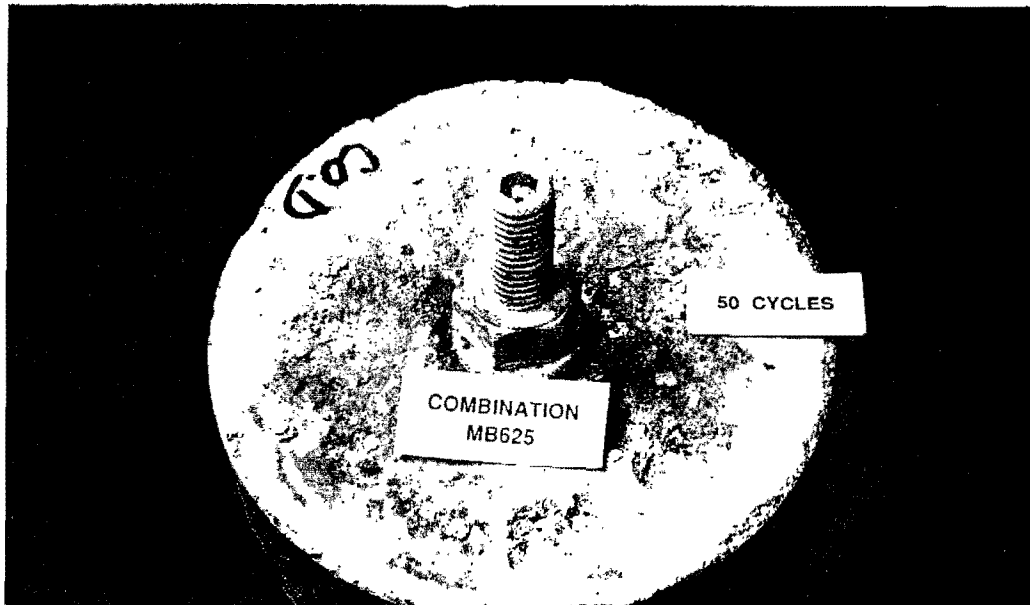
Figure A.27a Condition of Designation J anchors after 50 cycles of combination exposure.
