**ELASTOMERIC BEARINGS:
BACKGROUND INFORMATION AND FIELD STUDY**

Research Report No. 1304-1

**Research Project 3-5-92/4-1304
“ELASTOMERIC BEARINGS”**

Texas Department of Transportation

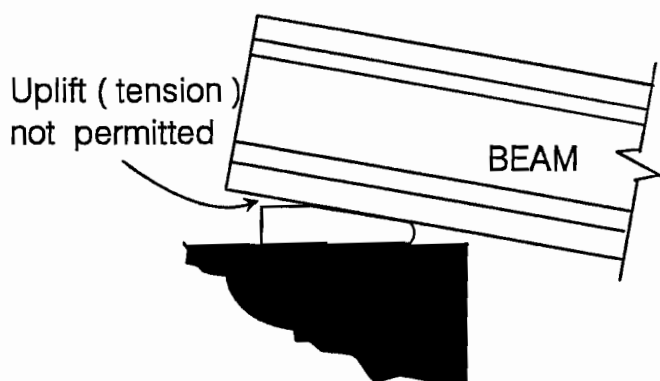
Figure 1.1 Current AASHTO rotation provision

- 2: Maximum permissible transverse and longitudinal end rotation are limited by the compressive strain in the bearing
- 3: Alternate design procedures may be used

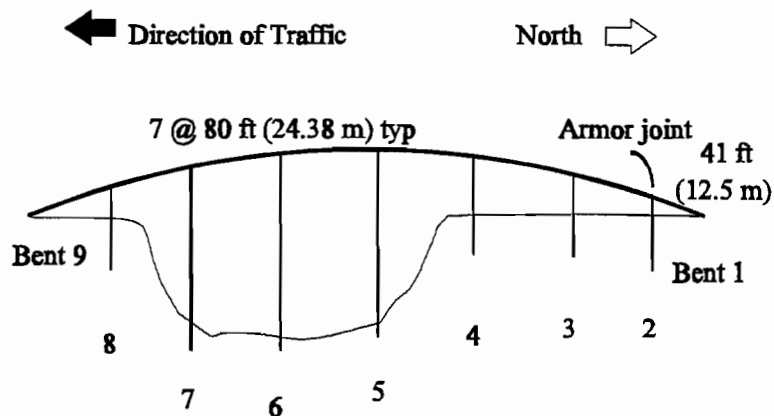
Figure 4.3 Profile of Paris Bridge

Inspection photographs taken in 1989, 1990 and 1991 showed bearing movement, which could have started before then, and which was worst near Bent 2. Bearings at Bent 2 moved 4 to 6 inches (101 to 152 mm), and are beginning to come out. On the north side of Bent 3, one bearing came out, and the bent cap is spalled where the girder is resting on it. Where dowels are used to hold the exterior girders in place, several bearings are torn in half. However, torn bearings are also visible at interior girders, which do not normally have dowels. Possibly the tearing is also caused by digging of the end of the girder into the bearing.

4.6.3 Pertinent Information on Paris Bridge. In this project this bridge is the first one studied with slipping neoprene bearings. Although the bearings were under-designed by current standards for the amount of movement they must accommodate, it is clear that slip is possible in some circumstances with neoprene bearings as well as natural rubber ones. At several bents, bearings on the two girders slipped towards each other, so that their free ends are curved upwards into the space between the girders. This clearly shows that the bearings on each side of the bent have moved in opposite directions. Again, it is possible that this is due to the ends of the cambered girders digging into the bearings.

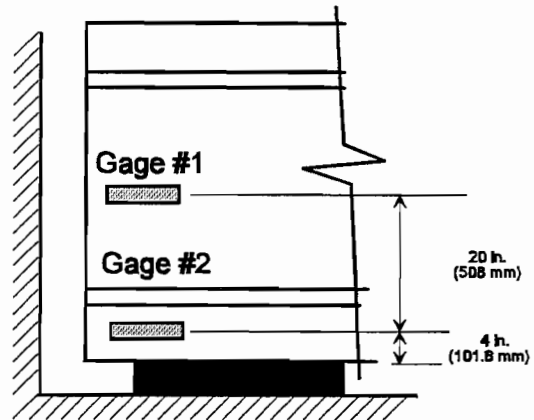
Figure 5.9 Position of thermal displacement gages

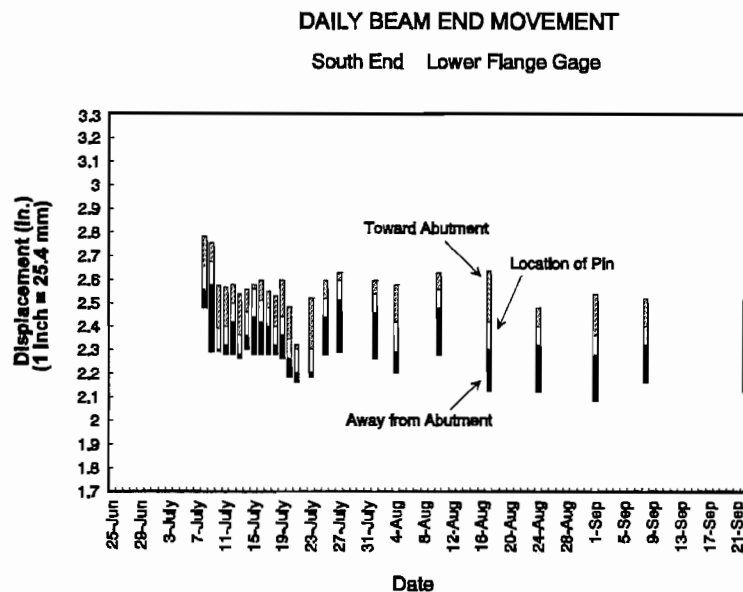
Figure 5.10 Girder movement at Slaughter Creek

Figure 5.10 shows girder movement of the lower flange of Girder 1 at the south end (Y axis) as a function of time (X axis). The figure shows the maximum displacement recorded by the thermal displacement gage between June 25, 1992 and September 21, 1992. The vertical axis in Figure 5.10 is the displacement reading. For example, between August 10, 1992 and August 17, 1992 the girder contracted approximately 0.25 inches (6.35 mm) and expanded 0.25 inches (6.35 mm). This is shown on the graph as movement away from the abutment and movement toward the abutment, respectively. The gage was then reset to the pin position, as shown by the middle portion of the bar on the graph. Also, the figure

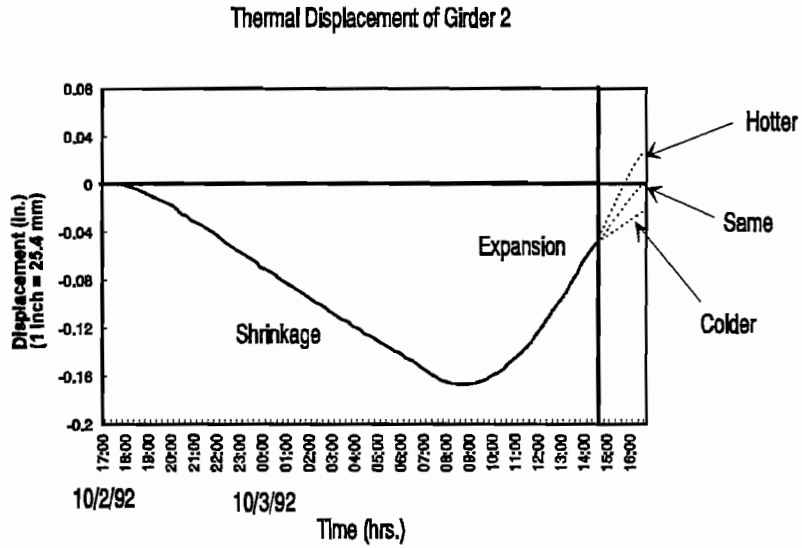
Figure 5.11 Daily temperature movement at Slaughter Creek

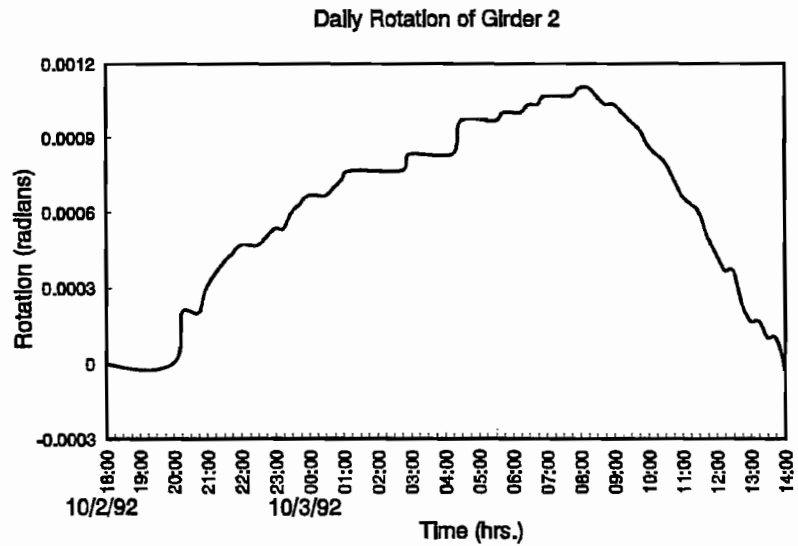
Figure 5.12 Daily rotation at Slaughter Creek

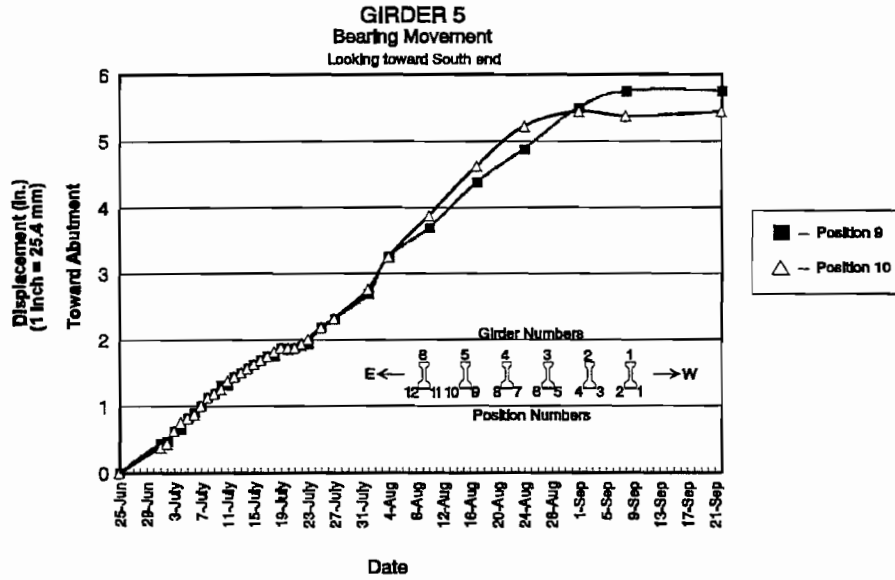
Figure 5.14 Unlimited bearing movement at Slaughter Creek

- After the various resetting and replacement operations the bearing movement measured at Slaughter Creek was inconsistent and not reproducible. Movement was found to be zero at one time and then unlimited at another time, with no apparent change in loading conditions. However, when it did occur, bearing movement was immediate.

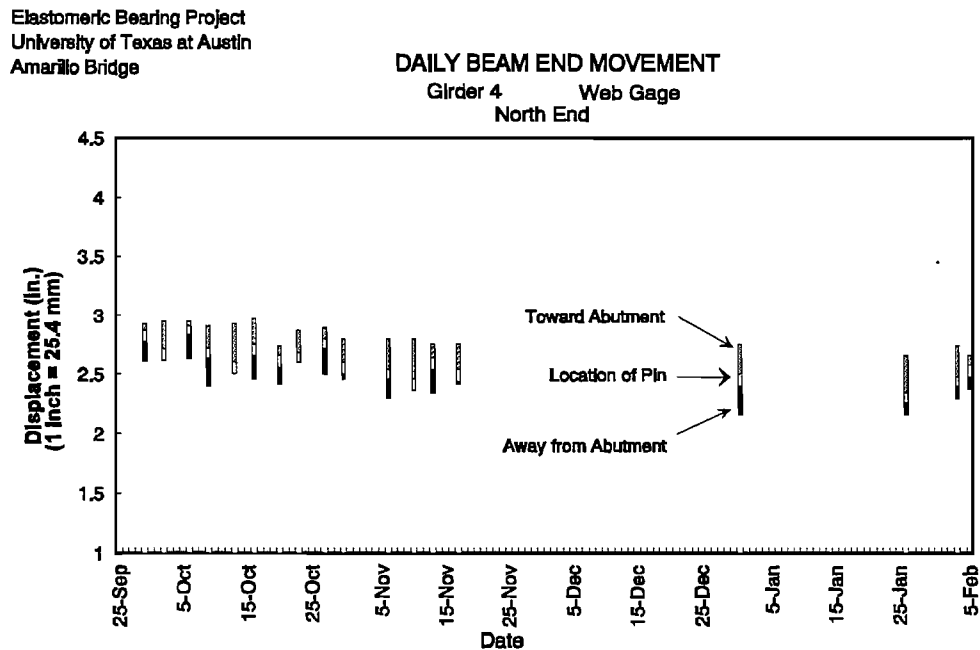
Figure 5.16 Typical girder movement at Alanreed

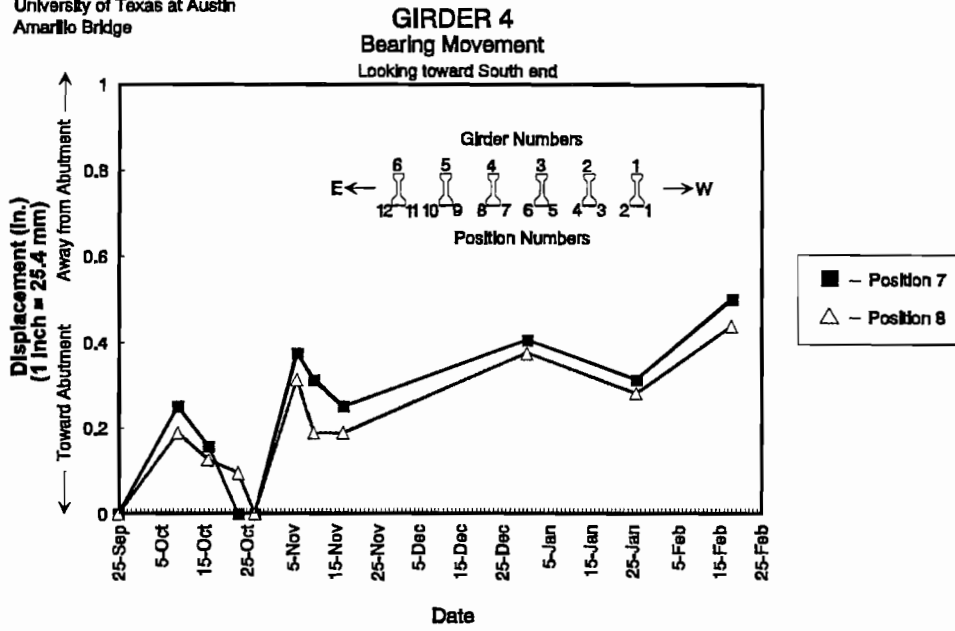
Figure 5.17 Typical bearing movement at Alanreed

Bearing movement at Alanreed occurred only on the Northeast side of the bridge. Typical bearing movement is shown in Figure 5.17; bearing movement for Girders 4, 5, and 6 (Figure 4.4) can be found in Appendix B. The bearings appear to be "walking" in both directions, toward and away from the abutment. This type of behavior was not observed at Slaughter Creek. As mentioned in the preliminary study, the Alanreed girders do not sit squarely on the bearings (Figure 4.5); this implies that lack of uniform contact between the bearing and the girder, or possibly girder rocking, may have a significant effect on bearing movement. In other words, rocking of the girder causes the bearing to "walk" back and forth. By extrapolation of the data and from past experience, the bearings at the Northeast end will eventually need to be replaced or reset.

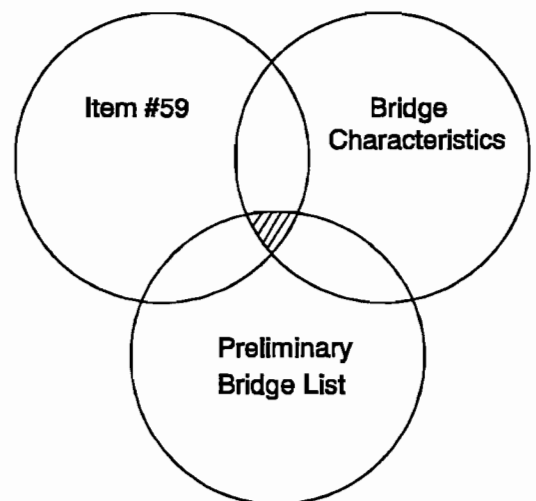
Figure 6.1 Search components
