THE BEHAVIOR OF MULTIPLE LAP SPLICES IN WIDE SECTIONS

Research Report No. 154-1

Research Project No. 3-5-72-154
Factors Affecting Splice Development Length

CENTER FOR HIGHWAY RESEARCH
THE UNIVERSITY OF TEXAS AT AUSTIN

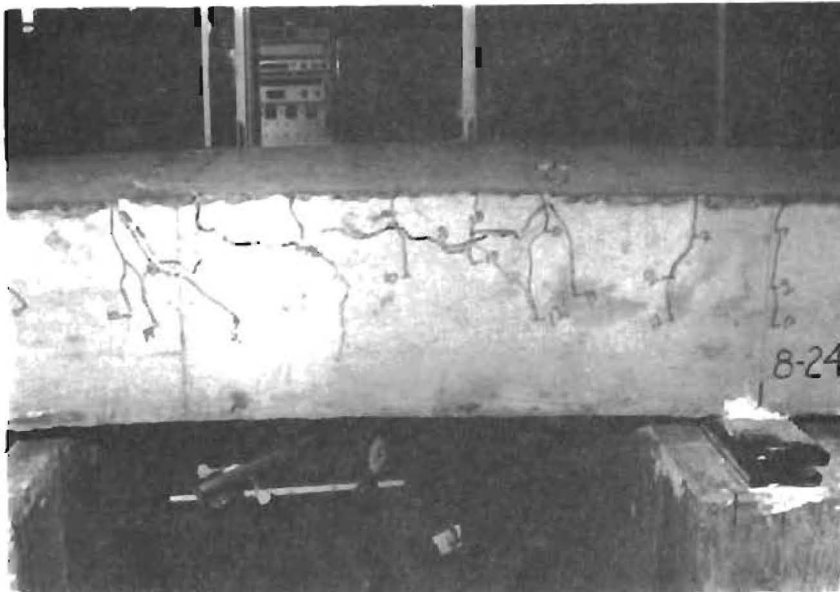
Fig. 3.5. Side view of 8-24-4/2/2-6/6 after failure

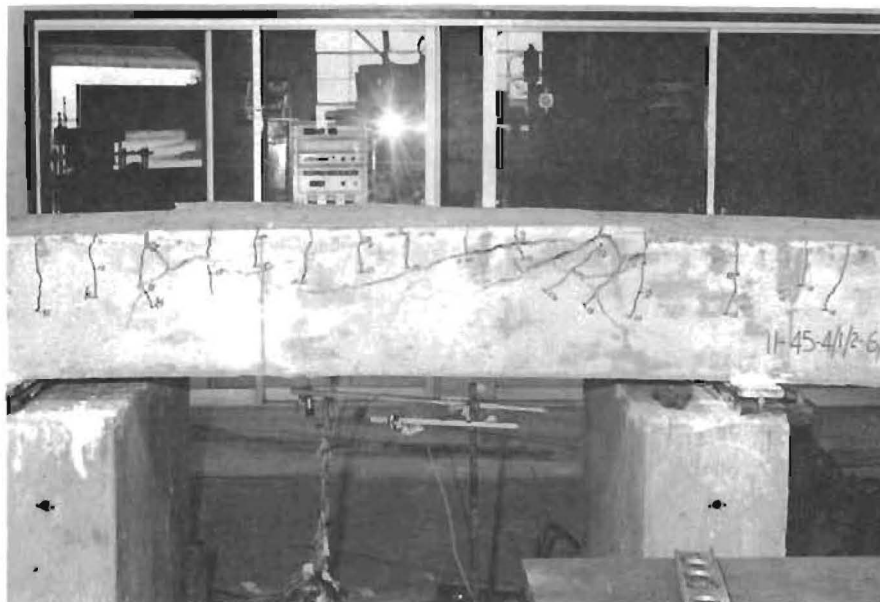
Fig. 3.7. Side view of 11-45-4/1/2-6/6 after failure

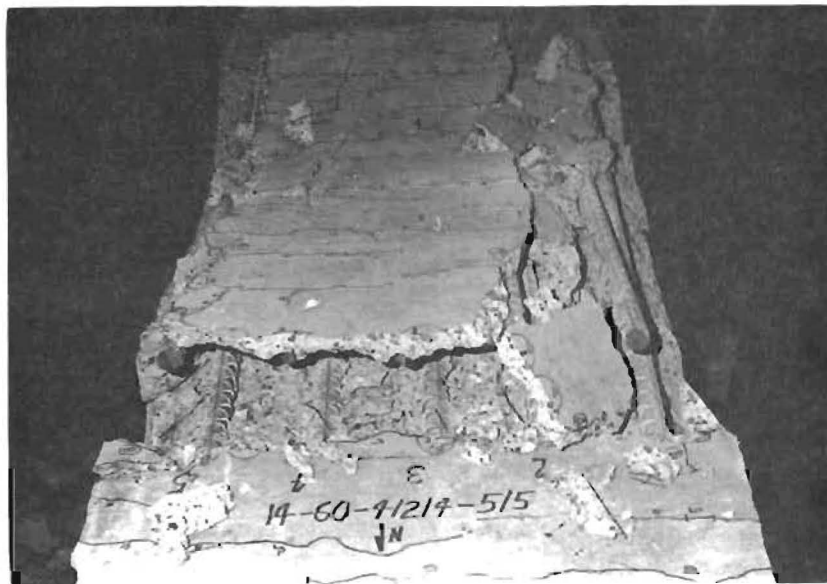
Fig. 3.9. Side View of 14-60-4/2/4-5/5 after failure

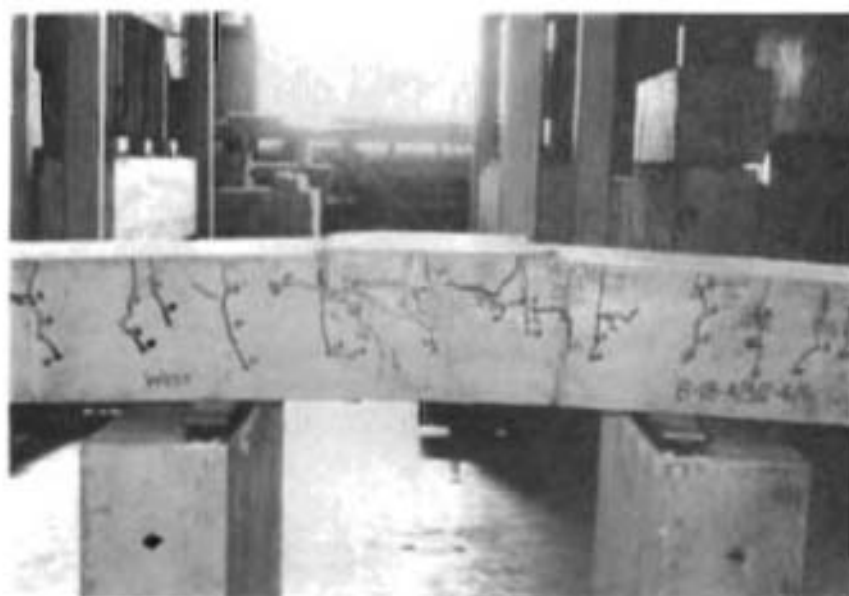
Fig. 3.13. Side view of 8-18-4/3/2-6/6 after failure

of the specimen. The failure surfaces for this specimen are shown in Figs. 3.12 and 3.13.

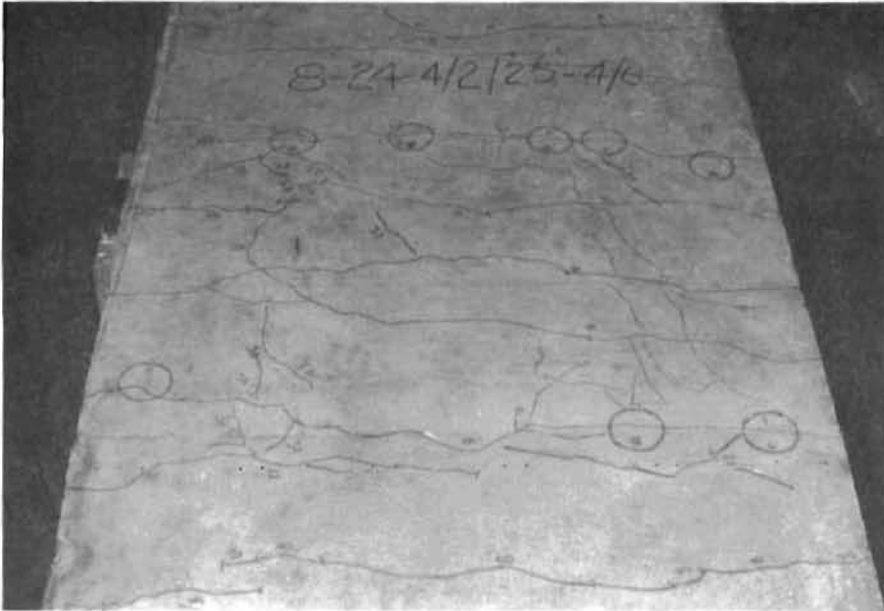
Fig. 3.14. Tension face of 8-24-4/2/2.5-4/6 after failure

Figures 3.14 and 3.15 show typical failure surfaces for a specimen employing continuous edge bars. As expected, the edge splices showed no splitting on the tension or side faces. Some splitting cracks appeared over interior splices, with cracking normally starting on the interior splices next to the continuous edge bars. The splitting appeared to be more uniformly distributed over the interior splices than in other tests with all bars spliced (see Fig. 3.14). In general, side splitting cracks were not a problem in specimens with continuous edge bars (see Fig. 3.15). The failure mode of these specimens would be classified as the confined face split (see Fig. 3.2).

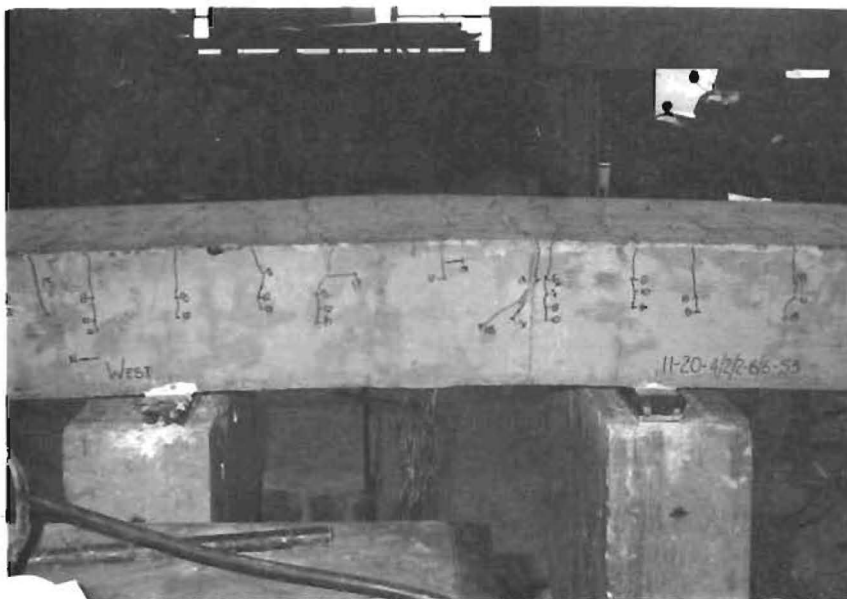
Fig. 3.17. Side view of 11-20-4/2/2-6/6-S3 after failure

3.1.3 Splices with Transverse Reinforcement. Seven specimens contained transverse reinforcement, six with U-stirrups and one with spiral reinforcement. Several of these specimens failed by splitting of the concrete. The condition of a typical specimen at failure is shown in Figs. 3.16 and 3.17.

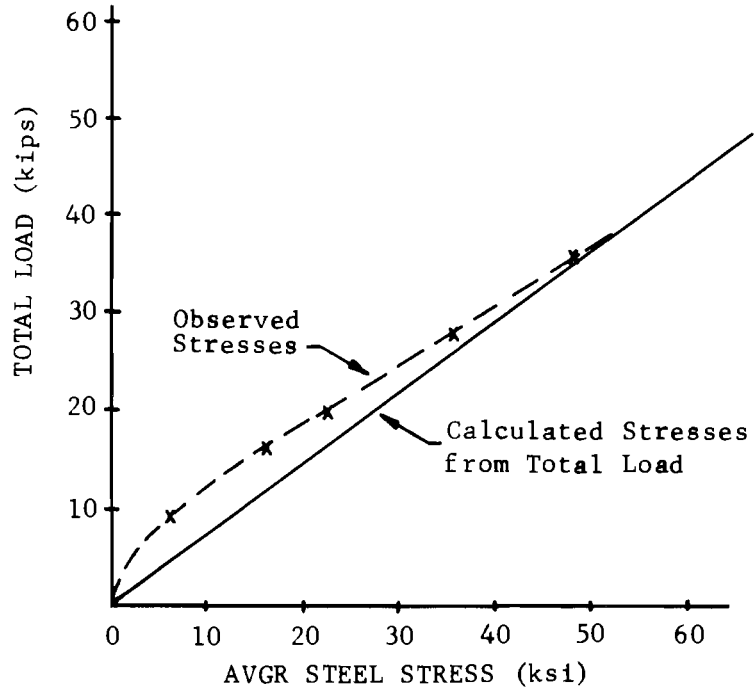
Fig. 3.18. Load versus steel stress for 8-36-4/1/4-6/6

Typical plots of the load versus average bar stress are shown in Figs. 3.18 and 3.19. The load includes the dead weight of the specimen and the loading frame. Using a cracked transformed section, the bar stress calculated from total loads is a straight line. On the same figure, the average bar stress obtained from the strain gage readings is plotted for various levels of total loading.

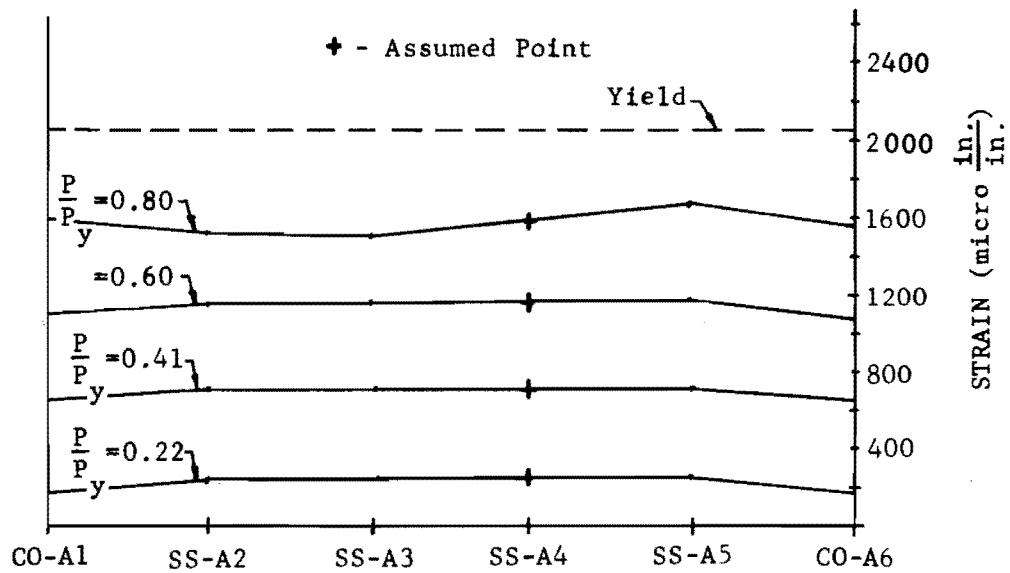
Fig. 3.23. Steel strain distribution across splice end of specimen 8-18-4/3/2.5-4/6 (continuous edge bar)

Figures 3.20 through 3.24 show strain distributions in the longitudinal steel across the end of the splice at various load levels for five different specimens. Steel strains are plotted rather than steel stresses. With yielding, the steel stress remains constant but the strain may change and provide a better indication of the behavior of the splice.

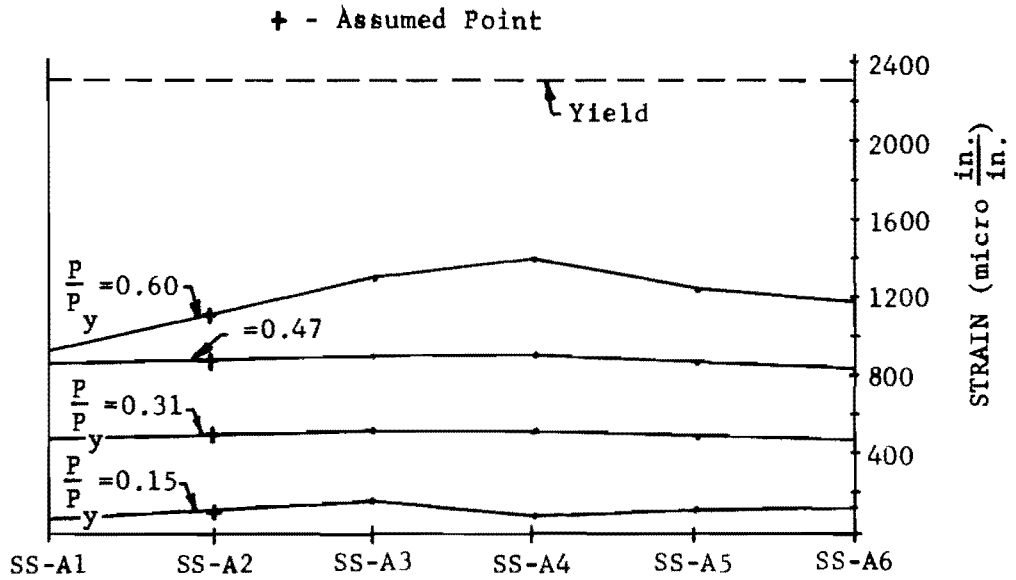
Fig. 3.24. Steel strain distribution across splice end of specimen 11-20-4/2/2-6/6-S5 (stirrup reinforcement present in splice region)

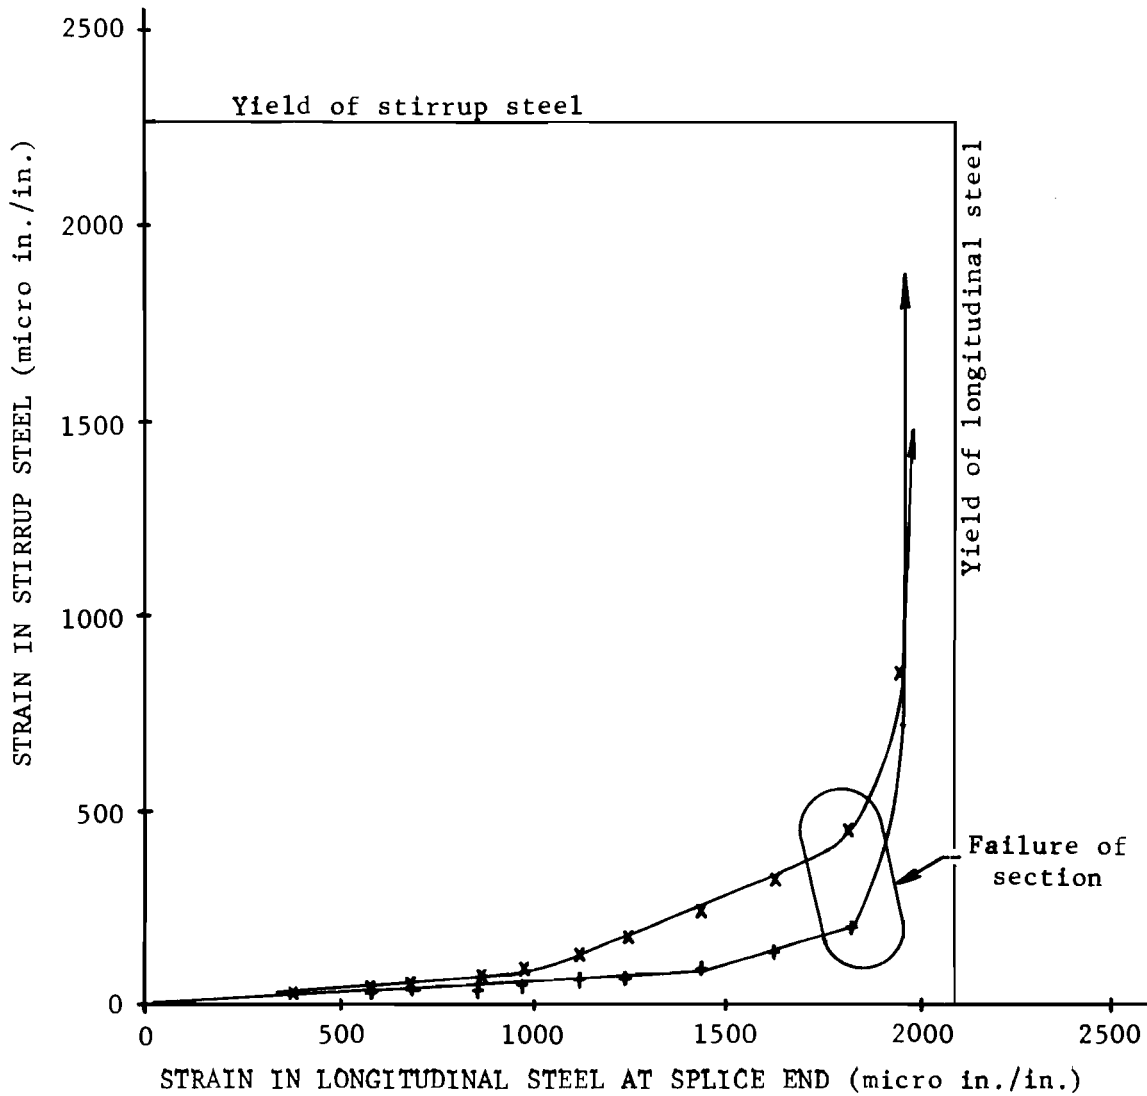
Fig. 3.28. Stirrup steel strain versus longitudinal steel strain for an interior splice (#3) for specimen 11-15-4/2/2-6/6-S5

Figures 3.28 and 3.30 show that when the failure of the specimen occurs the strains in transverse steel surrounding interior splices increased rapidly. Figures 3.29 and 3.31 show that for edge splices the strain in the transverse steel increases greatly prior to failure of the

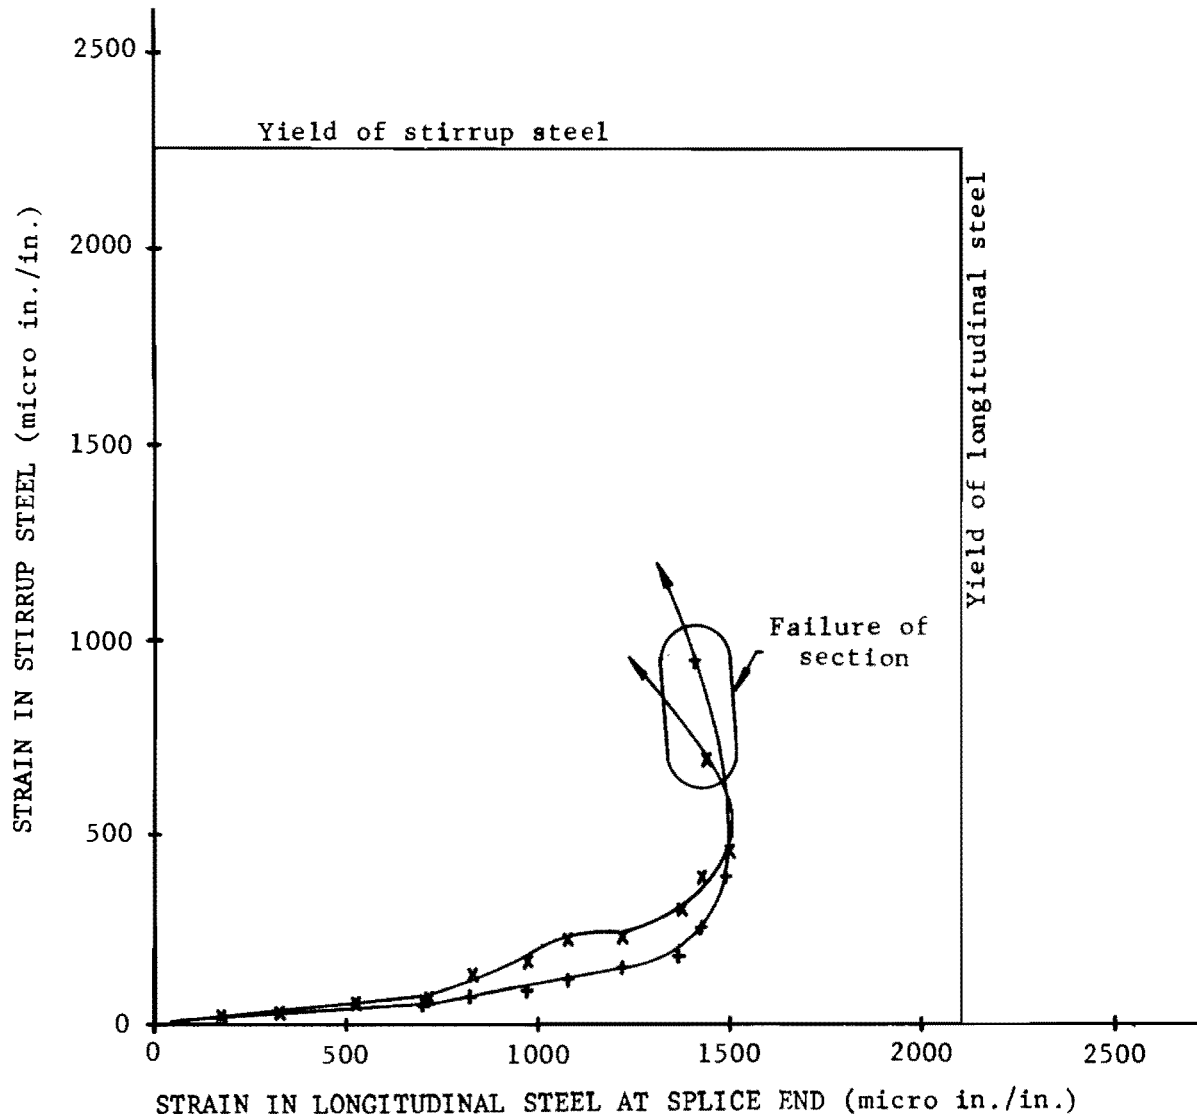
Fig. 3.29. Stirrup steel strain versus longitudinal steel strain for an edge splice (#1) for specimen 11-15-4/2/2-6/6-S5

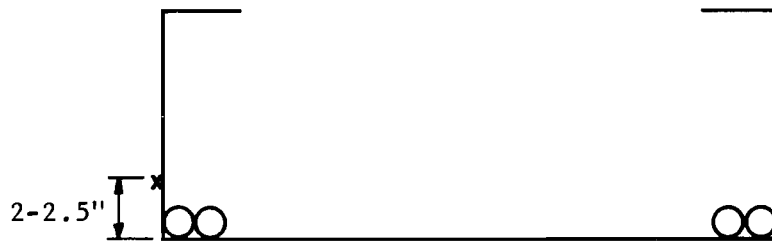
Detail of gage location on stirrups
