A PERFORMANCE SURVEY OF CONTINUOUSLY REINFORCED  
CONCRETE PAVEMENTS IN TEXAS

Research Report 21-1F

Pragmatic Application of Rigid Pavement Research  
Research Project 3-8-74-21

CENTER FOR HIGHWAY RESEARCH  
THE UNIVERSITY OF TEXAS AT AUSTIN

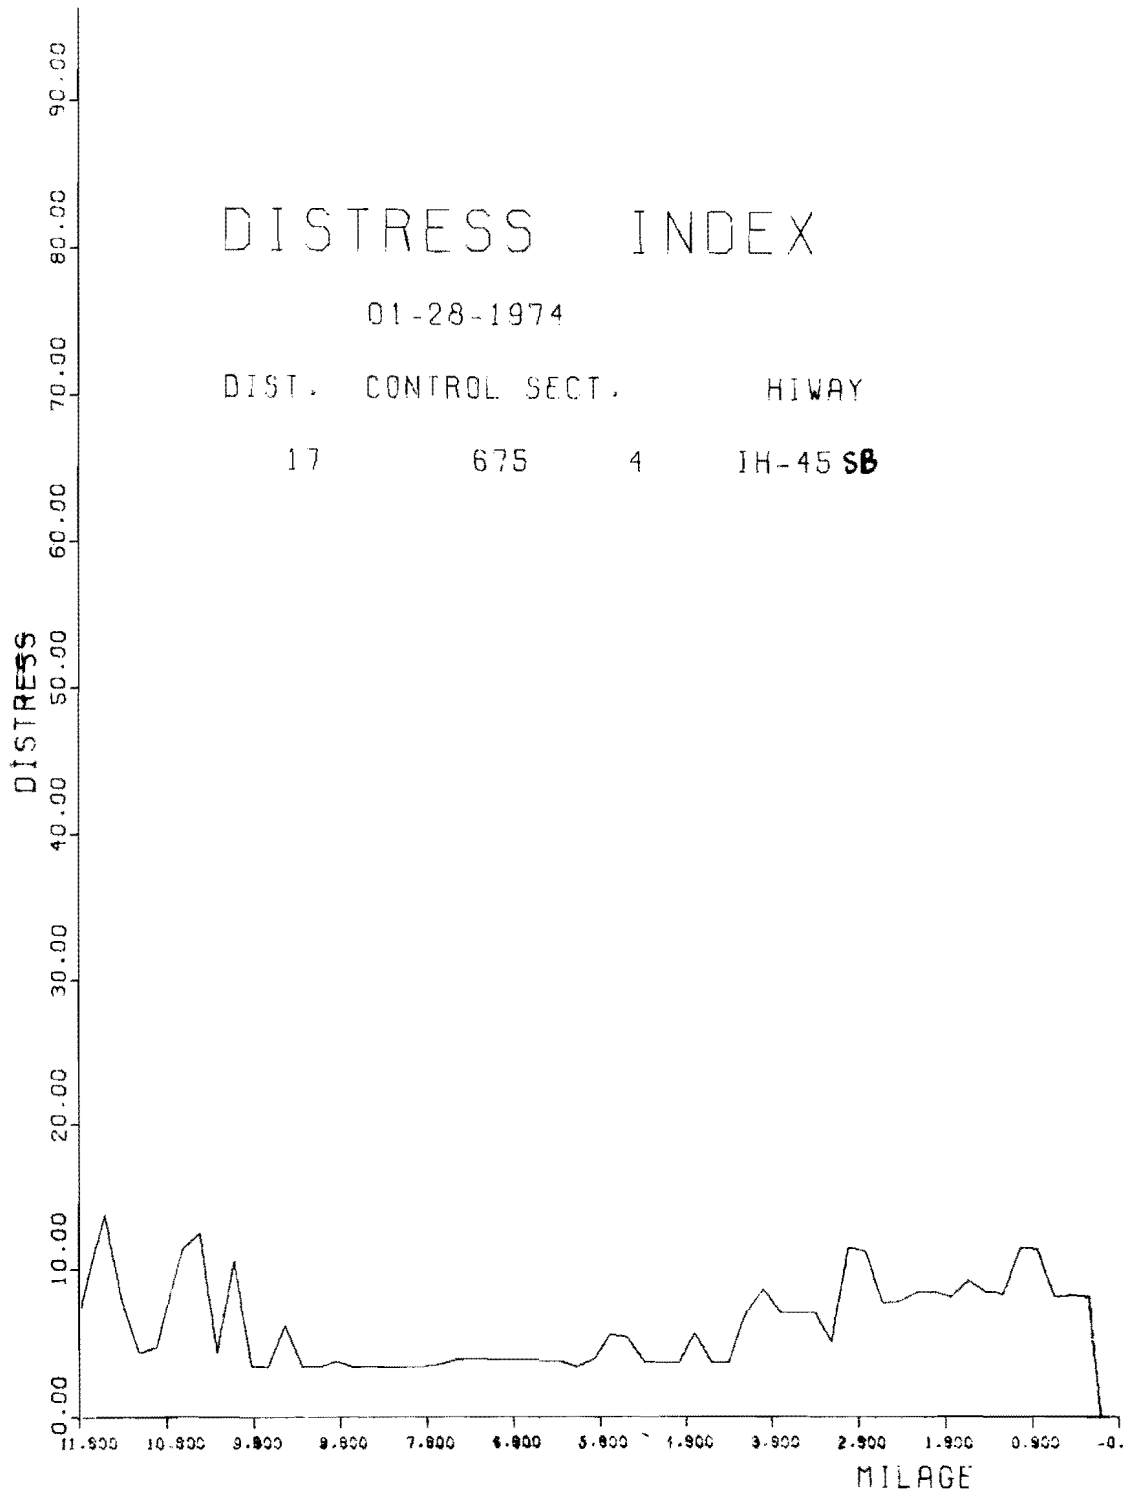
Fig 6. Example of distress index versus distance.

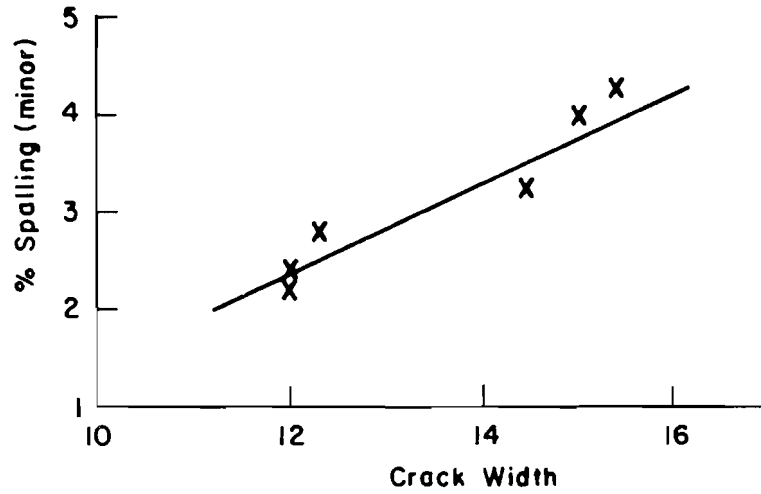
Fig 10. Influence of crack width on minor spalling..

It can be concluded that minor, or deep, spalling is affected by the crack width in the CRCP and that everything that is related to it, such as percentage steel, friction, and shrinkage, and by the deflection of the pavement and everything associated with it, such as poor subgrade, loss of support, and pumping. Severe of surface spalling, on the other hand, relates purely to the concrete properties and probable techniques utilized in the

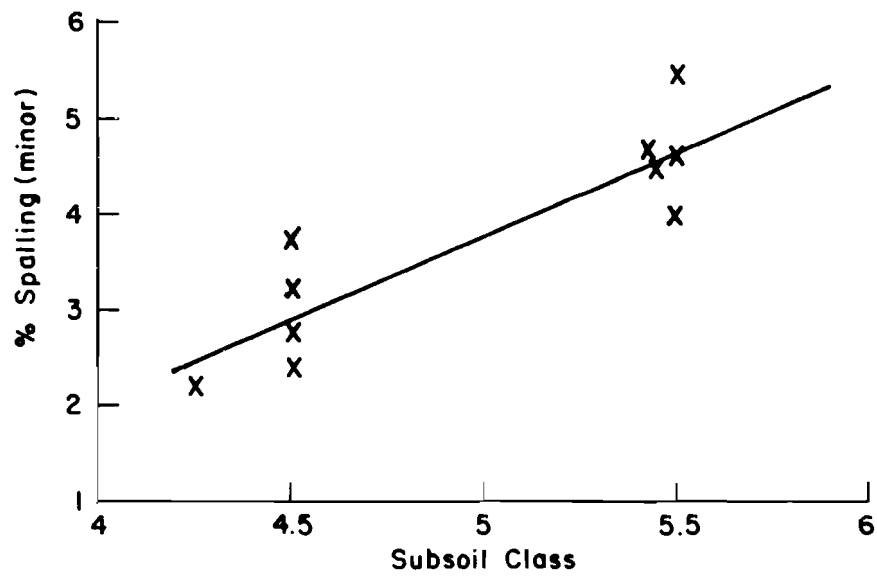
Fig 11. Influence of subsoil on minor spalling.

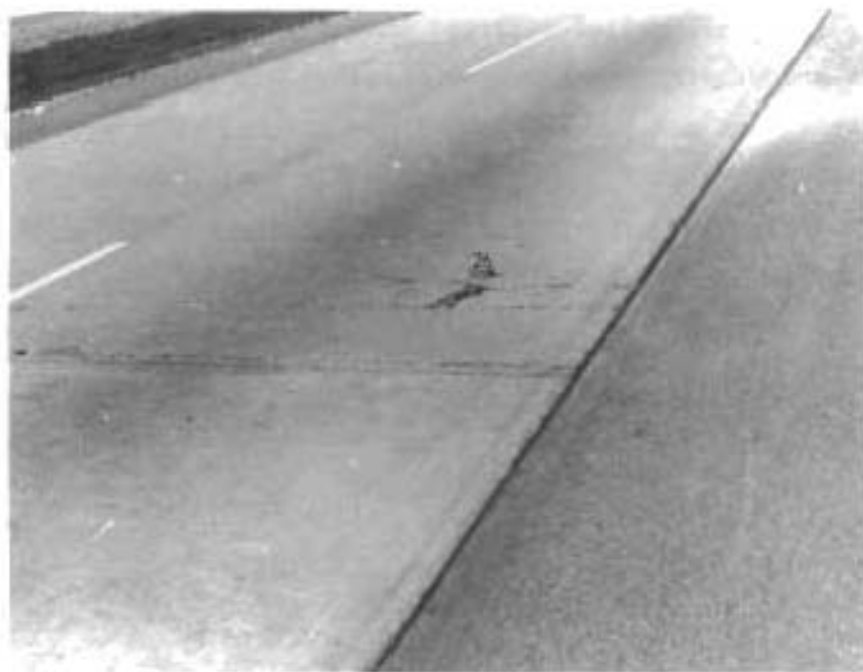
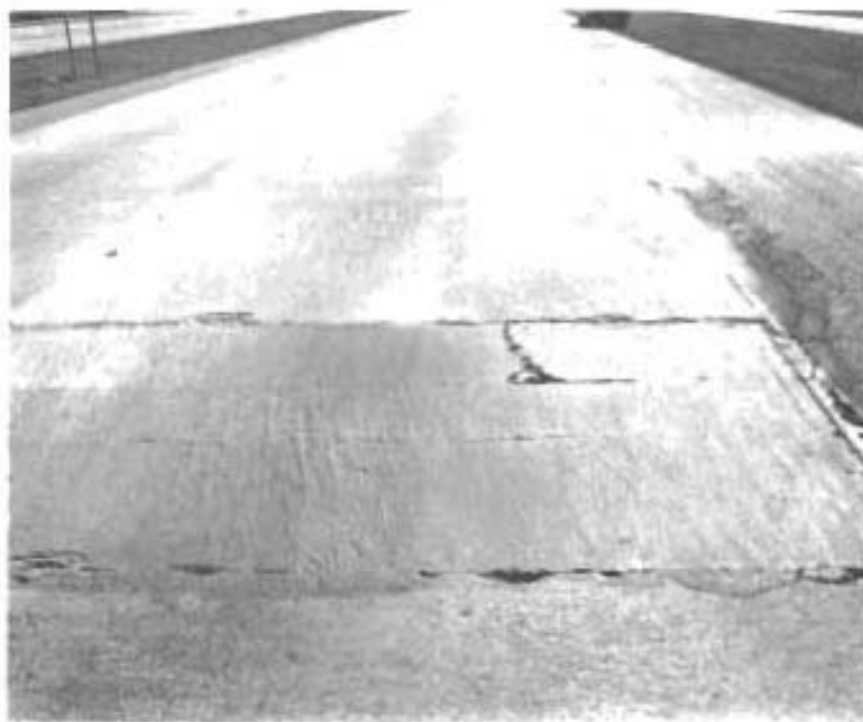
Fig 13. Effect of early pumping on later failures.

Figure 13(a) is a picture taken in the early days of the pavement, namely 1964. The failure at that stage occurred close to a construction joint and was due to poor vibration at this spot. As a result of an open side joint, cracking, and therefore the entrance of surface water, minor pumping occurred farther down the road. Note the progress of failures in Fig 13(b), taken in 1974, as well as more pumping farther down the road. Evidently the trouble has not been solved yet at the joint either, and pumping, with minor spalling, still occurs at this spot. It can be concluded, therefore, that stains of materials loss from the subbase are an indication of later failure. It is important not only to repair the failed slab but also to prevent a further loss of subgrade support through pumping or whatever causes exist. Closely related to the above point is the fact that the size of the first repair should be big enough to encompass adjoining pavement that shows signs of distress that may lead to failure. Traffic plays a big role in pumping; more pumping occurred where heavy trucks travelled close to the pavement edges, such as at the inside of curves and on uphill sections. The most important factor, however, is to provide proper drainage or to prevent water from accumulating under the pavement. This stresses the point made earlier that preventative maintenance becomes increasingly important.

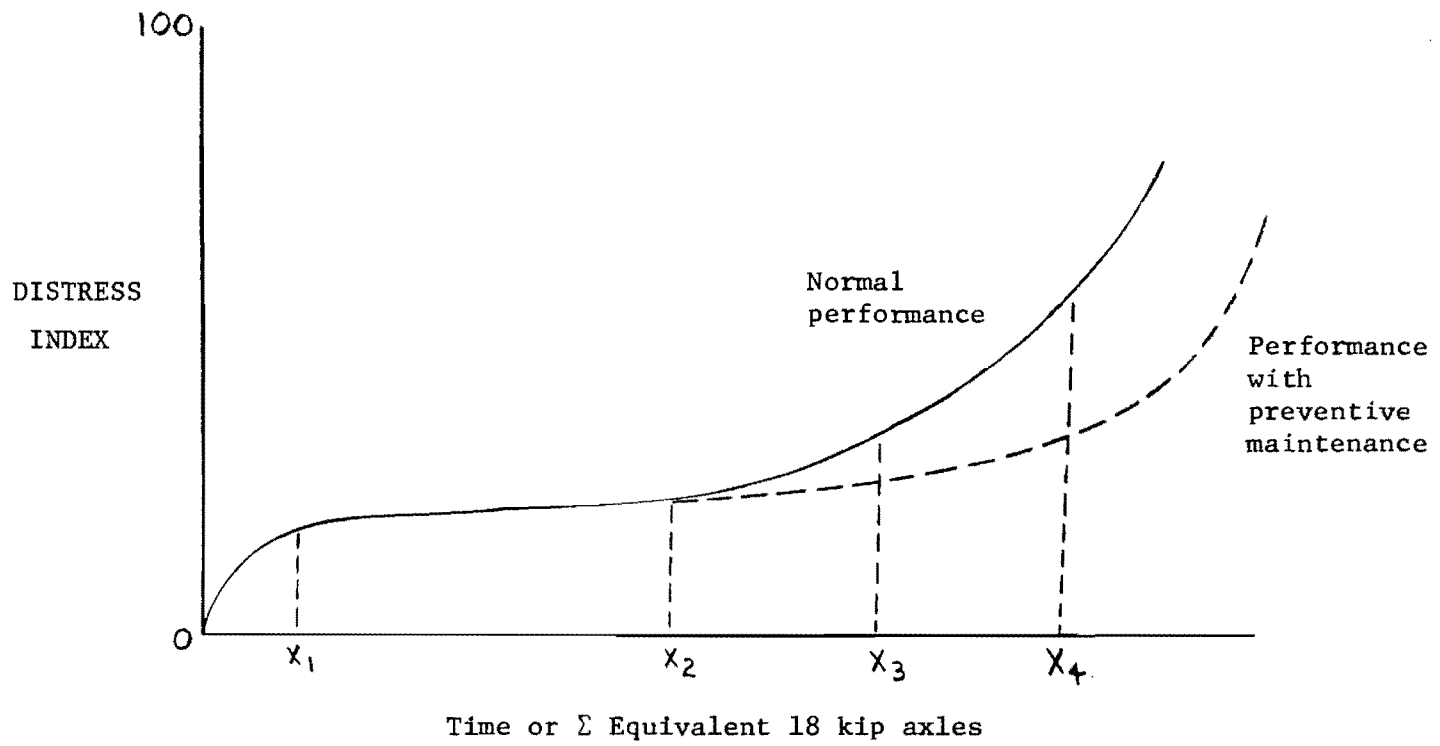
Fig 14. Hypothetical distress index with time.

Figure 14 illustrates this point by giving a pictorial view of the possible change of distress index with time, or increase in cumulative traffic load. Just after construction, the D.I. will increase due to shrinkage cracking in weaker sections. With an increase in traffic, D.I. will stay more or less constant until further cracking occurs due to fatigue, etc. From this time on,  $X_2$ , water will enter the pavement with a subsequent loss of subgrade support by soaking or pumping, increase in spalling, and, from time  $X_3$  onwards, occurrence of punch outs. At a time  $X_4$  the rideability

may be low enough to consider overlaying the pavement. The effect of preventive maintenance is illustrated on the same figure by a dotted line. It is evident from the above discussion that different techniques or strategies of maintenance are possible. This will allow the maintenance engineer to predict areas of future maintenance as well as provide the means to decide on the maintenance strategy, whether it be preventing pumping, entrance of water, or other distress.

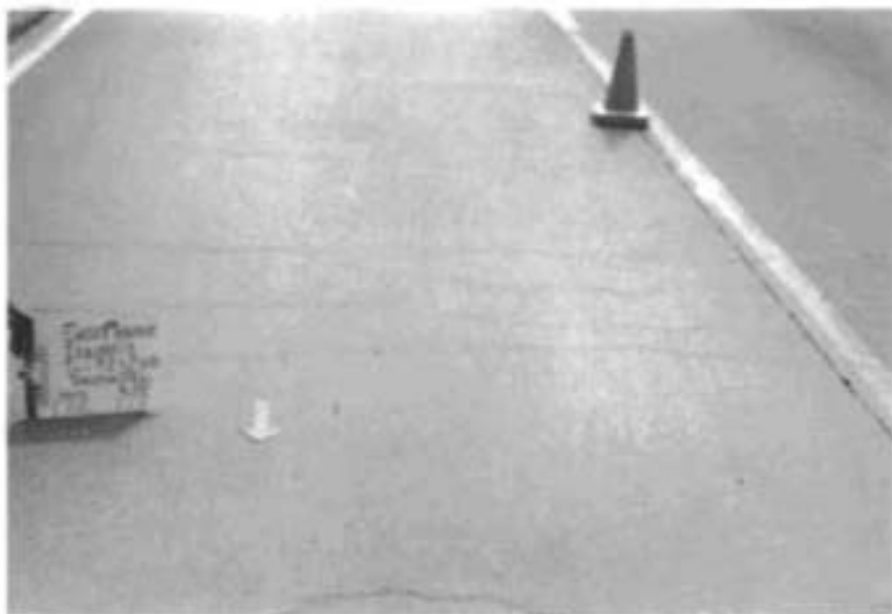
Fig B.3. Minor localized cracking.

When the closely spaced transverse cracks start to deteriorate by the formation of Y - cracks that link the transverse cracks, it is called localized cracking. See Fig B.3.

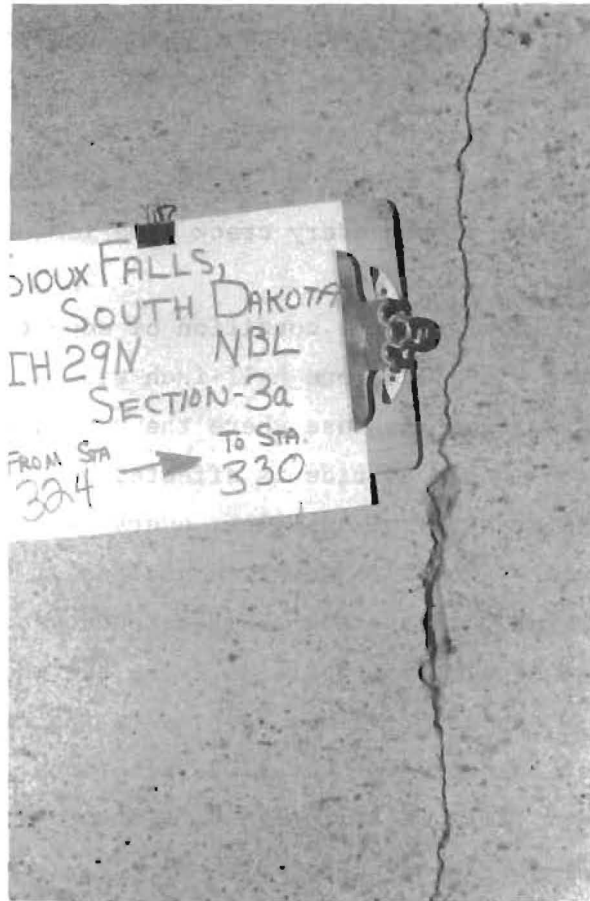
Fig B.5. Minor spalling.

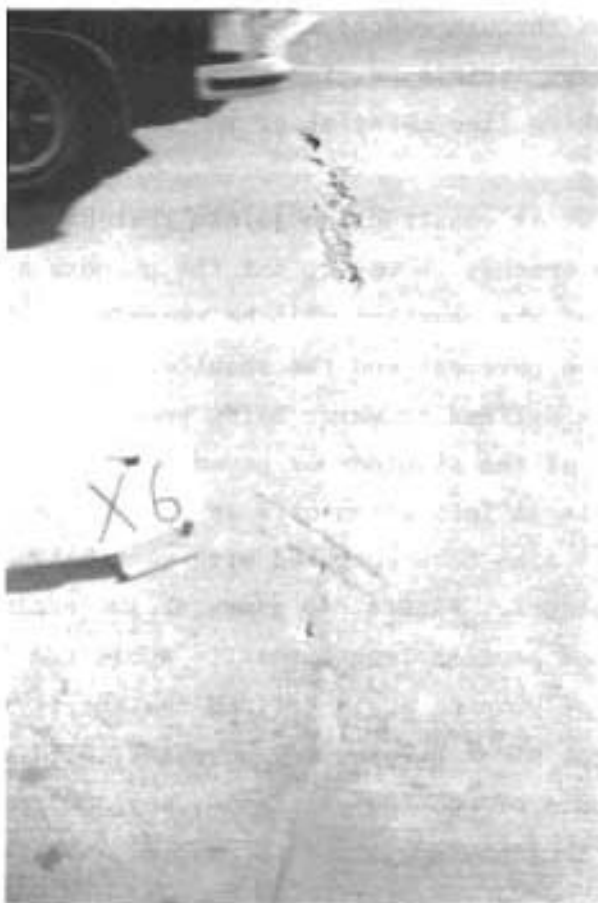
Fig B.6. Severe spalling.

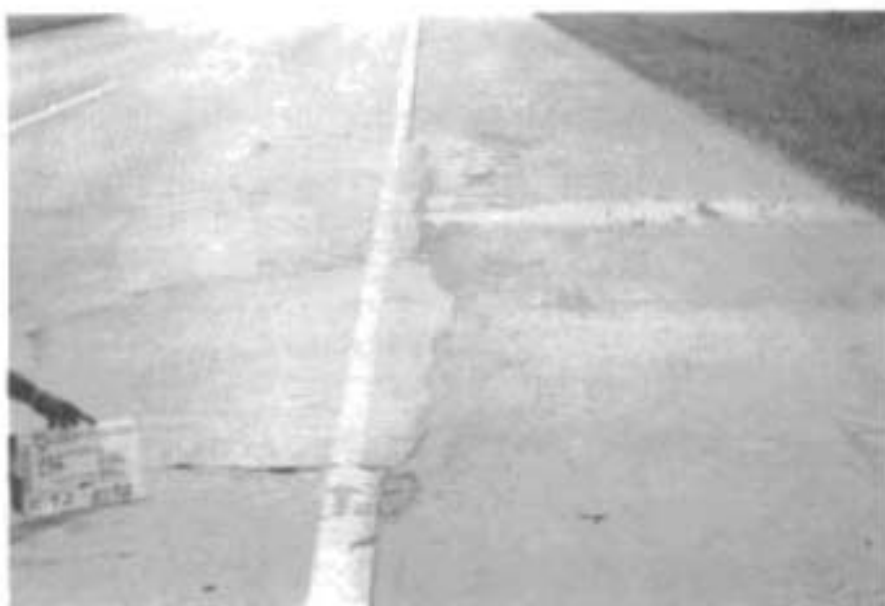
Fig B.8. Severe pumping.

Severe pumping is an indication of a severe loss of fines from the sublayers and it will also be associated with vertical movement of the pavement where pumping occurs. Figure B.8 gives an indication of severe pumping.

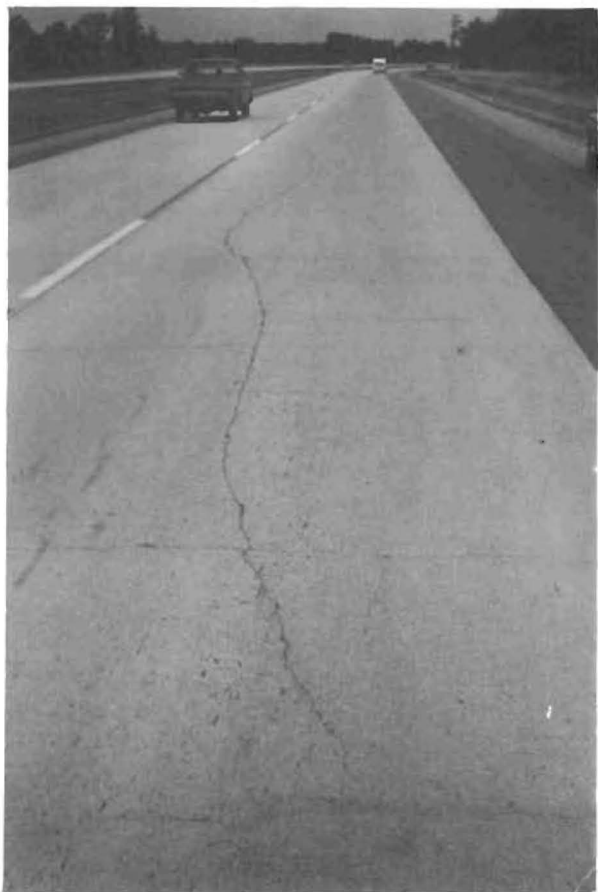
Fig B.9. Longitudinal cracking not to be rated.

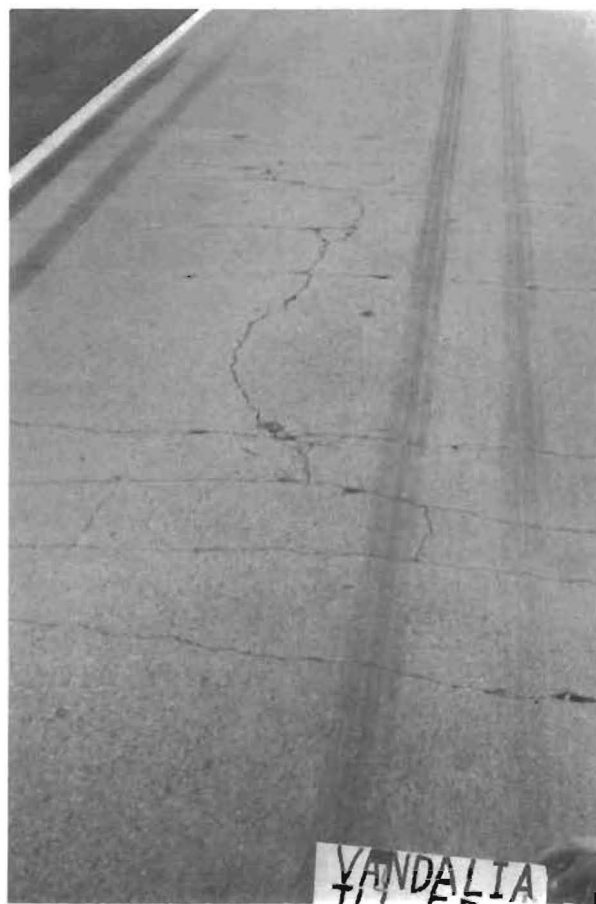
Fig B.10. Minor punch out.

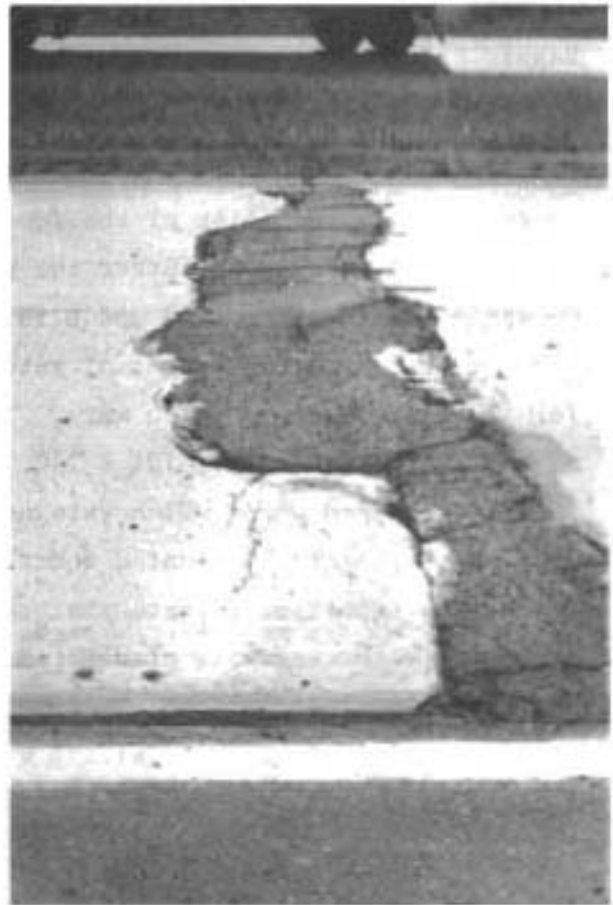
Fig B.12. Asphaltic concrete patch defined as minor.

The pavement needs to be repaired in the final stages of distress. Repairs can be made either with Portland Cement concrete or asphalt cement concrete. The condition of the repair patch will not be determined. Columns are provided to record whether the patch is made in asphaltic or Portland Cement concrete, Figs B.12 and B.13.

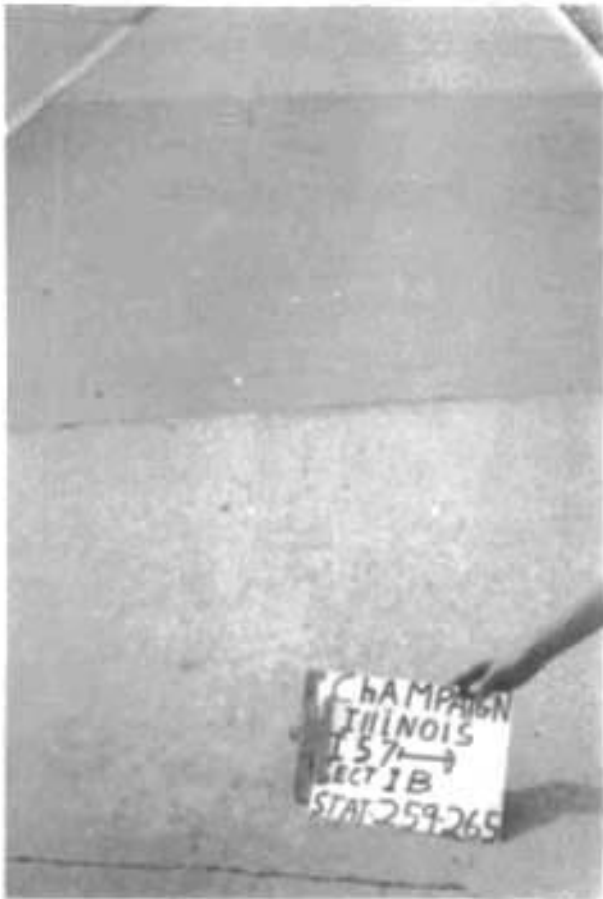
Fig B.13. Portland cement concrete patch defined as severe.

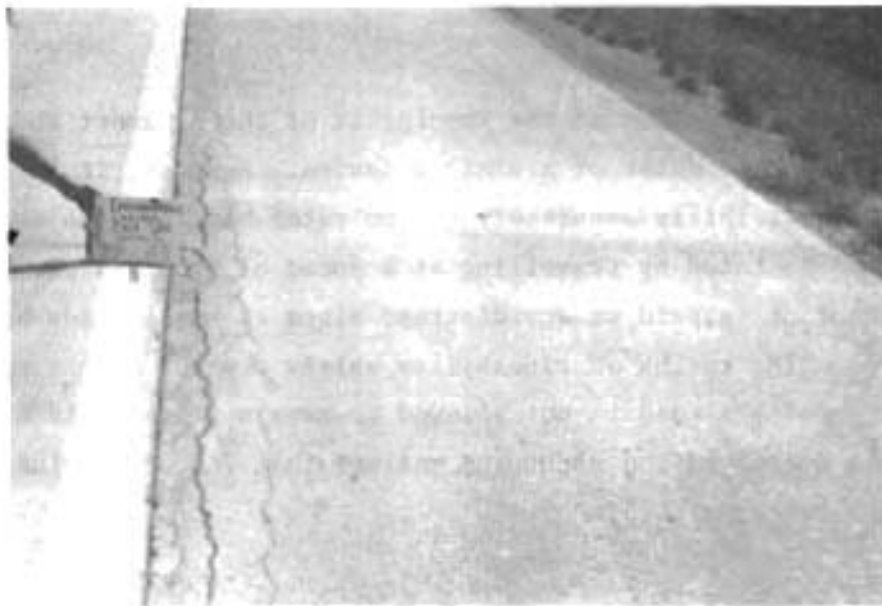
Fig B.14. Shoulder distress, open joint with cracking.

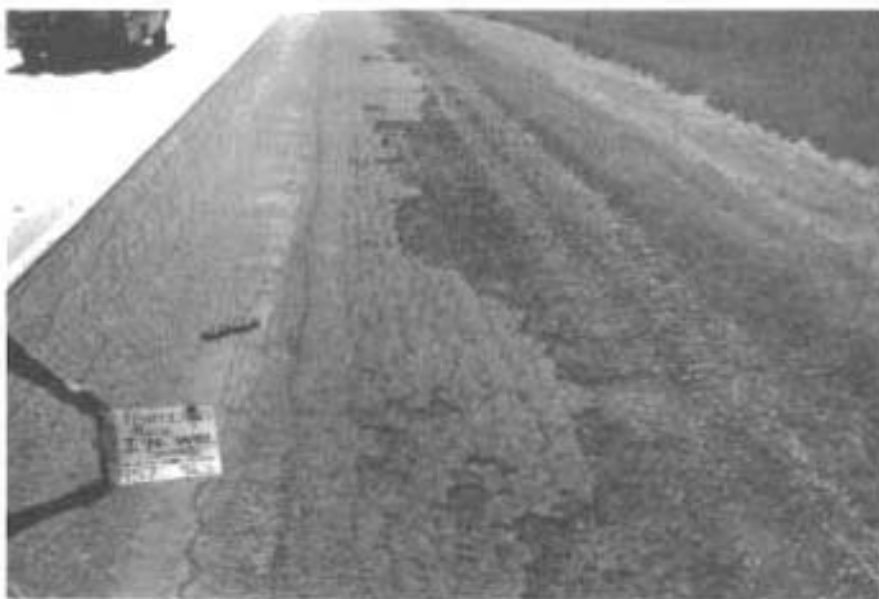
Fig B.15. Shoulder distress, scuffing of surface.

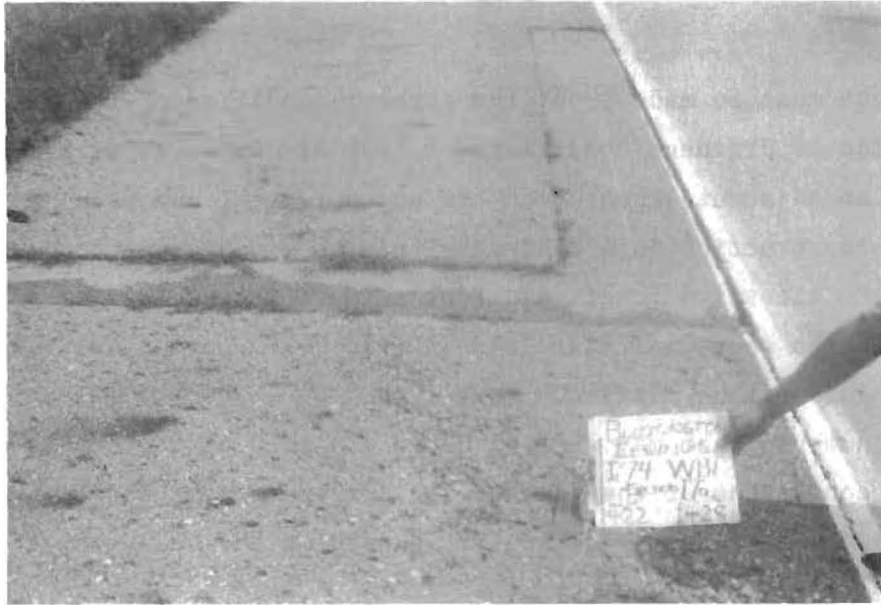
Fig B.16. Subsurface drain installed.

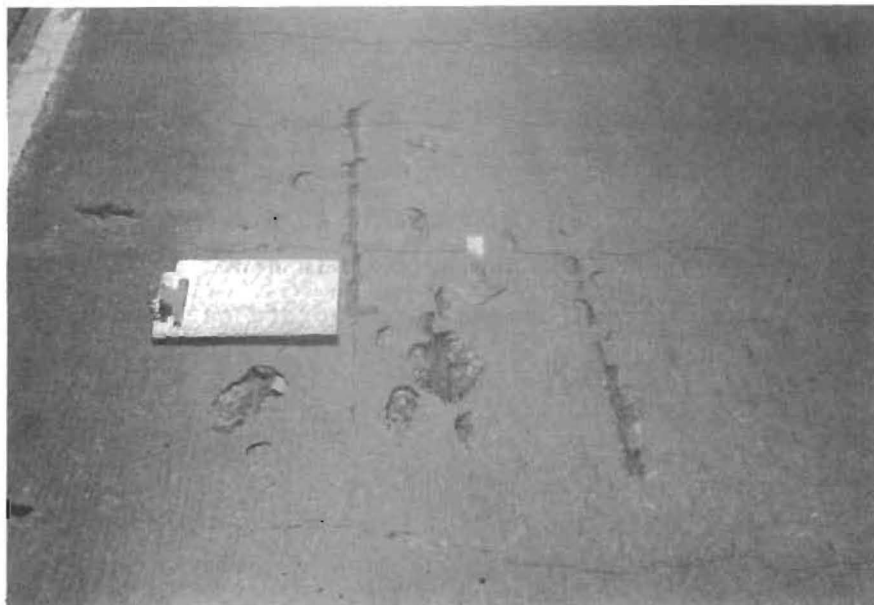
Fig B.17. Steel reinforcement too close to surface.

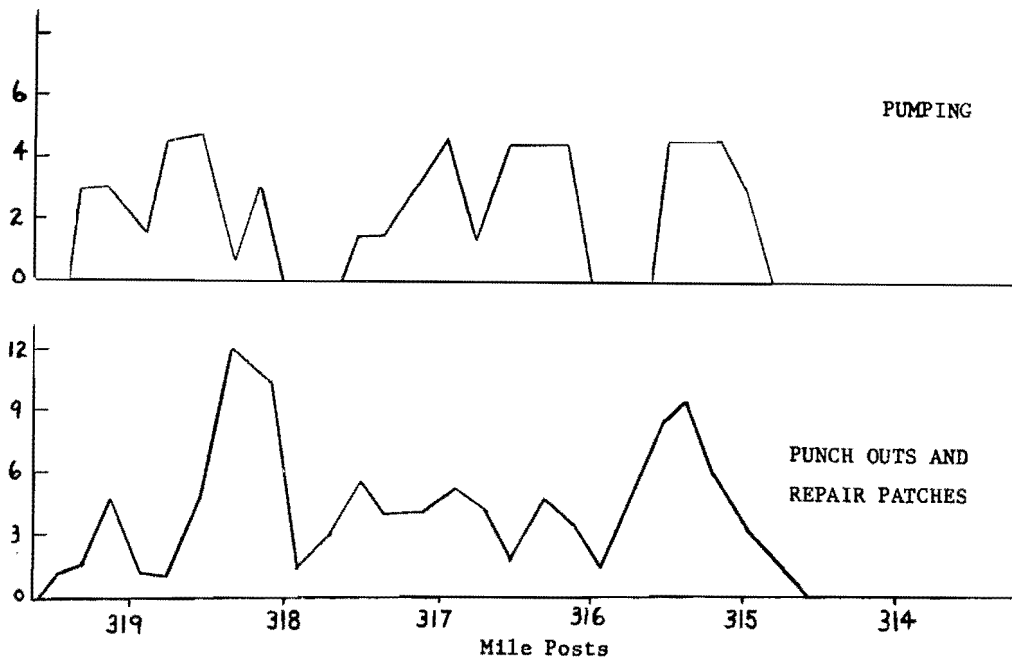
Fig D.13. South bound lane: relative distress with distance.

to combine the two are not reported on. Areas that were pumping in 1962 are marked with arrows in Fig D.13 on the plot of repair patches and punch outs combined.
