1. Report No. FHWA/TX-82/45+249-3		2. Government Accession No.		3. Recipient's Catalog No.	
4. Title and Subtitle VOID DETECTION AND GROUTING PROCESS				5. Report Date April 1983

VOID DETECTION AND GROUTING PROCESS

Research Report Number 249-3

Implementation of Rigid Pavement Overlay and Design System  
Research Project 3-8-79-249

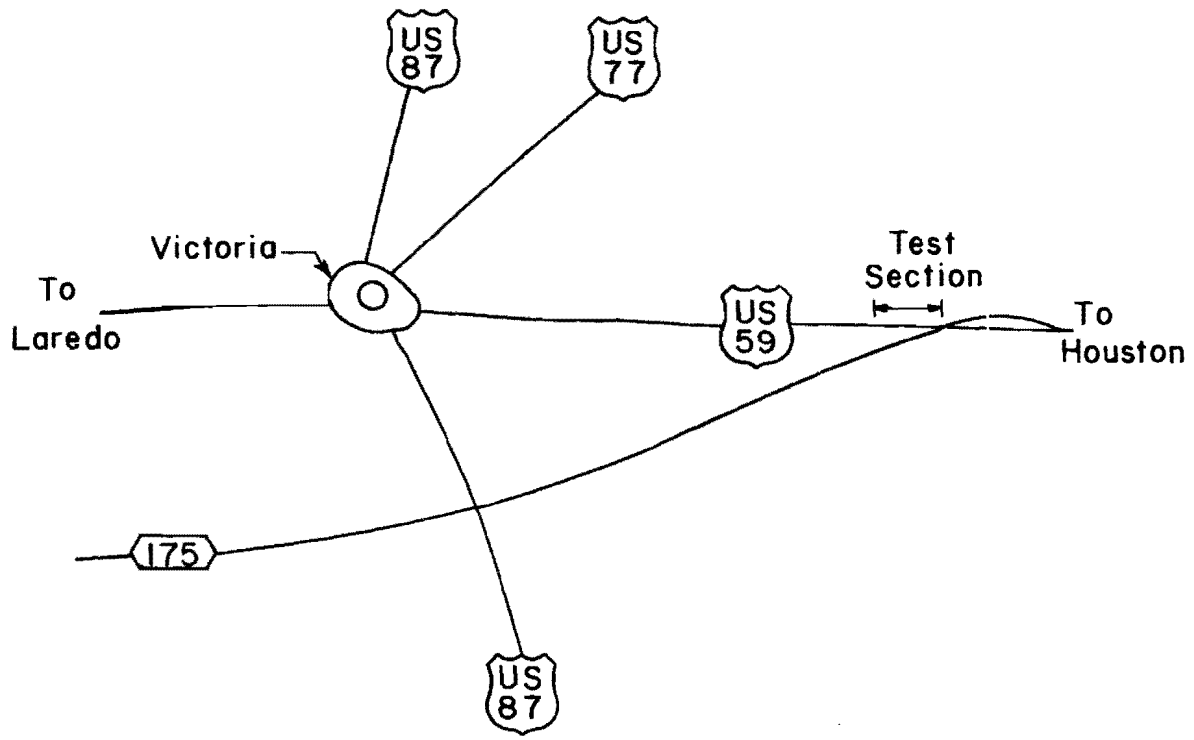
Fig 1.2. Location of the test sections, Victoria project US-59, District 13.

US 59 , Victoria , District 13

Based on these results, it was decided to follow up in a more detailed way the method proposed for void detection as well as the grouting process that should be utilized to fill those voids. For these purposes, the representatives from the SDHPT and the Center for Transportation Research met together to select the section that best fulfilled the requirements for such an experiment. After analyzing condition surveys and deflection measurements for several projects, the one located on Highway US-59 about ten miles northeast of Victoria, Texas, was selected. The area shows considerable evidence of pumping and distress in the form of punchouts. The basic decision to select a 1000-ft (304-m) test section that is typical of the average conditions for the project was made. The cross section of the pavement consisted of 8 inches (20.24 cm) CRC pavement on a 6-inch (15.31-cm) cement-treated base which extends into the shoulder area. A map showing the location of the test section is presented in Fig 1.2.

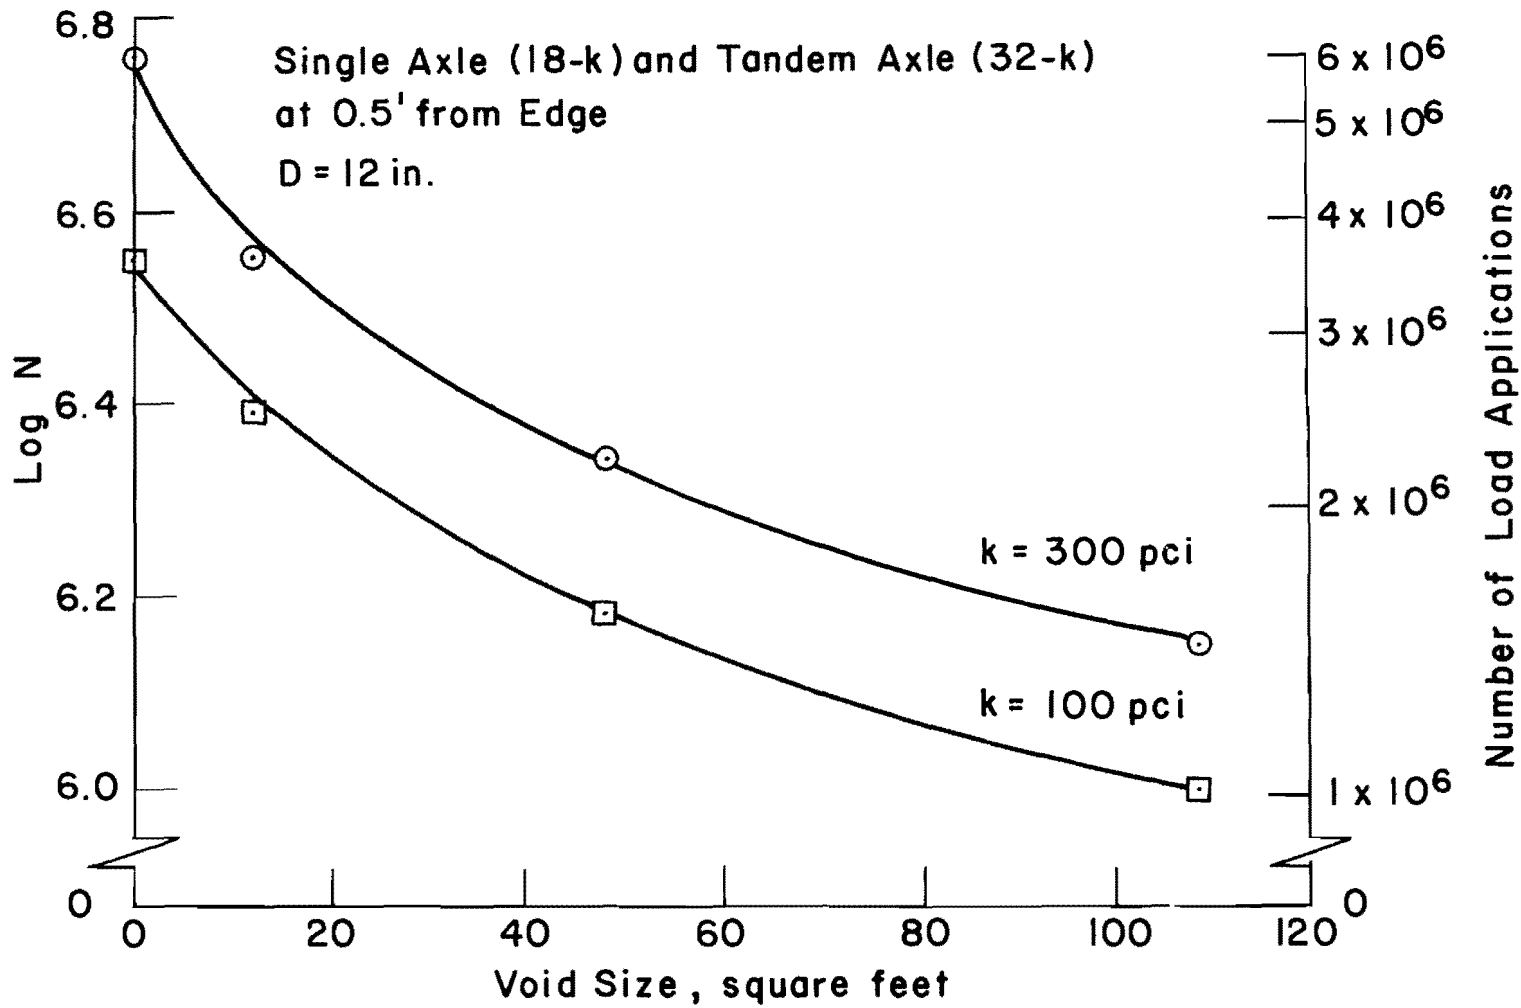
Fig 2.4. Effect of the soil support value on the fatigue life of the pavement with single axle (18k) and tandem axle (32k) loads applied at 0.5 feet from the edge on a 12-inch pavement.

The effect of increasing the k-value is shown in Fig 2.4. As expected, a slab resting on a strong subgrade would provide a better service life than one resting on a poor subgrade ( $k = 100$  pci) which correspond to the existing conditions when a void exists beneath the pavement.

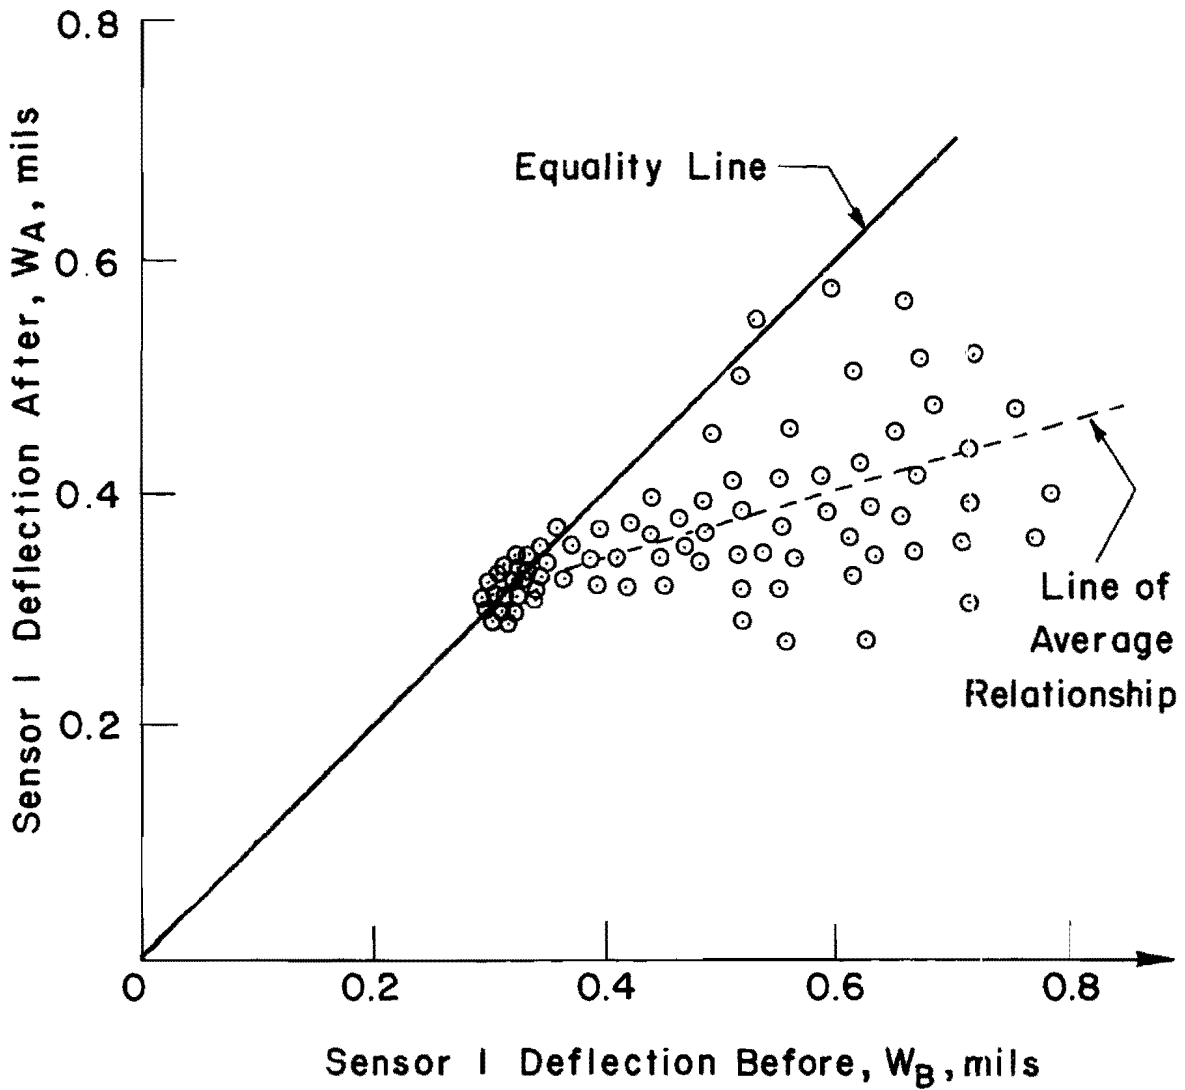
Fig 2.7. Example plot used in the recommended procedure for estimating the effectiveness of undersealing operations.

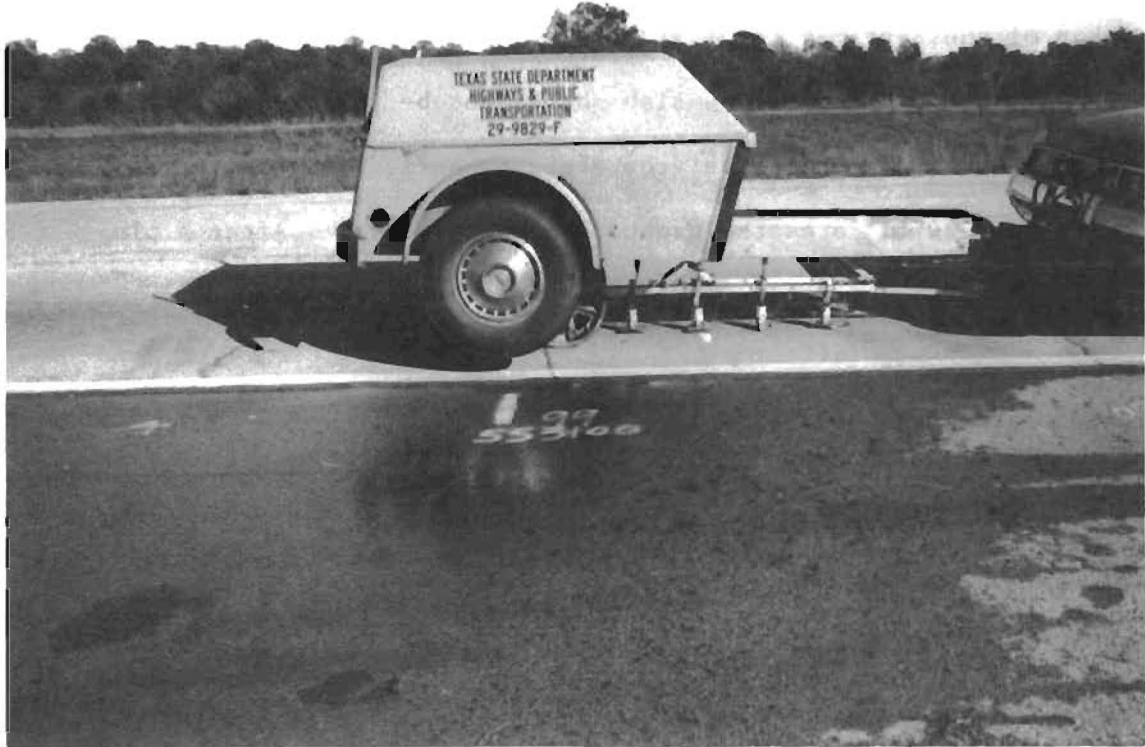
Fig 3.2. Dynaflect device currently used as the standard equipment in Texas to measure deflections on the pavement.

The first method proposed is deflection testing, in which the Dynaflect, which is standard equipment in Texas, is utilized for measuring the deflections in the pavement. The principle of operation involves a cyclic force generated by a pair of unbalanced flywheels which rotate in opposite directions at 480 rpm. This produces a cyclic vertical force of 1,000 lb on the loading wheels. The resulting deflections are picked up by the five geophones, each 12 in. apart, on the surface of the pavement, as shown in Fig 3.2 (Ref 6).

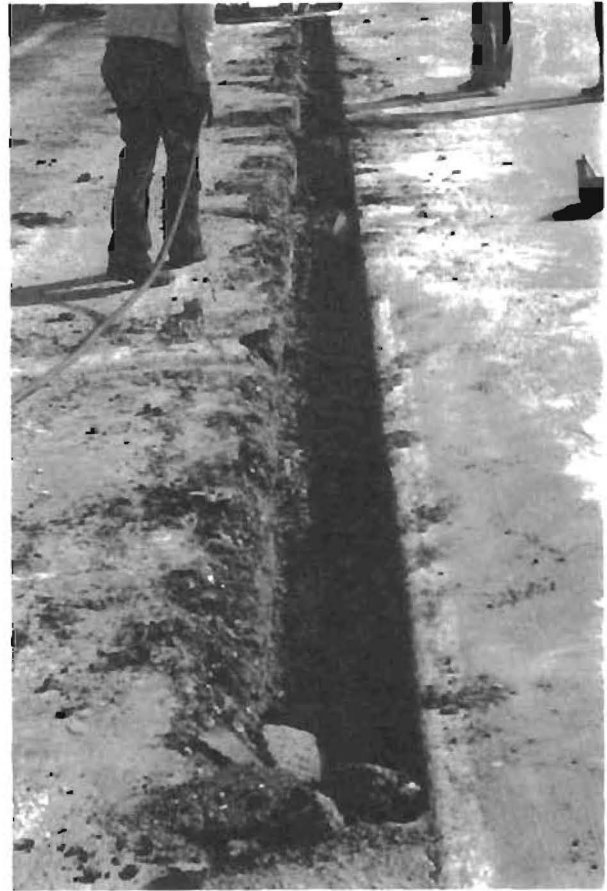
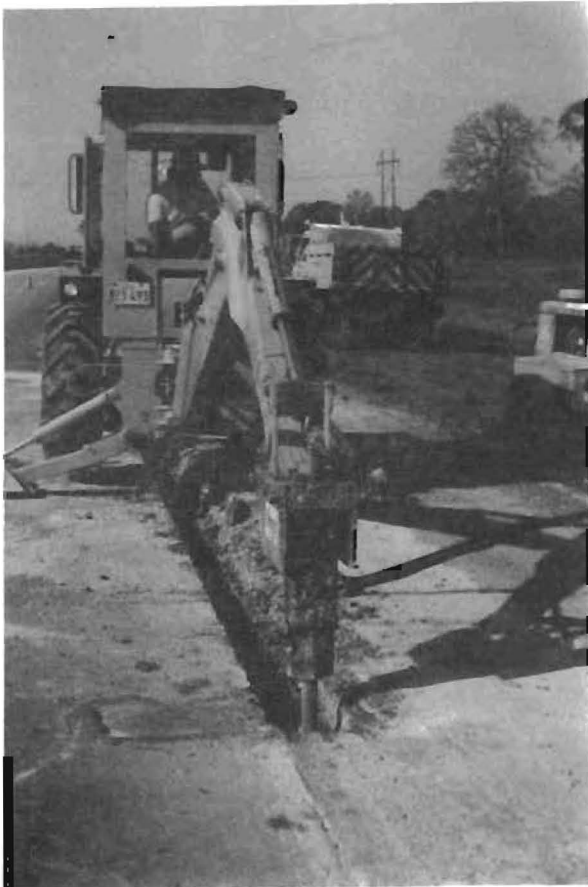
Fig 4.2. Breaking the CTB with an air hammer.

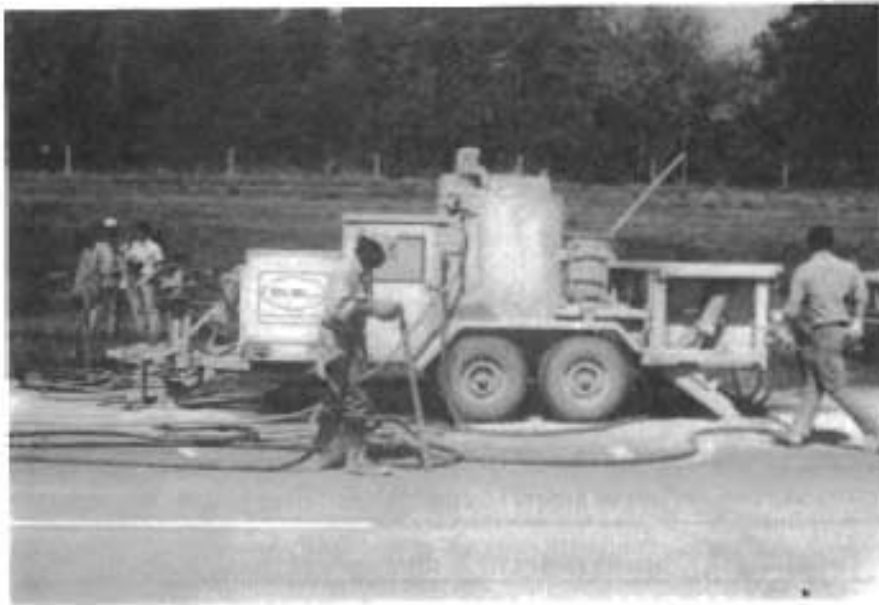
Fig 4.4. High speed centrifugal mixer.

The material used for the grout subsealing was a mixture of portland cement and Puzzolan, which was one part portland cement, 3 parts flyash, and water to achieve the fluidity equal to a flow cone flux time of 12 to 14 seconds. The material was mixed in a high speed centrifugal mixer and placed with a Moyno positive displacement pump (Fig 4.4).

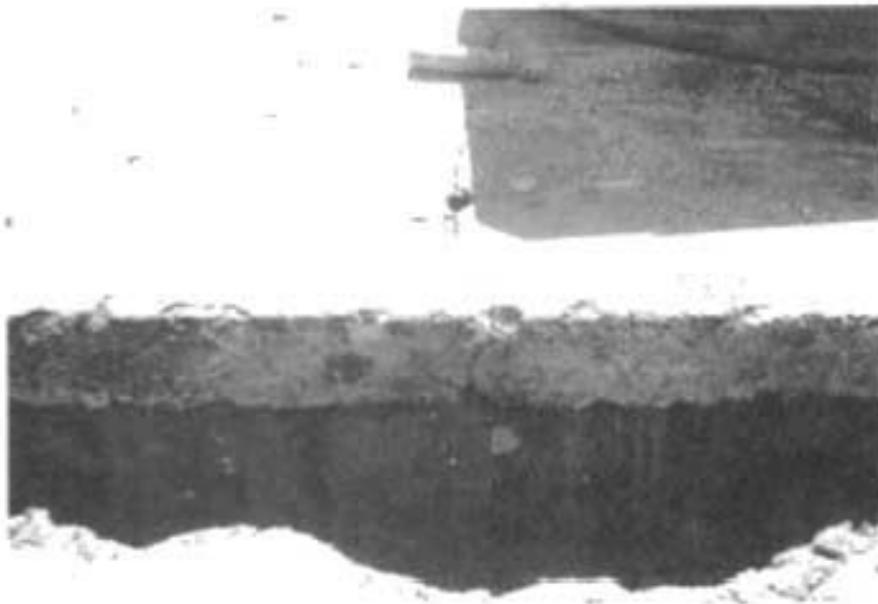
Fig 4.5. Grout coming out at the interface between the pavement and the CTB.

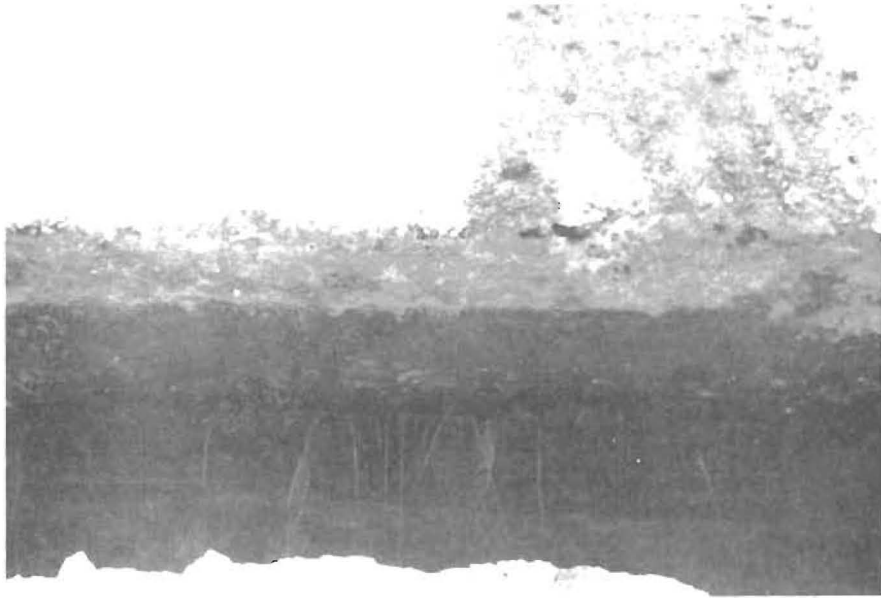
Fig 4.6. Grout coming out at the interface of CTB and the Clay Subgrade material.

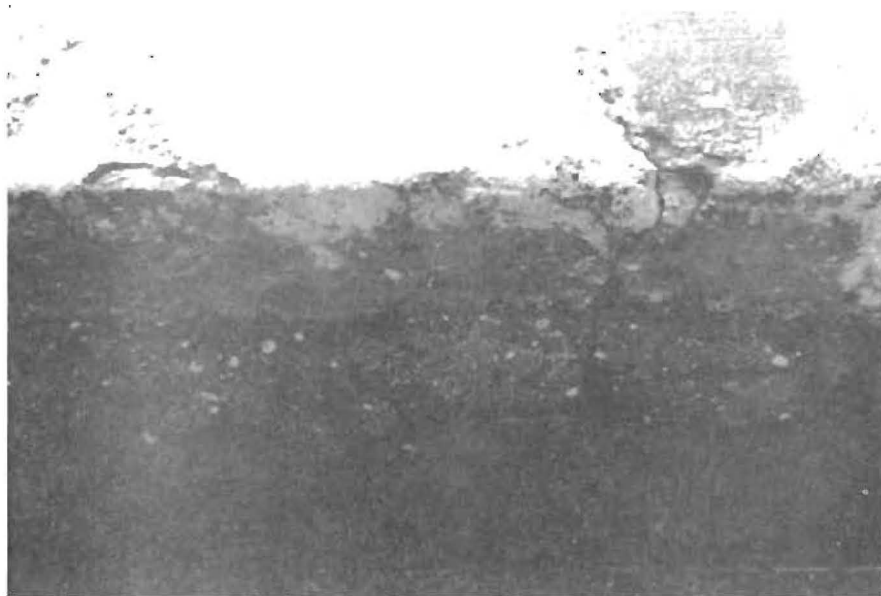
Fig 4.7. Punchout crack going through the CTB.

close as 18 in. from the edge of the pavement. The grout then flowed and fanned out horizontally about 15 in. on either side of the temperature crack. In general, there was no indication that the temperature cracks propagated vertically into the CTB.

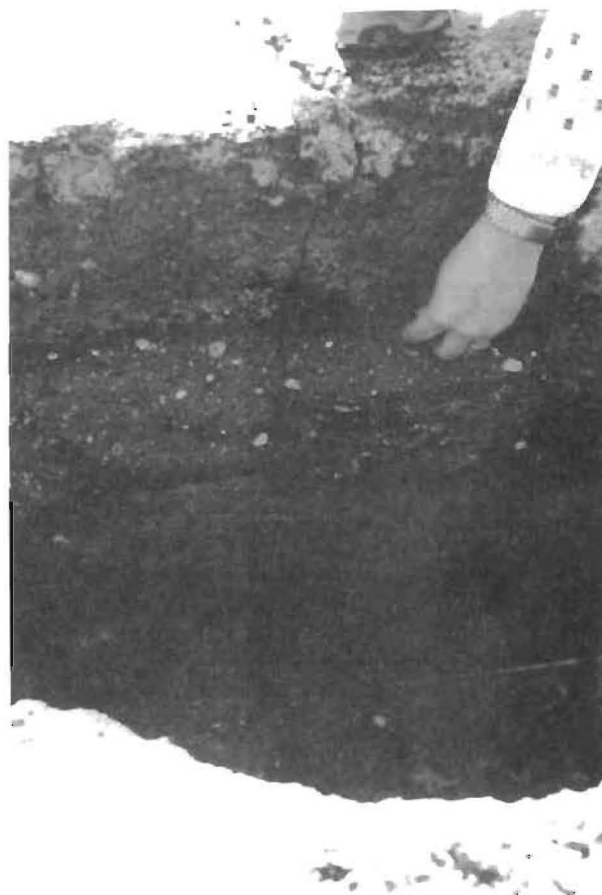
Fig 4.8. Punchout crack going through the CTB.

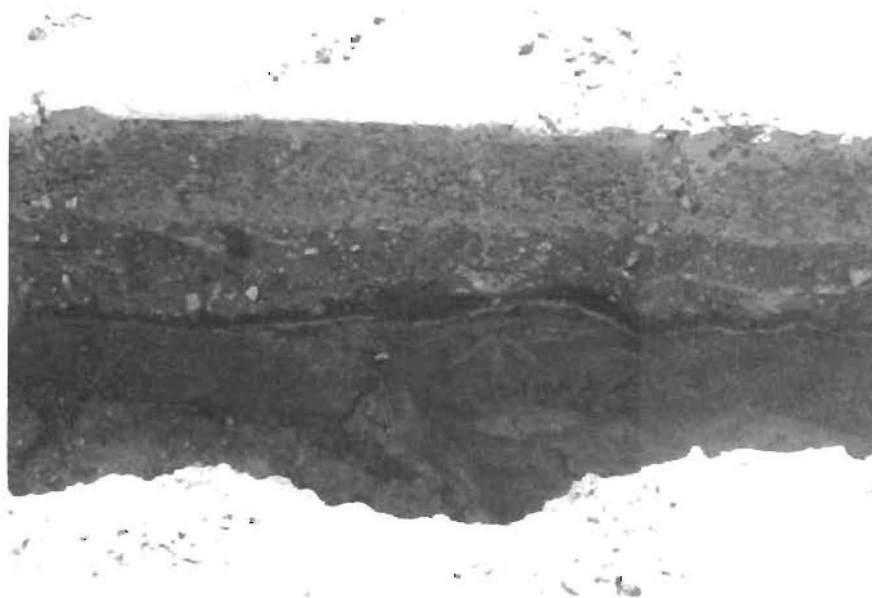
Fig 4.9. Lenses of grout at the interface between CTB and the Subgrade Clay material.

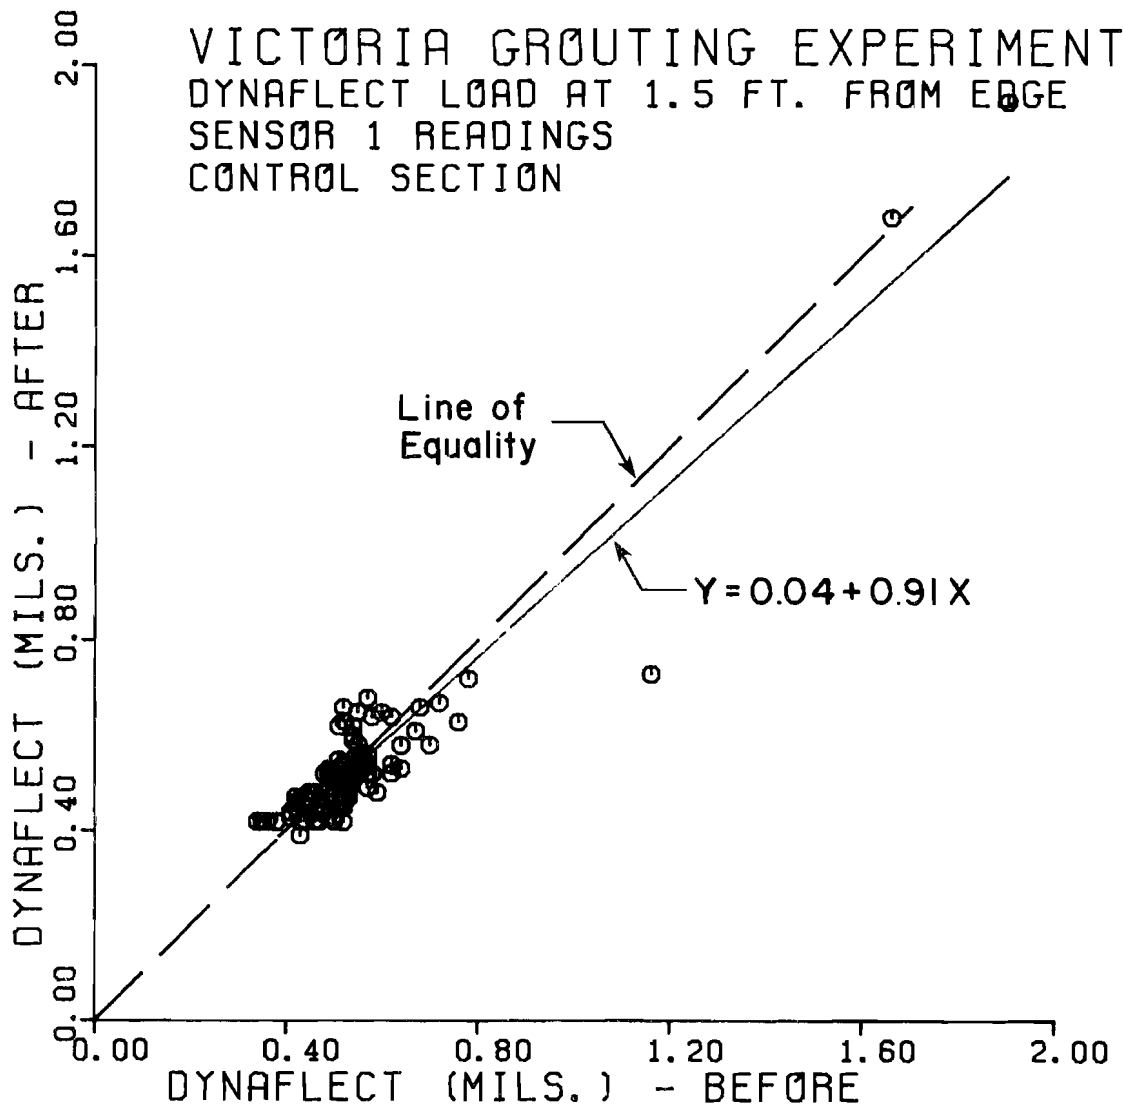
Fig 5.1. Influence of weather conditions on Dynaflect deflections. Victoria project, US-59, District 13. Regression equation is applicable only for the range of data shown.

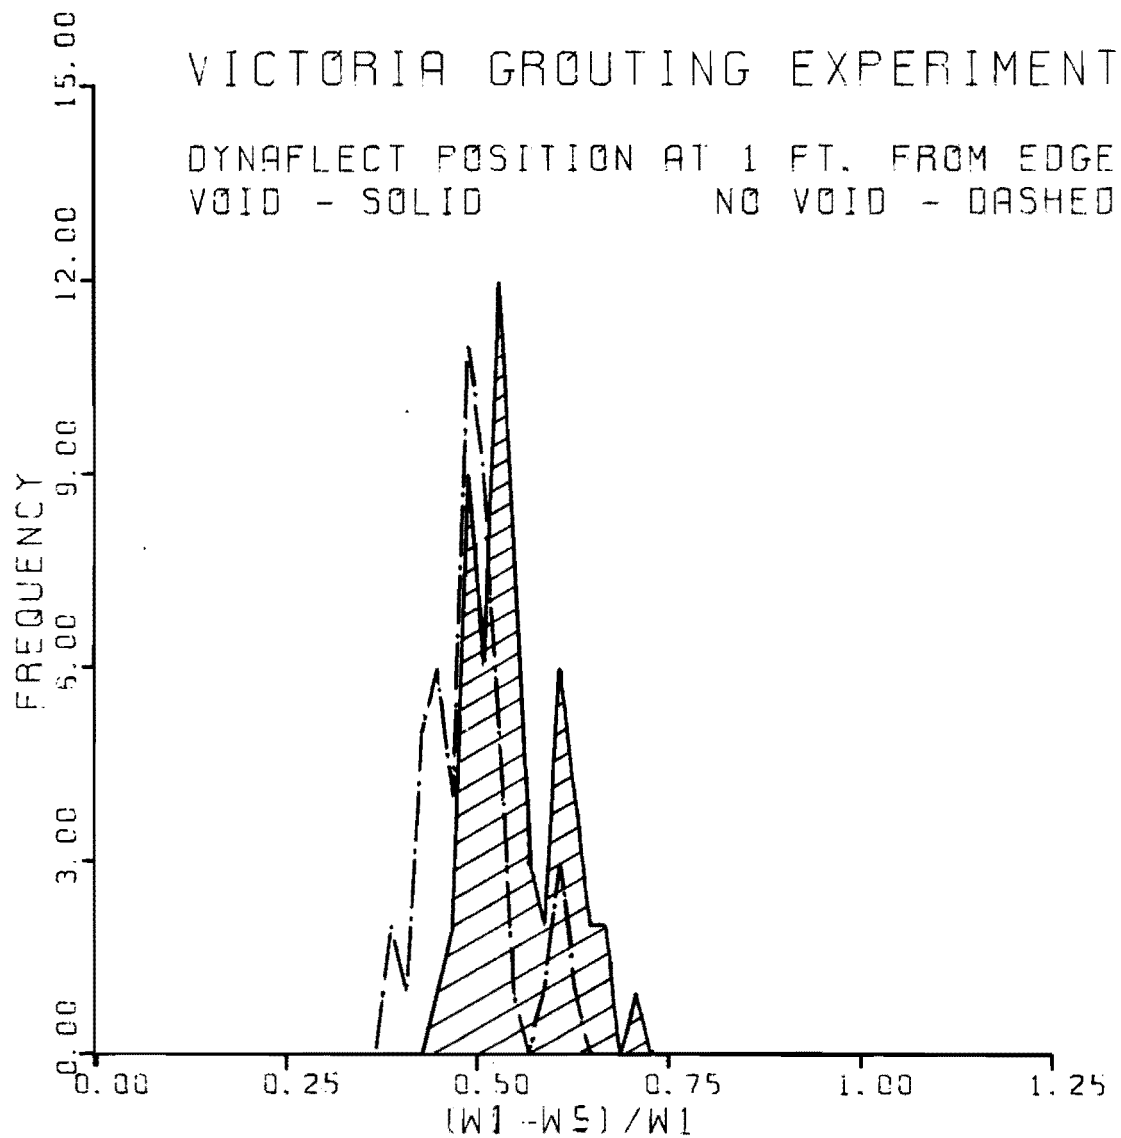
Fig 5.6. Frequency distribution of normalized Dynaflect deflections recorded at one foot from the edge.

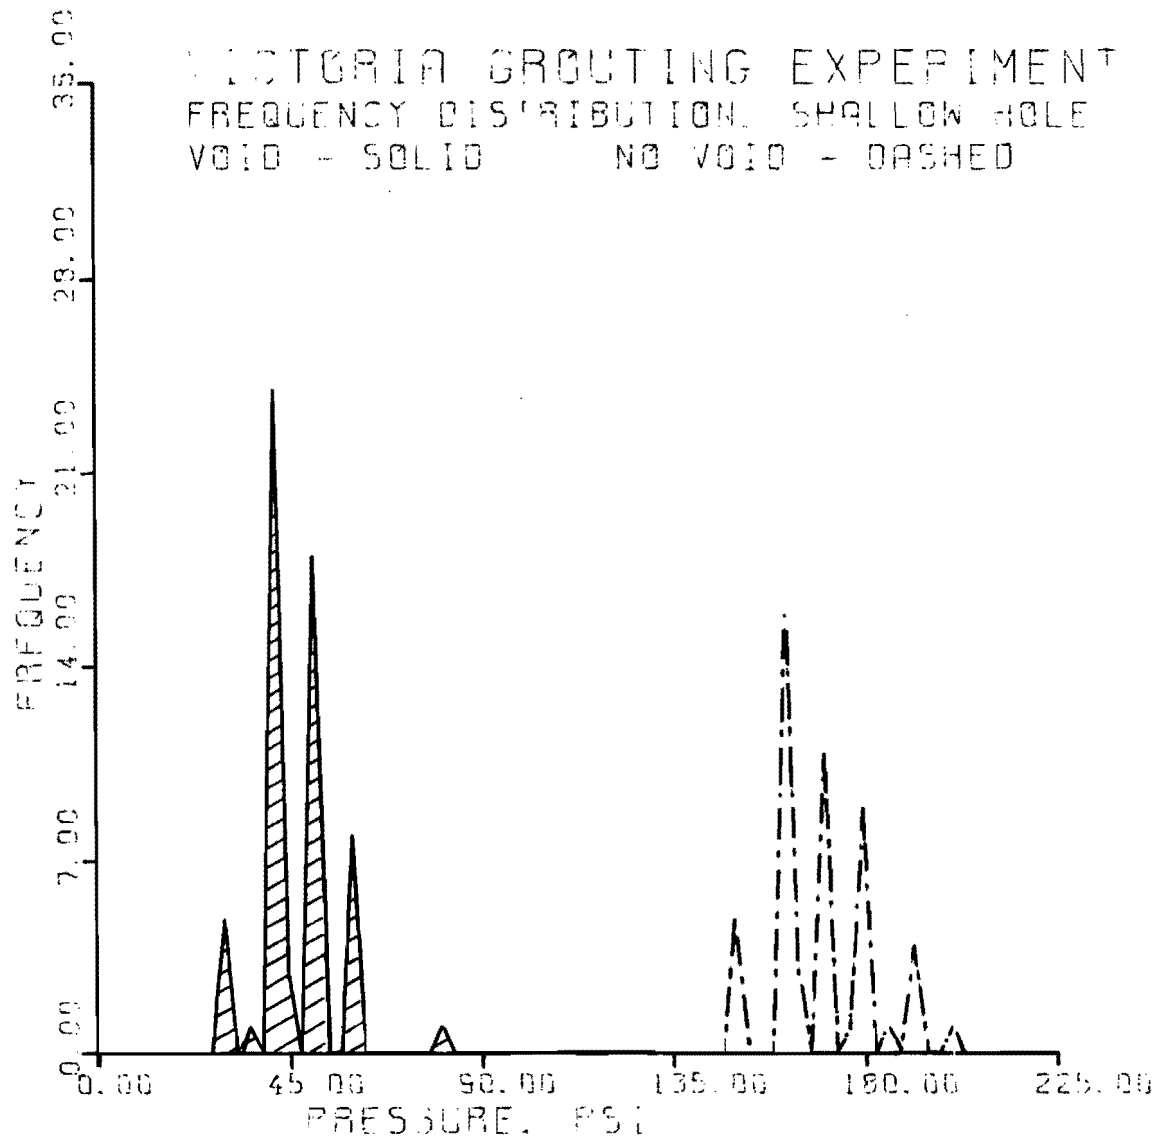
Fig 5.7. Frequency distribution for grouting pressure following the shallow hole pattern.

Figure 5.7 shows the frequency distribution of the pressure applied during the grouting process, considering both cases. It was observed that whenever the grout was first injected for the void case, the pressure was usually about 150 psi. However, immediately after the grout began to flow, pressures quickly dropped into the range of 30 to 65 psi. On the other hand,

for the cases in which no voids existed beneath the pavement, the pressure varied from 140 to 185 psi, which means that no injection of grout was achieved.

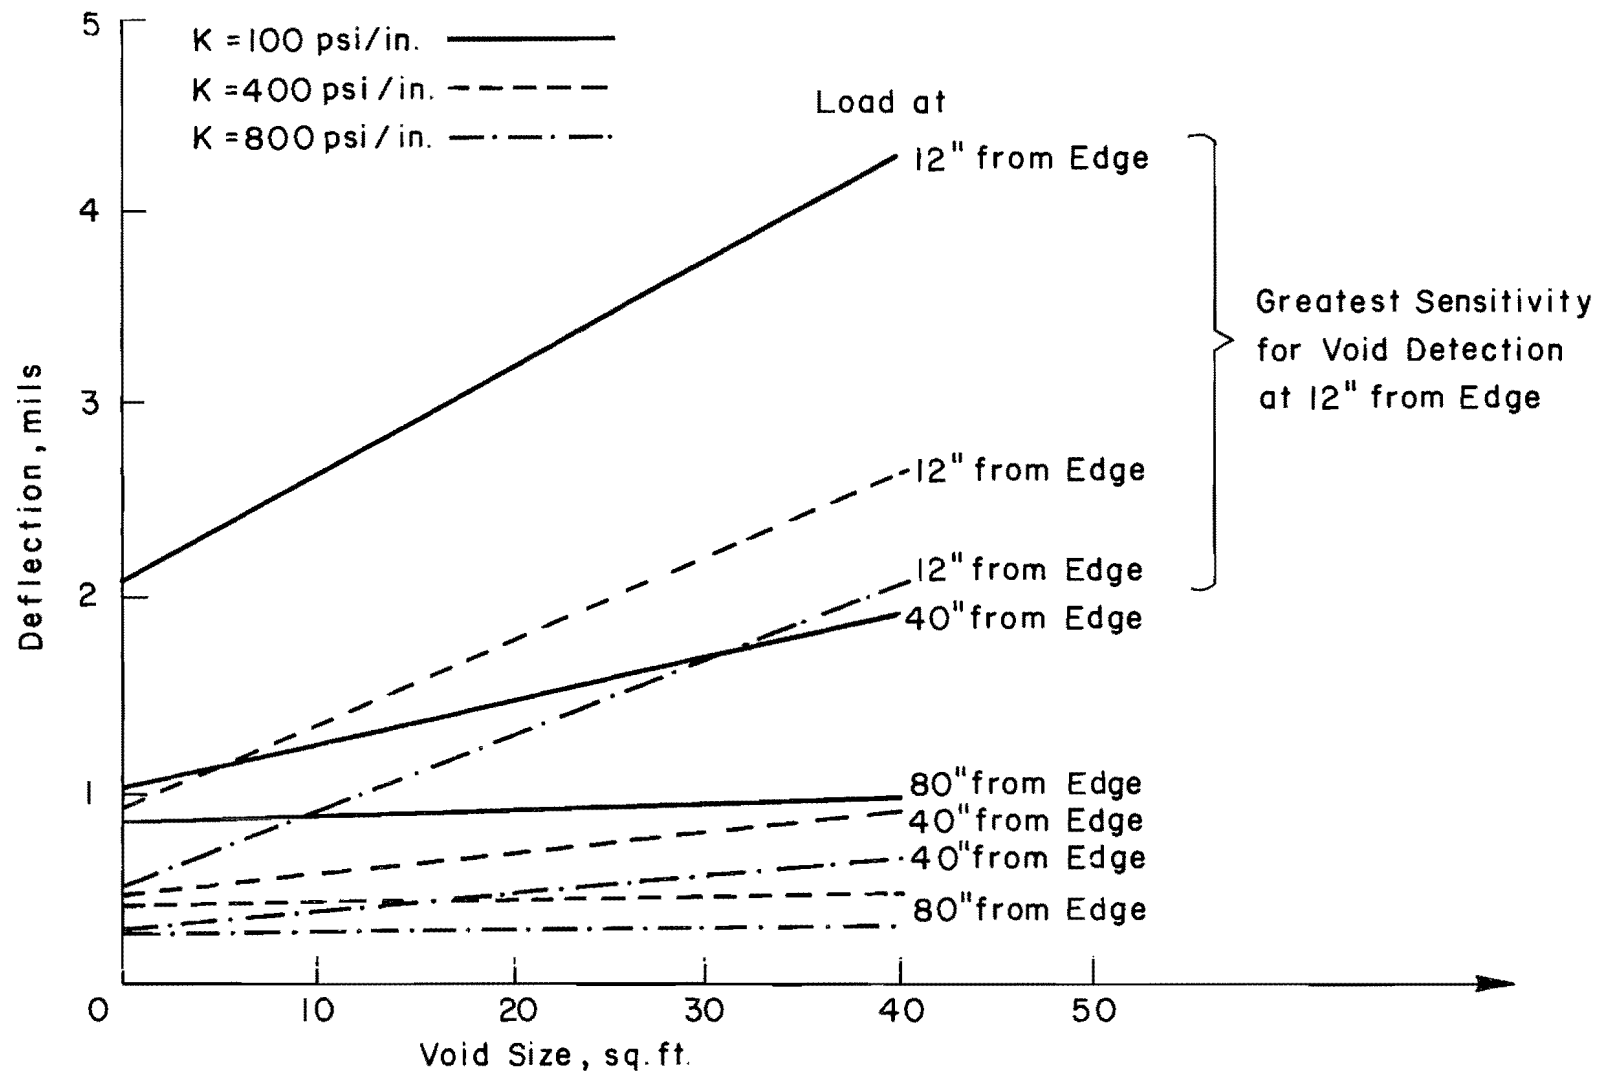
Fig 5.8. Effect of void size on Dynaflect deflection measurements.

Analyzing the deflection measurements recorded during the experiment, were more sensitive for void detection purposes than the ones recorded at any other point on the pavement. In order to corroborate this result, a theoretical analysis using the SLAB 49 computer program was developed (Ref 13). The results of this study are presented in Fig 5.8, which shows the effect of void size on the deflection measurement taken at different distances from the edge. The graph evaluates the effect for three different soil support values, i.e.,  $K = 100$  pci,  $K = 400$  pci, and  $K = 800$  pci. Studying this graph, it may be noted that the greatest sensitivity of Dynaflect deflection is obtained when measurements are taken at 12 in. from the edge. No matter what soil support value is considered, the slope of the line is greater as the load approaches the pavement edge, and the effect of voids is more noticeable in high strength soils. Therefore, according to the results obtained in both analyses, it may be concluded that deflection

measurements recorded at 12 in. from the edge provide the most reliable information for void detection purposes. Of course, temperature corrections may be required for measurements near the edge.

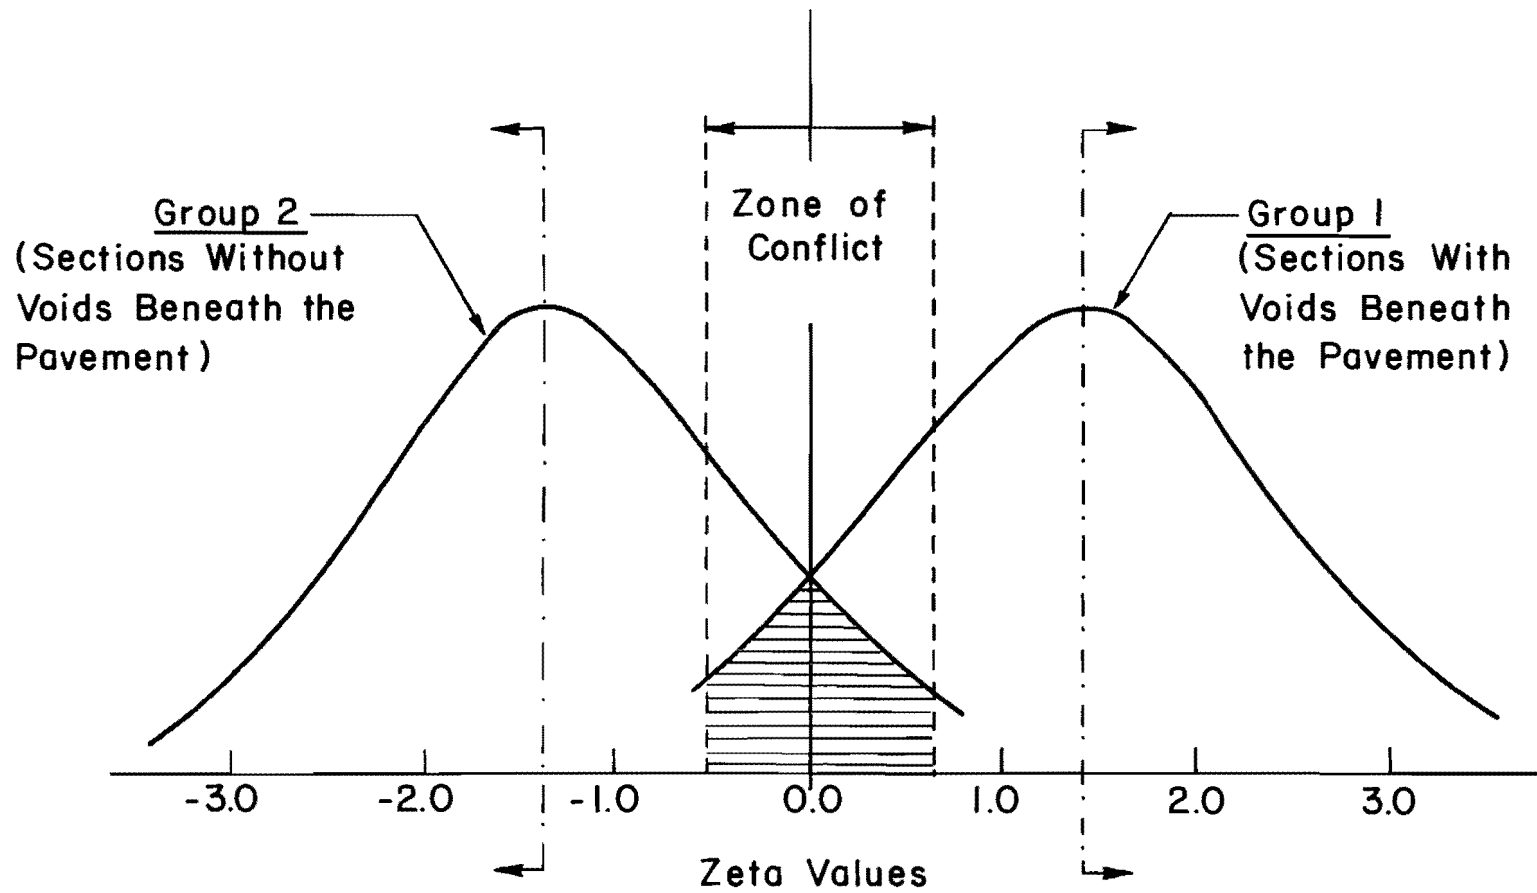
Fig 5.9. Graphic representation of the distribution of data for the development of a criterion to detect voids beneath pavements.

From this analysis, it can be concluded that the greater the value of zeta, the higher the probability of finding a void beneath the pavement, whereas, as the value of zeta decreases, the probability of no void increases.

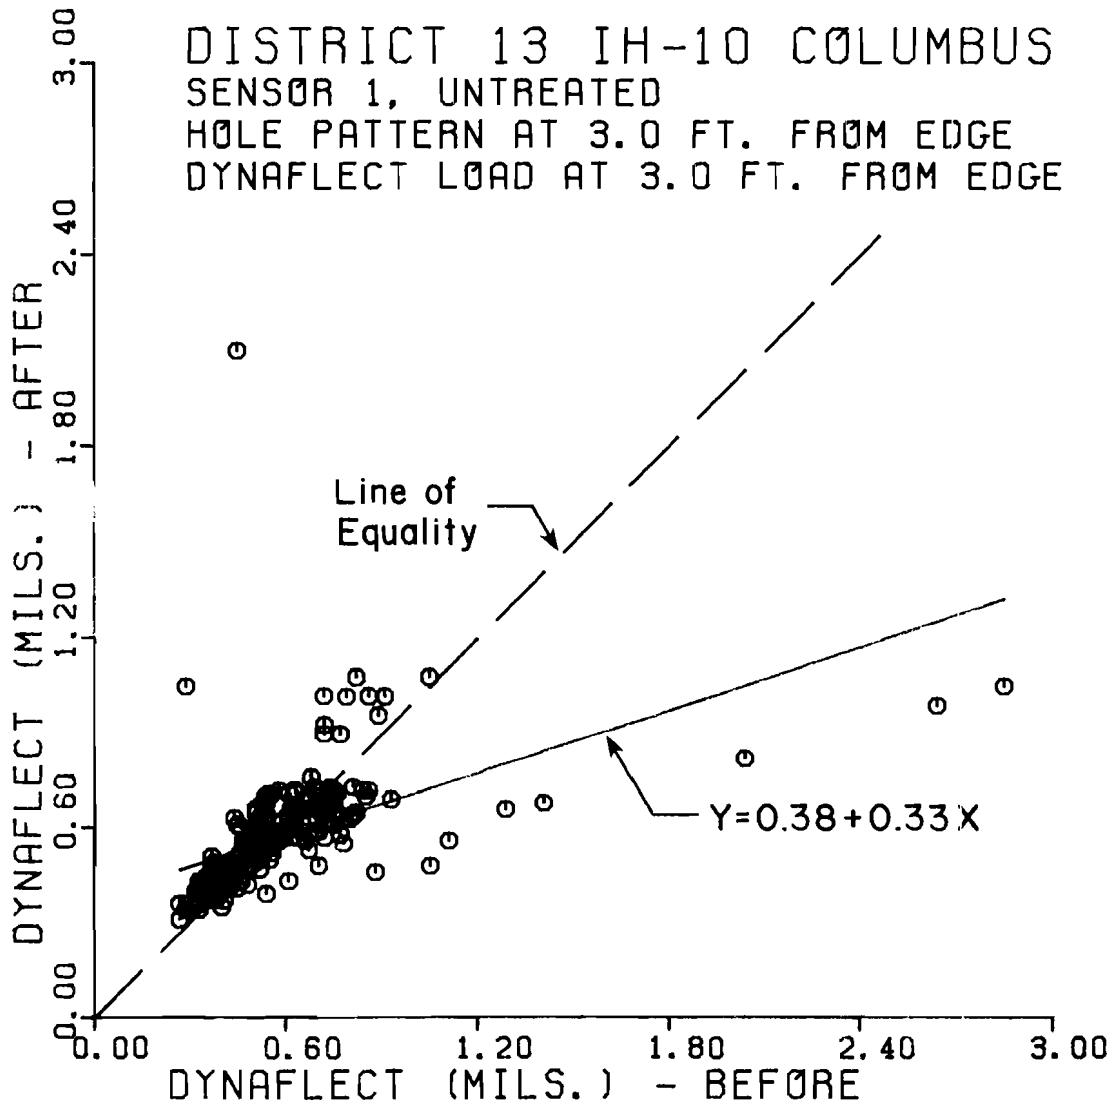
Fig 6.3. Columbus control section. District 13, IH-10.  
Regression equation is applicable only for the  
range of data shown.

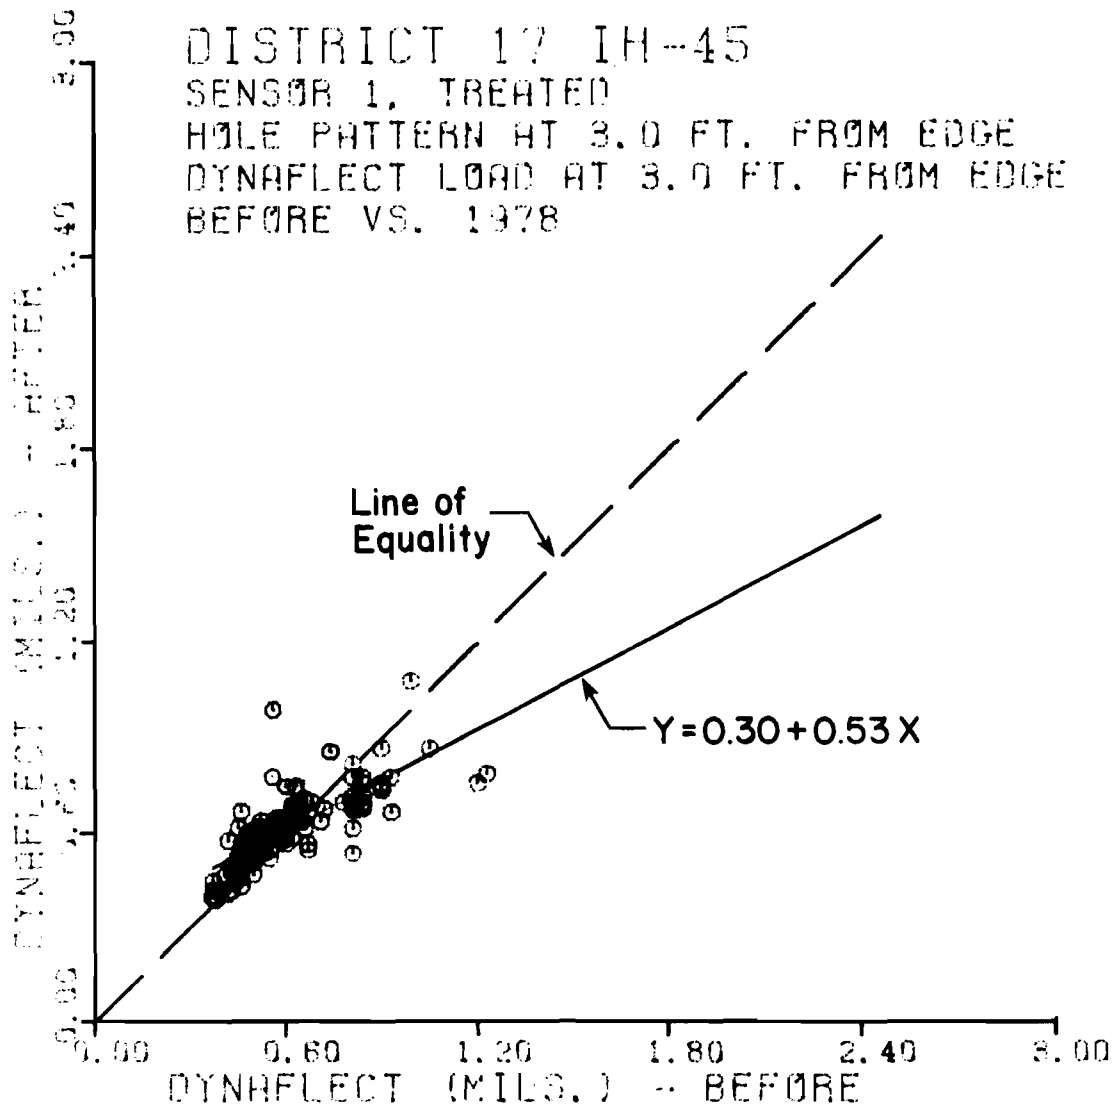
Fig 6.4. Fairfield deflections recorded before and after the grouting process. Regression equation is applicable only for the range of data shown.
