DYNAMIC TESTING PROGRAM
OF THE T. & N. O. RAILROAD OVERPASS
EL PASO COUNTY, TEXAS

B. C. GERSCH
DESIGNING ENGINEER
BRIDGE DIVISION

Final Report
On
Research Project
Part 2 of 2

Research Project 1-5-62-26

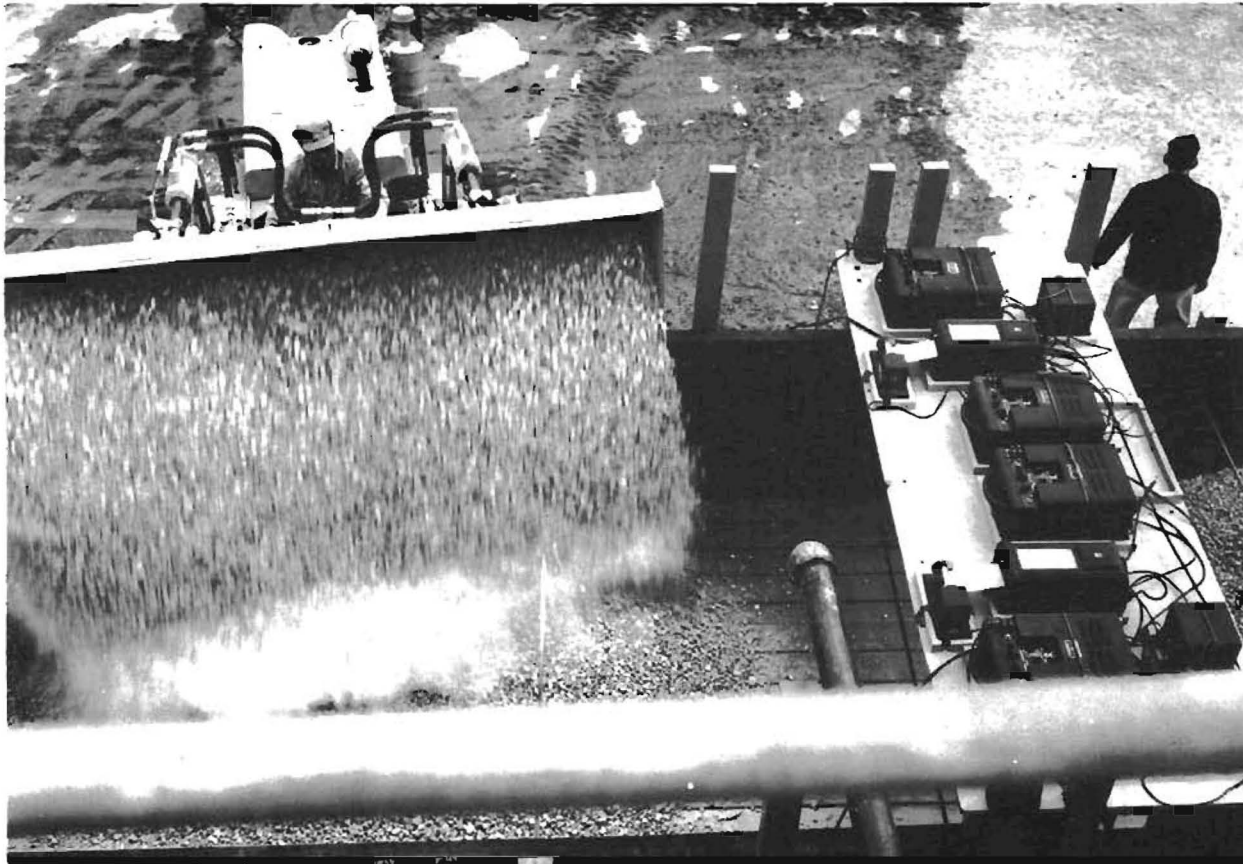
FIGURE 2A LOADING AGGREGATE INTO TEST TRUCK

The test truck was loaded with crushed stone aggregate to approximately an H20-S16 loading. (Fig. 2A) Wheel loads were measured with Department of Public Safety loadometer scales (Fig. 2B) The total weight of loaded truck was 67,400 lbs. Individual wheel loadings and spacings are shown in Fig. 3.

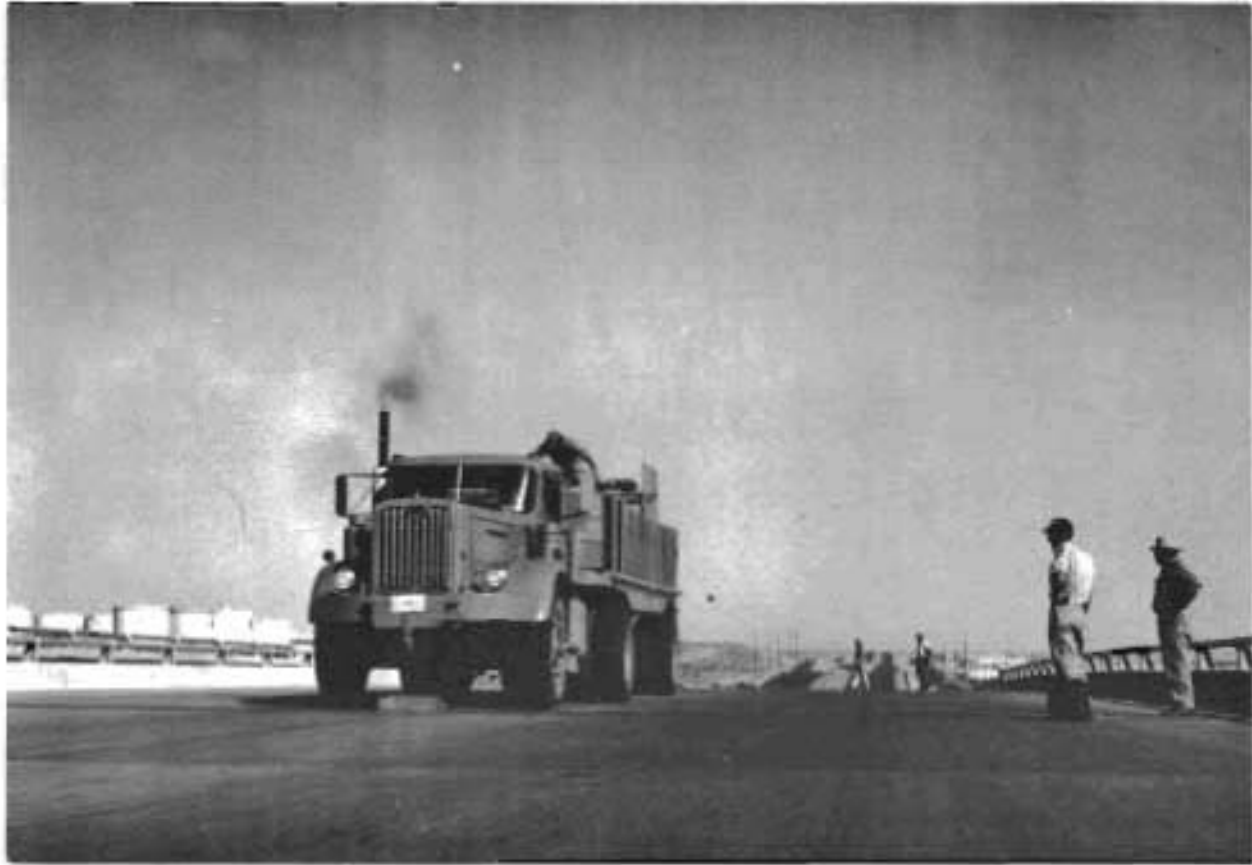
FIGURE 5 TYPICAL TEST RUN OF TRUCK

mounted on the truck to enable the driver to accurately guide the truck along these paths. A small metal arm extended down from the front bumper of the truck low enough to strike and knock over a position marker. This position marker consisted of a row of wooden clothespins clipped at 1" intervals to a two-foot long horizontal bar. This bar was mounted on a short stand and placed on the bridge deck along the path of travel. As the metal arm on the truck passed over the position marker a clothespin was knocked over thus recording the position of the centerline of the truck in relation to the intended path of travel. Figure 5 shows a test run in progress.

The test runs made by the loaded truck followed predetermined paths along the centerline of the bridge and along lines 16'-0" Left and Right of the centerline (Curb Lanes Fig. 1). These paths of travel were marked on the bridge deck and extended approximately 200 feet beyond each end of the structure. This enabled the truck driver to get positioned correctly before proceeding across the bridge. "Sights" were
