1. Report No. FHWA/TX-04/0-4396-1		2. Government Accession No.		3. Recipient's Catalog No.	
4. Title and Subtitle Best Practices for Pavement Edge Maintenance				5. Report Date May 2004

BEST PRACTICES FOR PAVEMENT EDGE MAINTENANCE  
RESEARCH REPORT

Research Report Number 0-4396-1  
Project Number 0-4396  
Project Title: Improving Edge Repair and Stabilization

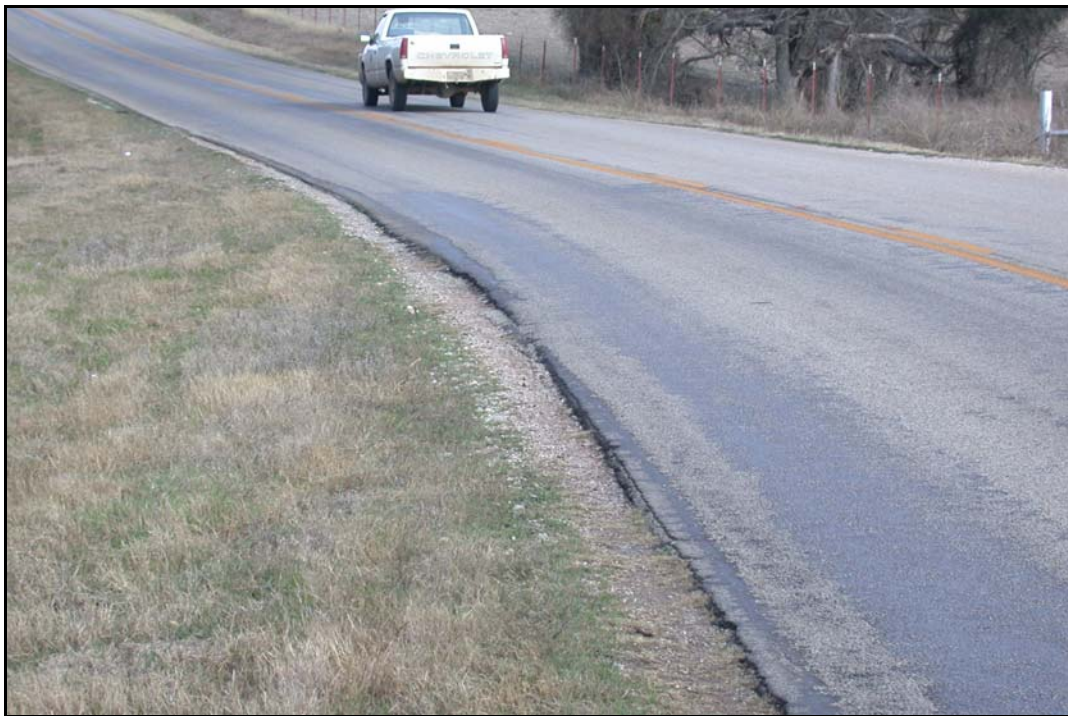
**FIG. 4.11.** Typical Edge Drop-off at Inside Horizontal Curve on a Low Volume FM Road.

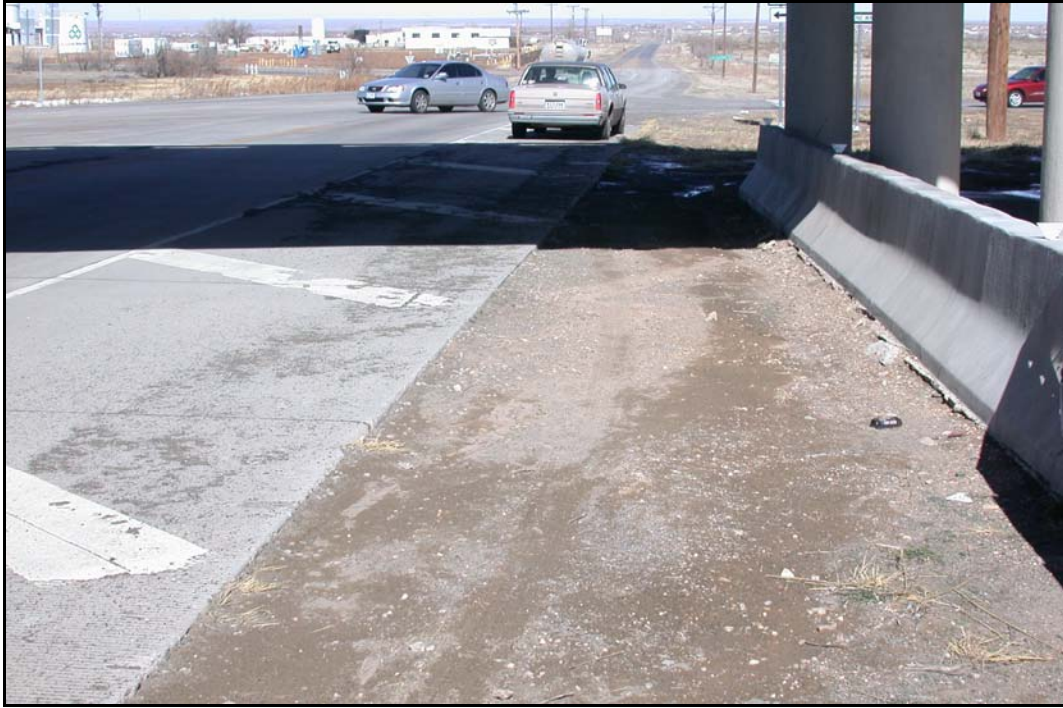
**FIG. 4.16.** Pavement Edge Damage Associated with Vehicle Pull-offs Beneath an Overpass.

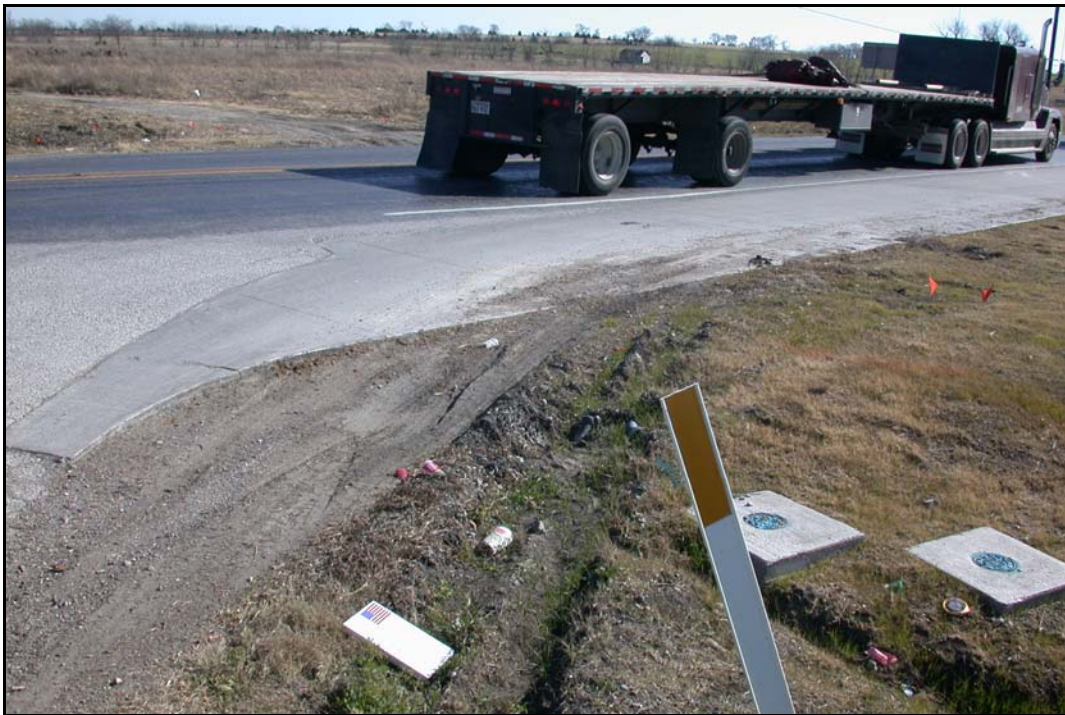
**FIG. 4.20.** Edge Damage Caused by Cutting Corners at a Convenience Store Access Drive.

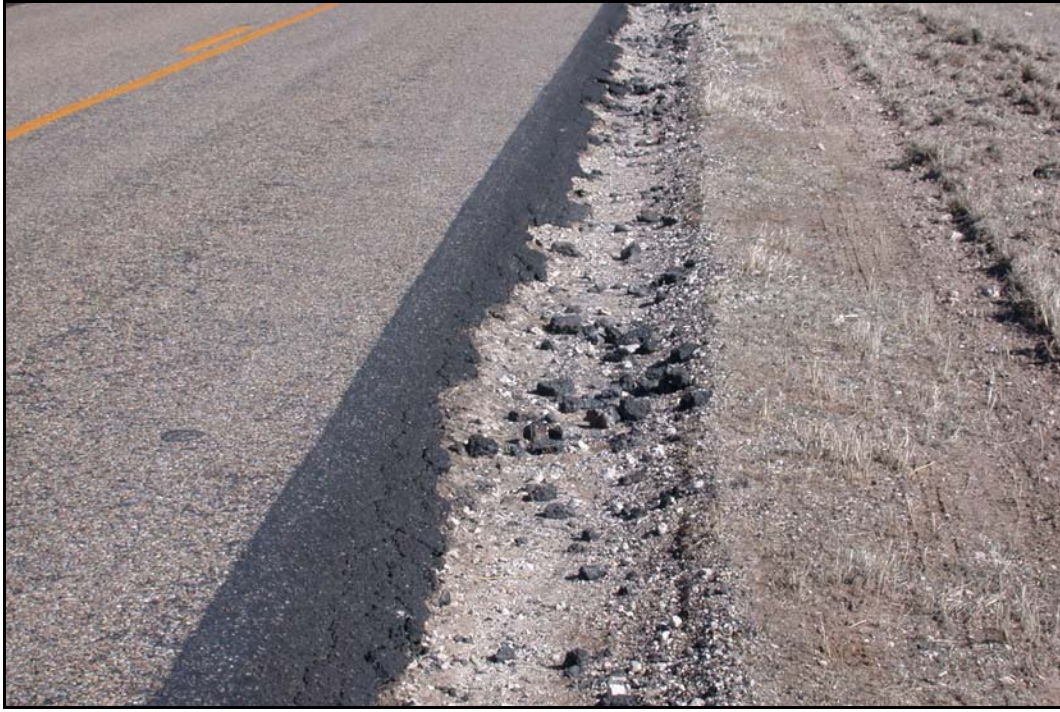
**FIG. 4.22.** Typical Edge Damage on a Low Volume Road Caused by Snow Plow Operations.

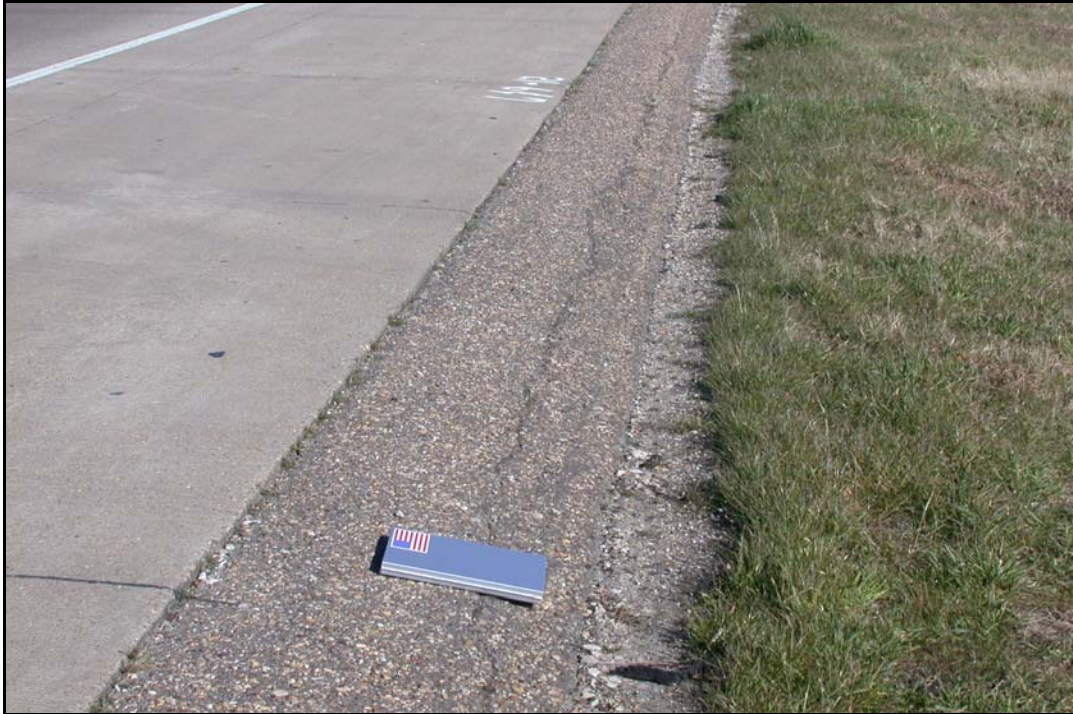
**FIG 5.7** Tapered Edge Detail, Dallas District (see Dallas District Profile, Photo 6)

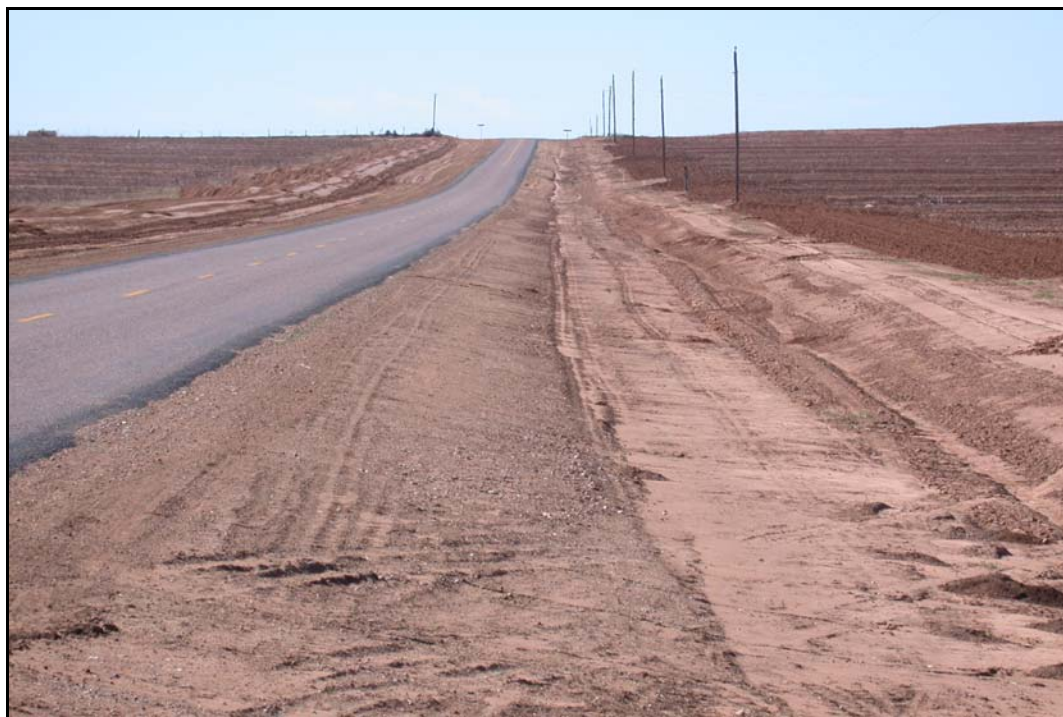
**FIG 5.23** Reshaping (Pulling) Shoulders, Childress District (see Childress District Profile, Photo 15)

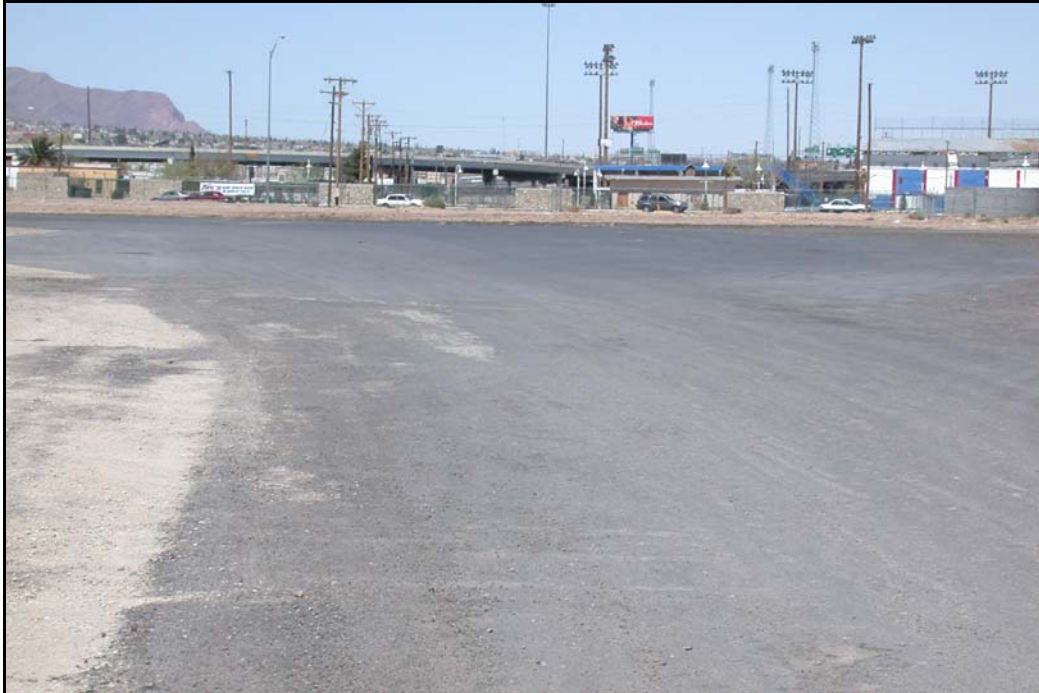
**FIG. 5.31** US Customs Truck Parking Lot, RAP Treated with Magnesium Chloride, El Paso District, (see El Paso District Profile, Photograph 23)

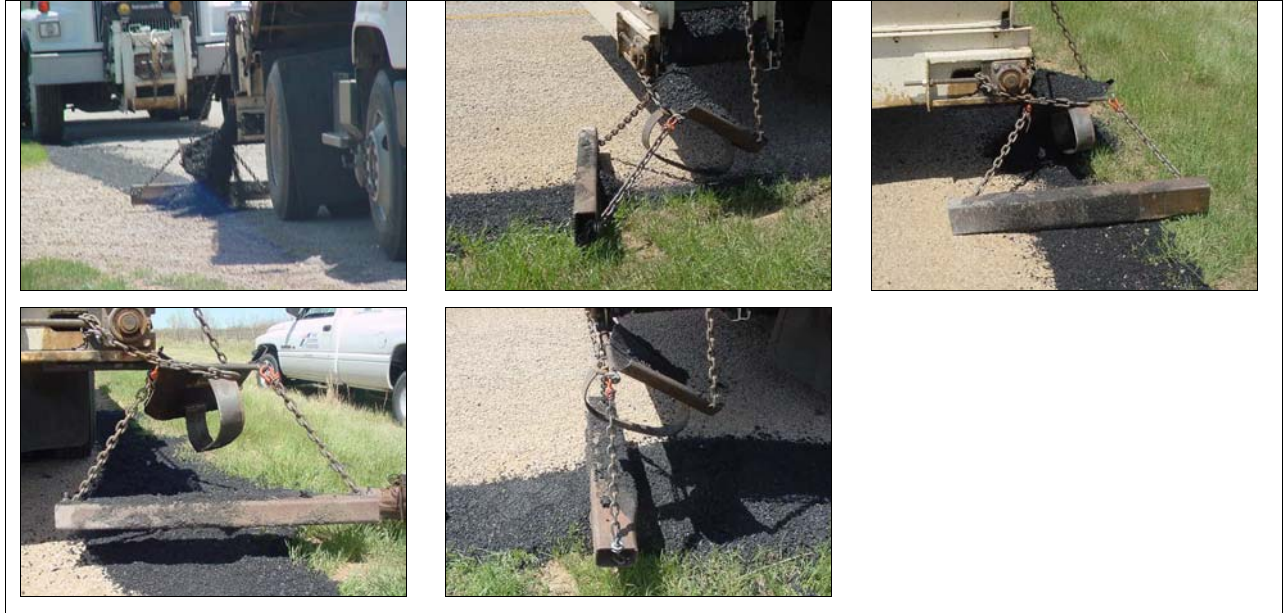
**FIG. 7.15** Photo Series: Side Discharge Chute and Tow-Behind Drag Bar for Edge Repair, Wichita Falls District
