1. Report No. FHWA/TX-04/0-4396-1		2. Government Accession No.		3. Recipient's Catalog No.	
4. Title and Subtitle Best Practices for Pavement Edge Maintenance				5. Report Date May 2004

BEST PRACTICES FOR PAVEMENT EDGE MAINTENANCE  
RESEARCH REPORT

Research Report Number 0-4396-1  
Project Number 0-4396  
Project Title: Improving Edge Repair and Stabilization

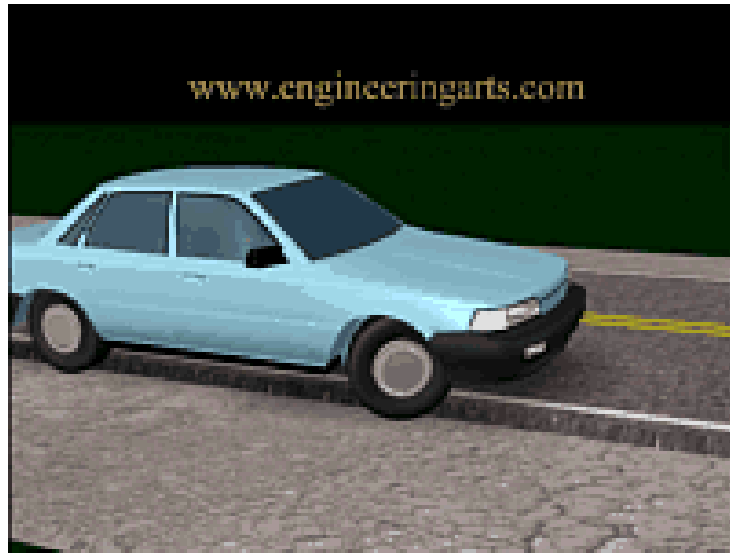
**FIG 3.2.** The Scrubbing Phenomenon. *Source:* <www.engineeringarts.com>

Figure 3.2 provides a graphic which illustrates the scrubbing phenomenon. Unlike static drawings, the online graphic actually shows, in slow motion, vehicle movements during scrubbing.

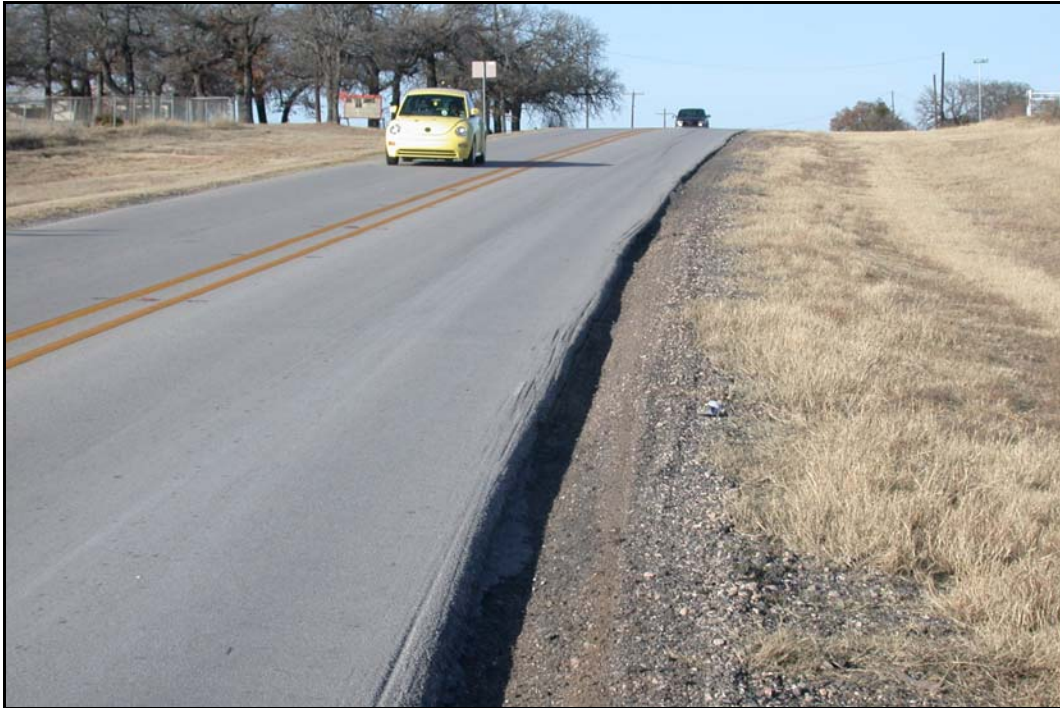
**FIG. 4.8.** Edge Drop-off at Relatively High-Volume, Narrow FM Road (21-foot width, ADT 4,400 vehicles/day).

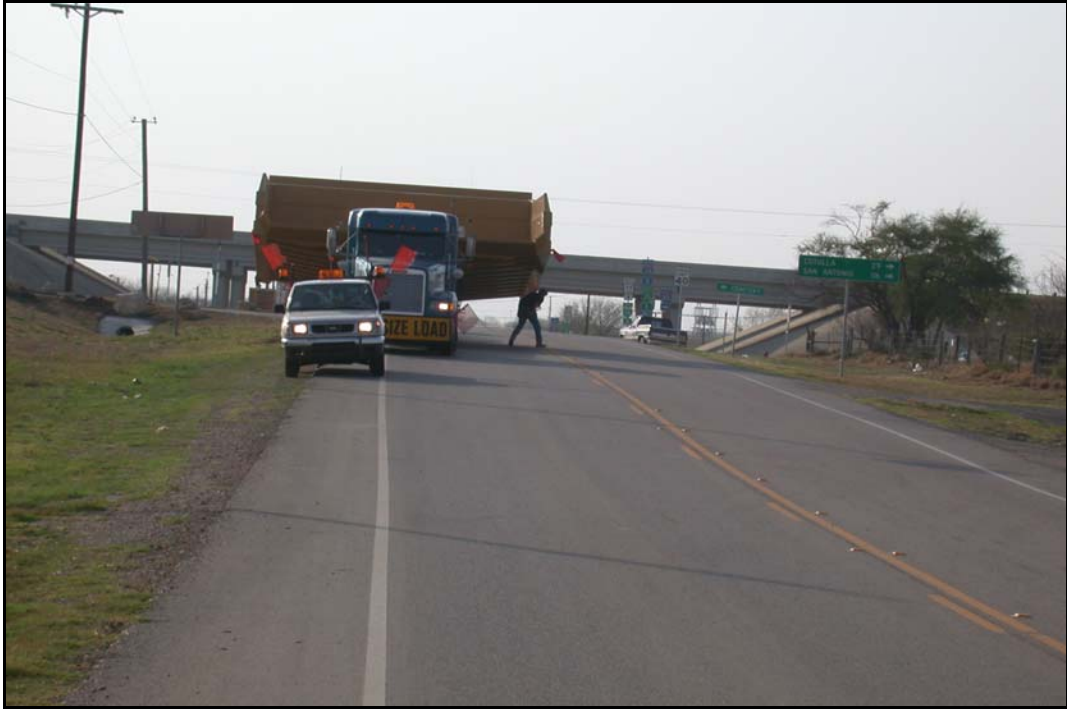
**FIG. 4.9.** Edge Damage due to Unconventional Traffic.

“unconventional traffic”, as explained in the low volume roads section (see Figure 4.9). On the other hand, roads in densely-populated urban areas frequently experience edge damage associated with the abusive or unauthorized use of the roadway such as left turn bypass maneuvers, cutting corners, or vehicle pull-offs. These unauthorized or abusive uses of the roadway actually can produce significant edge damage in a short period of time.

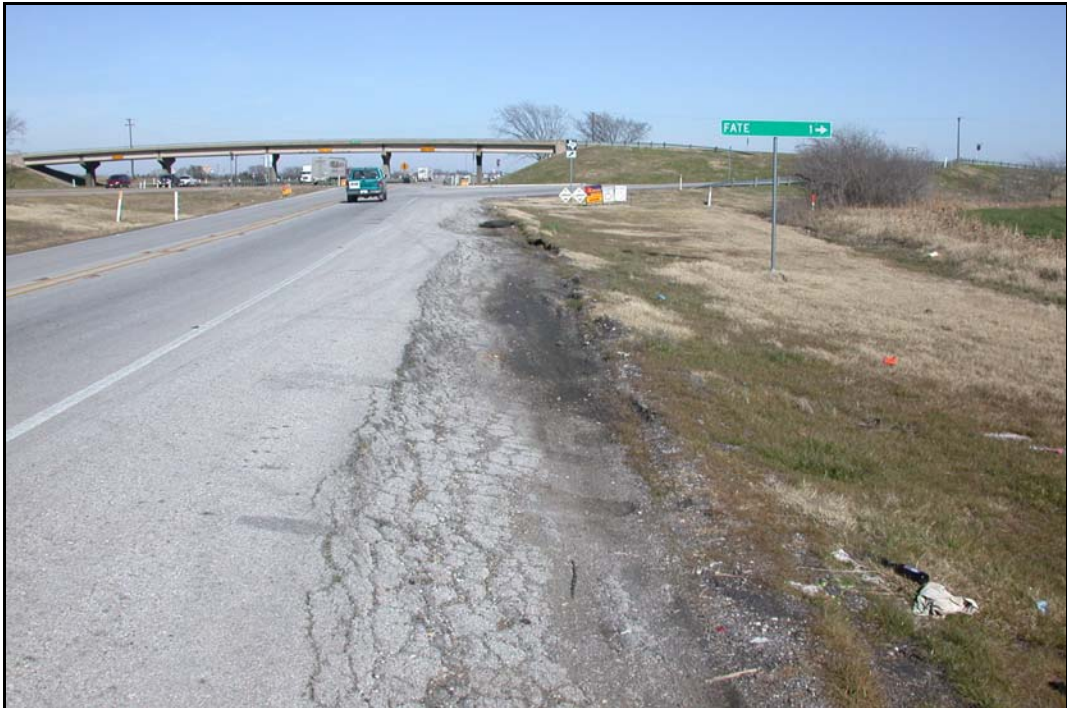
**FIG. 4.10.** Edge Damage Along Interstate Highway Access Road.

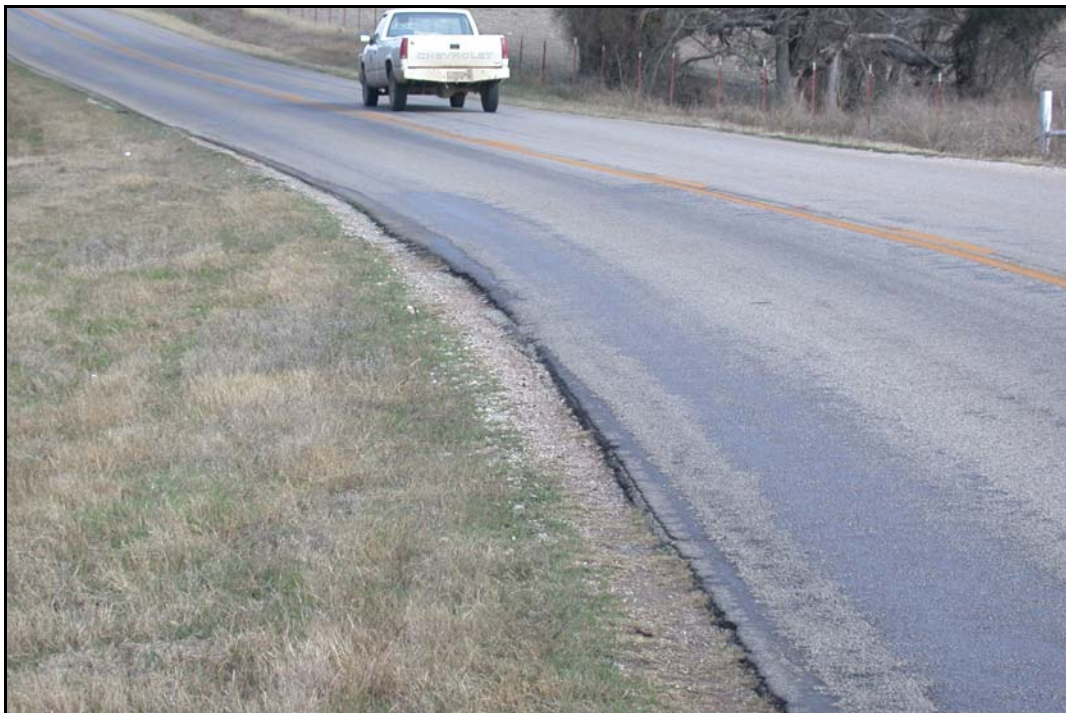
**FIG. 4.11.** Typical Edge Drop-off at Inside Horizontal Curve on a Low Volume FM Road.

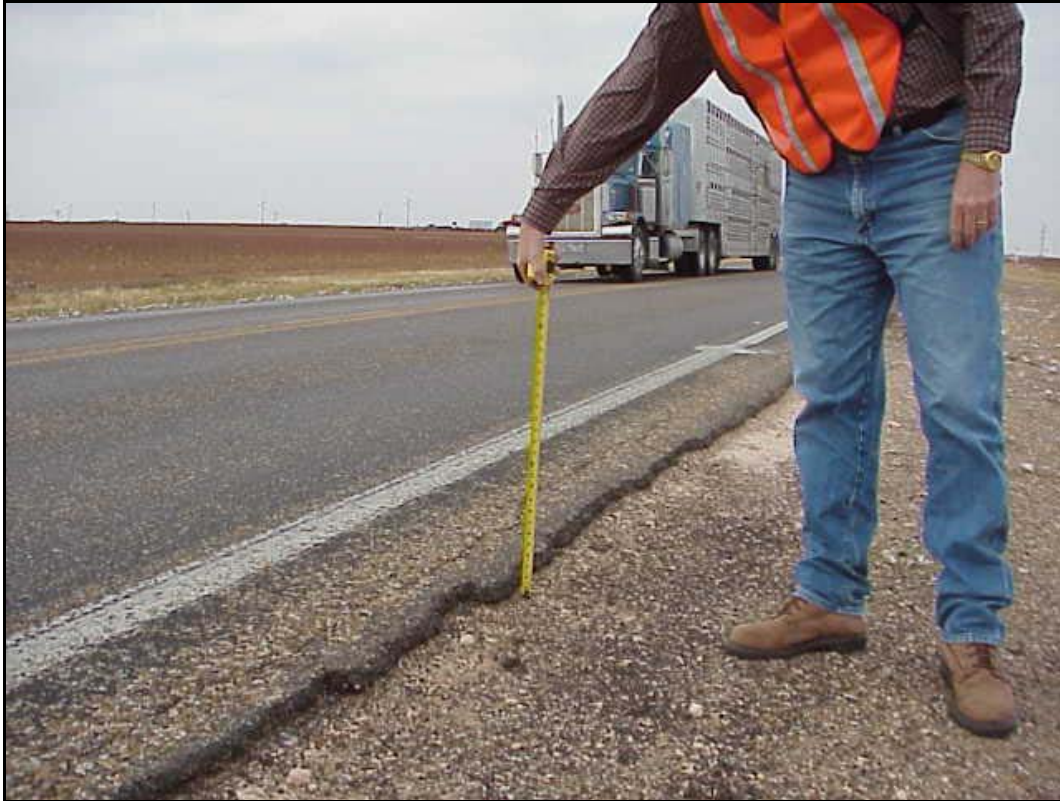
**FIG. 4.15.** Typical Pavement Edge Damage Associated with Cotton Production in West Texas.

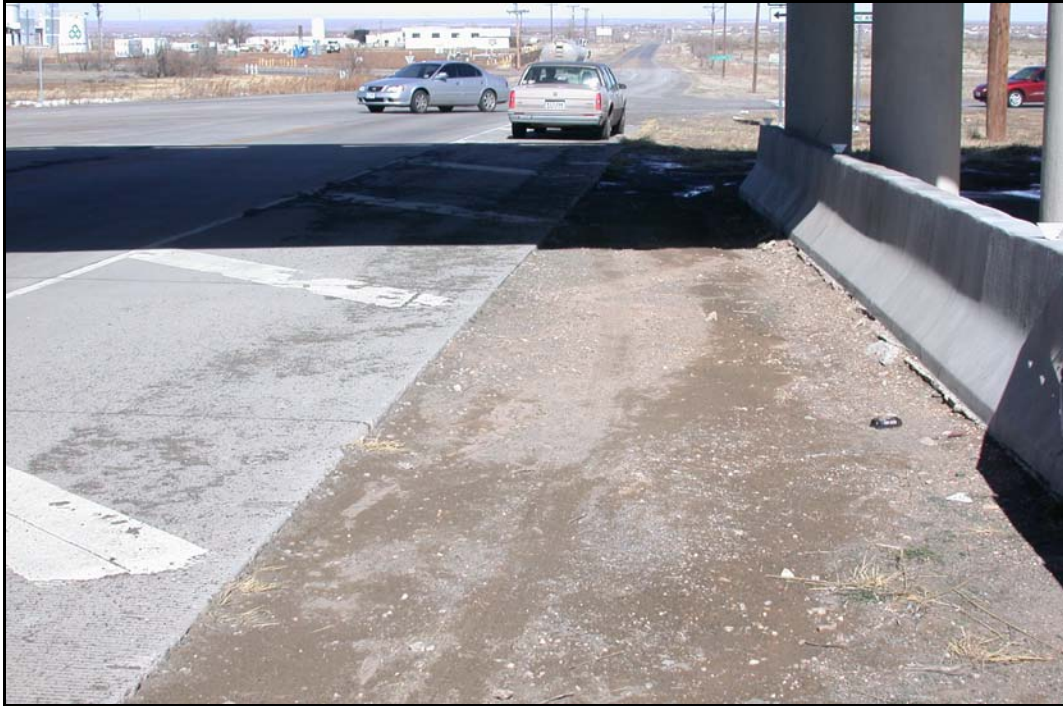
**FIG. 4.16.** Pavement Edge Damage Associated with Vehicle Pull-offs Beneath an Overpass.

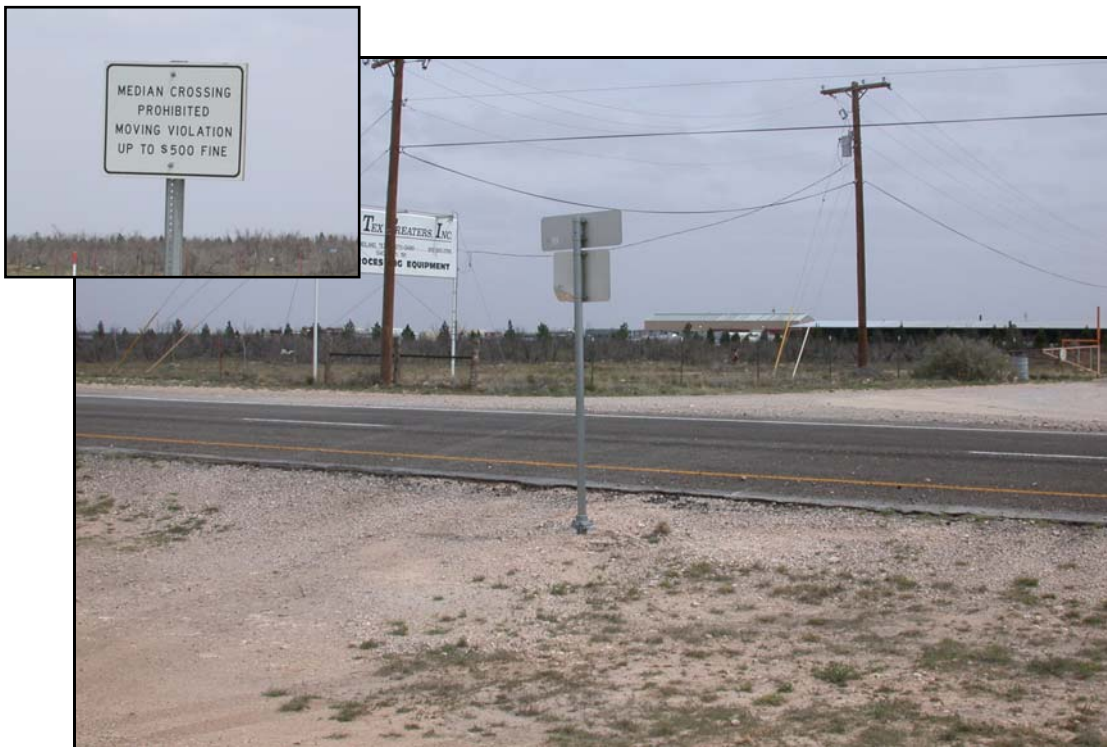
**FIG. 4.17.** Pavement Edge Damage Associated with Illegal Median Crossing. The Inset Shows the Regulation Sign Posted Where the Crossing Continues to Occur

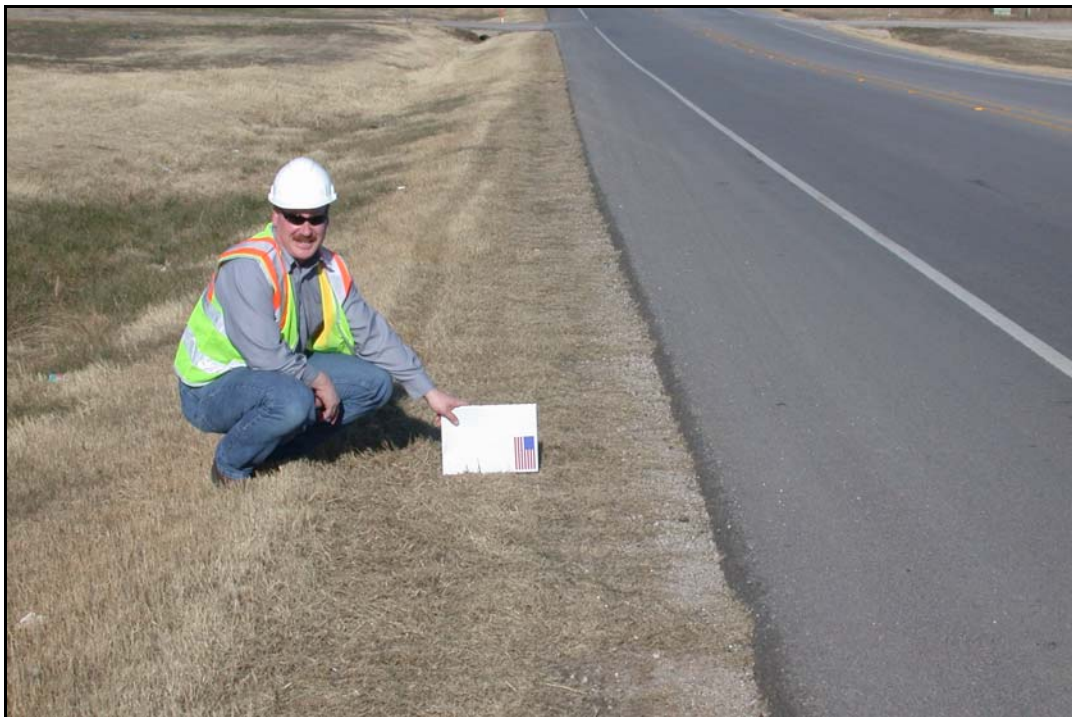
**FIG. 4.19.** Typical Edge Damage Associated with Illegal Left-Turn Bypass Maneuver.

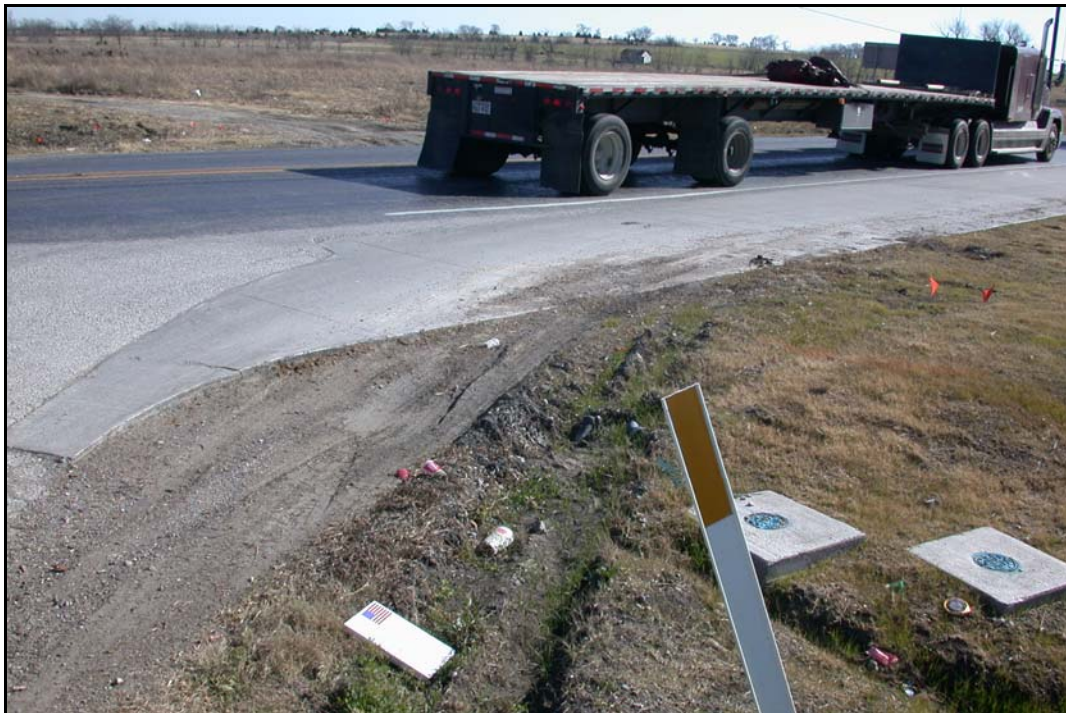
**FIG. 4.20.** Edge Damage Caused by Cutting Corners at a Convenience Store Access Drive.

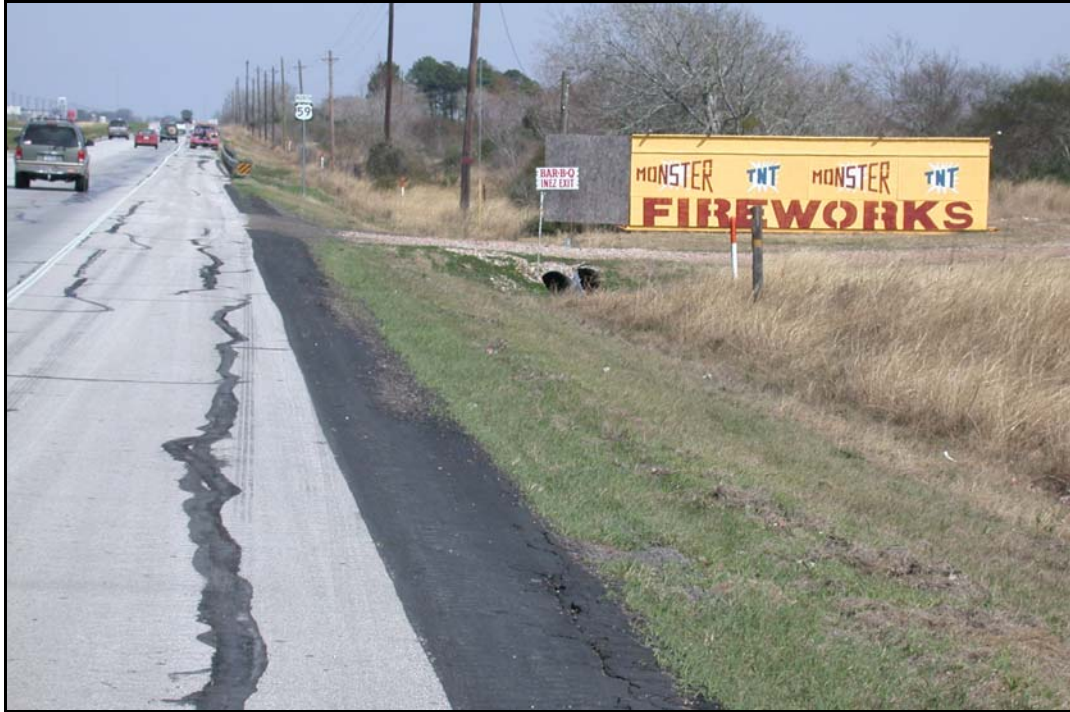
**FIG. 4.21.** Typical Edge Damage at Location of Roadside Vendor.

Vehicles pull over to make illegal access or exit to roadside vendors such as firecracker stands, farmers' produce stands, or shrimp vendors (see Figure 4.21). These types of maneuvers are repetitive in nature and can create significant damage in a short time.

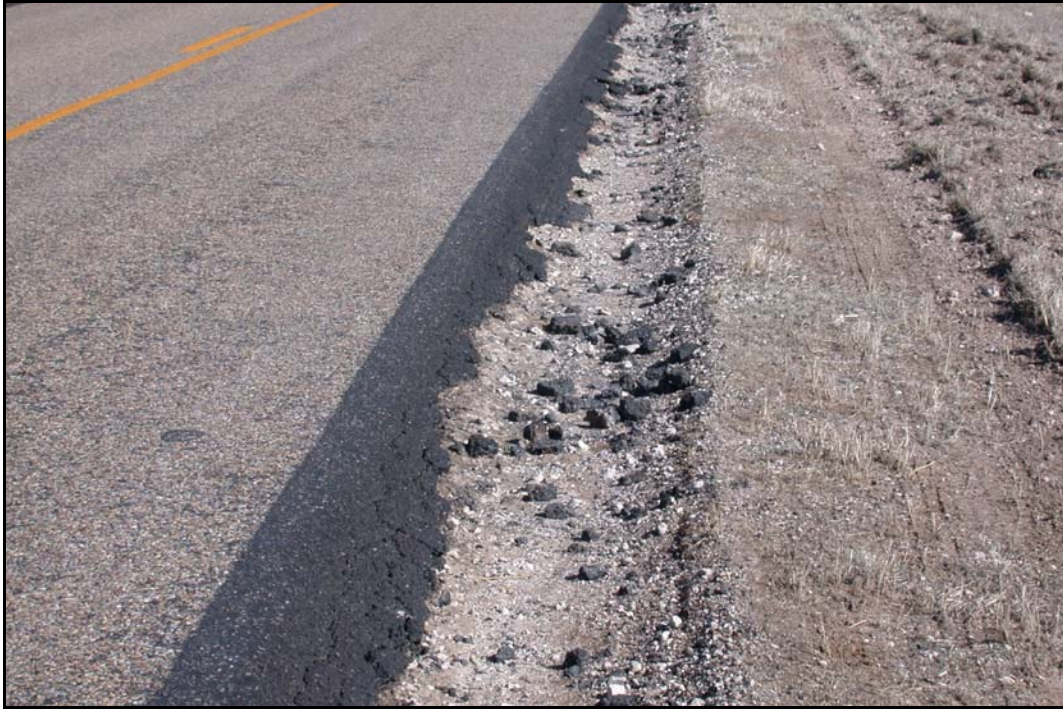
**FIG. 4.22.** Typical Edge Damage on a Low Volume Road Caused by Snow Plow Operations.

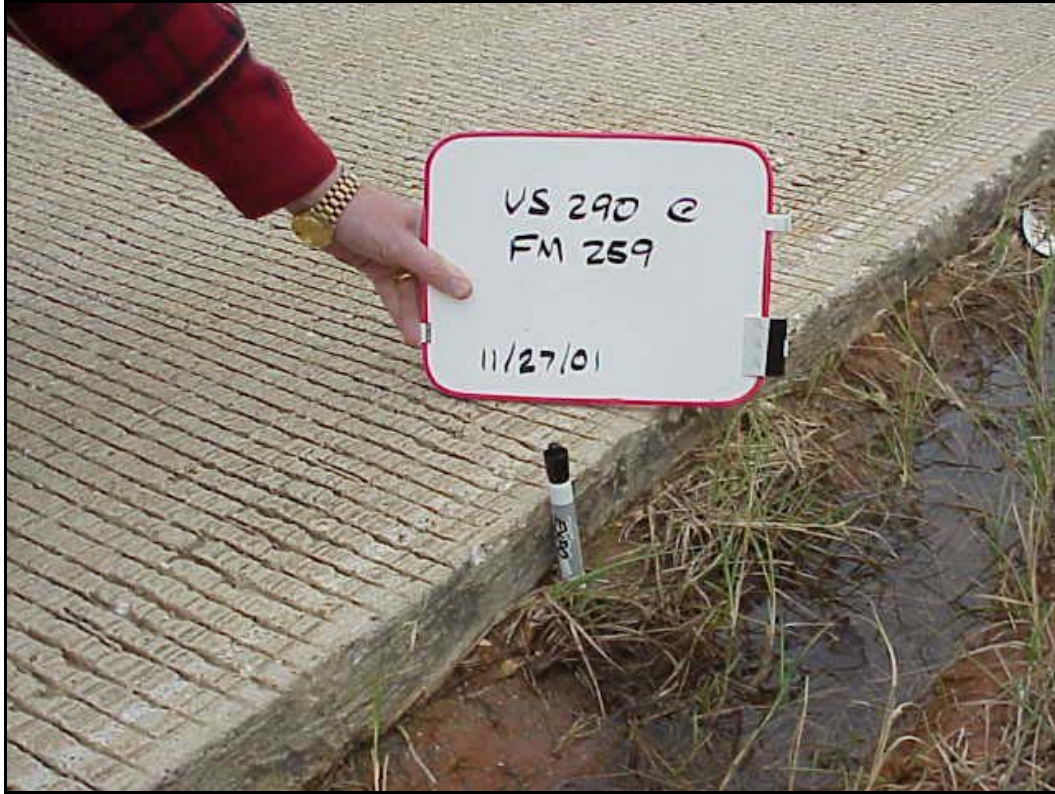
**FIG. 4.26.** Edge Drop-off Associated with Wet Subgrade Along the Edge of Pavement

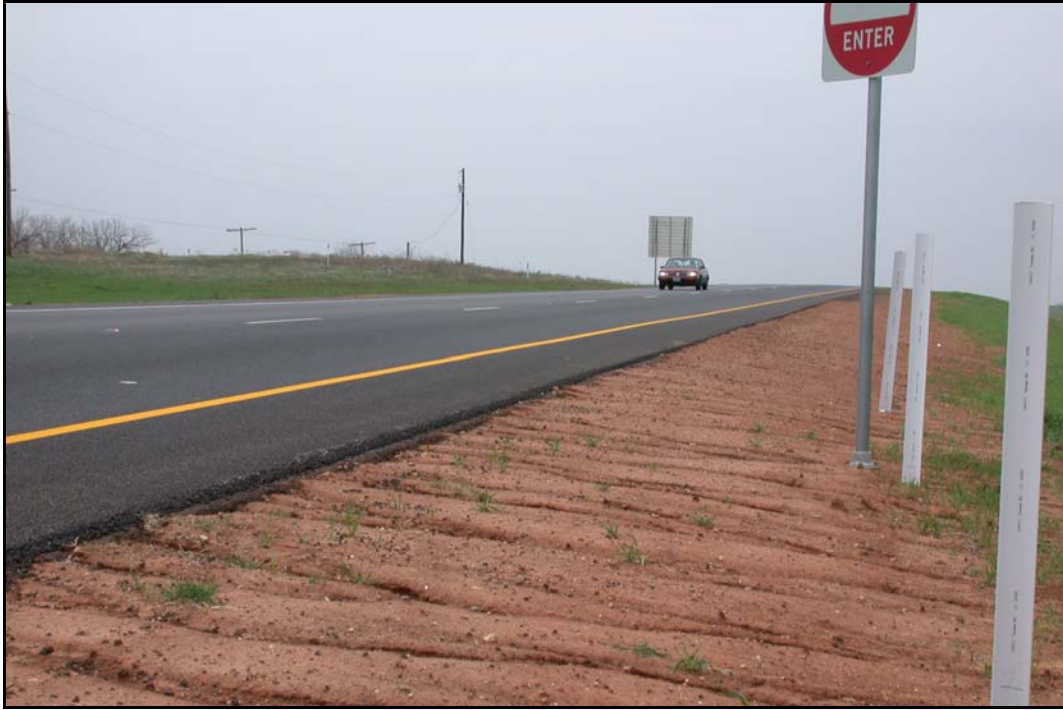
**FIG 5.6** Soil Erosion of Pavement Edge Backfill due to Improper Specification, Wichita Falls District (see Wichita Falls District Profile, Photo 7)

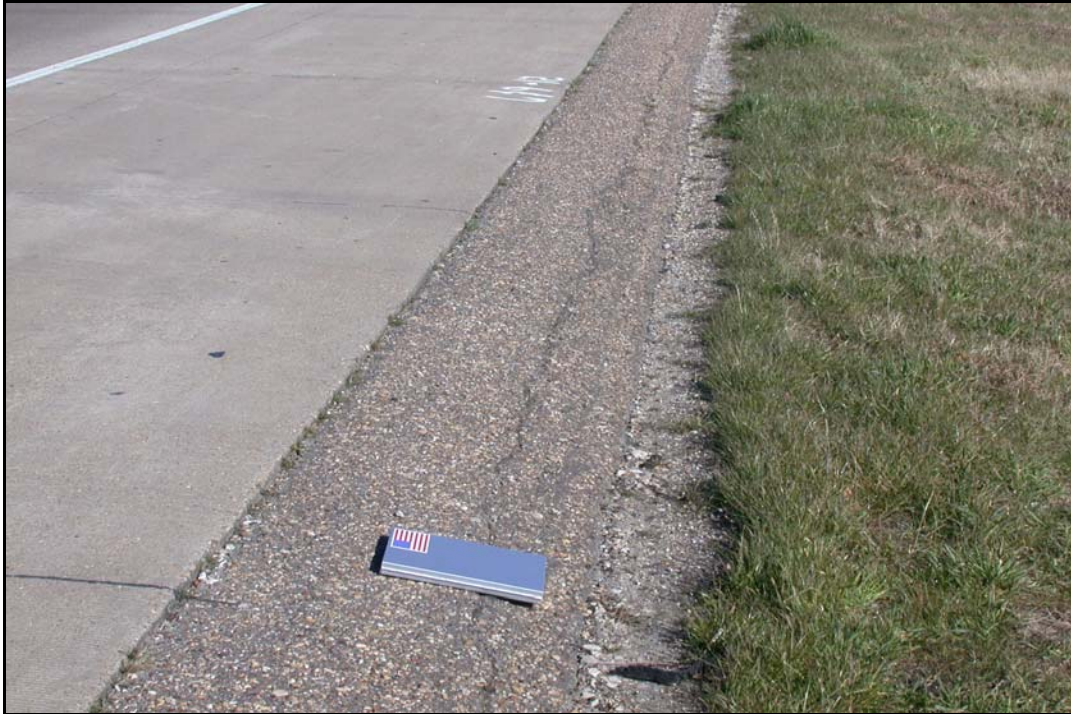
**FIG 5.7** Tapered Edge Detail, Dallas District (see Dallas District Profile, Photo 6)

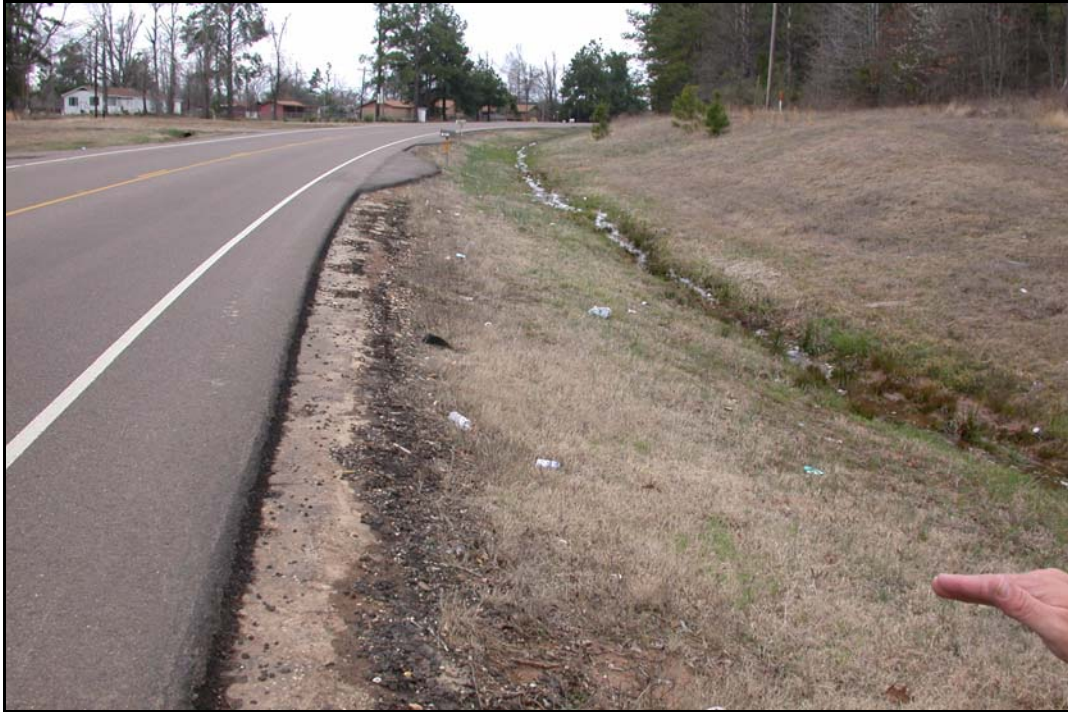
**FIG 5.13** Erosion-induced Edge Drop-off Following an Overlay, Atlanta District (see Atlanta District Profile, Photo 11)

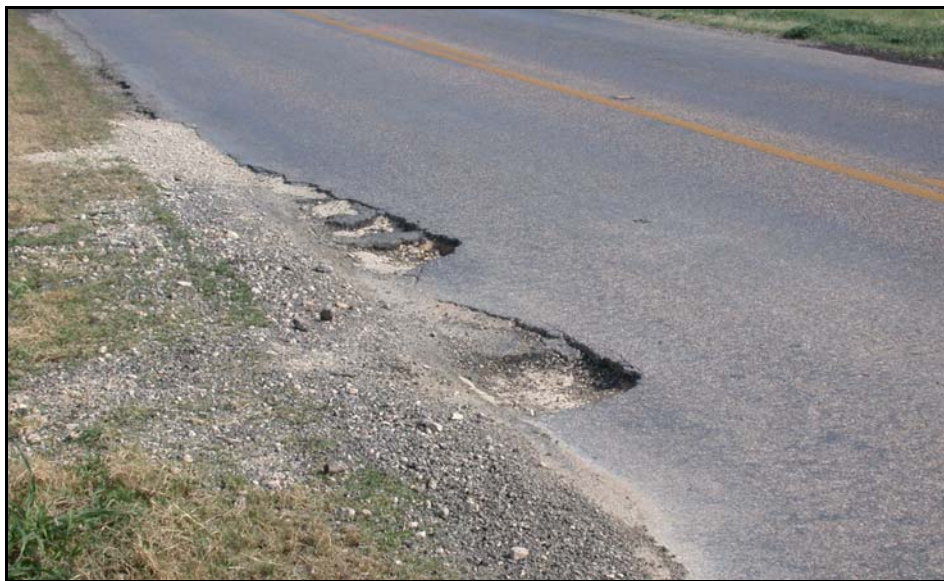
**FIG 5.22** Fishmouth-type Edge Failure, San Antonio District (see San Antonio District Profile, Photo 12)

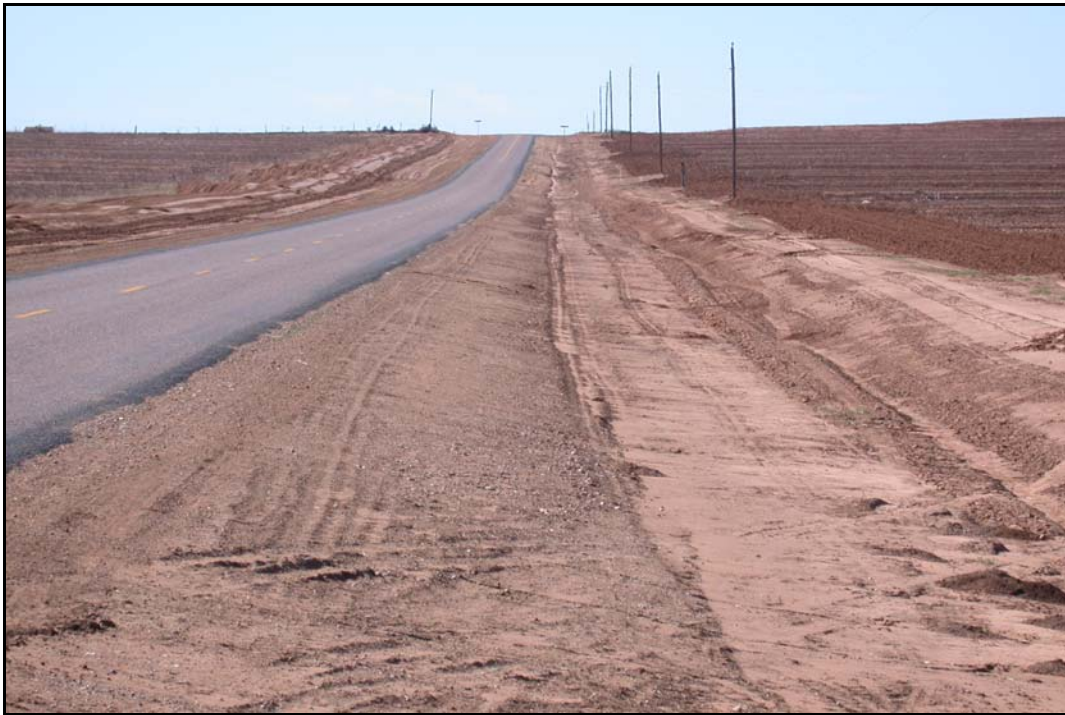
**FIG 5.23** Reshaping (Pulling) Shoulders, Childress District (see Childress District Profile, Photo 15)

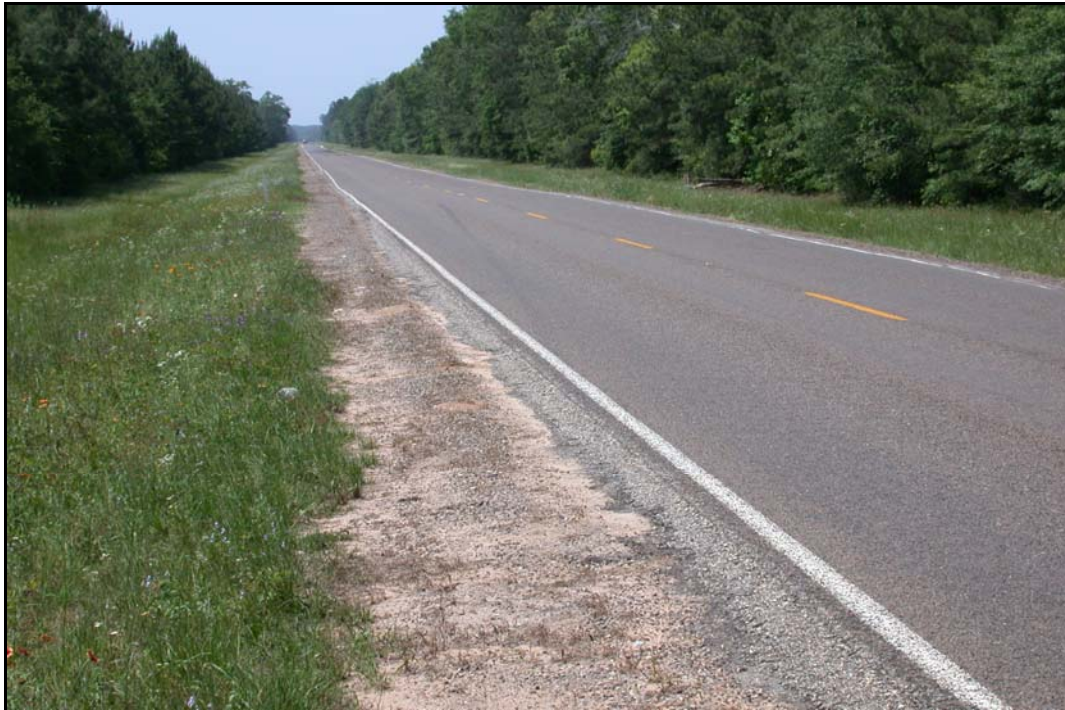
**FIG 5.24** Cutting High Edges, Lufkin District (see Lufkin District Profile, Photo 14)

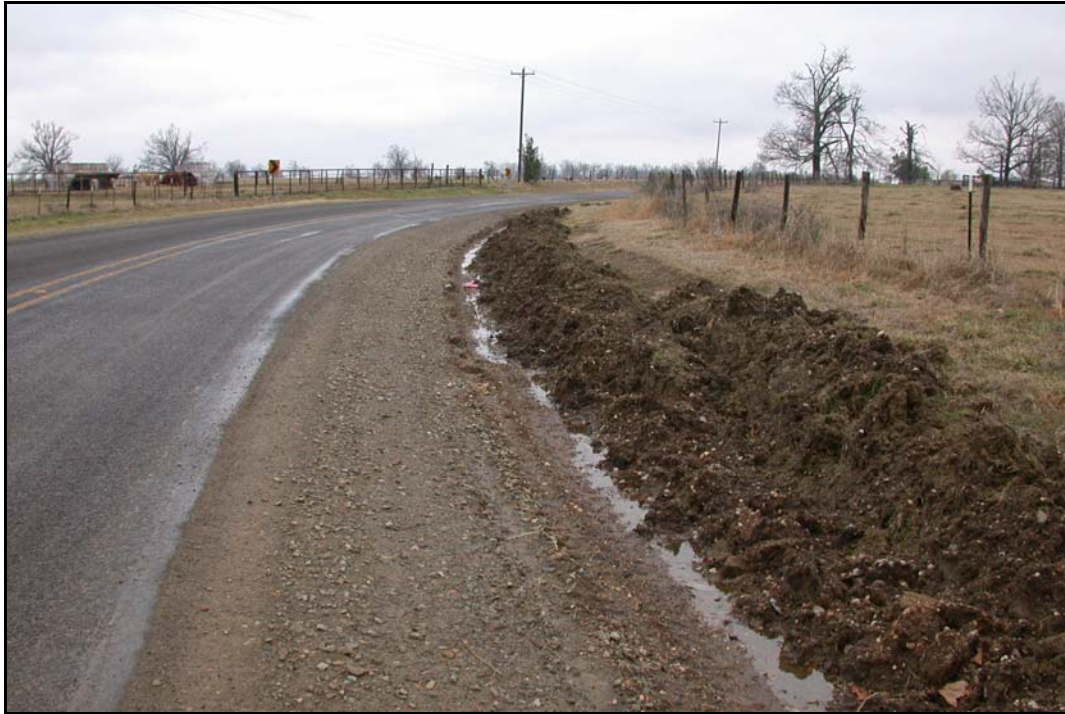
**FIG. 5.26** Replenishing Repair at the Inside Horizontal Curve of an FM Road, Paris District (see Paris District Profile, Photo 23)

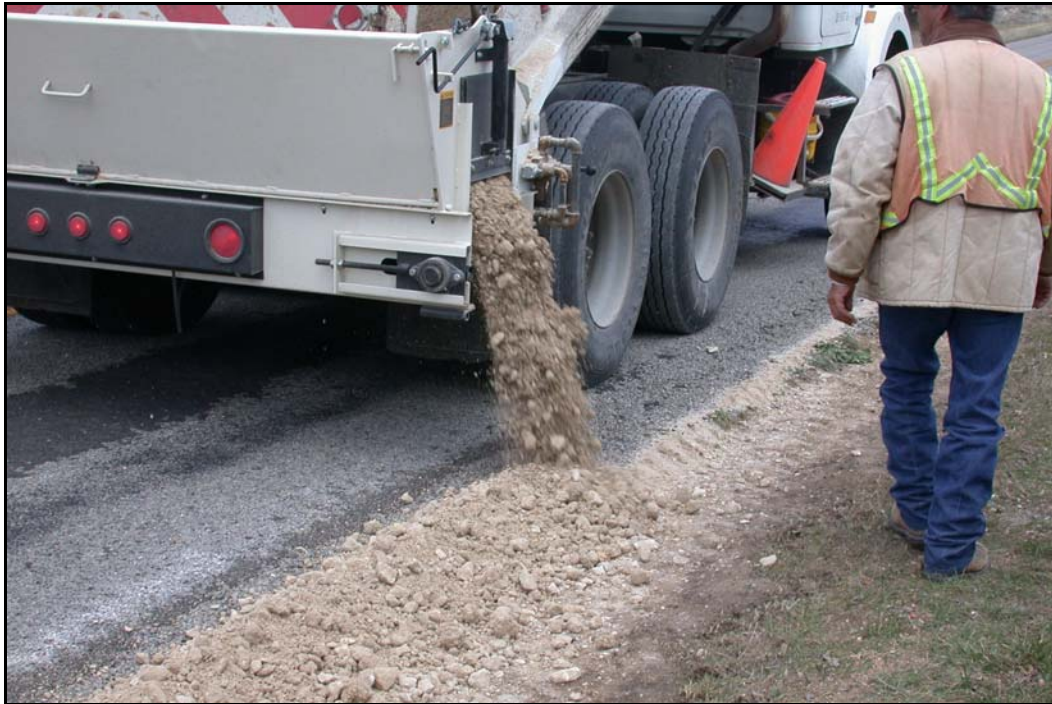
**FIG. 5.27** Delivering Flex Base to the Pavement Edge Using a Swenson Tailgate Cross Conveyor (a.k.a. “Swenson Spreader”), Brownwood District (see Brownwood District Profile, Photo 13)

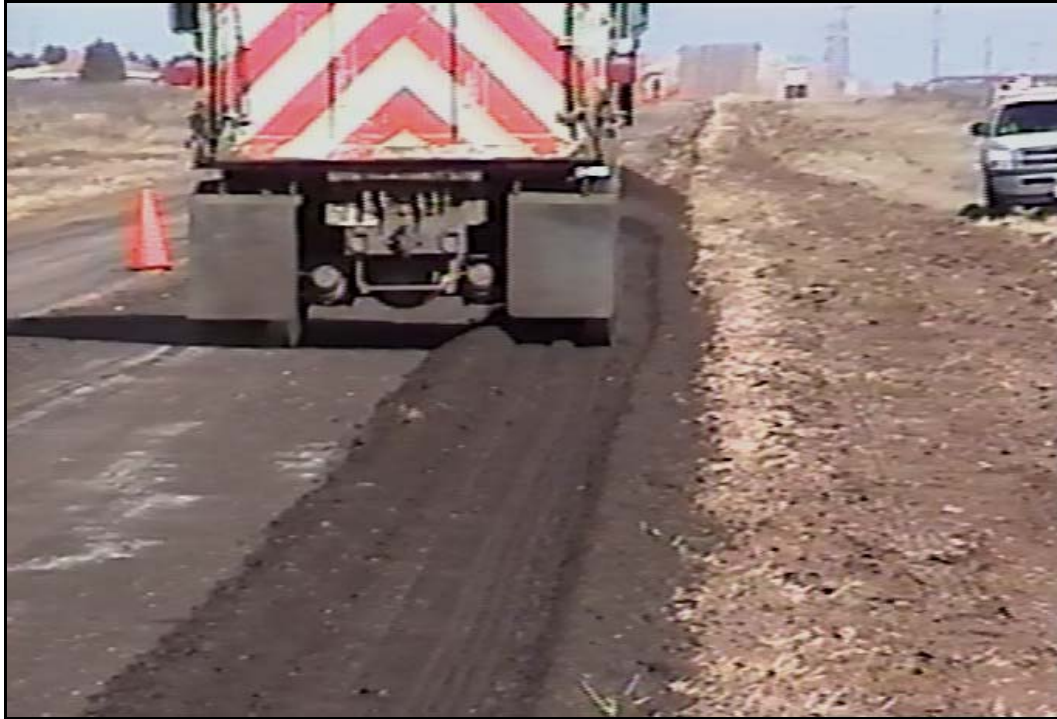
**FIG. 5.28** District Forces Use Dump Truck Tires to Achieve Ordinary Compaction for Edge Repair, Amarillo District

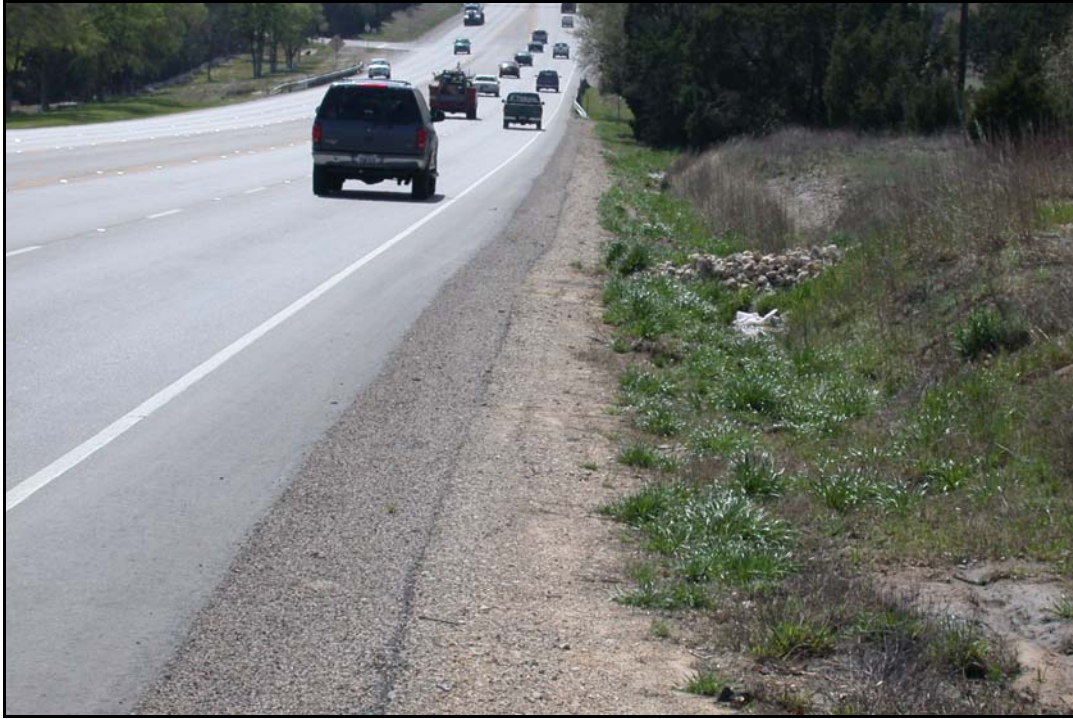
**FIG. 5.29** Strip Seal Coat on a Contract Replenishing Project Using Flex Base, Austin District (see Austin District Profile, Photograph 4)

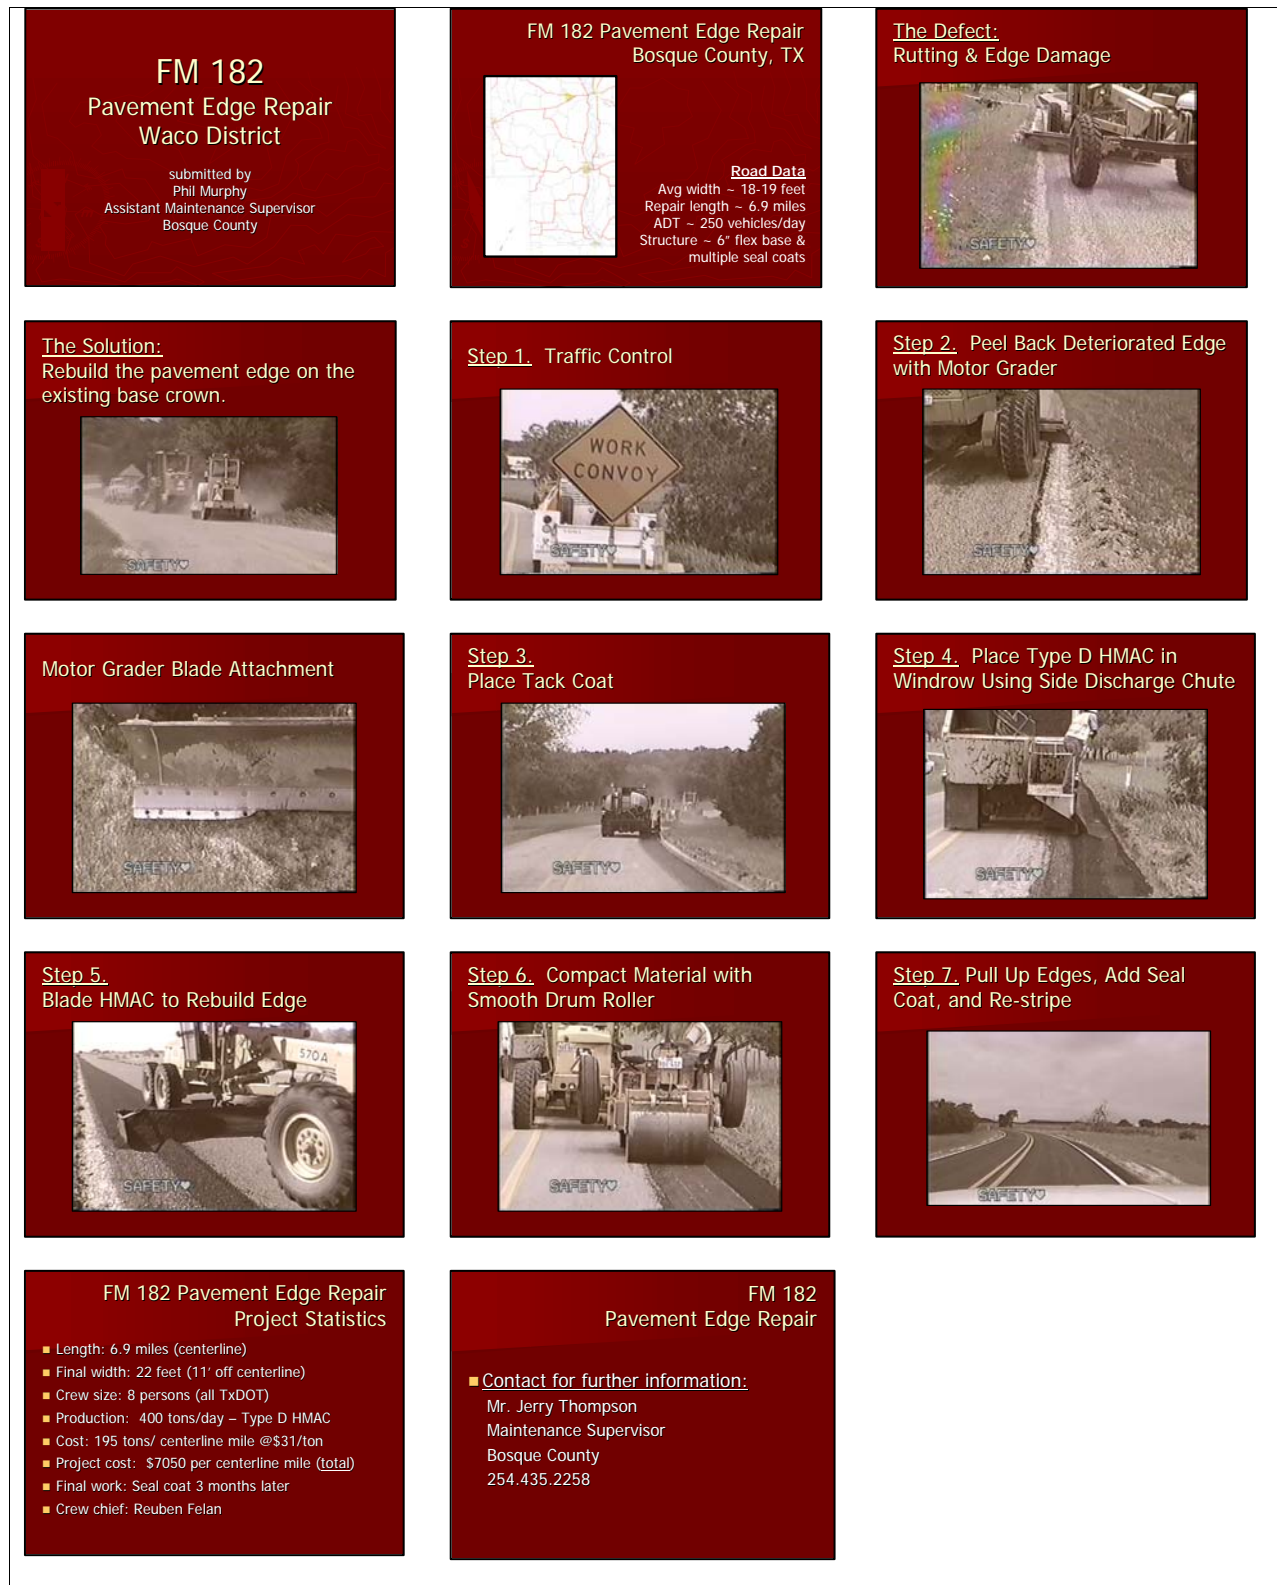
**FIG. 5.34** FM 182 Pavement Edge Repair, Bosque County, Texas, Waco District

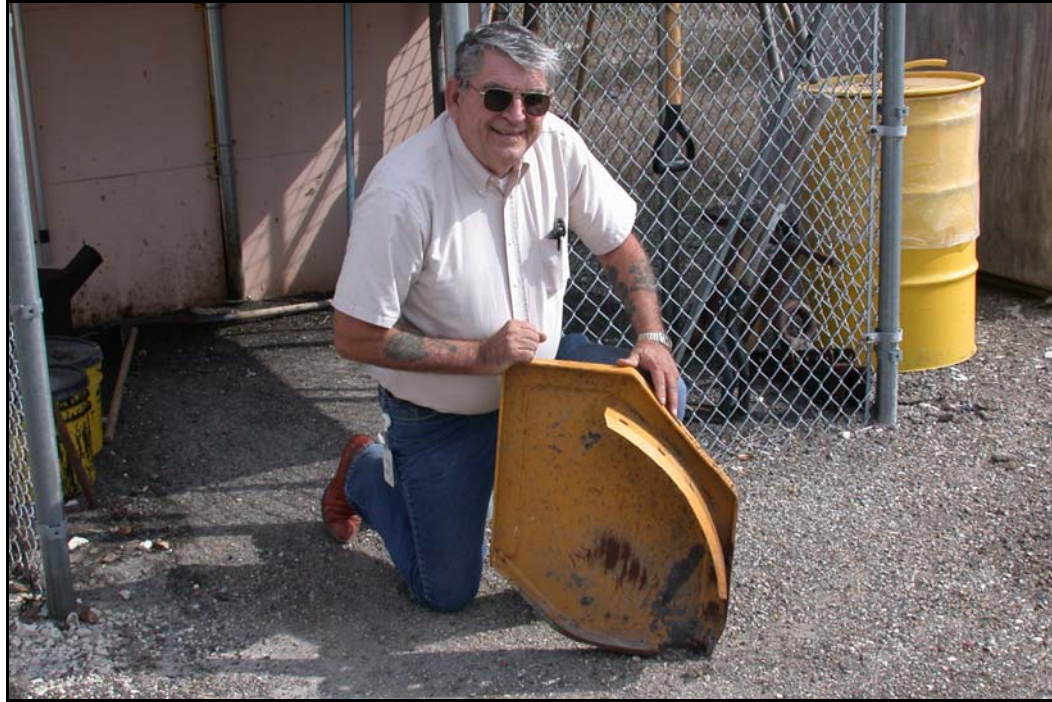
**FIG. 7.3** Motor Grader Blade Shoe for Pulling Shoulders, Corpus Christi District (see Corpus Christi District Profile, Photo 9)

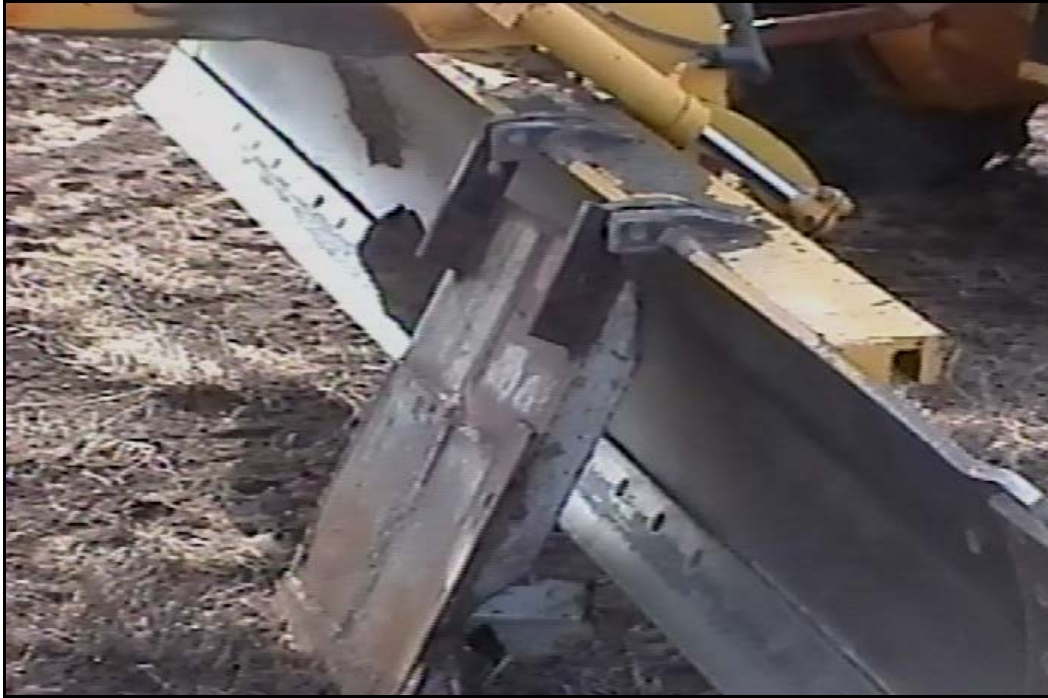
**FIG. 7.4** Motor Grader Blade Shoe for Road Widening, Amarillo District

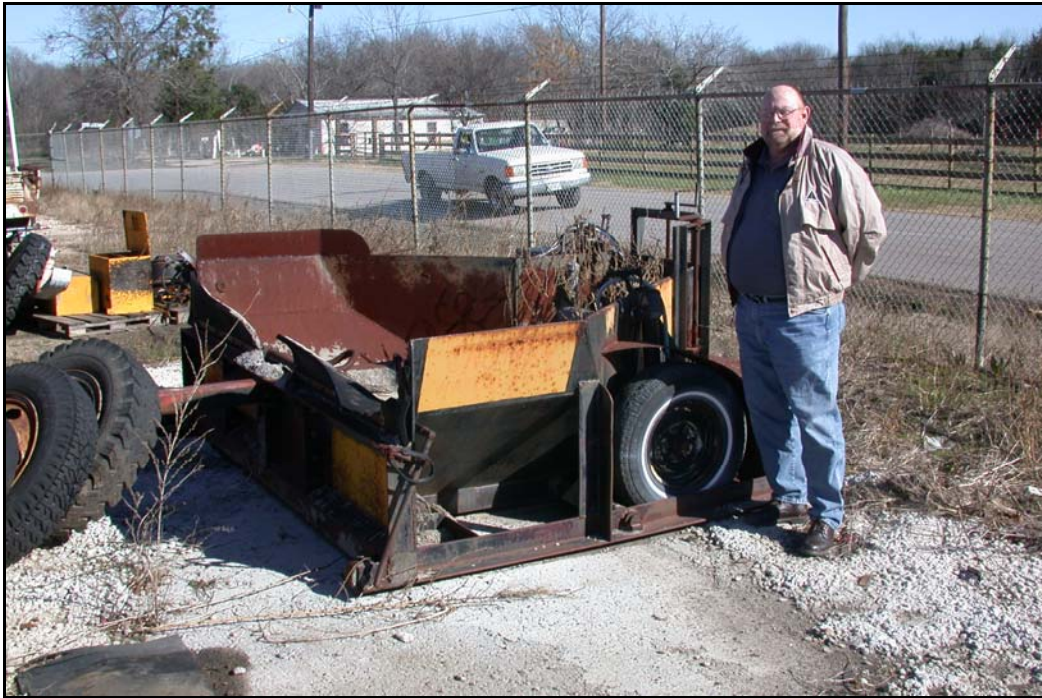
**FIG. 7.8** Drag Box; Tow-Behind, Used for Delivering Material to the Left, Center, or Right Side of Pavement, Waco District (see Waco District Profile, Photo 8)

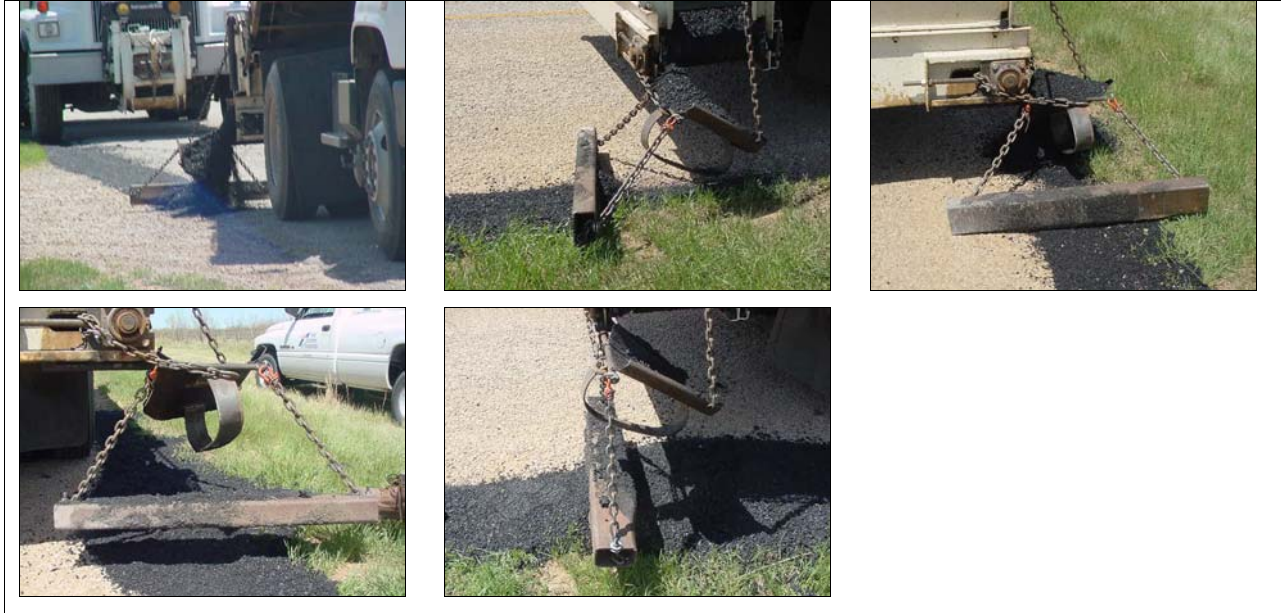
**FIG. 7.15** Photo Series: Side Discharge Chute and Tow-Behind Drag Bar for Edge Repair, Wichita Falls District
