1. Report No. FHWA/TX-04/0-4396-1		2. Government Accession No.		3. Recipient's Catalog No.	
4. Title and Subtitle Best Practices for Pavement Edge Maintenance				5. Report Date May 2004

BEST PRACTICES FOR PAVEMENT EDGE MAINTENANCE  
RESEARCH REPORT

Research Report Number 0-4396-1  
Project Number 0-4396  
Project Title: Improving Edge Repair and Stabilization

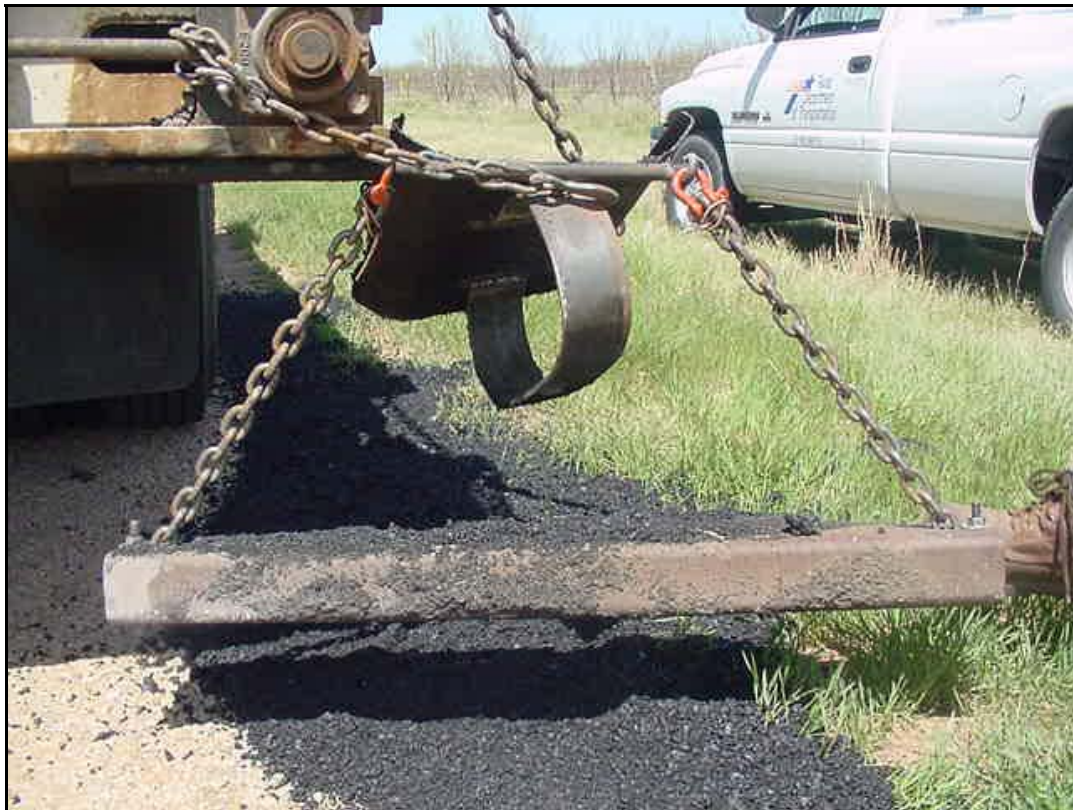
**FIG. 7.16** Close-up View, Side Discharge Chute and Tow-Behind Drag Bar for Edge Repair, Wichita Falls District

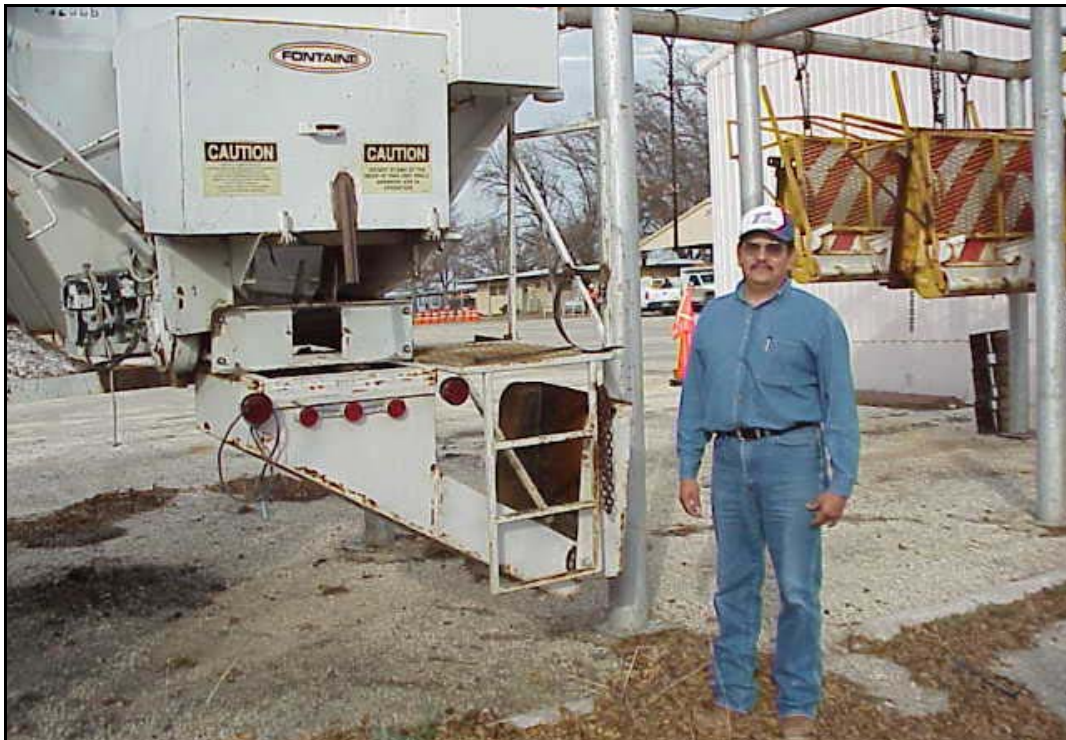
**FIG. 7.17** Modified V-Box Side Discharge Spreader: End View, San Angelo District (see San Angelo District Profile, Photo 16)

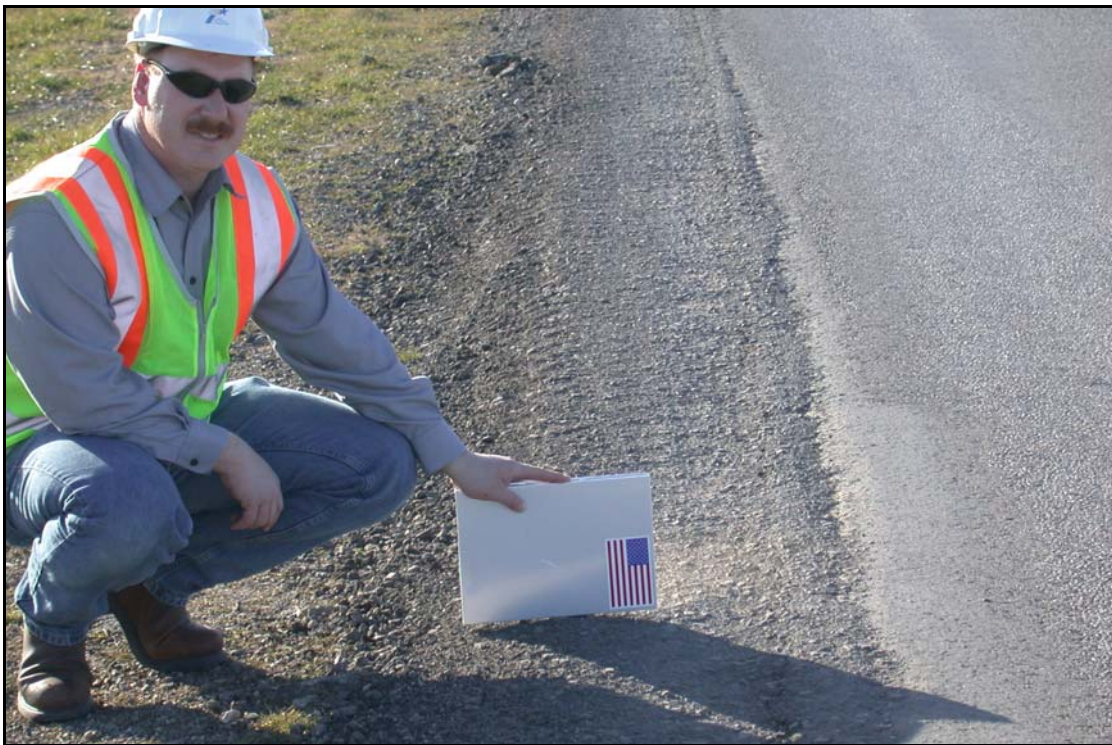
**FIG. 7.35** Completed Edge Repair Project Using Midland Machinery Road Widener, Fort Worth District (see Fort Worth District Profile Photo 43)
