FATIGUE STRENGTH OF 3/4 INCH
STUDS IN LIGHTWEIGHT CONCRETE
(Push-out Tests)

Research Report Number 76-1F

Research Project Number 3-5-64-76
Fatigue Strength of Stud Shear Connectors in Lightweight
Concrete (Push-Out Tests)

CENTER FOR HIGHWAY RESEARCH
THE UNIVERSITY OF TEXAS
AUSTIN, TEXAS

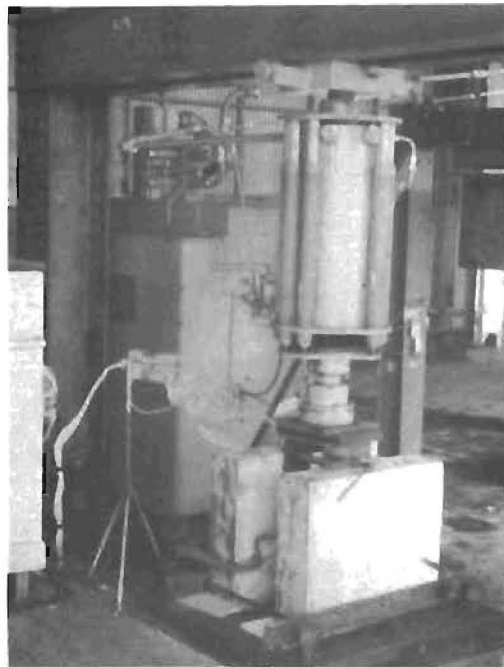
FIGURE 3
OVERALL VIEW OF TEST SET-UP

An overall view of the loading arrangement and the platform on which the specimen was placed are shown in Figures 3 and 4. The specimens were set on a 2 inch thick steel plate and levelled by means of threaded bolts in the same plate.

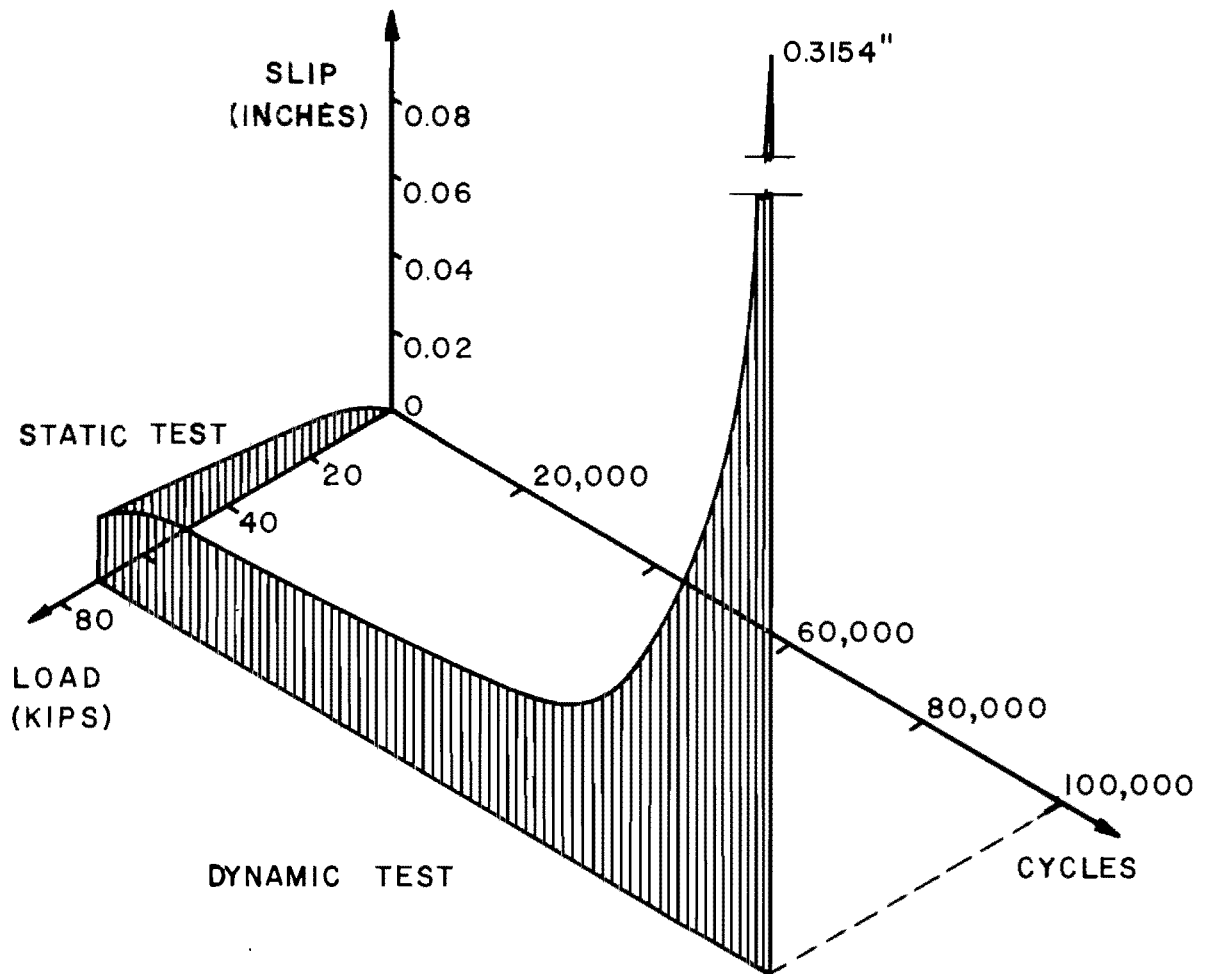
FIG.7. LOAD-SLIP-CYCLES (SPECIMEN 220)
FOR STRESS RANGE OF 18 k.s.i.

The general behavior of a specimen can be depicted by a load-slip-cycle curve. For three of the stress ranges (10, 14 and 18 ksi) a typical load-slip-cycle curve is plotted for the side that had larger slip (Figures 5, 6 and 7). In these figures the curves on the load-slip axes plane and on the slip-cycle axes plane represent the slip measurements of a specimen under static and dynamic loads, respectively. With this load-slip-cycle curve available the complete testing history can be traced.

These figures show that all specimens exhibited three separate stages of slip characteristic under fatigue load: first, a gradual increase of slip characteristic under fatigue load; second, a "plateau level" of slip curve with little increase in slip until failure* became imminent; and third, a sharp increase in the rate of slip as specimens reached failure. Having observed this type of slip characteristic of the first few specimens, it was possible to predict impending failure of other specimens.

However, when the slip data are plotted against the cycle, (Figures 5, 6, and 7), all specimens exhibited a definite slip characteristic under dynamic loading as described in Section II. 4. A similar characteristic was also observed in composite beam tests.⁽¹⁾ Thus in both beam and pushout tests, sudden increase in slip can be used as a failure criterion.

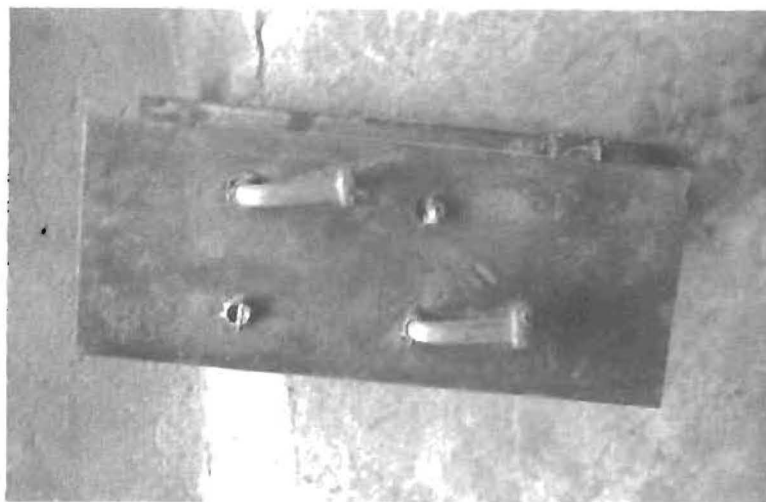
FIGURE 10.
TYPICAL STUD FATIGUE FAILURES
IN STEM OF STUD

In most casts fractures took place in the heat affected base metal (flange of stub column). Only in a few cases with higher stress range did studs fracture in the stem of the stud near the bottom. Both of these cases are shown in Figures 9 and 10. As a typical example a schematic mapping of these figures showing fractured and unfractured areas of studs are presented in Figure 11 with the percent of remaining area indicated. This is a typical figure with values for uncracked areas of studs of all other individual specimens listed in Table 4.
