FATIGUE TESTING OF RIBBED ORTHOTROPIC
PLATE BRIDGE ELEMENTS

Research Report No. 77-1

Fatigue Strength of Plate Girder Webs
Under Constant Moment

CENTER FOR HIGHWAY RESEARCH
THE UNIVERSITY OF TEXAS
AUSTIN, TEXAS
May 1965

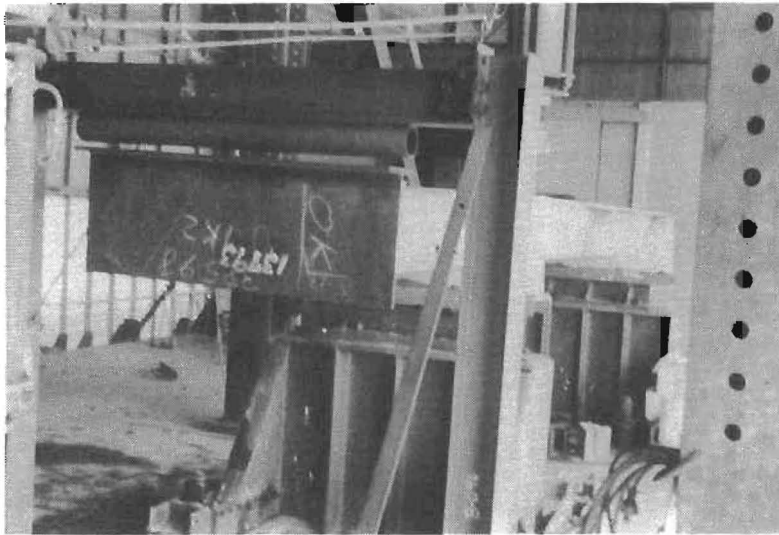
FIGURE 6.

TEST SET UP

The test set-up (Fig. 5) was devised so that the critical stresses were produced primarily by the local loads on the deck rather than by overall flexure of the specimen. This was accomplished by providing continuity over the interior support, thus reducing the bending moment in the span. The test set-up also closely approximated actual field conditions. Figure 6 is a photo of one of the specimens under test.

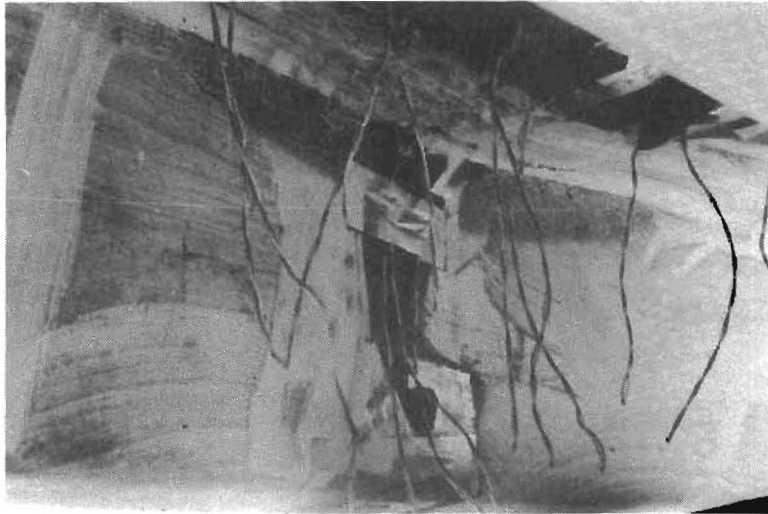
FIGURE 25.

Buckling of Rib Inner Wall
Flanged Specimen

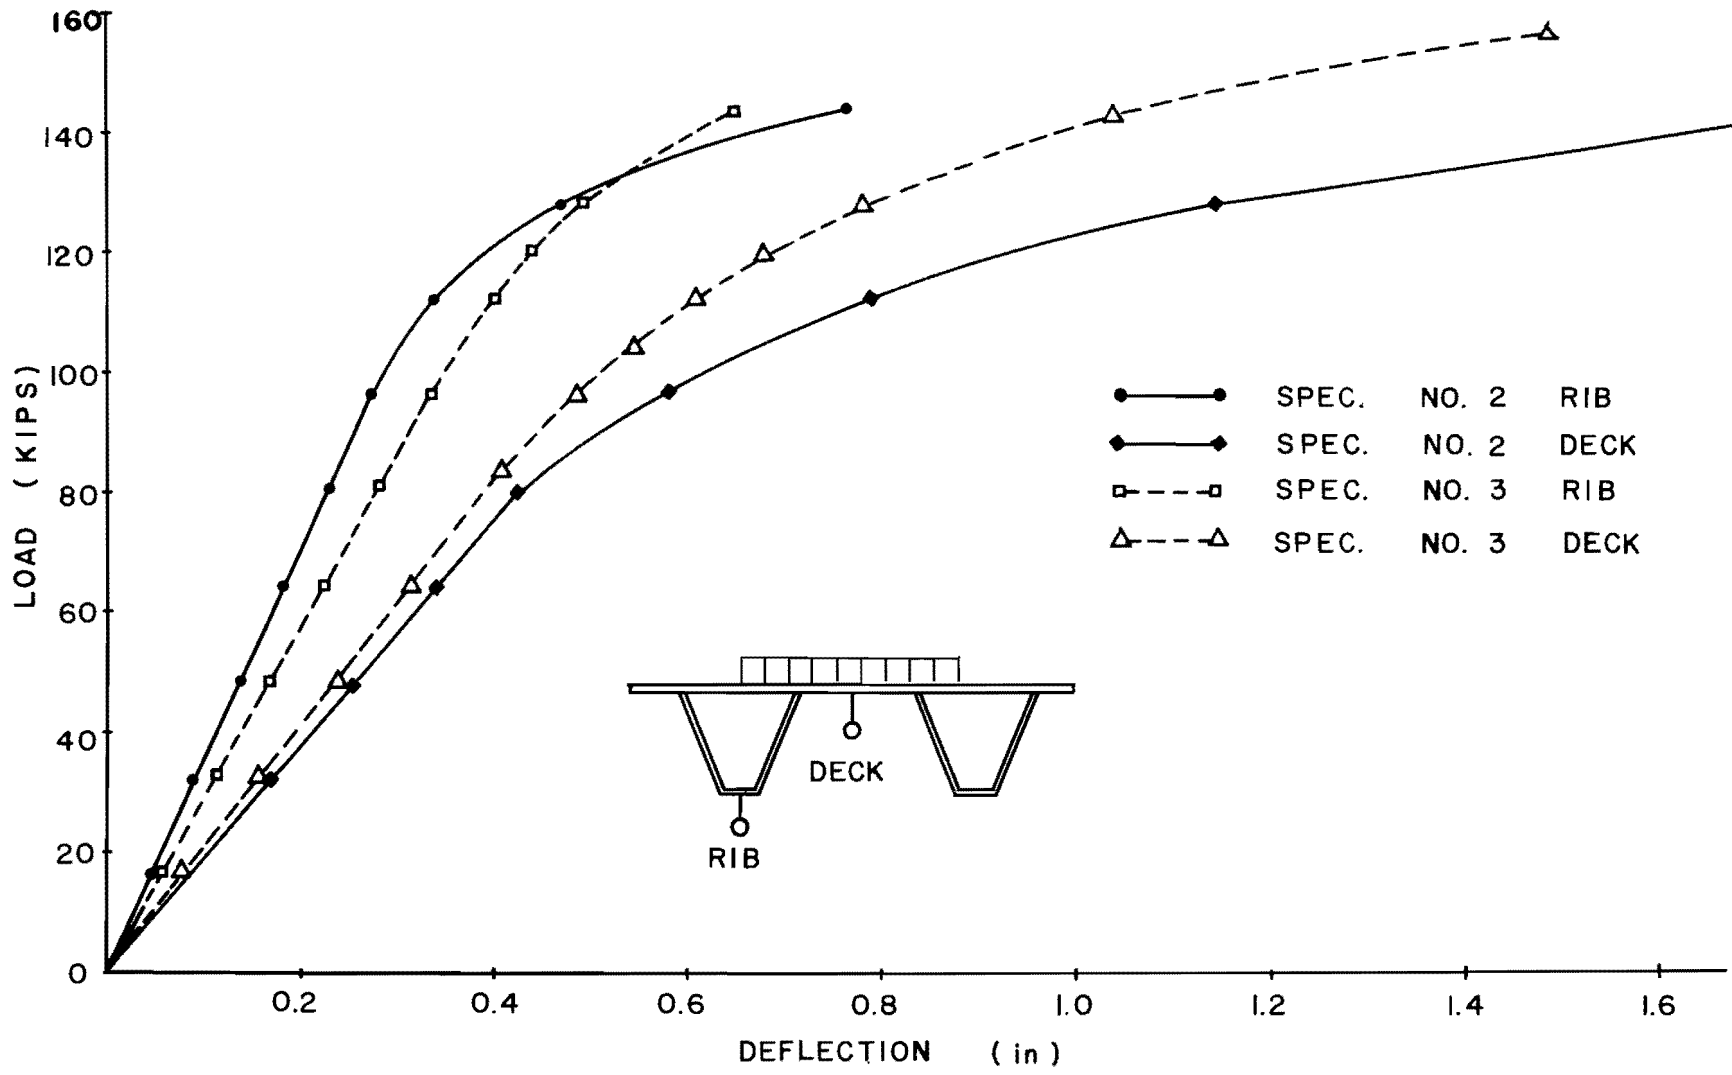
FIGURE 26.

Measured Deflections
 Ultimate Load Test
 Load Point

Buckling of the deck plate occurred at a load of 152.0 kips. The deflections of the specimen became uncontained at this time and the specimen was considered to have reached its ultimate load capacity (Fig. 26). Considerable compression yielding had occurred in the upper compression portion of the ribs (Fig. 27). The depth of these yield lines indicated that the neutral axis had moved considerably downward from its initial position, characteristic of a compression failure. Large permanent deformations had occurred directly under the load pad.

The load was then increased to 160.0 kips, the maximum capacity of the loading jack. The deflections of the specimen (Fig. 26) were still contained and failure was not considered to have occurred. At this load the tension yield lines on the ribs had moved upward to nearly the full height of the ribs indicating an upward shift in the neutral axis. This shift of the neutral axis was also indicated by a decrease in the compression stresses in the upper edge of the ribs (Fig. 24).

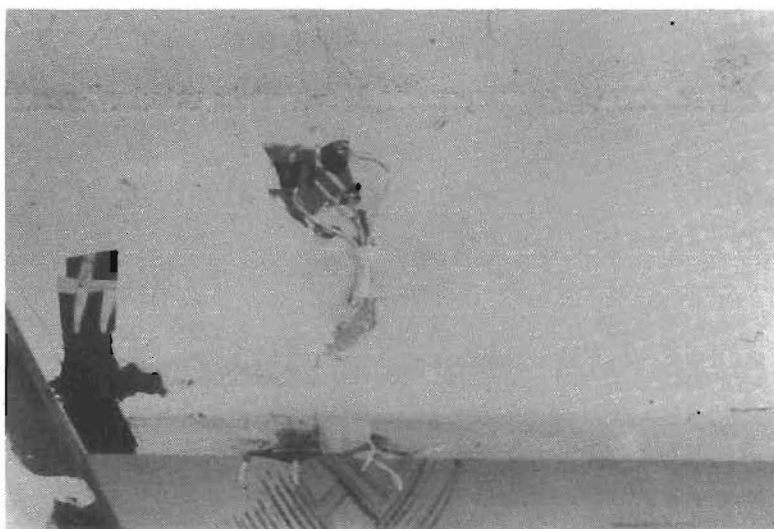
Rib Yielding
Unflanged Specimen
FIGURE 28.

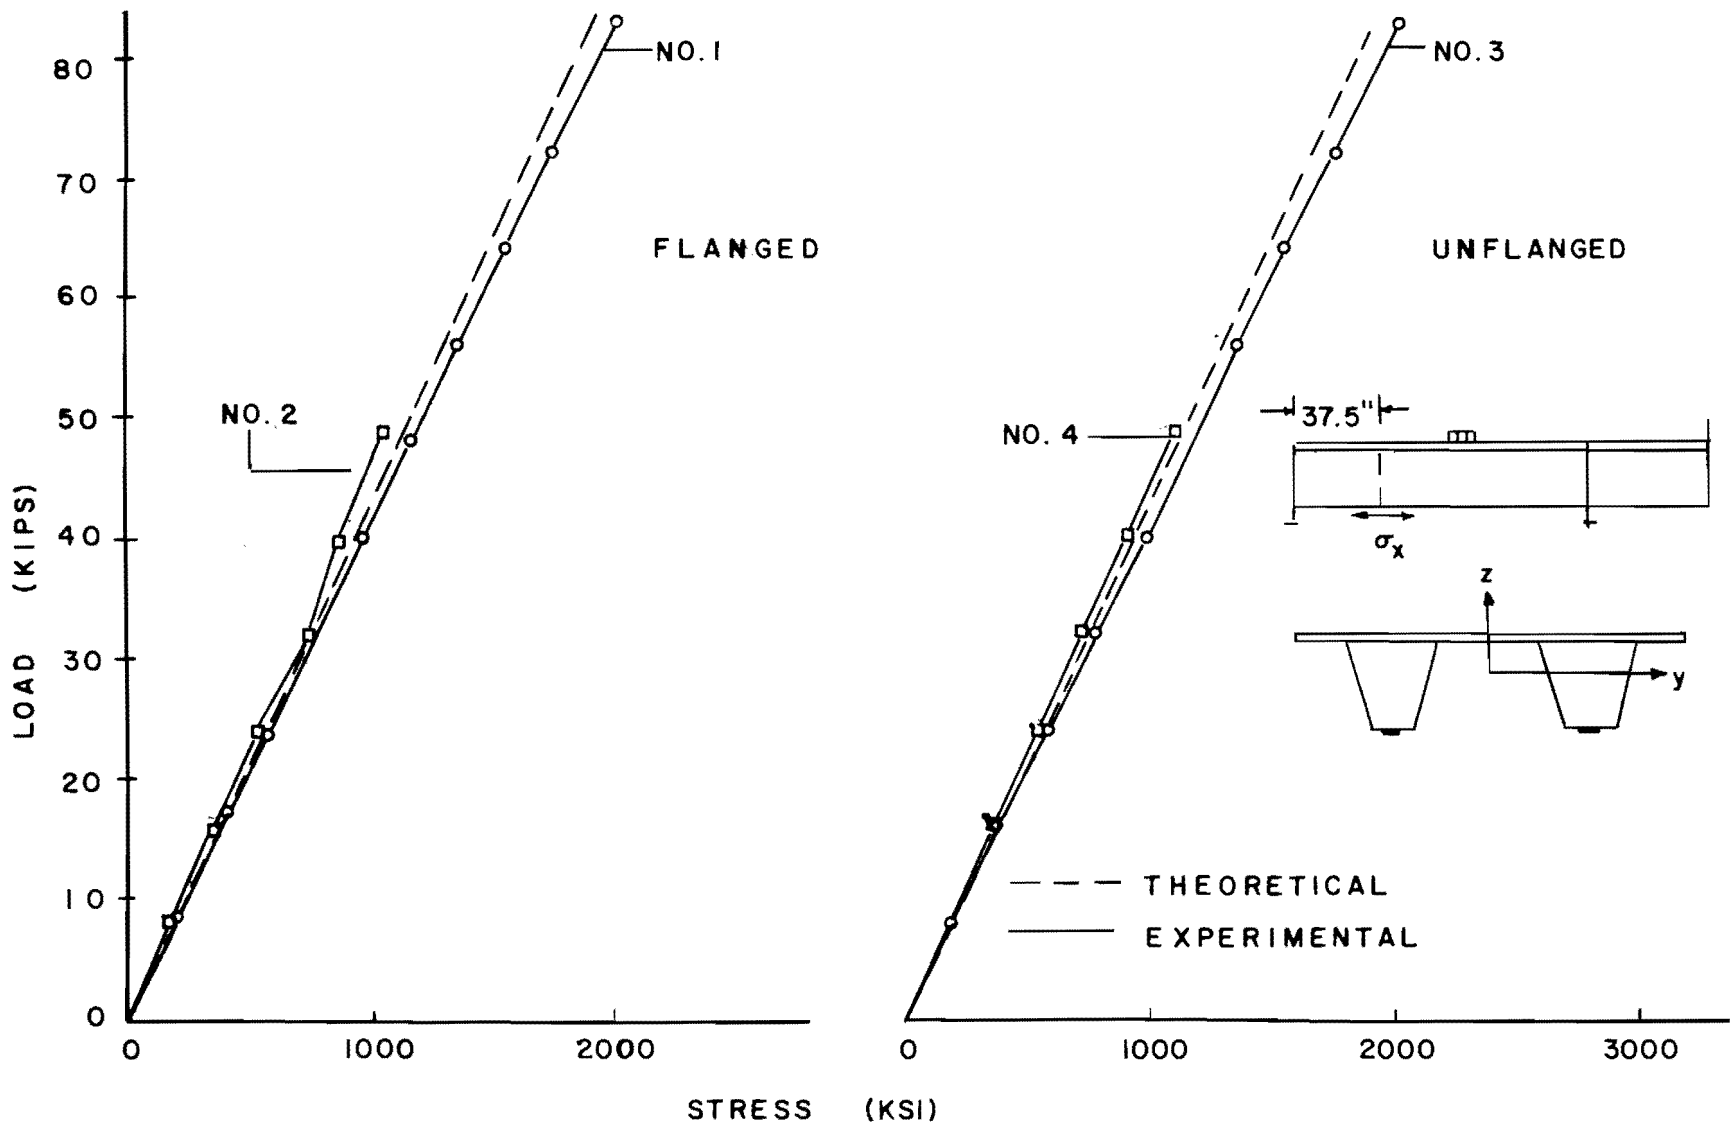
FIGURE 31.

Measured Stresses
 Rib Lower Face
 One-Quarter Point

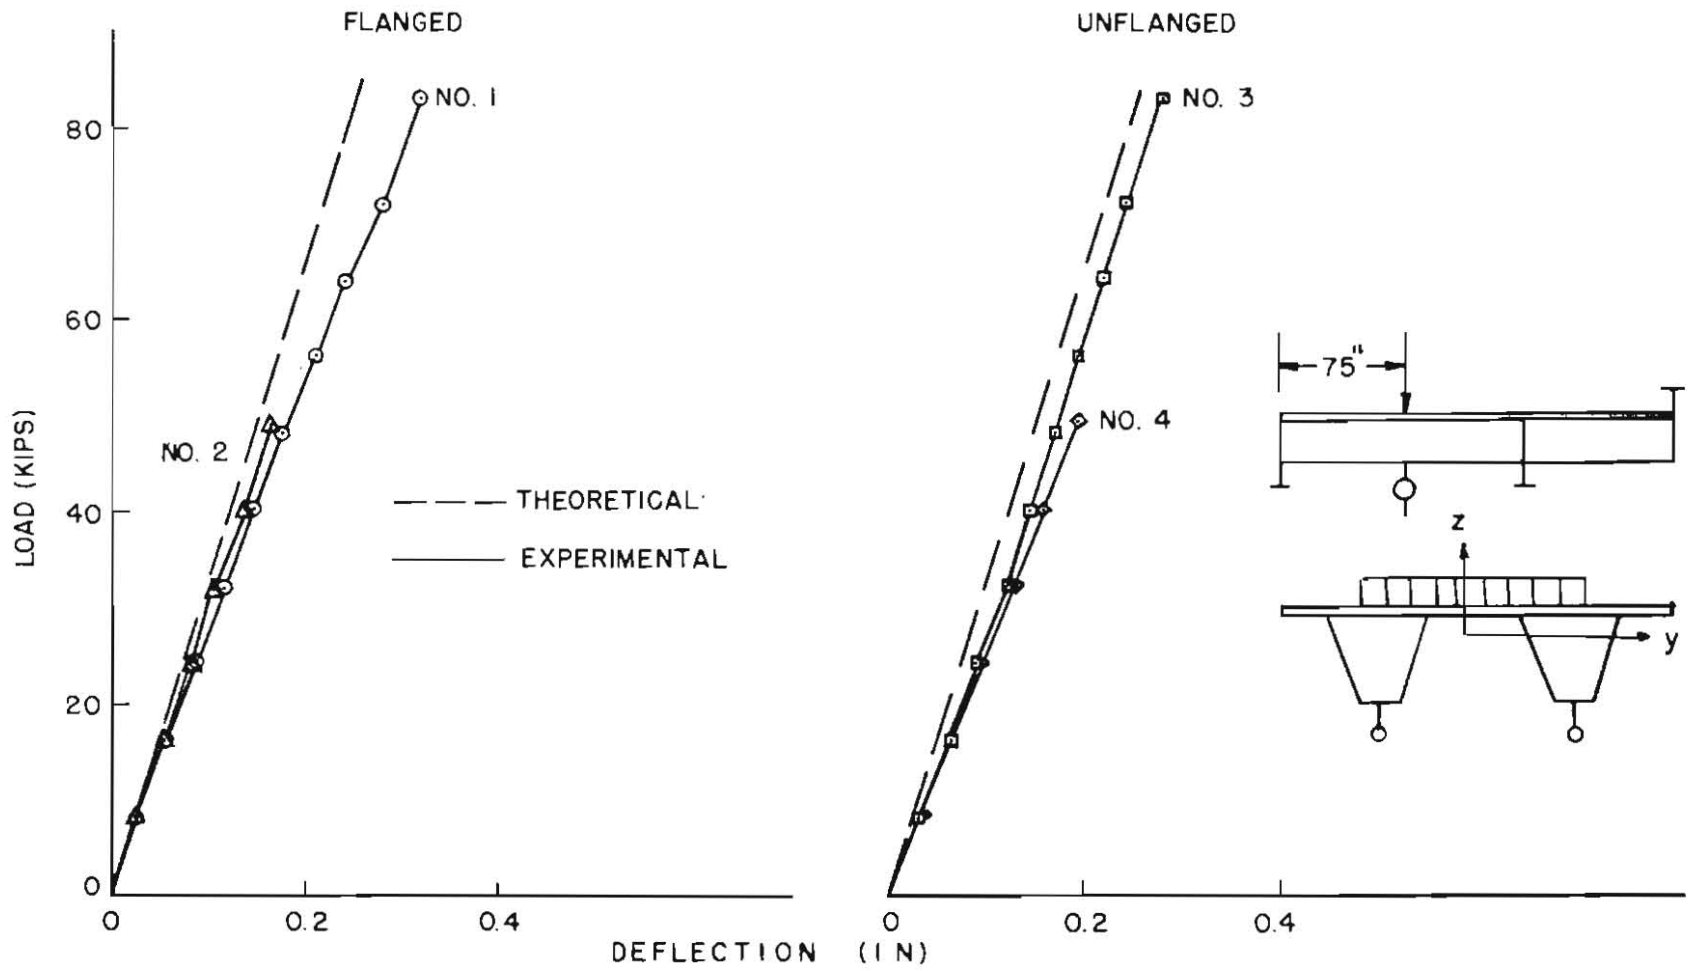
FIGURE 32.

Measured Deflections
 Rib Lower Face
 Load Point

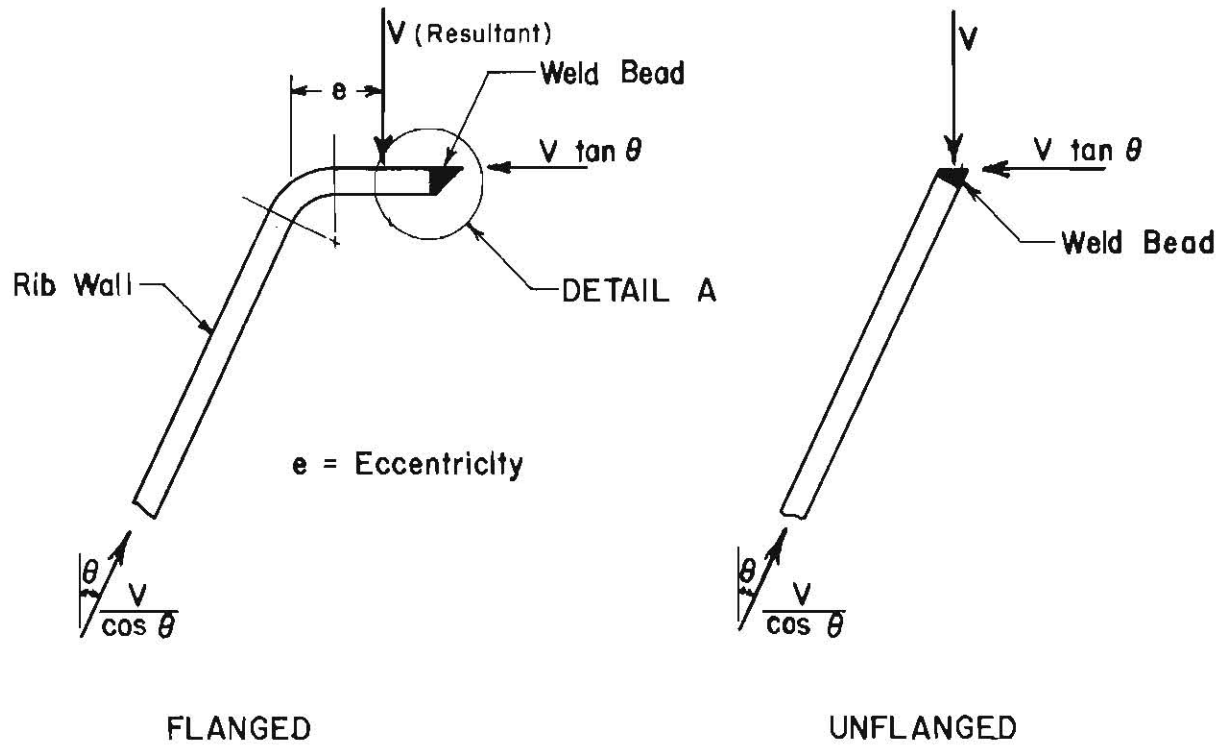
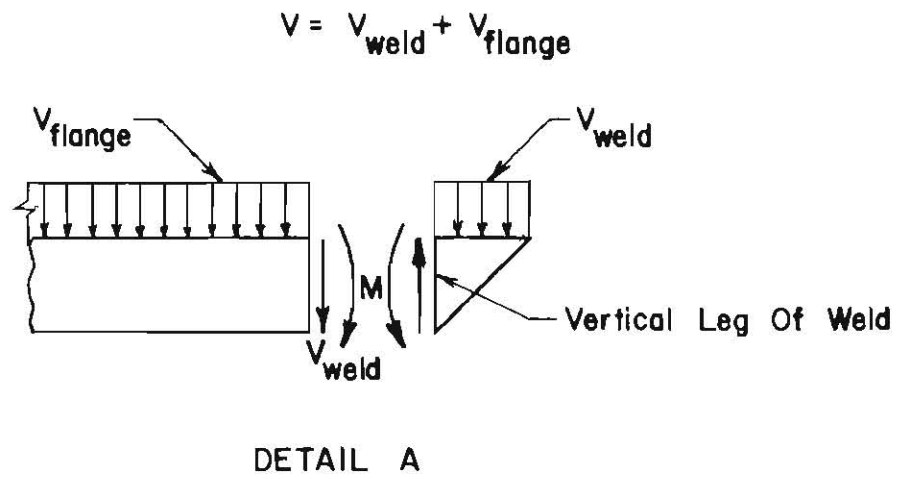
FIGURE 33.

Load Equilibrium -- Rib to Deck Connection

The flanged specimens were found to have a very low fatigue strength. In every case, failure of the weld between the rib flange and deck occurred at a very low number of cycles. This was in sharp contrast to the behavior of the unflanged specimens in which no fatigue cracks occurred in the rib to deck welds. Sufficient test data is not available to accurately determine the exact conditions that resulted in the low strength of the flanged specimen; however, a possible explanation is shown in Fig. 33. In the load equilibrium shown the bending moment transmitted across the vertical leg of the weld would produce tensile stress of sufficient magnitude to produce a fatigue failure in the weld at a low number of cycles. This failure would occur along the vertical leg of the weld which agrees with the actual test results.

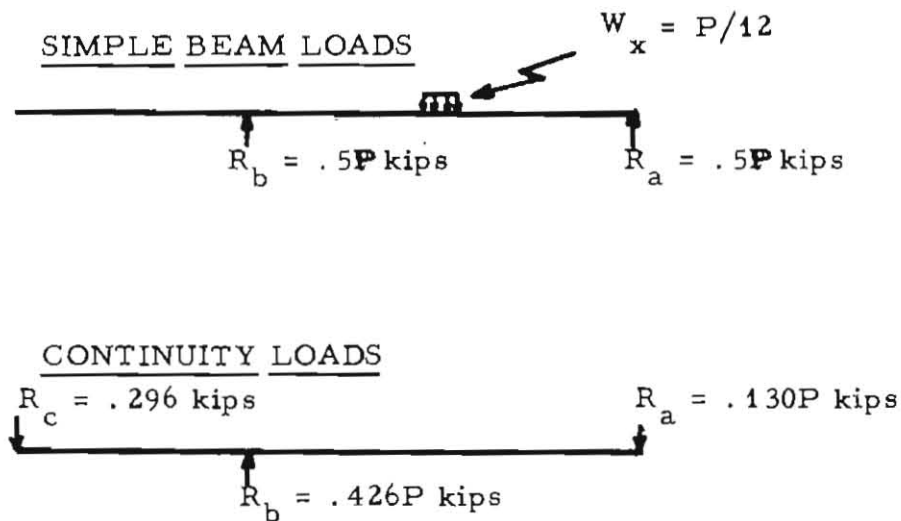
FIGURE 37. Loads-Unyielding Supports

Flexural deflections can be more easily calculated if the external load equilibrium due to the applied loads is divided into two parts as shown in Fig. 37.

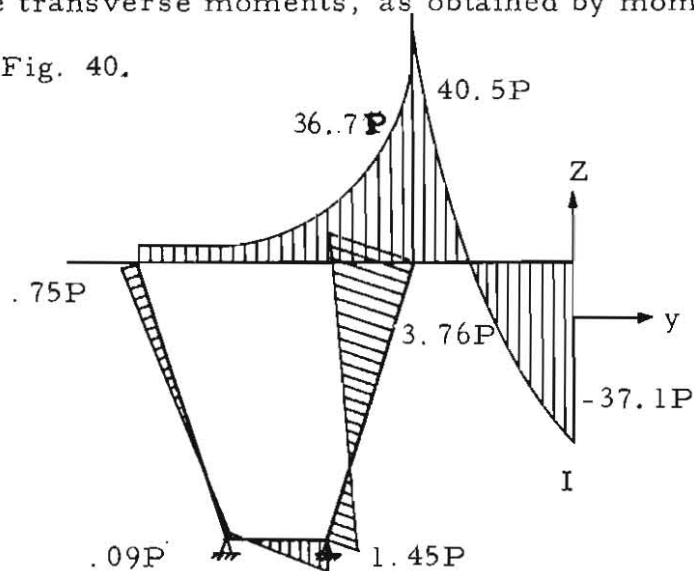
FIGURE 40. Moment

The transverse moments, as obtained by moment distribution, are shown in Fig. 40.

$$M = (.71)(37.1P) = 26.4 P \text{ in-kips}$$

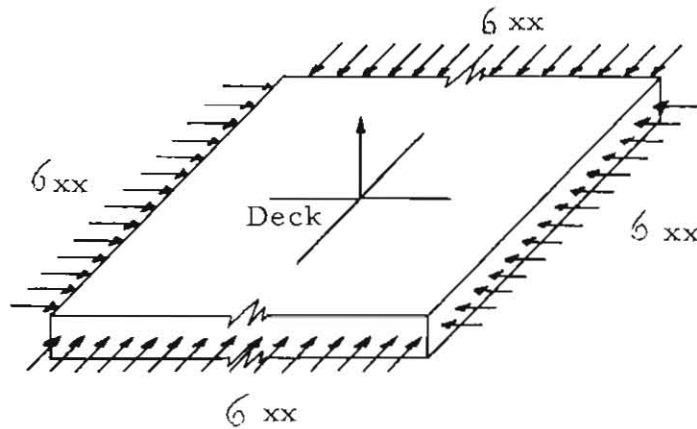
FIGURE 44.

The transverse stresses can then be calculated assuming a plane strain condition in the transverse direction ($\epsilon_y = 0$) and a plane stress condition in the vertical direction ($\sigma_z = 0$) Fig. 44.
