STUDY ON FATIGUE OF HYBRID PLATE GIRDERS
UNDER CONSTANT MOMENT

Research Report Number 96-3

Fatigue Strength of Hybrid
Plate Girders Under Shear
Research Project Number 3-5-66-96

CENTER FOR HIGHWAY RESEARCH
THE UNIVERSITY OF TEXAS
AUSTIN, TEXAS

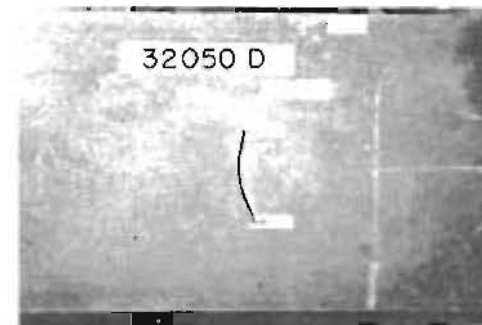
FIG. 14 CRACK DETAILS FOR GIRDER 32050 D

The only crack found in this specimen was observed at 496,000 cycles. Testing was stopped and as the crack was being repaired a

After resuming the test the crack reappeared at 566,000 cycles. Because of its quick propagation, at 571,540 cycles the test was terminated.

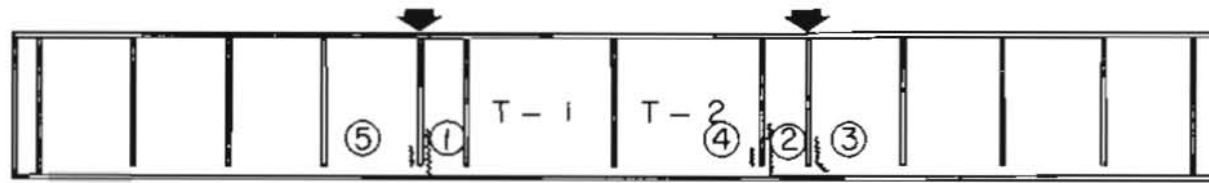
FIG. 15 CRACK DETAILS FOR GIRDER 32050 DR

This specimen was a replica of 32050D except for the dimensions of the flanges (Table 3). Crack 1, along the bearing stiffener-to-web weld, appeared on the near side at 439,000 cycles and extended to the far side at 487,000 cycles. At 527,000 cycles, cracks 2 and 3 were detected and found to be 3 1/8 in. and 2 1/4 in. long respectively. These three cracks were repaired and testing was resumed. Cracks 4 and 5, which are similar to 1 and 2, were noted at 560,000 cycles on the other side of the stiffener. The test was discontinued at 656,720 cycles.

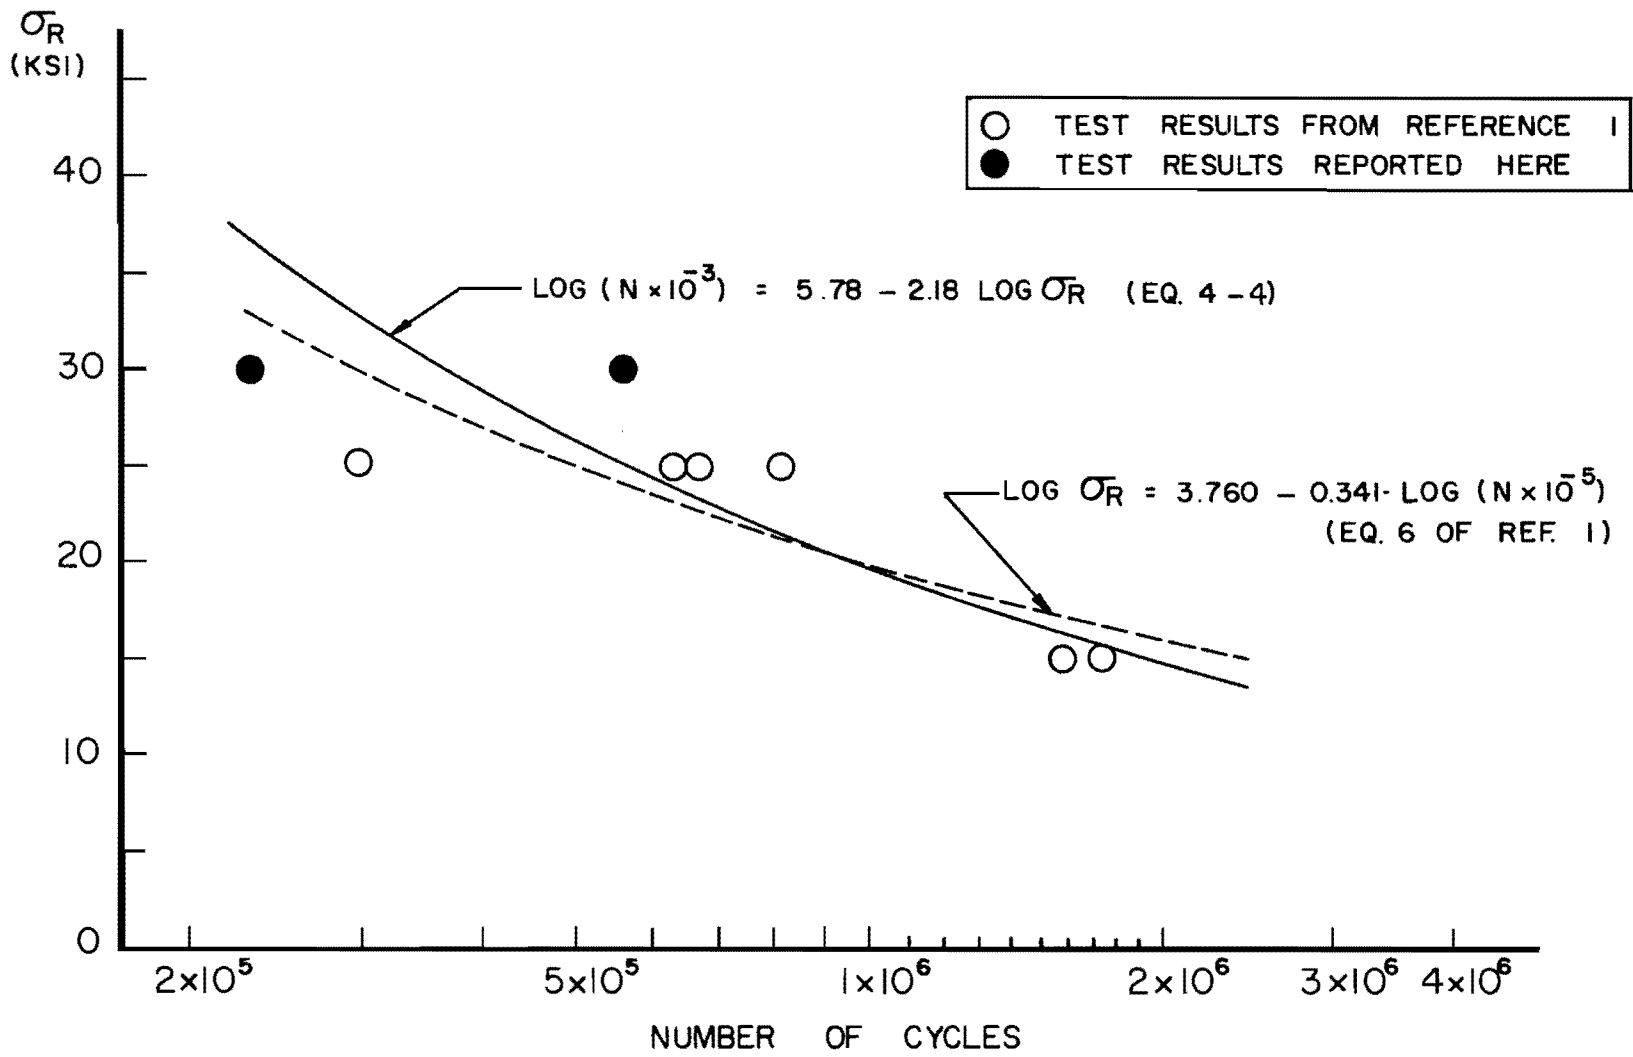
FIG. 27 RESULTS OF TYPE I CRACK

These three equations are plotted in Figs. 27, 28 and 29, respectively. In these figures, the corresponding equations for type 1 and type 2 cracks from Reference (1) are also plotted for comparison.
