**BEHAVIOR OF STATICALLY LOADED
PRETENSIONED CONCRETE BEAMS
WITH 0.5-INCH DIAMETER
DEBONDED STRANDS**

Research Report Number 1210-4

**Influence of Debonding of Strands on Behavior of
Composite Prestressed Concrete Bridge Girders**

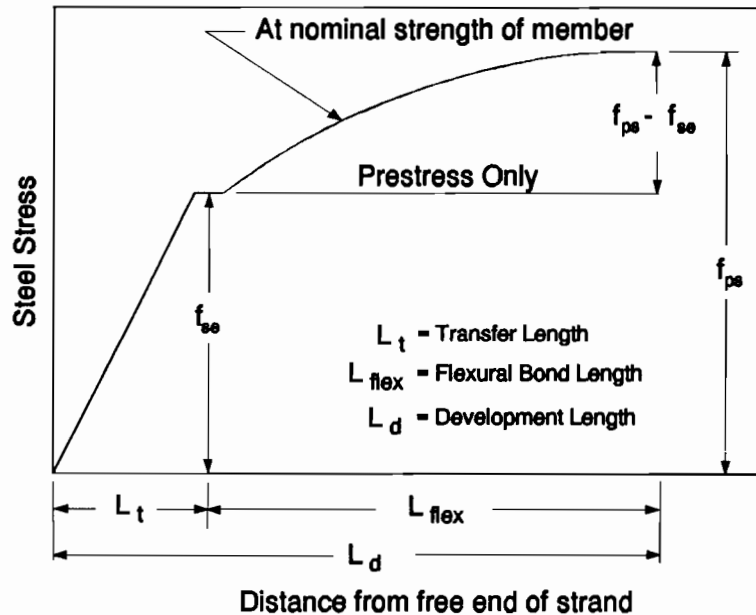
Figure 2.1 - Variation of Steel Stress ⁽³⁾

The total force of prestressing is transferred to the concrete by the bonding of the tendon to the concrete surrounding it. The bonding mechanism consists of two parts: transfer bond and flexural bond. Activation of the transfer bond occurs due to the initial tensioning and release of the prestressing strand in pretensioned, precast concrete specimens. It uses a portion of the available tensile force in the strand to establish compression in the concrete. The distance in which the prestressing stress, f_{se} , is transferred by bond to the concrete is the transfer bond length, L_t (Figure 2.1).

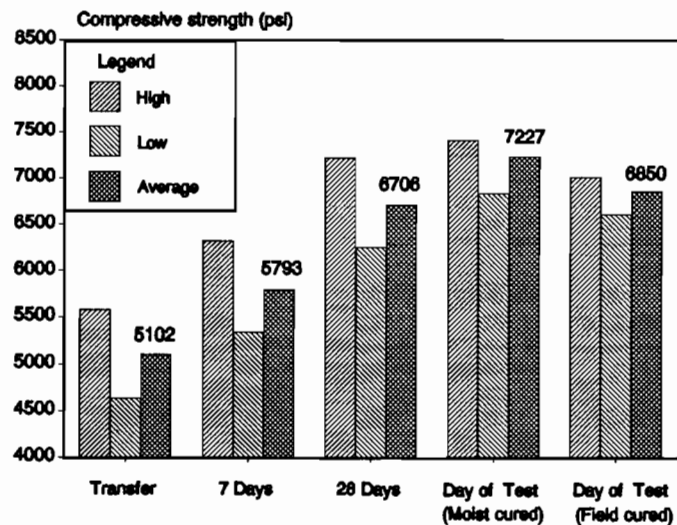
Figure 3.5 Compressive Strength of Concrete Cylinders

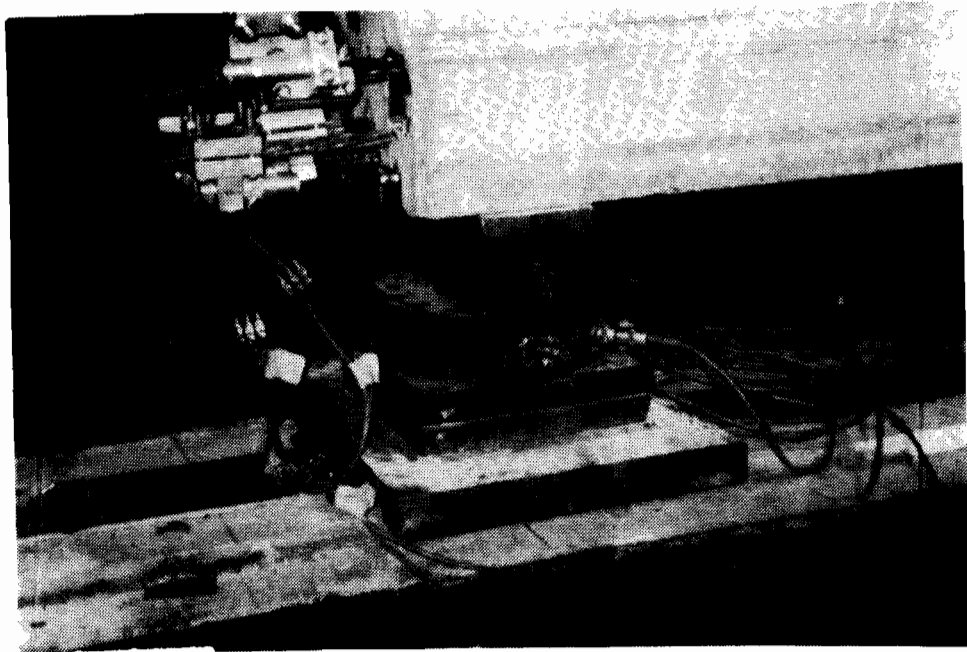
Figure 3.9 Specimen Support

Figure 3.9 is a photograph illustrating a specimen support. In the arrangement, a load cell was sandwiched between two steel plates. The bottom plate bore directly against the floor beam and provided a complete bearing surface for the load cell. The top plate was permanently attached and had a piece of one inch diameter round stock welded to it. A second plate was positioned between the round stock and the specimen to provide a

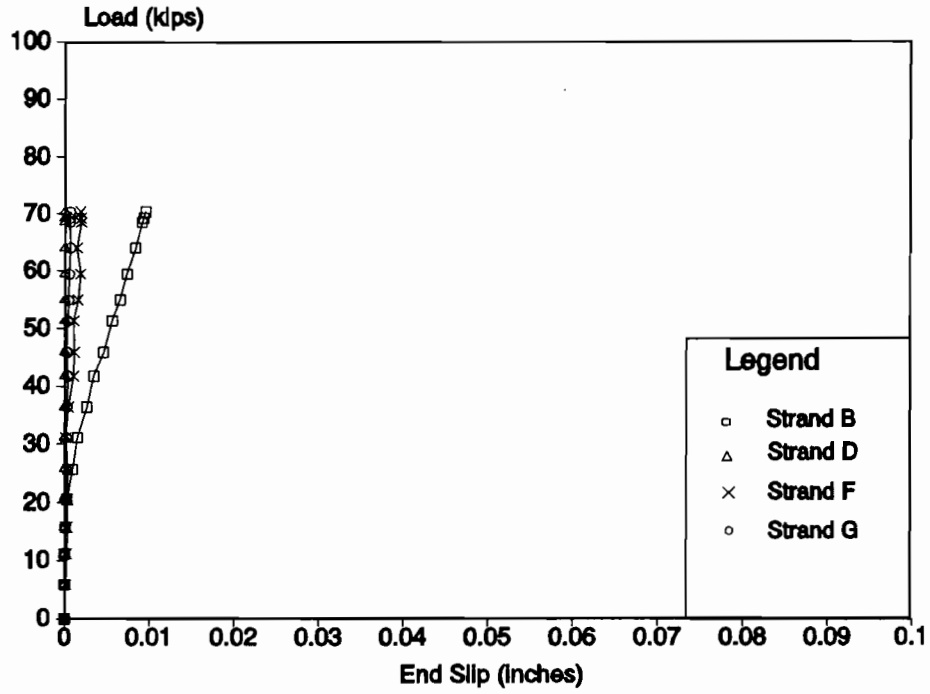
Figure 4.12 Load vs. End Slip, DB850-4A (G)

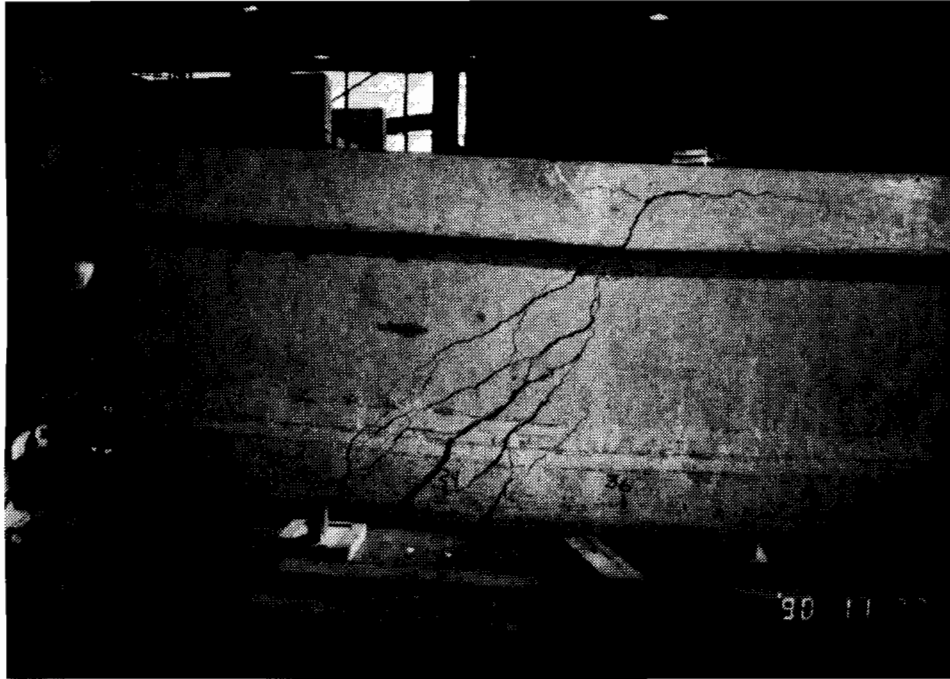
Figure 4.30 Web Shear Cracking, DB850-1A (G)

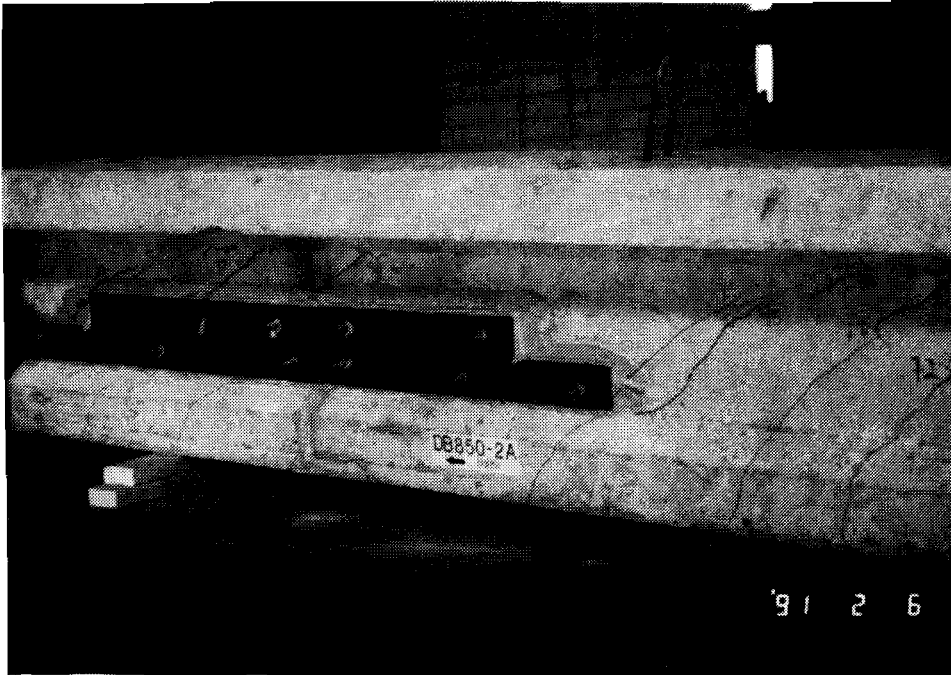
Figure 4.36 Flexural Cracking in the Debond/Transfer Zone, Test DB850-2A (G)

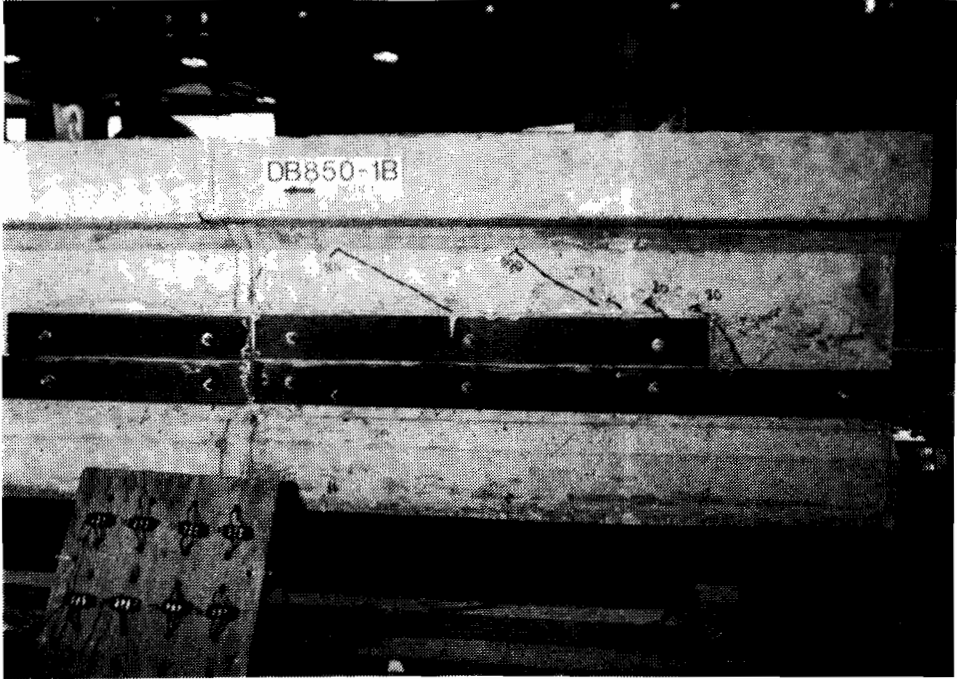
Figure 5.4 Web Shear Cracking in Debond/Transfer Zone

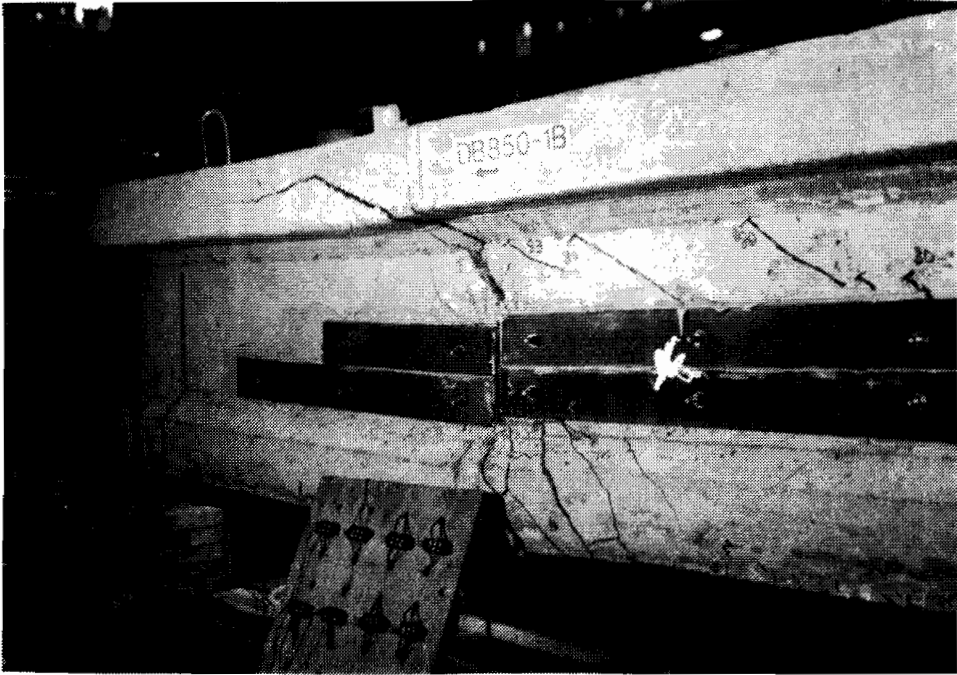
Figure 5.5 specimen Collapse from Web Shear Cracking

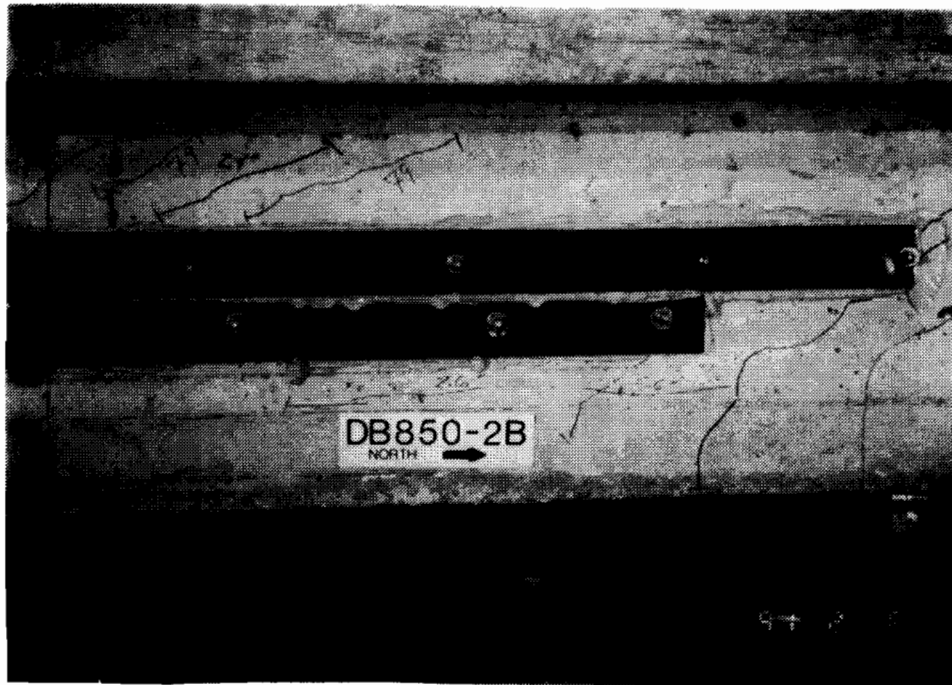
Figure 5.6 Bursting Crack Developed During Test DB850-2B (S)
