1. Report No. FHWA/TXDOT-96/1394-2F		2. Government Accession No.		3. Recipient's Catalog No.	
4. Title and Subtitle DETECTION AND MITIGATION OF ROADWAY HAZARDS FOR BICYCLISTS			5. Report Date December 1995

DETECTION AND MITIGATION OF ROADWAY HAZARDS FOR BICYCLISTS

Research Report 1394-2F

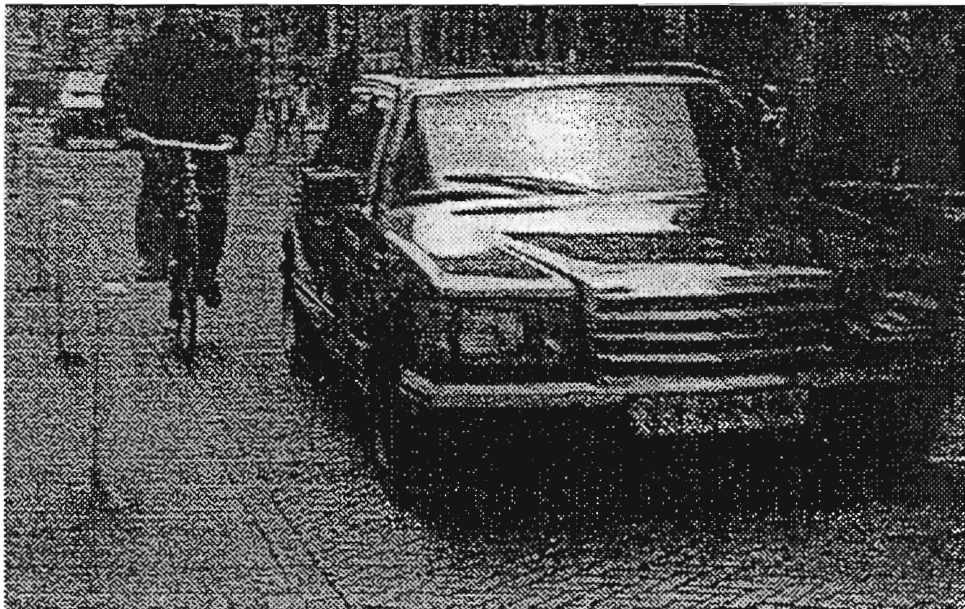
Figure 2.1 Narrow-width Right Lane (CROW, 1993)

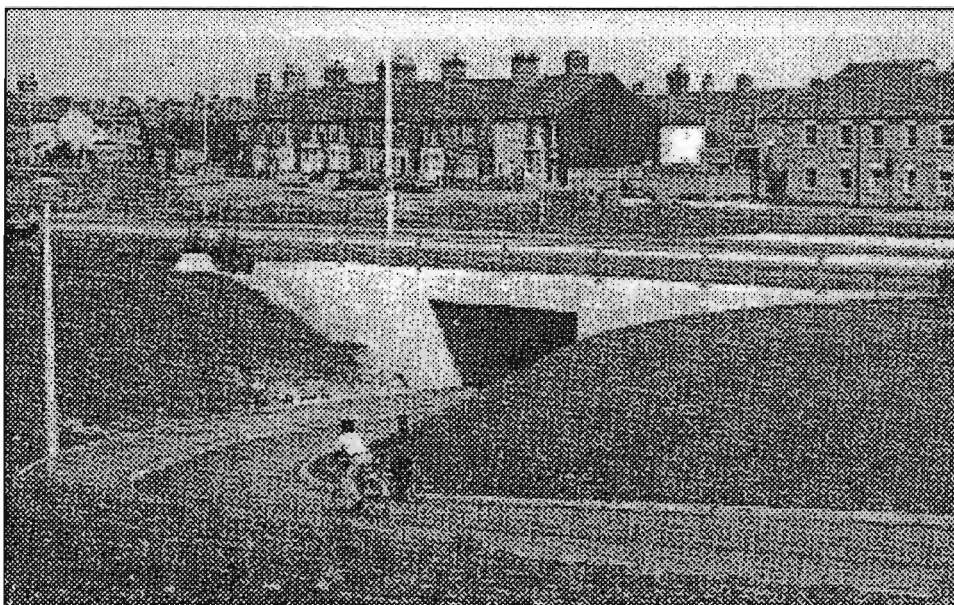
Figure 2.2 Effective Segregation of Bicycles and Pedestrians (Hudson, 1982)
The sharp curve at the bottom of the hill constitutes a bicycle hazard.

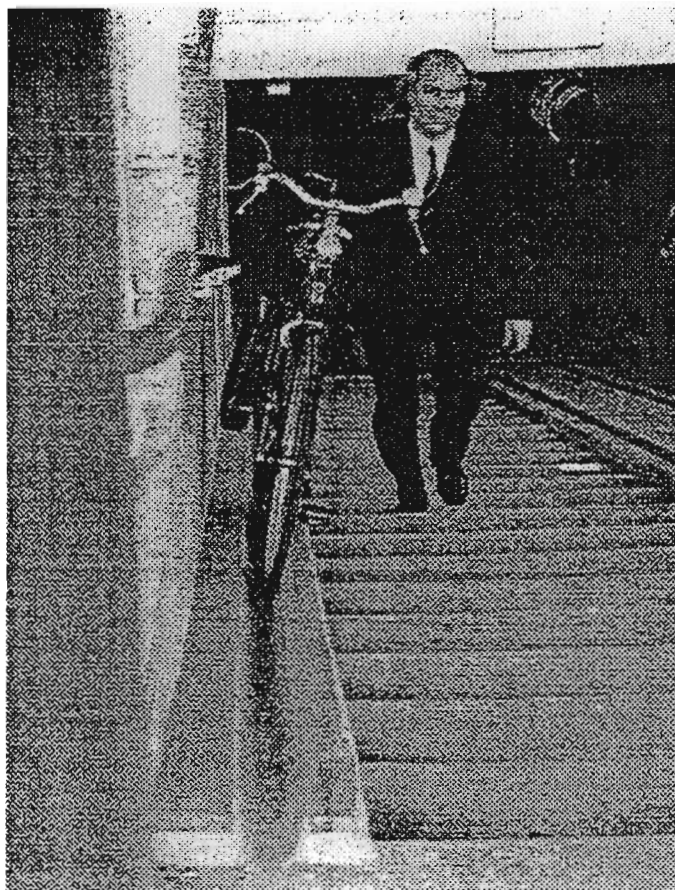
Figure 2.7 A Cycle Ramp to Circumvent Staircases (CROW, 1993)

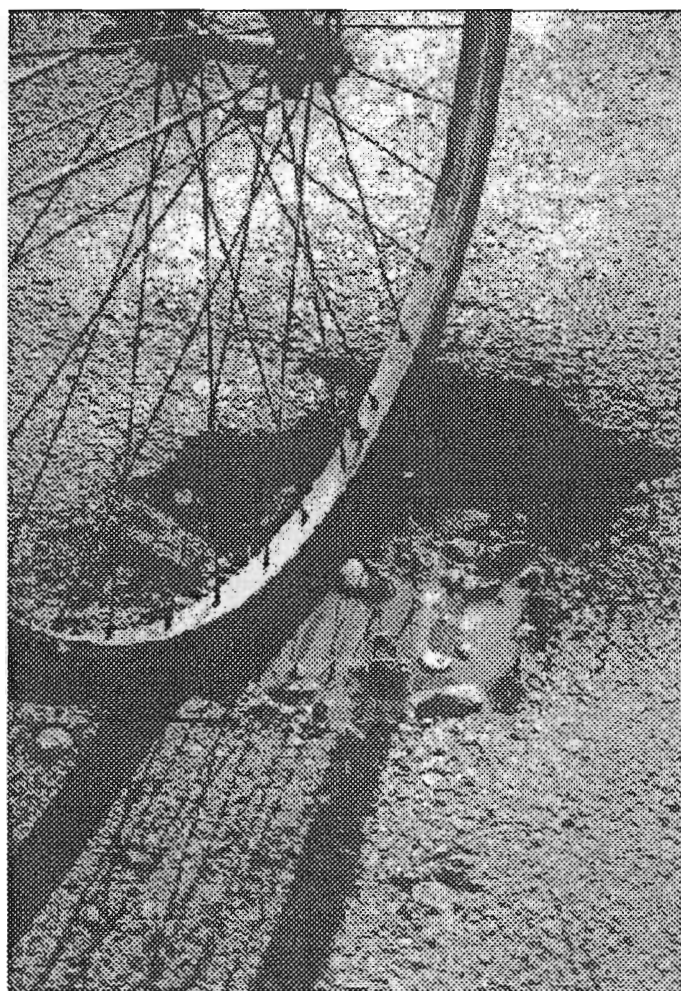
Figure 2.8 Potholes Damage Bike Tires (Hudson, 1982)

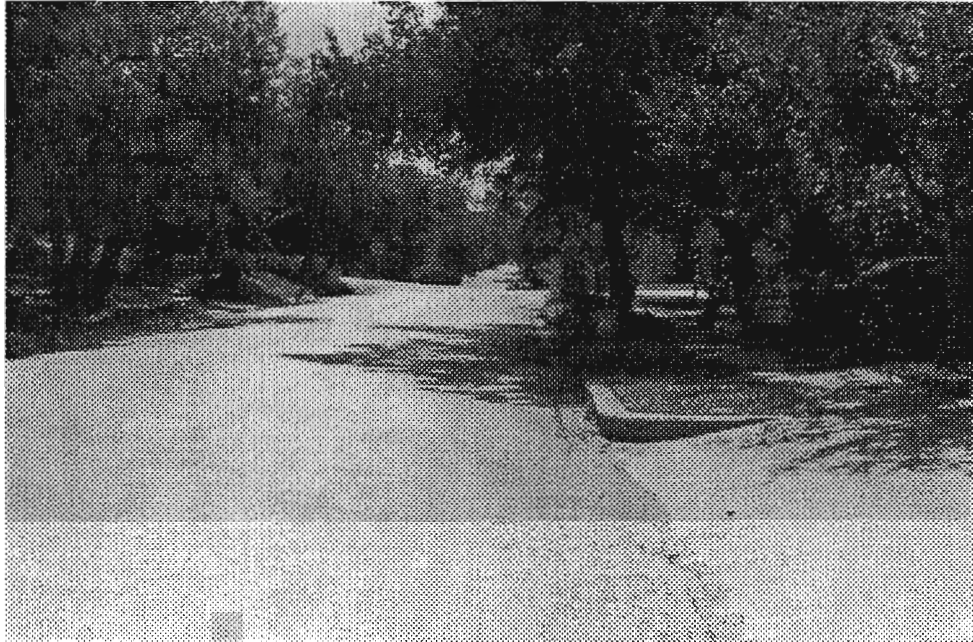
Figure 3.13 A Cyclist's View of the Hazards at Speedway and 31st Street

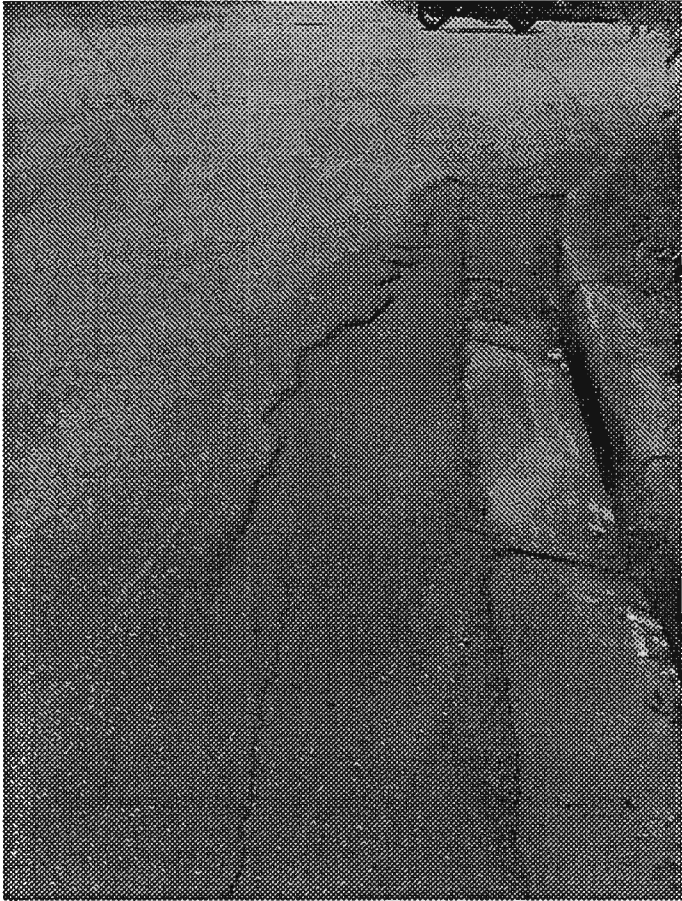
Figure 3.15 Close-up of Asphalt Ripples and Drop-offs at Speedway and 31st Street

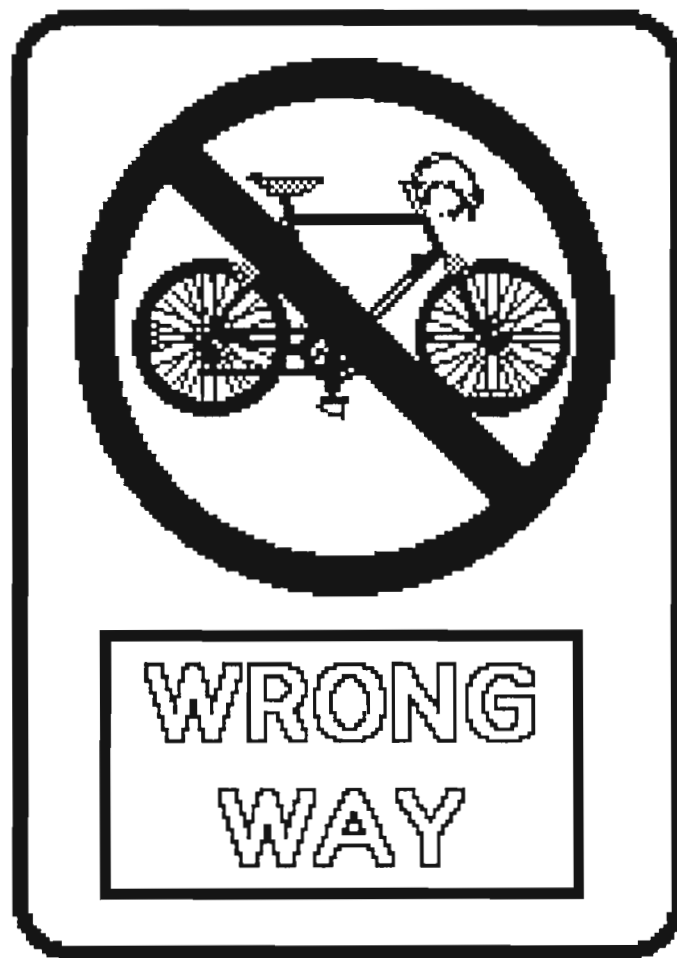
Figure 5.14 One Possible Design of a “Wrong Way” Sign for Bicyclists

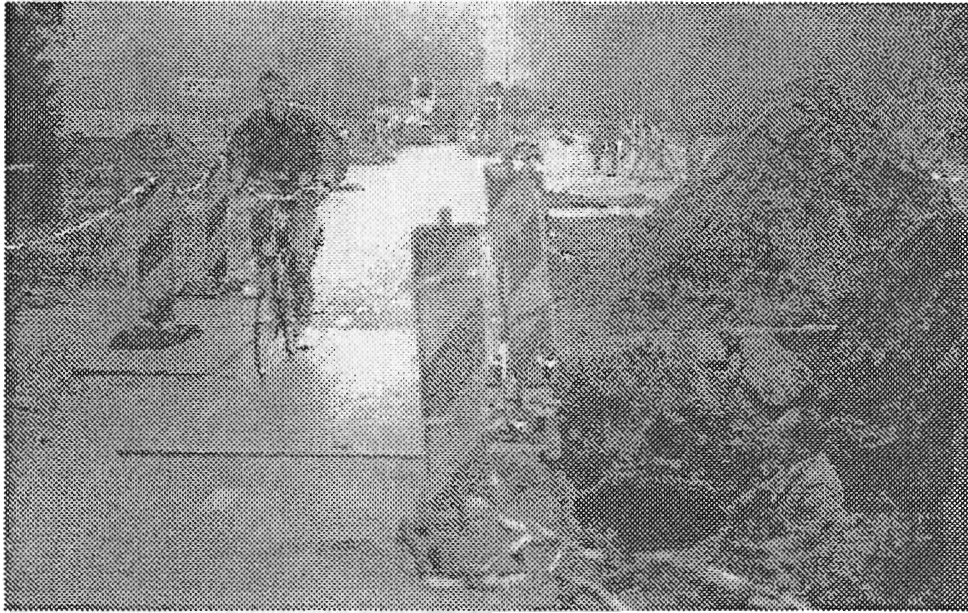
Figure 5.17 Smooth Road Surface Maintained with Planks in a Construction Zone

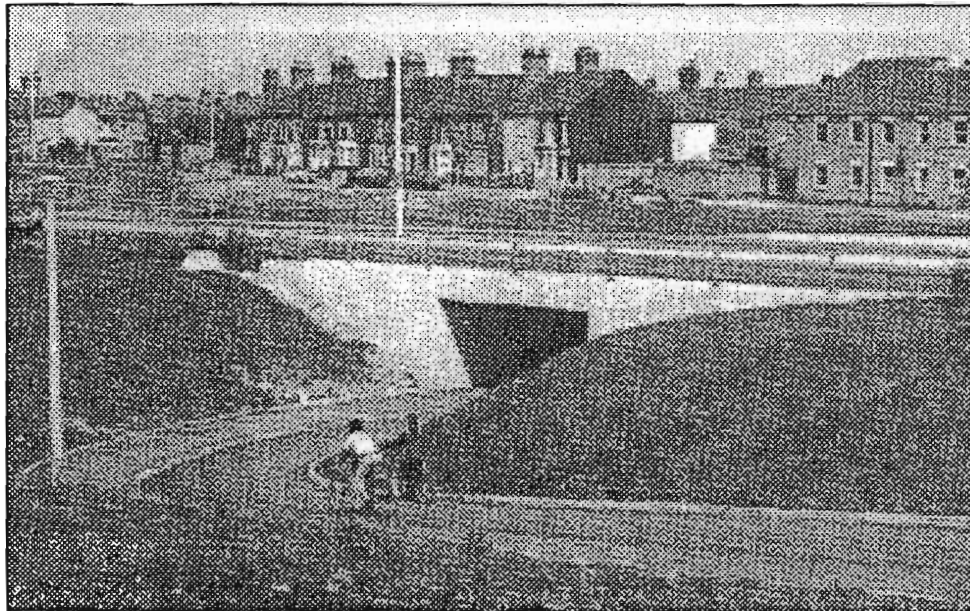
Figure 5.21 Hazardous Sharp Curve at the Bottom of a Hill Leading to a Dark Underpass

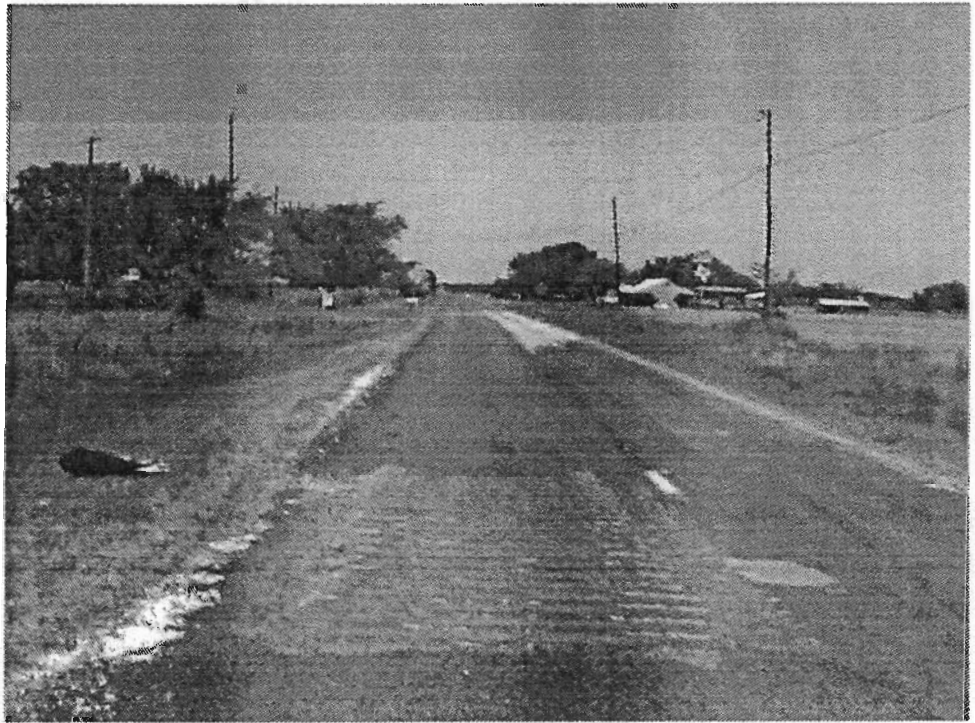
Figure 5.24 Overview of the Two Rumble Strips, Type 1 and Type 2, on SH 1183 at Ennis

- Type 1: 198 mm wide plain flush pavement followed by a 107 mm wide depressed stripe. The depressions are approximately 2.5 mm deep. This pattern is repeated to create the rumble strip. (Figure 5.24)
- Type 2: 183 mm wide plain flush pavement followed by a 122 mm wide depressed stripe. The depressions are approximately 5.0 mm deep. This pattern is repeated to create the rumble strip. (Figure 5.25)
- Type 3: 457 mm wide plain flush pavement followed by a 152 mm wide depressed stripe. The depressions are approximately 5.0 mm deep. This pattern is repeated to create the rumble strip. (Figure 5.26)
