**CORROSION PROTECTION FOR BONDED INTERNAL TENDONS
IN PRECAST SEGMENTAL CONSTRUCTION**

J. S. West, R. P. Vignos, J. E. Breen, and M. E. Kreger
Research Report 1405-4

*DURABILITY DESIGN OF POST-TENSIONED
BRIDGE SUBSTRUCTURE ELEMENTS*

October 1999

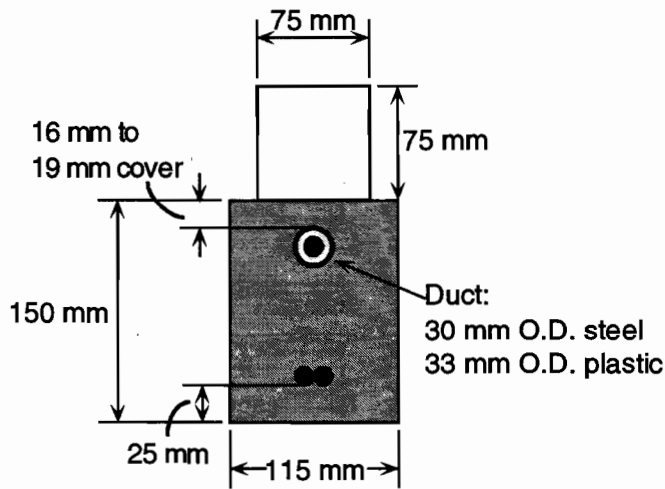
Longitudinal Section

End View

Figure 2.1 – Macrocell Specimen Details

Similar to ASTM G109, two 12.7 mm (#4) mild steel bars were used as the cathode. These bars would represent non-prestressed reinforcement within the segment. The use of two bars increases the ratio of cathode area to anode area, accelerating macrocell corrosion. The cathode bars were discontinuous across the transverse joint, consistent with precast segmental construction. The end cover for the cathode bars at the segmental joint was 6 mm (0.25 in.). Following ASTM G109, the exposed length of the anode and cathode were limited to 125 mm (5 in.) by painting the steel with epoxy paint as shown in Figure 2.2.

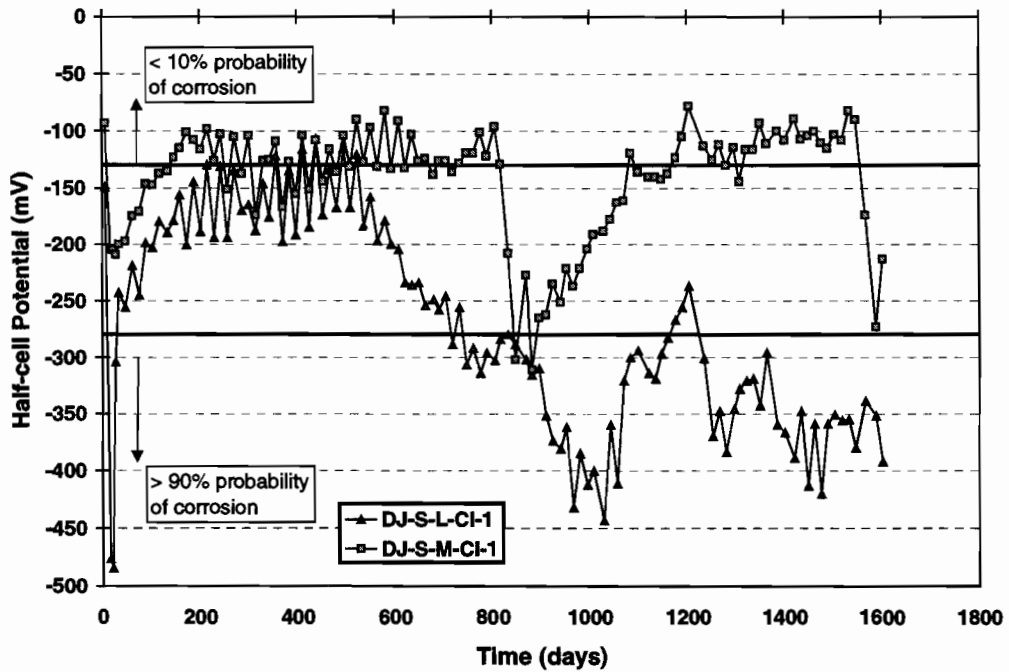
Figure 3.6 – Half-Cell Potentials: Dry Joint, Steel Duct and Corrosion Inhibitor

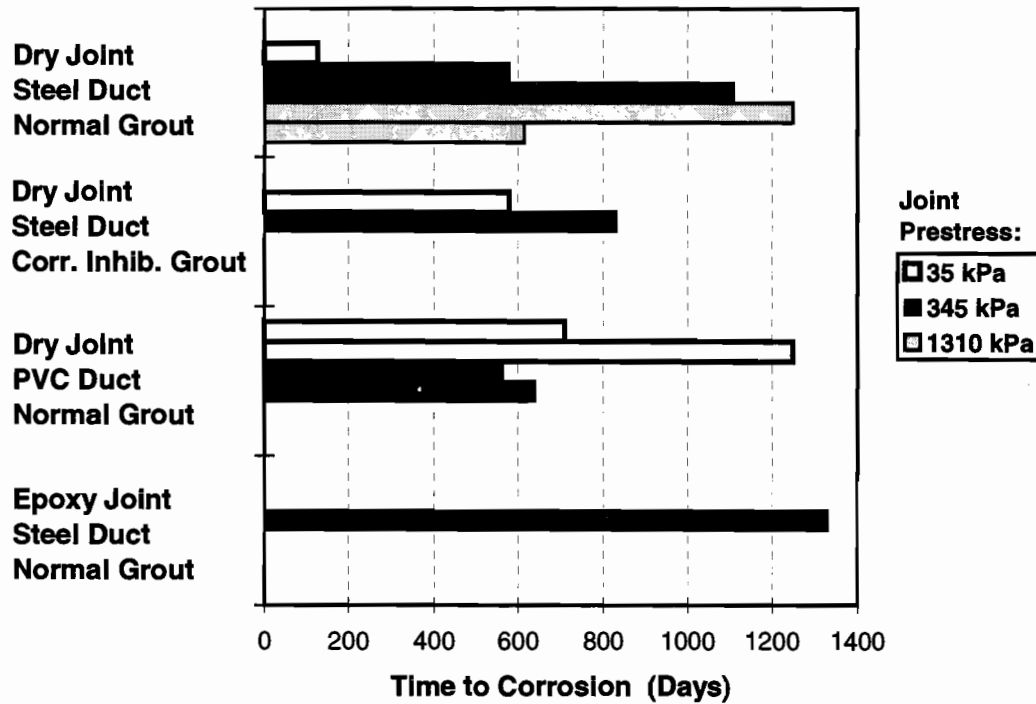
Figure 3.9 – Time to Corrosion Initiation for Active Specimens

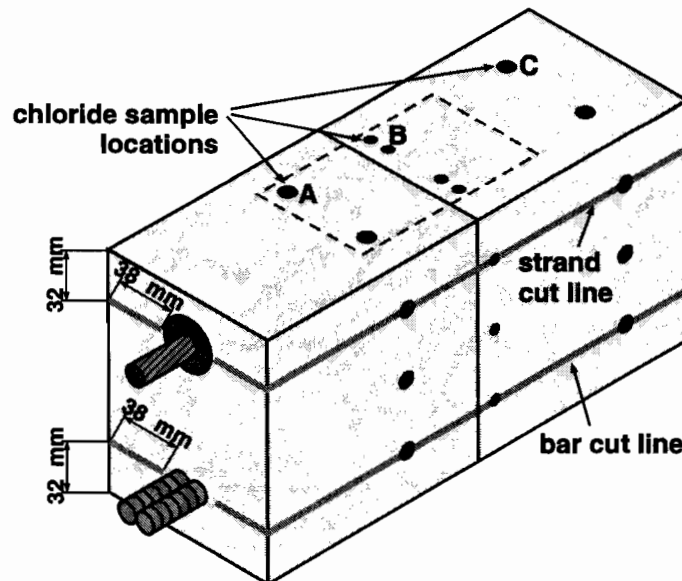
Figure 4.3 – Longitudinal Saw Cuts

Four longitudinal saw cuts were made on each specimen to facilitate removal of the duct/strand unit and mild steel bars. Saw cuts were made to a depth of 38 mm (1.5 in.) at the level of the tendon and bars, as shown in Figure 4.3. These cuts are referred to as the strand cut line and bar cut line respectively. The specimen remained intact after cutting, but was easily opened using a hammer and chisel. Saw cuts were performed using a high torque circular saw fitted with a diamond dry-cut concrete blade.

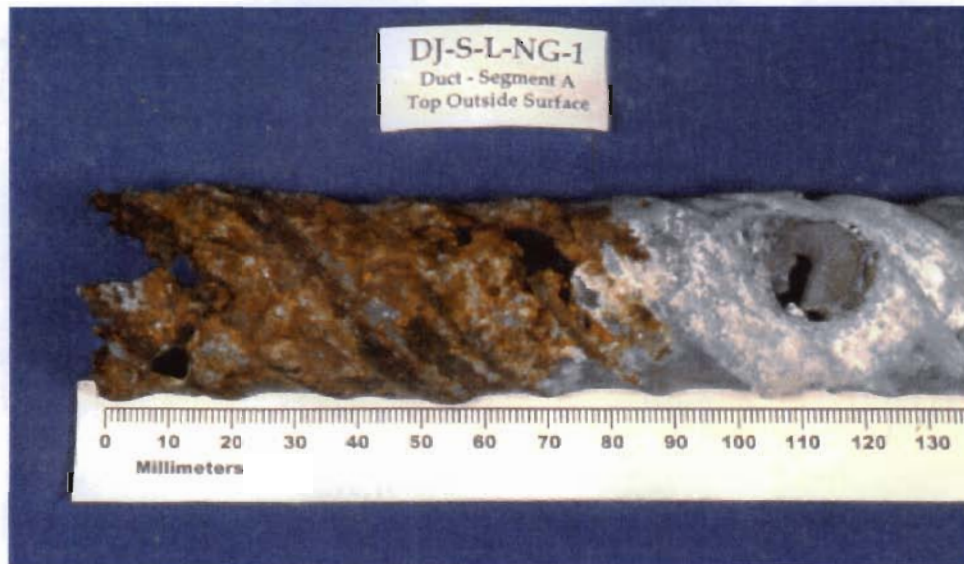
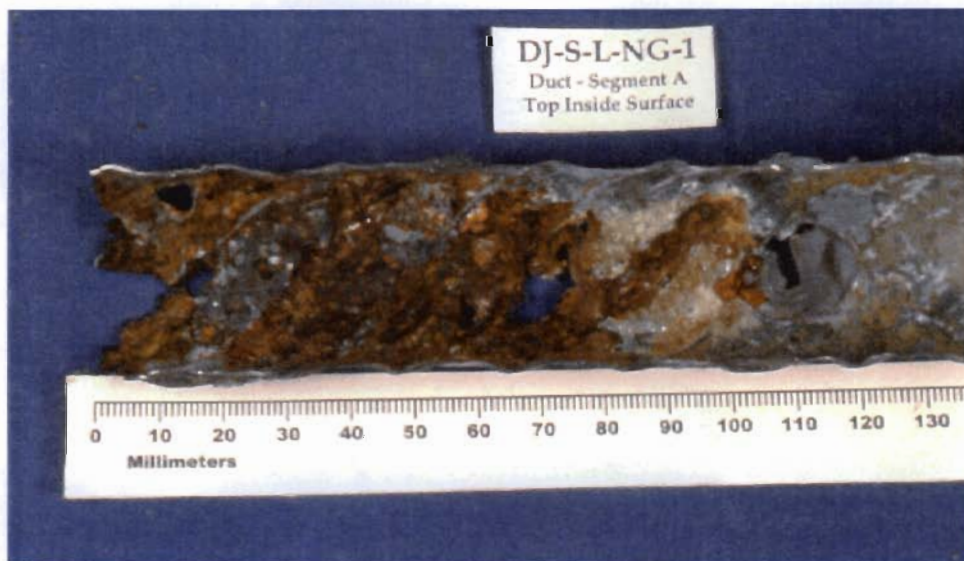
(a) Outside Surface of Duct (joint location at left end)

(b) Inside Surface of Duct (joint location at left end)

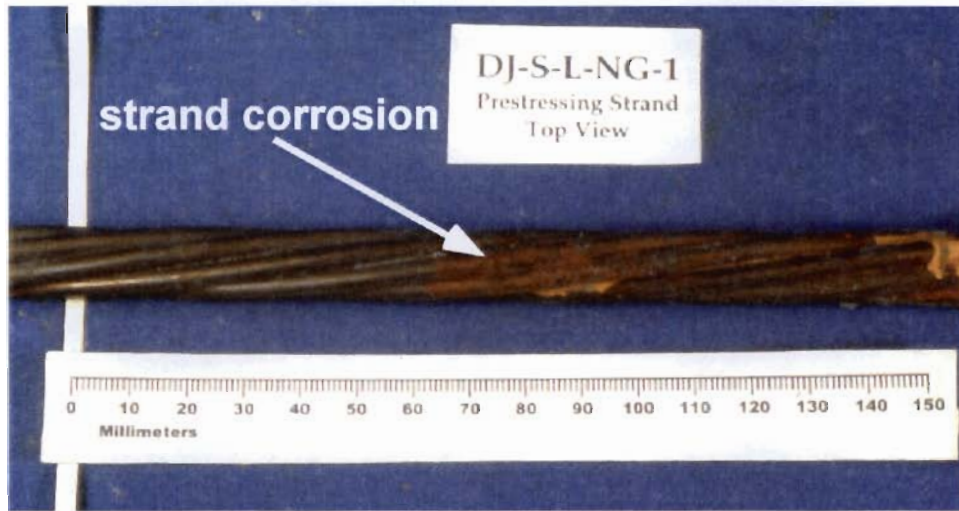
Figure 4.11 – Moderate Prestressing Strand Corrosion Where Epoxy Paint Peeled Away (Segmental Joint Location Indicated by Vertical White Line)

One interval each of light and moderate corrosion was found on both the outer wires and the center wire of the prestressing strand. Corrosion was located near end A where the epoxy paint had peeled off of the strand, as shown in Figure 4.11. No corrosion was found in the unpainted length of the strand.

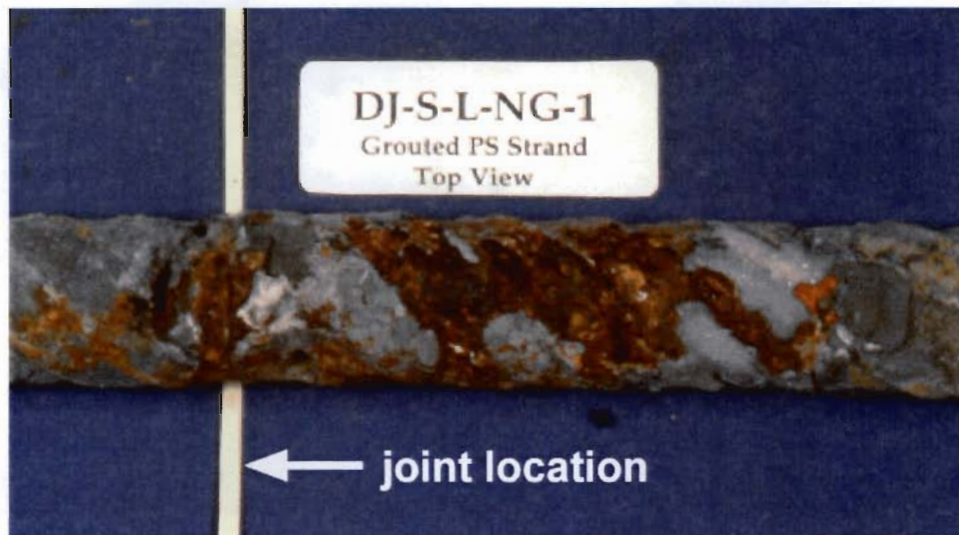
Figure 4.12 – Heavy Rust Staining on Grout Surface

The match-cast dry joint was intact with no voids or cracks. Some grout infiltrated the joint during grouting. The extent of infiltration was approximately 15 mm, uniform around the duct opening. Some rust stains were visible around the duct opening. The entire face of the joint was covered with a white residue that may be salt or leaching.

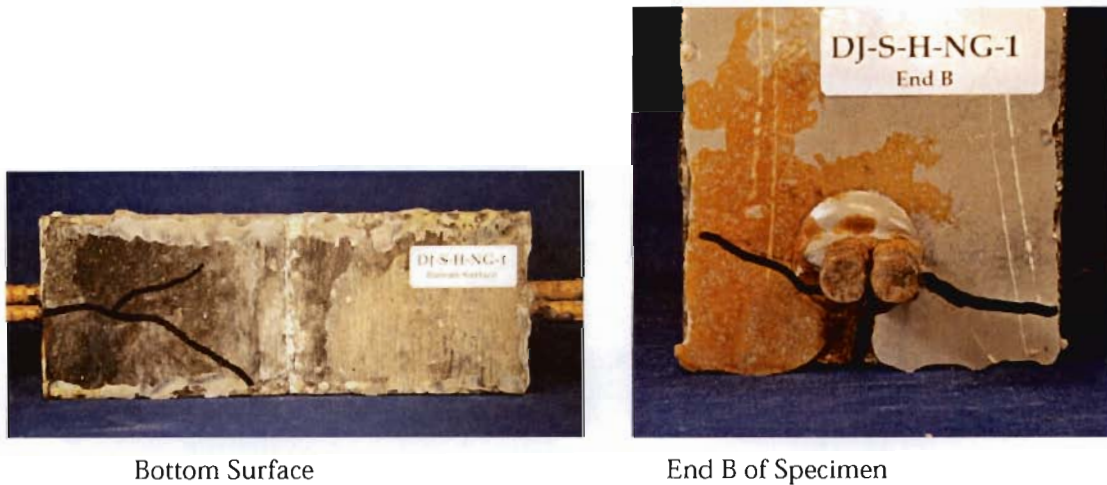
Figure 4.14 - Cracking Due to Rebar Corrosion

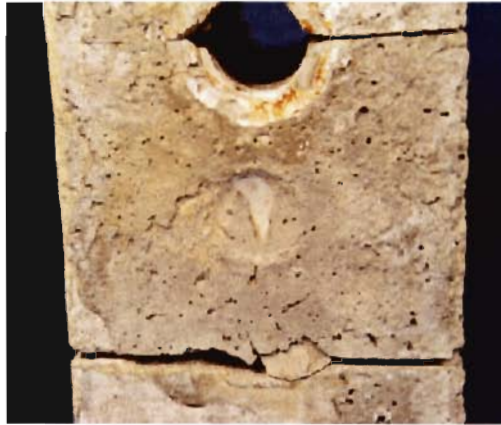
Figure 4.15 – Grout Infiltration Into Joint: Specimen DJ-S-L-CI-1

The concrete surface of the match-cast dry joint was intact with no voids or cracks. Significant grout leakage occurred during grouting, and approximately 80% of the joint surface was covered with grout, as shown in Figure 4.15. Rust and salt stains are present on the face of the joint around the duct opening.

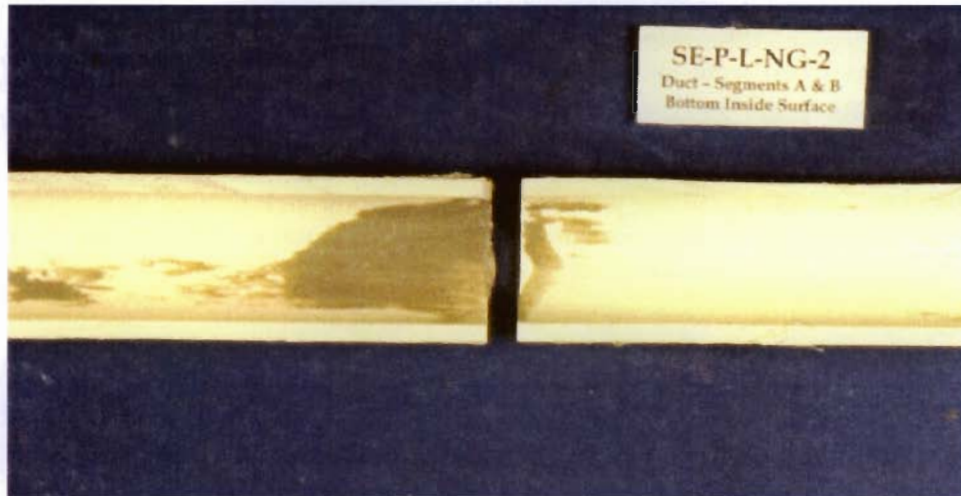
Figure 4.17 – Joint Epoxy Smearred Inside Plastic Duct During Swabbing

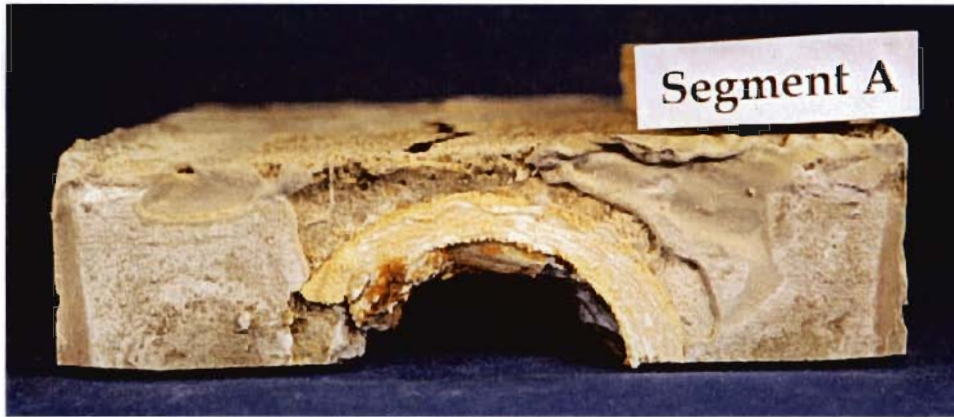
Figure 4.18 – Incomplete Epoxy Coverage in Epoxy/Gasket Joint (EG-S-M-NG-2)

The side and bottom perimeter of the joint were intact and appeared filled with epoxy. A thin void was visible at the joint on the top surface. Sections through the joint at the mid-height, bar cut line and strand cut line showed it to be completely filled with epoxy and free from voids or cracks. However, the gasket appears to have prevented complete bonding of the segments immediately above the duct opening. As a result, the top portion of the specimen above the strand cut line separated at the joint during autopsy. When the face of the joint was examined, incomplete epoxy coverage was revealed as shown in Figure 4.18. Salt and rust stains were visible on the joint.

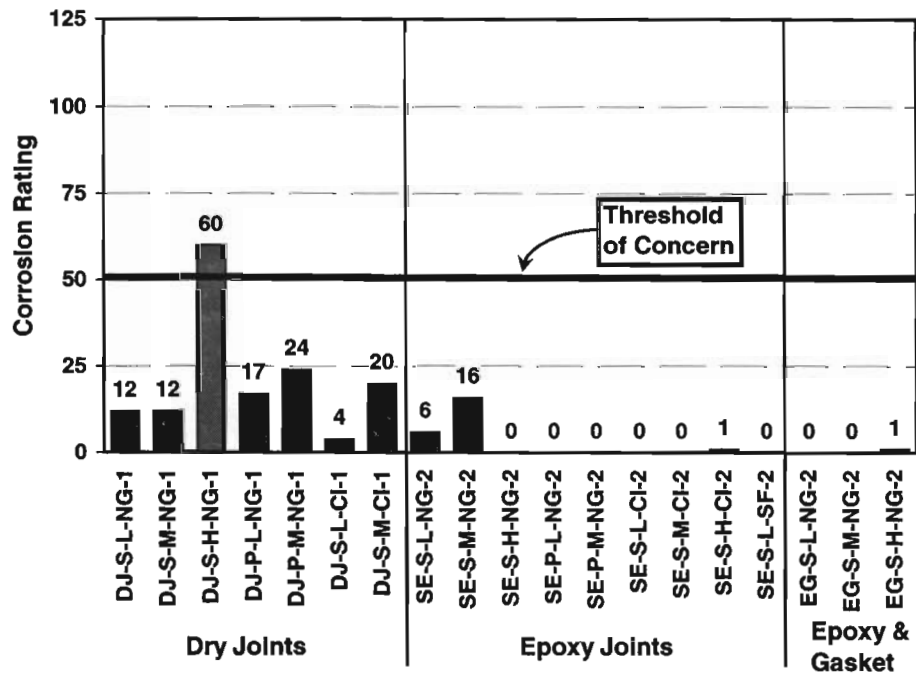
Figure 4.20 – Mild Steel Bar Corrosion Ratings for All Specimens

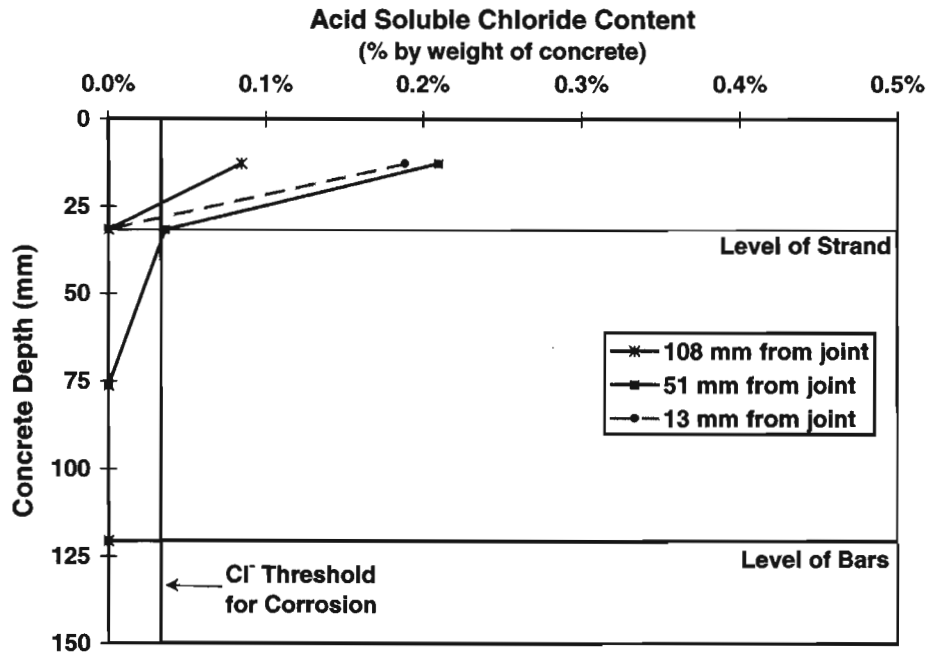
Figure 4.23 – Concrete Chloride Ion Profiles for Specimen SE-S-L-NG-2

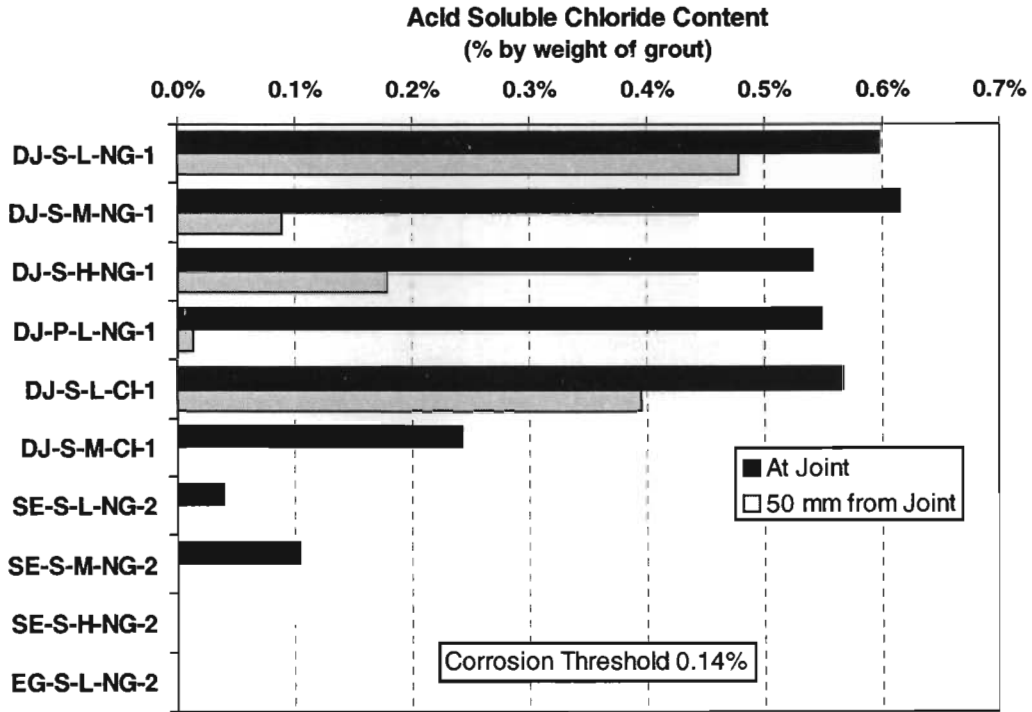
The results of the chloride analysis on grout samples are shown in Figure 4.26. The values are plotted as acid soluble chlorides, as a percentage of the grout weight. The chloride threshold for corrosion in grout is taken as approximately 0.14%, assuming a chloride threshold 0.2% of by weight of cement and a water-cement ratio of 0.44. The dry joint specimens show very high chloride contents, particularly in the vicinity of the joint. The two dry joint specimens with steel ducts and low precompression (DJ-S-L-NG-1 and DJ-S-L-CI-1) also show large chloride contents inside the duct, 50 mm (2 in.) from the joint. The dry joint specimen with a plastic duct, DJ-P-L-NG-1, showed a high chloride content at the joint, but only negligible chlorides 50 mm inside the duct. The four epoxy joint specimens analyzed show very low or unmeasurable chlorides at the joint. At a distance of 50 mm inside the duct, all samples showed unmeasurable chloride levels for the epoxy joint specimens.

Figure 4.26 – Measured Chloride Contents in Post-tensioning Grout

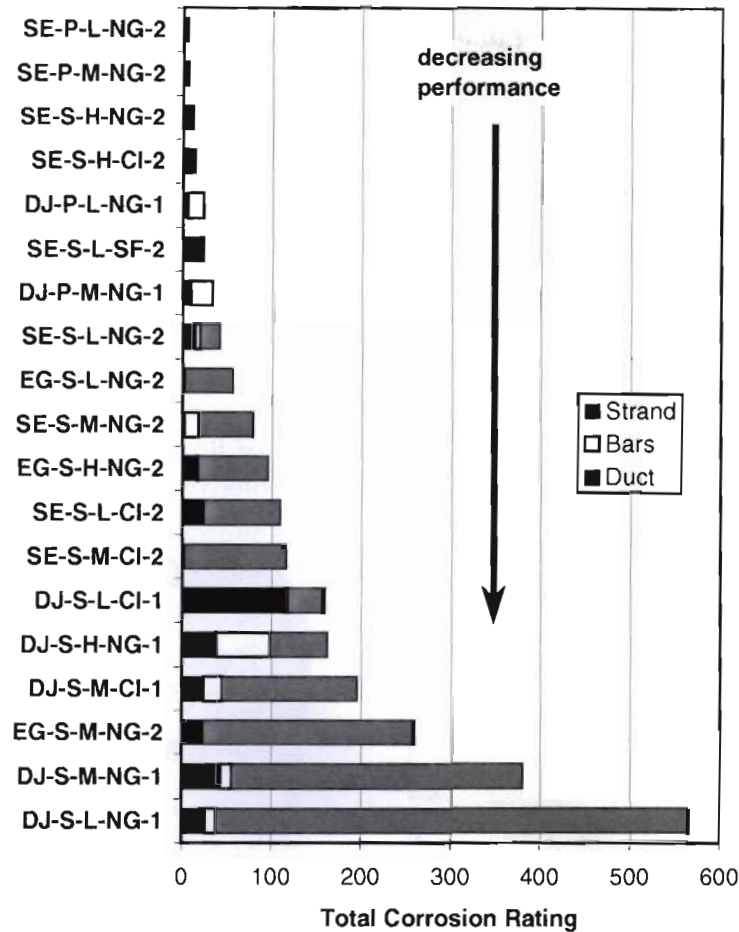
The overall performance of the specimens in this testing program can also be compared by considering the total corrosion rating, obtained by summing the ratings for strand, bars and duct. This data is plotted in Figure 5.2. Similar to Figure 5.1, the best performance occurred with standard epoxy joints. Plastic ducts performed well with both dry and epoxy joints. The worst performance occurred for dry joints with steel ducts. The ordering in Figure 5.2 is strongly influenced by the duct corrosion rating.

Figure 5.2 – Total Corrosion Rating Ordered According to Performance

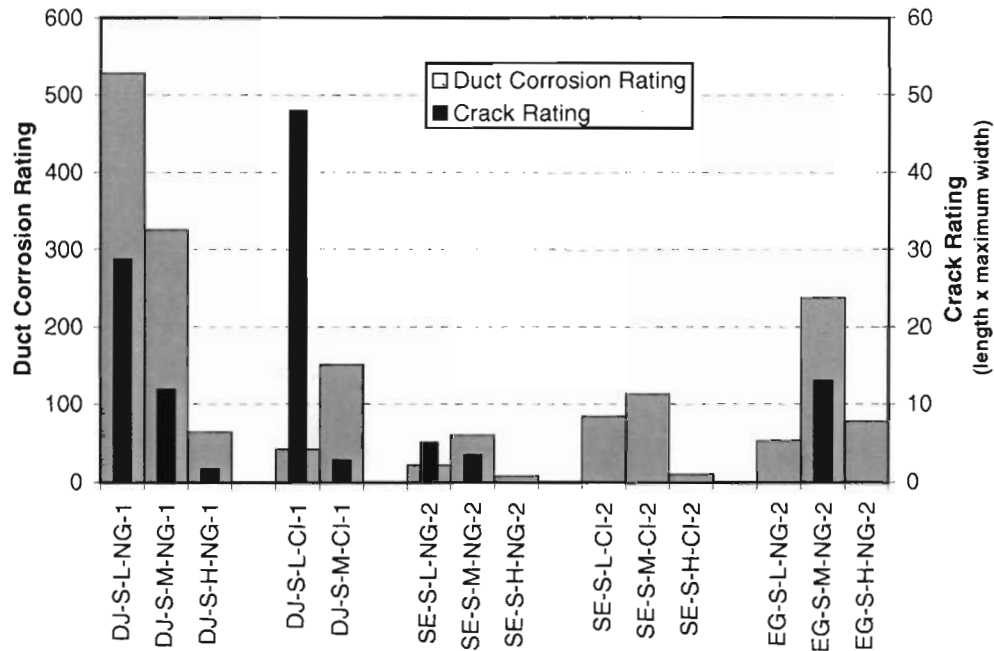
The duct corrosion ratings and crack ratings for the autopsied specimens with steel ducts are plotted in Figure 5.4. The effect of joint precompression on duct corrosion can be seen by comparing similar specimens where the joint precompression is the only variable. For example, consider DJ-S-L-NG-1, DJ-S-M-NG-1 and DJ-S-H-NG-1. The corrosion and crack ratings for these specimens decrease as the joint prestress increases, suggesting improved corrosion protection. A similar trend is present for the pair of specimens with a dry joint and corrosion inhibitor grout (DJ-S-L-CI-1 and DJ-S-M-CI-1). Duct corrosion in the standard epoxy joint specimens was not influenced by the presence of the joint (see Section 5.2), and thus the joint precompression does not appear to affect duct corrosion. Two of the epoxy/gasket joint specimens, EG-S-M-NG-2 and EG-S-H-NG-2, had partially defective joints resulting in chloride ingress at the joint. The duct corrosion and crack ratings for these two specimens again shows reduced corrosion damage for the specimen with higher joint prestress. The most significant effect would be expected to occur for dry joint specimens, as demonstrated in Figure 5.4.

Figure 5.4 – Effect of Joint Precompression on Duct Corrosion

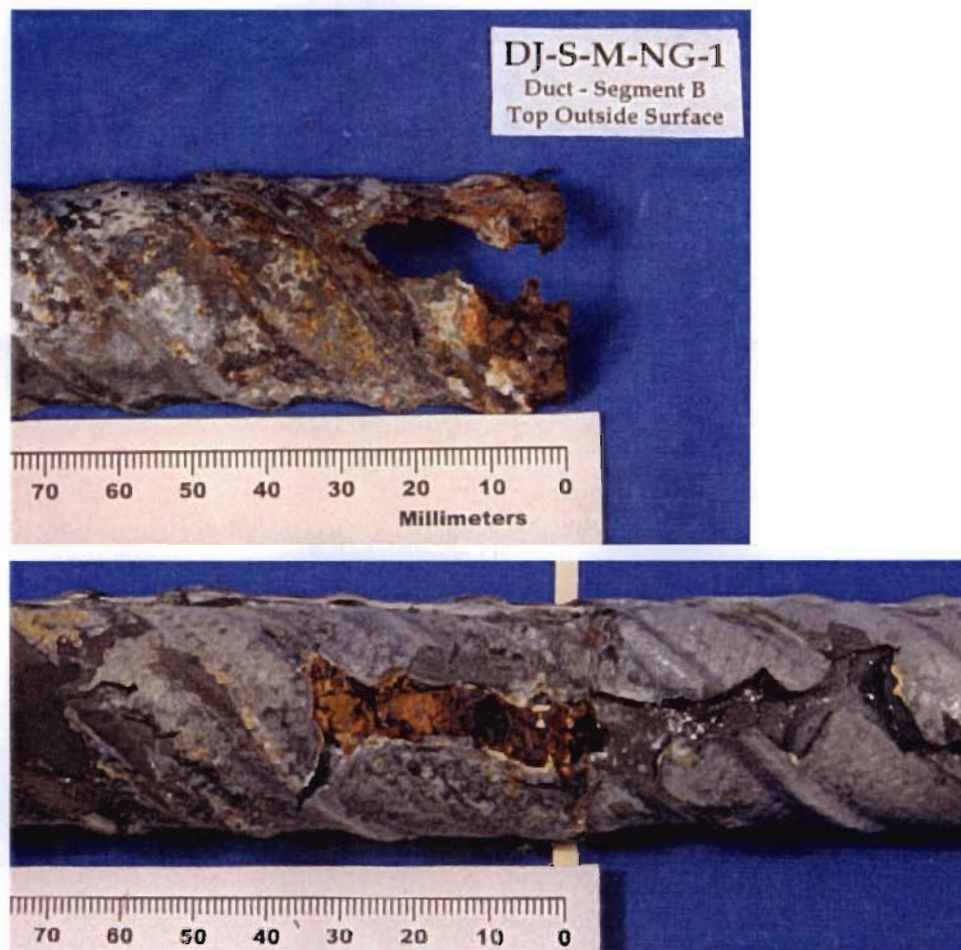
Figure 5.6 - Hole in Duct Corresponding to Grout Void

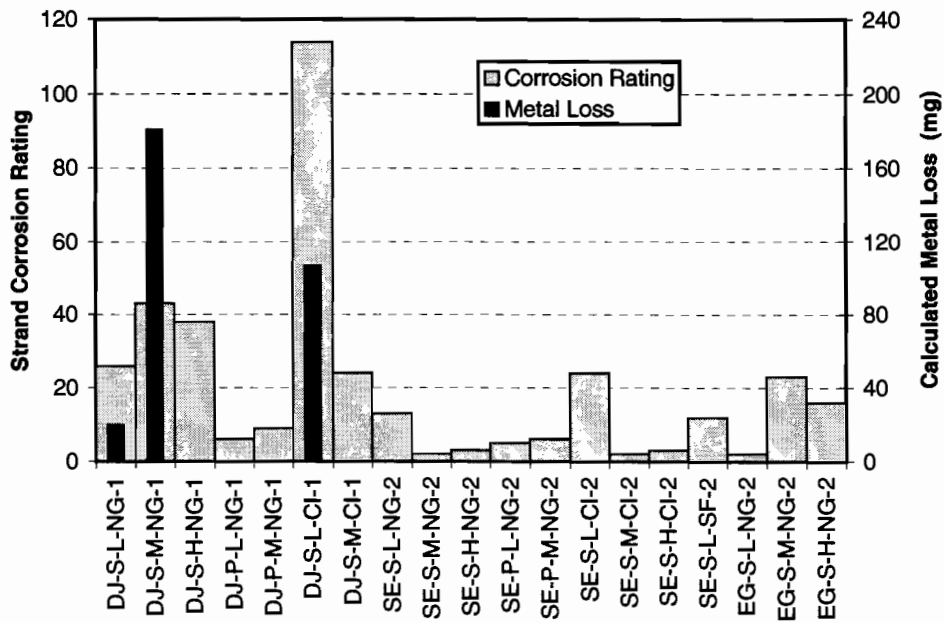
Figure 5.9 – Comparison of Corrosion Rating and Metal Loss for Prestressing Strand

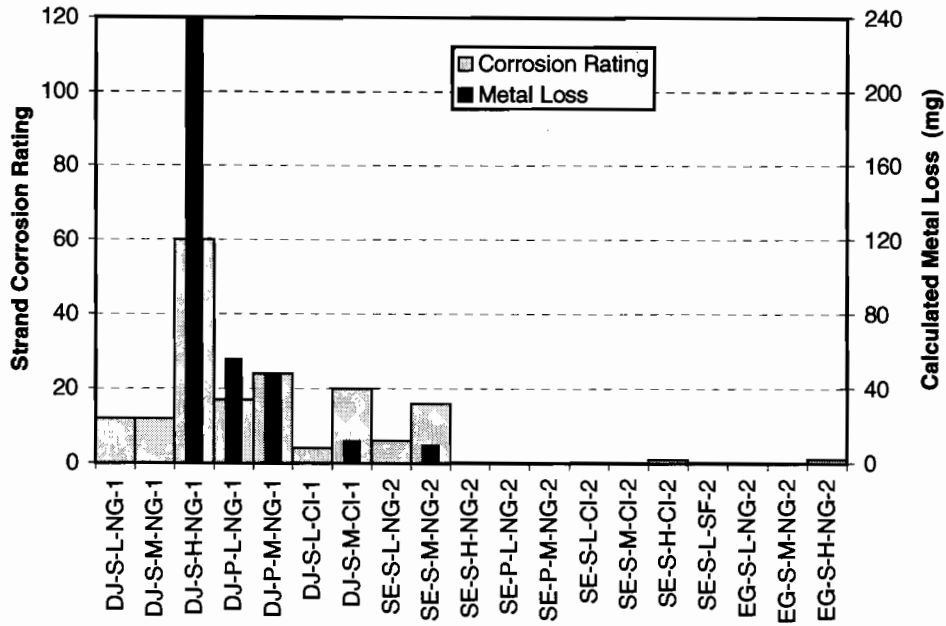
Figure 5.10 – Comparison of Corrosion Ratings and Metal Loss for Mild Steel Bars
