**PERFORMANCE OF CONTINUOUSLY REINFORCED CONCRETE
PAVEMENT CONTAINING RECYCLED CONCRETE AGGREGATE**

Report 1753-1
Project Number 0-1753
Research Project Title: The Use of Crushed Portland Cement Concrete As
Aggregates For Concrete Pavement

January 2001

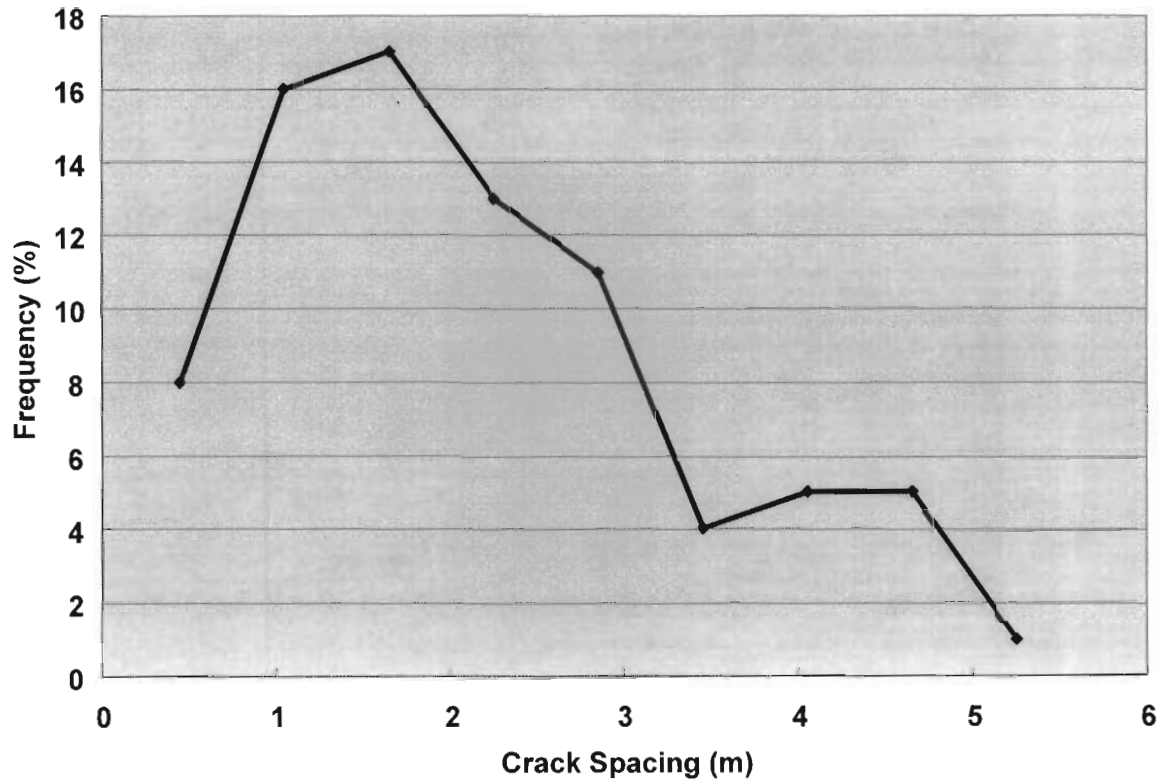
FIGURE 4 Transverse crack spacing distribution.

Field performance of the pavement was evaluated in terms of transverse crack spacing, crack widths, and spalling. Figure 4 shows the crack spacing distribution. The average crack spacing was 2.19 m (7.19 ft) with a standard deviation of 1.36 m (4.45 ft). This crack spacing is larger than that of SRG concrete and is comparable to that of limestone concrete (10). Low modulus of elasticity and medium COTE of this concrete appear to offset the effect of low concrete strength on cracking behavior of this concrete. Crack width was measured in the shoulder. Overall, cracks were tight, with the majority of crack widths ranging from 0.2 mm (0.008 in) to 0.7 mm (0.028 in). For the CRCP to perform satisfactorily, cracks need to be kept tight. Tight crack width provides good load transfer and minimizes the water intrusion into cracks. Even though the measured crack widths are small, the variability in the crack width measurements can be substantial, mainly due to the changes in crack width along a crack. The variability is also due to the temperature effect. In an experiment in this study, crack width was measured every 3 inches along the crack. In one crack, the crack width varied from 0.4 mm (0.016 in) to 0.8 mm (0.031 in). Therefore, during the crack width measurement, caution was taken to measure representative crack width.

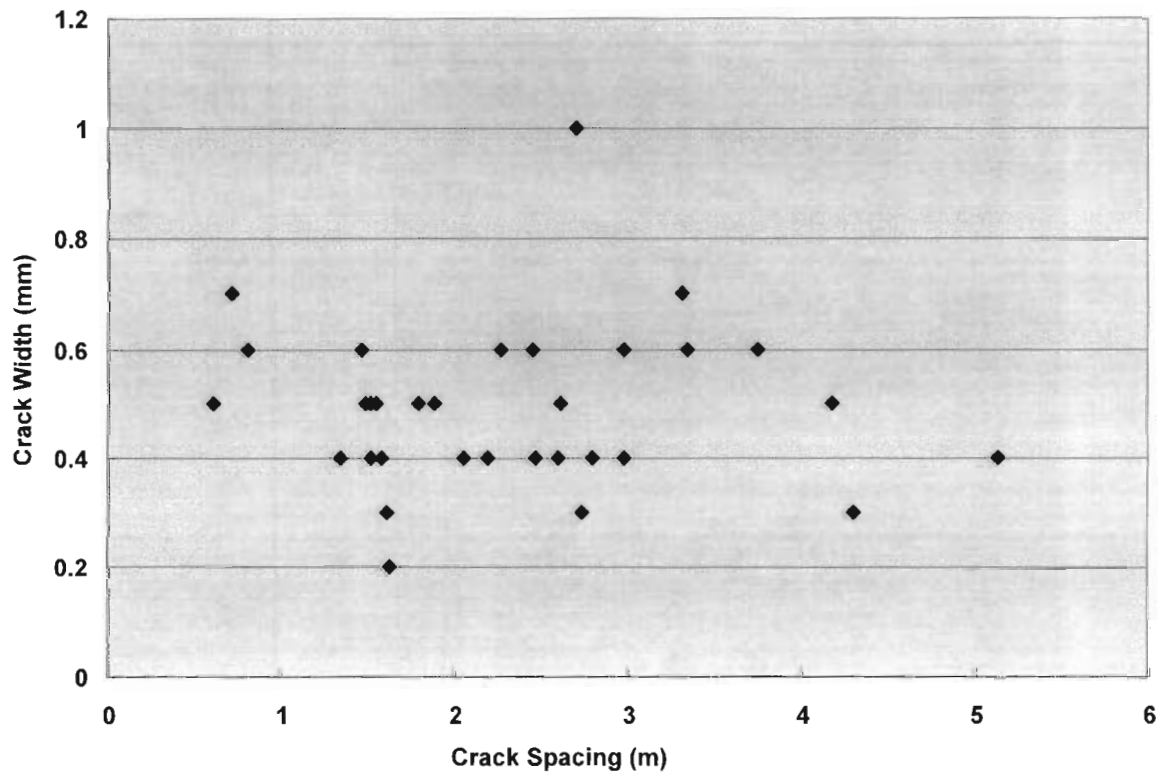
FIGURE 5 Correlation between crack spacing and crack width.

Some researchers have suggested that crack width depends on the crack spacing (11) because the crack width is the summation of concrete volume changes in the concrete between the cracks and, therefore, the longer the crack spacing, the larger the crack width. Figure 5 shows the relationship between crack spacing and crack width obtained in this study. Crack spacing used here is the sum of the two halves of the slab lengths on both sides at the crack. Figure 5 does not show a good correlation between crack spacing and crack width. There is at least one study that shows the same finding (5).

Several reasons are possible for the poor correlation, even though theoretical models predict a good relationship. One of them is the time of crack occurrence. If the cracks occur at early ages, say within several days after the concrete pouring, those cracks will open up relatively wider than the cracks that occur later. Any decrease in concrete volume due to subsequent drying shrinkage after cracking will show up as wider cracks. On the other hand, if the cracks develop at later ages, the concrete volume change due to the subsequent drying shrinkage will be small, resulting in smaller crack widths. Another reason for the poor correlation would be the existence of cracks that do not go through the slab. During the full depth repair of several CRCP sections that were between 10 and 30 years in service, it has been observed that some cracks do not go all the way through the concrete slab. The widths of these partial-depth cracks will be smaller than those of

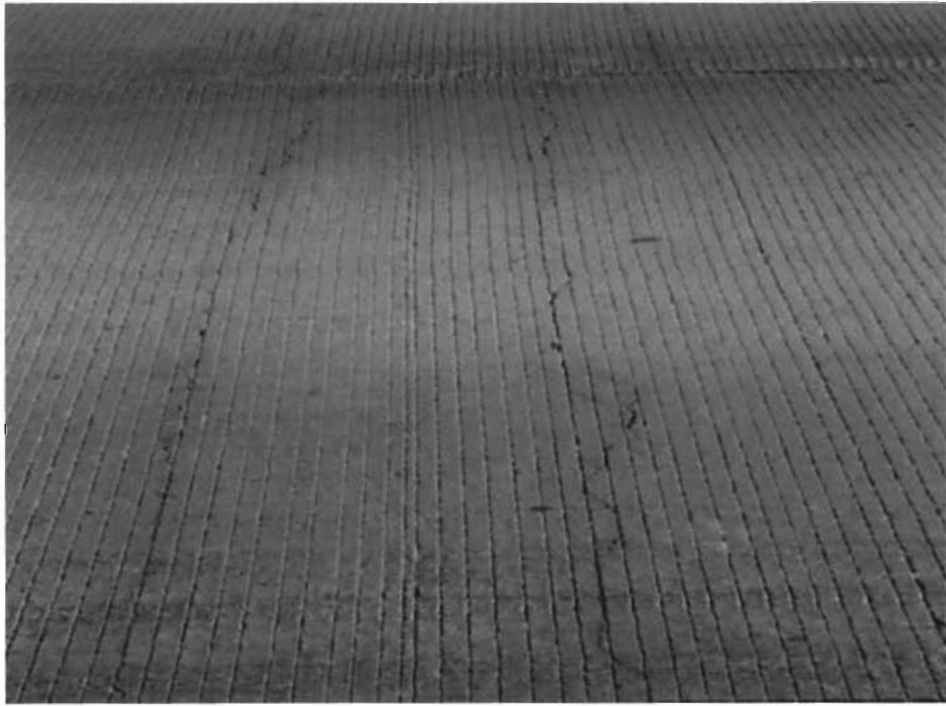
FIGURE 6 Typical CRCP section with 100 % recycled aggregates.

Spalling has not been a problem in this project. Figure 6 shows the typical surface condition of the pavement in this project. As mentioned above, spalling has been the major problem in CRCP in Houston when virgin SRG is used as a coarse aggregate. One 12-year-old CRCP project in Houston, where the coarse aggregate used was SRG, had such severe spalling that the project had to be overlaid with limestone aggregate concrete. Another CRCP project in Houston, which is also about 12 years old and has SRG aggregate, will be overlaid next year due to severe spalls. Figure 7 shows a typical CRCP section containing virgin SRG with a spalling problem. In these two projects, severe spalling occurred within a few years. There are a couple of theories proposed to explain the spalling mechanism. One is the intrusion of incompressible materials into the crack and the other is the development of horizontal cracks due to poor curing (12). However, neither theory explains the difference in spalling occurrence between CRCP sections with virgin SRG and RCA. Perhaps poor bond strength at the early ages between the smooth surface of virgin river gravel and mortar might have been responsible for severe spalling problems in sections with virgin SRG. It appears that the weak bond between virgin SRG and mortar develops at early ages when the concrete is still plastic and undergoes large moisture loss. This topic is under investigation in TxDOT research project 0-1887. On the other hand, petrographic analysis shows a good bond between old mortar and original siliceous river gravel aggregate in coarse RCA. It appears that once the bond between mortar and SRG surface survives the volume change strains and stresses during the hardening stages of concrete without cracking, good bond will eventually develop. Also, there is a good bond between old and new mortar, as shown in Figure 2. It is believed that this good bond is responsible for the minimal spalling problems in the RCA section.
