1. Report No. FHWA/TX-99/1818-1		2. Government Accession No.		3. Recipient's Catalog No.	
4. Title and Subtitle USE OF WEATHERING STEEL IN TxDOT STRUCTURES				5. Report Date Dec. 1999

Performance of Weathering Steel in TxDOT Bridges

**Project 1818
Use of Weathering Steel in TxDOT Structures**

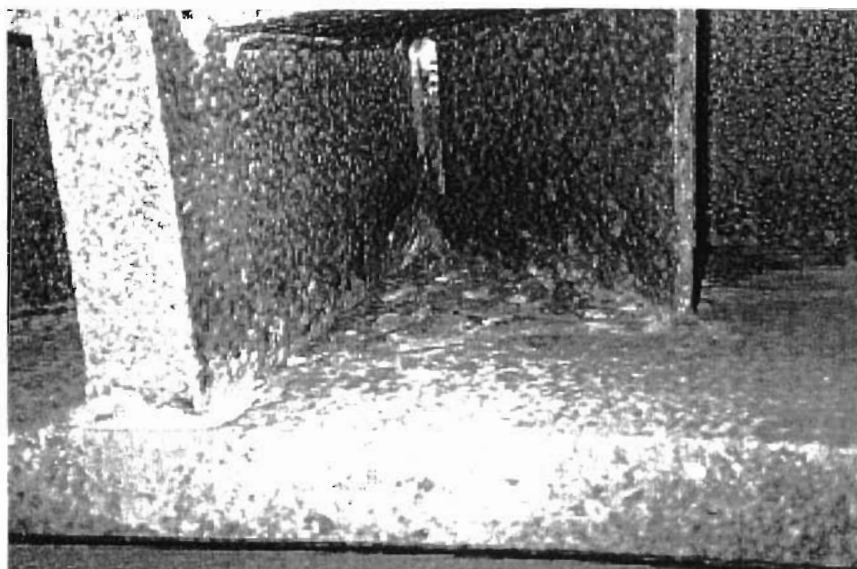
Stiffener clips on some bridges were of inadequate size and did not provide enough ventilation and drainage. They closed due to an accumulation of debris and corrosion. The clips shown in **Figure 1** were detailed as 1" by 1", which is not adequate for proper drainage.

Figure 1 - Gap closure due to inadequately-sized clips

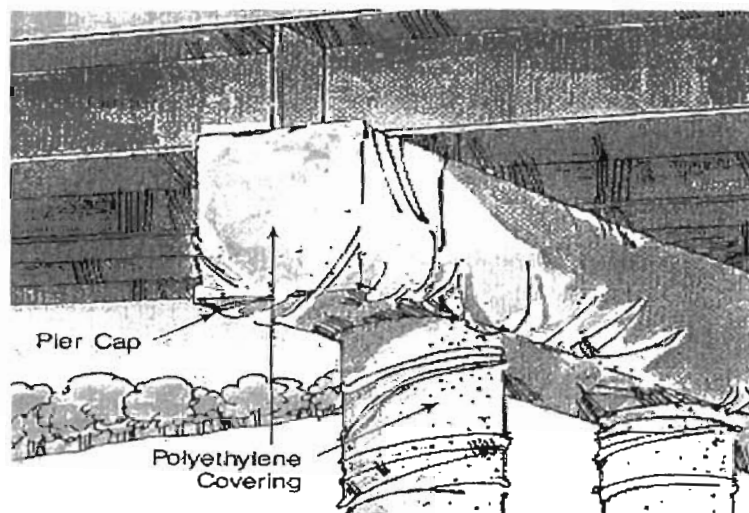
Figure 24 - Wrapping of bents and column

During bridge construction, the most severe staining conditions occur prior to placement of the deck. When water running over the weathering steel superstructure is free to flow onto piers and abutments. To prevent staining during this period, all affected concrete surfaces should be draped, wrapped, or otherwise sheltered with a heavy-gauge water-proof covering, such as polyethylene sheeting, capable of resisting tearing by wind gusts and construction operations [4]. Once the deck is in place and systems are installed to carry away rust-laden water, the plastic sheets can be removed. Only piers without drip pans need to be wrapped.

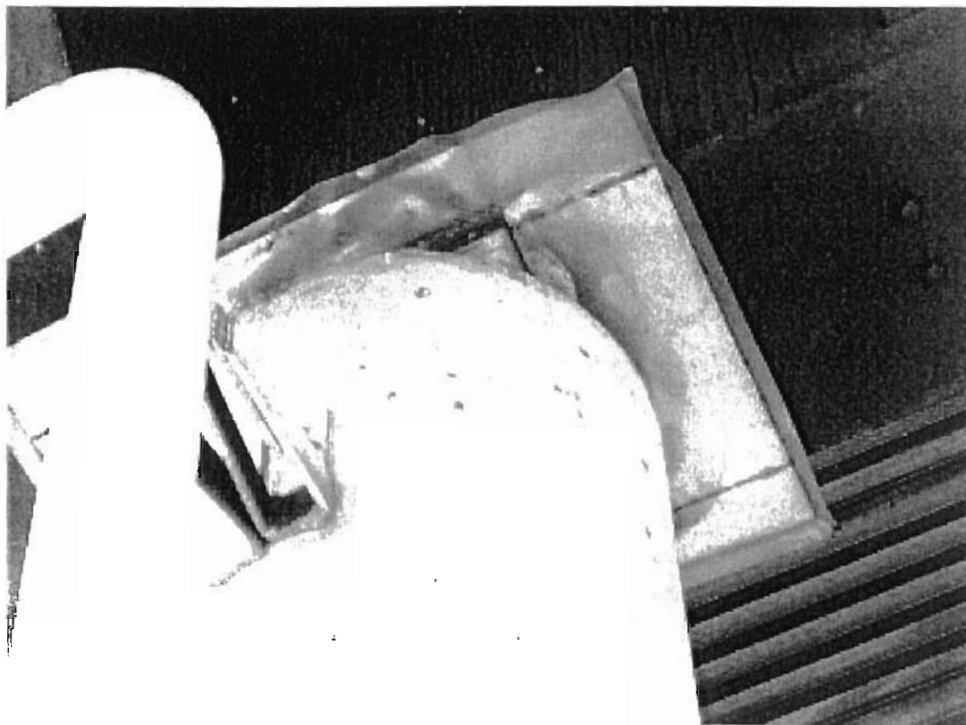
Figure 27 - Properly retrofitted drip pan on pier

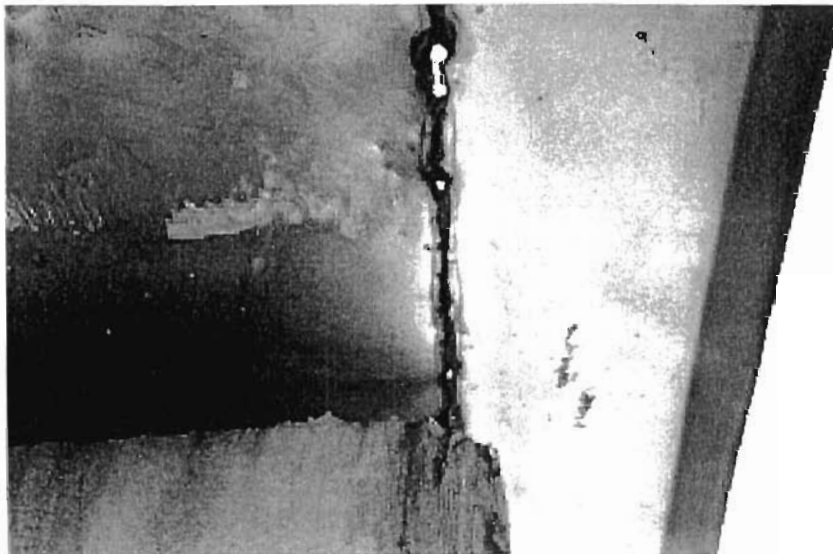
Notice in **Figure 29** that improper welding has created holes in the drip pan, allowing run-off water to leak through, staining the column below.

Figure 29 - Retrofitted drip pan, showing poor welding

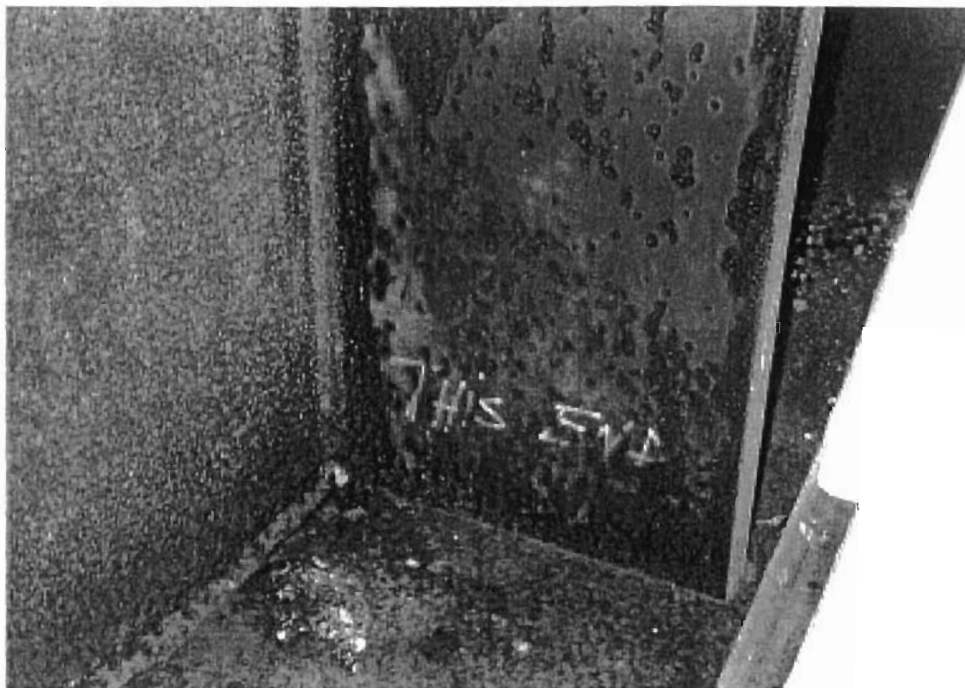
bridge on SH 124 north of High Island. This structure is 22 years old and is corroding so slowly that it still has mill scale present on some locations (**Figure 34**).

Figure 34 - High Island Bridge stiffener with mill scale still visible

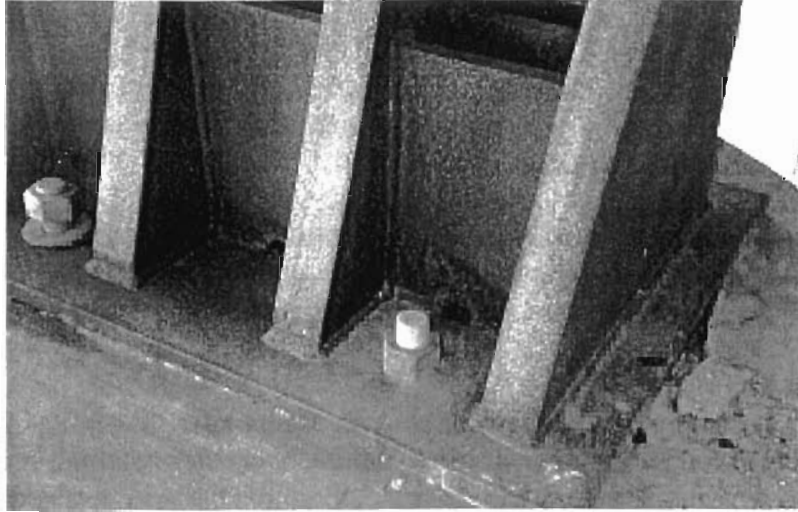
Figure 37 - Proper detailing with drain holes allows good drainage

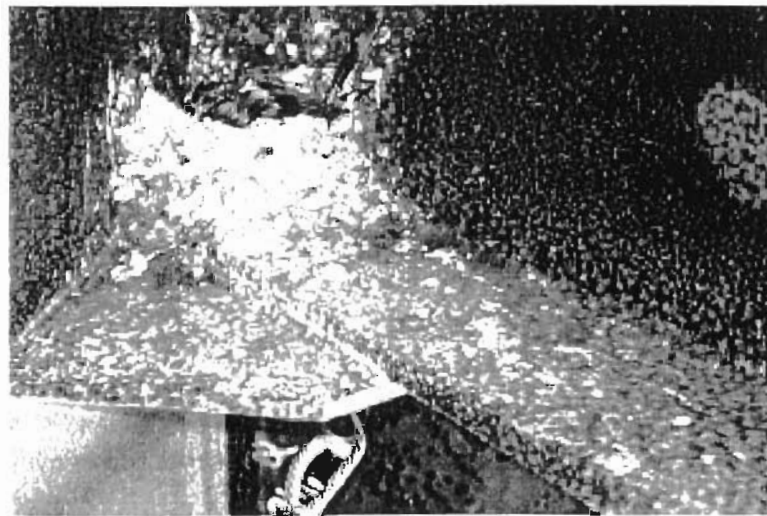
Debris is also detrimental. Debris that collects due to poor detailing tends to absorb moisture and/or inhibit the flow of run-off water, as shown in **Figure 38**.

Figure 38 - Accumulated debris completely restricts water flow
