**Bridges with Premature Concrete Deterioration:
Fatigue Testing of Full-Scale, Prestressed
Concrete Box Girders Failing in Shear**

Research Report 1857-3

*STRUCTURAL ASSESSMENT OF IN-SERVICE BRIDGES
WITH PREMATURE CONCRETE DETERIORATION*

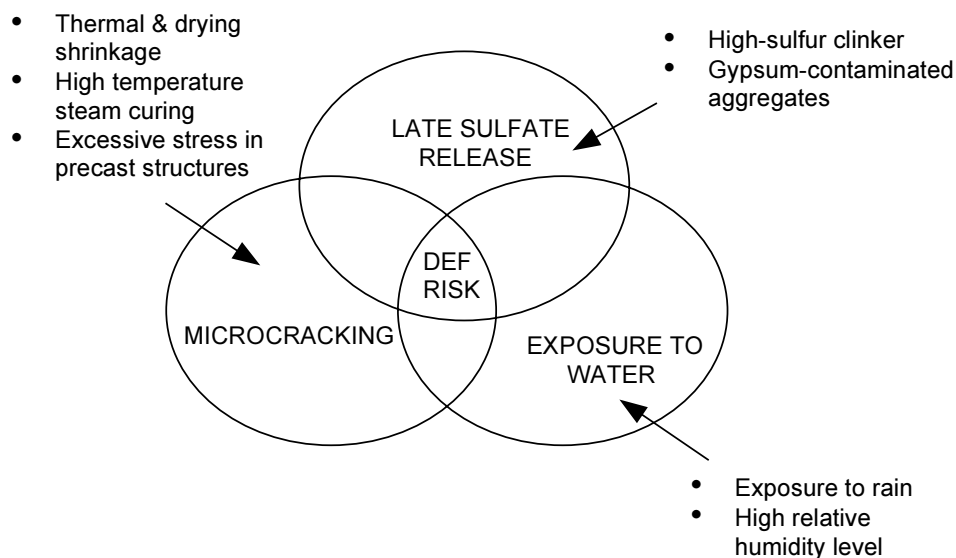
Figure 2.1 A holistic model showing DEF-damage as a function of late sulfate release, microcracking, and exposure to water (Collepari 1999)

- 1) microcracking,
- 2) exposure to water or saturated air, and
- 3) late sulfate release.

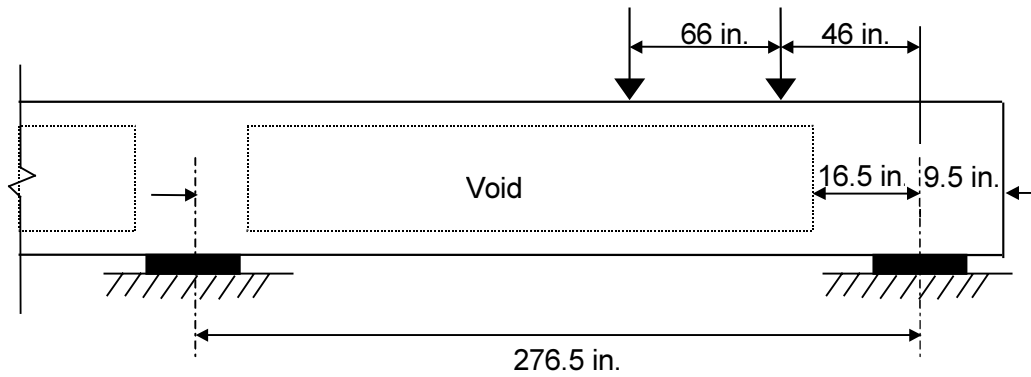
Figure 3.5 Support conditions and loading points for shear-dominated fatigue tests

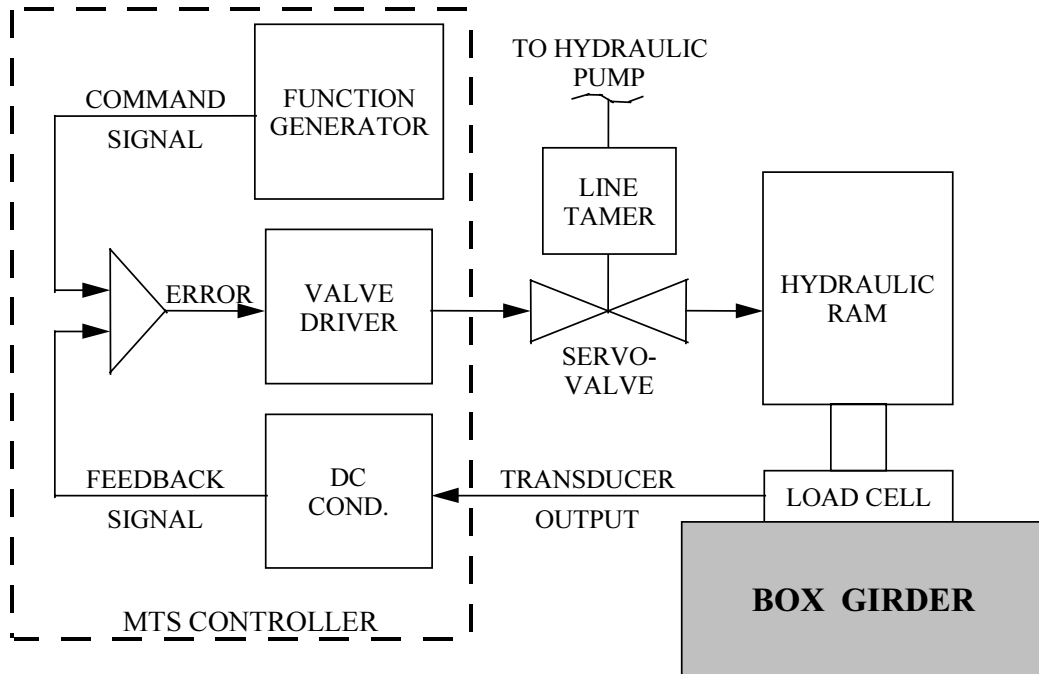
Figure 3.6 Schematic representation of the closed-loop system used for static and fatigue tests (Graddy 1995)

A closed-loop system, shown schematically in Figure 3.6, was used to control applied loads during tests. An MTS controller monitored the load on specimens through the load cell, compared it with the command signal, and supplied the appropriate corrective signals to the valve driver controlling the flow of fluid through the hydraulic rams. If the load deviated from the command signal by some pre-set limit, the controller was programmed to stop the test by removing pressure from the hydraulic rams. These limits, as well as the command signal, required occasional adjustments during each test to maintain smooth and continuous application of load cycles (Graddy 1995). Sinusoidal loading was used, at frequencies between 0.25 Hz and 1.3 Hz.

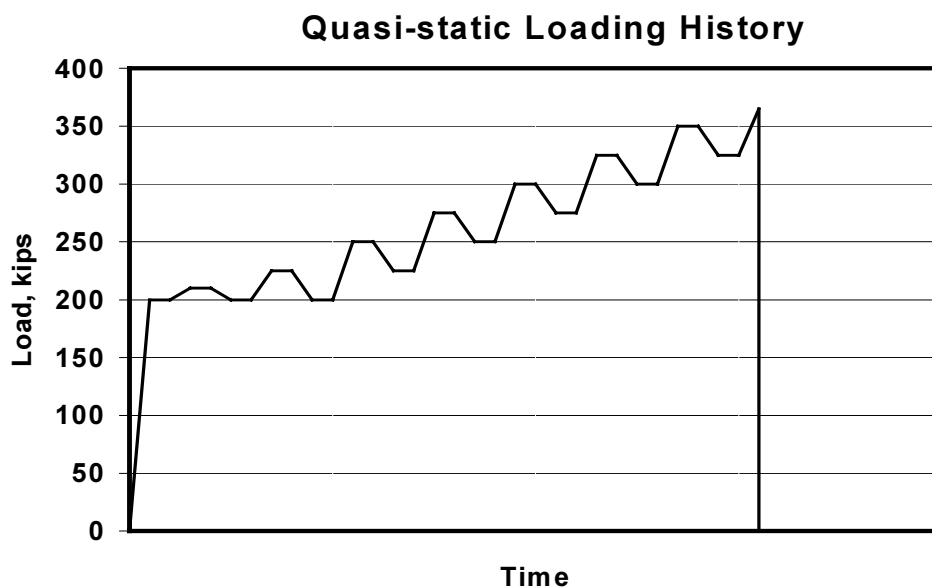
Figure 3.16 Quasi-static loading history for Specimen BG3S

After 3,328,600 cycles, the girder was tested quasi-statically to failure, using a stepped loading procedure (Figure 3.16) with intermediate unloading to obtain acoustic emission data. The load was held constant for several minutes after each of the loading and unloading periods, until significant acoustic emissions had subsided. The test procedure was as follows: the girder was first loaded to 200 kips (890 kN) and held, increased to 210 kips (930 kN), reduced to 200 kips (890 kN), increased to 225 kips (1000 kN), reduced to 200 kips (890 kN), and increased to 250 kips (1110 kN). Thereafter, the load was decreased by 25 kips (110 kN), and then increased by 50 kips (220 kN). This pattern was repeated until failure occurred at 365 kips (1620 kN).

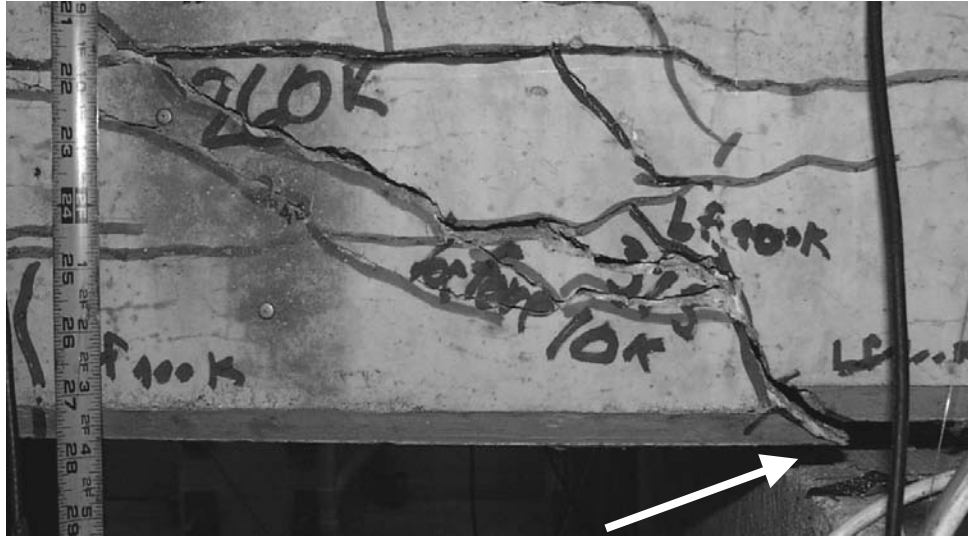
Figure 4.12 Displaced concrete section at the bottom of the east web of BG3N at failure

The MTS controller automatically stopped the test at 4 AM on September 25, 2000, after 28,133 cycles, when the pre-set DC error limit was exceeded. The east web of the girder had failed first, causing the controller to stop the test before completely failing the west web (Figures 4.10, 4.11 and 4.12). The mode

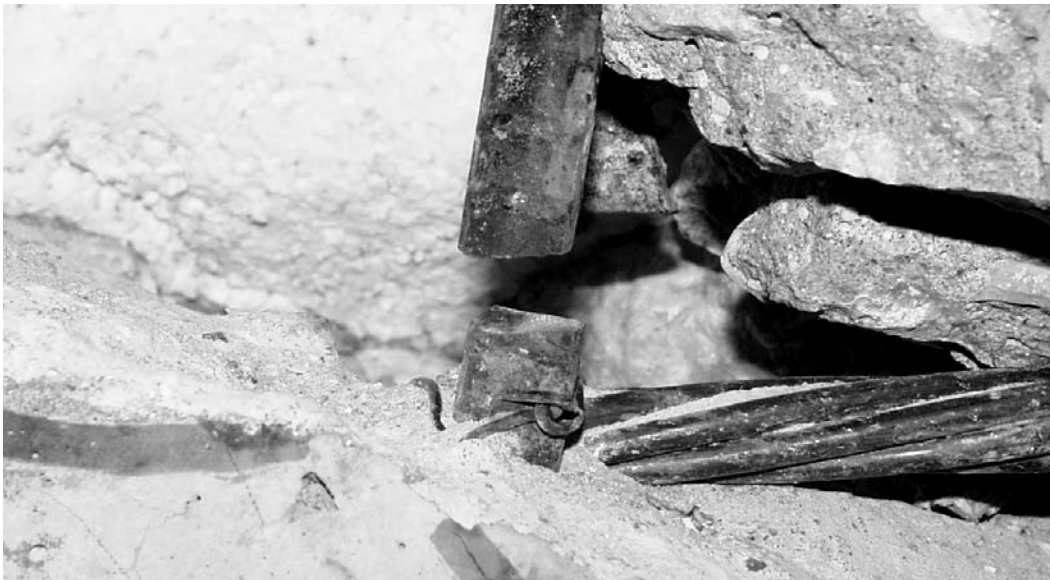
Figure 4.13 Fractured shear reinforcement (stirrup) in the east web of BG3N at failure, after removal of concrete

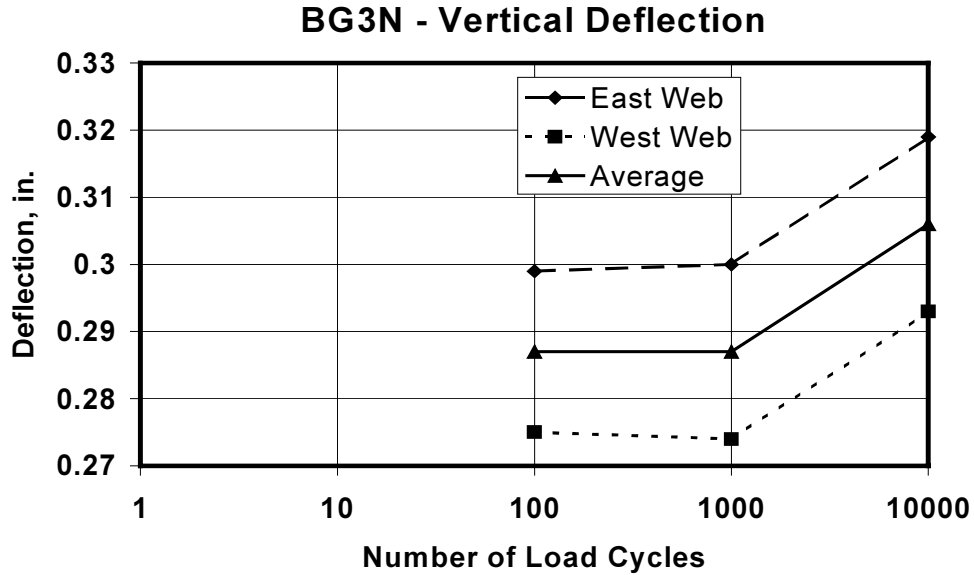
Figure 4.14 Vertical deflection vs. number of load cycles for BG3N

Vertical deflections were measured under each web at a distance 88.5 in. (2.25 m) from the girder end (midway between the two hydraulic rams) after 100, 1000, and 10,000 load cycles. Vertical deflections under each web, and the average of these two deflections, are plotted versus number of load cycles (Figure 4.14).

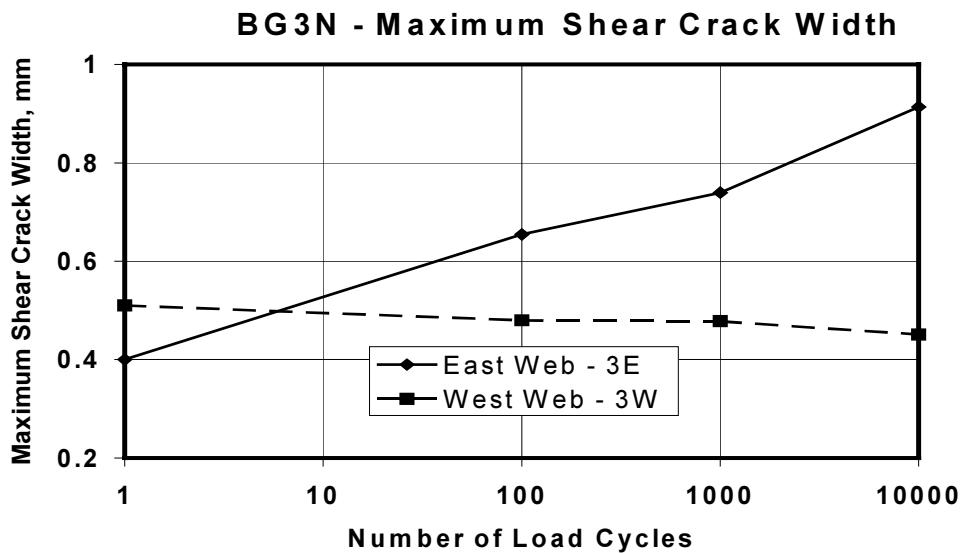
Figure 4.18 Changes in maximum shear crack widths in both webs of BG3N

Demec gauges were used to monitor changes in crack widths, specifically the changes in width of the widest cracks within the shear-critical regions of both the east and west webs (Figure 4.18). The widest initial crack in the shear-critical region of the east web was monitored with Demec Point 3E. From zero load cycles to 10,000 load cycles, the crack width at Point 3E increased by 0.020 in. (0.50 mm). The widest initial crack in the shear-critical region of the west web was monitored with Demec Point 3W. From zero load cycles to 10,000 load cycles, the crack width at Point 3W decreased by 0.002 in. (0.05 mm). Although Point 3W decreased slightly in width, Point 6W, a narrower parallel crack monitored in the same region, increased in width by 0.002 in. (0.05 mm). Width changes varied for the ten remaining cracks monitored. These crack widths increased very slightly, decreased slightly, or remained constant. Overall, there was very little change in the existing crack widths during fatigue testing. This was not unexpected, because new parallel cracks formed in the same region.

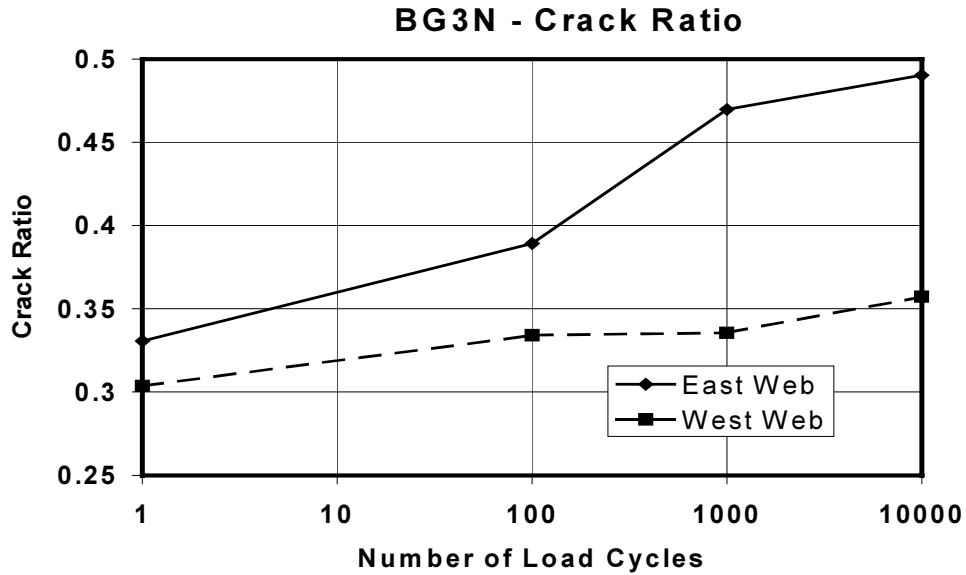
Figure 4.19 Change in crack ratio for BG3N

Crack ratio (CR) and damage index (DI) were monitored as defined in Section 3.6.3. Figure 4.19 shows the change in crack ratio with the number of load cycles, and Figure 4.20 shows the change in damage index with the number of load cycles. The total increases in crack ratio and damage index during fatigue testing were more pronounced in the east web. The increase in east-web crack ratio was 56 percent, and the corresponding change in damage index was 154 percent.

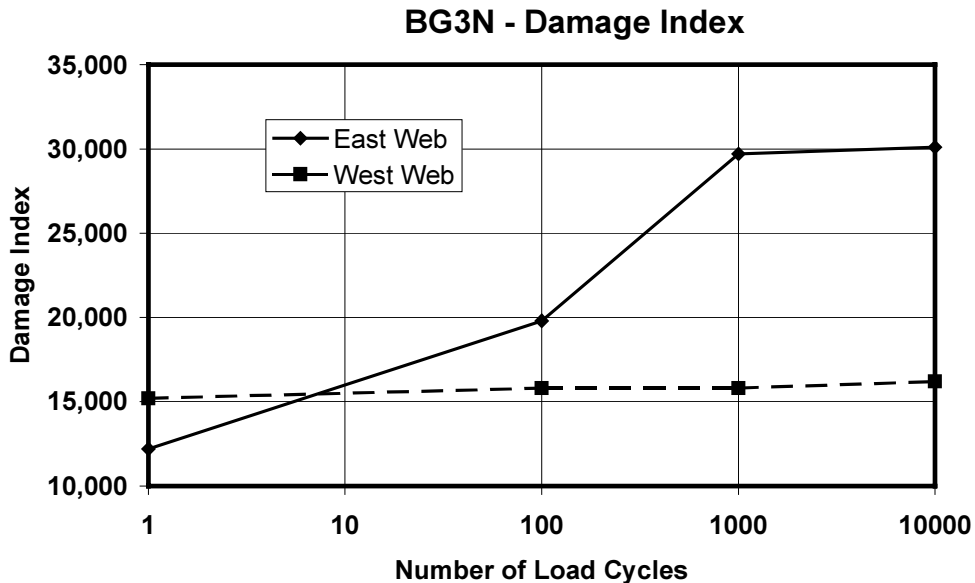
Figure 4.20 Change in damage index for BG3N

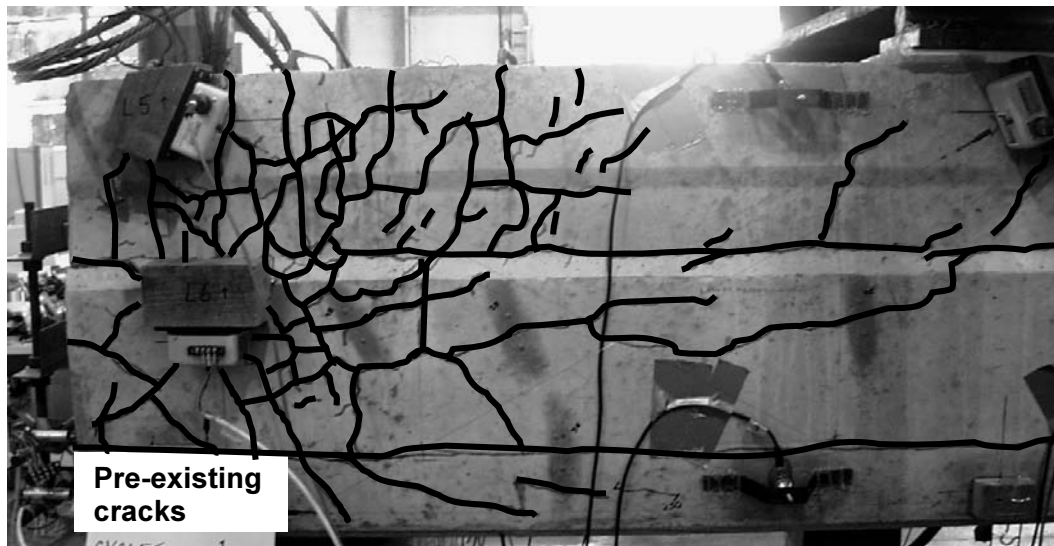
Figure 4.21 Pre-existing cracks in the east web of BG3S

The pre-existing cracks in the east and west webs of BG3S are shown in Figures 4.21 and 4.22.

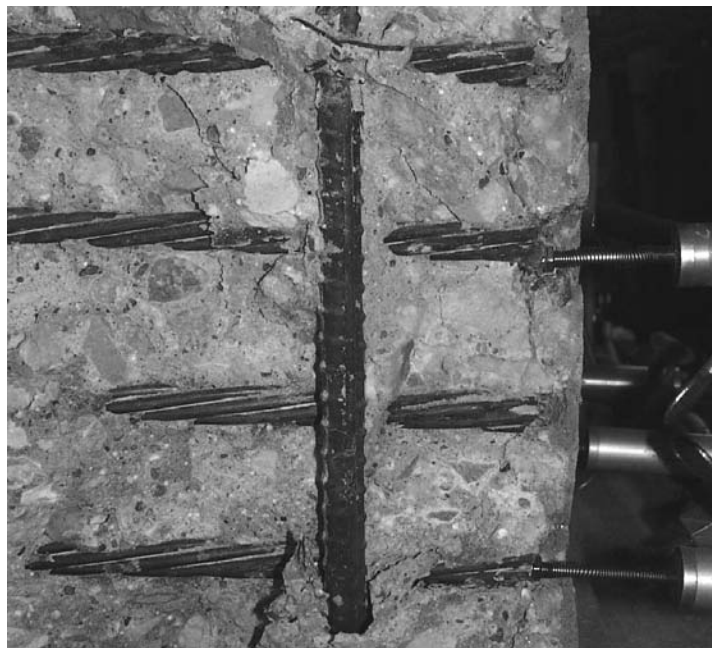
Figure 4.32 Slip of exterior prestressing strands after failure of BG3S

There was no significant slip of prestressing strands during the fatigue test. In the final moments of the quasi-static test to failure, however, as the concrete cover spalled off and the web concrete crushed, several interior prestressing strands and all of the strands nearest to the exterior surfaces of the webs slipped (Figure 4.32). The amount of slip was not measured accurately by the linear potentiometers because as the girder failed, the potentiometers slipped off of the ends of the prestressing strands. Slip was verified by visual inspection, and was manually measured to be between 0.125 in. (3 mm) and 0.25 in. (6 mm) for the interior strand, and approximately 0.5 inch (13 mm) for the exterior strand.
