***FINAL EVALUATION OF A
SAND-ASPHALT-SULFUR TEST SECTION US 77,
KENEDY COUNTY, TEXAS***

Research Report 187-19

conducted by
Texas Department of Transportation
Division of Materials and Tests
Bituminous Section

March 1992

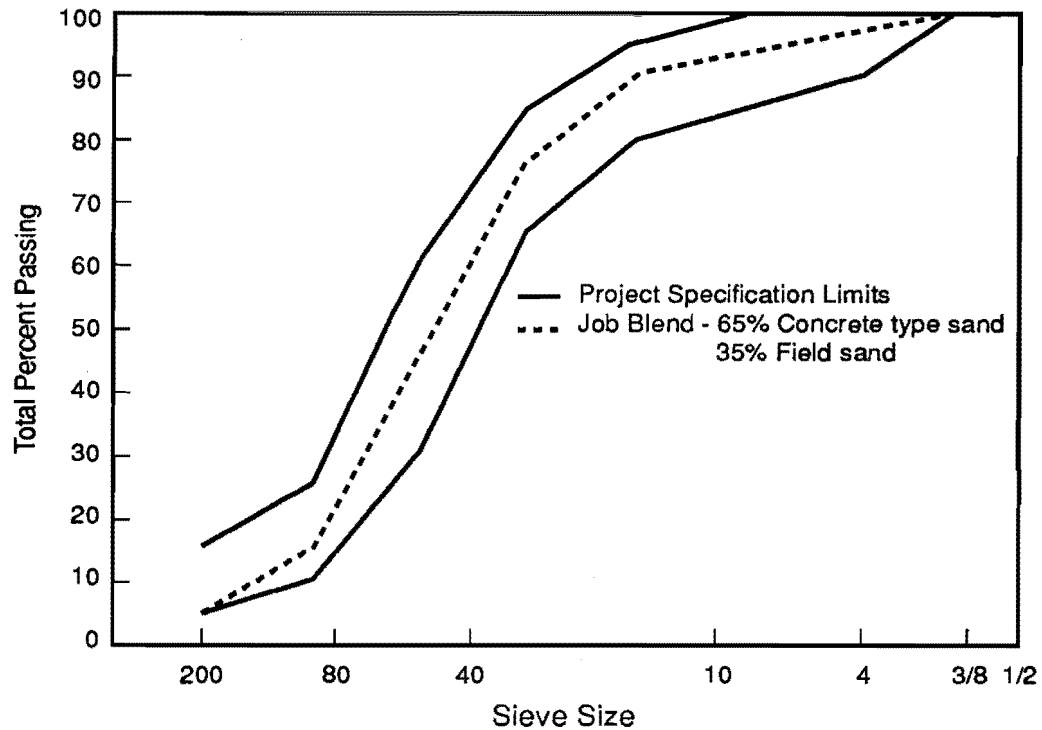
Figure 3. Gradation chart (for SAS mixture).

The sand-asphalt-sulfur mix design was comprised of 80.8 percent sand, 13.0 percent sulfur and 6.2 percent asphalt. The gradation chart is shown in Figure 3. The 80.8 percent sand portion was comprised of 65 percent "Bluntzer" concrete type sand and 35 percent field sand. The sulfur was elemental sulfur from Fashing, Texas, and Newgulf, Texas, respectively. The asphalt for the SAS mixture was Gulf States AC-20.

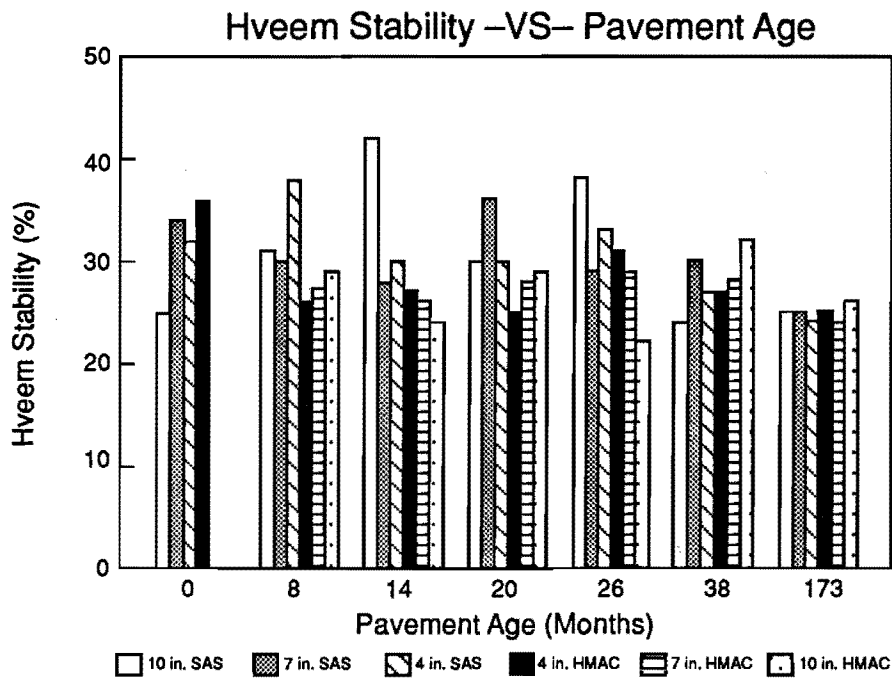
Figure 7. Hveem stability versus pavement age.

The Hveem stability values are shown in Figure 7. All of the cores have a Hveem stability of approximately 25 percent after 173 months of pavement life, a slight decrease over the years. Based on these figures, it appears that the aggregate interlock properties are approximately equal for both mixtures.

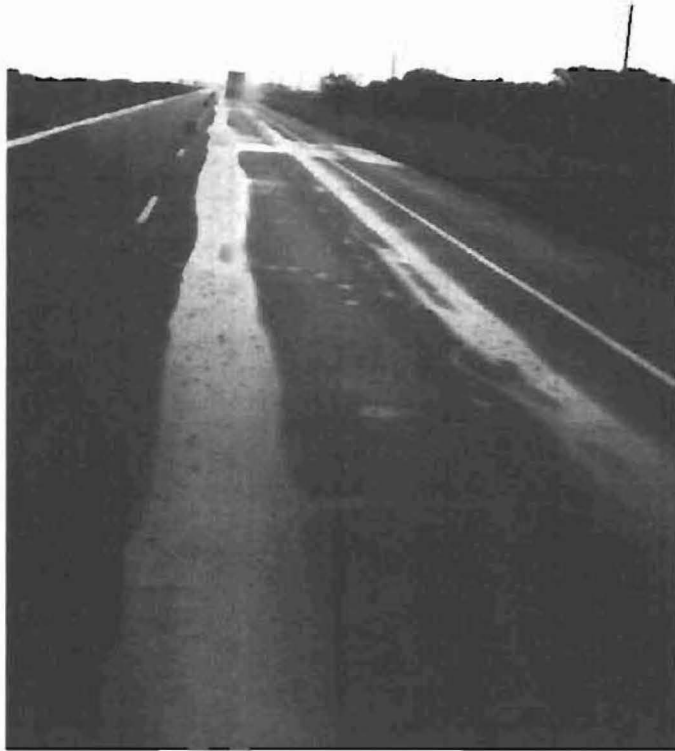
Figure 11. Channelized ponding in 7-inch HMAC subsection. (View is from south to north.)

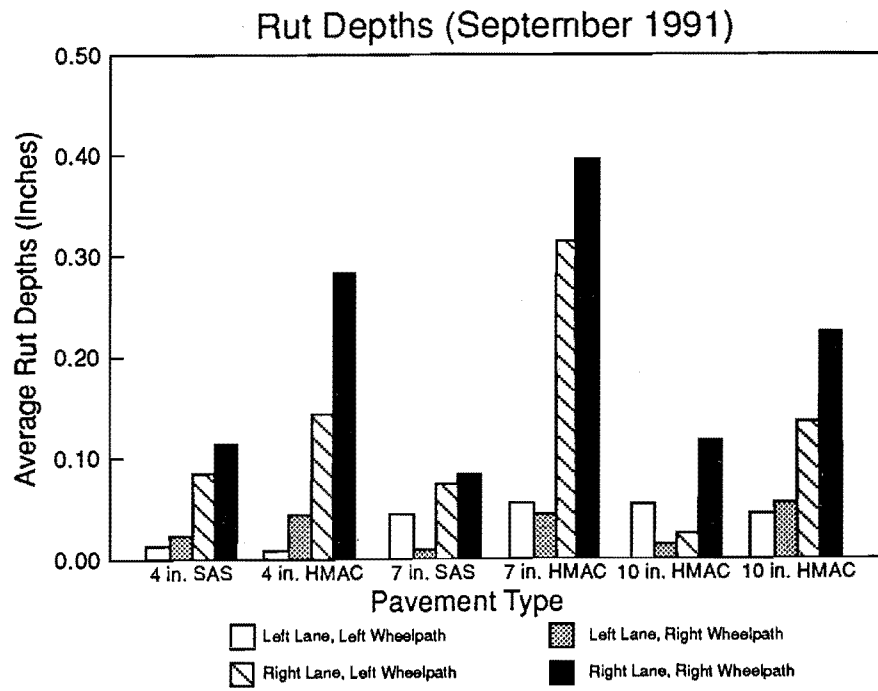
Figure 12. Rut depths.

Rut depths were measured using the ARAN equipment. A summary of the rut depth values are listed in Table 8. The left lane (i.e., passing lane) had virtually no rutting. The right lane (i.e., driving lane) had minimal rutting in the SAS subsections; however, the HMAC subsections had ruts that would be considered severe. During the visual evaluation, a brief rain caused considerable channelized ponding in the right lane of the HMAC subsection, as shown in Figure 11. Figure 12 is a bar graph that illustrates the rut depths for all of the subsections. The rut depths are broken down into right and left wheelpaths as well as right and left lanes.

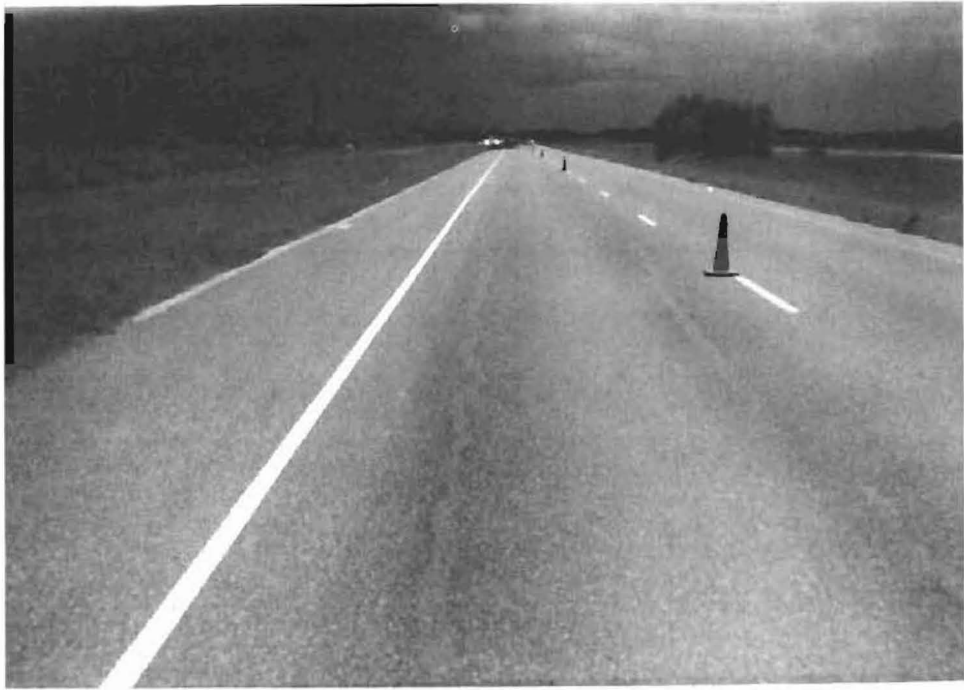
There was a very substantial amount of longitudinal cracking throughout the 4 inch and 7 inch HMAC subsections. The cracks were generally isolated to the wheelpaths. The sketches in Figures 13 through 18 and the photograph in Figure 19 indicate the extent of the cracking problem. As with the rut depths, the distresses were more prevalent in the HMAC subsections.

Figure 19. Longitudinal cracking in 4-inch HMAC subsection. (View is from north to south.)

The conventional HMAC subsections were rutted and cracked much more severely than the SAS subsections. The entire 3,000 foot test section was rebuilt in November of 1991. The primary reasons for reconstruction were the rutting in the three HMAC subsections and the failures in the 4 inch SAS subsection. In addition to being rutted, the conventional HMAC subsections contained numerous longitudinal cracks.

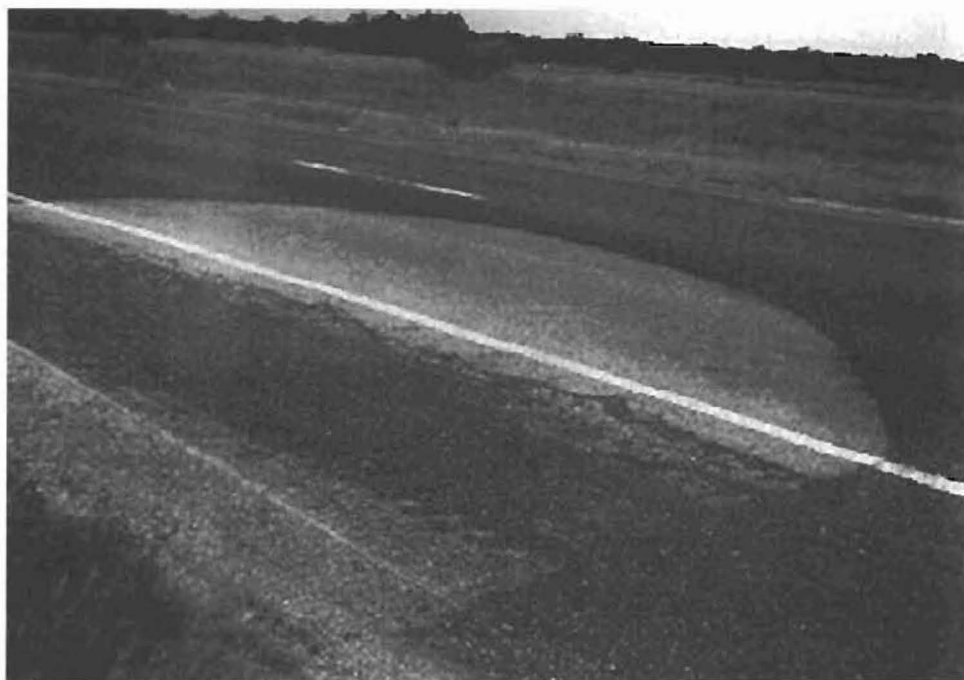
Figure 20. Pavement failure in 10-inch SAS subsection.

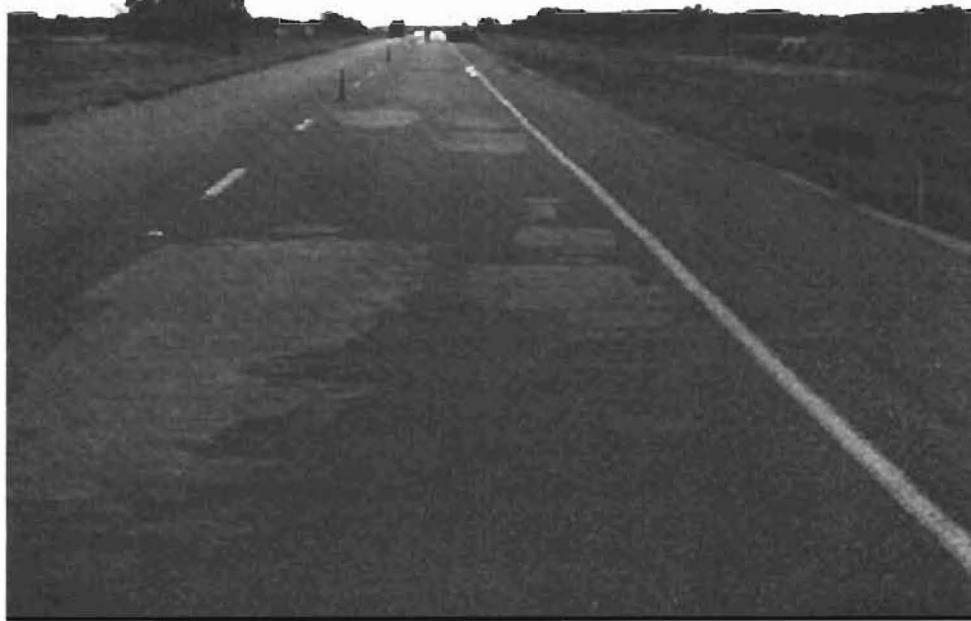
The 4 inch SAS subsection had experienced a considerable amount of localized alligator cracking. The cracked locations were removed and patched prior to the final evaluation. The cause of the cracking is unknown. Texas Department of Transportation personnel reported that the lime treated subgrade was in excellent condition. Their observations were made during the recent reconstruction of the experimental project (November of 1991). The 10 inch SAS subsection also experienced an apparent base failure. Photographs of the pavement failures in the 10 inch and 4 inch SAS subsections are illustrated in Figures 20 and 21 respectively. As mentioned previously, a video of the project was made to document the condition of the experimental project prior to the scheduled reconstruction of the project.

Figure 21. Pavement failure in 4-inch SAS subsection. (View is from south to north.)
