1. Report No. FHWA/TX-81/8+208-2		2. Government Accession No.	
4. Title and Subtitle BEHAVIOR OF POST-TENSIONED GIRDER ANCHORAGE ZONES		5. Report Date April 1981

BEHAVIOR OF POST-TENSIONED GIRDER
ANCHORAGE ZONES

Research Report No. 208-2

"Design Criteria for Post-Tensioned Anchorage Zone
Bursting Stresses"

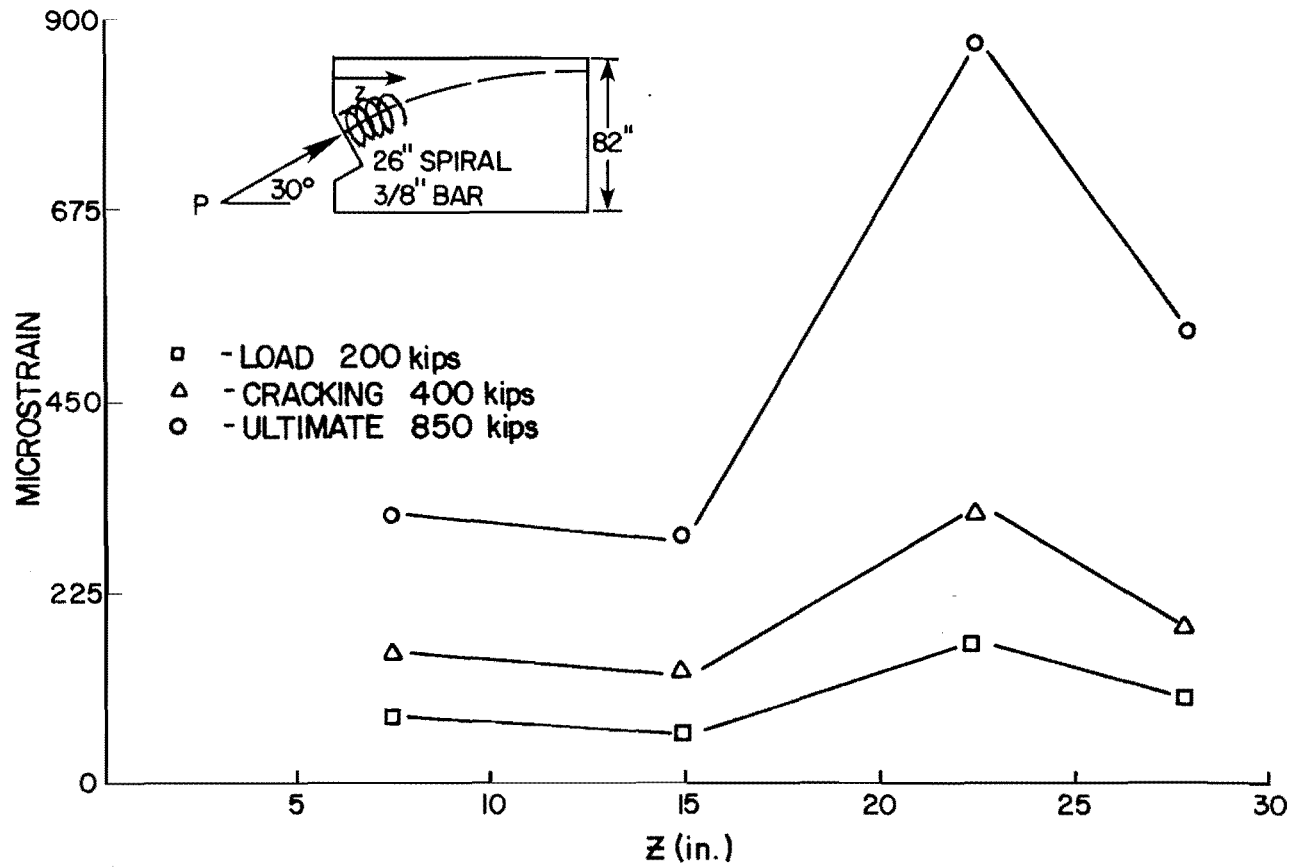
Fig. 3.30 FS4A measured spiral strain distribution

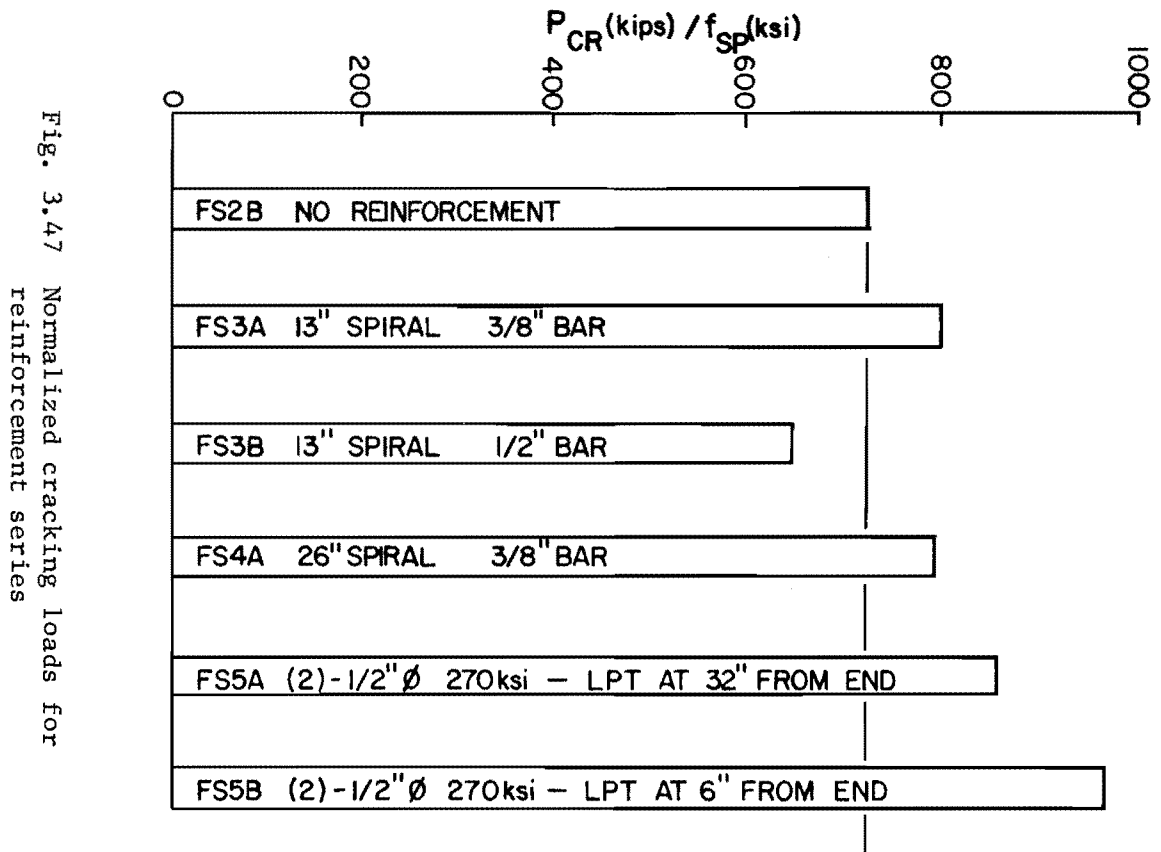
Fig. 3.47 Normalized cracking loads for reinforcement series

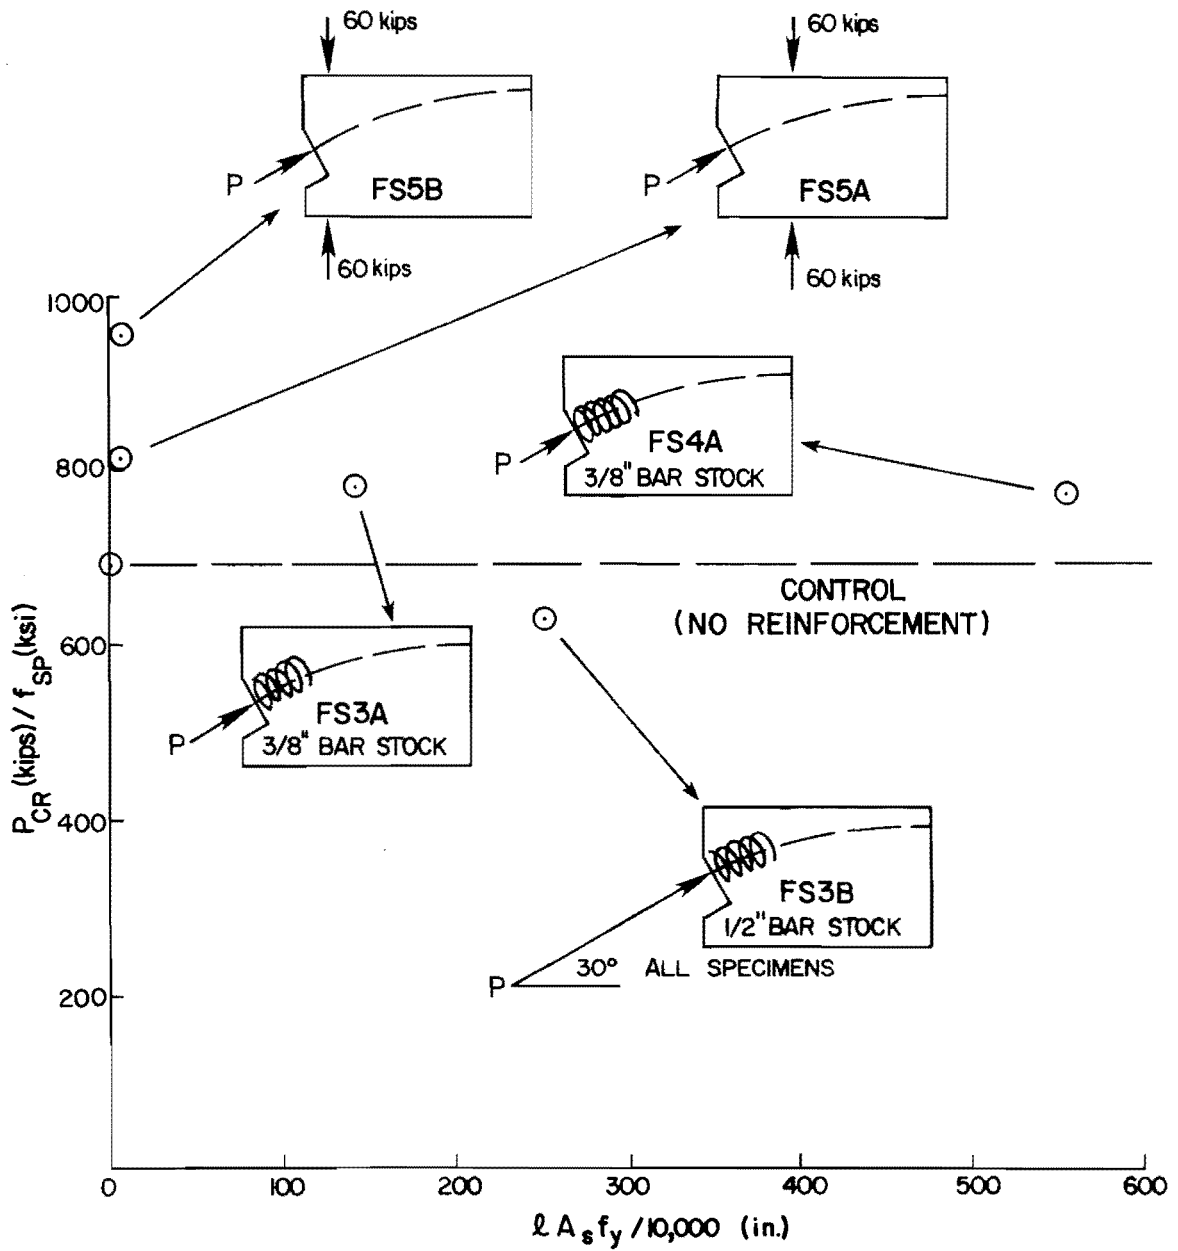
Fig. 3.49 Reinforcement efficiency

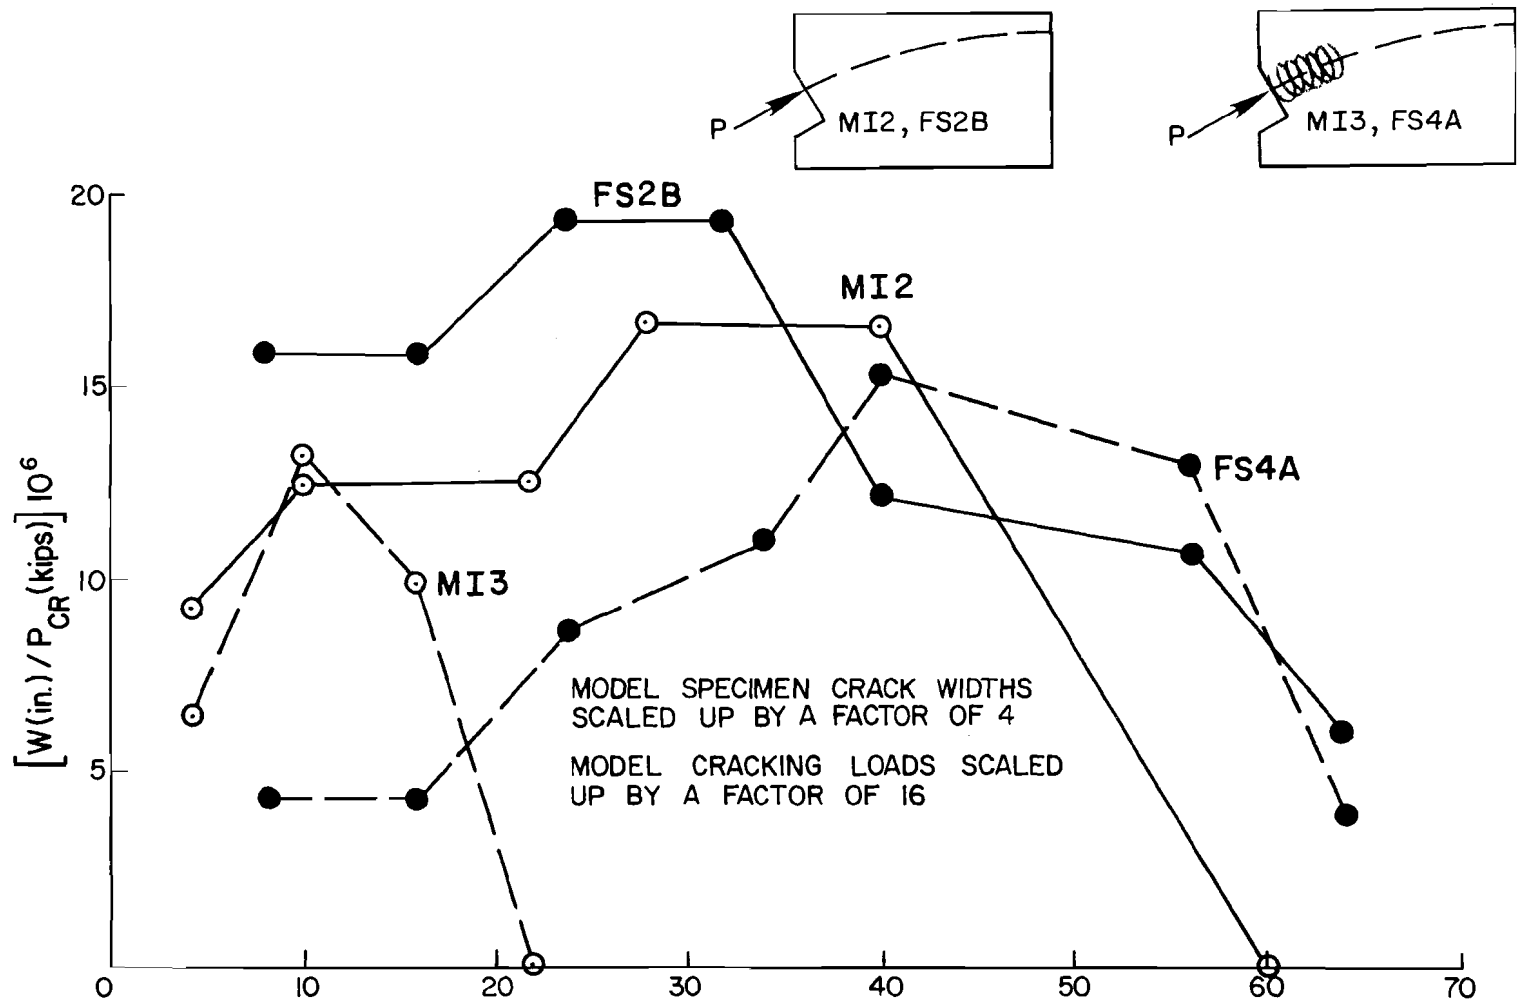
Fig. 4.31 Comparison--full-scale vs model crack widths
