**HIGH EARLY STRENGTH BONDED CONCRETE OVERLAY DESIGNS AND
CONSTRUCTION METHODS FOR REHABILITATION OF CRCP**

Research Report 2911-4

Project Title: *Full-Scale Bonded Concrete Overlay on IH-10 in El Paso*

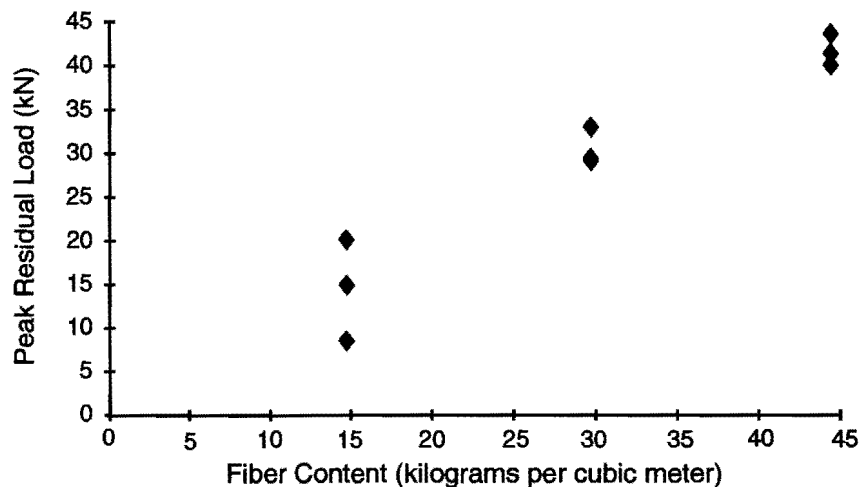
Figure 3.6 Comparison of SFRC beams at different fiber contents

3.6.1.4 Discussion. Third-point flexure beams are commonly used to compare different types and quantities of fibers. They cannot, as yet, be used to directly predict the long-term performance of SFRC. Consequently, it would be useful to construct test sections and evaluate long-term performance, and then compare these results with third-point flexure beam predictions.

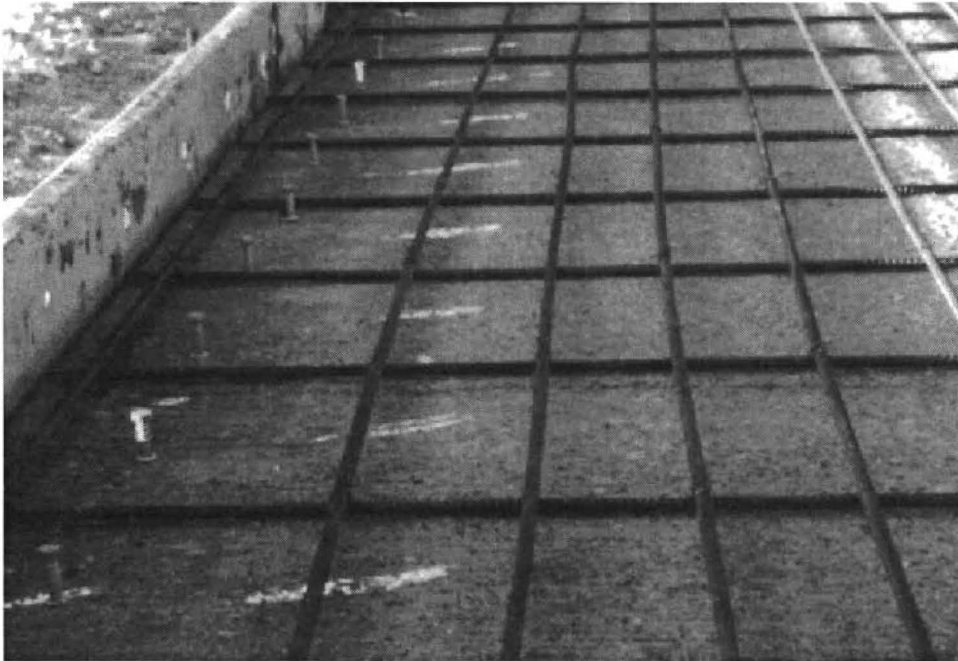
Figure 4.3 Installed nails and reinforcement with formwork

4.2.2.3 Reinforcement. For four sections, the longitudinal steel was 12.7 mm bars (US #4), 152 mm on center and was not continuous between sections. Transverse steel was 12.7 mm bars (US #4), 457 mm on center (Figure 4.3). These steel percentages were selected to match the amount of steel in the base CRCP. Steel was placed directly on the base slab, without chairs. No steel was placed in the remaining four sections.

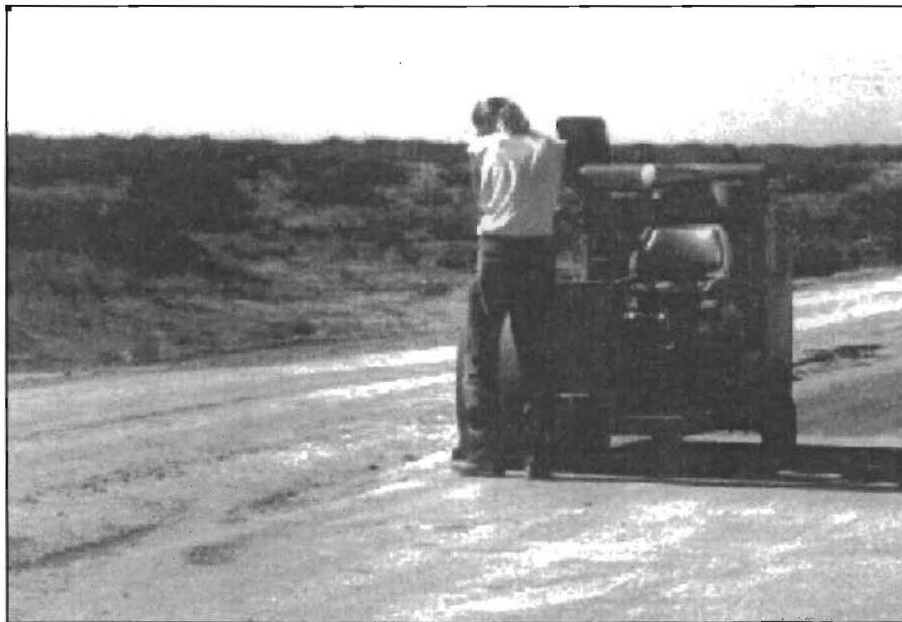
Figure 4.5 Shotblasting equipment used

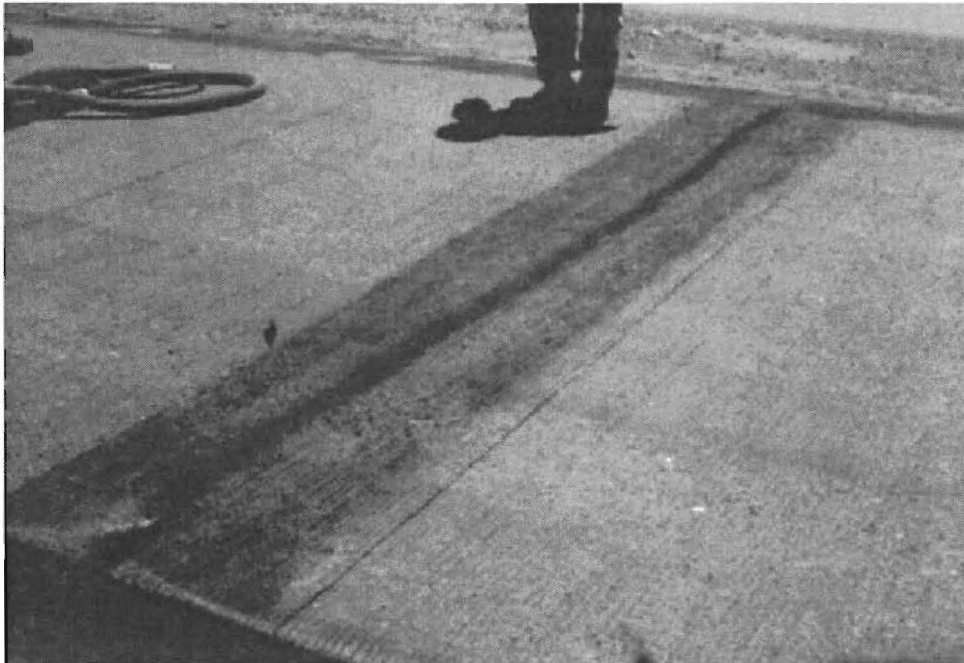
Figure 4.6 Debonding agent between sections

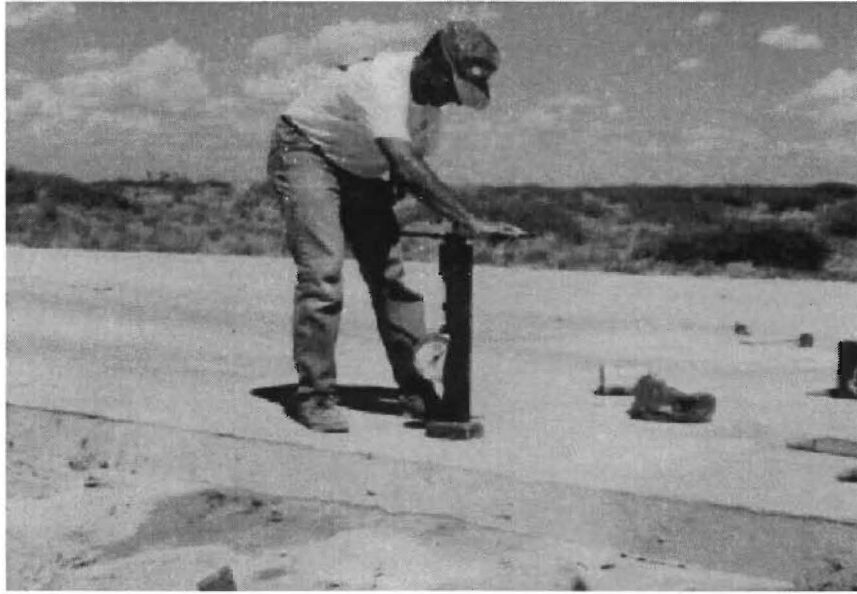
Figure 4.9 Pull-off testing procedure

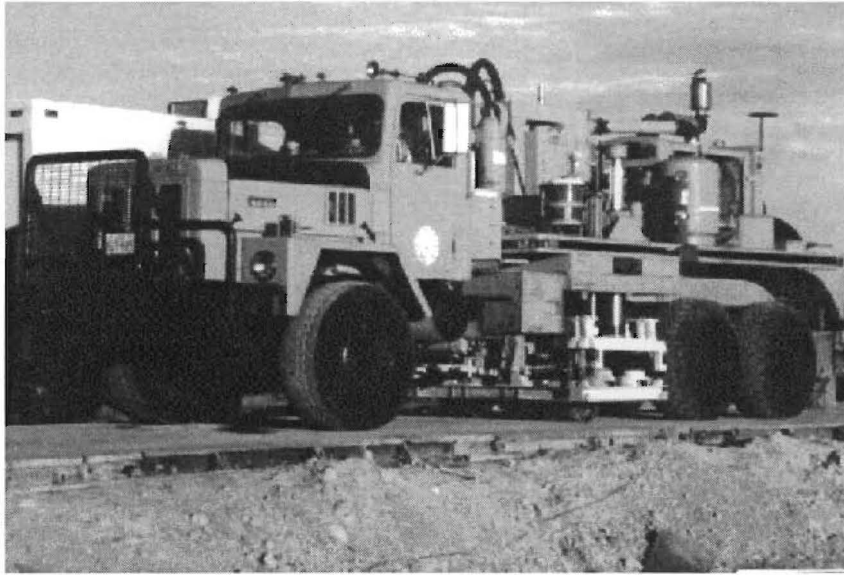
Figure 4.11 Rolling Dynamic Deflectometer (RDD)

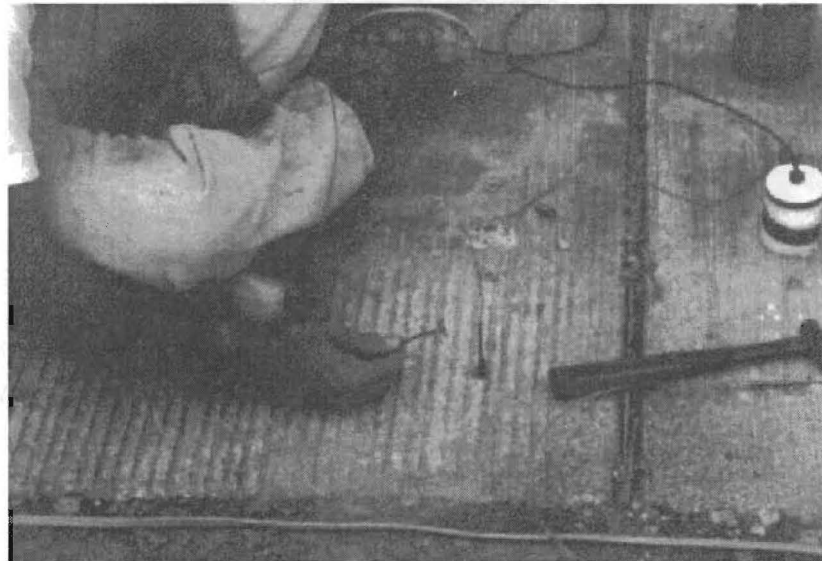
Figure 4.12 Impact-echo testing

4.4.2.6 Delamination Detection. Several electronic and nonelectronic, nondestructive testing methods were used in an attempt to detect and map delaminations. They were SASW (Refs 62, 63, 64) (Figure 4.10), three different impact-echo devices (Figures 4.12, 4.13, 4.14) including the Defect Orientation Confirmation Tester (DOCTer) (Figure 4.14) (Ref. 65), impulse-response (Figure 4.15), the Rolling Dynamic Deflectometer (RDD), and the falling weight deflectometer (FWD) (Figure 4.16).

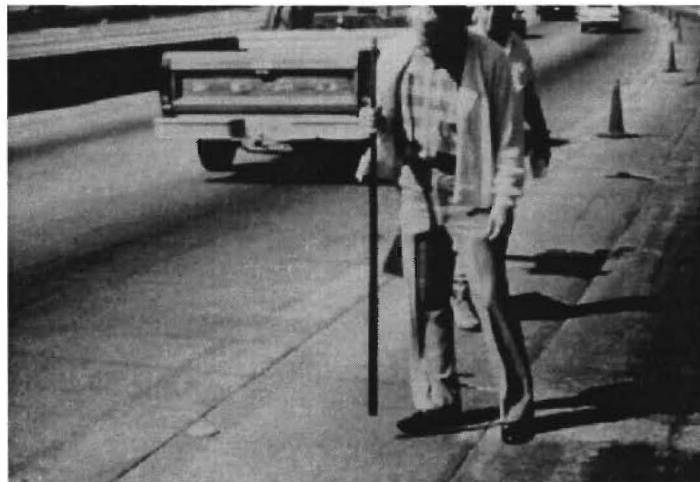
Figure 4.17 Rebar sounding

- a. *Nonelectronic Methods.* Rebar sounding and the impact (Schmidt) hammer were used.
1. Rebar sounding. In this method a piece of reinforcing steel 10 to 20 mm in diameter and 1 to 1.5 meters long is dropped on the overlay from a height of 100 to 300 mm (Figure 4.17). Rebar dropped on the overlay over a delamination sounds *hollow* compared to a sounding made in the interior of the slab, where the BCO is presumably well bonded. Also, it is possible for the operator to feel vibrations in his feet when the rebar is dropped over a delamination. This method is subjective and dependent upon the skill of the operator.

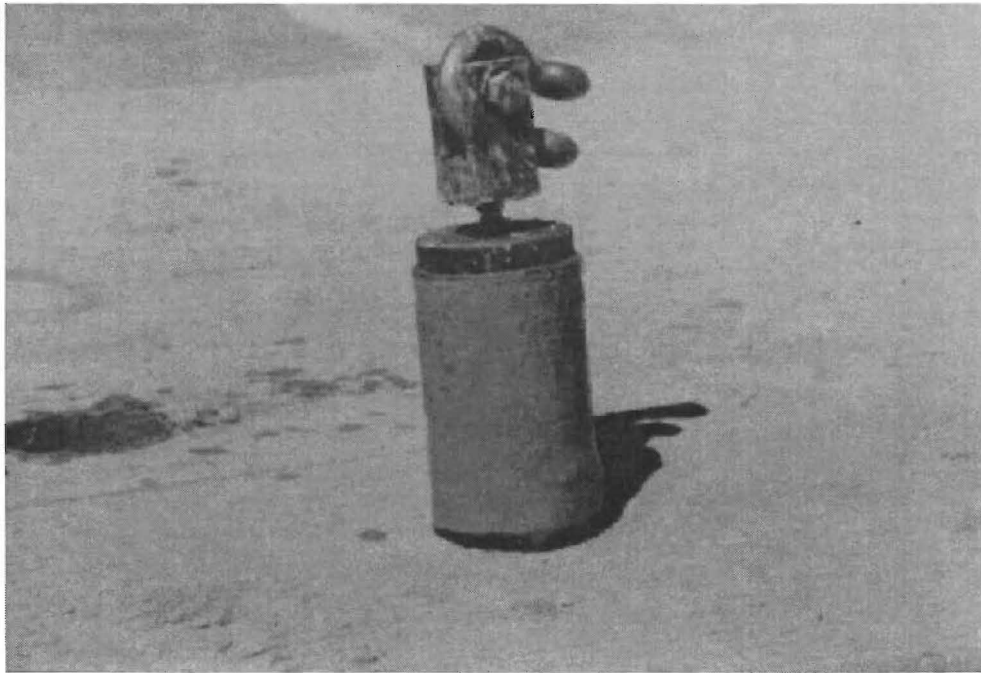
Figure 6.2 Pull-off test specimen after bond failure

It was very difficult to secure steel caps to cores for pull-off testing. First, the curing compound had to be removed from the top of the cores since it was a bond breaker. Second, the tines at the surface of the concrete were weaker than the rest of the overlay. Two two-part quick curing epoxies were used. In many cases the specimen failed at the epoxy-concrete interface or at the top of the core, usually in the tines.

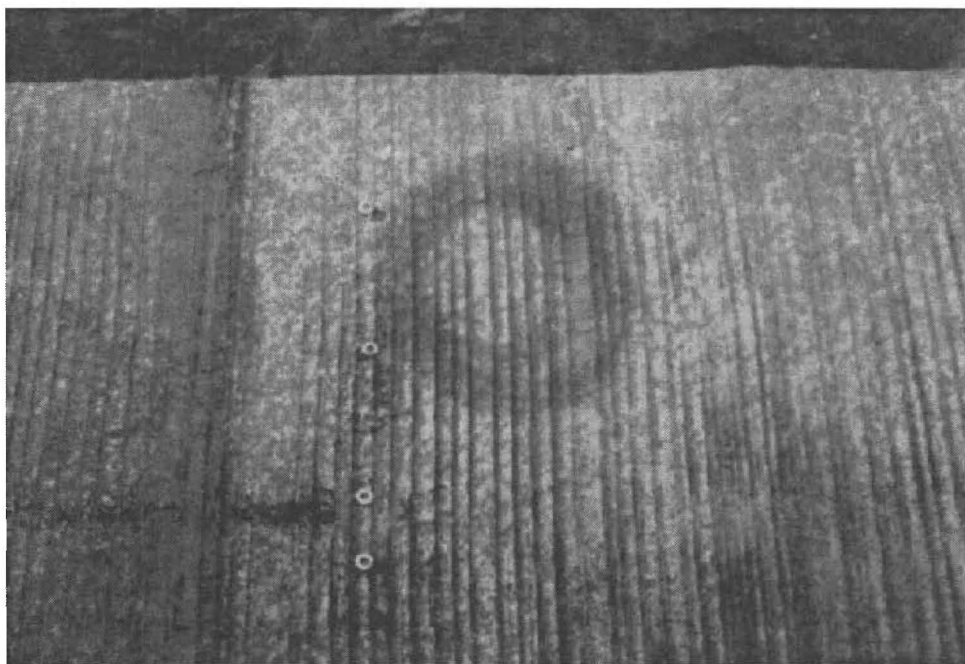
Figure 6.19 Steel washers used to attach magnetic accelerometers

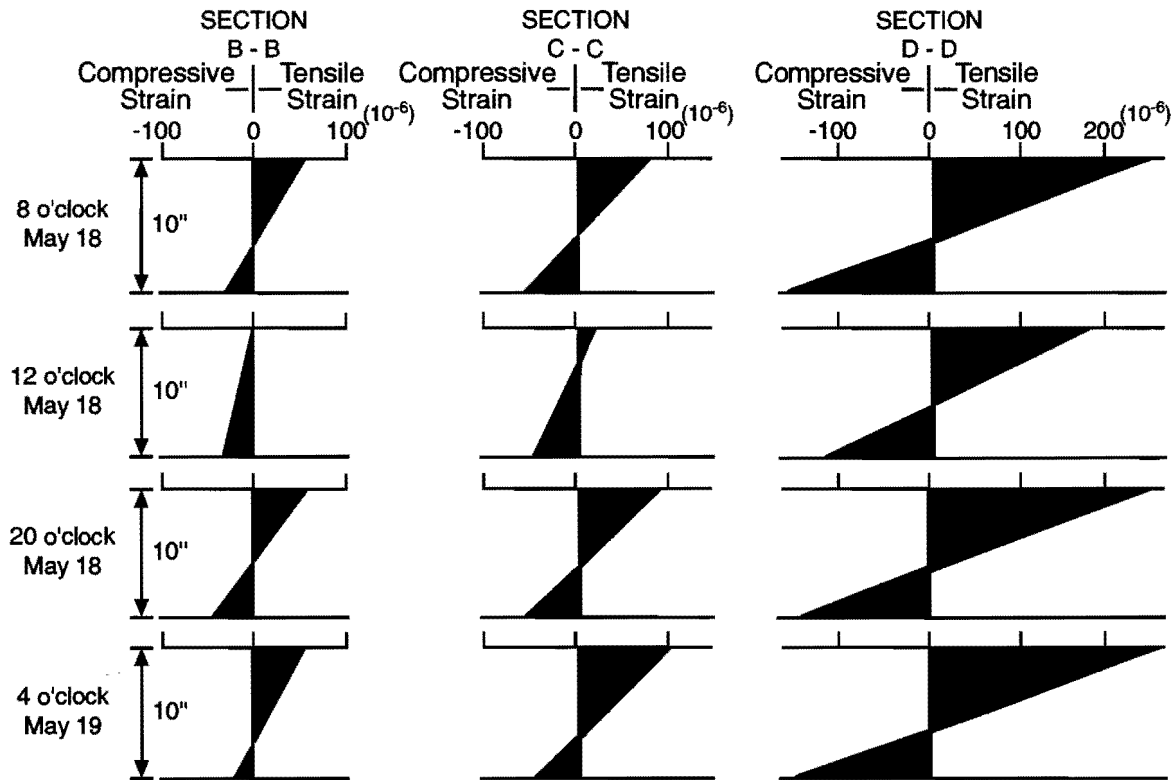
Figure 8.17 Distribution of restrained strain due to daily temperature cycle and drying shrinkage (Ref 96)

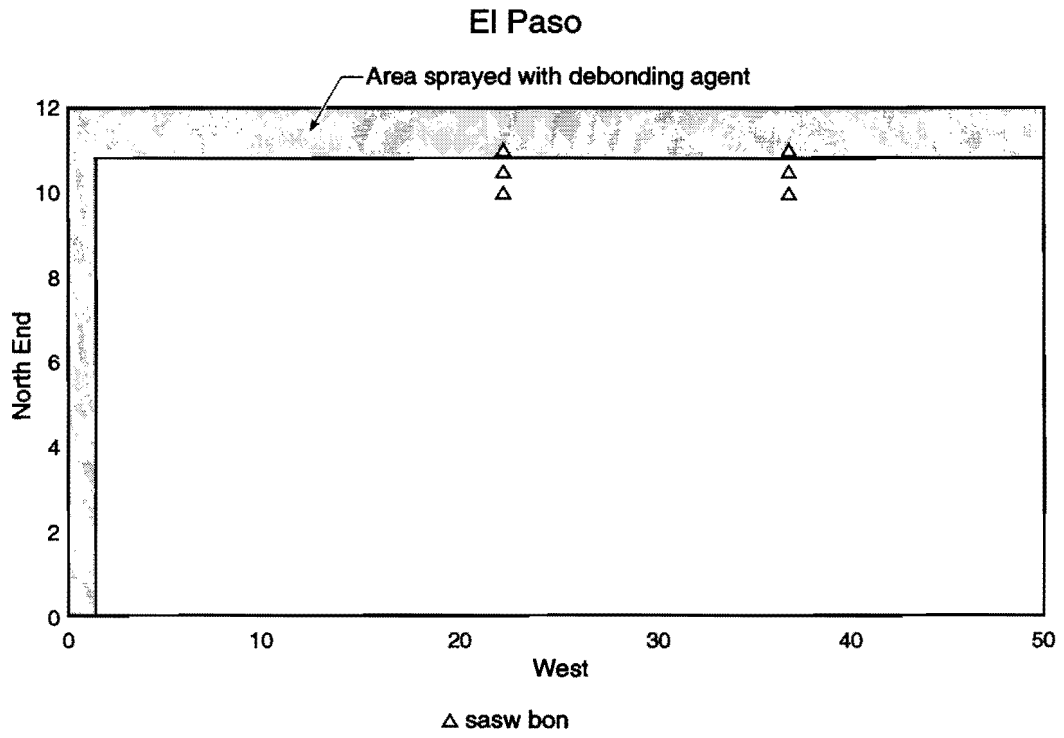
Figure C.5: Nondestructive Testing Results, Section 7

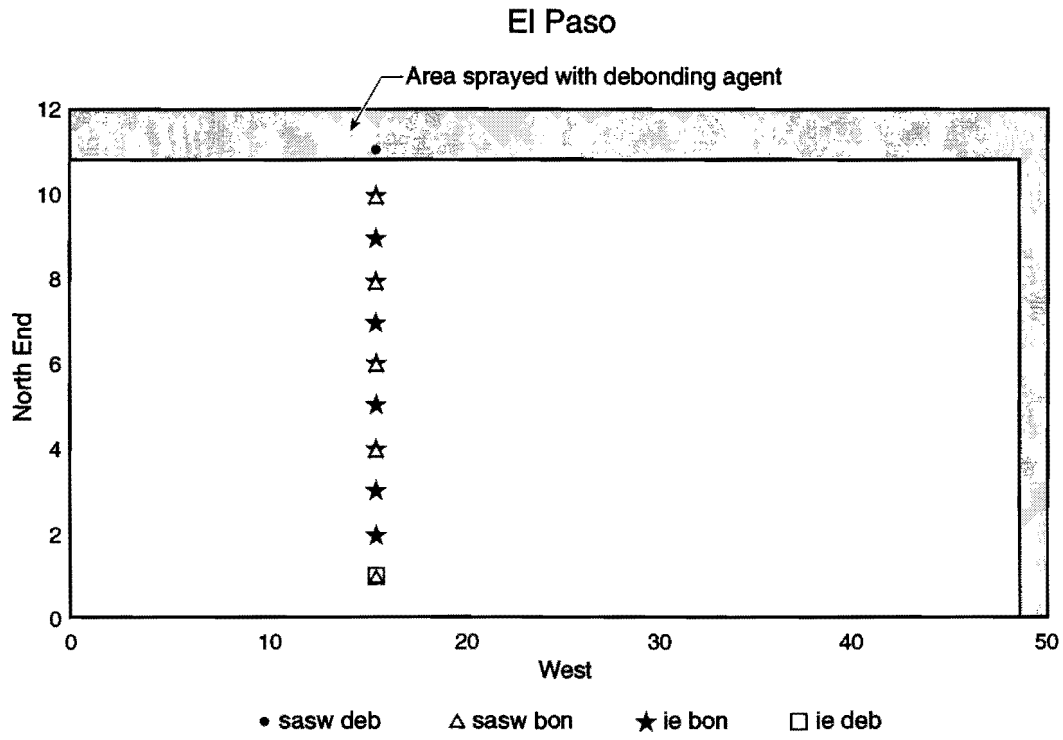
Figure C.6: Nondestructive Testing Results, Section 8
