1. Report No.		2. Government Accession No.		3. Recipient's Catalog No.	
4. Title and Subtitle INVESTIGATION OF PREMATURE DISTRESS IN CONVENTIONAL ASPHALT MATERIALS ON INTERSTATE 10 AT COLUMBUS, TEXAS				5. Report Date August 1982

INVESTIGATION OF PREMATURE DISTRESS
IN CONVENTIONAL ASPHALT
MATERIALS ON INTERSTATE 10
AT COLUMBUS, TEXAS

Research Report Number 313-1

CENTER FOR TRANSPORTATION RESEARCH
BUREAU OF ENGINEERING RESEARCH
THE UNIVERSITY OF TEXAS AT AUSTIN

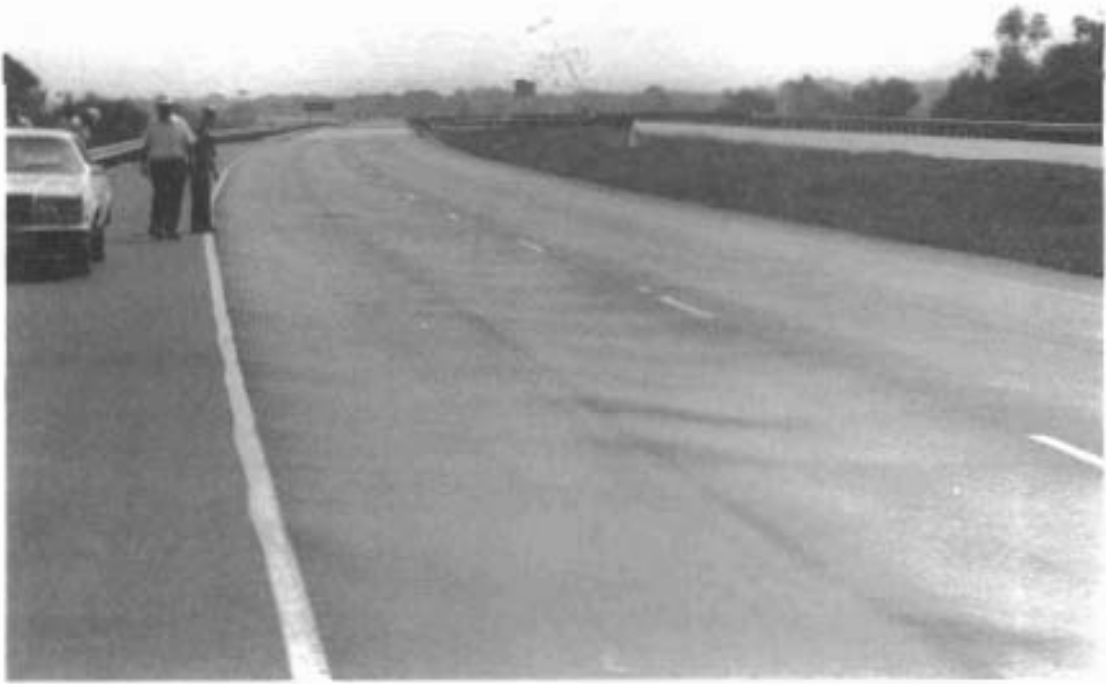
Fig 1. Typical rutting and corrugation distress occurring on IH-10, Columbus.

The types of distress were rutting, shoving, and bleeding (Figs 1-4). The results of four condition surveys conducted between October 9, 1980 and September 9, 1981 by project personnel from the Center for Transportation Research are summarized in Fig 10. Four pavement distress conditions were designated as described in Table 2. These distress conditions were (1) minor or none, (2) moderate, (3) moderate to severe, and (4) severe. In some areas of the westbound lane the severe distress was so extensive that traffic was diverted to adjacent lanes.

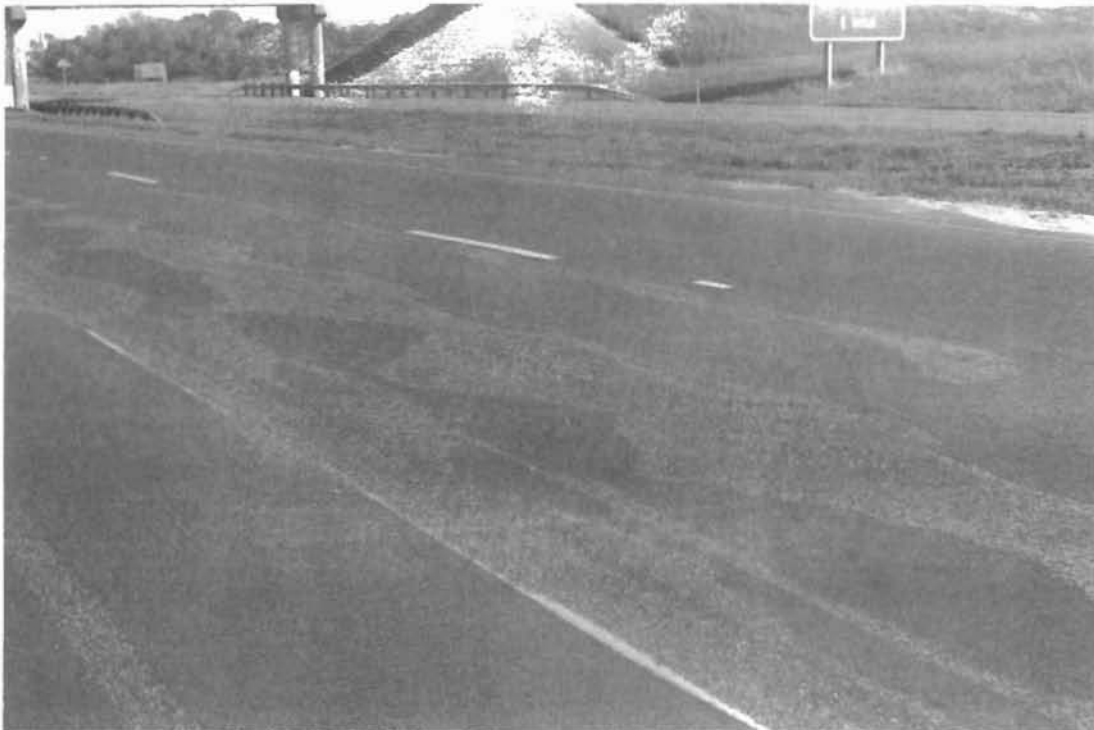
Fig 4. Planing that outlines the longitudinal variation in rutting and shoving distress on IH-10, Columbus.

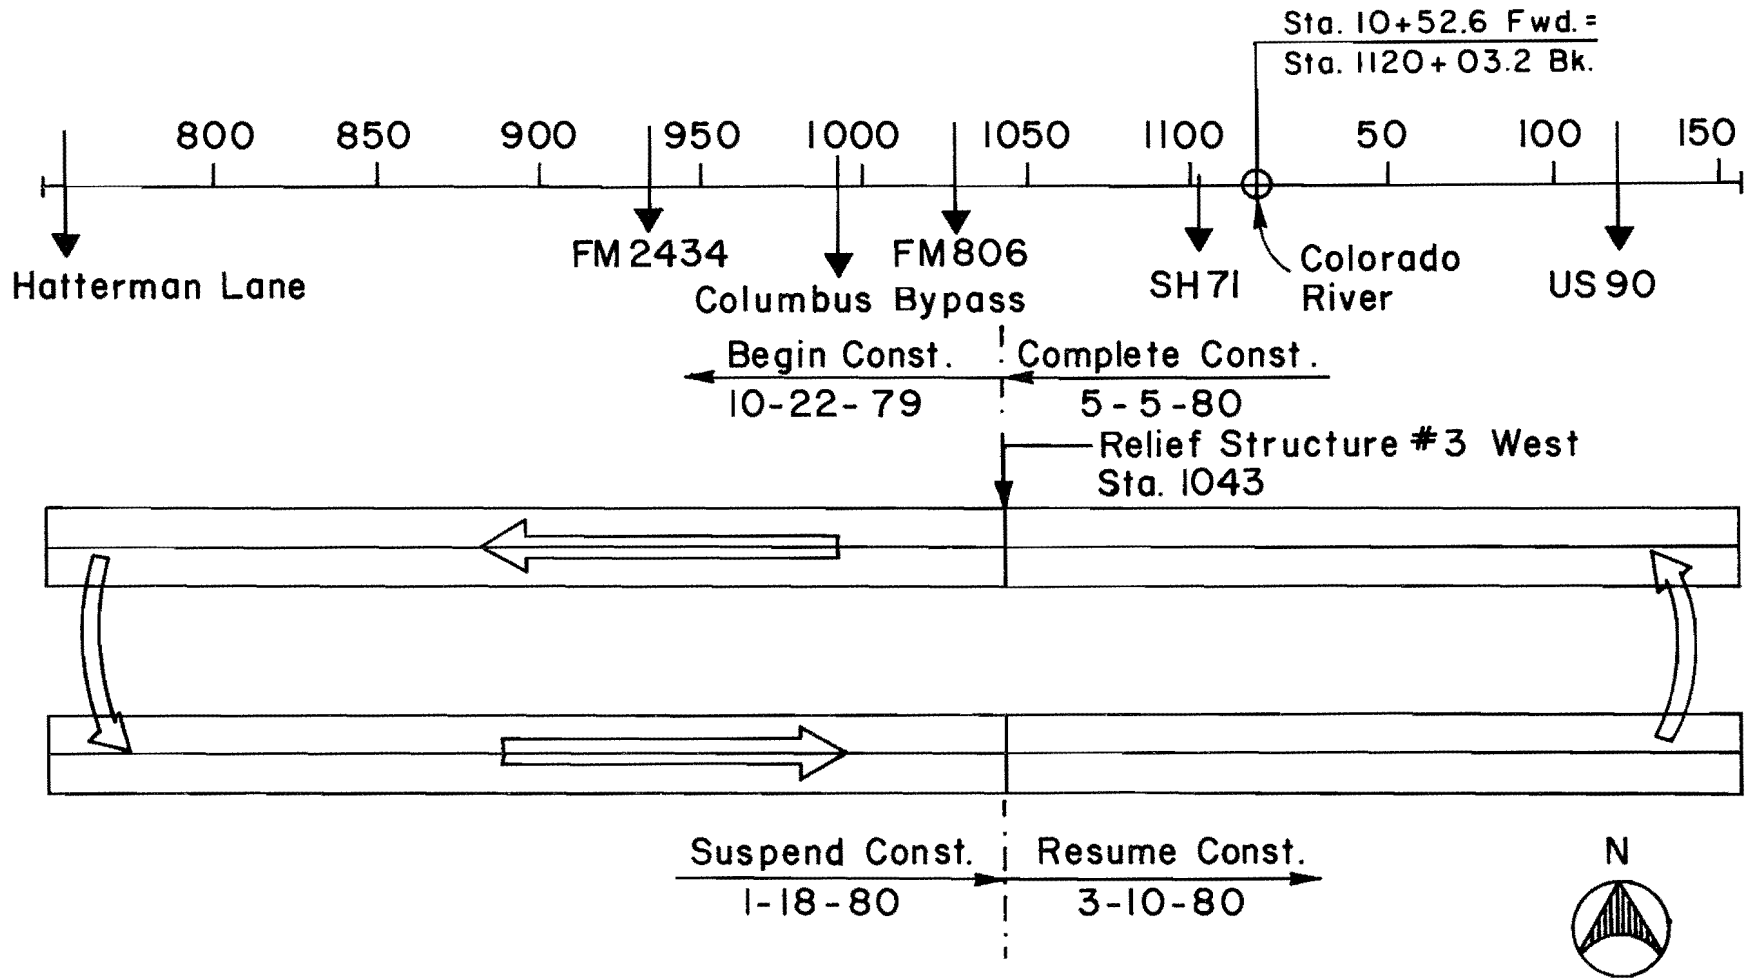
Fig 6. Construction limits and sequence for Type B base course mixture.

The progressive nature of the distress can be seen by observing that areas with initial distress designated as minor or moderate gradually became more severe. Overlay construction began on October 15, 1979, and the first evidence of distress was observed in June 1980 in the westbound outside lane. By April 1981 distress was observed in practically all sections of the project that were constructed between October 1979 and January 1980, i.e., everything west of Station 1043 (Fig 6).

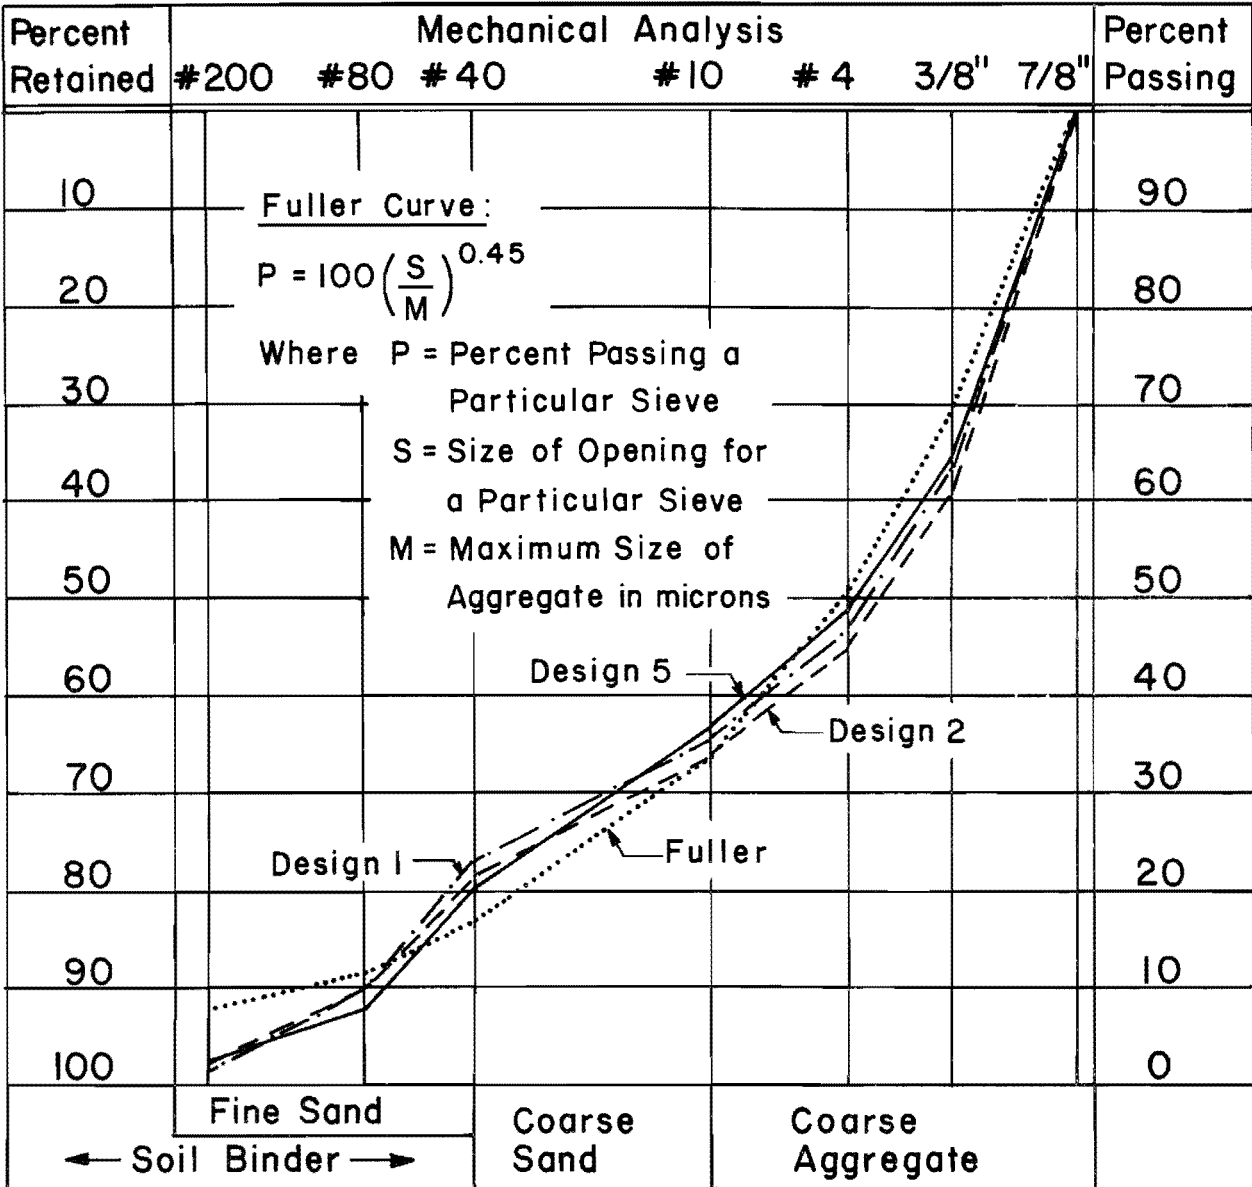
Fig 8. Comparison between Type B design gradations and Fuller gradations.

A comparison between the design gradation and the Fuller gradation, which produces a well-graded dense mixture, is shown in Fig 8. All three mixture designs had more material retained on the No. 4 sieve than the Fuller gradation. All three mixture designs are deficient in material passing the No. 200 sieve. The course sand is basically a material contained between the Nos. 10 and 40 sieves. While gradation was not the apparent cause of the observed distress, it is felt that gradation and its effect need to be considered and evaluated with respect to performance.

Three different mixtures were used in the overlay project, designated as designs 1, 2, and 5 (Table 1 and Fig 8). Designs 1 and 2 were similar with asphalt contents of 4.7 and 4.9 percent, respectively. Design 5 was markedly different from the other two, containing a different field sand and a much lower asphalt content of 4.0 percent. The areas in which each design was used are shown in Fig 9.

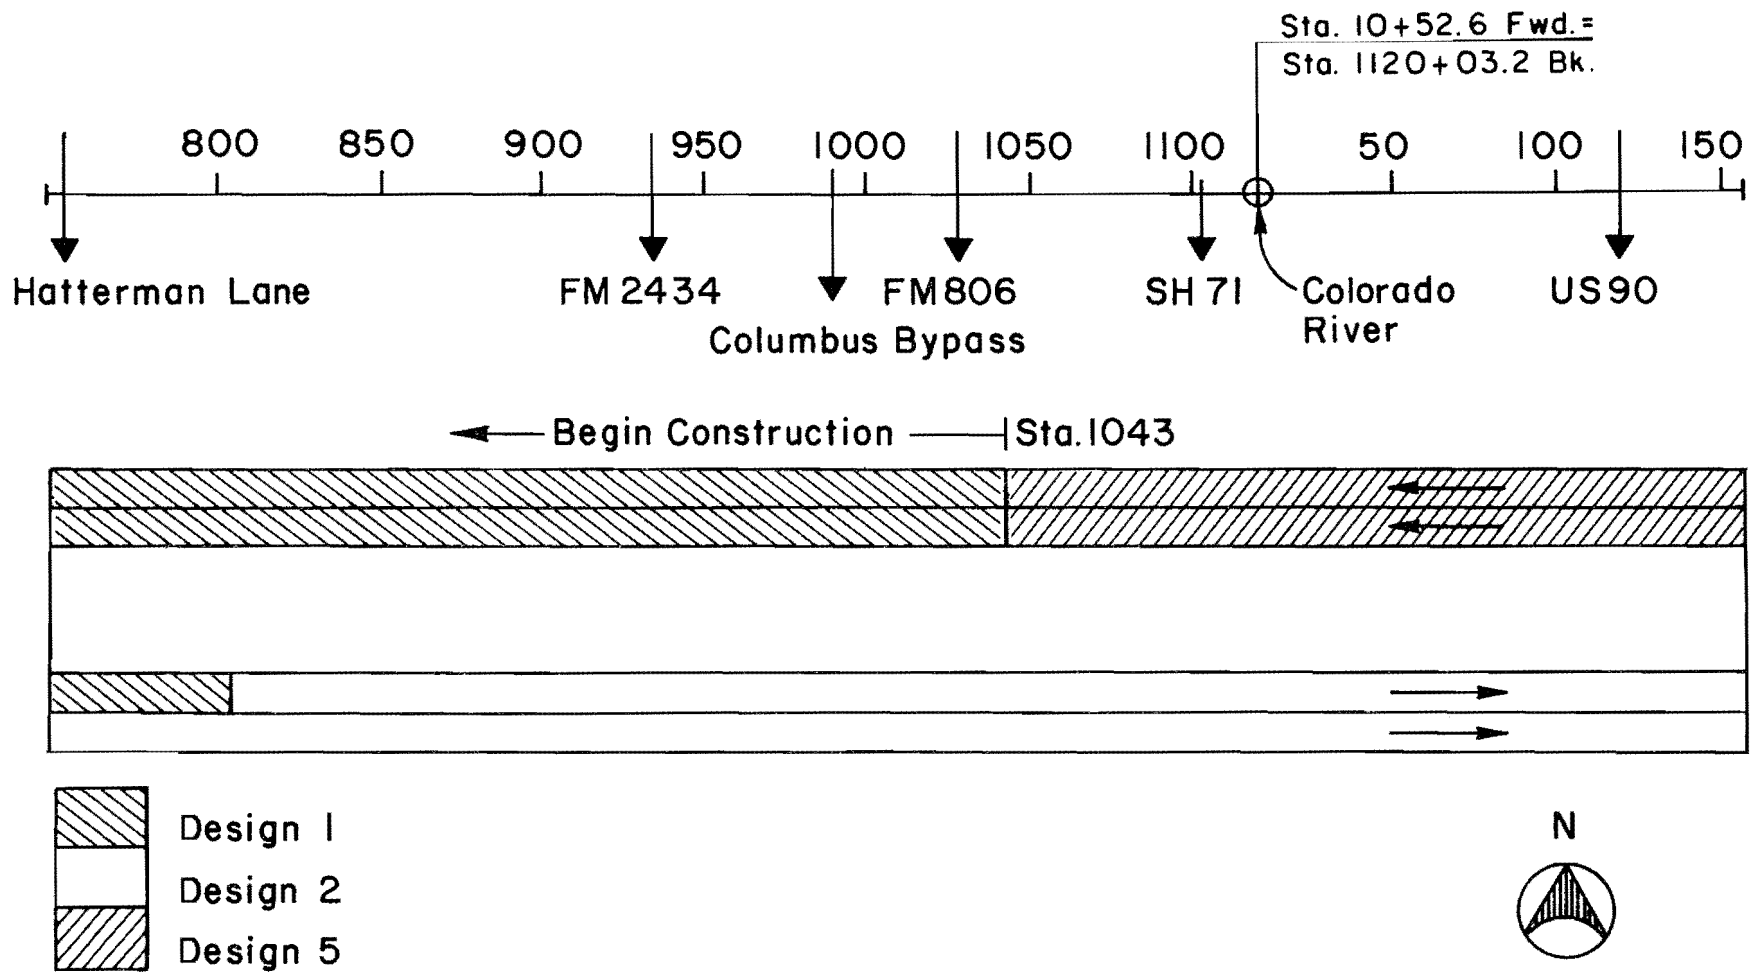
Fig 9. Locations of mixture designs.

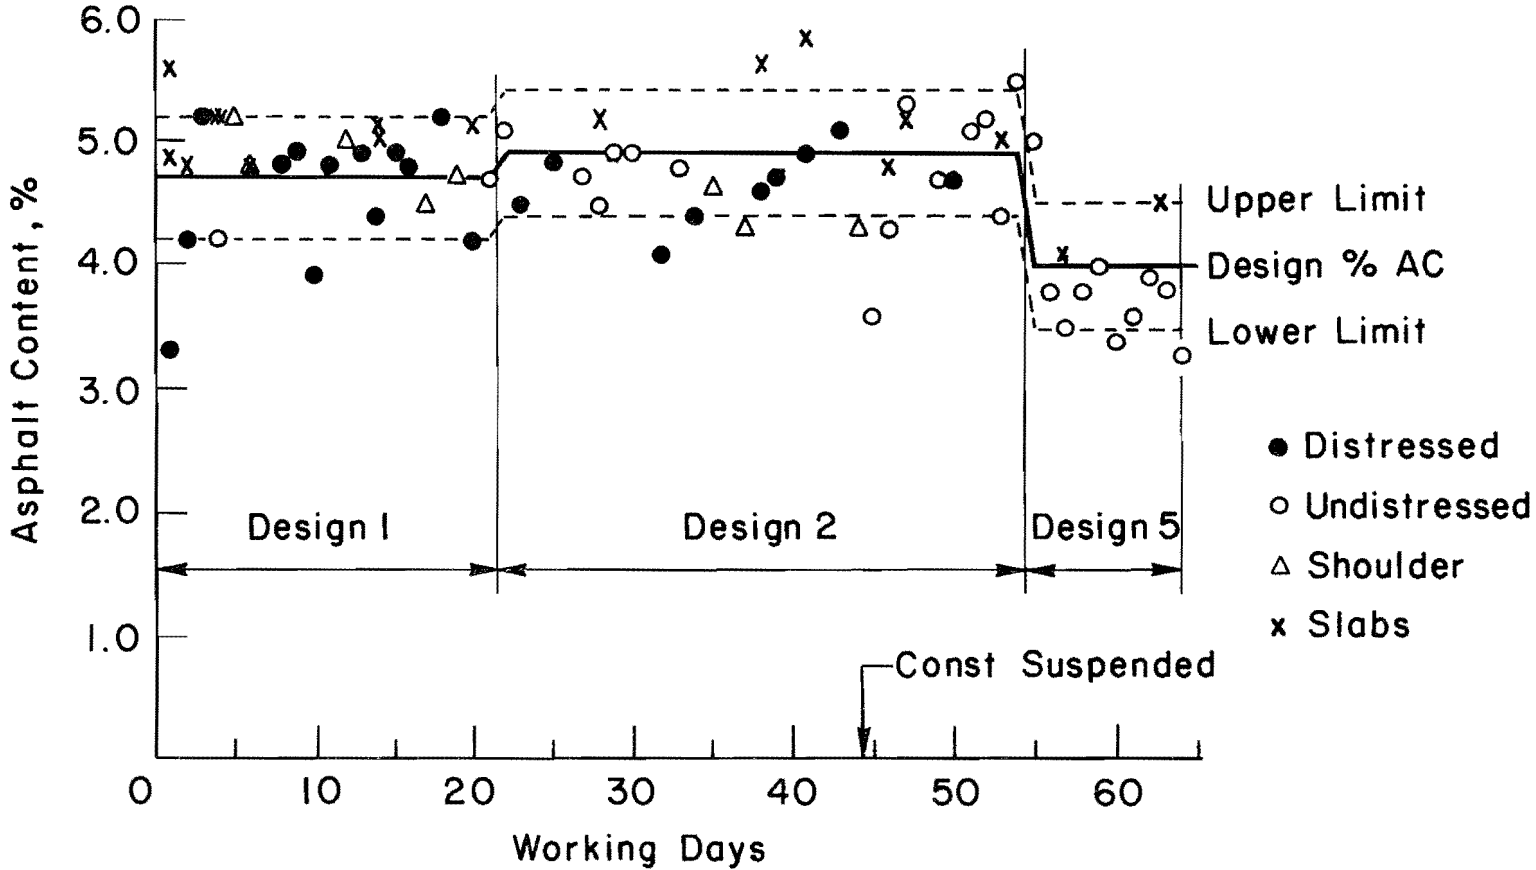
Fig 12. Relationship between extracted asphalt content and distress during construction.

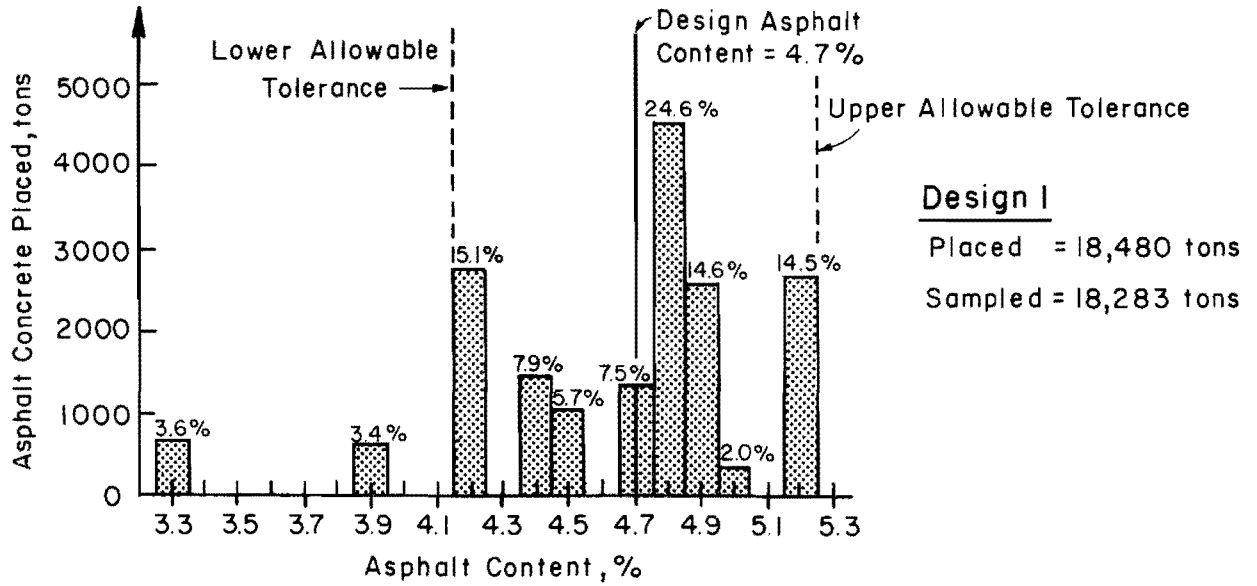
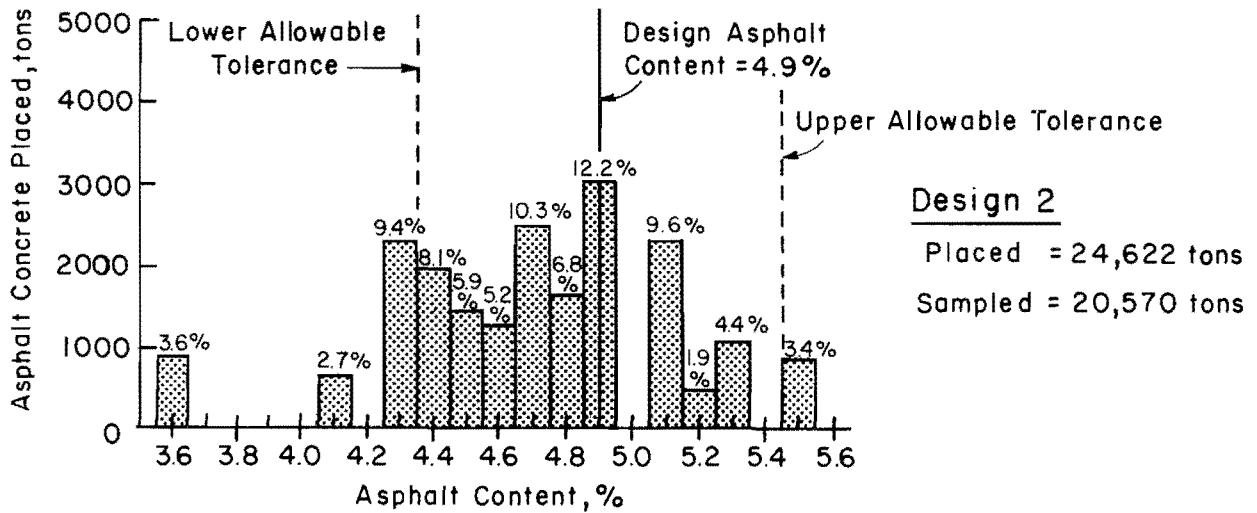
Fig 13. Asphalt variations, job control extractions.

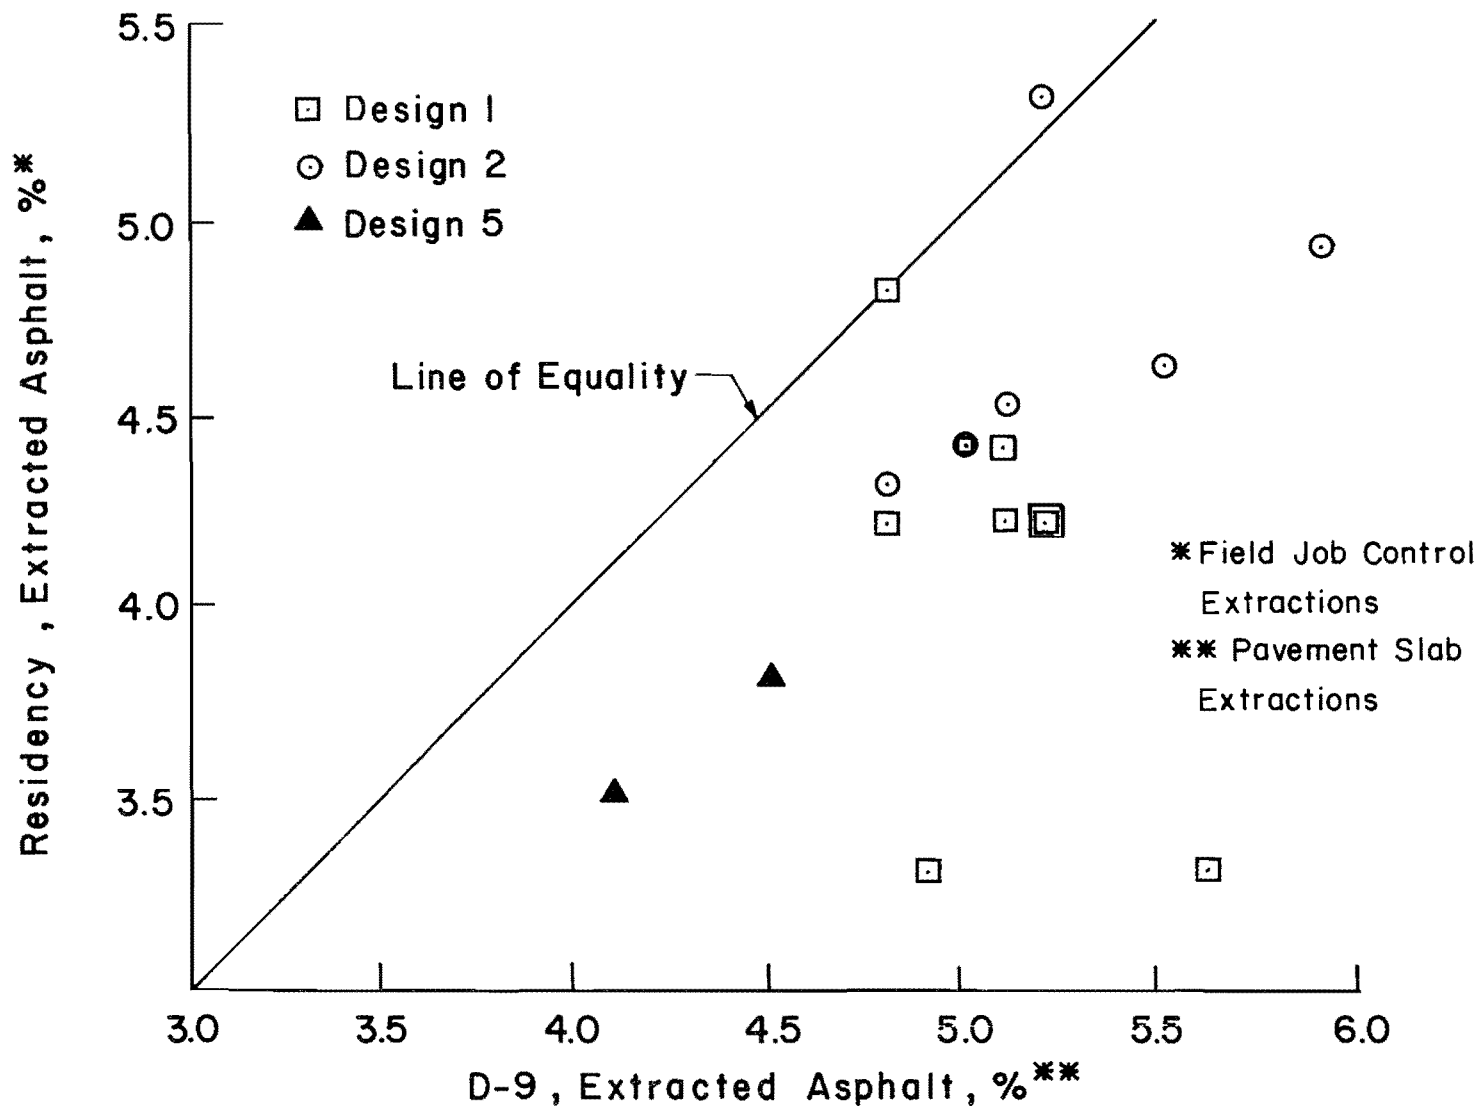
While the difference cannot be explained, two possible causes, which involve the testing and sampling procedure, are evident. Examination of the extraction test procedure used by the residency and D-9 suggested that a possible cause could relate to the ashing procedure. The procedure used by D-9 involved the use of an oven capable of producing temperatures in excess of 1400^oF. The residency laboratory,

Fig 14. Comparison between Residency and D-9 extractions.

however, used a Bunson burner which possibly would not produce enough heat in a short period of time to cause efficient and complete ashing. The second possibility is the fact that the slabs which were sent to D-9 were from the more distressed areas and with stripping beginning at the bottom of the base course a loss of some material could have resulted in an apparent increase in asphalt content. Finally, since the D-9 slabs were from the distressed areas, these slabs could possibly have had higher asphalt contents.

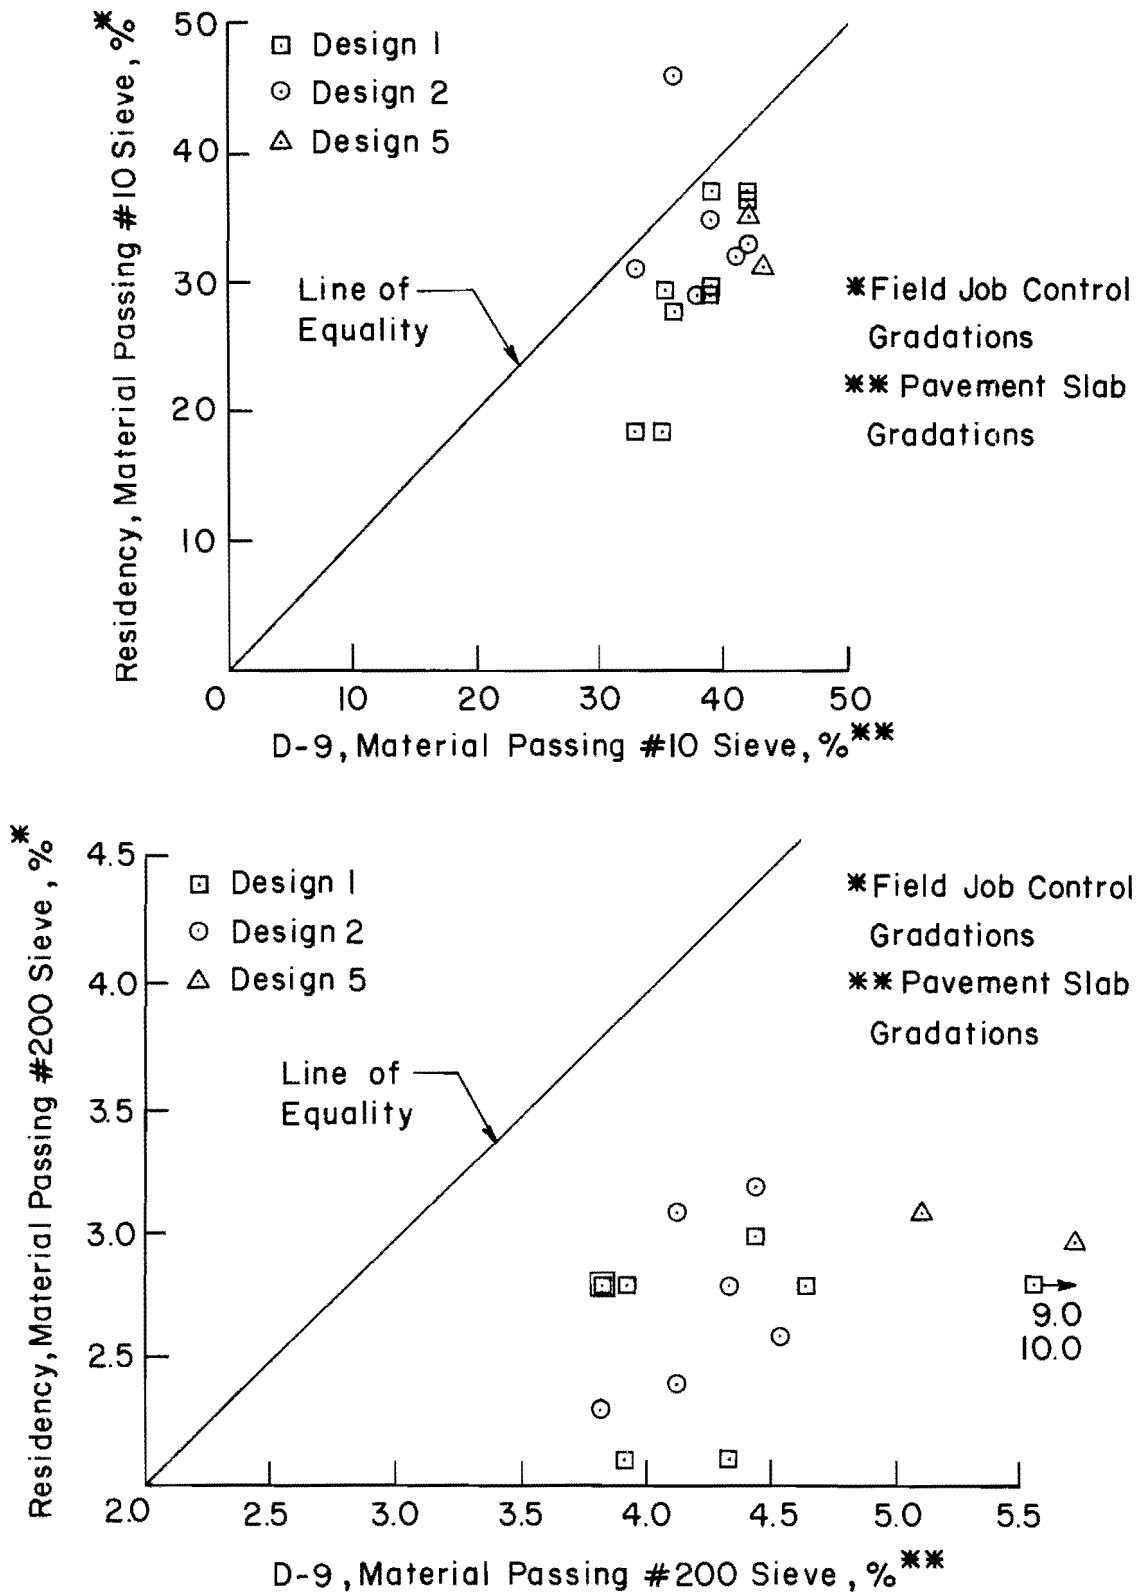
As with asphalt contents, differences were detected between gradations obtained by D-9 and gradations obtained by the residency. The gradations obtained from the slab samples supplied by the project to D-9 were finer than the gradations obtained by the residency during construction as indicated by the material passing both the No. 10 and the No. 200 sieves (Fig 15). Again, incomplete ashing at the residency laboratory may possibly account for the smaller amount of material passing the No. 200 sieve which was reported by the residency. The overall cause, however, is not apparent but is obviously consistent.

Fig 15. Comparison between Residency and D-9 gradations.

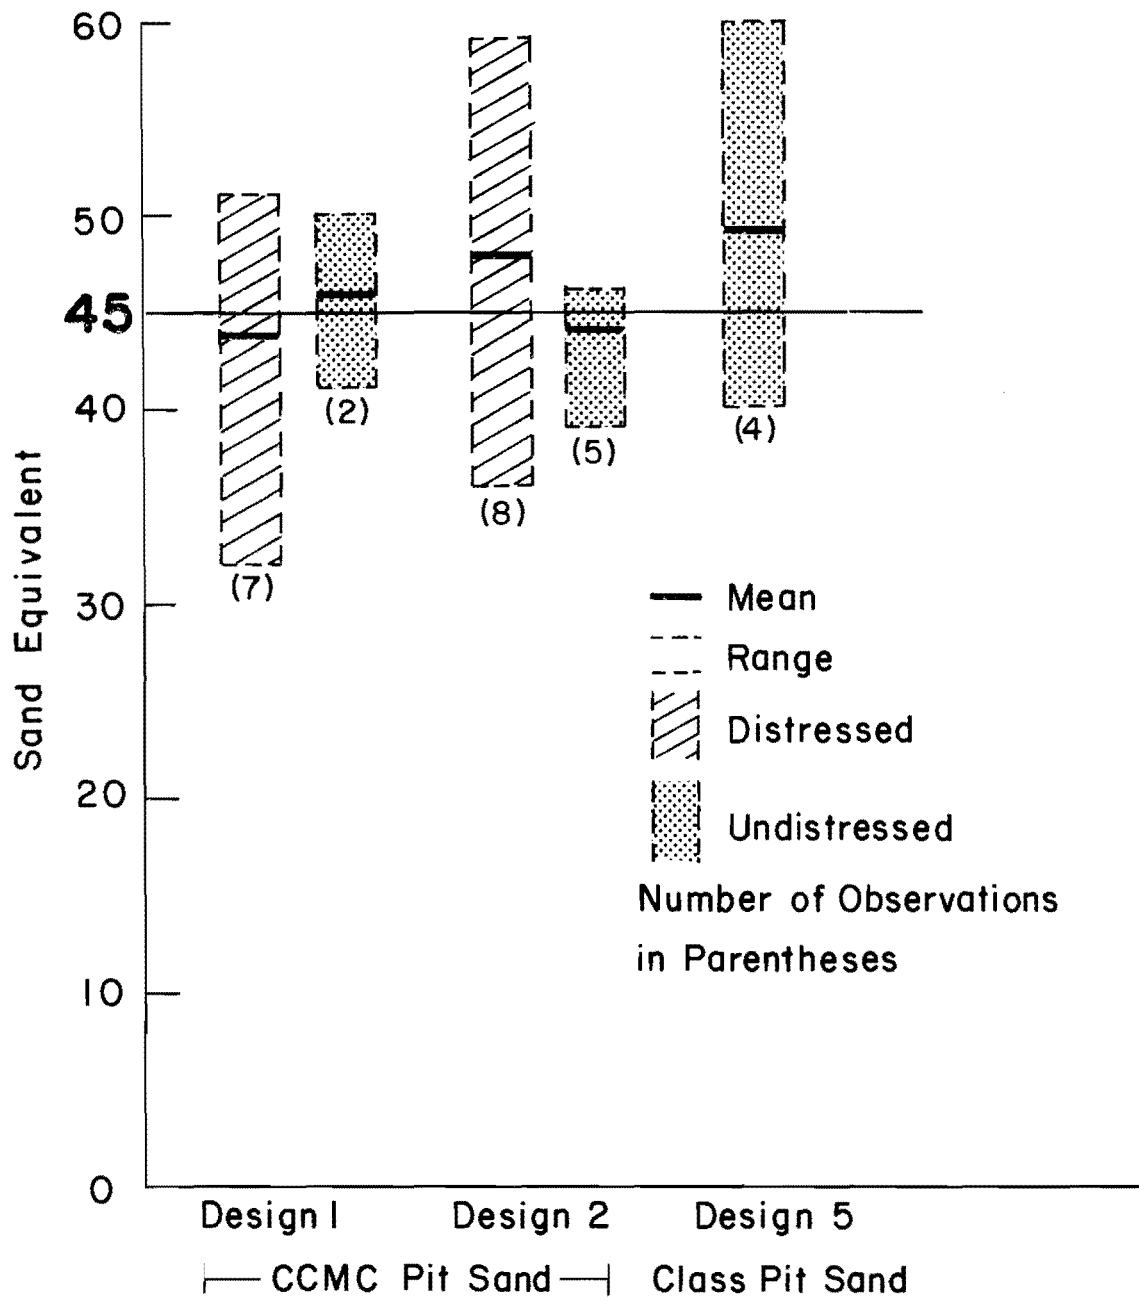
The average and range of the sand equivalent values by design and category of distress as computed by the residency laboratory during construction are shown in Fig 17. Designs 1 and 2 contained CCMC sand and design 5 contained Class sand. The average sand equivalents for the CCMC and Class sand were 45 and 49, respectively. Although these mean values were above the minimum acceptable value of 45 (Ref 2), 50 percent of the tests on the mixtures containing CCMC sand (designs 1 and 2) were below 45 with values as low as 32 and as high as 59, indicating a high degree of variability in this sand (Fig 17). For the Class sand only 25 percent were below 45 with values ranging from 40 to 60.

Fig 17. Sand equivalent values.

(2) The sand equivalent values were more variable for designs 1 and 2; the sand source used for these designs contained localized areas of dirty sand. While this may have been a contributing factor, there is no evidence to indicate that this was a definite and direct cause of the severe distress in designs 1 and 2.

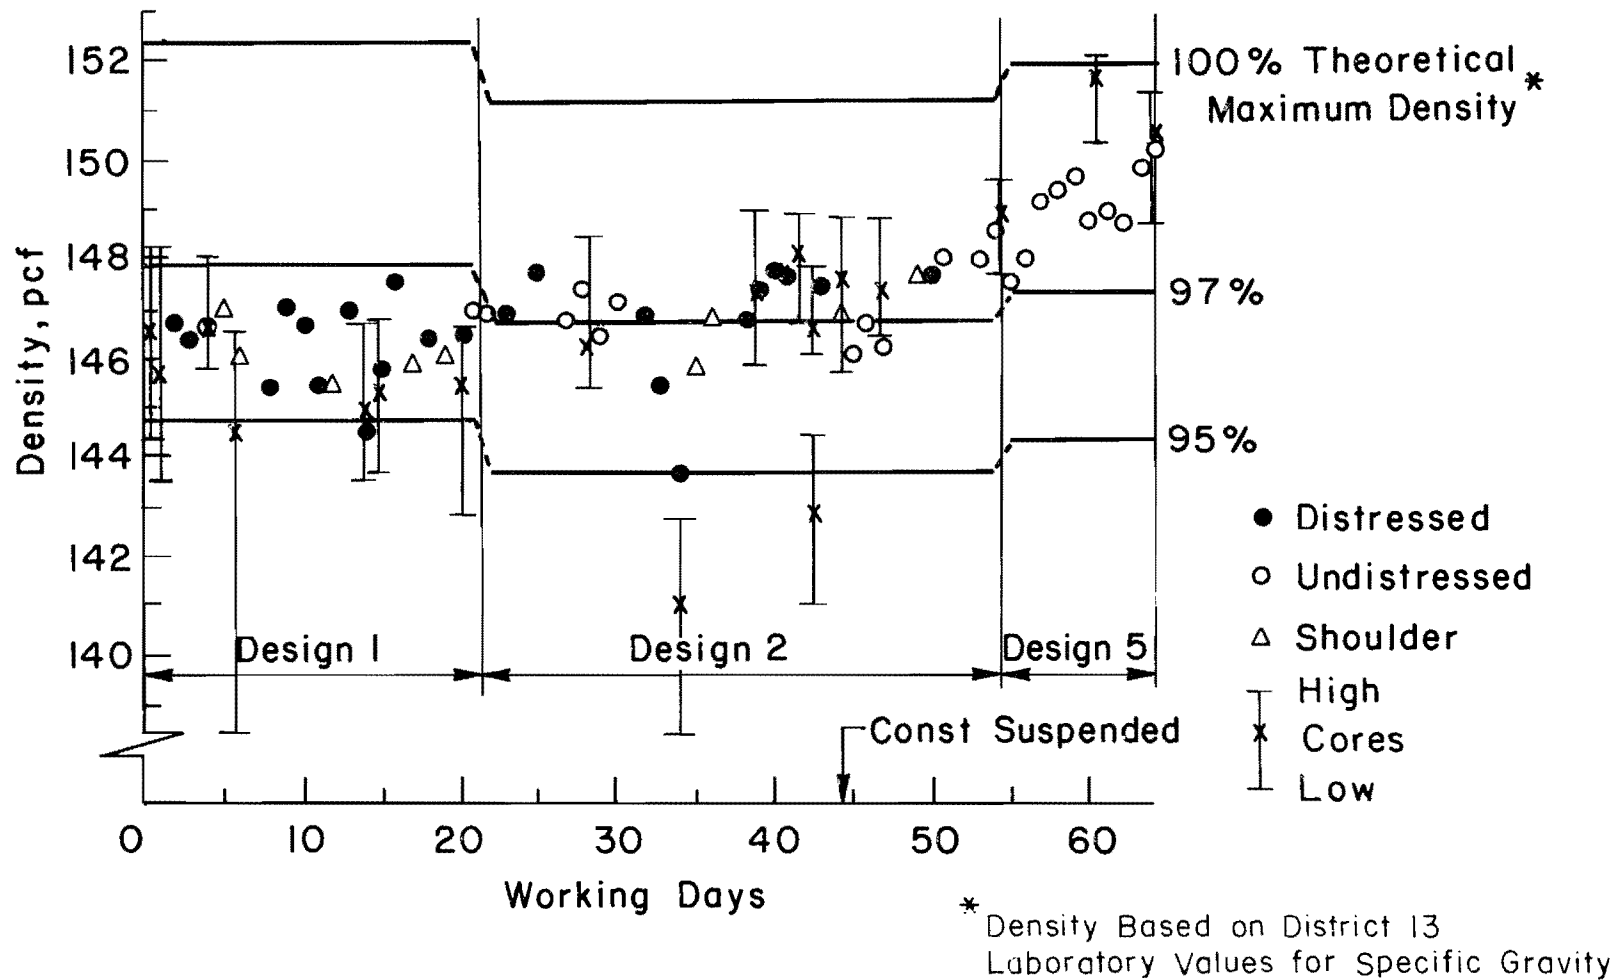
Densities for each core were determined by project personnel. Average core densities and the range of values for the three designs are shown in Figs 18 and 19. Average core density for design 5 (150.9 pcf) was significantly higher than the overall average core density for the undistressed areas of either designs 1 or 2 (146.5 and 146.2 pcf, respectively). A comparison of the core values and Hveem specimens suggests that the actual densities are correct. The values for design 5, however, appear to be quite large and it should be noted that these densities could not be duplicated in the laboratory.

Fig 18. Density of job control specimens and cores.

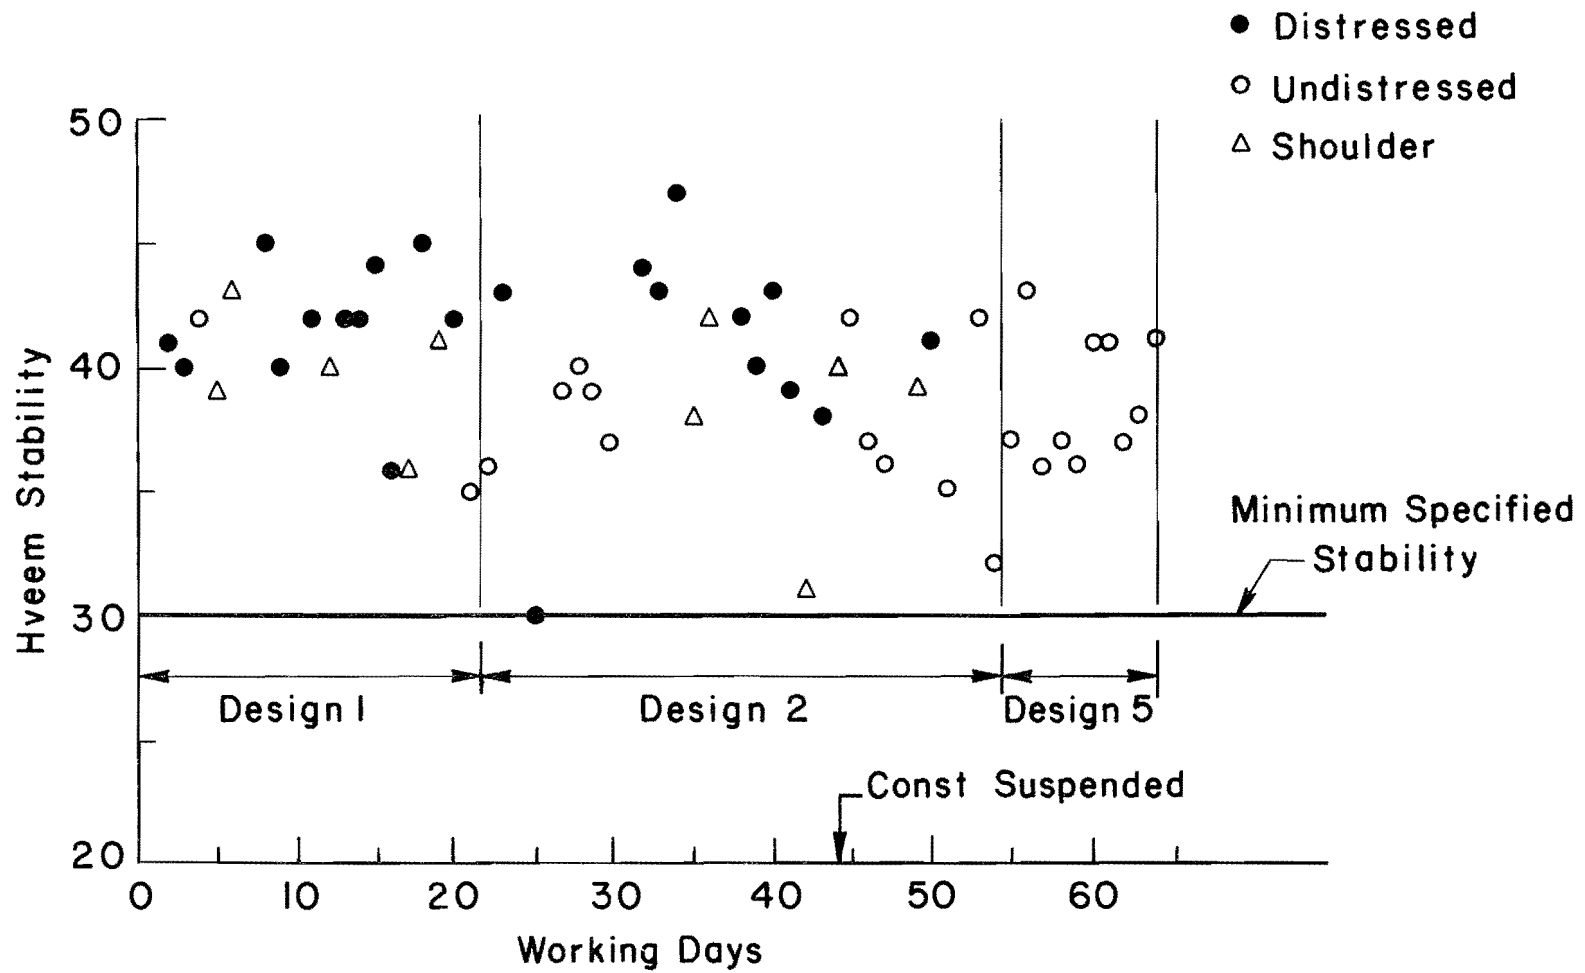
Figures 20 and 21 show the Hveem stability of laboratory specimens prepared daily during construction. Most of these values were between 35 and 45 and thus met the minimum stability requirement of 30 (Ref 2). There was no apparent relationship between stability and distress within designs 1 and 2. However,

Fig 20. Hveem stability of job control specimens.

While the mixtures on this project satisfied the commonly required Hveem stabilities of 30 and actually ranged from 35 to 45, it is still recommended that the required stability value be increased to 35 or 40 for high volume highways to help insure that stability problems are minimized.

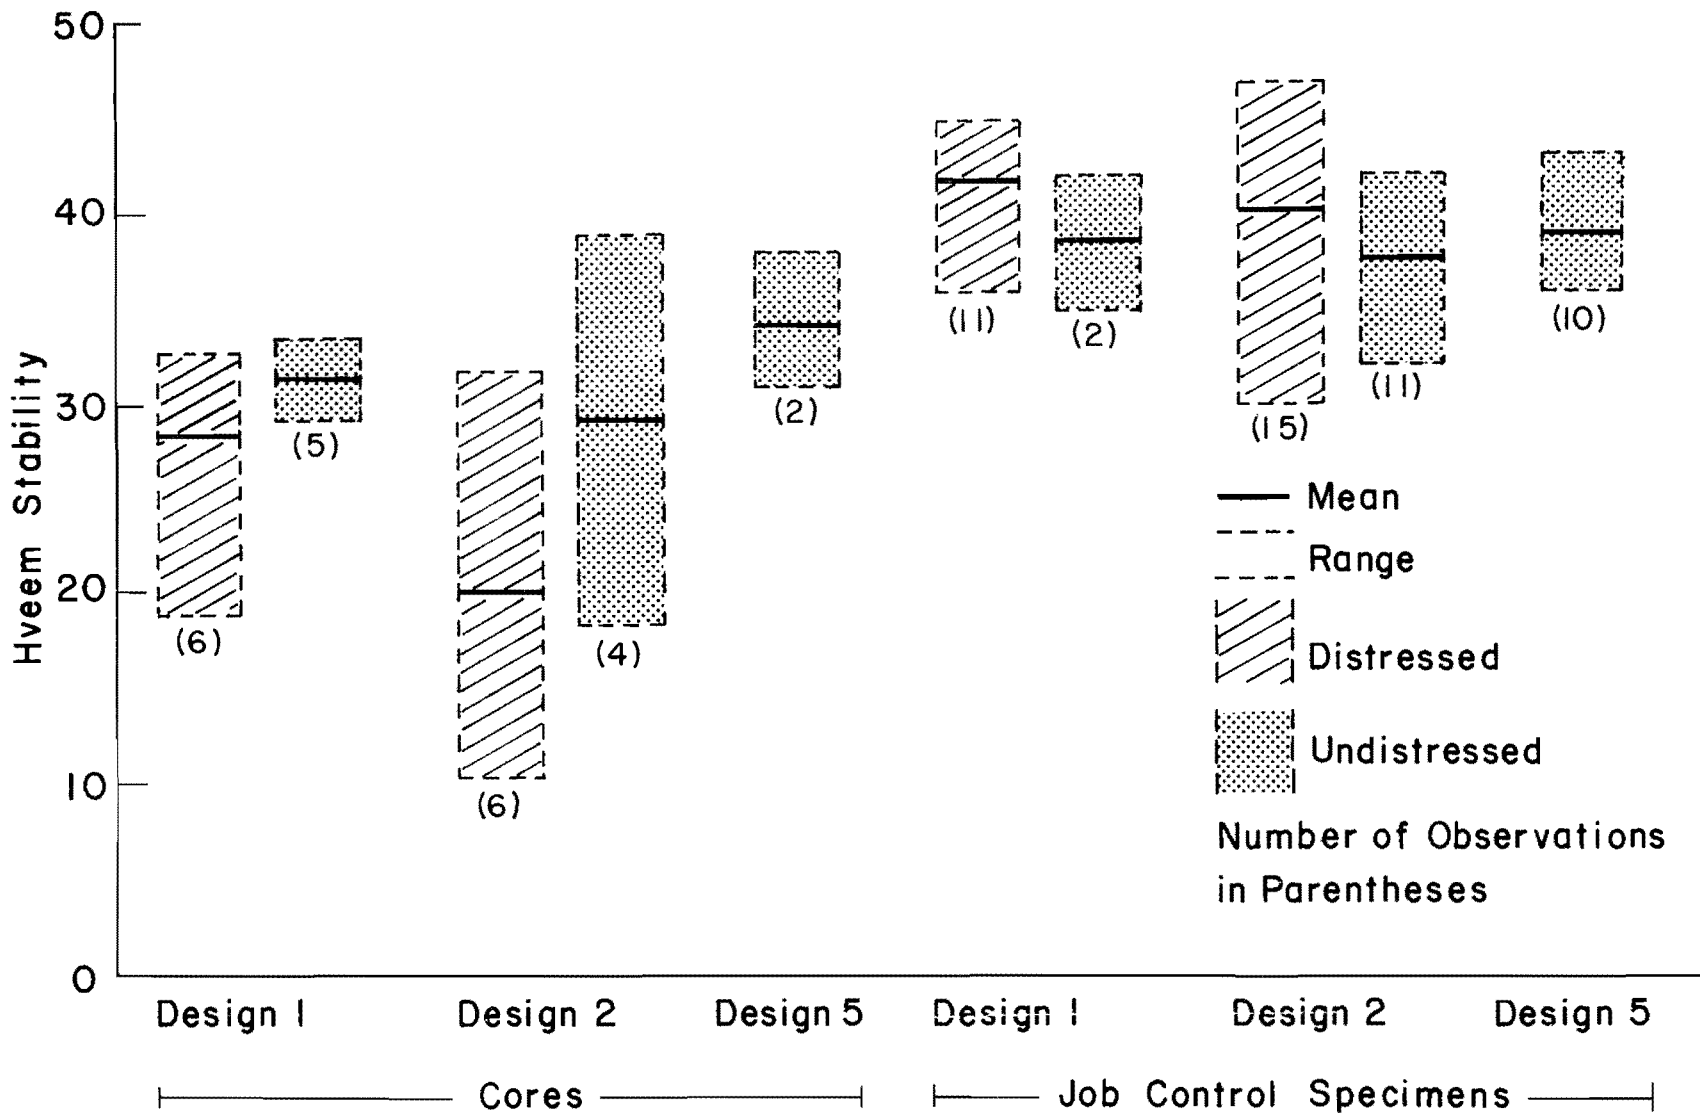
Fig 21. Hveem stability of cores and job control specimens.

Hveem stabilities were also determined for two or three cores at most sample locations and the results are summarized in Fig 21. It should be noted that these Hveem stability values cannot be interpreted in terms of specifications since the tests were on cores; however, they can be evaluated on a comparative basis. The results indicate that the average stability for design 5 was higher than that for either design 1 or design 2, but only two cores were tested for design 5. Stabilities were generally lower in the distressed areas than in the undistressed areas and the variation tended to be slightly smaller. Many of the values were extremely small, ranging as low as 10.

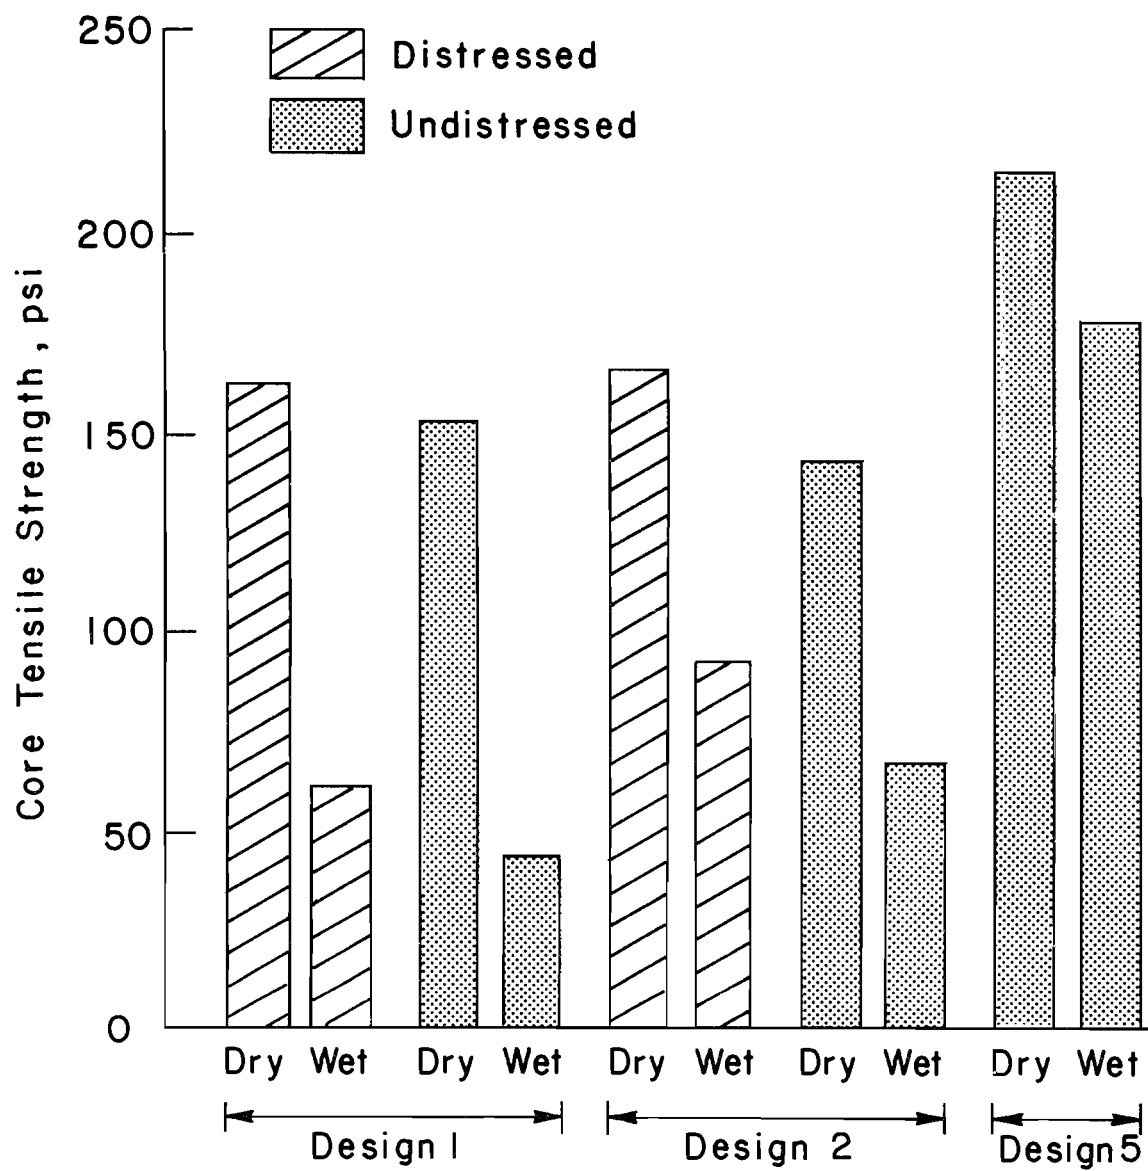
Tensile strengths were determined for cores taken from the roadway. These values are summarized in Fig 22. Static and resilient moduli of elasticity were also measured and showed the same trends as tensile strength. The dry tensile strengths for distressed and undistressed areas were not significantly different for designs 1 and 2. However, design 5 had a higher overall average dry tensile strength than either design 1 or design 2. Wet tensile strengths were also evaluated and are discussed under moisture susceptibility.

Fig 22. Average dry and wet core tensile strengths of the various mixture designs.

After conditioning, the tensile strength of each core was determined using the indirect tensile test. The results are contained in Fig 22.

Cores for design 5, after being moisture conditioned, retained a higher percentage of original dry tensile strength than those for either of the other mixtures. It has been suggested (Ref 6) that retention of less than about 70 percent of the dry tensile strength value when tested wet indicates a mixture that is moisture susceptible. When subjected to the most severe moisture conditioning methods, cores of mixtures from designs 1 and 2 generally retained less than 70 percent of the dry tensile strength, thus indicating their moisture susceptibility.

(5) The tensile strengths and the portion of the tensile strength retained after being subjected to moisture were much greater for design 5. This is attributed to the increased density which produced higher strengths and reduced moisture penetration.
