1. Report No.		2. Government Accession No.		3. Recipient's Catalog No.	
4. Title and Subtitle INVESTIGATION OF PREMATURE DISTRESS IN CONVENTIONAL ASPHALT MATERIALS ON INTERSTATE 10 AT COLUMBUS, TEXAS				5. Report Date August 1982

INVESTIGATION OF PREMATURE DISTRESS
IN CONVENTIONAL ASPHALT
MATERIALS ON INTERSTATE 10
AT COLUMBUS, TEXAS

Research Report Number 313-1

CENTER FOR TRANSPORTATION RESEARCH
BUREAU OF ENGINEERING RESEARCH
THE UNIVERSITY OF TEXAS AT AUSTIN

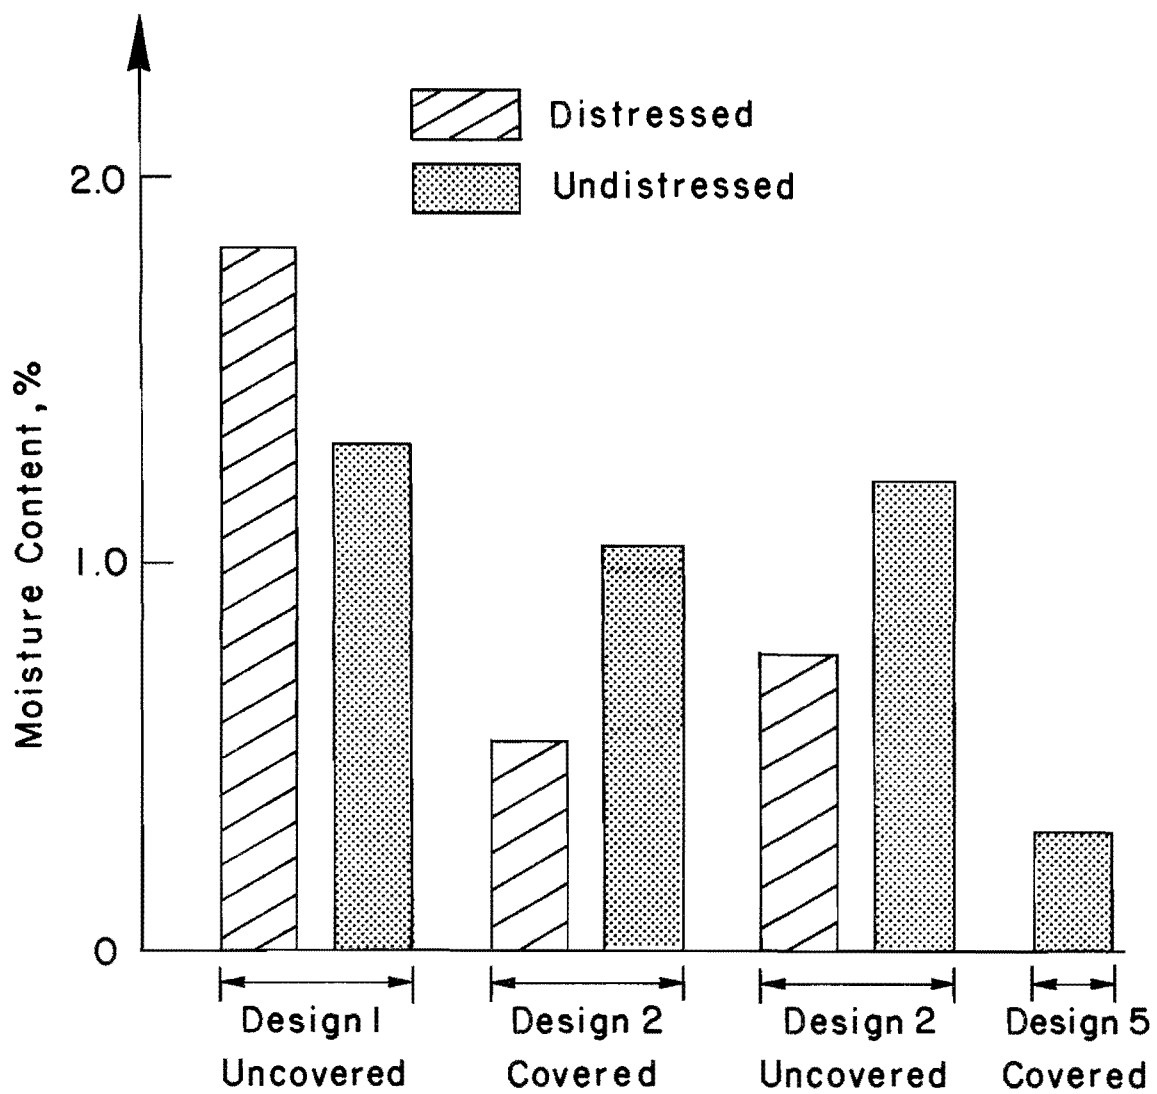
Fig 23. Moisture content of roadway slabs of the Type B base course.

In-situ moisture content was determined for the Type B base course mixture from slab samples obtained at each coring location. The results summarized in Fig 23 indicate that the mixtures for designs 1 and 2 contained more moisture than for design 5. This is not unexpected since the Type B base course mixture from design 5 was covered by the Type D wearing course almost immediately after placement and because its density was significantly greater than the density of the other two designs. In addition, the areas of design 2 which were covered contained less moisture than design 2 areas which were not covered. Thus it appeared that moisture content was related to distress and needed to be evaluated.

- (1) Design 5 and the portion of design 2 placed after the winter had a lower field moisture content than the rest of the project. This was due to the following:
 - (a) Both sections had higher densities although the density of design 5 was substantially higher.
 - (b) Neither design section was exposed during the winter.

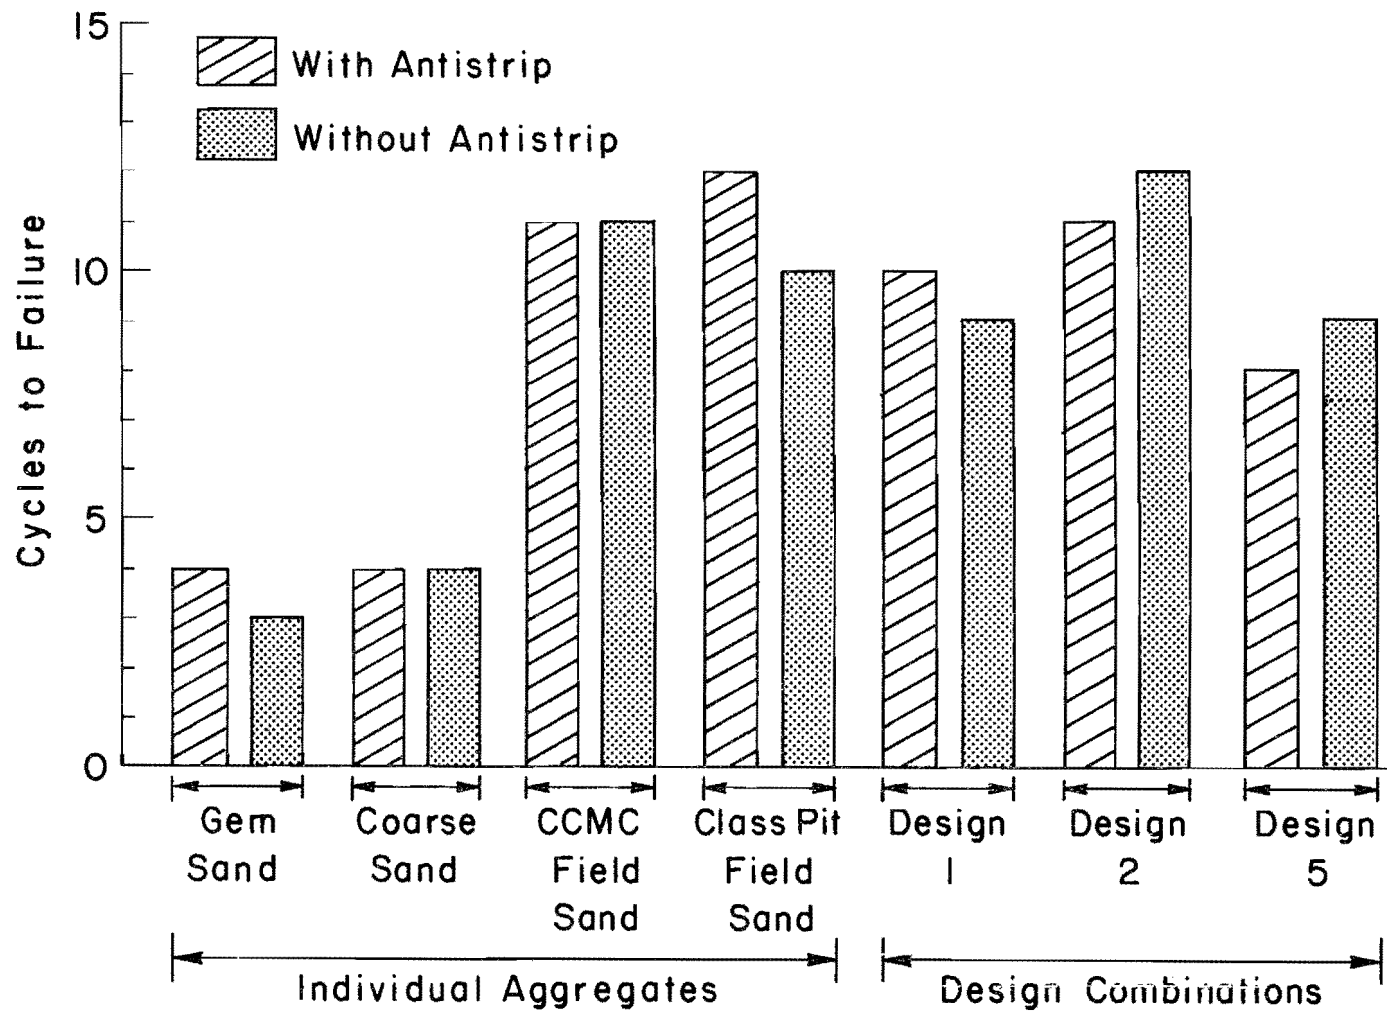
Pedestal tests (Ref 5) were performed on both the individual and the combined aggregates of the Type B base course, with and without the anti-stripping agent. Previous work at The University of Texas at Austin has demonstrated that the test can distinguish between those Texas aggregates which are susceptible to stripping and those which are not. Aggregate-asphalt mixtures which fail in less than 10 to 15 cycles generally can be considered to be susceptible to moisture damage or stripping. The test procedure is contained in Ref 5 and is summarized in Appendix B. The results of the study are summarized in Fig 24. The results indicate that all three designs were susceptible to moisture damage and that all four individual sands were moisture susceptible, especially the Gem sand and the coarse sand. It can also be seen that there was no difference in the moisture susceptibility of the CCMC and Class Pit field sand and that the antistripping agent apparently was not effective.

Fig 24. Texas freeze-thaw pedestal test results for individual aggregates and for Type B base course mixture.

(6) The Texas freeze-thaw pedestal values and the retained tensile strength after moisture conditioning indicated that all aggregates are highly susceptible to moisture damage.

(1) All asphalt-aggregate combinations including mixtures containing proposed antistripping agents should be tested to determine their susceptibility to stripping and moisture damage. Suggested test methods are the Texas Freeze-Thaw Pedestal Test (Ref 5), the Boiling Test (Ref 7), and the Wet-Dry Indirect Tensile Tests (Ref 8).
