1. Report No. FHWA/TX-86/16+316-1		2. Government Accession No.		3. Recipient's Catalog No.	
4. Title and Subtitle DURABILITY OF PRESTRESSED BRIDGE DECKS				5. Report Date July 1985

DURABILITY OF PRESTRESSED BRIDGE DECKS

Research Report 316-1

"Application of Transverse Prestressing to Bridge Decks"

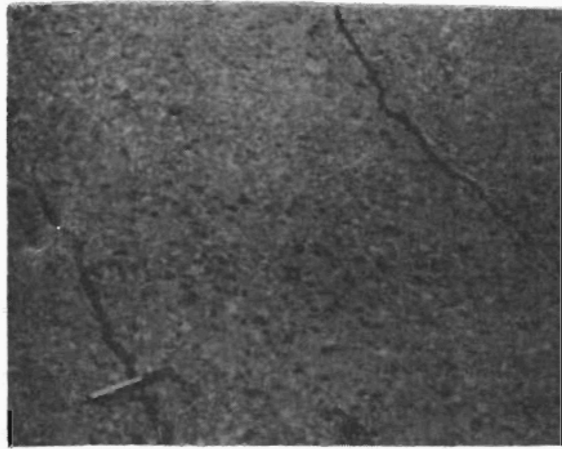
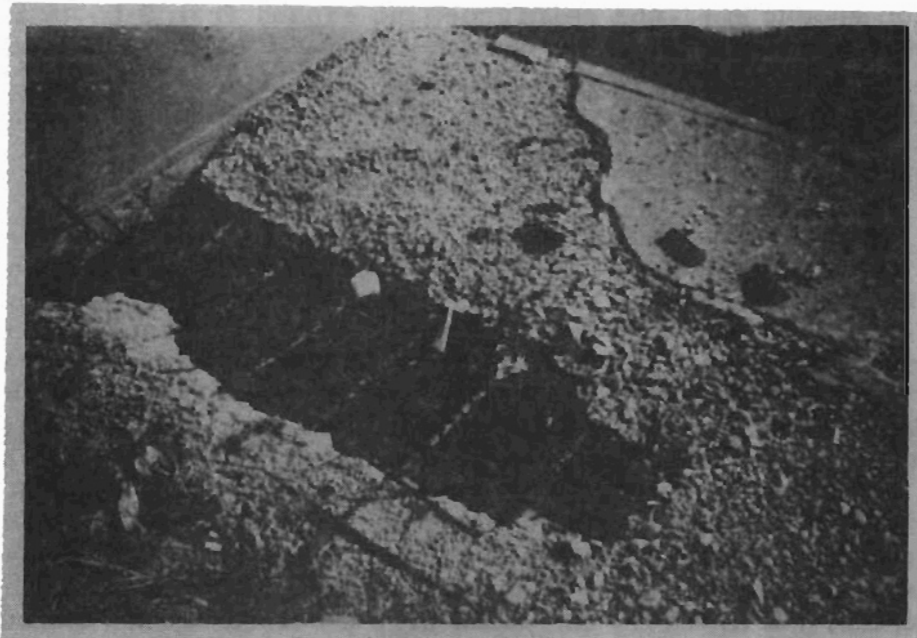
a) cracking in a bridge deck

b) bridge deck spalling

Fig. 1.1 Bridge deck deterioration

The major cause of the bridge deck deterioration is chloride containing deicing salts that have been applied to maintain trafficable winter roadway conditions [3]. In coastal areas, decks in the splash zones suffer similar attacks. The rate of corrosion accelerates rapidly when chlorides combine with moisture and oxygen and disrupt the passivity of reinforcing steel. In turn, the corrosion products of the reinforcement expand from 2 to 15 times, resulting in stresses large enough to crack and subsequently spall a concrete bridge deck, as seen in Fig. 1.1.

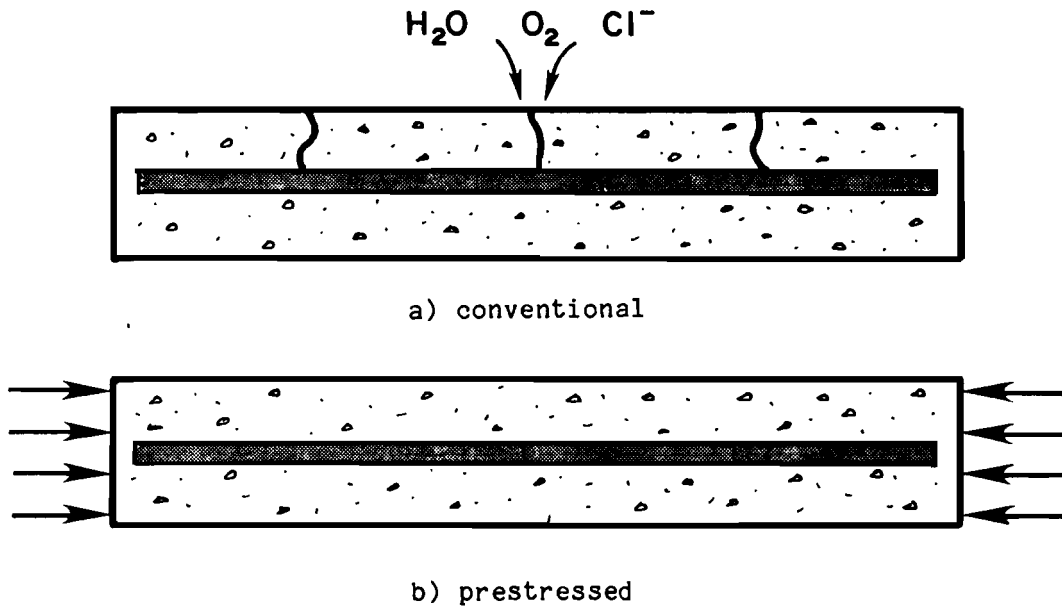
Fig. 1.2 Corrosion protection mechanism of prestressing

Figure 1.2 illustrates the corrosion protection mechanism of prestressing. Since corrosion producing elements can penetrate uncracked concrete with insufficient cover, concrete quality or compaction, it is assumed throughout this report that all normal precautions involving provision of adequate cover and concrete quality will be observed. Even in such a well-designed and constructed conventional reinforced concrete slab, which more than likely cracks under service load conditions, water, oxygen and salt can penetrate the concrete with subsequent corrosion of the reinforcing steel. However, under the action of prestressing the applied compressive force prevents cracks from forming or closes the cracks preventing penetration of the corrosion-producing elements.

In addition, prestressing provides an auxiliary level of corrosion protection. Even if cracks do form under load in a prestressed concrete member, upon removal of the load the cracks completely close. This is in contrast to a reinforced concrete member where once a crack forms, the crack never completely closes. In non-prestressed members, there will generally be a residual crack opening at the concrete surface allowing penetration of the corrosion-producing elements.

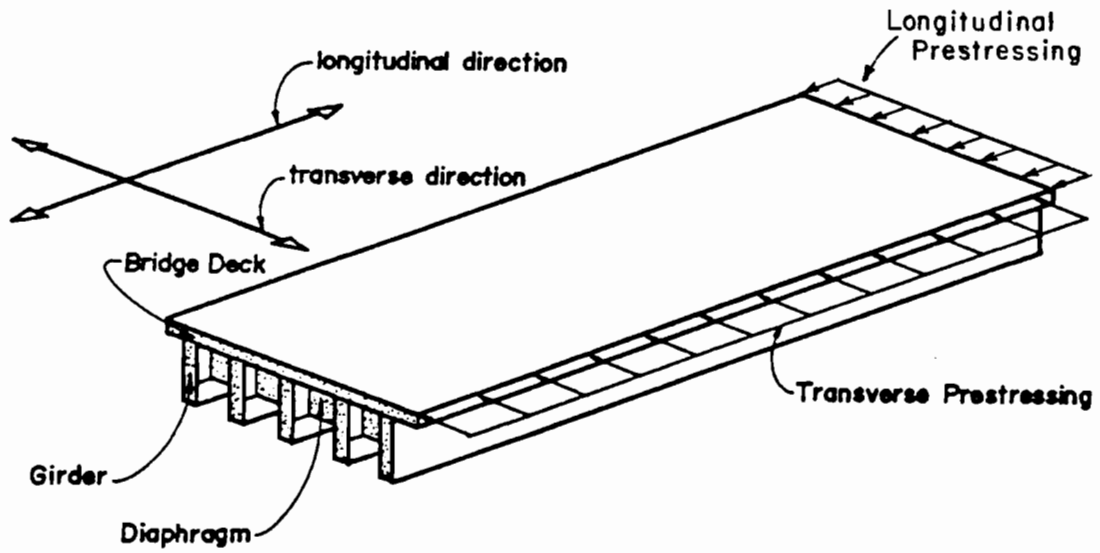
Fig. 1.4 Deck prestressing of a conventional slab-girder bridge

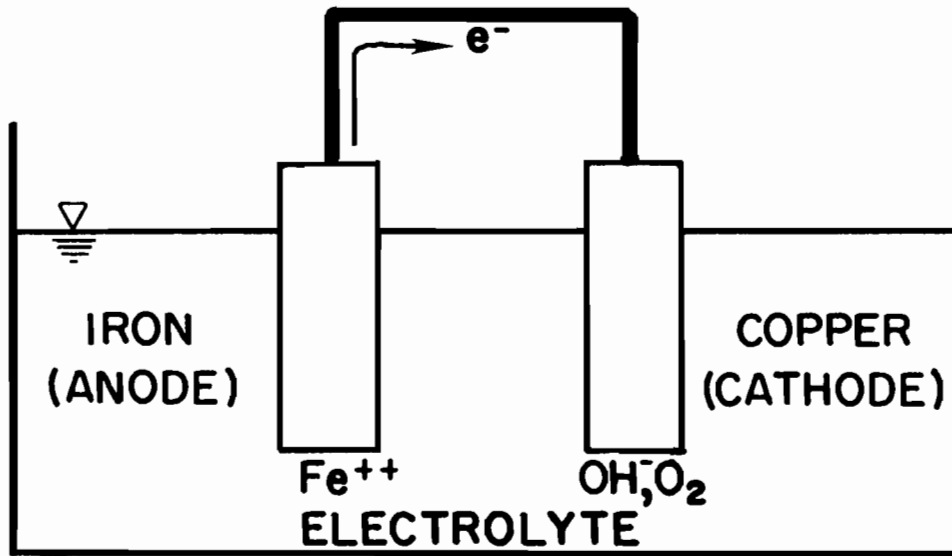
Fig. 2.1 Basic galvanic cell

A galvanic cell is formed when two dissimilar electrodes, separated by an electrolyte, are electrically connected by a conductor. Figure 2.1 illustrates a galvanic cell consisting of iron and copper in oxygenated water. Because of their relative positions in the electromotive force series as seen in Table 2.1, iron serves as

the anode and copper as the cathode. The result is electrochemical corrosion of iron resulting in an iron plating of the copper.

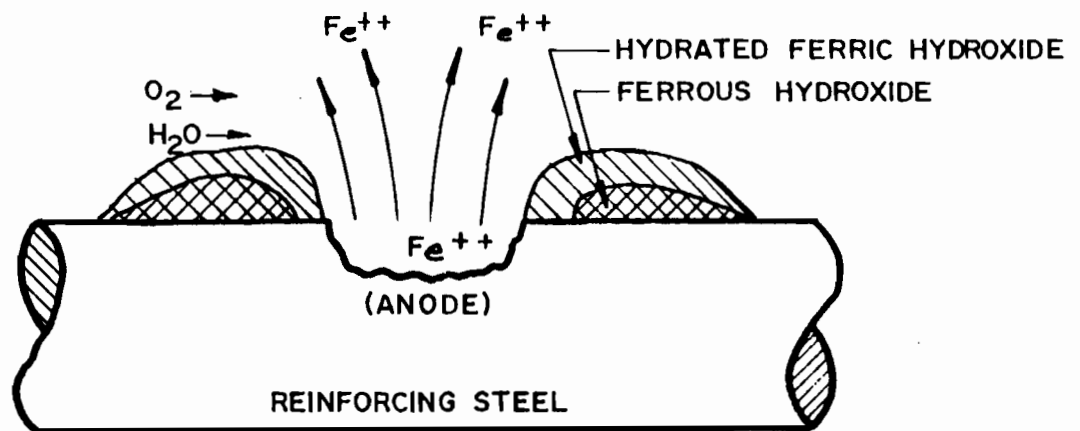
Fig. 2.3 Steel corrosion products

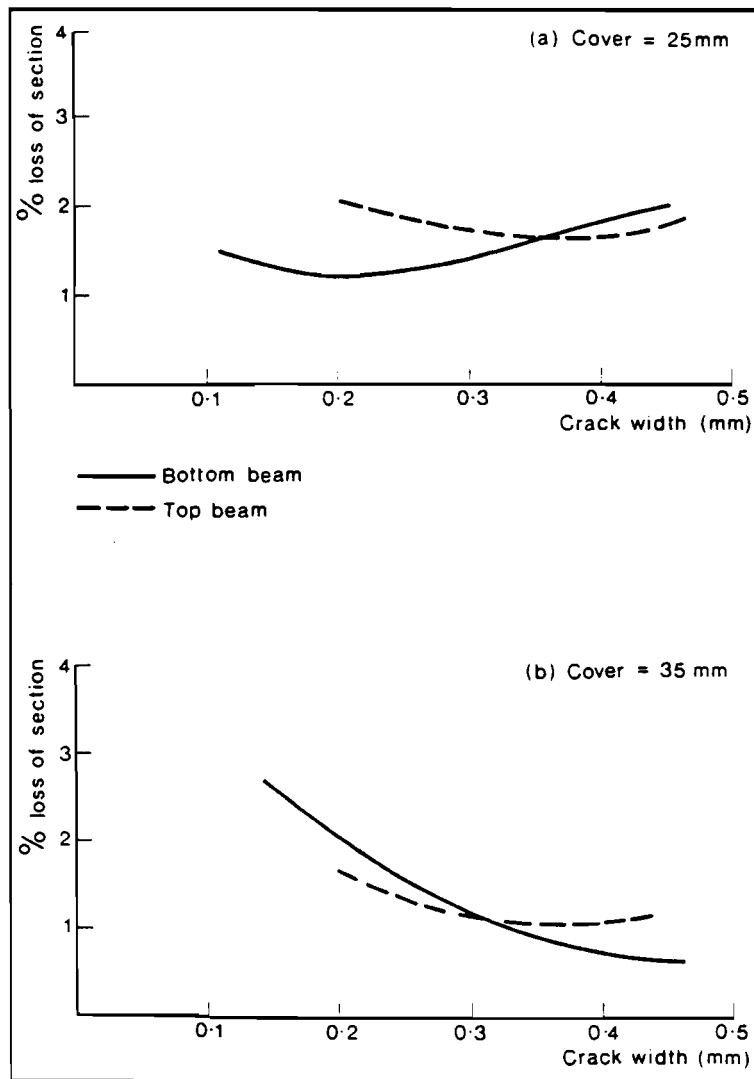
Fig. 2.4 Influence of crack width on corrosion of concrete in marine environment after 10 years exposure (from Ref. 19)

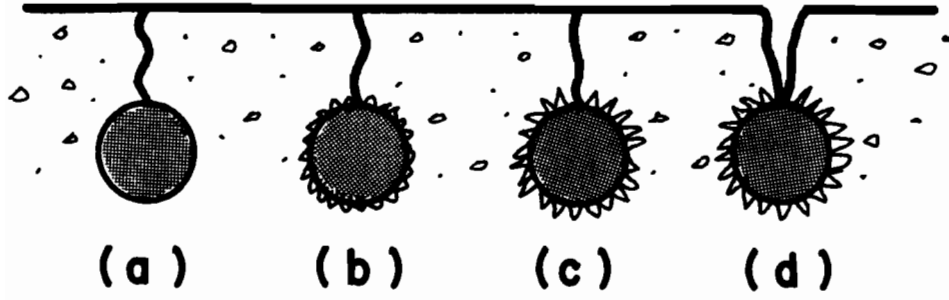
Fig. 2.5 Concrete deterioration mechanism

Spalling is a physical disruption or splitting of the concrete. Usually, the coarse aggregate fractures and the uncracked concrete appears to be sound. Spalling is particularly detrimental to

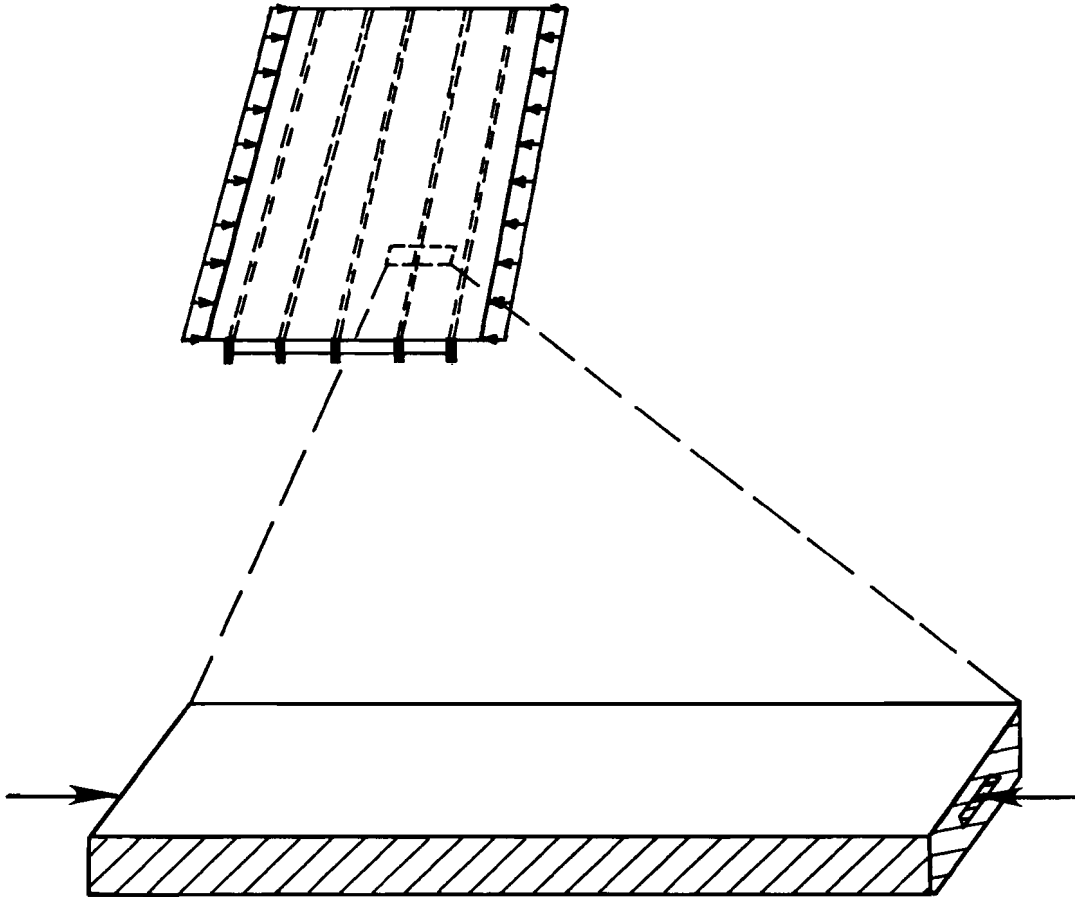
Fig. 3.2 Durability specimens representing a component of a transversely prestressed bridge deck

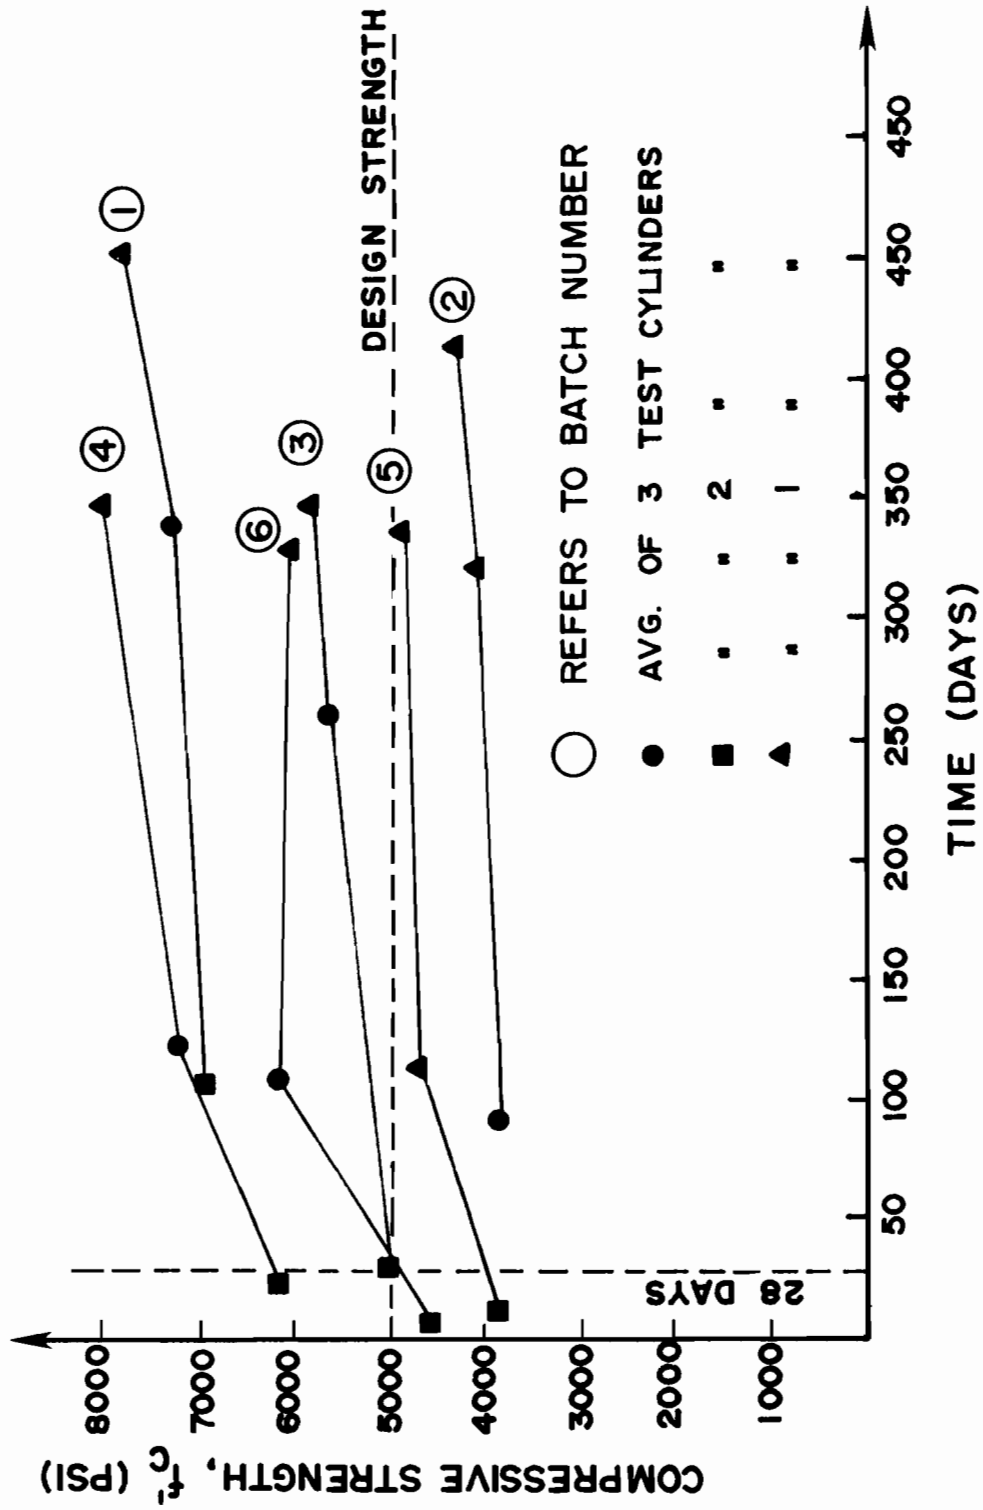
Fig. 3.5 Compressive strength versus time

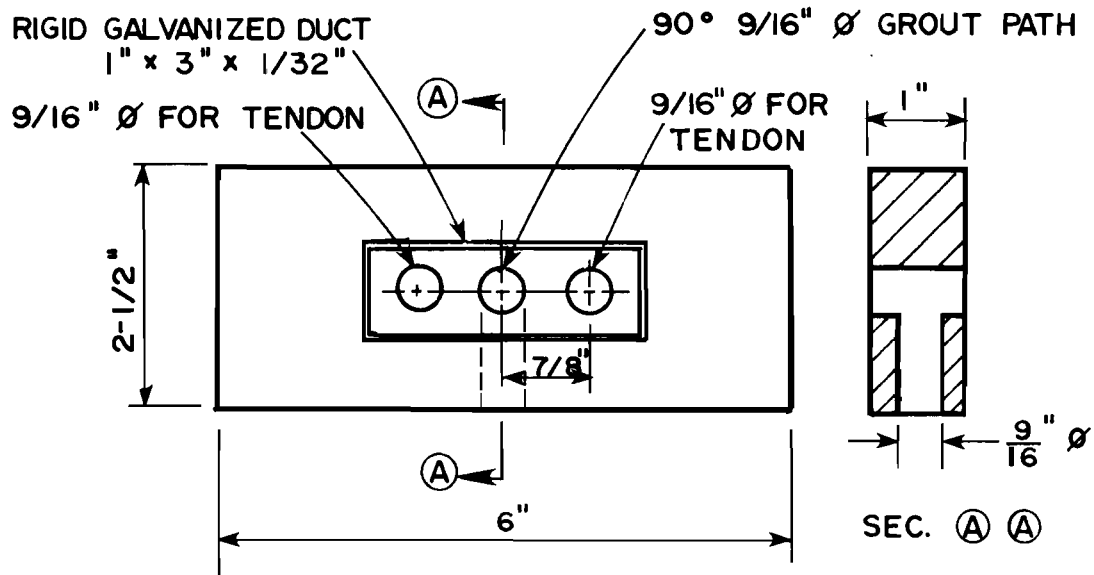
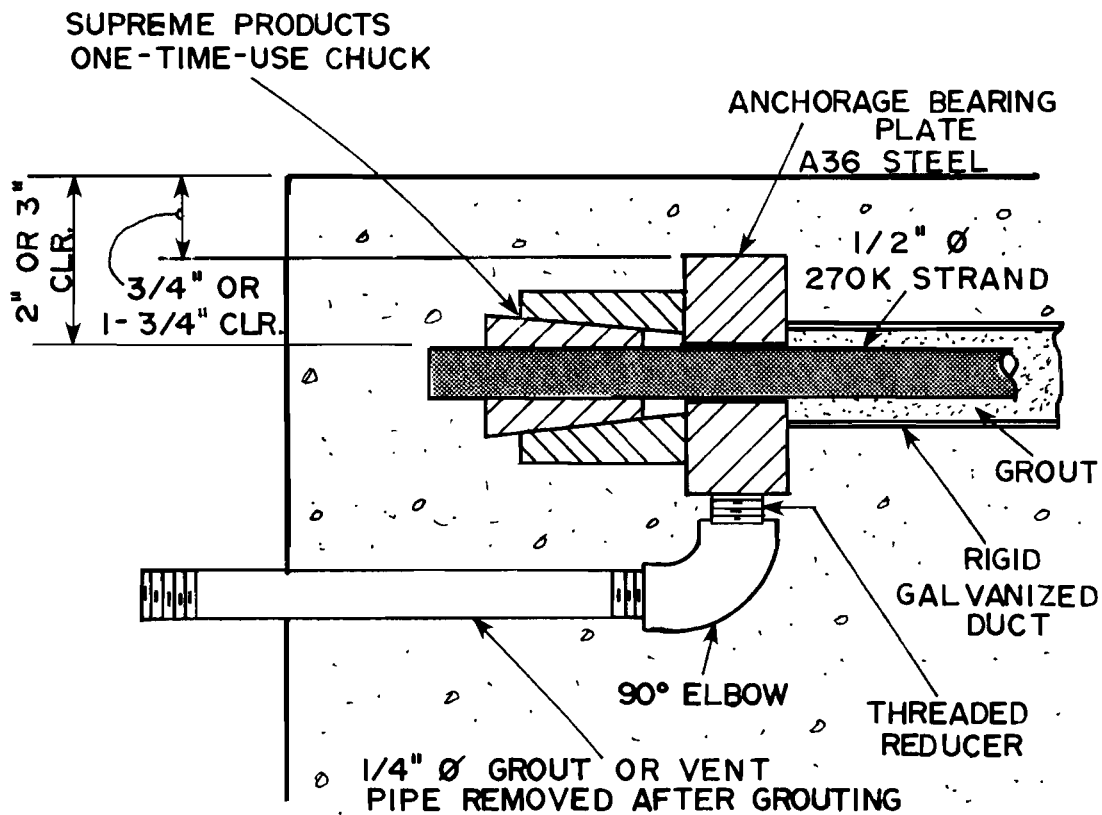
Fig. 3.7 Details of grouted specimen anchorages

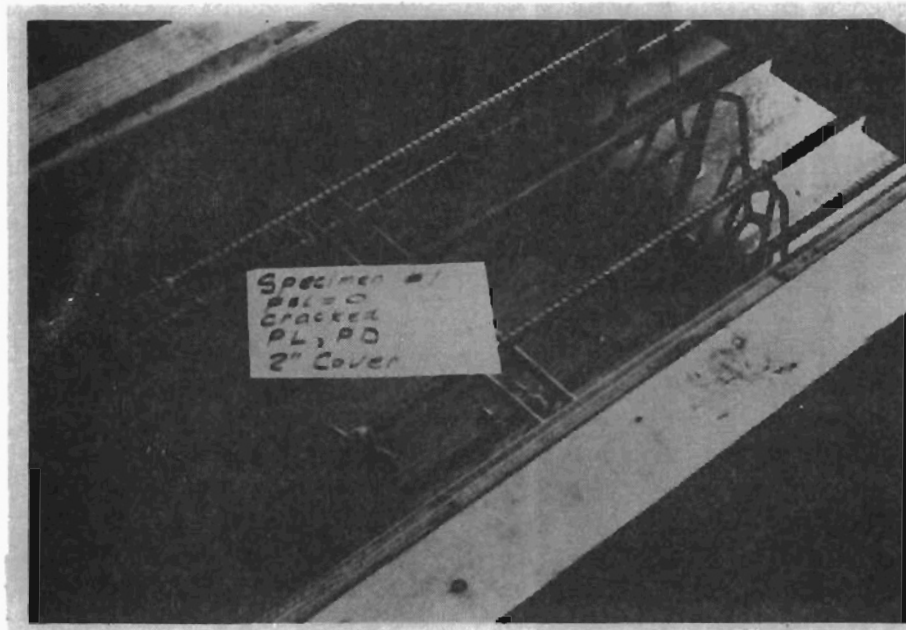
Fig. 3.8 Reinforcement tied to chairs in unbonded specimen; wood positioning template and coil ties in place

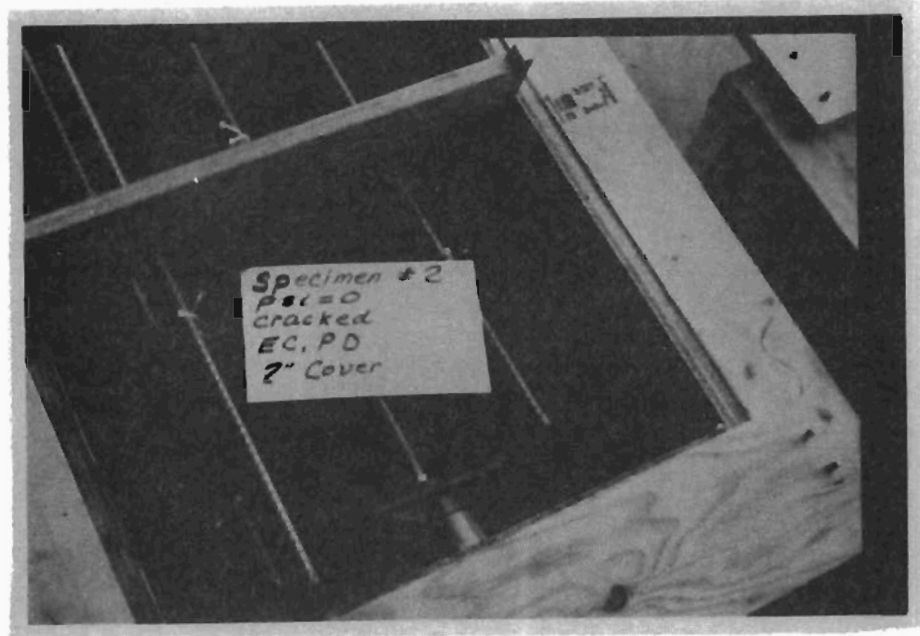
Fig. 3.9 Anchorage casting and pocket former on stressing end of unbonded specimen

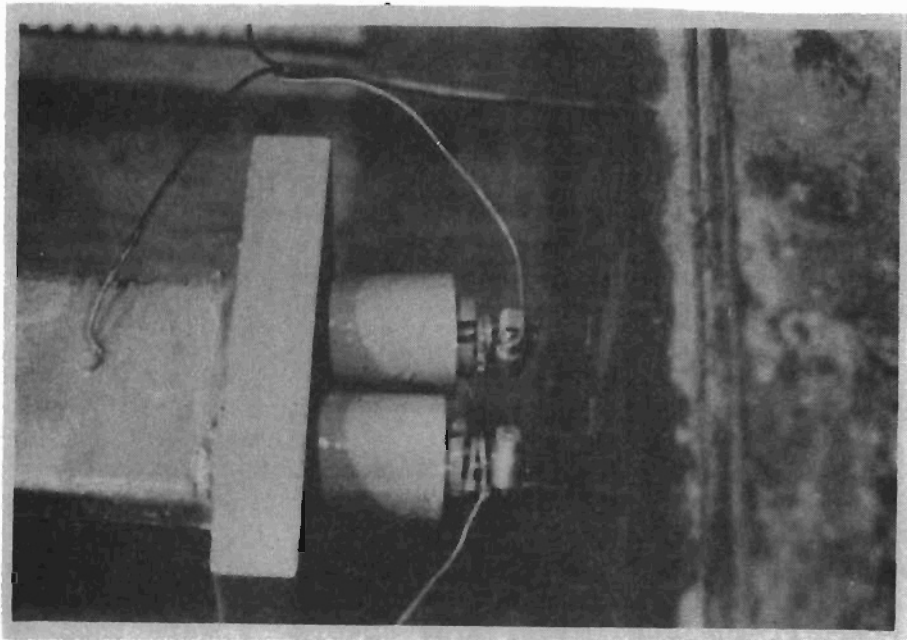
Fig. 3.14b Electrical connections to prestressing strand and galvanized duct

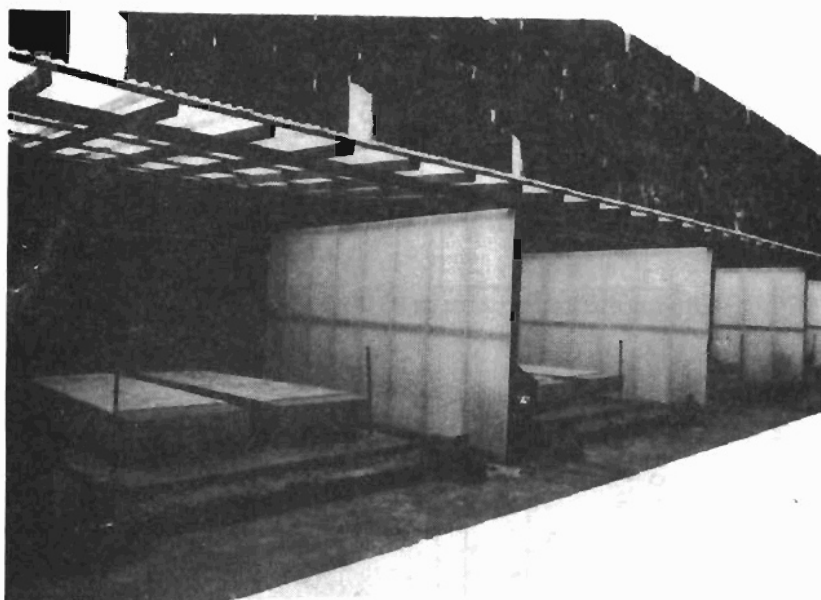
Fig. 3.15 Exposure facility

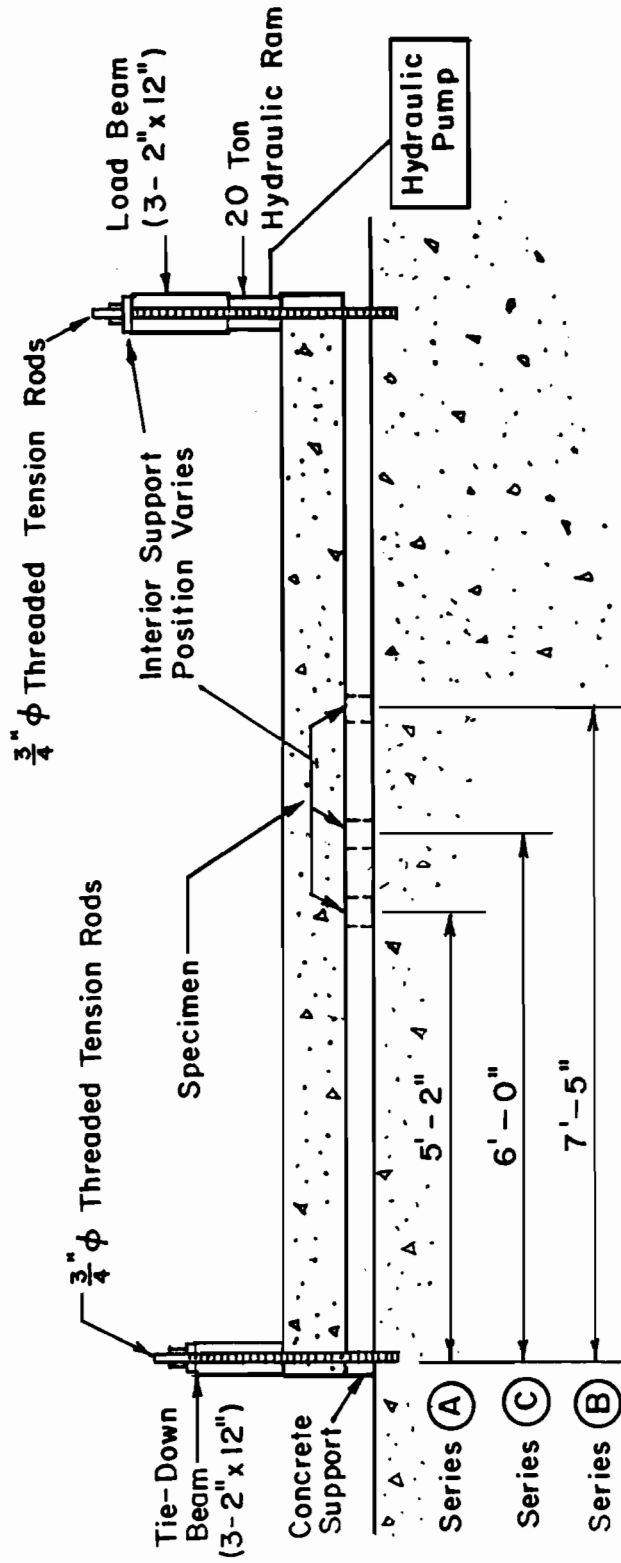
Fig. 3.17 Schematic of loading system

3.9.1 Cracking of Specimens. Before exposure testing began, the specimens were loaded until cracking occurred using the loading system shown in Figs. 3.16 and 3.17. After a specimen cracked, the load was removed and the crack locations were marked as shown in Fig. 3.20. Appendix A shows the locations of the induced cracks in all the specimens. The specimens were then reloaded gradually until the desired surface crack width was achieved as specified in Table 3.2. The crack widths were measured using a

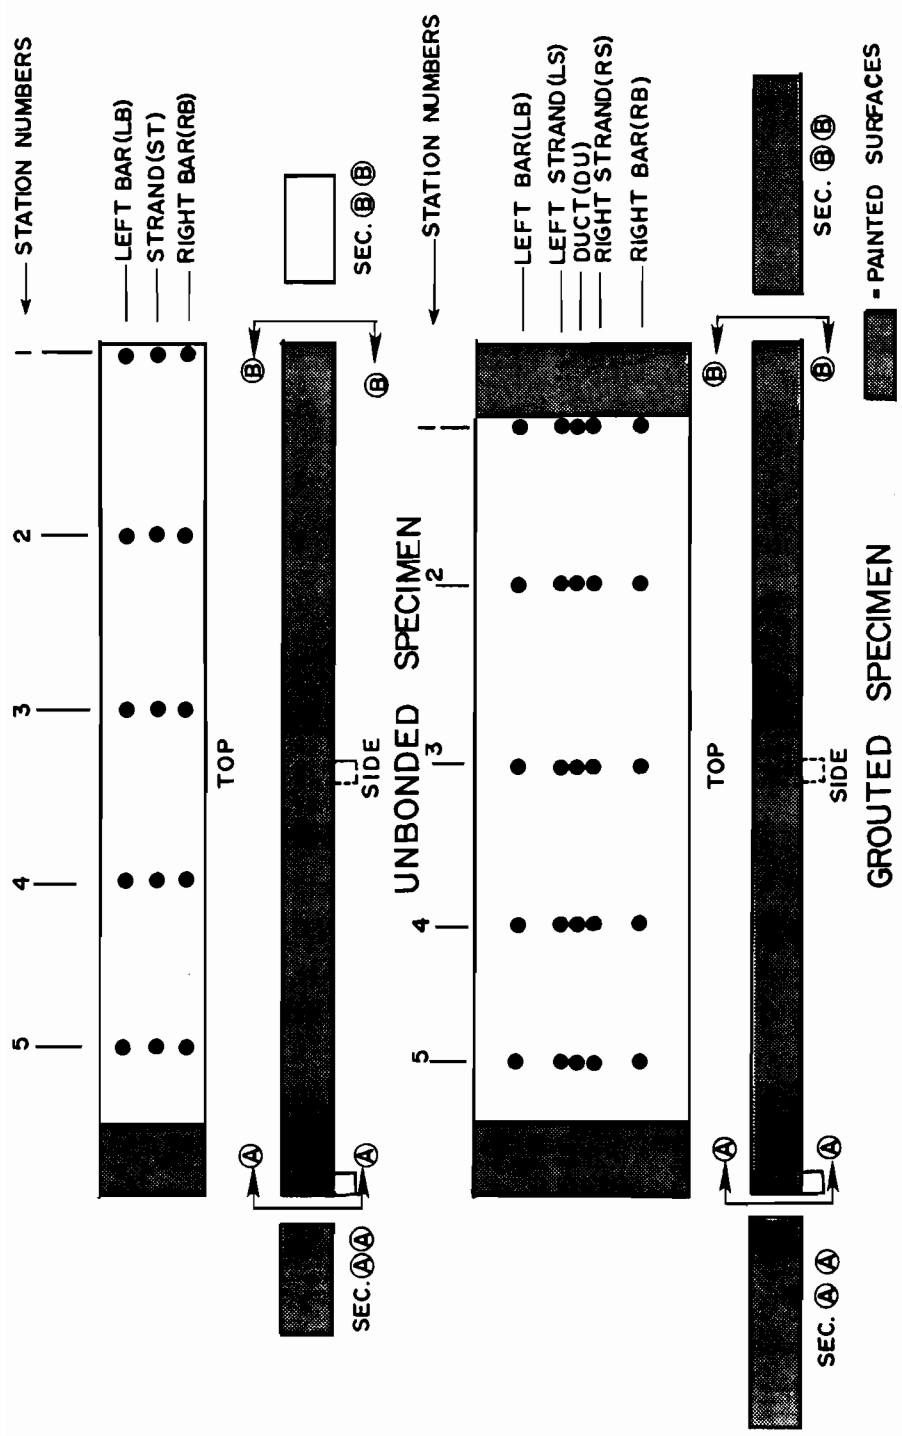
Fig. 3.18 Painted surfaces; half cell potential stations

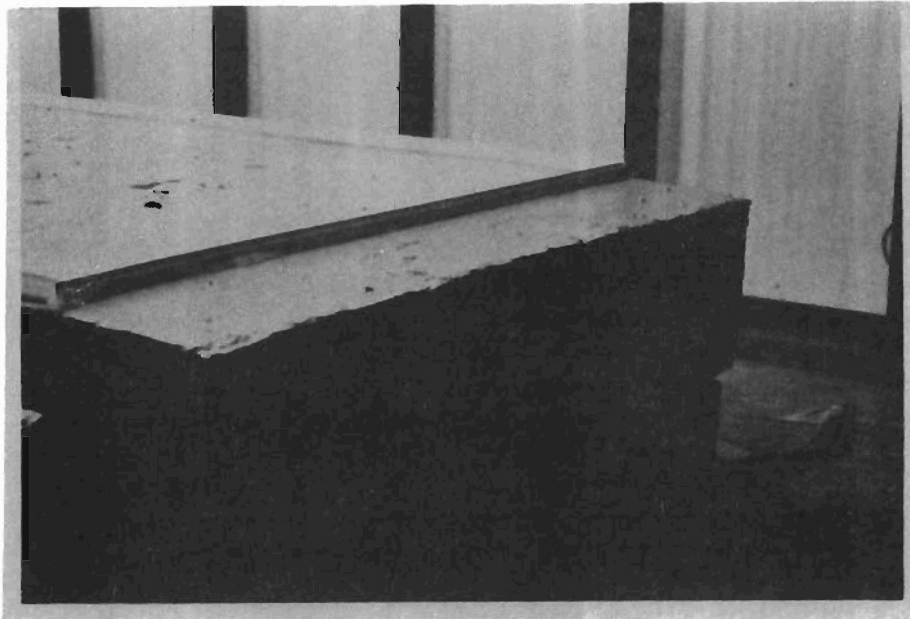
Fig. 3.19 Levee system on specimens

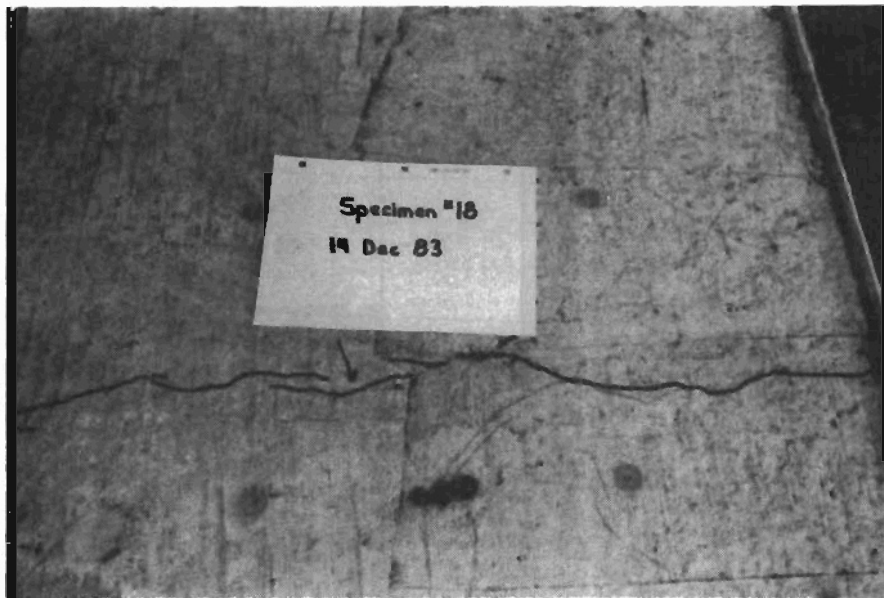
Fig. 3.20 Cracks marked on specimens during initial cracking

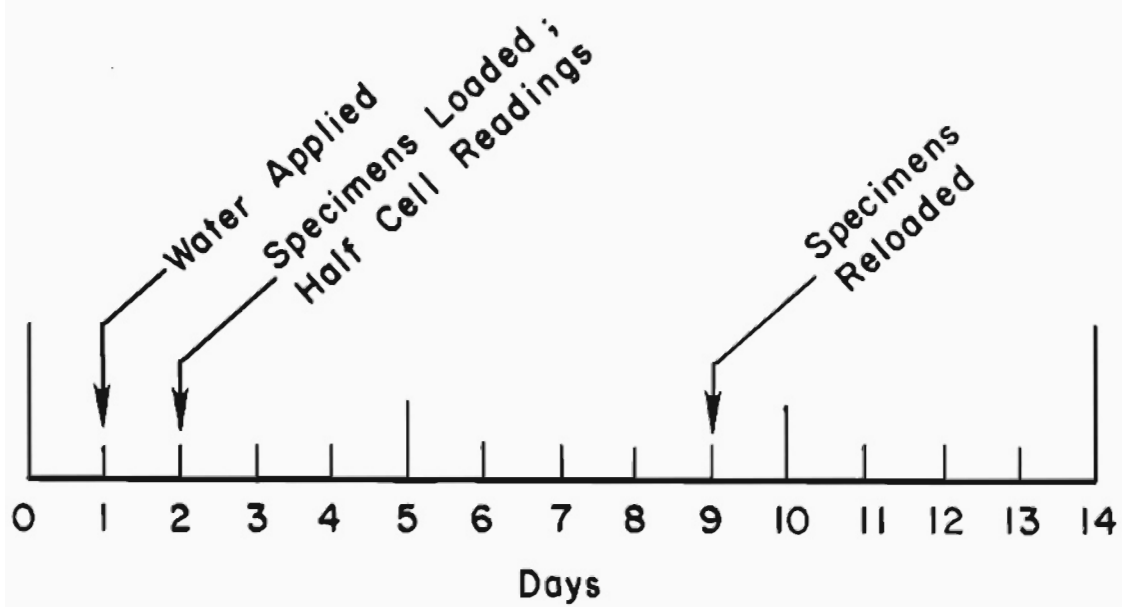
Fig. 3.21 Basic exposure cycle

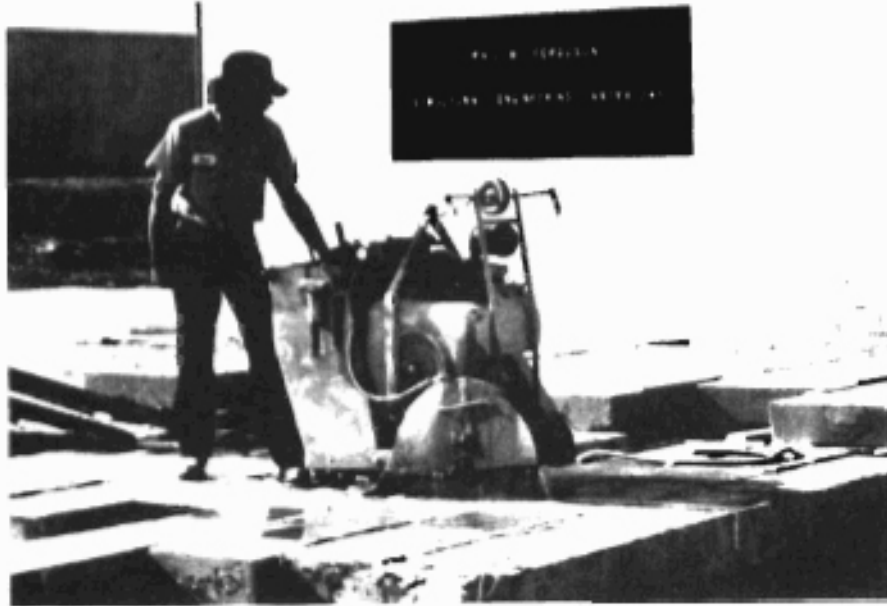
Fig. 3.23 Saw used to crosscut specimens at crack zones

In order to visually examine the reinforcement, two saw cuts, the locations of which are shown in Appendix A for each specimen, were made approximately 4 to 6 in. apart at the crack locations using the concrete saw shown in Fig. 3.23. The concrete section removed from each specimen, as seen in Fig. 3.24, was broken apart in order to examine the steel for corrosion. A few specimens were jackhammered apart in order to examine the full length of all the top reinforcement as well as the anchorages.

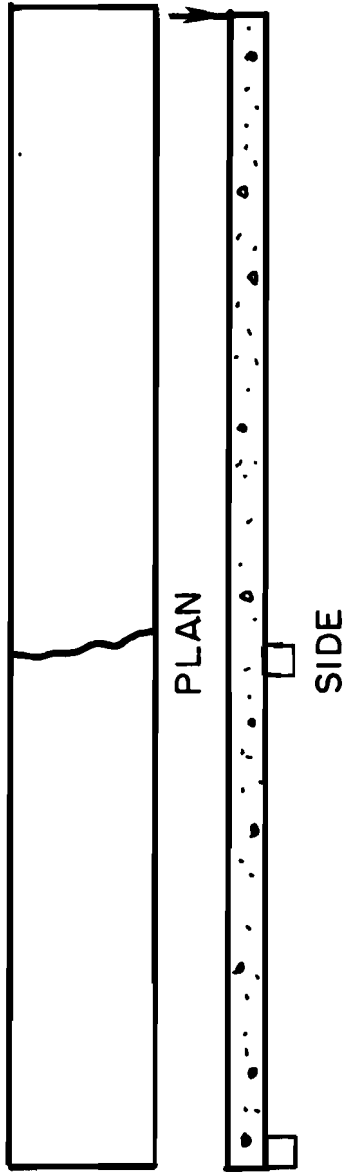
Fig. 4.1a Induced cracks for Specimen 1

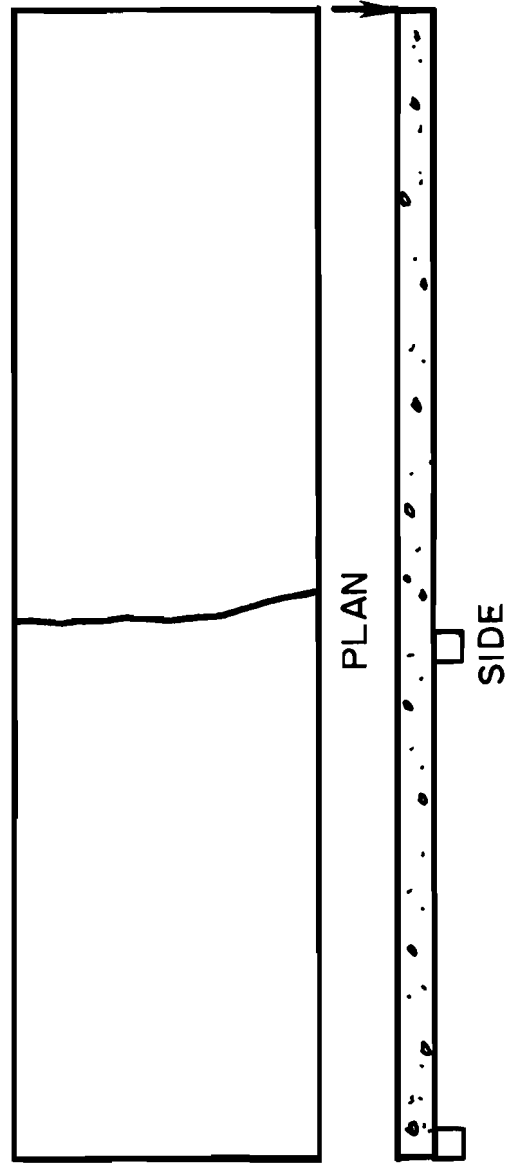
Fig. 4.1b Induced cracks for Specimen 13

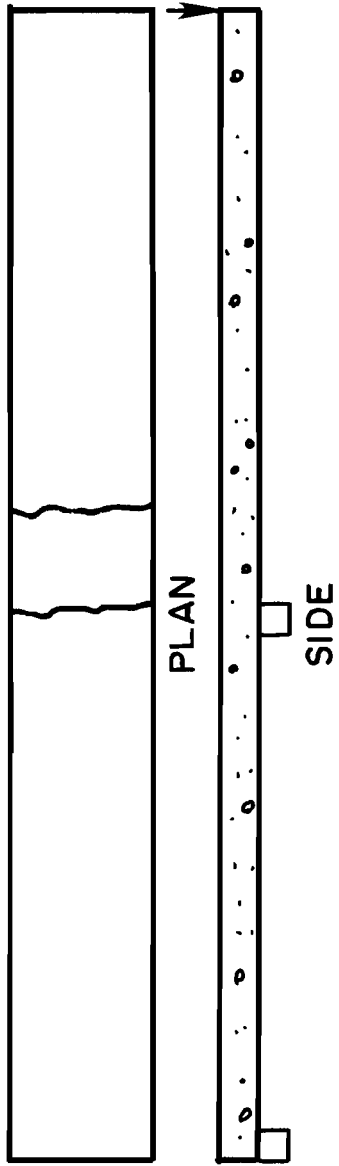
Fig. 4.2a Induced cracks for Specimen 2

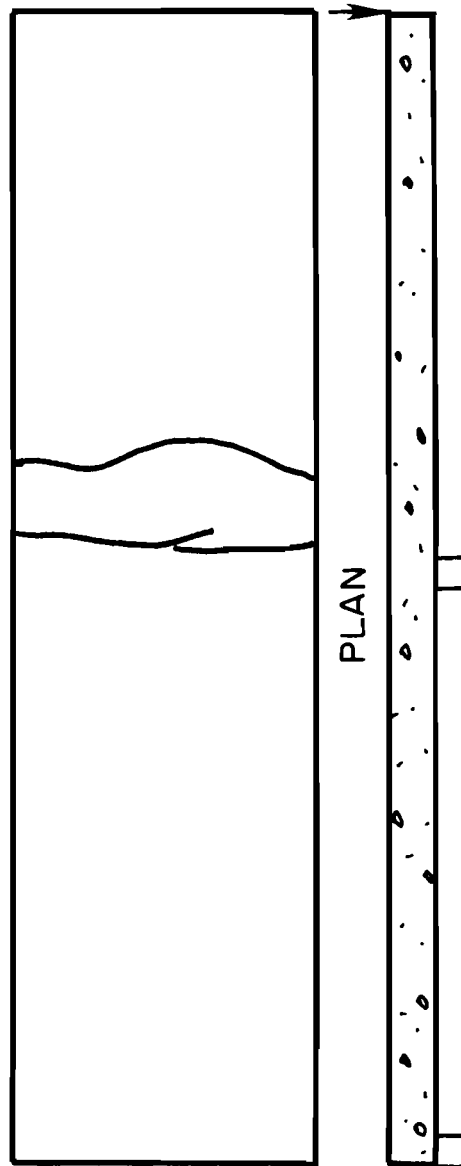
Fig. 4.2b Induced cracks for Specimen 18

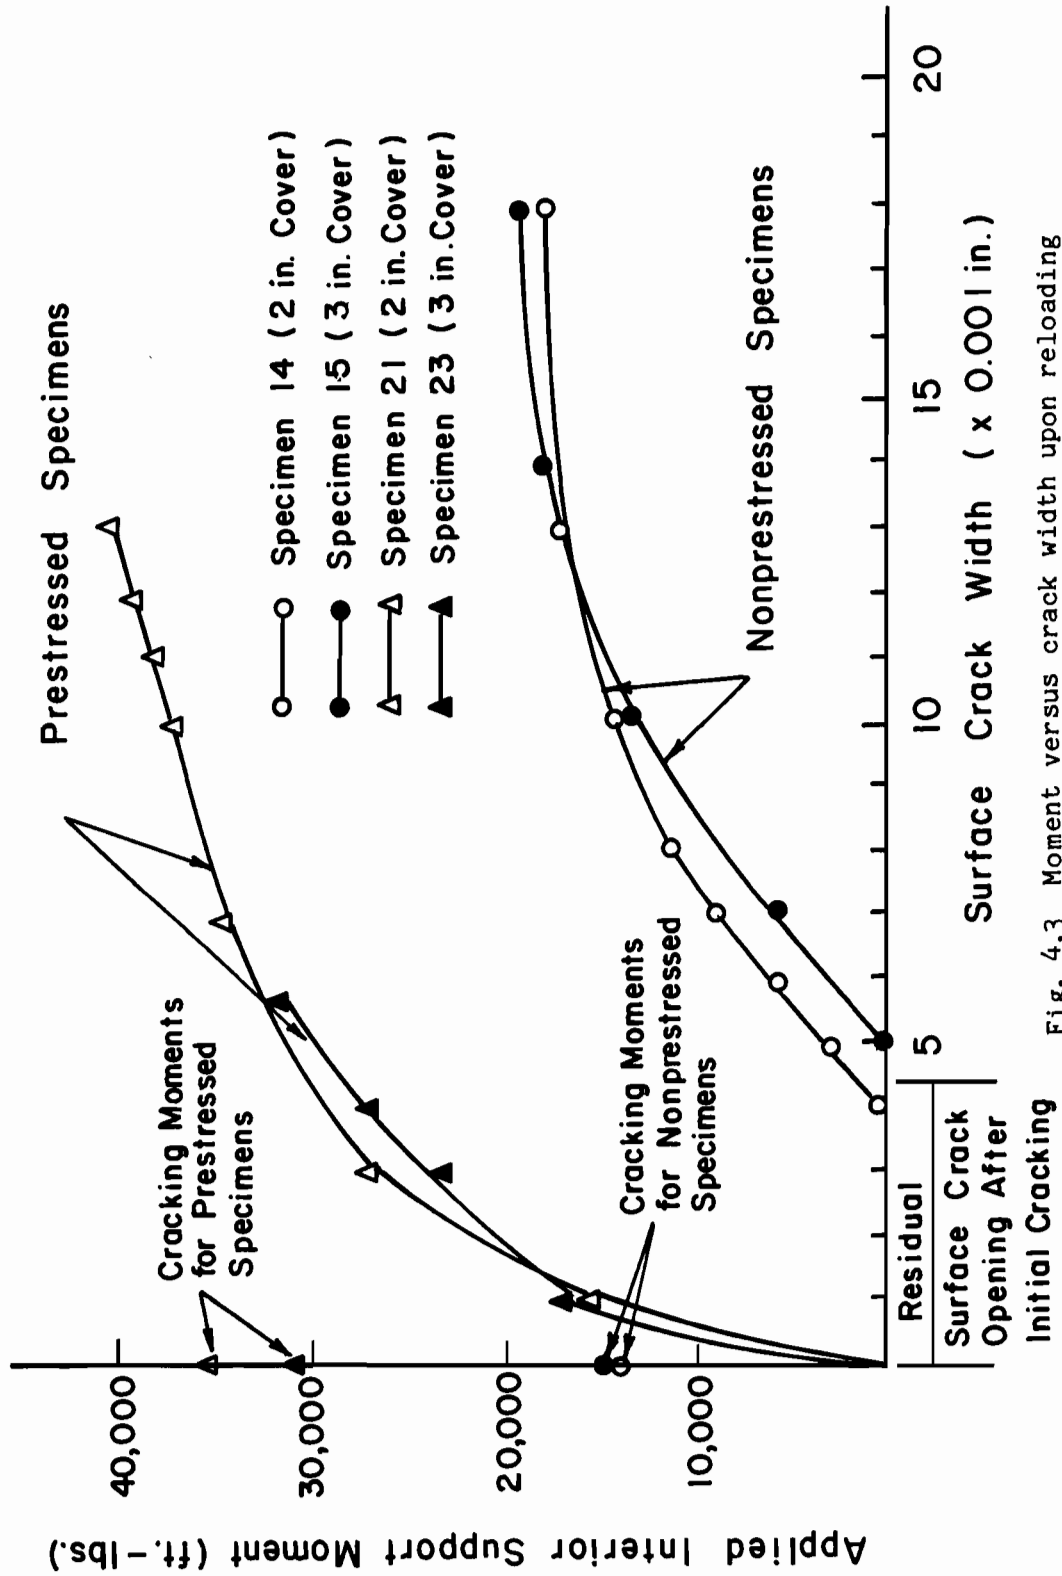
Fig. 4.3 Moment versus crack width upon reloading after initial cracking

Nonprestressed specimens represent conditions typical in conventionally reinforced concrete members, in which, upon removal of applied load, existing cracks remain open. In contrast, in prestressed specimens, existing cracks which open upon loading will close upon load removal. The moments to initiate cracking are shown for the specimens in Fig. 4.3. Moment at the interior support versus surface crack width upon reloading after initial cracking for the

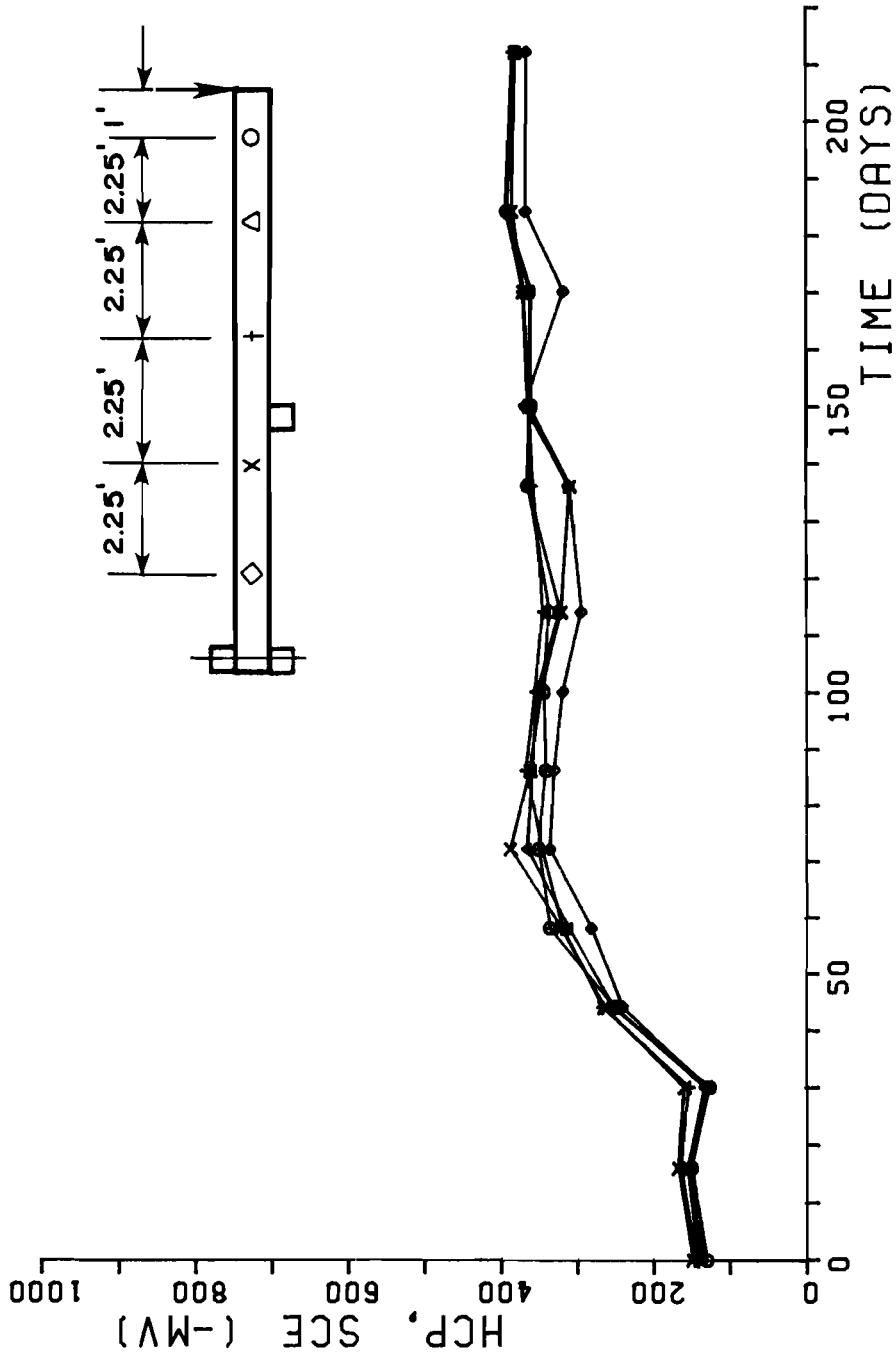
13 LB GROUTED OPSI .015IN 2IN PL

Fig. 4.4 Half cell potentials with time for left reinforcing bar in Specimen 13

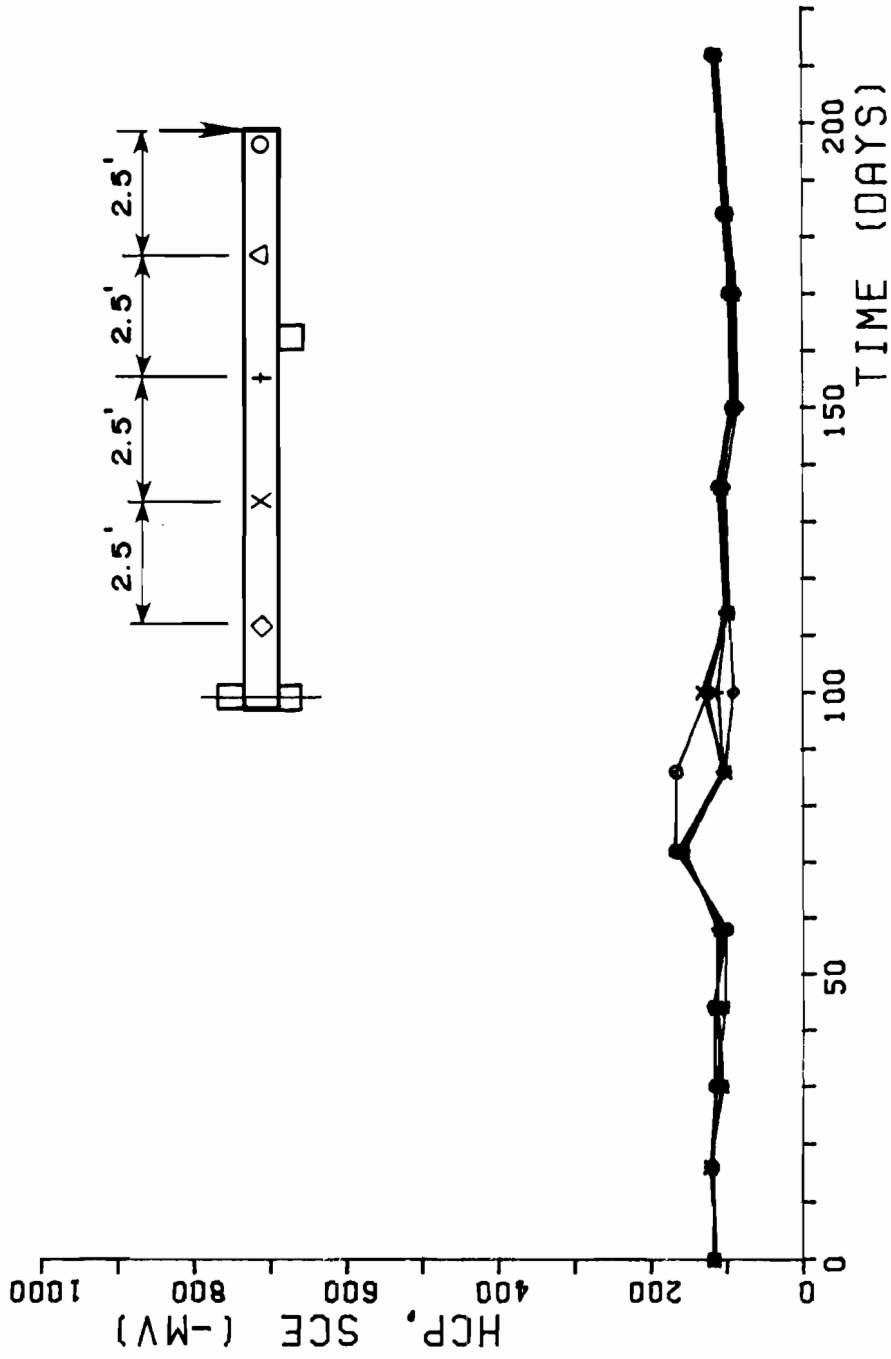
11 RB UNBONDED 160PSI .002IN 3IN PL

Fig. 4.5 Half cell potentials with time for right reinforcing bar in Specimen 11
