1. Report No. FHWA/TX-86/16+316-1		2. Government Accession No.		3. Recipient's Catalog No.	
4. Title and Subtitle DURABILITY OF PRESTRESSED BRIDGE DECKS				5. Report Date July 1985

DURABILITY OF PRESTRESSED BRIDGE DECKS

Research Report 316-1

"Application of Transverse Prestressing to Bridge Decks"

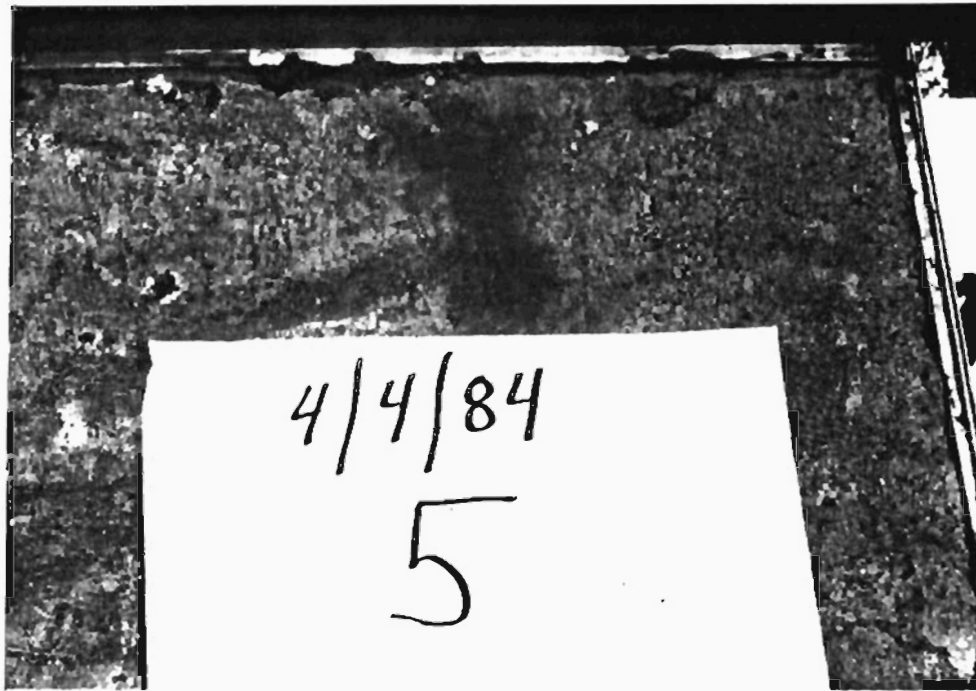
Fig. 4.6 Rust staining on specimen surface above anchorage

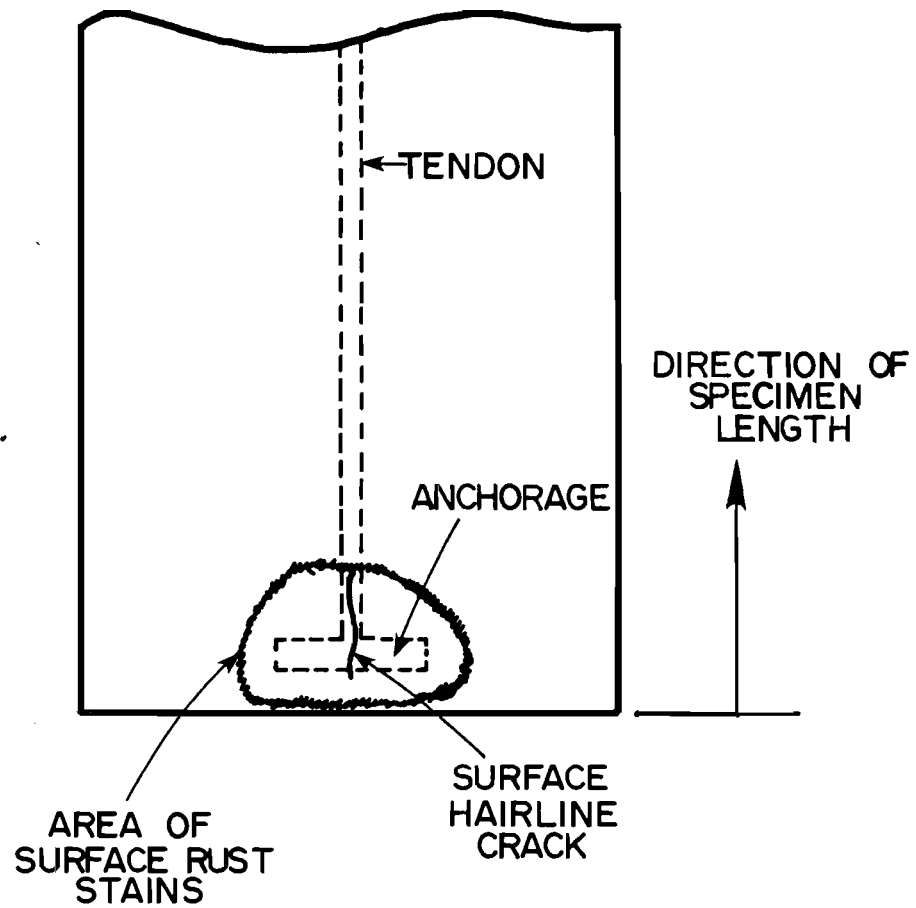
PLAN VIEW OF SPECIMEN END

Fig. 4.7 Surface rust staining and hairline crack along direction of specimen length

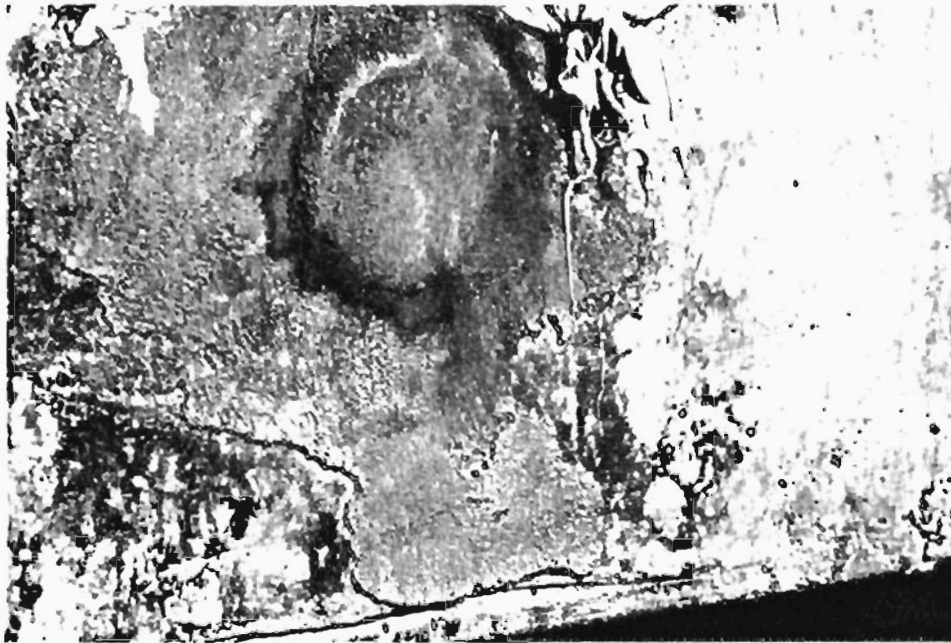
Fig. 4.8 ° Discoloration of mortar anchorage plug in some areas after prolonged exposure

The results of the visual inspection presented in Chapter 4 revealed a gradual discoloration of the mortar in the anchorage recesses. The color changed from a rich gray to a golden-brown. The color change resulted from a leaching of some of the cement out of the mortar. This suggests a water migration path as shown in Fig. 5.2. The cement was leached out of the mortar by the aggressive percolating action of the salt water. However, at the end of the

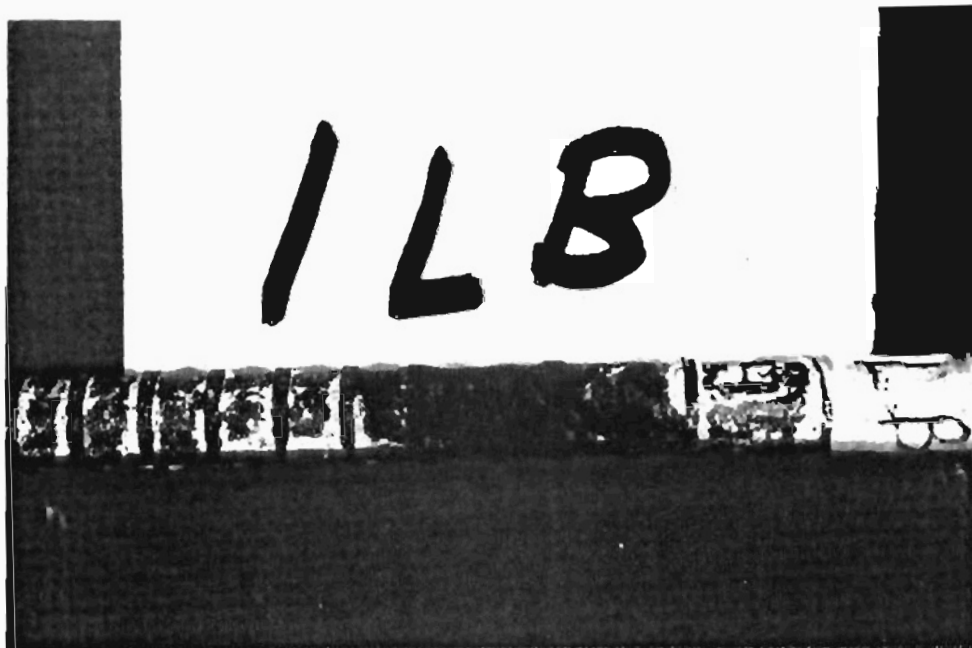
Fig. 4.9 Typical heavy corrosion of uncoated nonprestressed reinforcement in the region near cracks

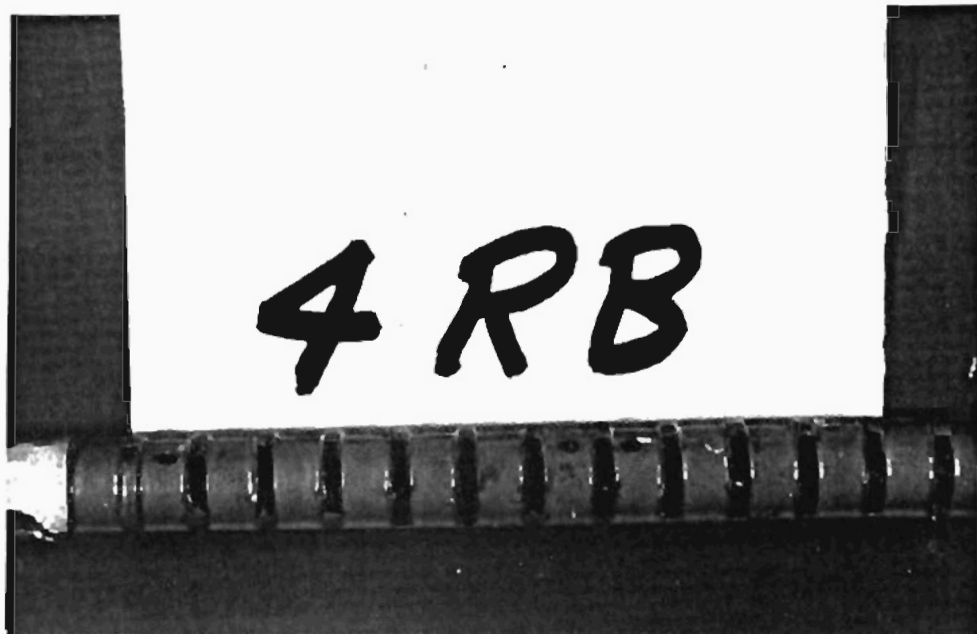
Fig. 4.10 Very light surface corrosion on epoxy-coated reinforcing bar

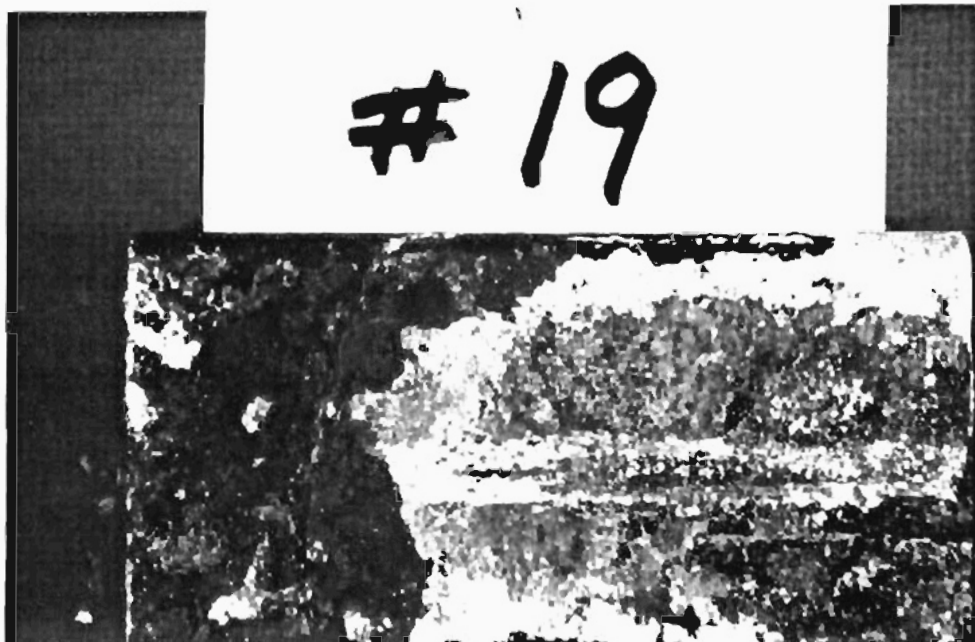
Fig. 4.11 Surface corrosion of zinc coating on galvanized duct of grouted specimens

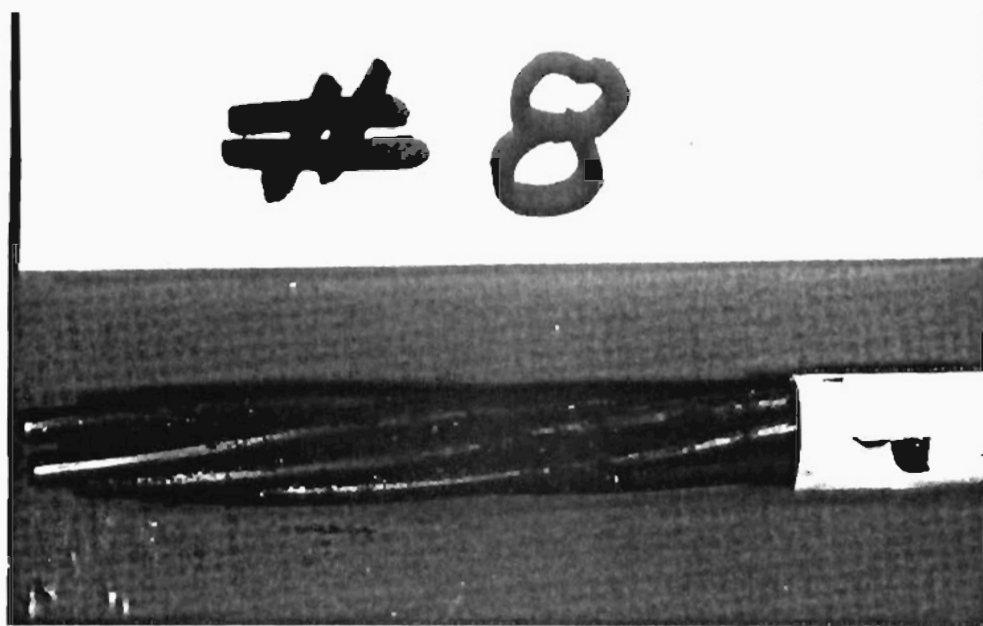
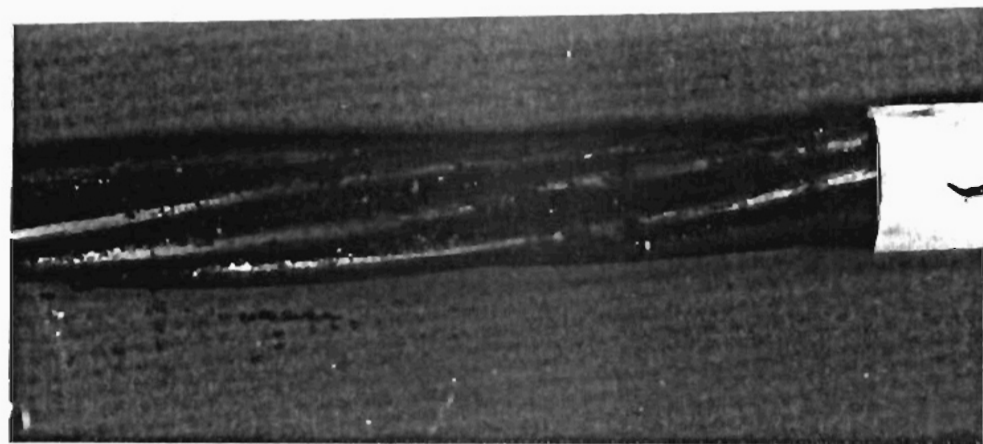
Fig. 4.12 Very light surface corrosion on unbonded tendon removed from Specimen 8

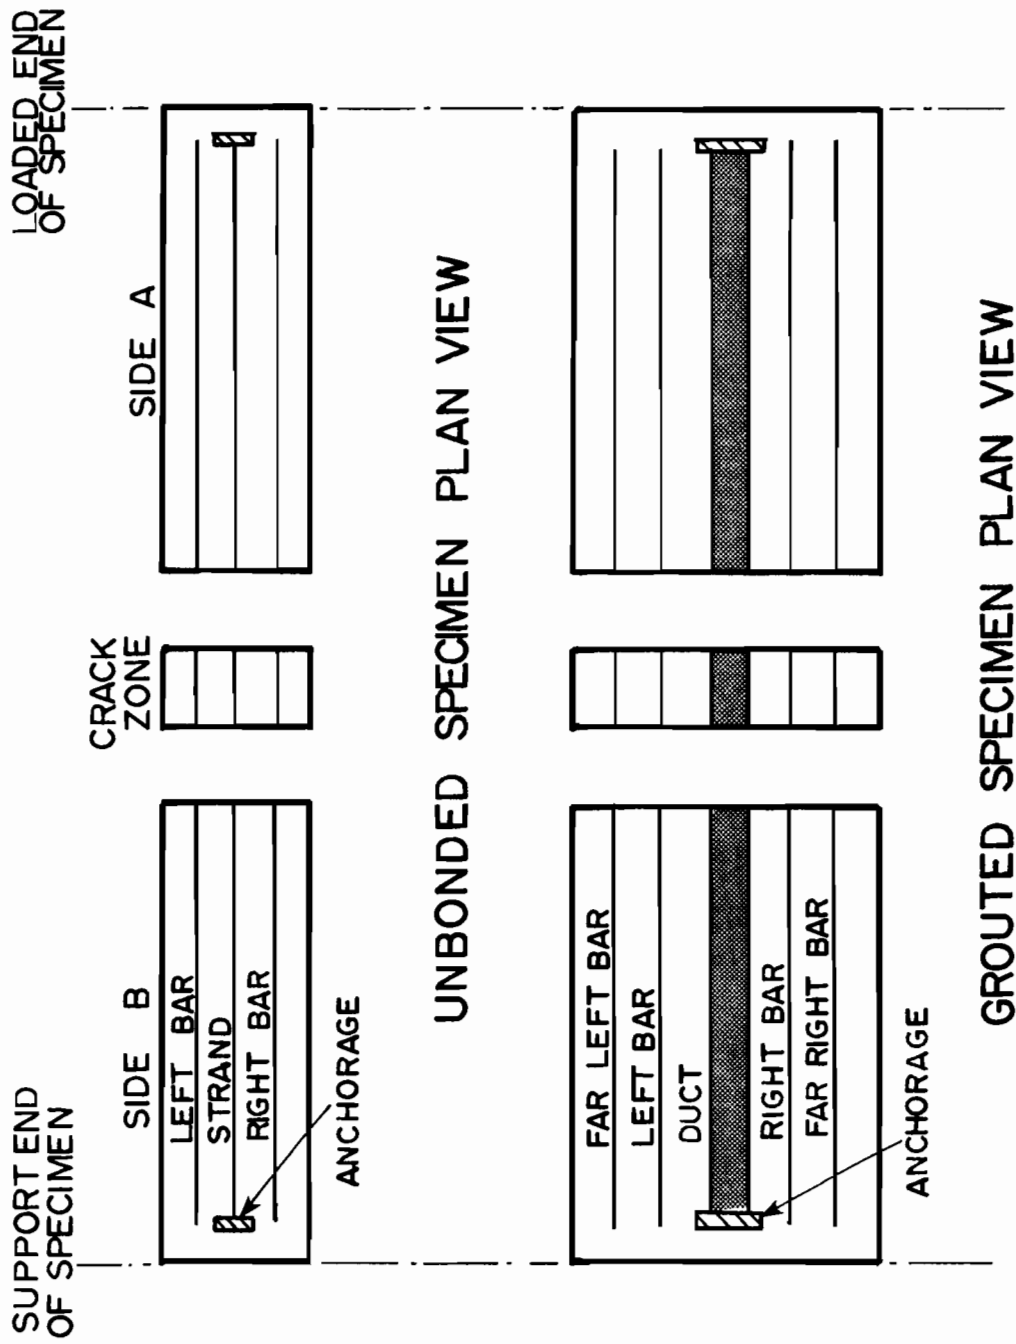
Fig. 4.14 Description of component codes used in Table 4.3

suggests advanced stages of corrosion. The results of the inspection and evaluation of each component are presented in Table 4.3. The codes used to describe the components in Table 4.3 are described in Fig. 4.14.

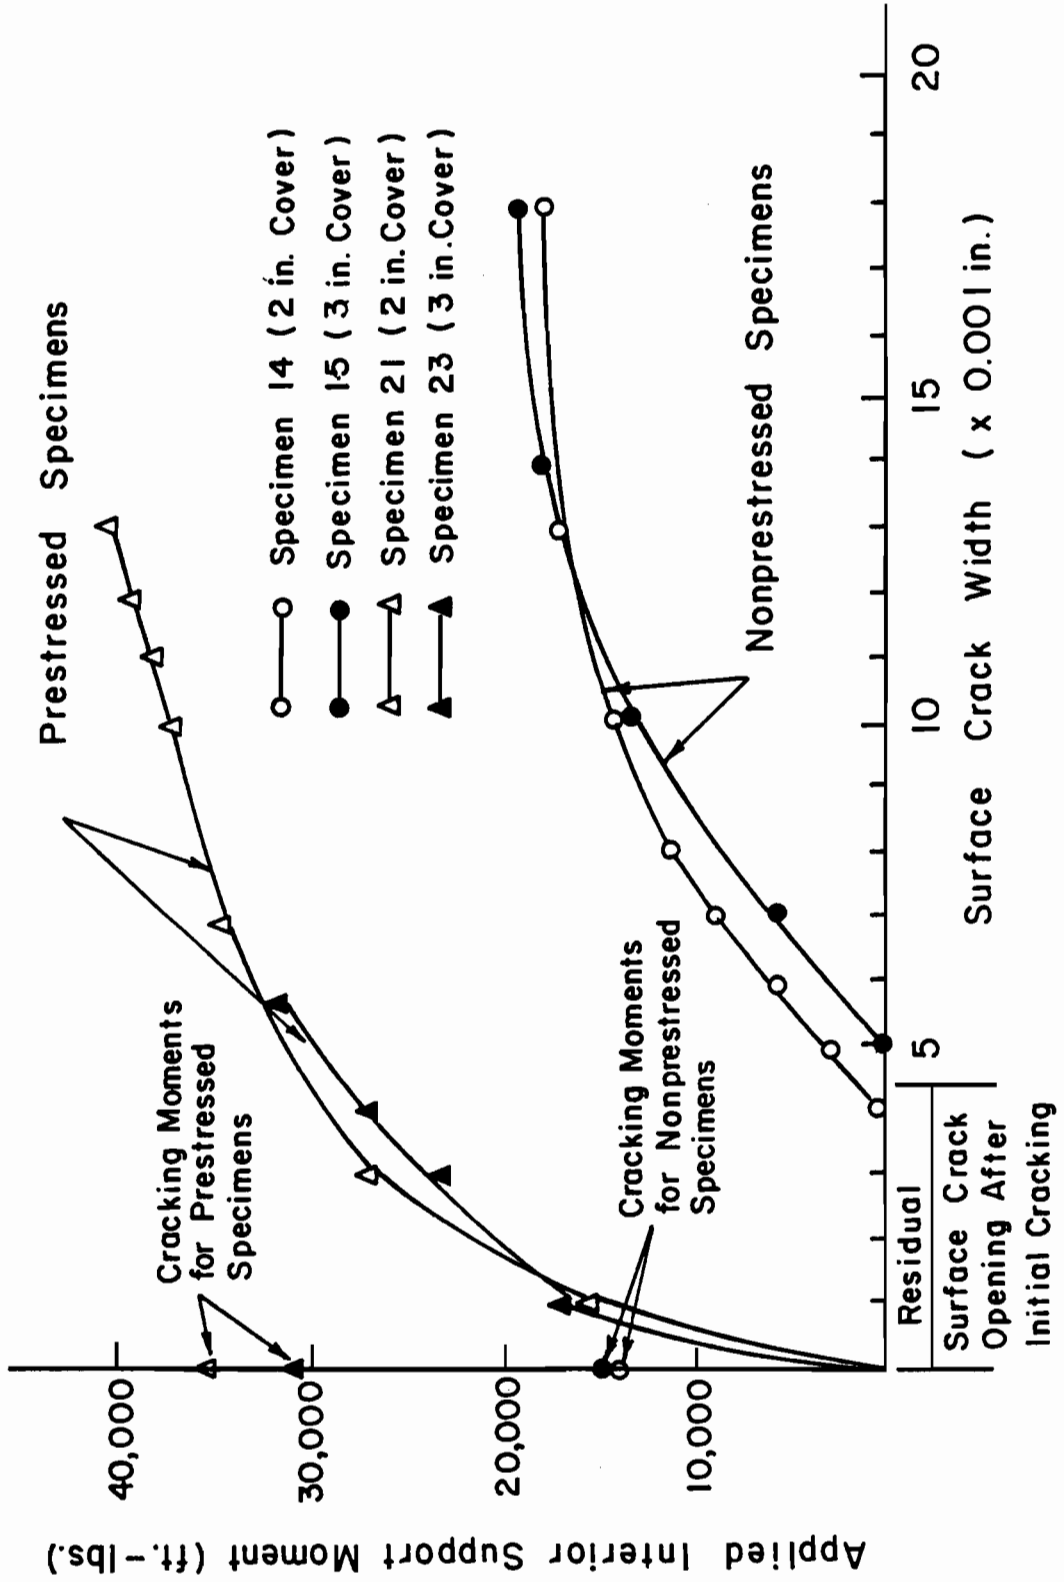
Fig. 5.1 Moment versus crack width upon reloading after initial cracking

The crack width data presented in Fig. 5.1 illustrate some additional advantages of prestressed concrete with regard to improved durability. Not only did it originally take a larger load to induce first cracking in the prestressed specimens, but once cracking occurred, a much larger load is required to produce a given crack width in the prestressed specimens. Or alternatively, once cracking has occurred, the crack width for a given load level is much smaller for the prestressed specimens than for the nonprestressed specimens.

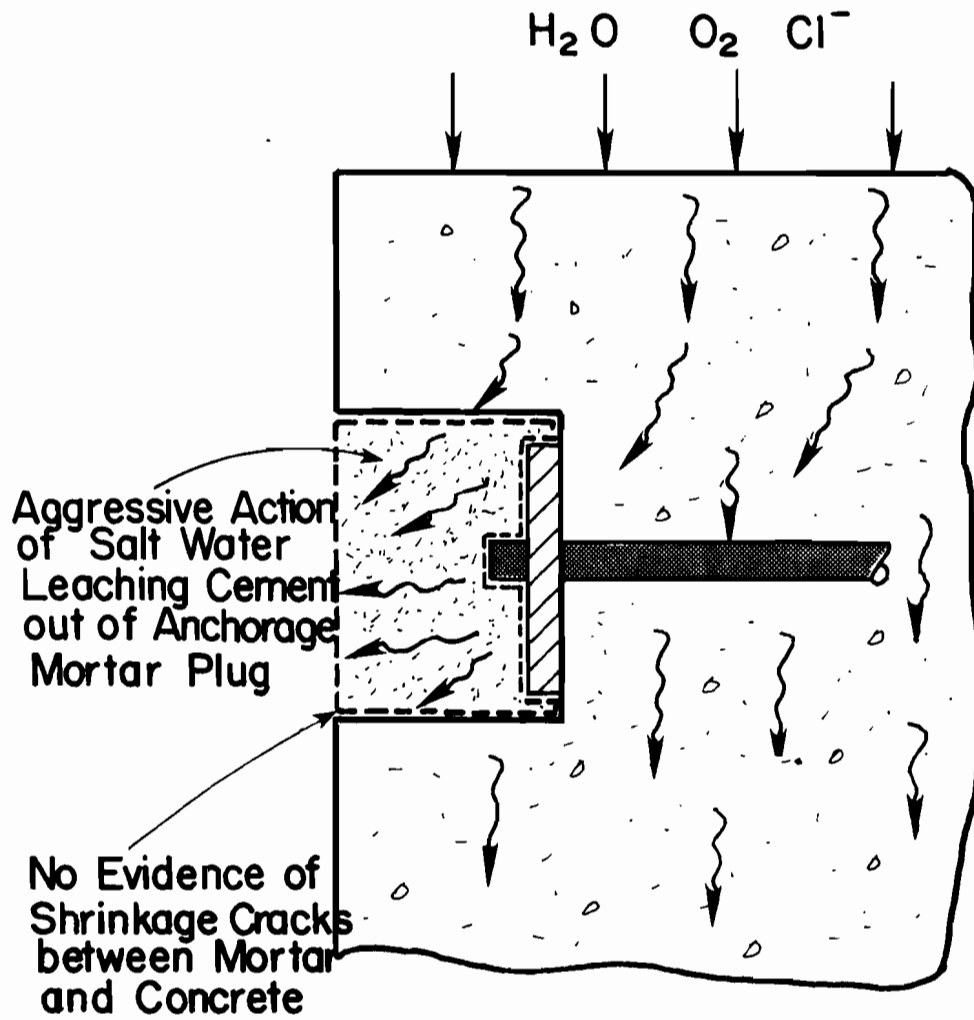
Fig. 5.2 Migration path of salt water

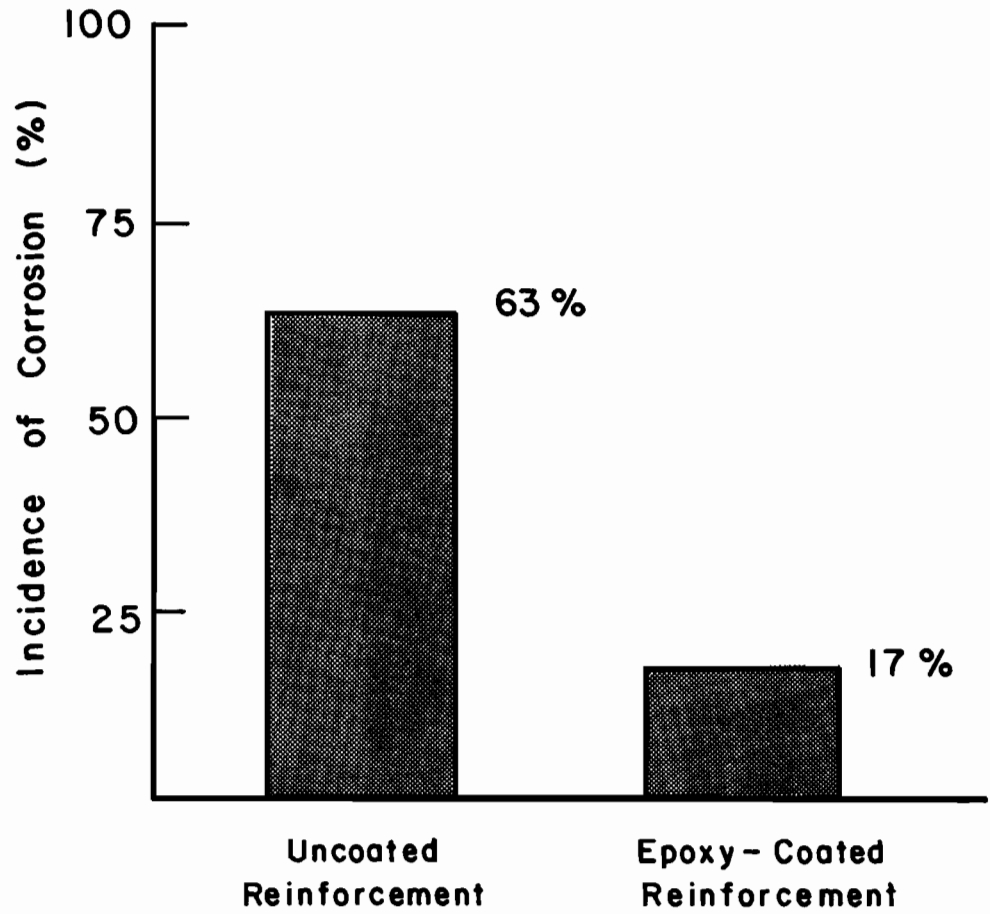
Fig. 5.3 Comparison of incidence of corrosion of uncoated and epoxy-coated reinforcement

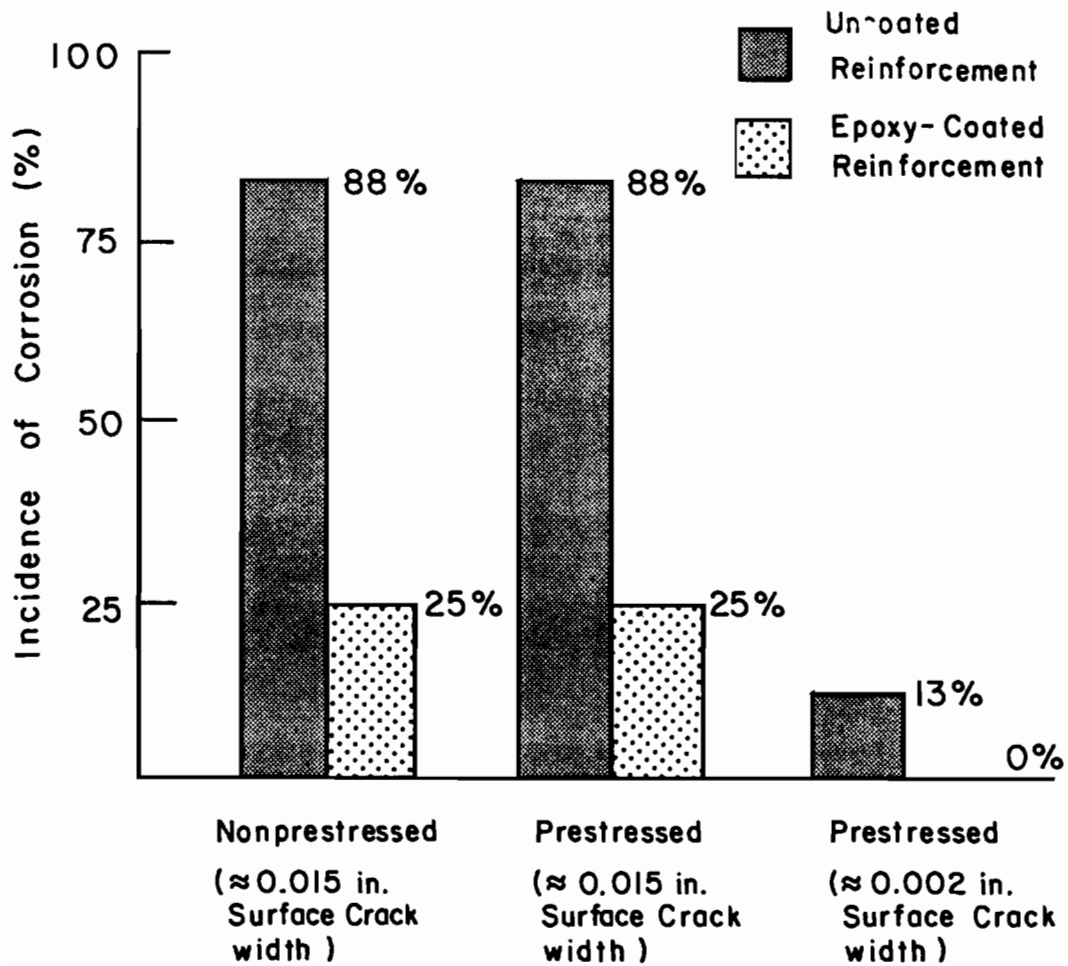
Fig. 5.4 Comparison of incidence of corrosion of reinforcement in nonprestressed and prestressed specimens

There are several other trends which are evident from Fig. 5.4. For the nonprestressed specimens (i.e., only conventionally reinforced), the use of epoxy-coated reinforcement reduced corrosion incidence. Thus, this result confirms the theories that the use of epoxy-coated reinforcement in conventionally reinforced decks would reduce the risk of corrosion. For the prestressed specimens in which crack widths were limited to 0.002 in., the corrosion incidence for uncoated and epoxy-coated reinforcement could be considered about equal. This result suggests that for a transversely prestressed bridge deck that epoxy-coated reinforcement would not be needed. Prestressing which limited cracking would be sufficient for corrosion protection of uncoated reinforcement.

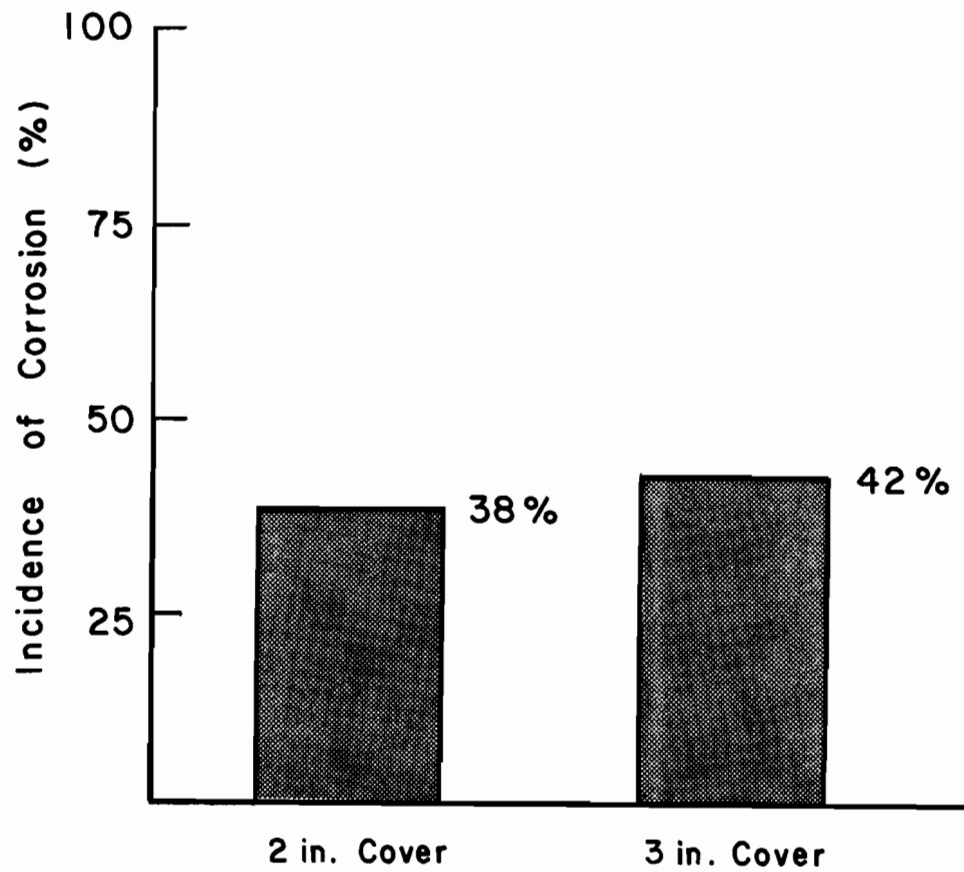
Fig. 5.5 Comparison of incidence of corrosion of reinforcement in specimens with 2 in. and 3 in. concrete covers without regard to other test variables

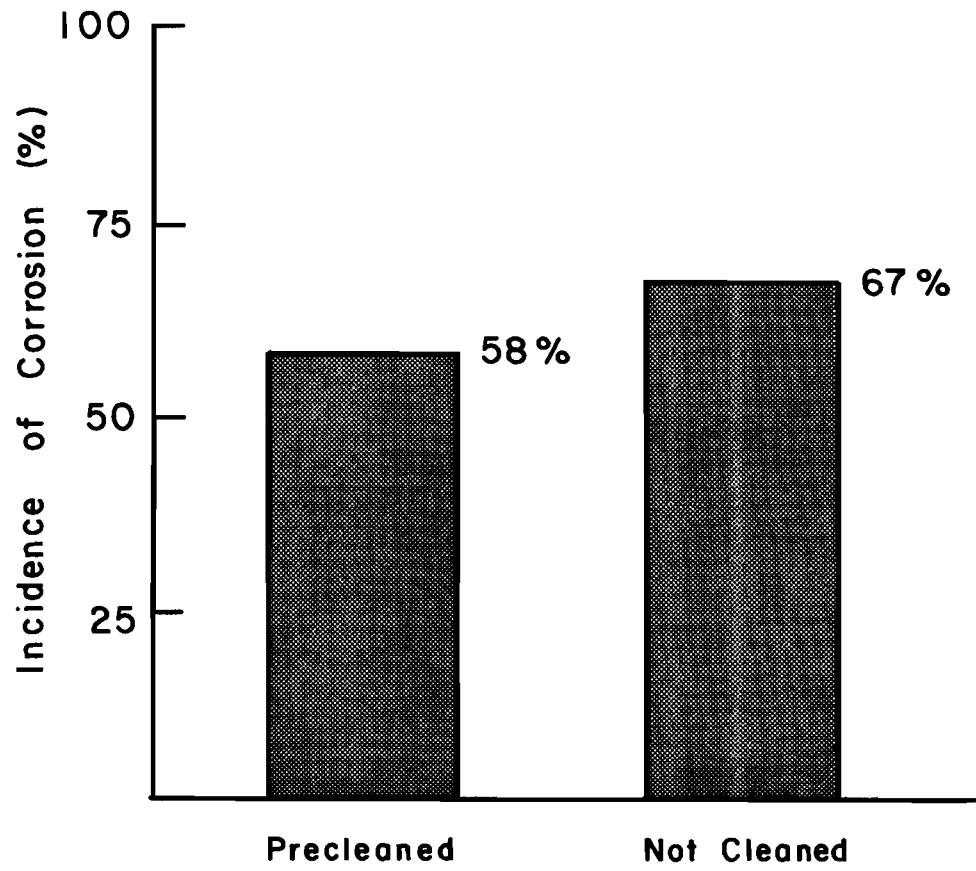
Fig. 5.6 Effect of precleaning uncoated reinforcement on incidence of corrosion

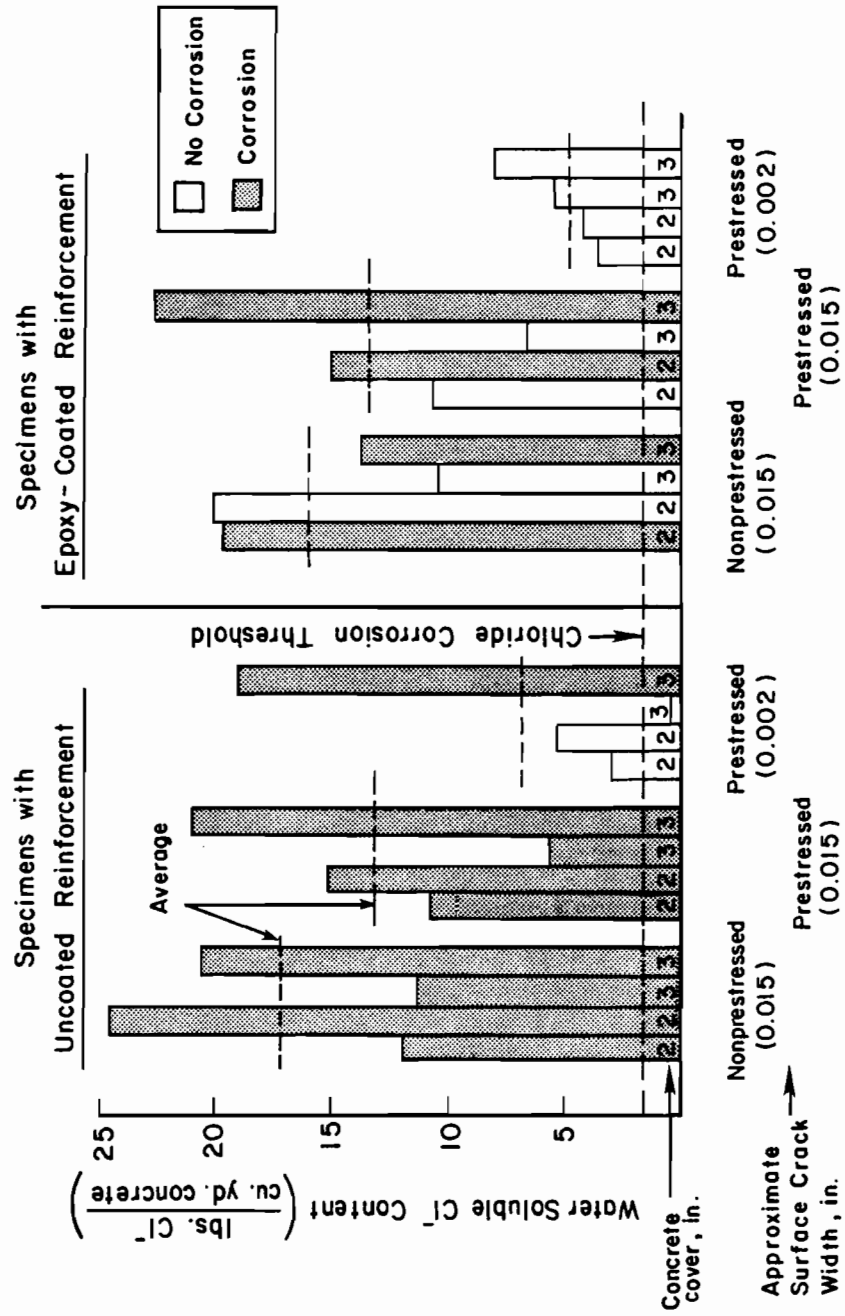
Fig. 5.7 Cl⁻ content at level of reinforcement at the crack location in the specimens (see Appendix A for crack locations)

It is evident from Fig. 5.7 that the prestressed specimens in which crack widths were limited to about 0.002 in. had on the average a much lower Cl^- concentration at the crack location than the other specimens. However, for almost all specimens and independent

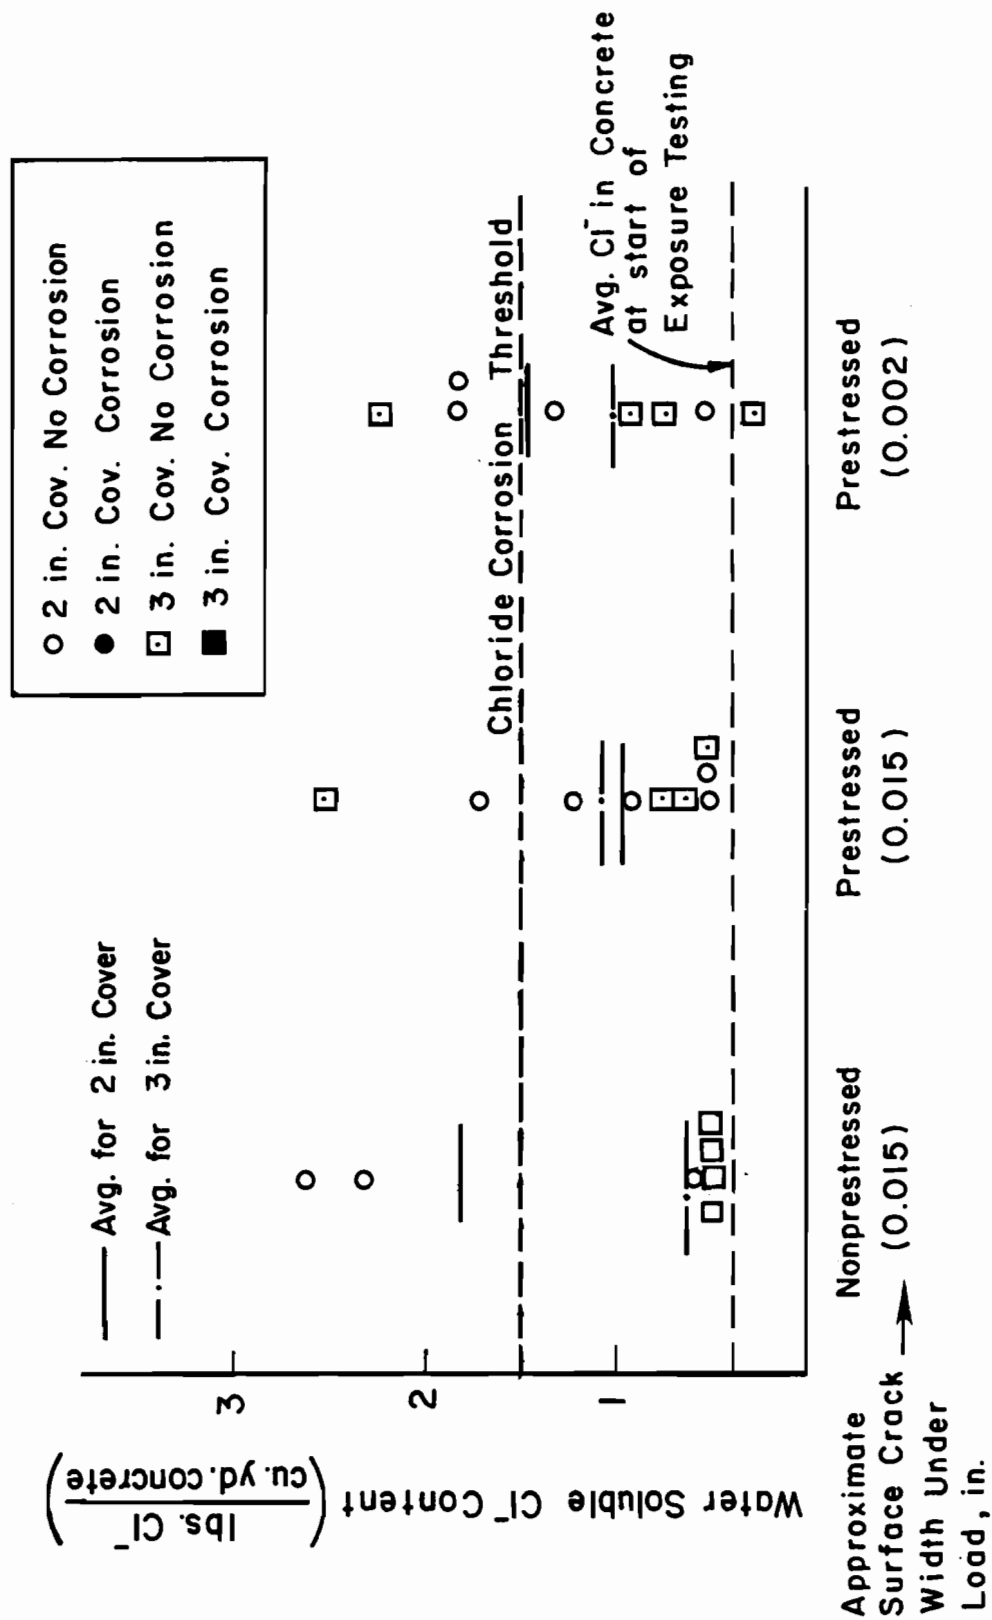
Fig. 5.8 Cl⁻ content at level of reinforcement at the uncracked location in the specimens (see Appendix A for core locations)

5.4.1.2 Uncracked Concrete. Figure 5.8 presents the water soluble Cl^- concentrations in the concrete samples taken at the level of the reinforcement in an uncracked section of the specimens (see Appendix A for core locations). In this figure, no differentiation is made with respect to reinforcement type since there was no evidence of corrosion of any reinforcement at uncracked concrete locations. The figure clearly shows that prestressing had little direct effect on the Cl^- penetration in the uncracked regions of the

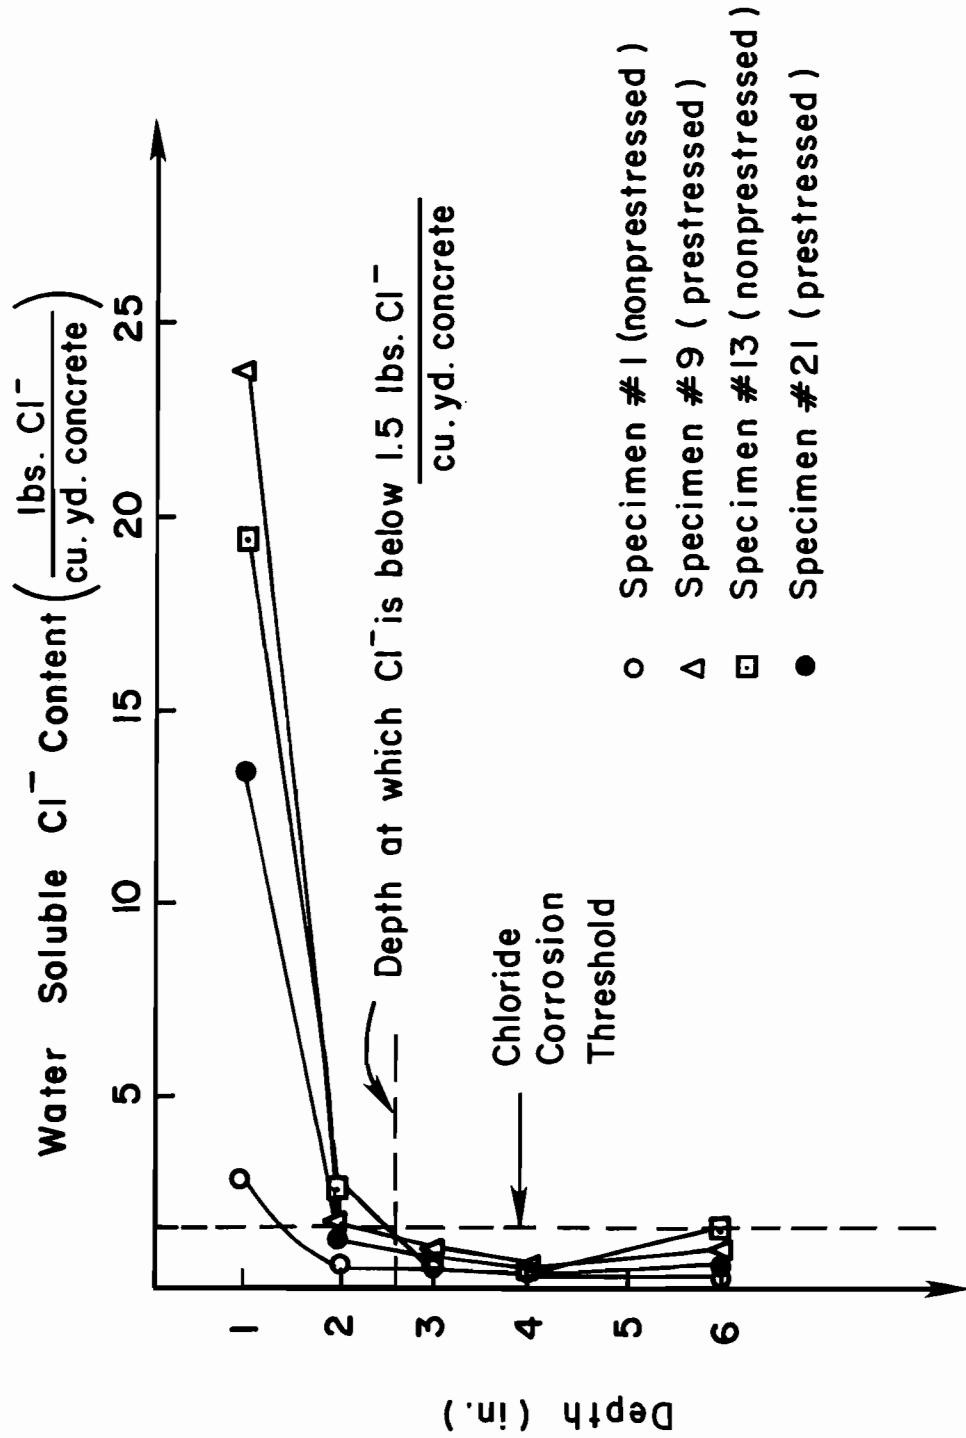
Fig. 5.9 Cl⁻ penetration with depth in uncracked concrete

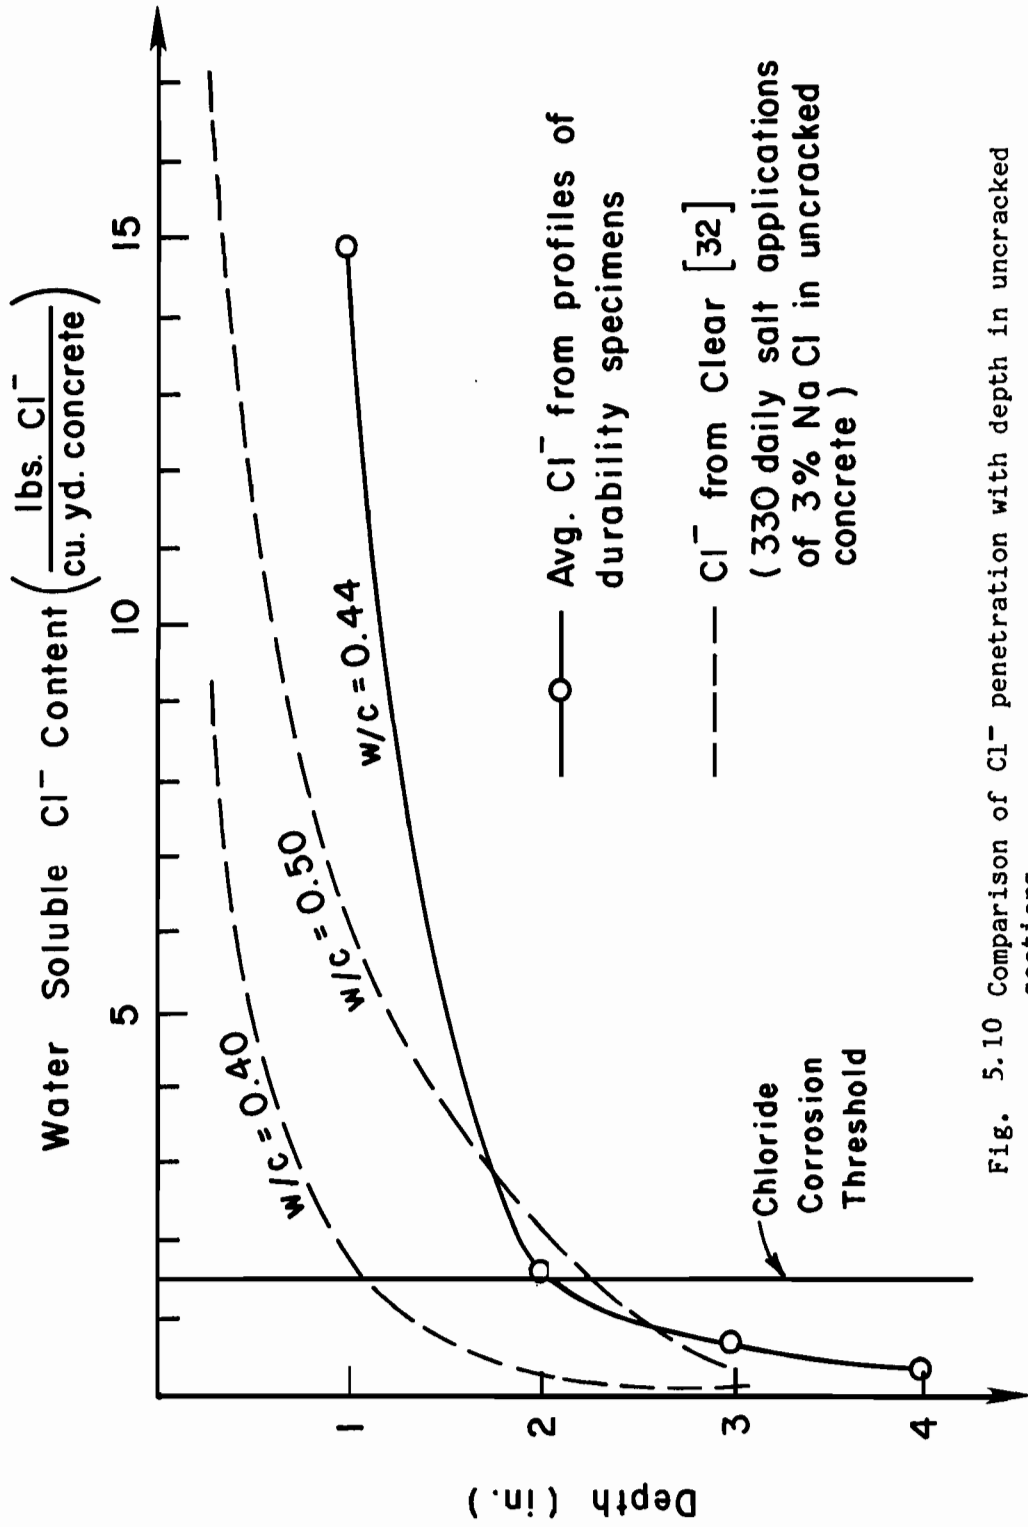
Fig. 5.10 Comparison of Cl⁻ penetration with depth in uncracked sections

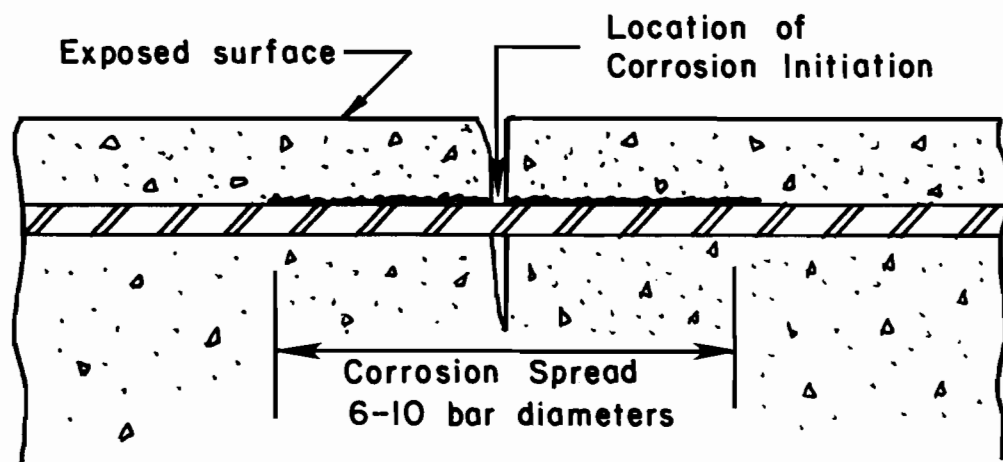
Fig. 5.11 Spreading effect of corrosion of uncoated reinforcement

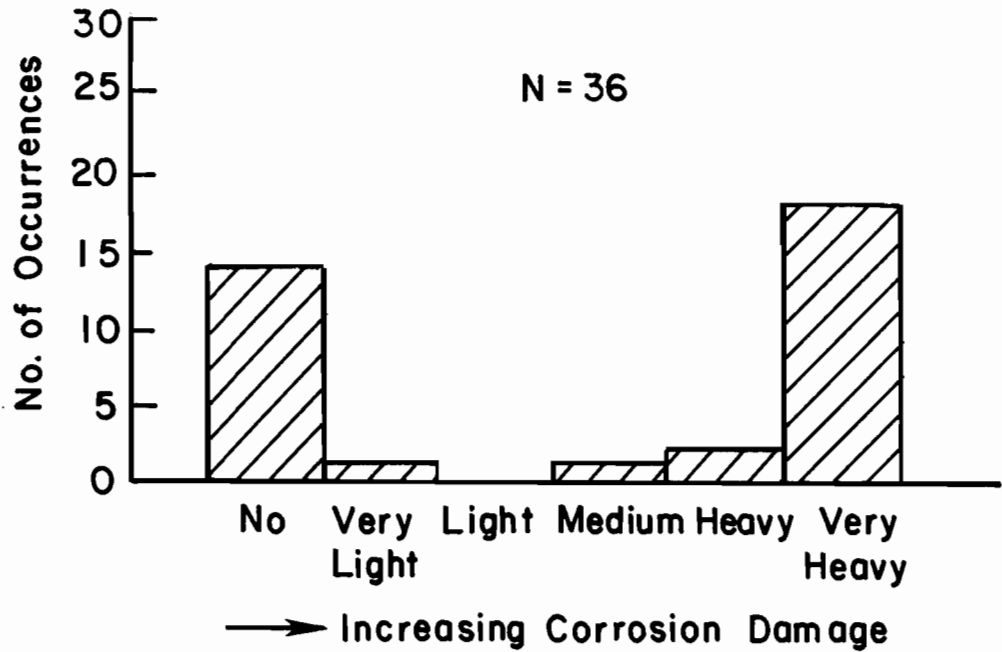
Fig. 5.12a Histogram of corrosion of uncoated reinforcement

Figures 5.12 through 5.14 present histograms for different categories of damage of the nonprestressed reinforcement. The categories of damage were summarized in Table 4.2. In the histograms, N represent the total number of occurrences for all categories. The histograms are based on all the top reinforcement which was removed from the crack zones of the specimens.

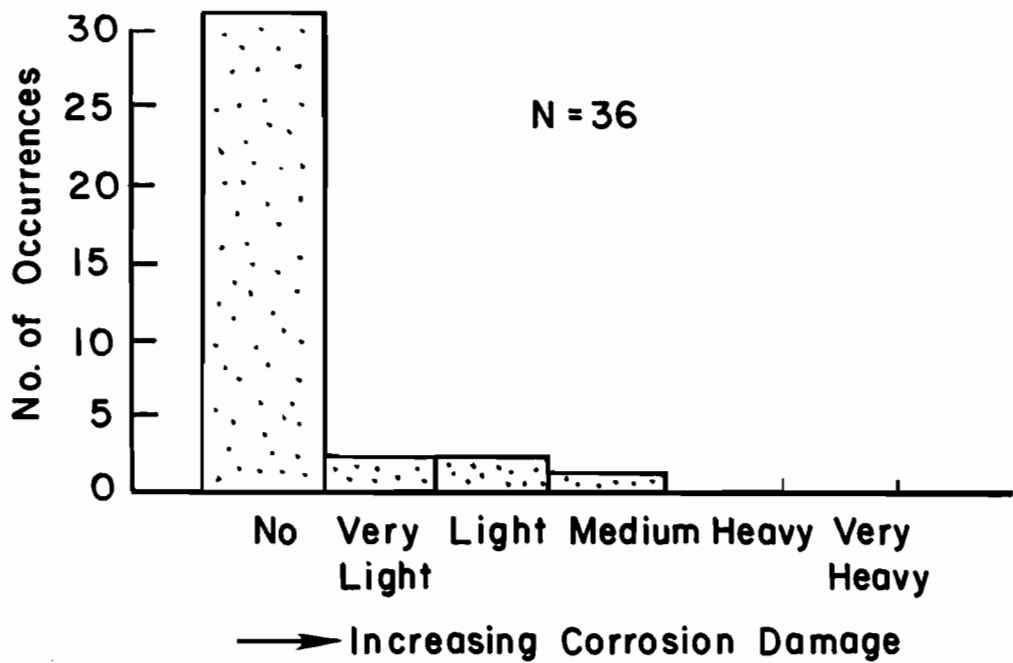
Fig. 5.12b Histogram of corrosion of epoxy-coated reinforcement

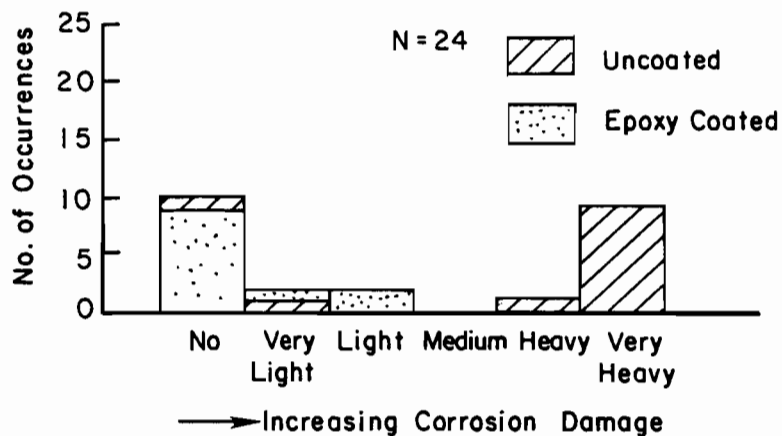
Fig. 5.13a Histogram of nonprestressed reinforcement corrosion in specimens (≈ 0.015 in. surface crack width)

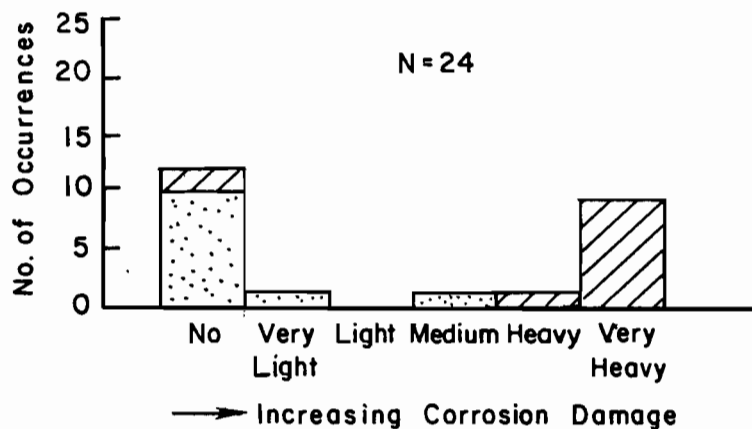
Fig. 5.13b Histogram of nonprestressed reinforcement corrosion in prestressed specimens (≈ 0.015 in. surface crack width)

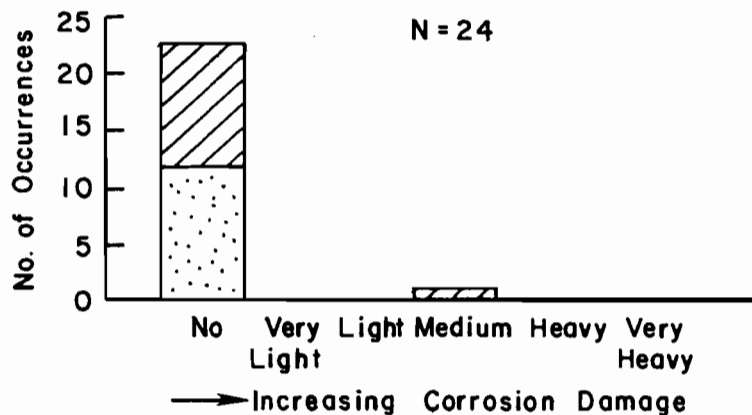
Fig. 5.13c Histogram of nonprestressed reinforcement corrosion in prestressed specimens (≈ 0.002 in. surface crack width)
