1. Report No. FHWA/TX-86/16+316-1		2. Government Accession No.		3. Recipient's Catalog No.	
4. Title and Subtitle DURABILITY OF PRESTRESSED BRIDGE DECKS				5. Report Date July 1985

DURABILITY OF PRESTRESSED BRIDGE DECKS

Research Report 316-1

"Application of Transverse Prestressing to Bridge Decks"

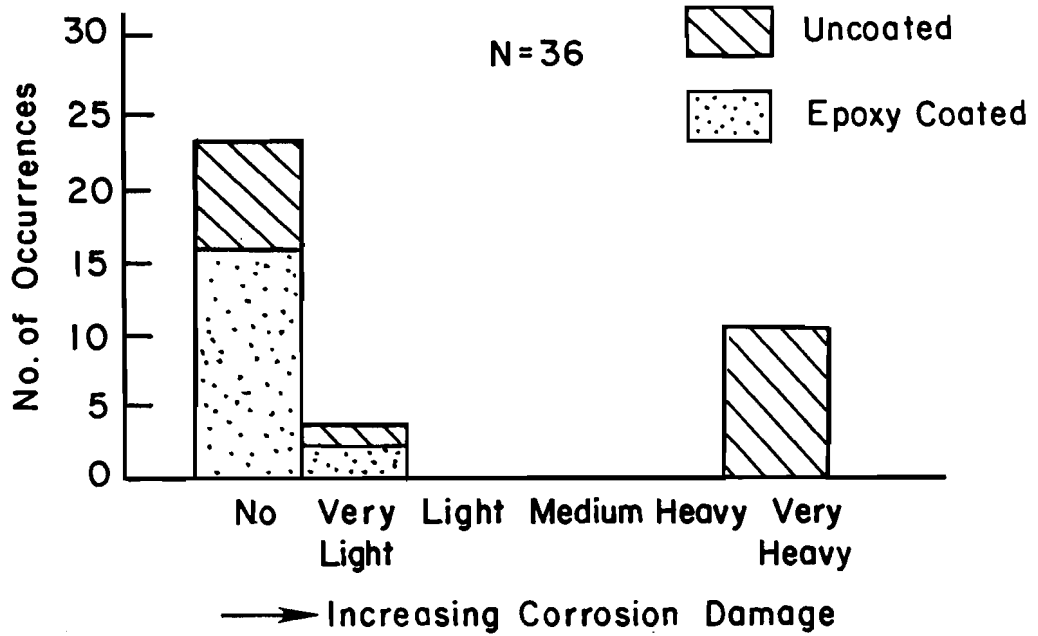
Fig. 5.14a Histogram of nonprestressed reinforcement corrosion with 2 in. cover

Figures 5.12 through 5.14 present histograms for different categories of damage of the nonprestressed reinforcement. The categories of damage were summarized in Table 4.2. In the histograms, N represent the total number of occurrences for all categories. The histograms are based on all the top reinforcement which was removed from the crack zones of the specimens.

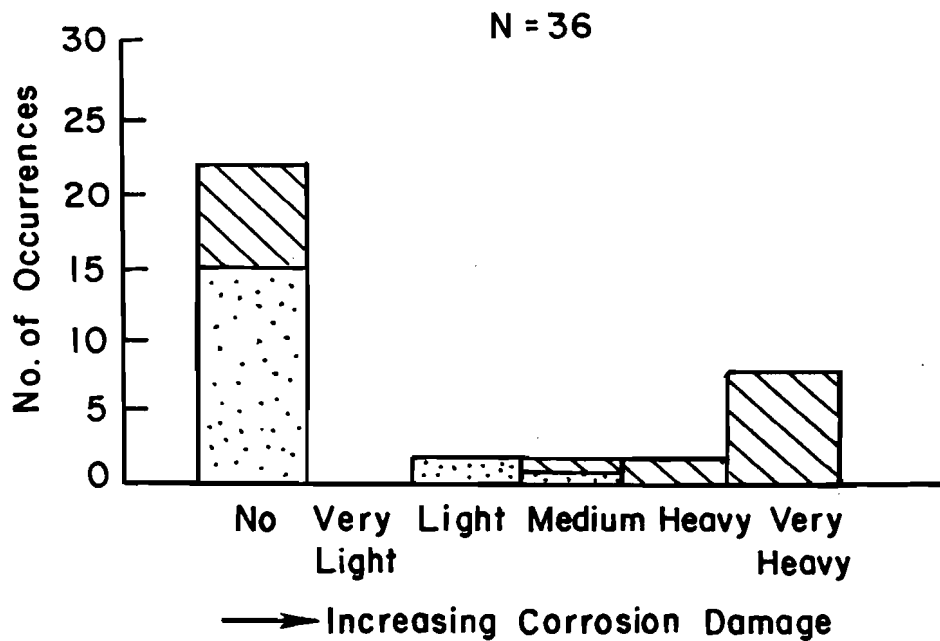
Fig. 5.14b Histogram of nonprestressed reinforcement corrosion with 3 in. cover
