1. Report No. FHWA/TX-87/63+357-2F		2. Government Accession No.		3. Recipient's Catalog No.	
4. Title and Subtitle AN EXPERIMENTAL THIN-BONDED CONCRETE OVERLAY PAVEMENT				5. Report Date November 1985

AN EXPERIMENTAL THIN-BONDED CONCRETE OVERLAY PAVEMENT

Research Report Number 357-2F

Experimental Thin-Bonded Concrete Overlay
Research Project 3-8-83-357

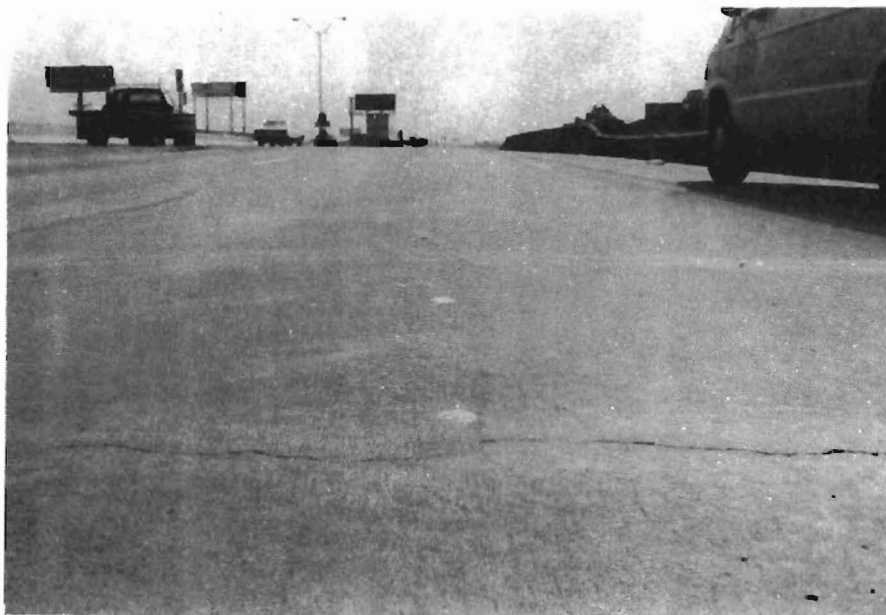
Fig 2.4. Transverse cracks -- original pavement.

To date, the original CRCP has performed well in general. At the site of the experimental project, the types of surface defects present were primarily closely spaced transverse cracks, spalled transverse cracks, longitudinal cracks, and asphalt and polymer concrete patches. Figures 2.4 and 2.5 illustrate a few of these distress manifestations.

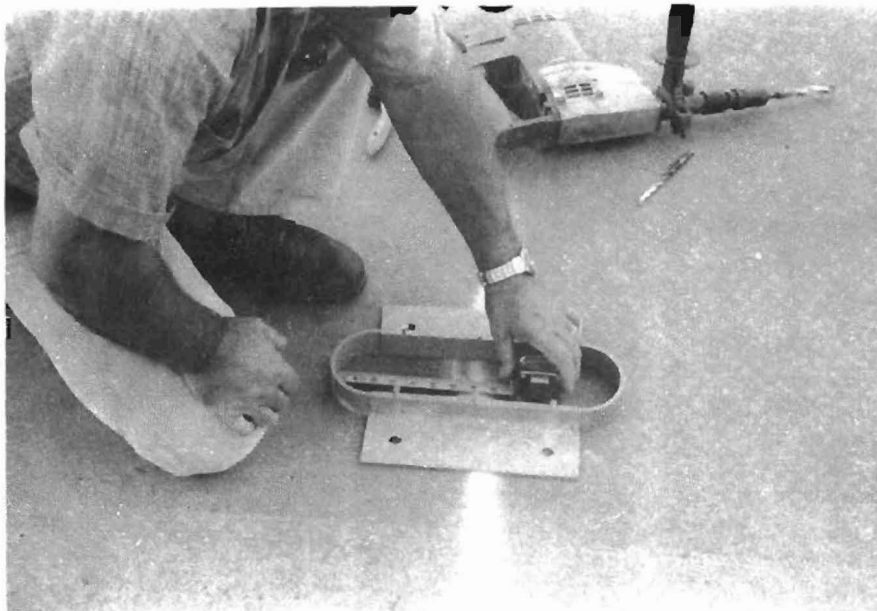
(a) Half length at 7 inches.

(b) Width at 4 inches.

Fig 3.2. Dimension of concrete movement measurement boxes.

Finally, it must be said that the shape and the dimensions of the boxes were designed to sustain traffic loading while allowing for easy access to the gauge plugs. By and large, this objective was achieved as revealed by the periodic condition surveys.

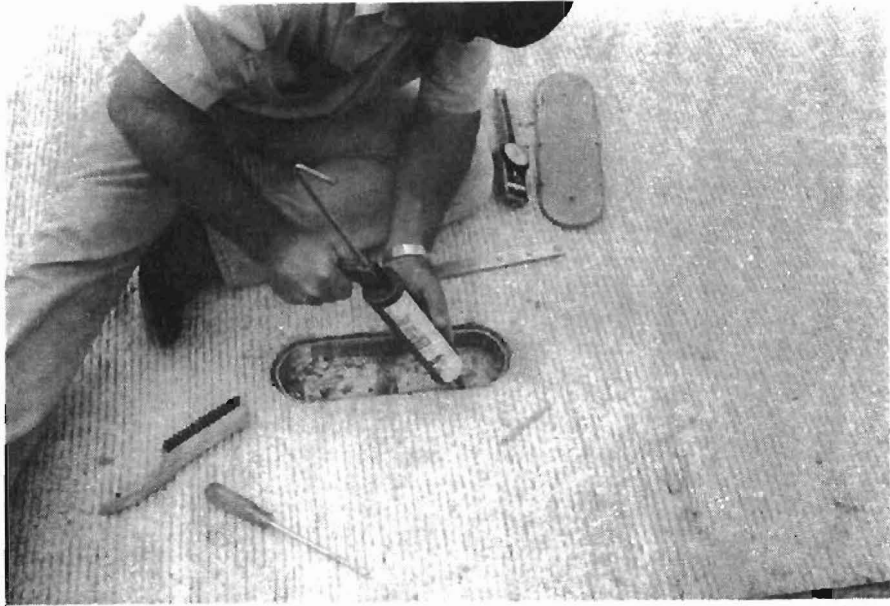
Fig 3.7 . Installation of inside gauge plugs; sealing bottom of a measurement box with silicone compound.

The sequence of the box and gauge plug installation is illustrated in Figs 3.4 through 3.7. The finished product is illustrated in Fig 3.8, and Fig 3.9 shows a typical measurement.

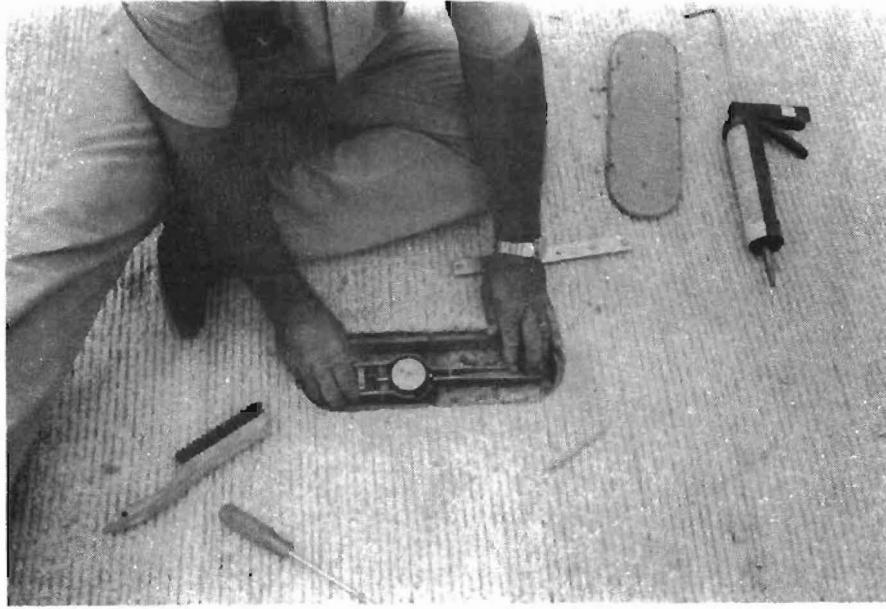
Fig 3. 9. Typical concrete movement measurement on inside plugs. Note easy access and position of hands. Also note standard bar on BCO surface.

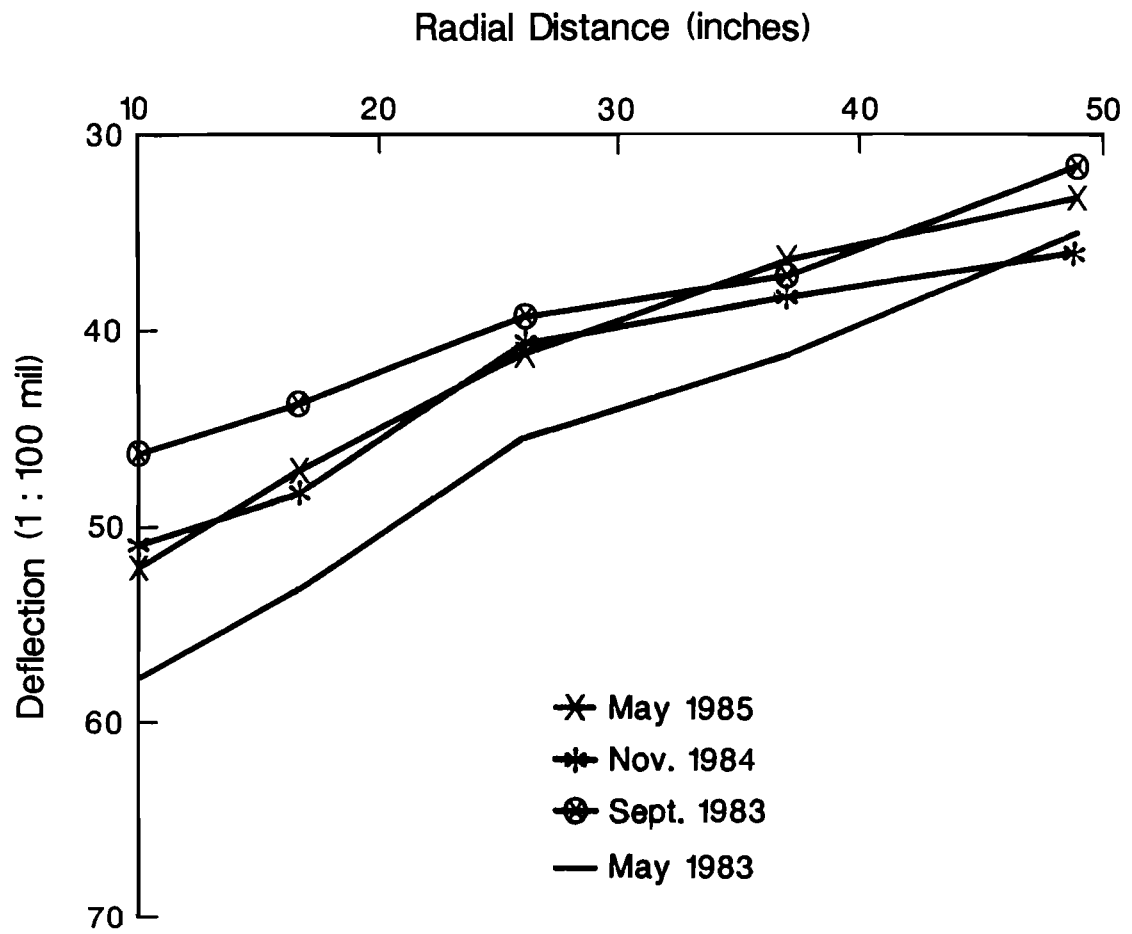
Fig B.2. Deflection basin by date: Section 3"R, Lane 2.

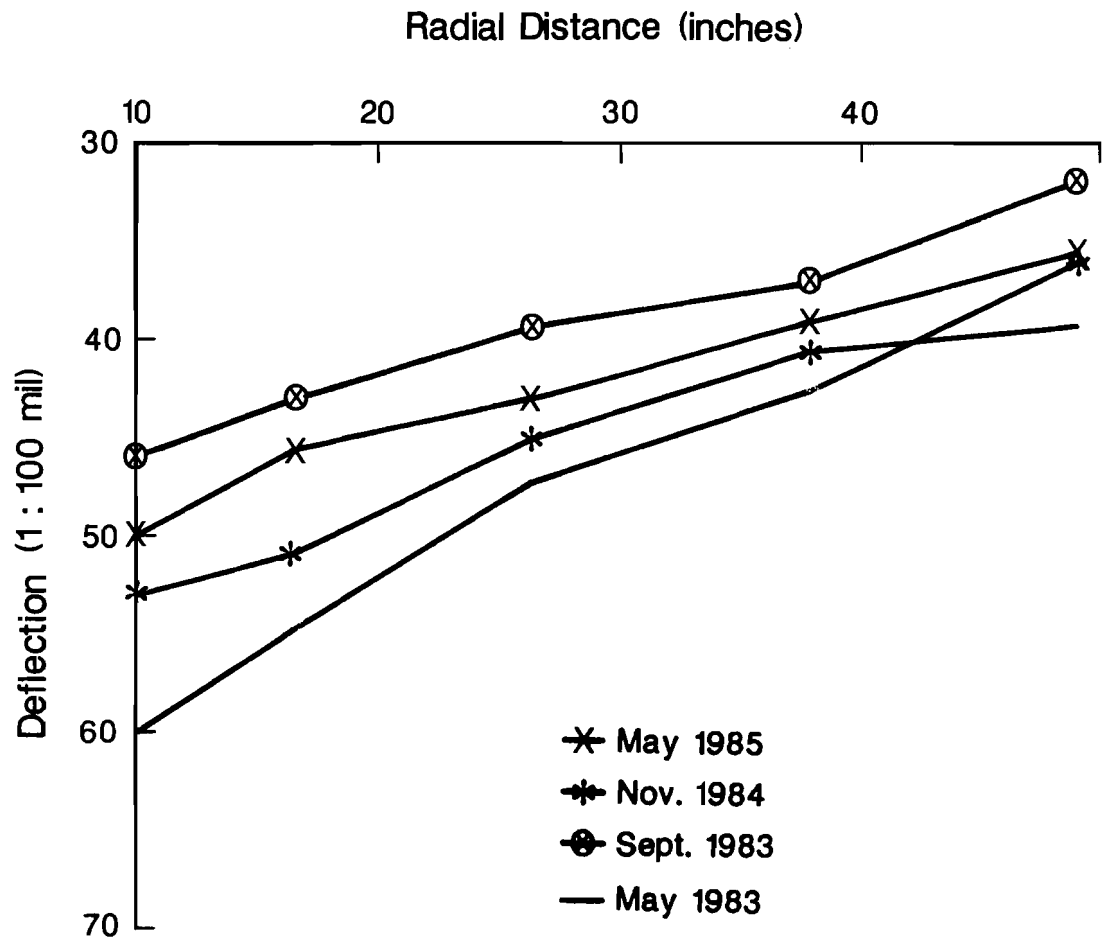
Fig B.4. Deflection basin by date: Section 3'R, Lane 4.
