1. Report No. FHWA/TX-89+381-3		2. Government Accession No.		3. Recipient's Catalog No.	
4. Title and Subtitle A STUDY OF PRETENSIONED HIGH STRENGTH CONCRETE GIRDERS IN COMPOSITE HIGHWAY BRIDGES—LABORATORY TESTS				5. Report Date January 1988

A STUDY OF PRETENSIONED HIGH STRENGTH CONCRETE GIRDERS  
IN COMPOSITE HIGHWAY BRIDGES - LABORATORY TESTS

Research Report 3-5-84-381-3

"Optimum Design of Bridge Girders Made Using High Strength Concrete  
and Deflection of Long-Span Prestressed Concrete Beams"

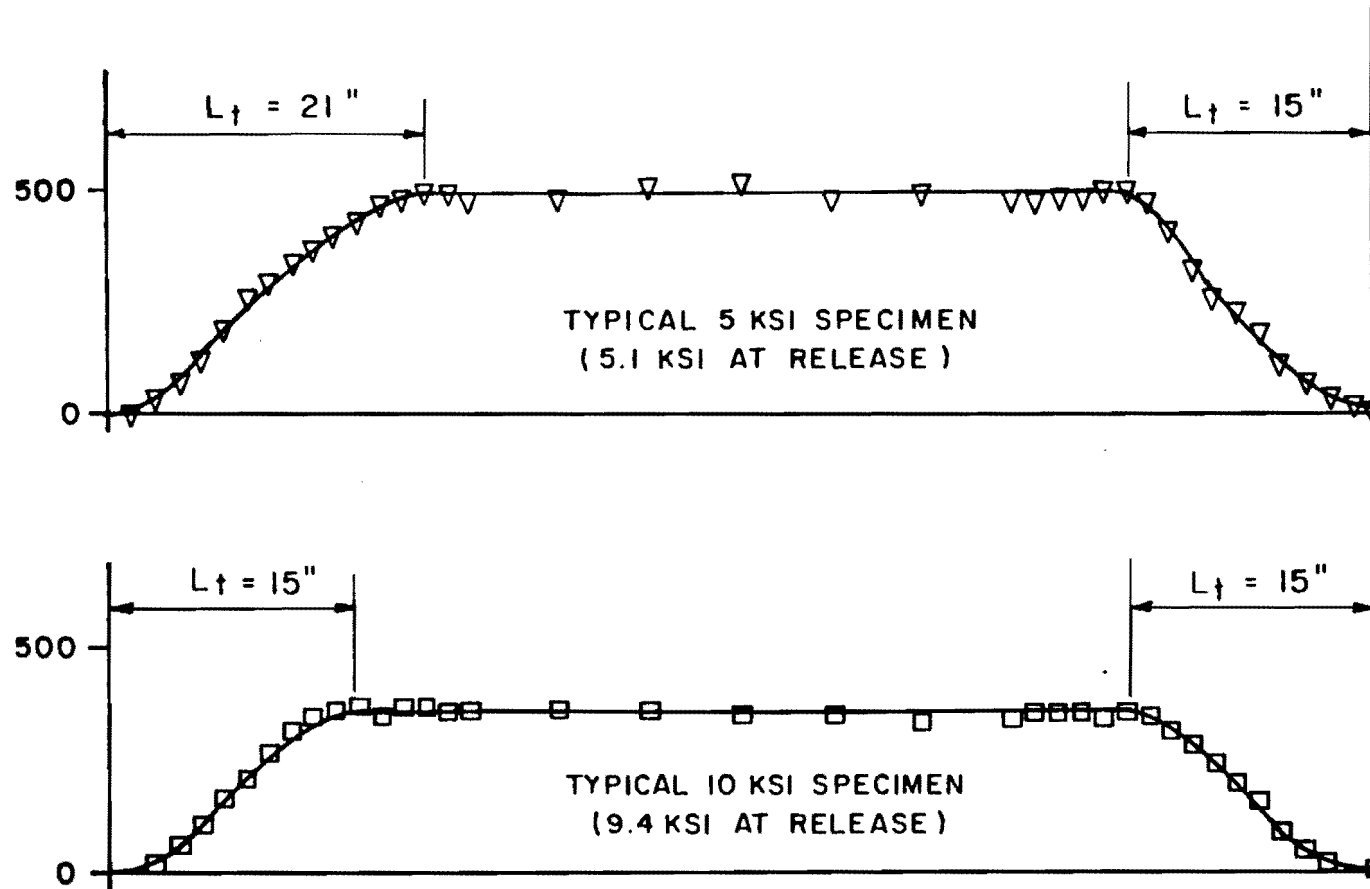
Fig. 2.7 Typical variation of strain with distance along specimens

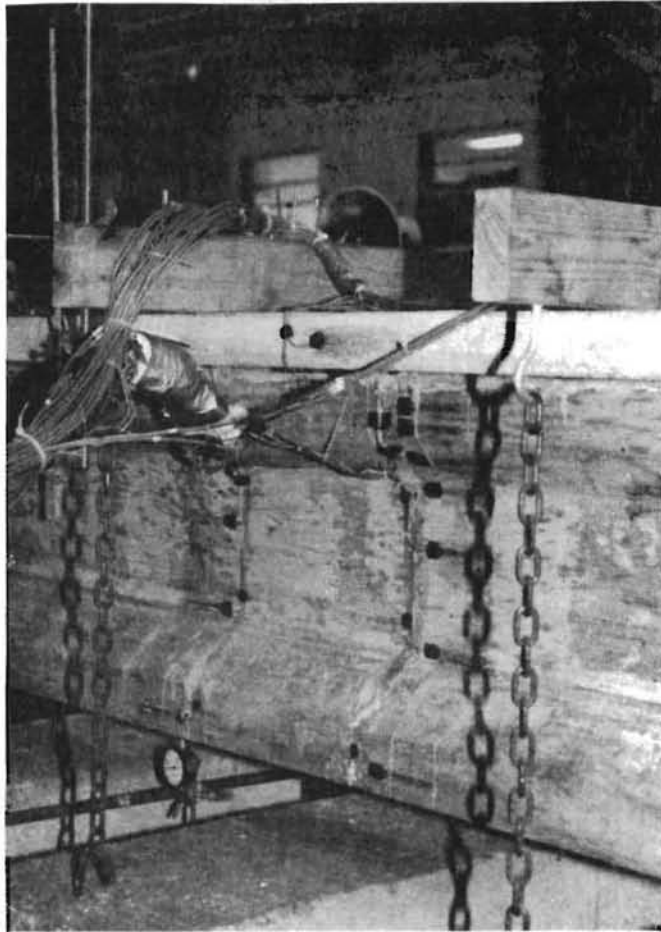
Fig. 3.18 Photograph of concrete surface gages at midspan

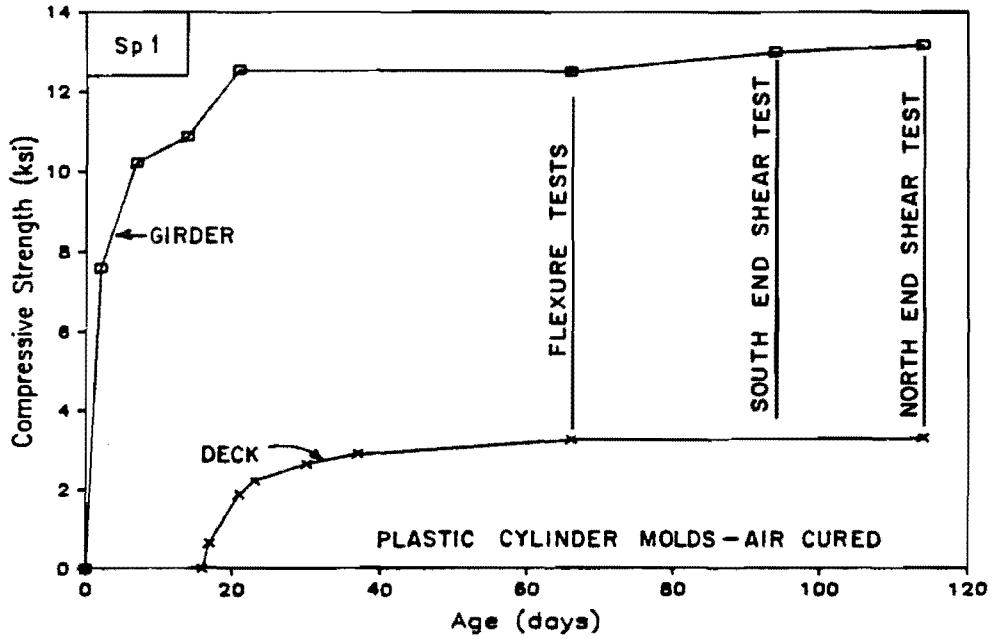
Fig. 4.1 Girder and deck concrete strength gain with age - Specimen 1

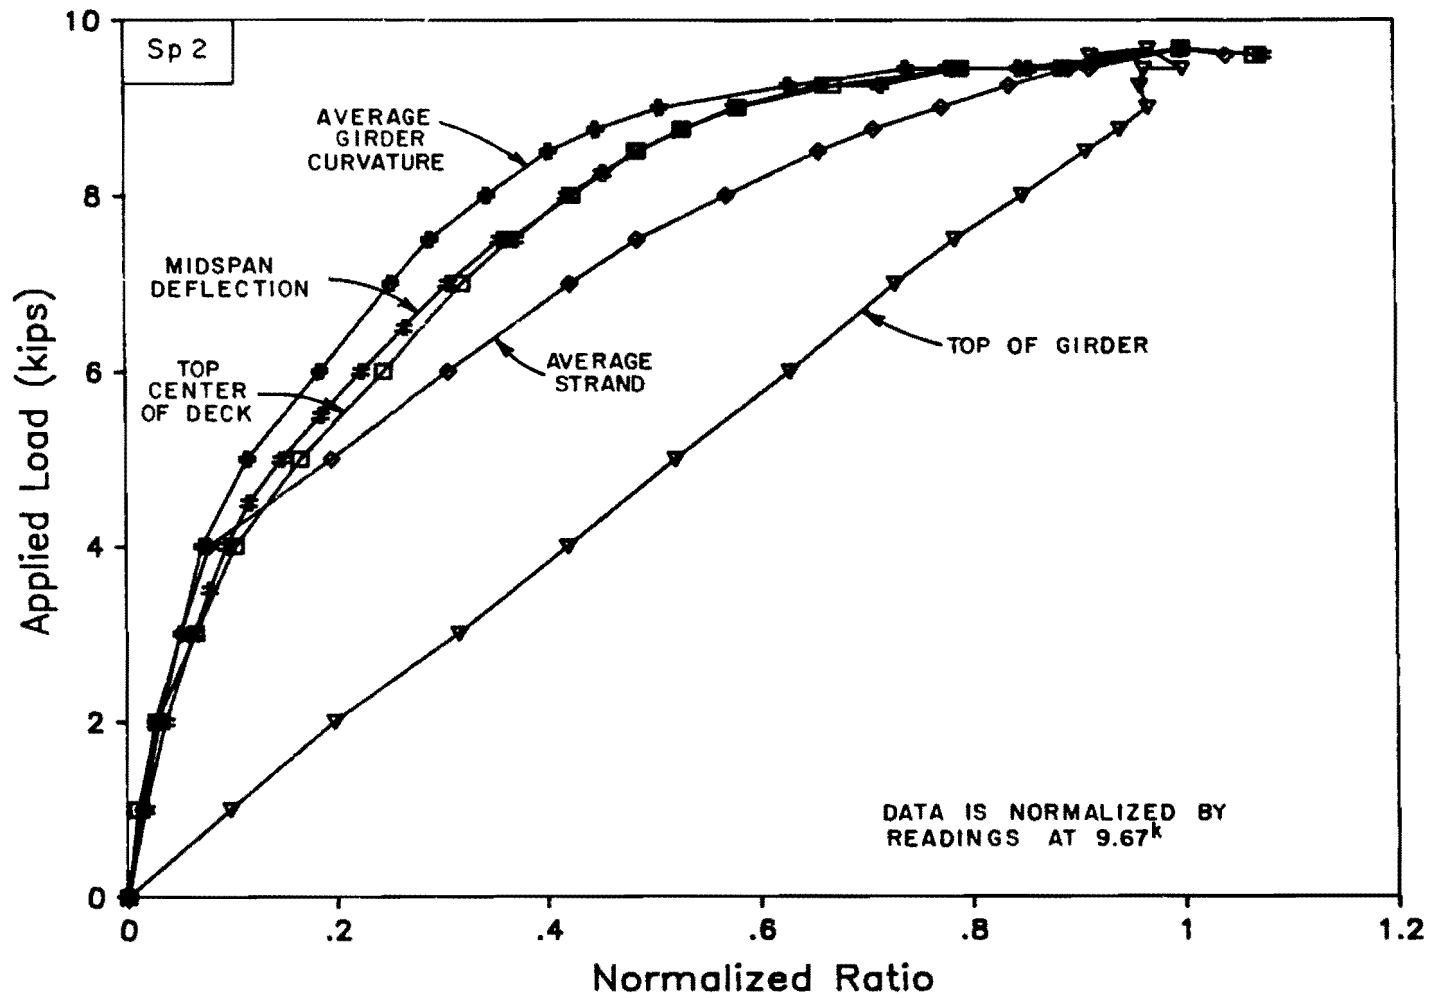
Fig. 4.65 Comparison of different types of data during flexure test

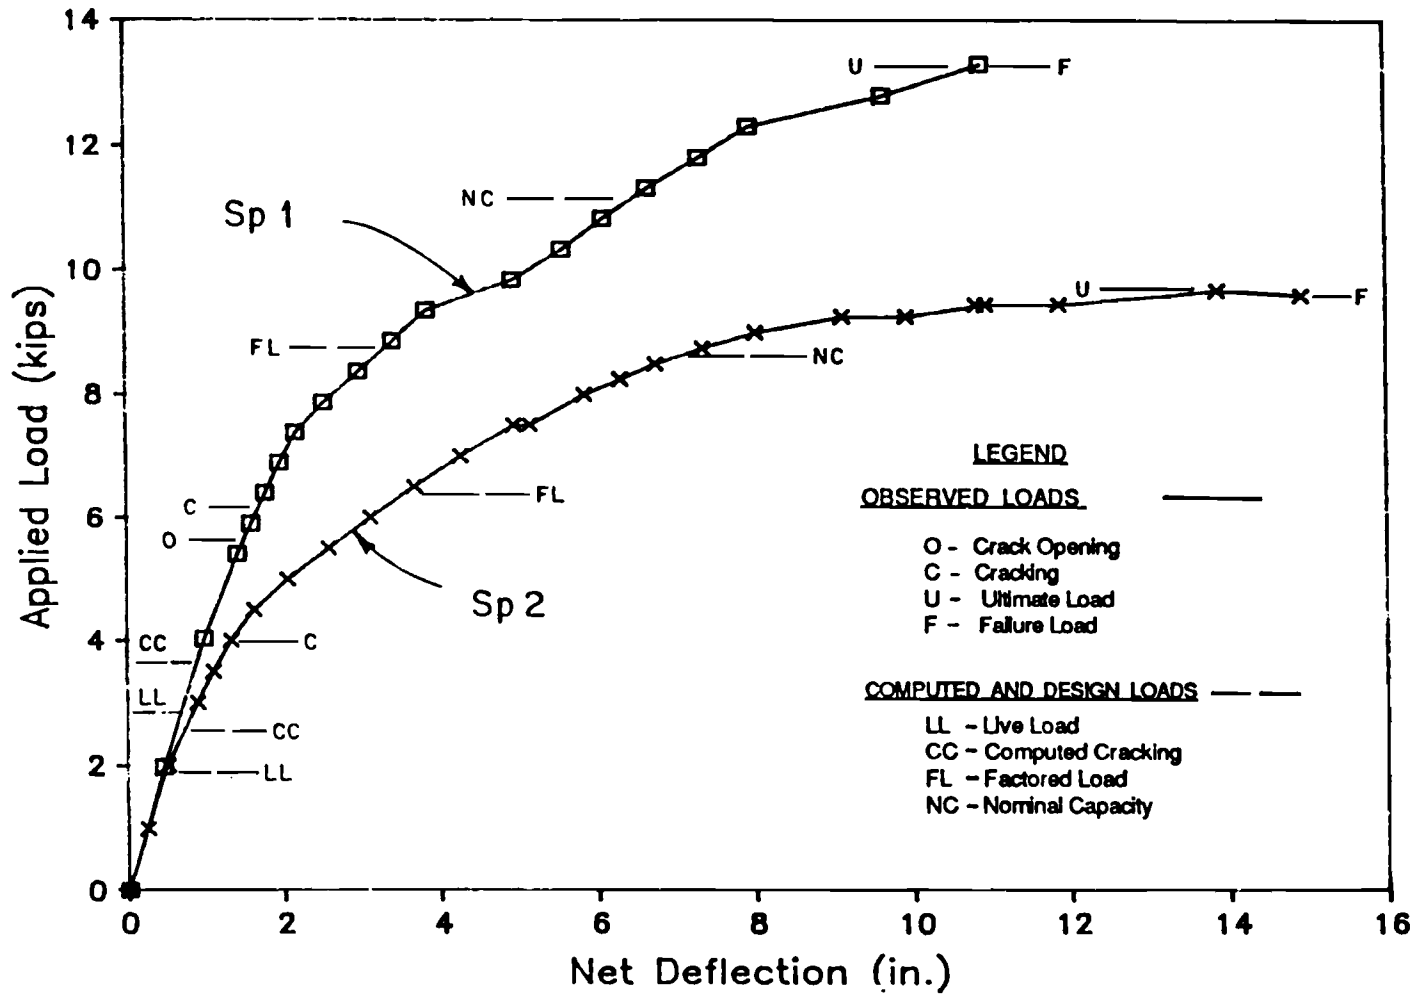
Fig. 4.72 Net deflection at midspan during ultimate flexure tests

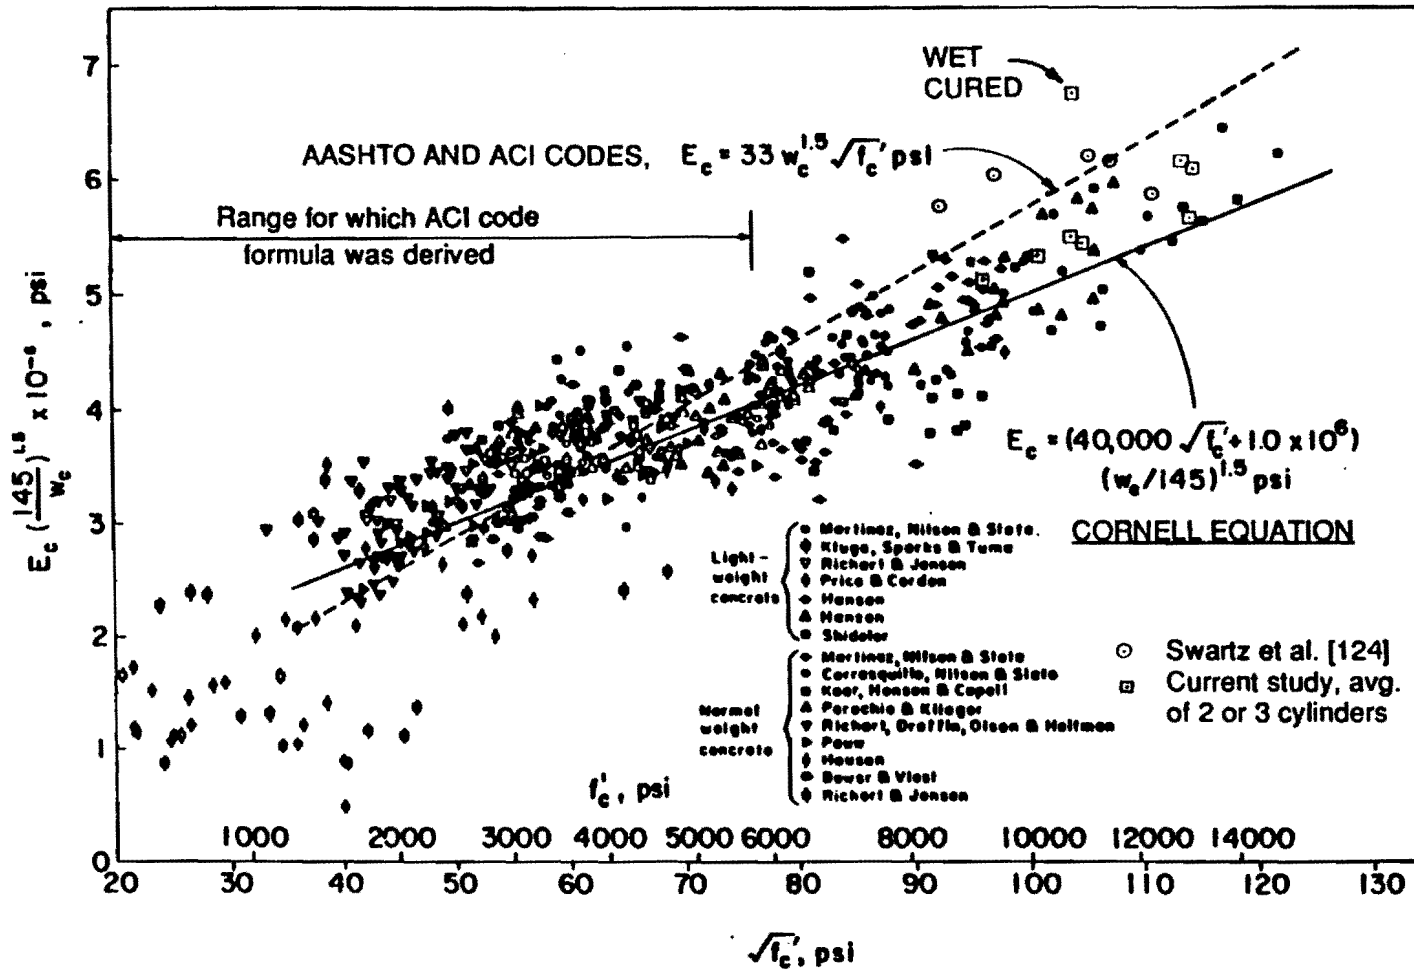
Fig. 5.1 Modulus of elasticity versus concrete strength including data from current study [79, 122]
