RESPONSE OF HIGHWAY BARRIERS TO REPEATED IMPACT LOADING:

STEEL POST BARRIERS

Research Report No. 382-1

Research Study 3-5-84-382
Resistance of Anchor Bolts to Impact Loading

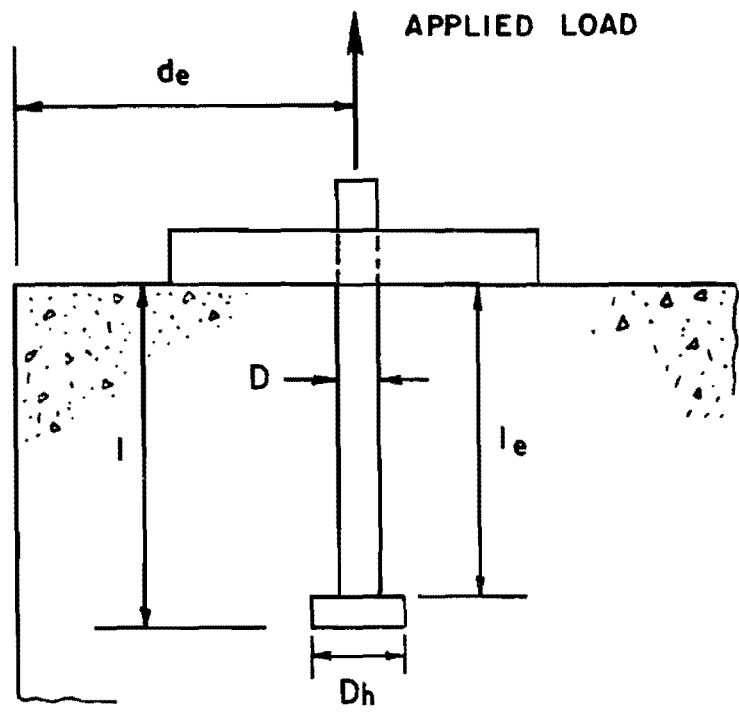
Fig. 2.1 Typical Tension Anchor

2.2.1 Tensile Loading Condition. A typical headed anchor, embedded in a block of unreinforced concrete and subjected to a tensile load, is shown in Fig. 2.1. If the depth of embedment and edge distance are sufficient, the capacity of the anchorage can be computed as the cross-sectional area of the anchor times its specified minimum yield strength [19]. For threaded anchors, the nominal tensile stress area should be used. If the anchor steel does not exhibit a definite yield plateau, yield strength can safely be taken as 90 percent of the specified minimum ultimate tensile strength [19]. For design of anchorage steel, the nominal tensile capacity should be modified by a capacity reduction factor of 0.90 [19]. Thus,

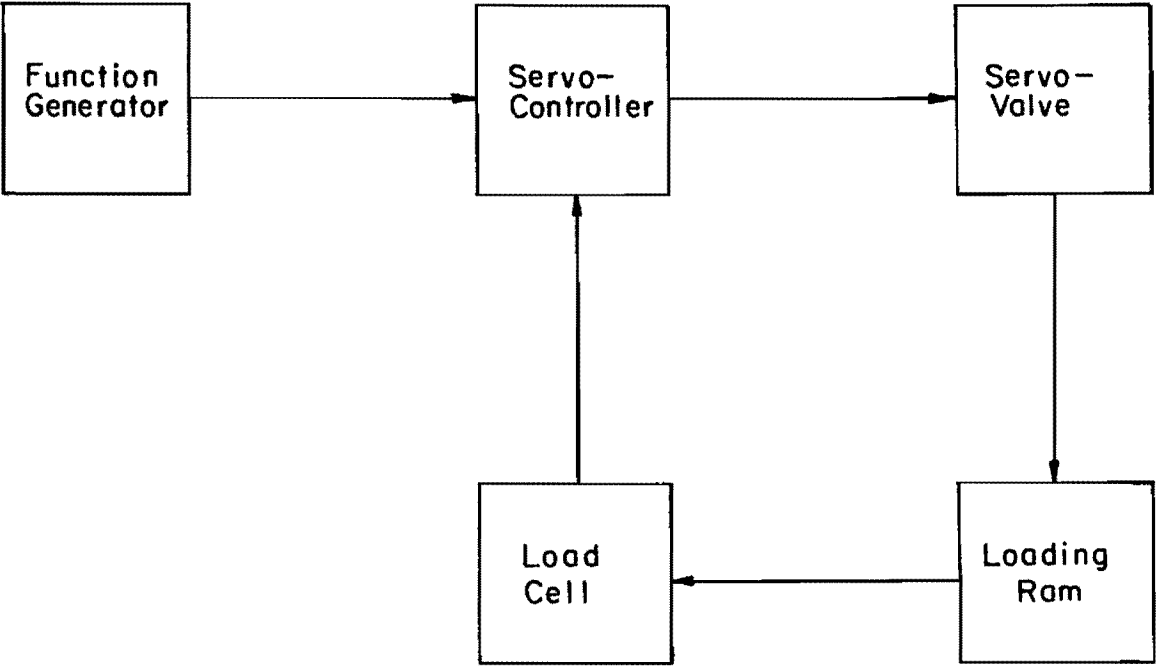
Fig. 4.13 Load Control System

A 100-kip capacity load cell was mounted between the actuator and the post to measure the applied load. A linear potentiometer was attached to the actuator to measure the deflection of the post. The load cell used had the capability of measuring load on two channels simultaneously and independently. Thus, one channel was fed into the data acquisition system, while the other channel monitored the load for the load control system. For the deflection-controlled test, a second linear potentiometer was added.

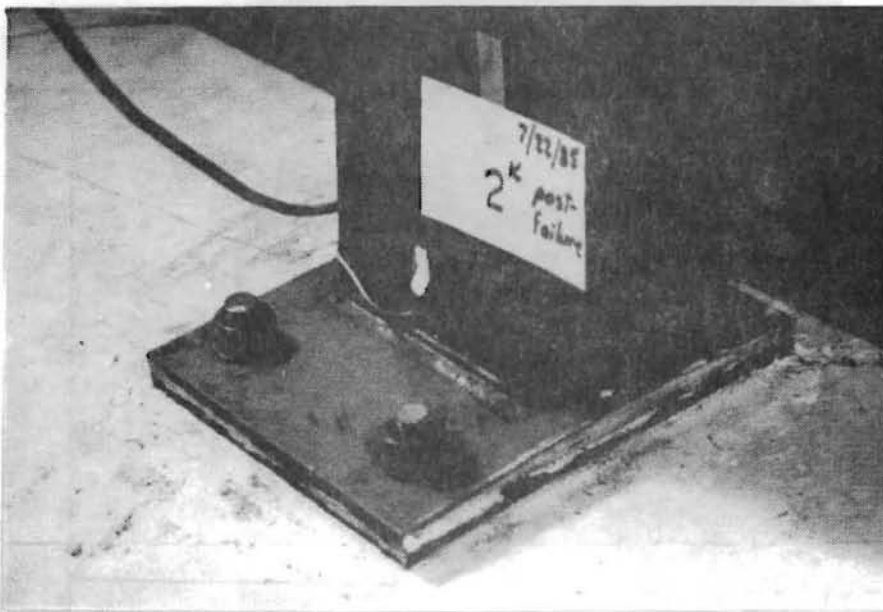
Fig. 5.12 Center post after weld failure

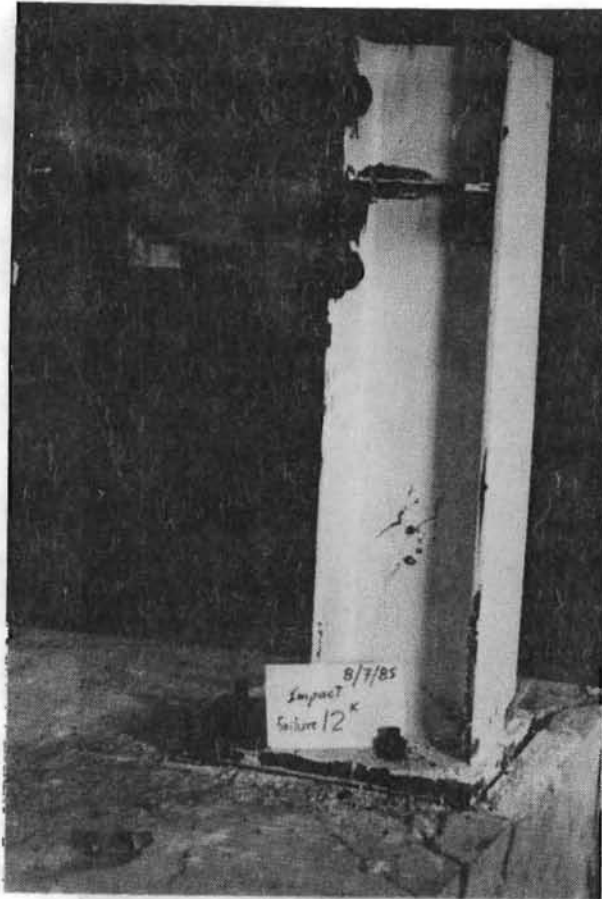
Fig. 5.32 Fracture of tension anchor at west-end post

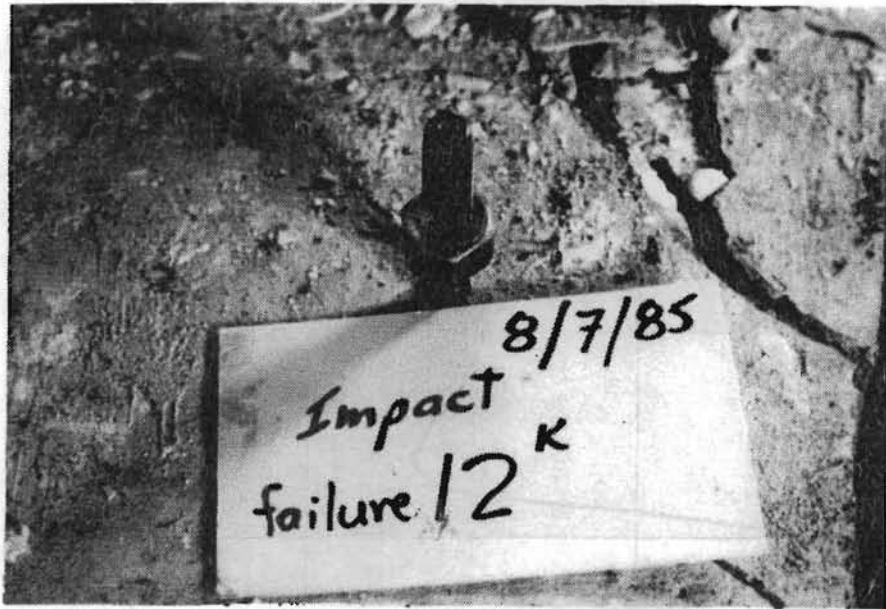
Fig. 5.33 Fractured tension anchor at west-end post

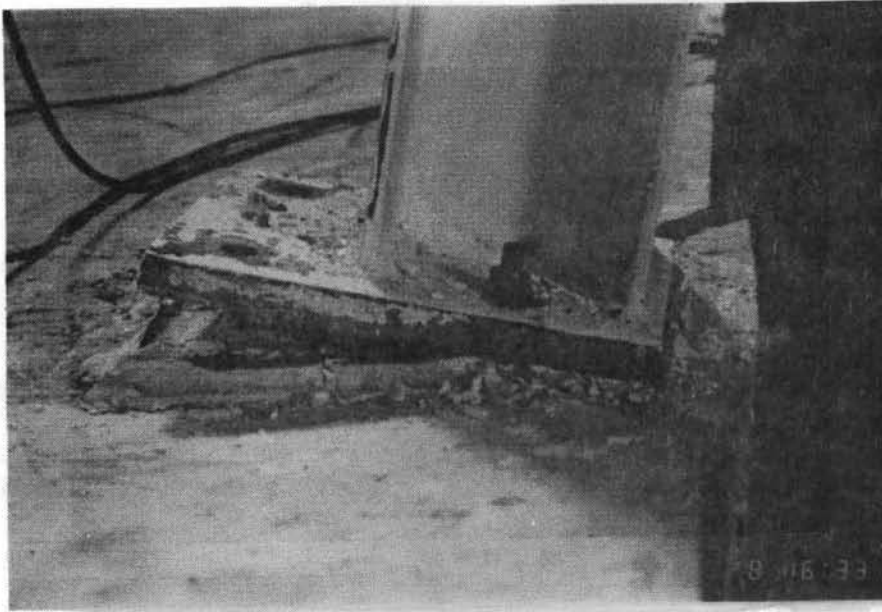
Fig. 5.61 East-end post location at failure
