RESPONSE OF HIGHWAY BARRIERS TO REPEATED
IMPACT LOADING: CONCRETE BARRIERS

Research Report Number 382-2F

Resistance of Anchor Bolts to Repeated Impact Loading
Research Project 3-5-84-382

CENTER FOR TRANSPORTATION RESEARCH
BUREAU OF ENGINEERING RESEARCH
THE UNIVERSITY OF TEXAS AT AUSTIN

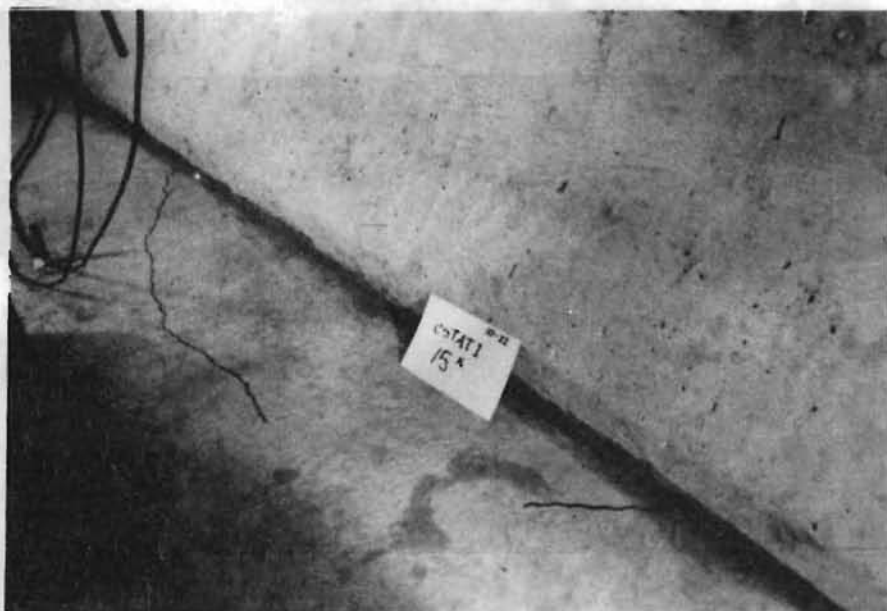
Fig. 4.2 Initial slab cracking: CSTAT1

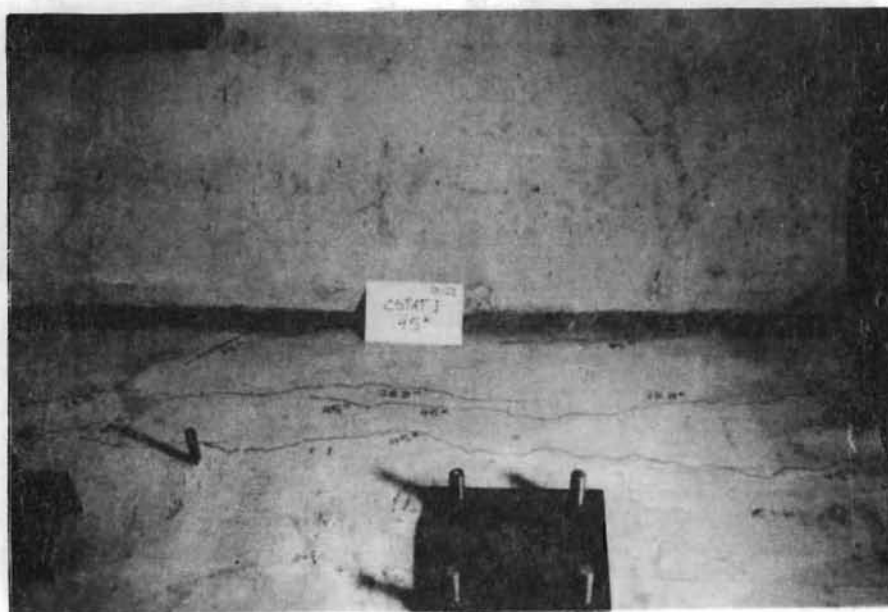
(a) East edge of slab

(b) Surface of slab

Fig. 4.3 Slab cracking: CSTAT1

4.2.1 CSTAT1 Results. CSTAT1 was a static test performed on the cast-in-place barrier using six 1-in. diameter A36, anchor bolts, spaced at 25 in. (Fig. 4.1). The load was applied in increments of approximately 5 kips. At a load of 15 kips, a curved flexural crack developed in the center of the slab (Fig. 4.2), surrounding the central anchor bolts 3 and 4. Straight flexural slab cracks later developed at loads of 28.8, 35, and 43.4 kips. These cracks are shown in Fig. 4.3.

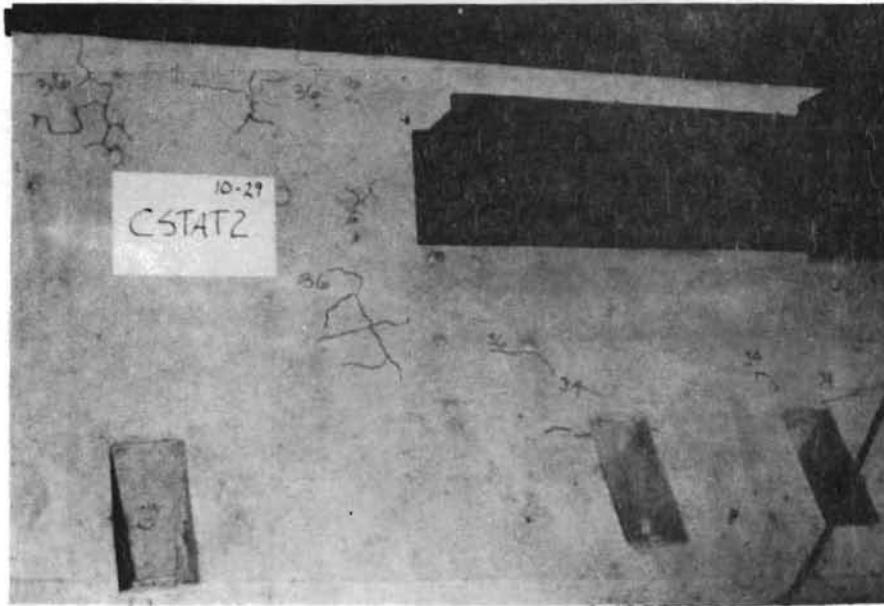
Fig. 4.12 Cracking of precast barrier: CSTAT2

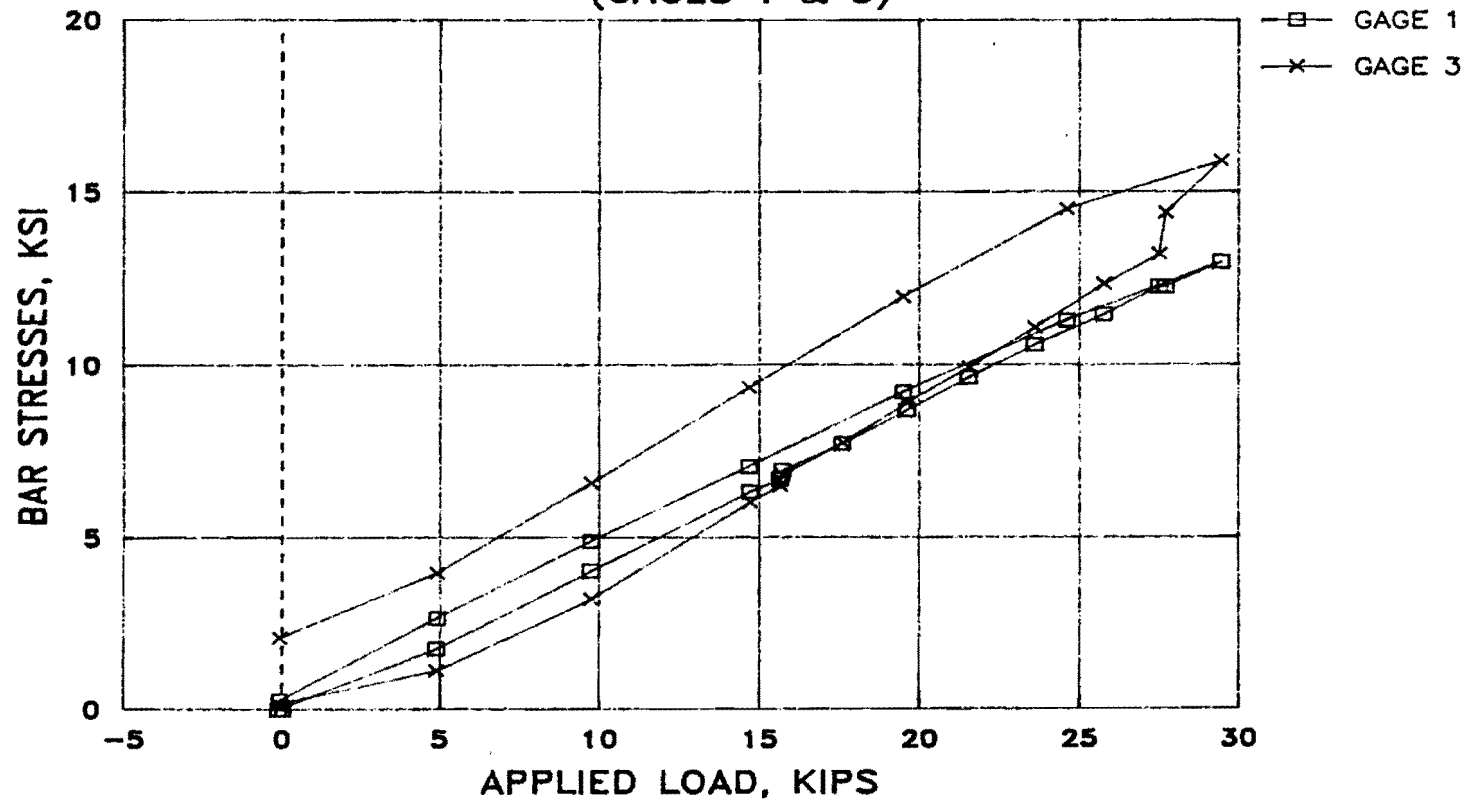
LOAD VS. BAR STRESSES (CSTAT3) (GAGES 1 & 3)

Fig. 4.19 Load vs. bar stresses - gages 1 & 3: CSTAT3
(refer to Fig. 3.21 for strain gage locations)

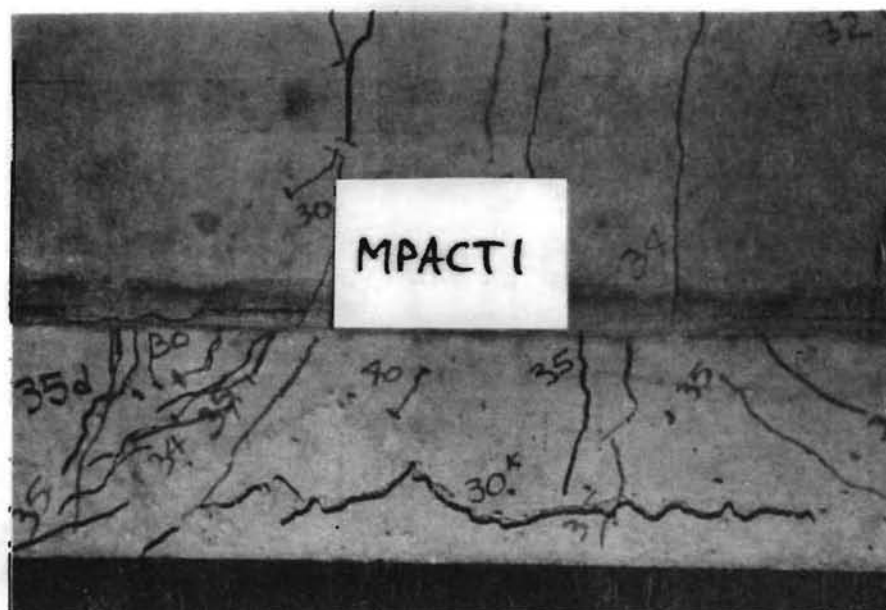
Fig. 4.20 Initial slab shearing crack: MPACT1

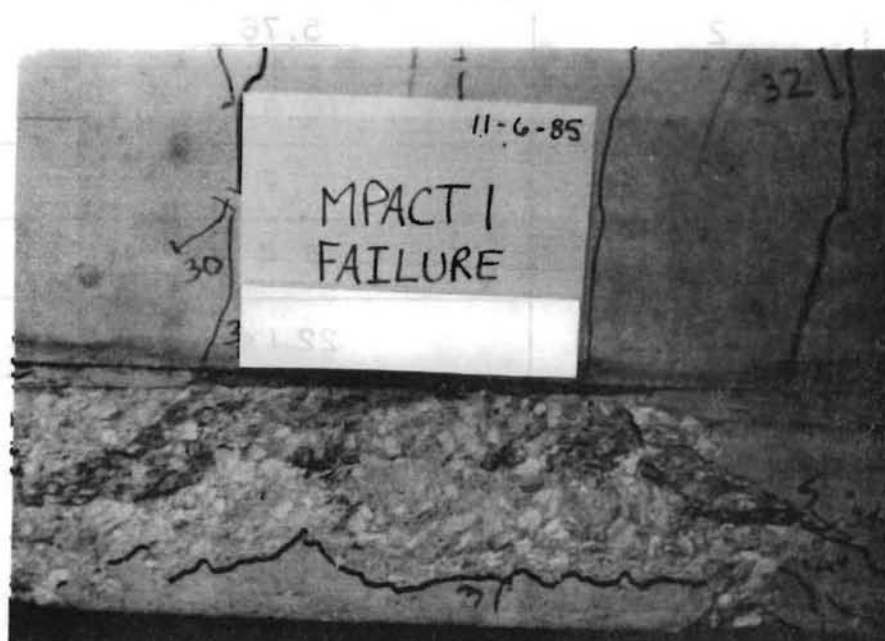
Fig. 4.21 Slab shearing failure: MPACT1

subsequent loads, the concrete above the crack began to shear downward.
