IMPROVED METHODS FOR SEALING JOINTS  
IN PORTLAND CEMENT CONCRETE PAVEMENTS

Research Report Number 385-1

Materials and Methods for Sealing Joints  
Research Project 3-18-84-385

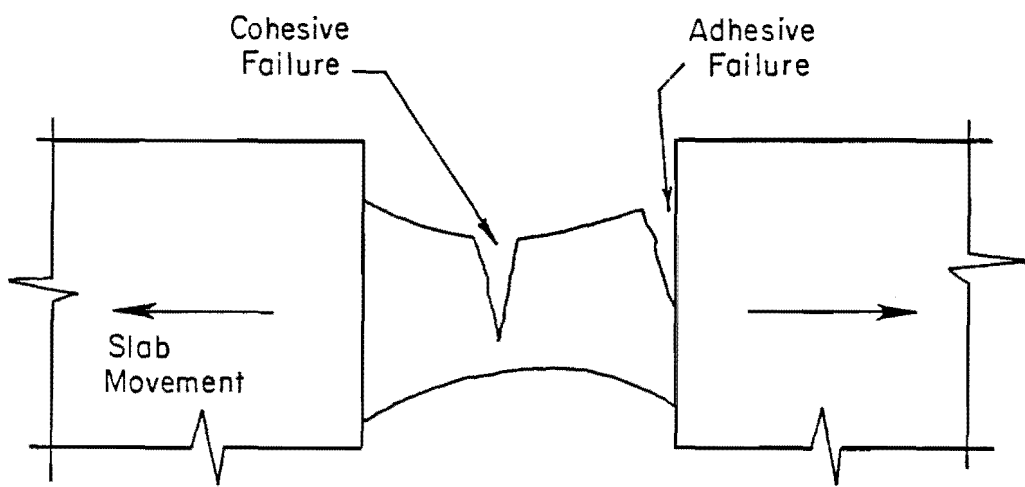
Fig. 1.3 Adhesive and Cohesive Joint Sealants

or 3-inch long failure is enough to be detrimental to pavement behavior when water enters the system. Fig. 1.3 illustrates a typical adhesive failure.

Cohesive failure is a tear in the body of the sealant which is also due to tensile stresses in the joint sealant. Yet, cohesive failure, unlike adhesive failure, will not occur because of inadequate joint preparation. Instead, cohesive failure occurs when the material is stressed beyond its tensile limit. Like adhesive failure, cohesive failure will allow water to enter the joint (Fig. 1.3).

Extrusion failure is most common when a joint has been resealed for maintenance reasons when the joint is open. As the joint closes at high temperatures, the material is placed in compression and the sealant either bulges or flows out of the joint. Once the sealant is higher than the pavement surface, it will be either flattened out onto the pavement or pulled out of the joint by passing vehicles. Then, when the joint again expands, there is not enough sealant left to properly seal it. The sealant may then fail as incompressibles puncture it or in either adhesion or cohesion (Fig. 1.3).

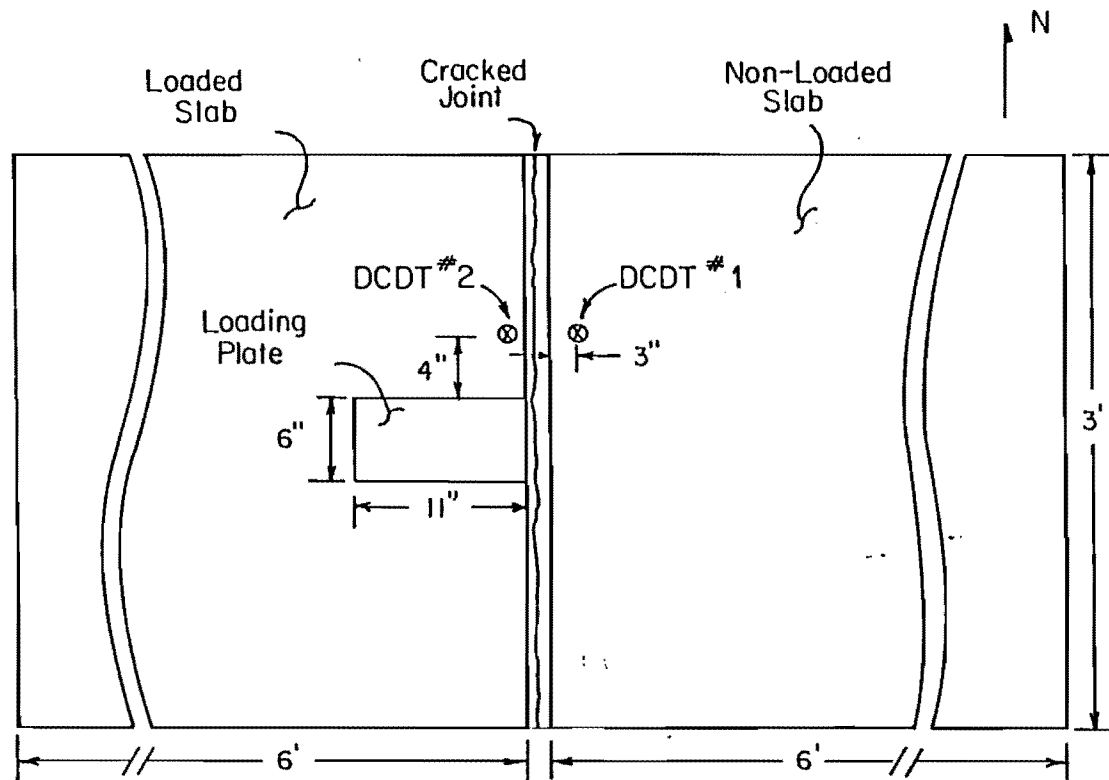
Fig. 3.4 Positions of Loading Plate and DCDT's #1 and #2 in Shear Fatigue Testing Apparatus

Deflections at DCDT's number 1 and number 2 (as shown in Fig. 3.4) were recorded continuously. The difference in deflection between DCDT 1 and DCDT 2 represents the amount of differential movement at the joint. These differences for both systems are plotted in Fig. 3.5. Although shear displacements in pavements with eroded subbases have been shown to be up to 2 times as large as the differential vertical deflections recorded here, these deflections are what may be expected to occur in a properly functioning pavement system.

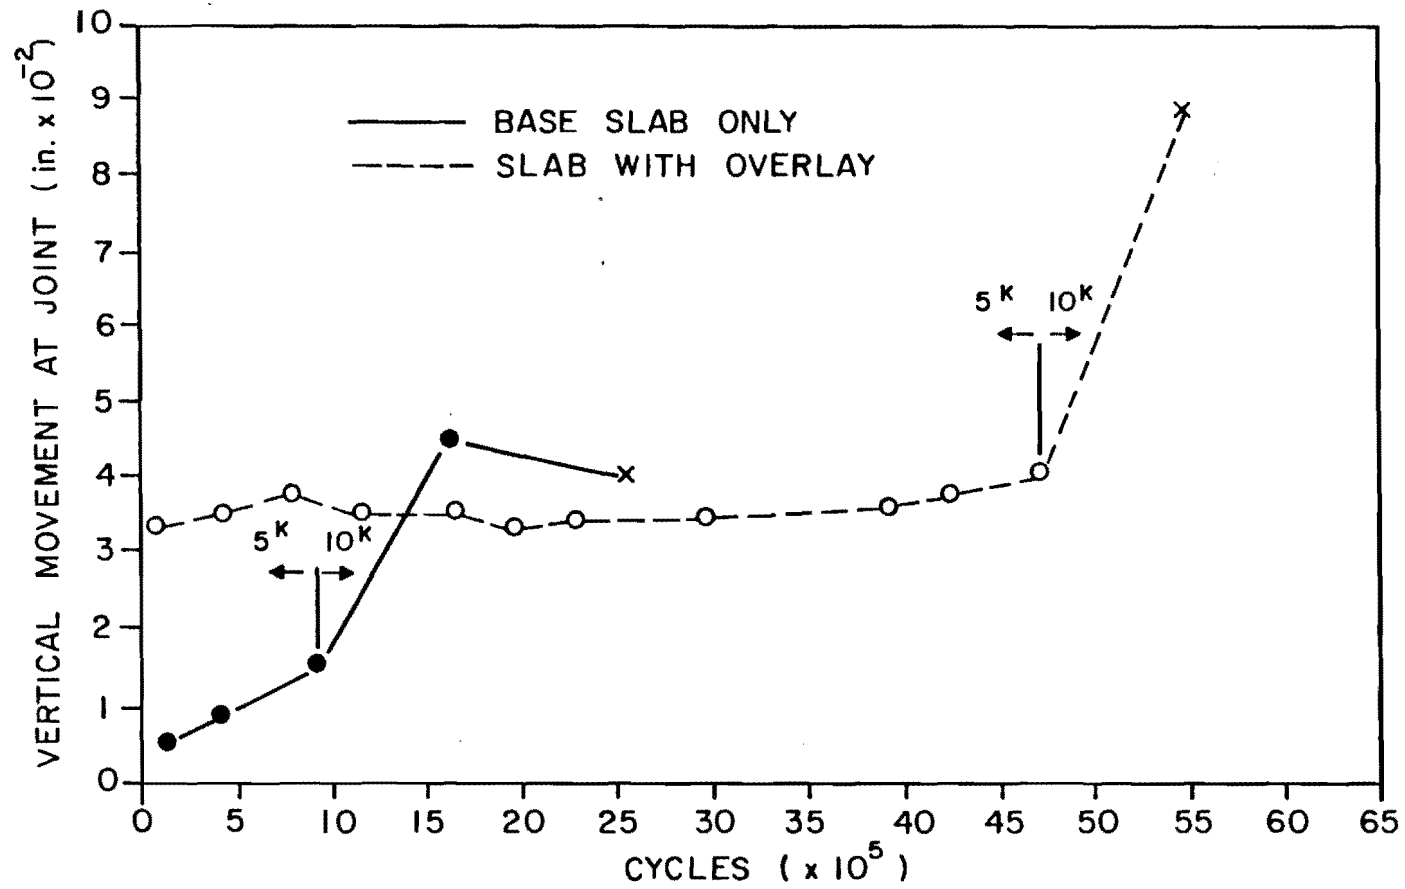
Fig. 3.5 Loading History for Shear Fatigue Test

The load on the slabs and then the slab and overlay system was applied at five cycles per second until each set-up failed. Originally, the loads were cycled between 5,000 pounds and 500 pounds. The minimum of 500 pounds was used to reduce the impact on the hydraulics of the loading system. For each separate system (slabs and slabs with overlay), the load was increased to 10,000 pounds to speed failure. For the system with only slabs, the load was increased to 10,000 pounds after 930,000 cycles. For the slab and overlay system, the load was increased to 10,000 pounds after 4,724,000 cycles.

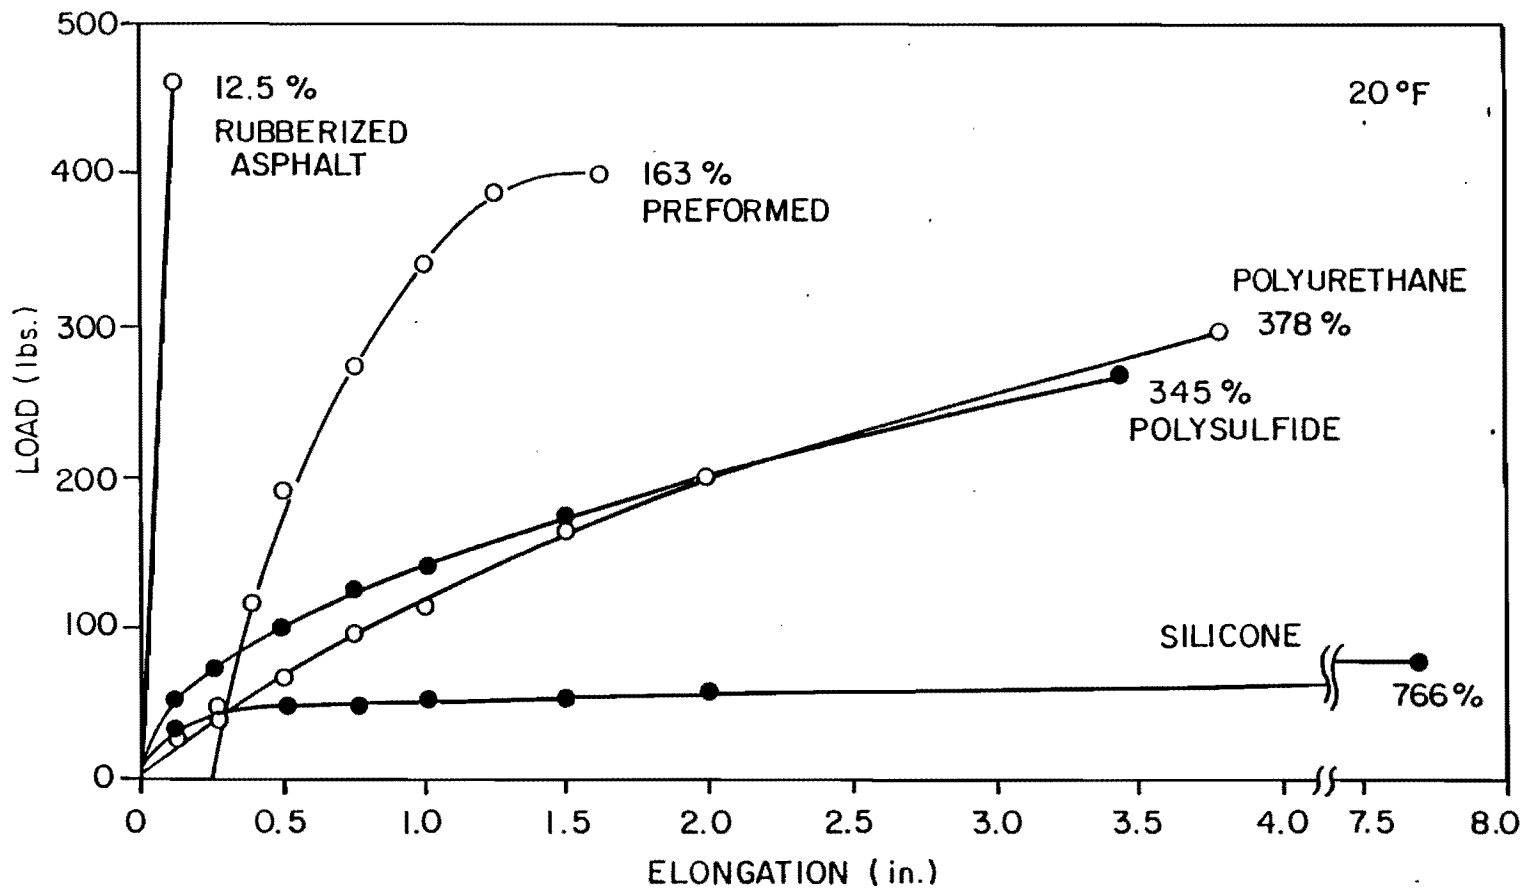
Fig. 3.9 Load vs. Elongation: 20°F

**3.3.1.1 Load vs. Elongation and Ultimate Extension.** The tension test illustrates the load vs. elongation properties, ultimate extension, and modulus of elasticity for each system at low, room and high temperatures. The load vs. elongation curves and ultimate extension of each system at 20°F, 72°F, and 130° are shown in Figs. 3.9, 3.10, and 3.11, respectively.

At 20°F, the rubber asphalt material became very stiff and yielded only a small amount before it suddenly failed in adhesion. This lack of ductility shows that it may

not extend sufficiently when pavement slabs contract. Instead, adhesive failure would occur and water and incompressibles would be free to enter the joint. At 72°F, the rubber asphalt's stiffness, ductility, and ultimate extension were all acceptable. However, at 130°F, the material flowed before testing began, indicating a severe loss of stiffness. Thus, as pavement slabs expand at high temperatures, the material would tend to extrude from the joint and be flattened onto the pavement by passing vehicles.

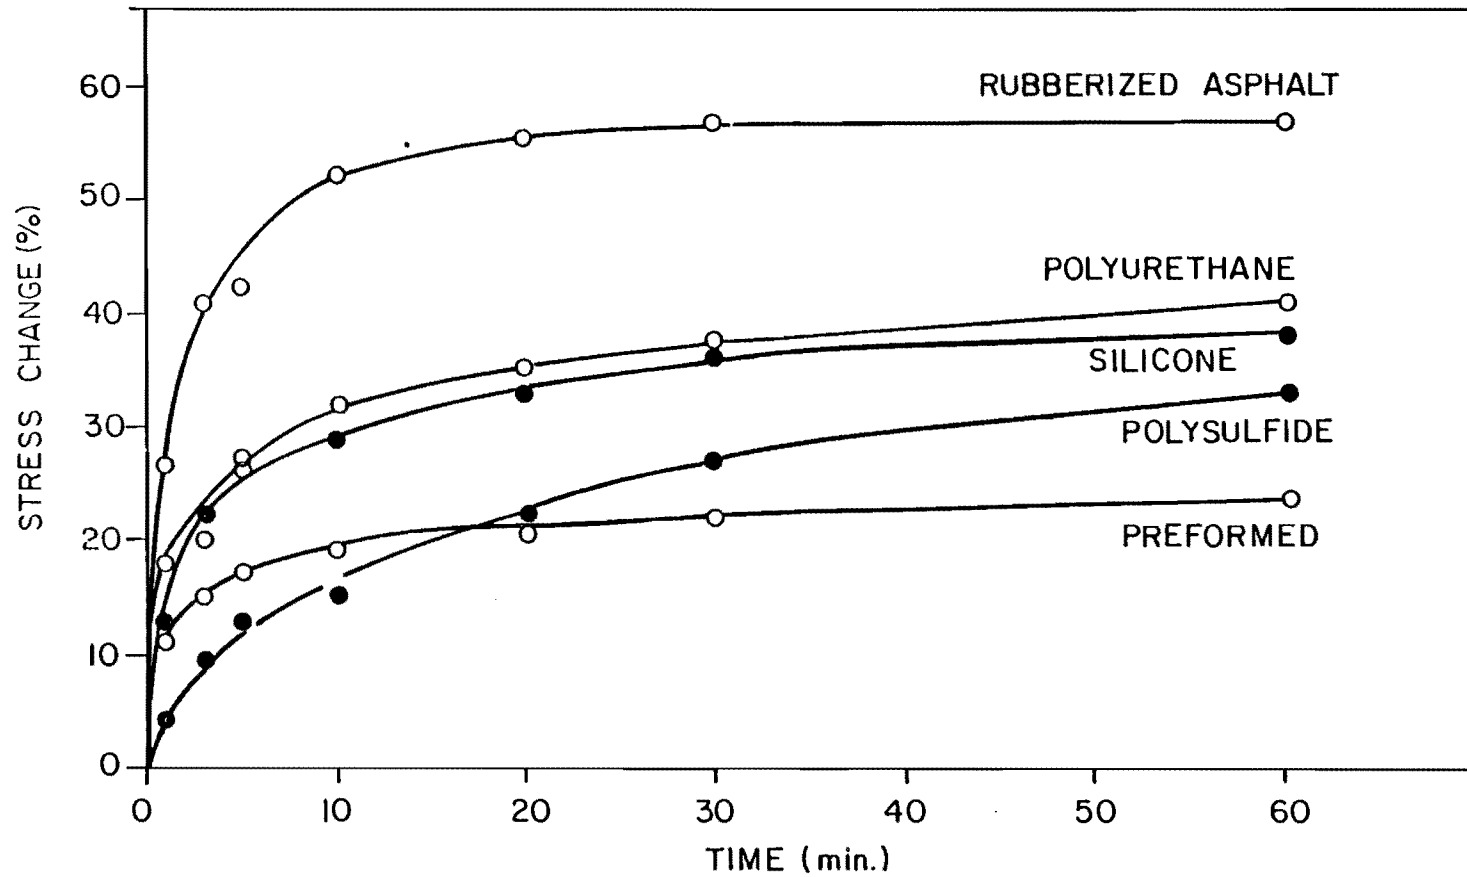
Fig. 3.16 Stress Relaxation Test: Stress Change vs. Time

The results of the stress relaxation tests are shown in Fig. 3.16. None of the sealant systems showed visible signs of failure at 50 percent elongation. The results of this test tend to agree with what one might expect from the results of the other tests. Namely, at 72°F, the rubberized asphalt shows the greatest tendency to relieve stress while the preformed material shows the least relaxation.

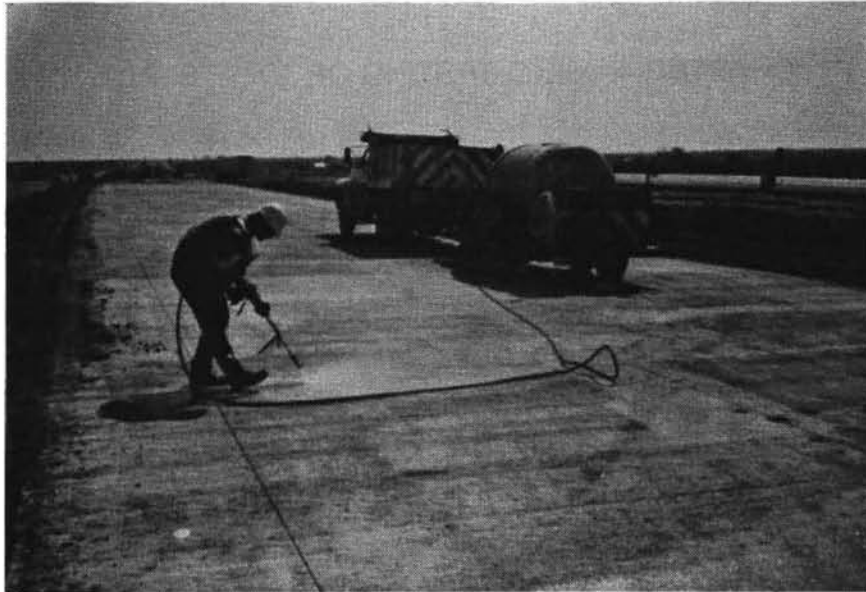
Fig. 4.1 Water Blasting Joints

The water blasting of the joint faces was accomplished by making two passes on each joint - one for each joint face. Fig. 4.1 shows that the nozzle of the spray gun was held to within 6 inches of the joint. After the joints were water blasted, compressed air was used to dry them. The air hose was held 1 to 2 feet from the joints. Fig. 4.2 shows the air drying operation. The next step was to install backer rod at the proper depth. A small, aluminum wheel mounted on a handle was used to roll the backer rod into place. Fig. 4.3 shows the backer rod installation. Finally, the joints that were to receive polysulfide were primed.
