1. Report No. FHWA/TX-87/48+385-2F		2. Government Accession No.		3. Recipient's Catalog No.	
4. Title and Subtitle REPAIRING CRACKS IN PORTLAND CEMENT CONCRETE USING POLYMERS				5. Report Date November 1986

REPAIRING CRACKS
IN PORTLAND CEMENT CONCRETE
USING POLYMERS

Research Report Number 385-2F

Repairing Cracks in Portland Cement Concrete Using Polymers
Research Project 3-18-84-385

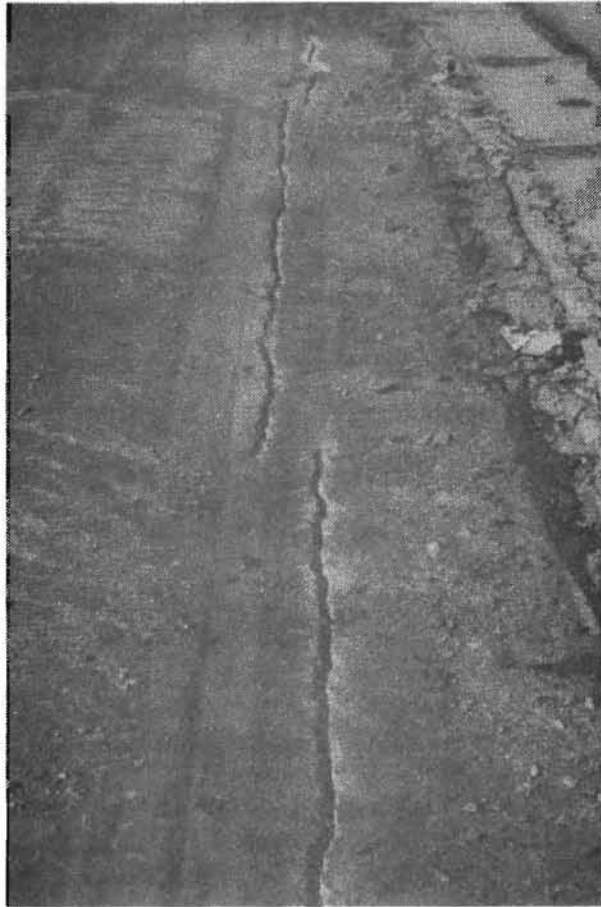
Fig. 2.2 Enlarge cracks

A single-piston pneumatic crack router was selected as the best available piece of equipment to enlarge the cracks (Fig. 2.2). The bit usually has a 0.75-in. diameter, and the crack is usually enlarged to a width of one in. in a single pass (Fig. 2.3). The depth is variable, but is usually one to two in. (Fig. 2.4)

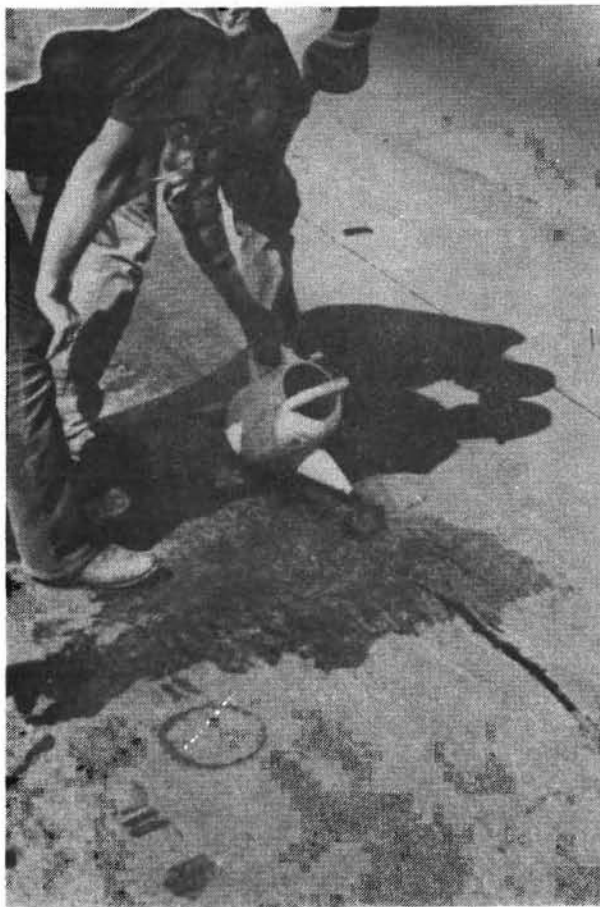
Fig. 2.4 Pouring monomer over sand

The polymer concrete is placed by filling the enlarged crack with clean dry concrete sand and pouring methyl methacrylate (MMA) monomer system over the sand until it is completely saturated.

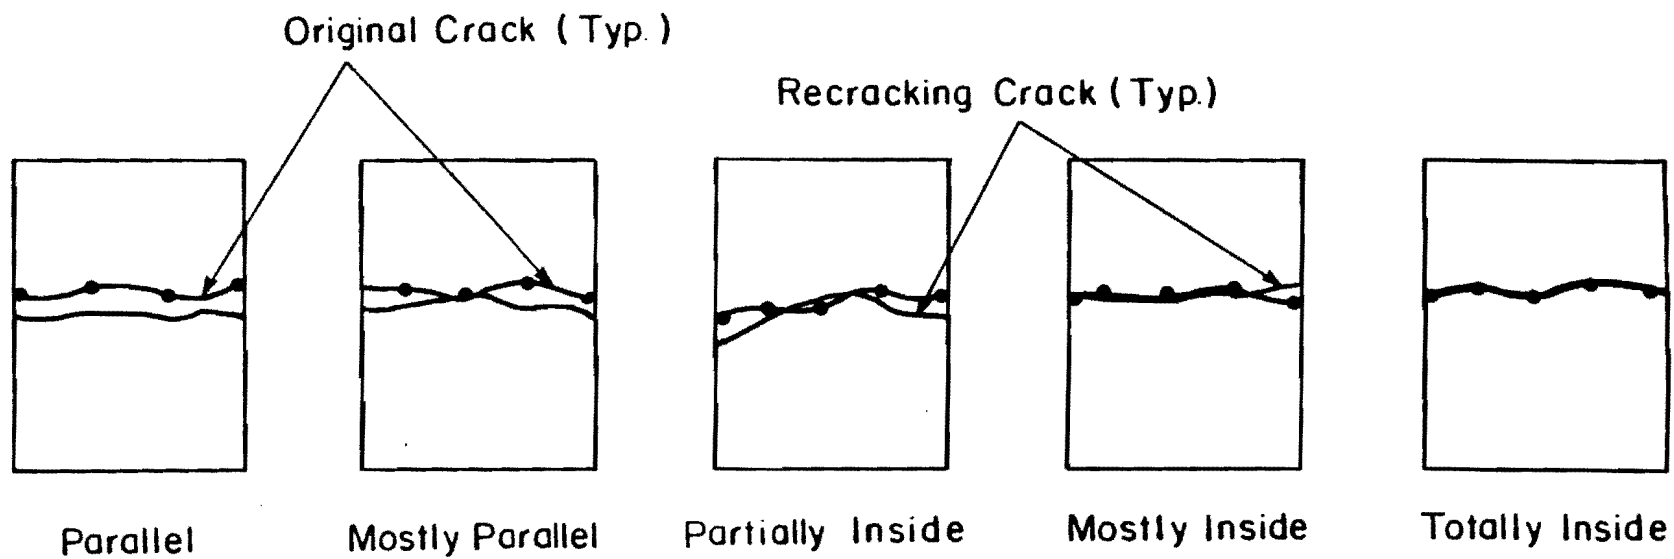
Fig. 4.3 Location of Recracking Crack Relative to Initial Crack

* Fig. 4.3 Defines cracks locations

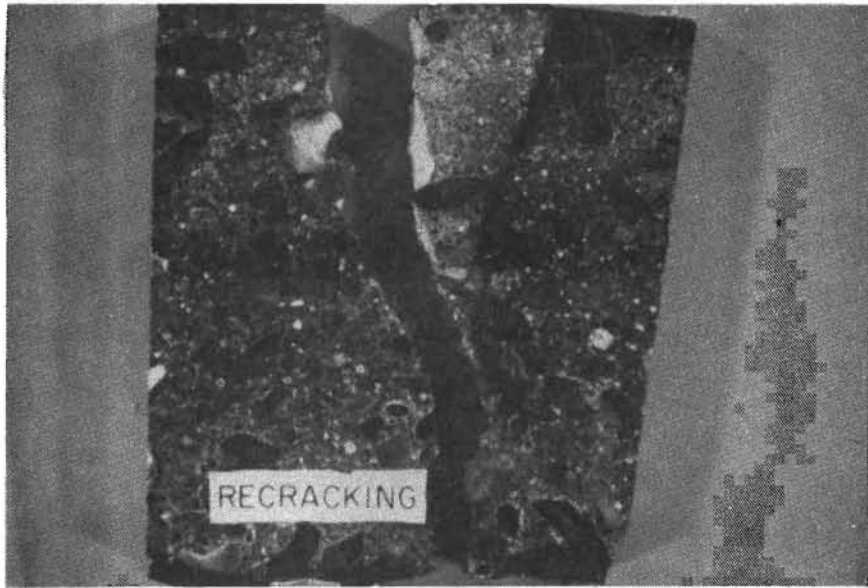
Fig. 4.4 Recracked Monomer - Filled Specimen

As can be seen in Fig. 4.4, often the crack produced in this test did not coincide with the initial crack of the specimen. The observations recorded in Table 4.4 reveal that, in general, cracks resulting from the re-cracking test coincided with the initial crack along less than half its length in specimens where the re-cracking stress values are larger than the initial stress values. Even when the second crack did not coincide at all with the original crack, the re-cracking stress was sometimes lower. This is most likely due to the fact that during the first loading microcracking developed that resulted in cracking which caused failure at lower loads during the second loading. Although there is a significant variation in the re-cracking to initial stress ratio, it is apparent that the monomer treatment restores a great deal of the strength to the concrete.

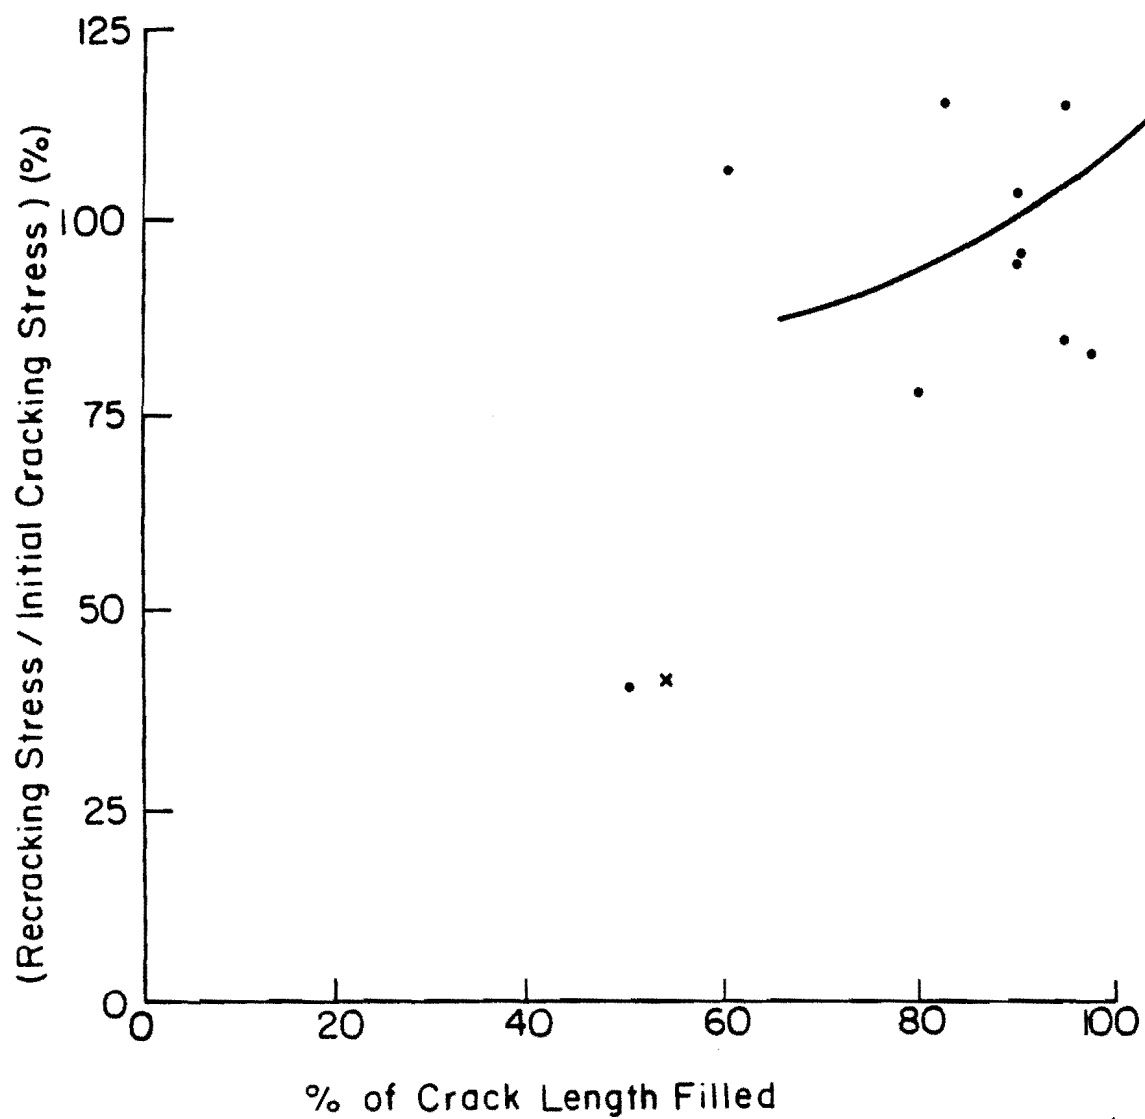
Fig.4.6 Ratio of Recracking Stress to Initial Cracking Stress vs. Percentage of Crack Length Filled

The presence of water in the crack at the time of monomer application decreased the recracking strength of the rehabilitated concrete. Examination of Fig. 4.6 suggests that the decrease in strength is due in part to the decrease in the percentage of the crack filled with polymer. However, the substantial decrease in the initial to recracking stress ratio of the wet specimen, as compared to dry specimens with similar filling percentages, suggests that the presence of water within a crack adversely affects both the filling capability of the monomer and the bond between the monomer and the faces of the crack.

The relationship of the recracking to initial stress ratio and the percentage of the crack filled by the monomer is plotted in Fig. 4.6. There is a great deal of scatter in the data. However, there is a noticeable upward trend of the recracking to initial stress ratio, with increasing percentages of the crack length filled by the monomer.

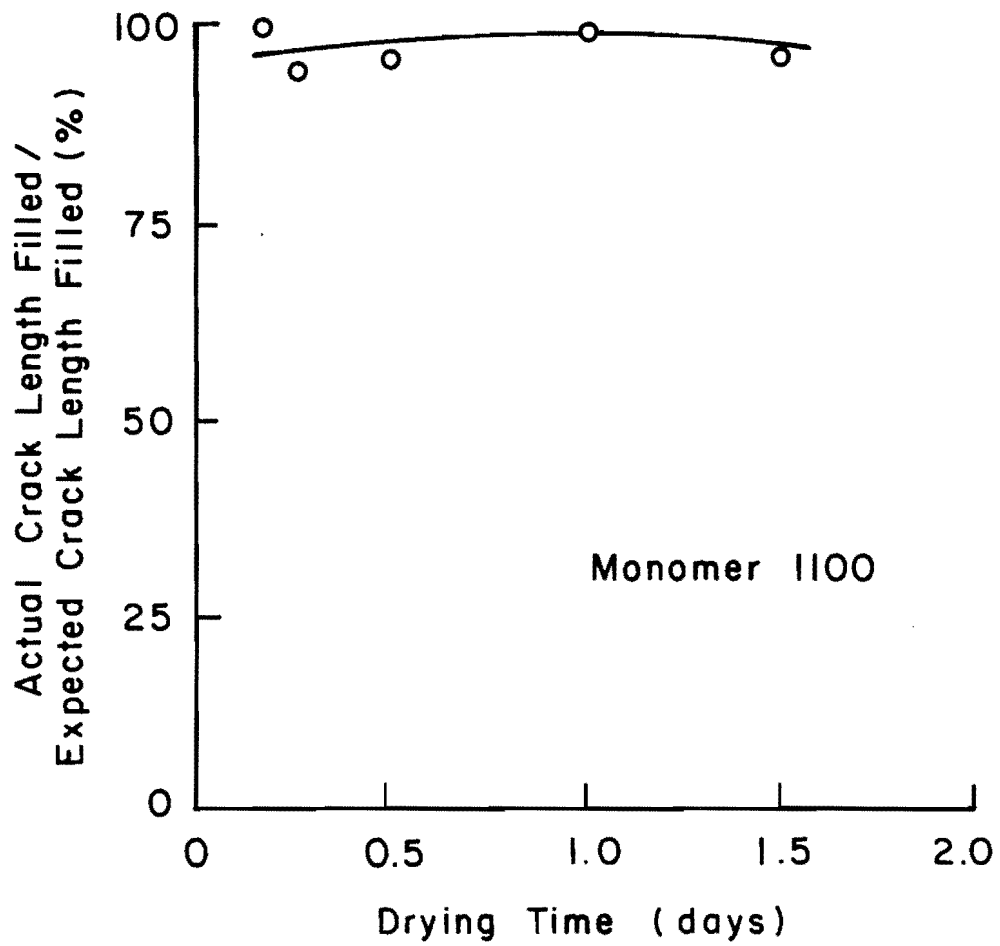
Fig. 4.11 Ratio of Actual Crack Length Filled to Expected Crack Length Filled vs. Drying Time for Small to Medium Size Cracks.

Figure 4.11 indicates that the drying time was less significant than for the slabs tested in the initial study (Fig. 4.7). It does appear that a drying time of 24 to 48 hours would be adequate to achieve good crack sealing.

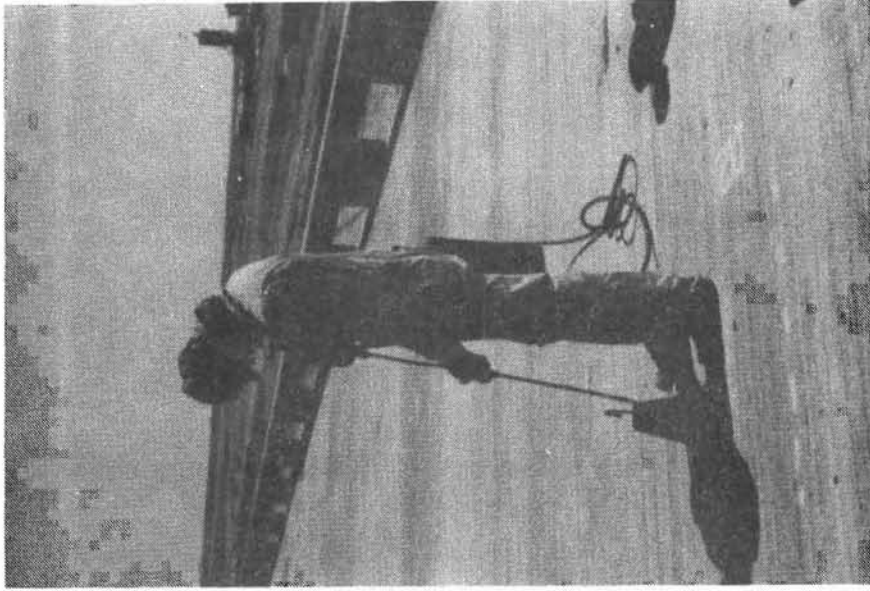
Fig. 5.2 Drying The Cracks

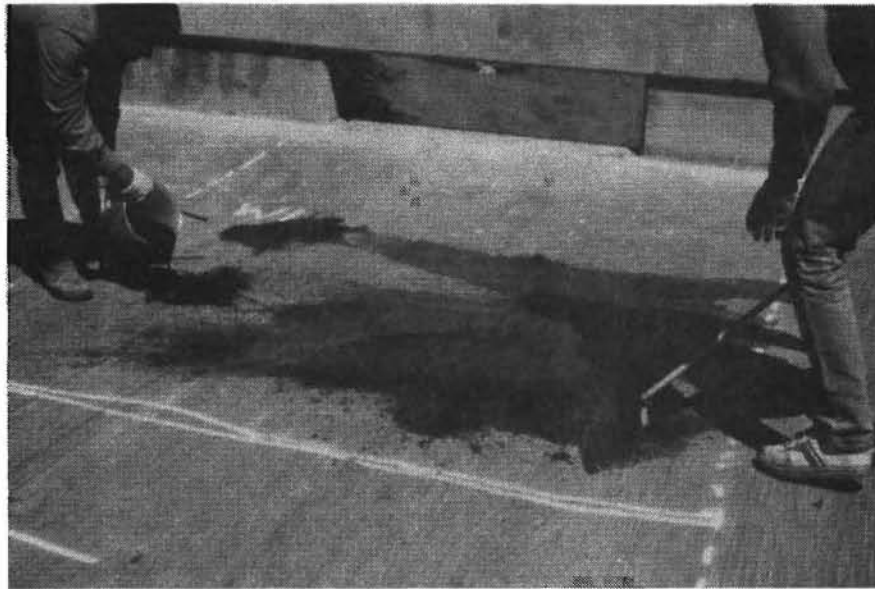
Fig. 5.3 Monomer Application

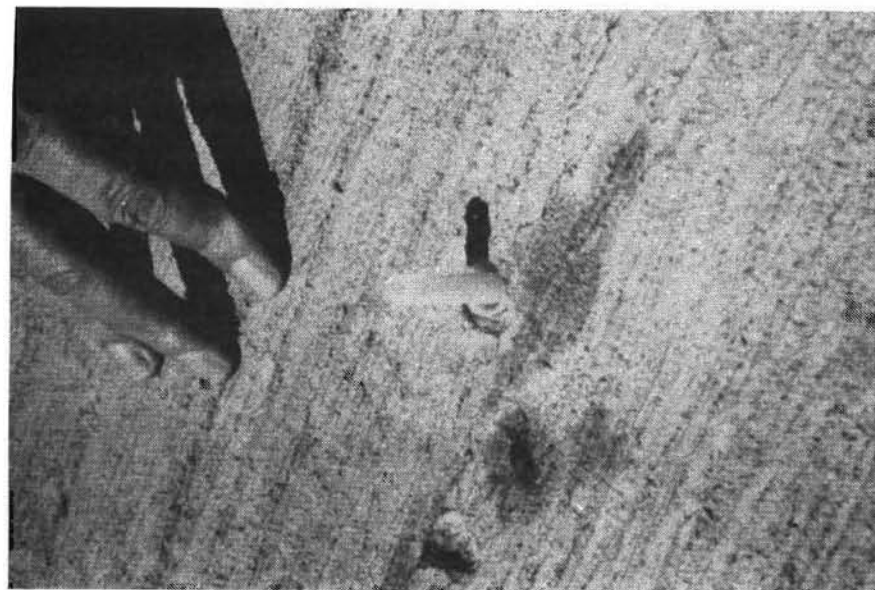
Fig. 5.5 Drilled Injection Ports

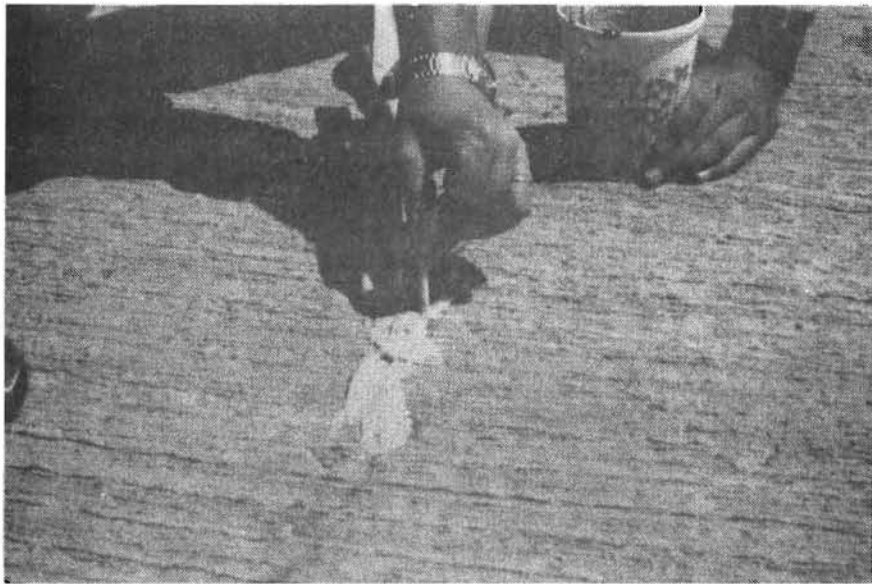
Fig. 5.7 Applying Putty to the Port and Cracks's Surface

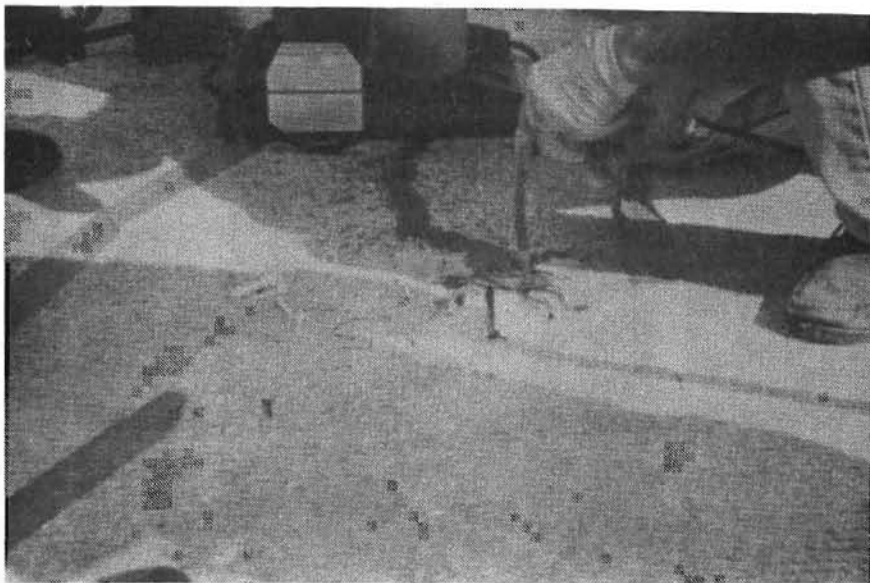
Fig. 5.11 Monomer Injection

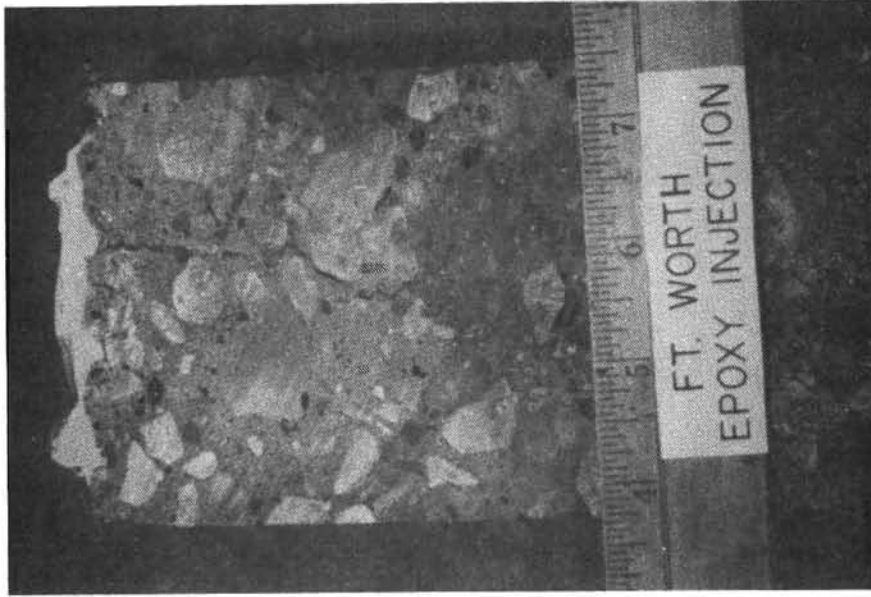
Fig. 5.14 Epoxy Injection Core

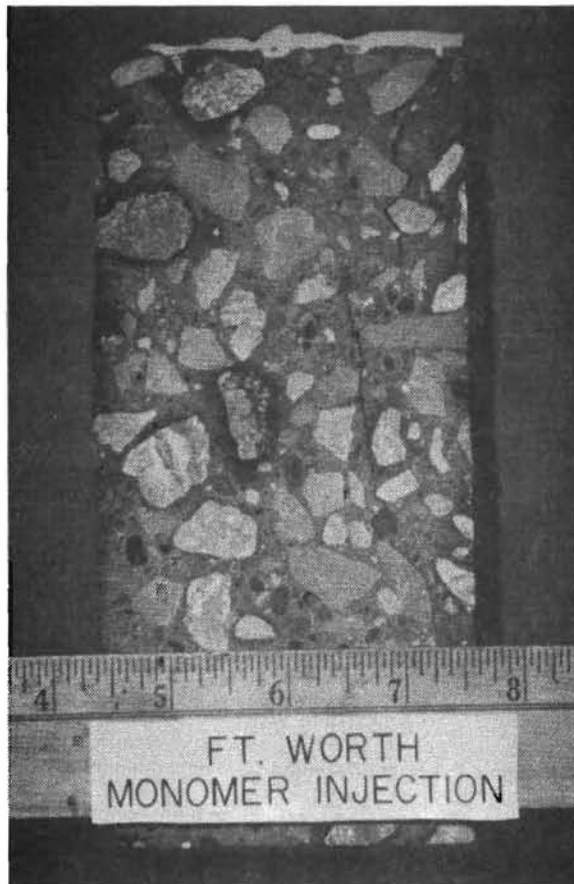
Fig. 5.16 Monomer Injection Core

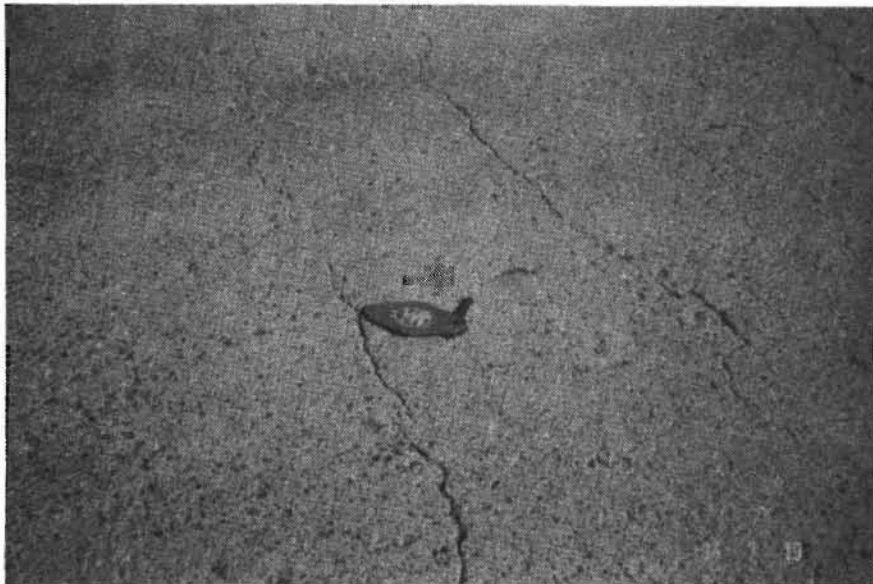
Fig. 5.17 Typical Cracks

This bridge was built more than 25 years ago. Cracking, reportedly, had occurred soon after its slab was poured. As could be expected, over the years a large amount of debris, including salt, had accumulated in the crack. The penetration of debris into the cracks was facilitated by the large width of the cracks at the slab surface. Examination of the sliced cores revealed debris in large amounts near the slab surface.

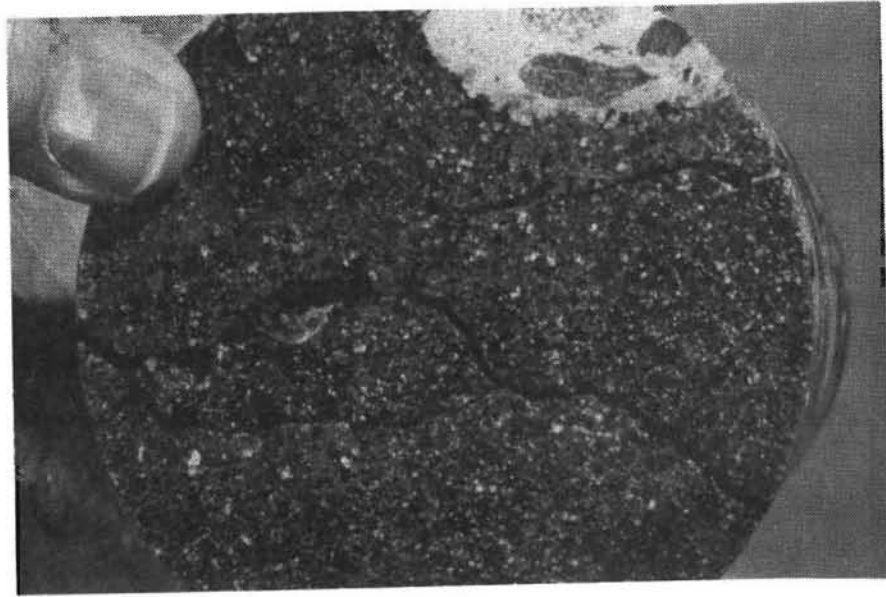
Fig. 5.18 Top View of Core

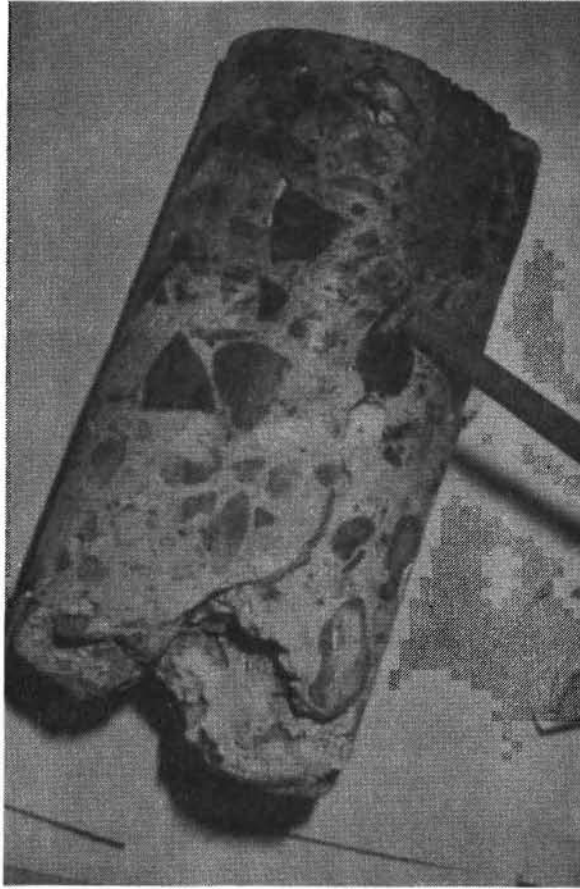
Fig. 5.20 Core from Repaired Pot Hole

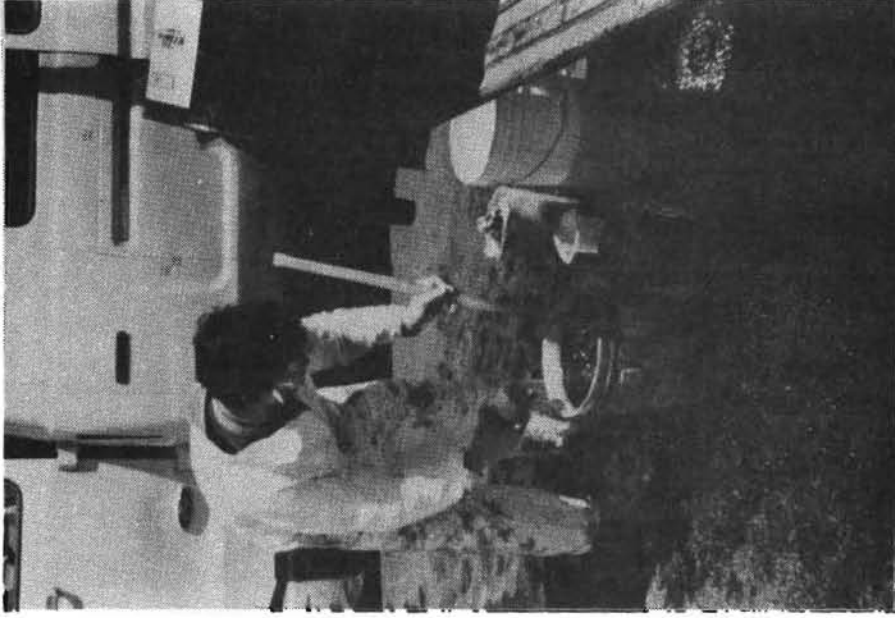
Figures 5.21 and 5.22 Mixing of Materials at the Site.

In order to provide more time to work with the material, an extender was added to the mix. This extender, provided by Rohm and Haas personnel, decreased the curing rate of the monomer system. The extender was used from the fifth batch on. Unfortunately, the temperature of the deck kept increasing (up to about 120 degree F within an hour after the application was begun), which in turn accelerated the rate of curing of the material. Thus, even with the added extender, not much time was available to work with the material. In slight depressions, the material ponded and set very quickly, creating slick spots on the deck. In order to prevent this, sand was poured on these areas, right after the monomer was poured, to restore the surface skid

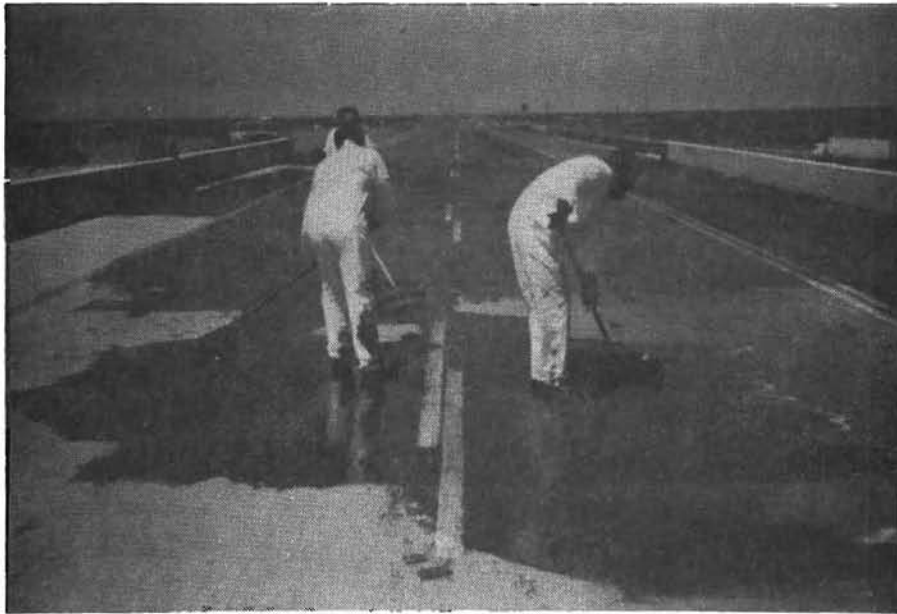
Fig. 5.24 Sweeping Excess Material Towards the Cracks.

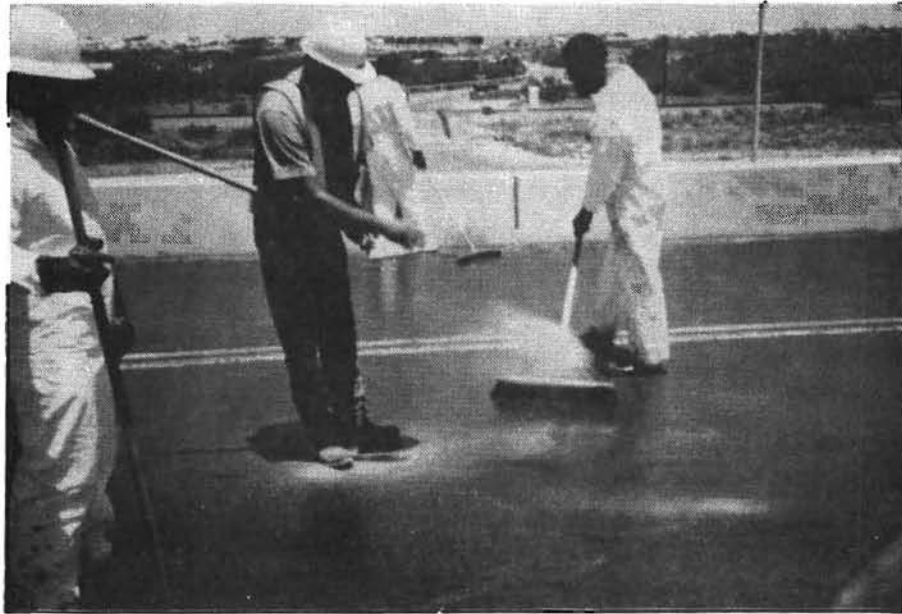
Fig. 5.25 Pouring Sand Onto the Slab in order to Restore the Surface Skid Resistance of the Concrete Topping.

resistance of the concrete topping (Fig. 5.25). The work was performed between 10:30 a.m. and 1:30 p.m. Three people were involved in sealing the first half of the deck, while five people sealed the second half.
