FIELD VERIFICATION OF BRIDGE DECK POST-TENSIONING

Research Report 389-1F

Research Project 3-5-86-389

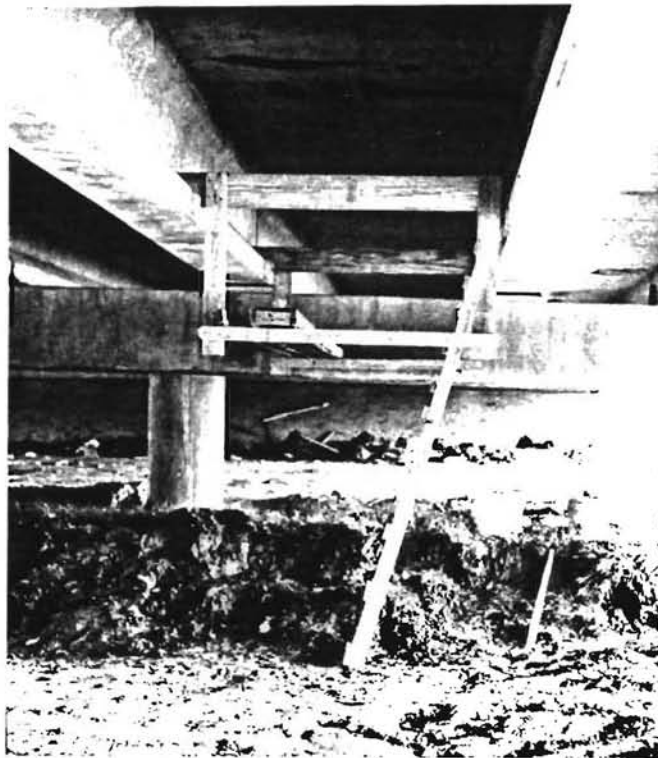
Fig. 2.6 Platform used to reach bottom surface of slab at east end of bridge for instrumentation application

(a) Bottom surface: The bottom surface was easily prepared for strain gage application. Because of the height above the ground, the use of ladders and platforms was required (as shown in Fig. 2.6) which caused substantial difficulty and slowed down the application procedure.

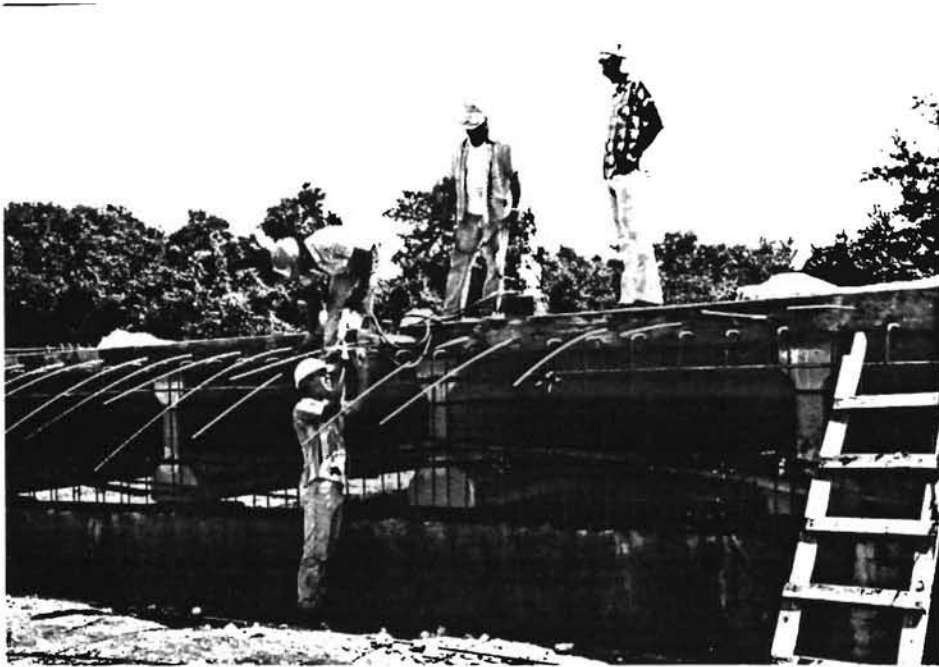
Fig. 2.7 Access to the bottom of the slab at the west end of bridge was possible without the use of platform

(a) Bottom surface: The bottom surface was easily prepared for strain gage application. Its height above the ground level permitted easy access to the concrete surface without the need of ladders or platforms. (See Fig. 2.7.) However, there was lack of light and artificial lighting was needed.
