A Laboratory Study of the Fatigue of Bonded PCC Overlays

Research Report 457-2

**Thin-Bonded Overlay Implementation
Research Project 3-8-86-457**

Report 457-2, "A Laboratory Study of the Fatigue of Bonded PCC Overlays," by Karen T. Reilley, Chhote Saraf, B. Frank McCullough, and D. W. Fowler, presents the findings of laboratory fatigue experiments which simulate the field conditions of IH-610 in Houston, Texas.

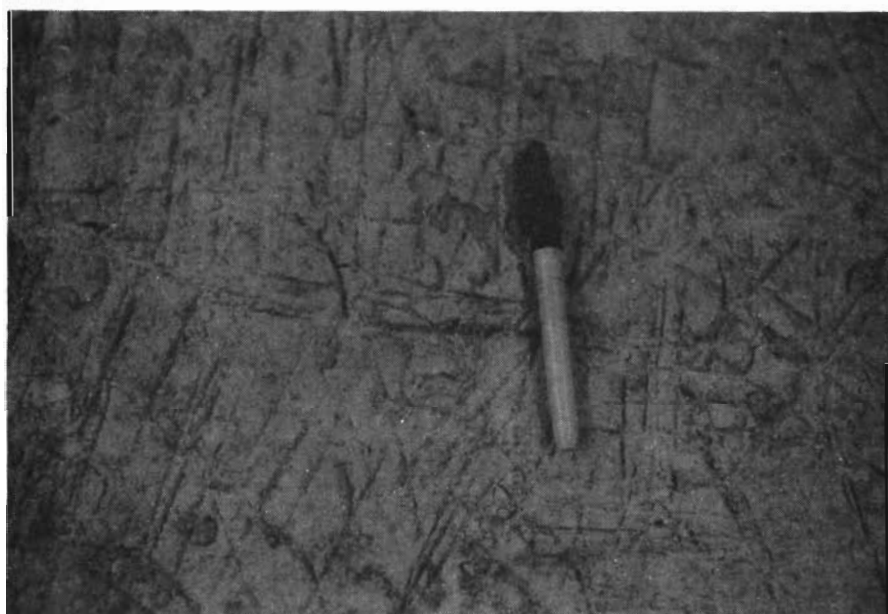
Fig 3.2. Roughened surface of base slab.

About 3 hours after the base slabs were placed, the surfaces were roughened (Fig 3.2) with a trowel to simulate the scarified base slab. This prevented the need for scarifying the dry concrete surface before placing the overlay.

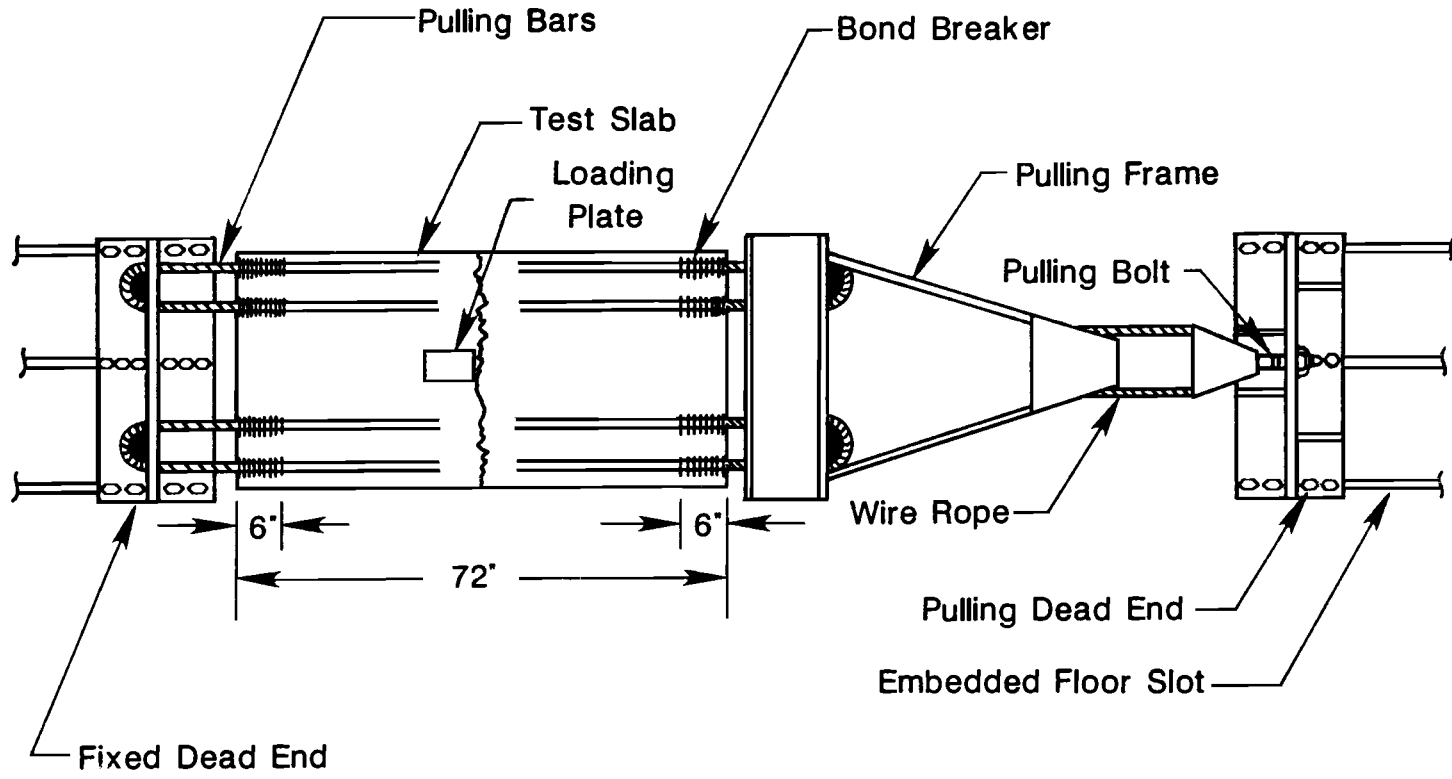
Fig 3.3. Schematic of the pulling mechanism used to form the simulated temperature crack at midspan.

The slabs were cracked within a maximum of 24 hours after placing the concrete. The pulling mechanism (Fig 3.3) used to crack the slab and overlay consisted of the following parts:

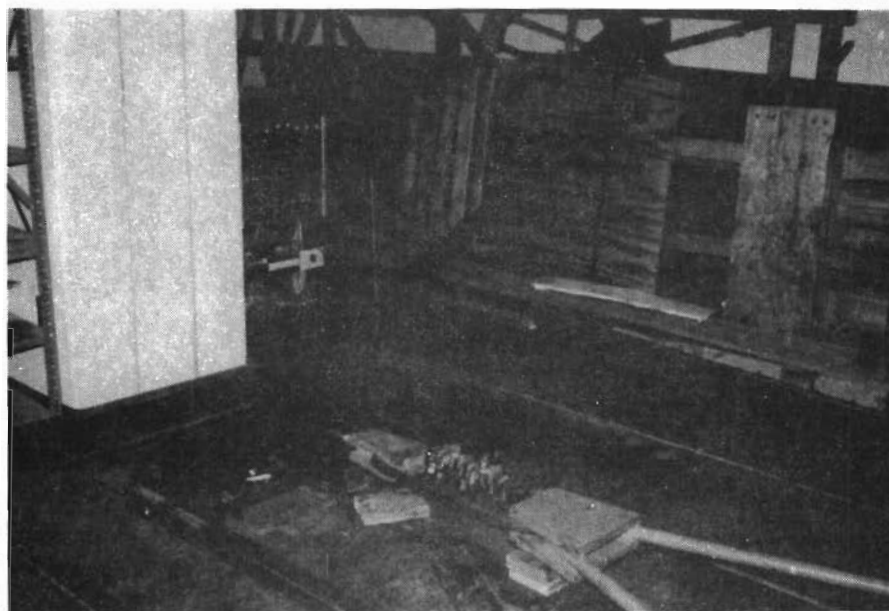
Fig 3.6. Wrench used at pulling end to crack slab.

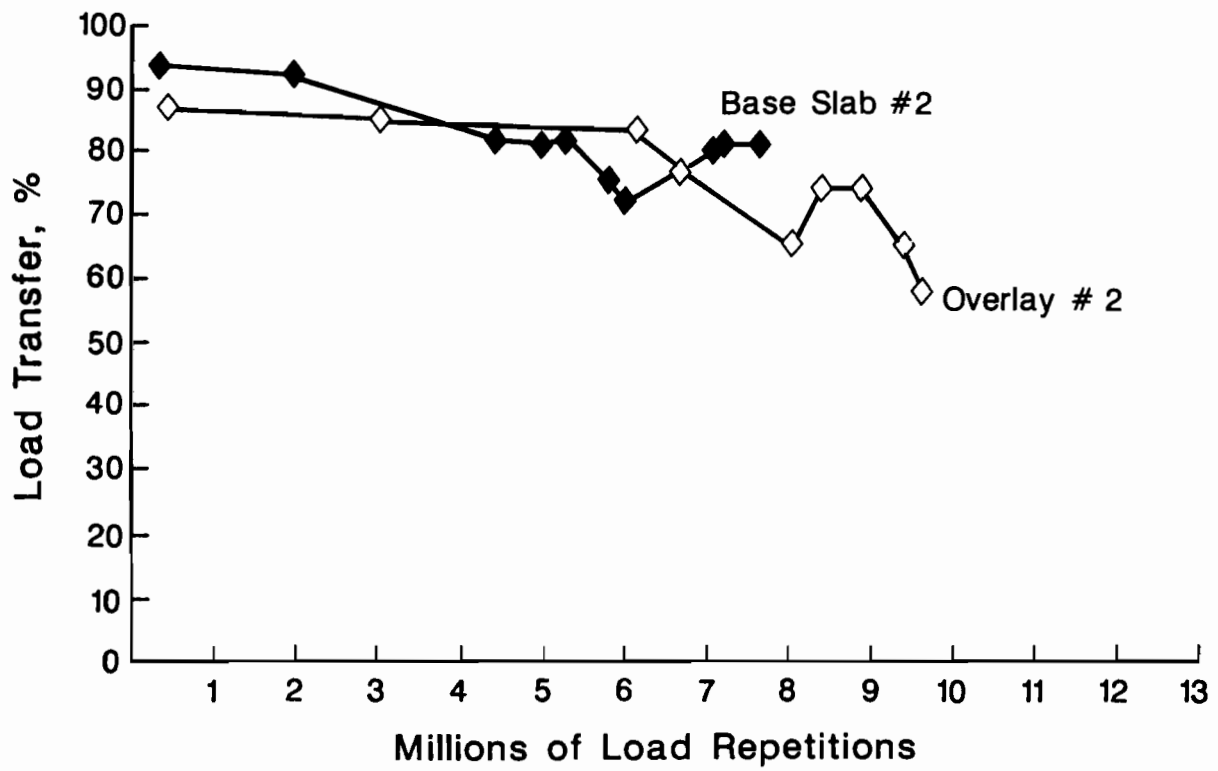
Fig 4.2. Load transfer of Base Slab and Overlay No. 2.

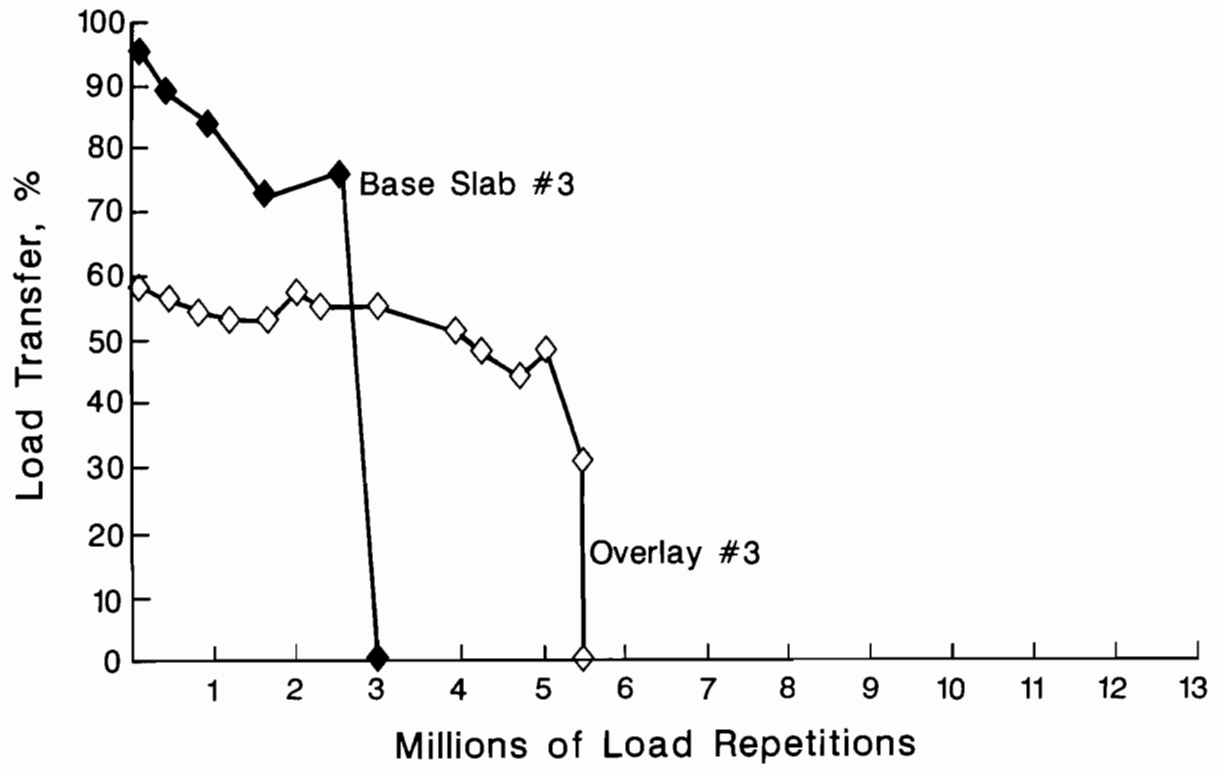
Fig 4.3. Load transfer of Base Slab and Overlay No. 3.

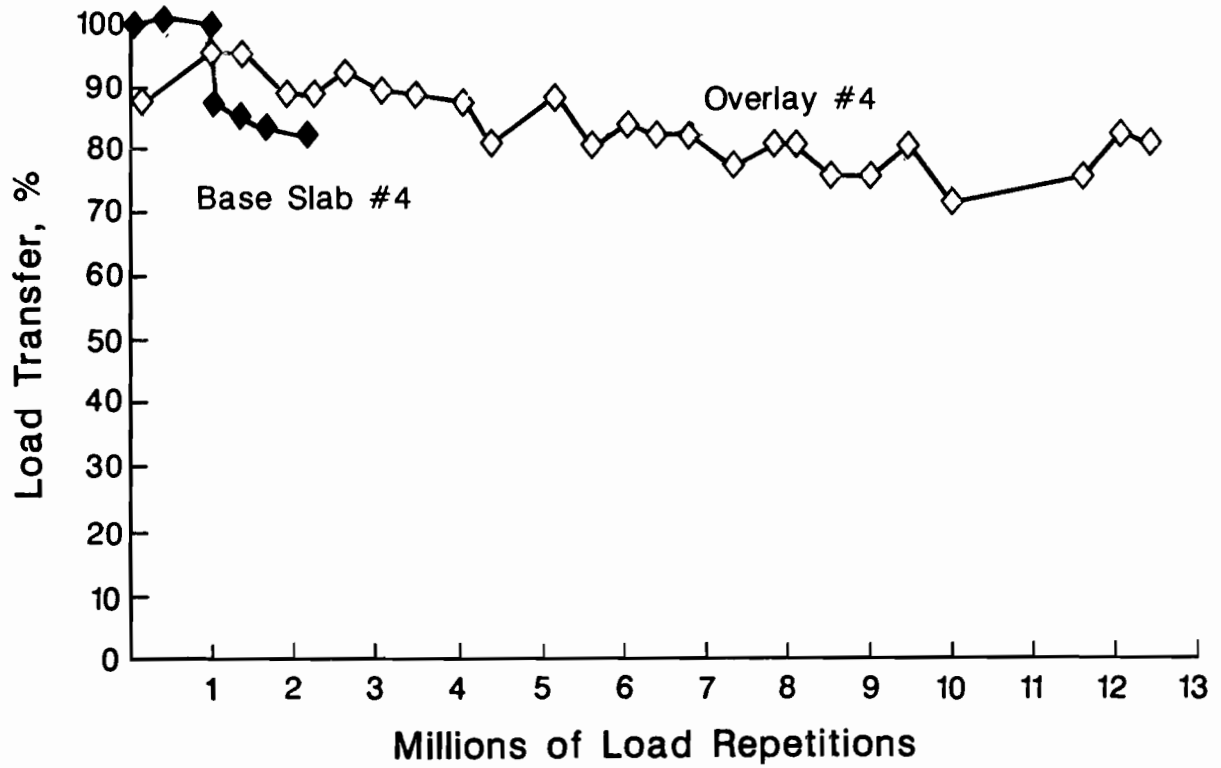
Fig 4.4. Load transfer of Base Slab and Overlay No. 4.

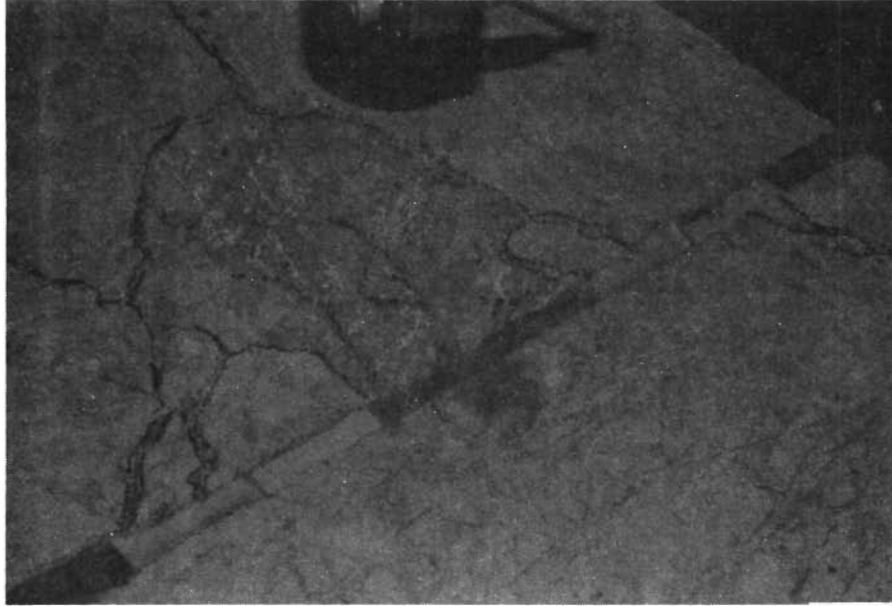
(a) Before repair.

(b) After repair.

Fig 4.5. Punchout failure of Base Slab No. 3.

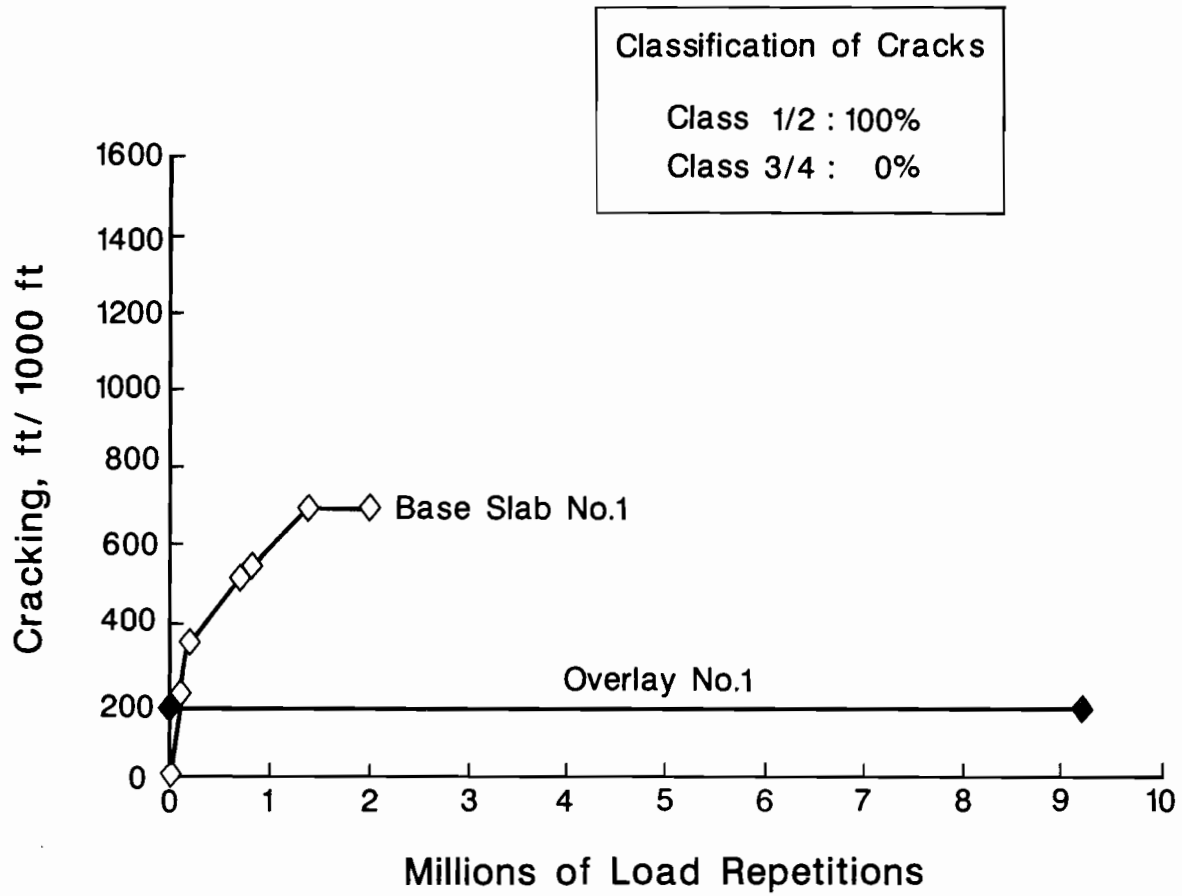
Fig 4.7. Development of cracking for Base Slab and Overlay No. 1.

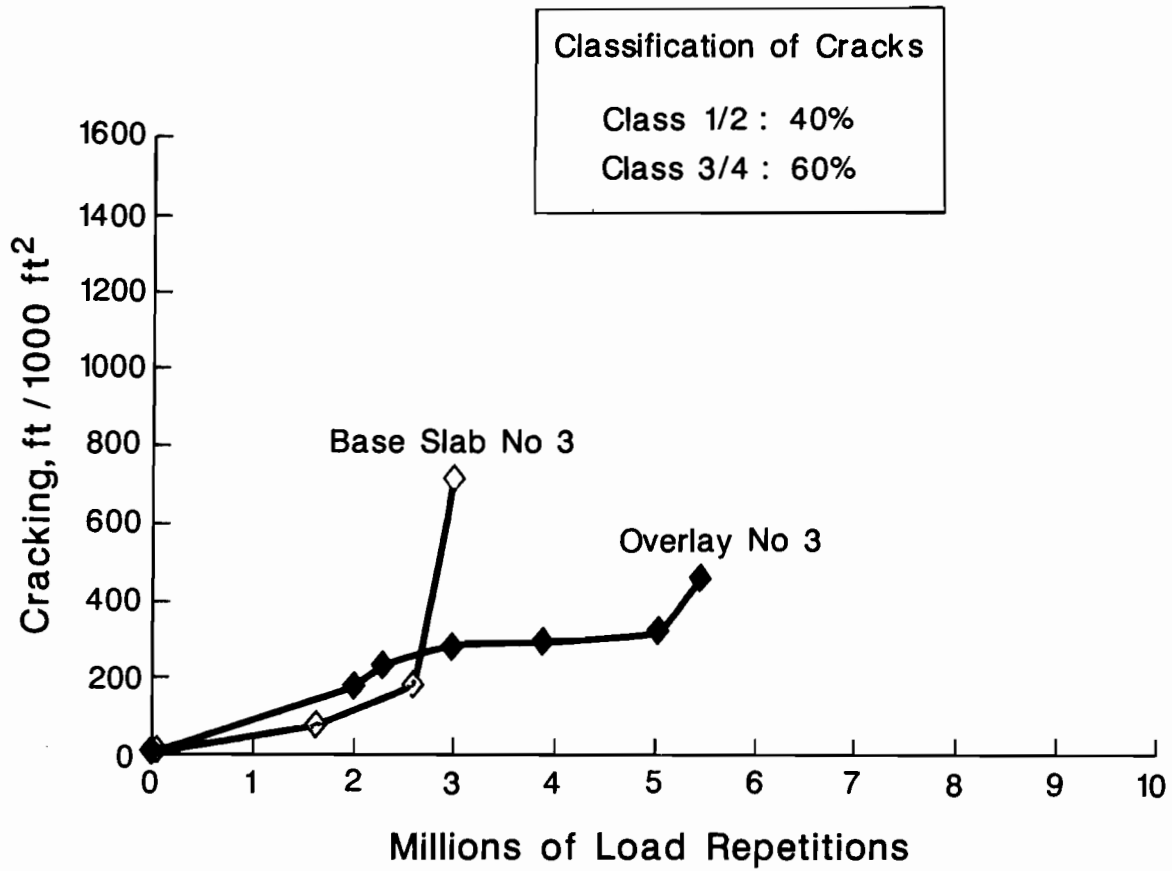
Fig 4.9. Development of cracking for Base Slab and Overlay No. 3.

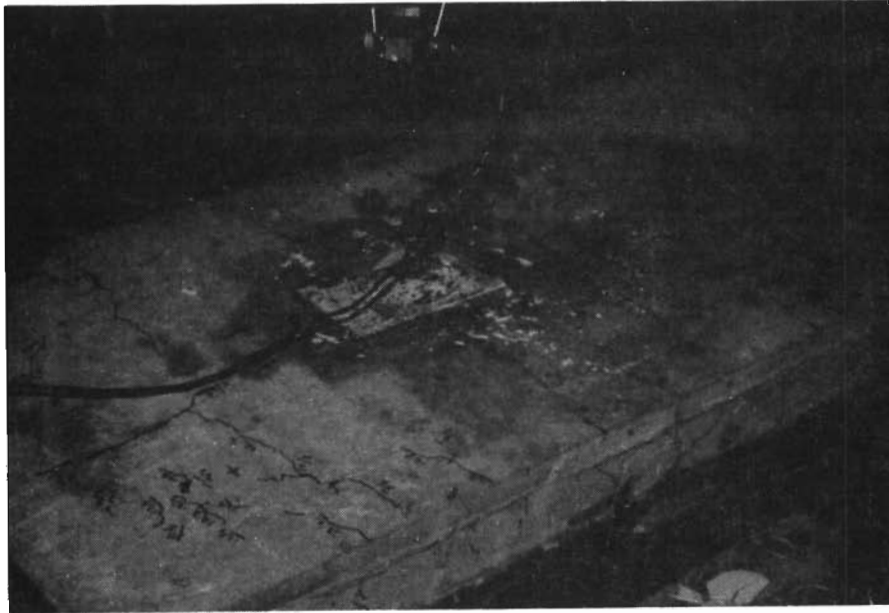
Fig 4.14. Overlay No. 2 after 9 million cycles.

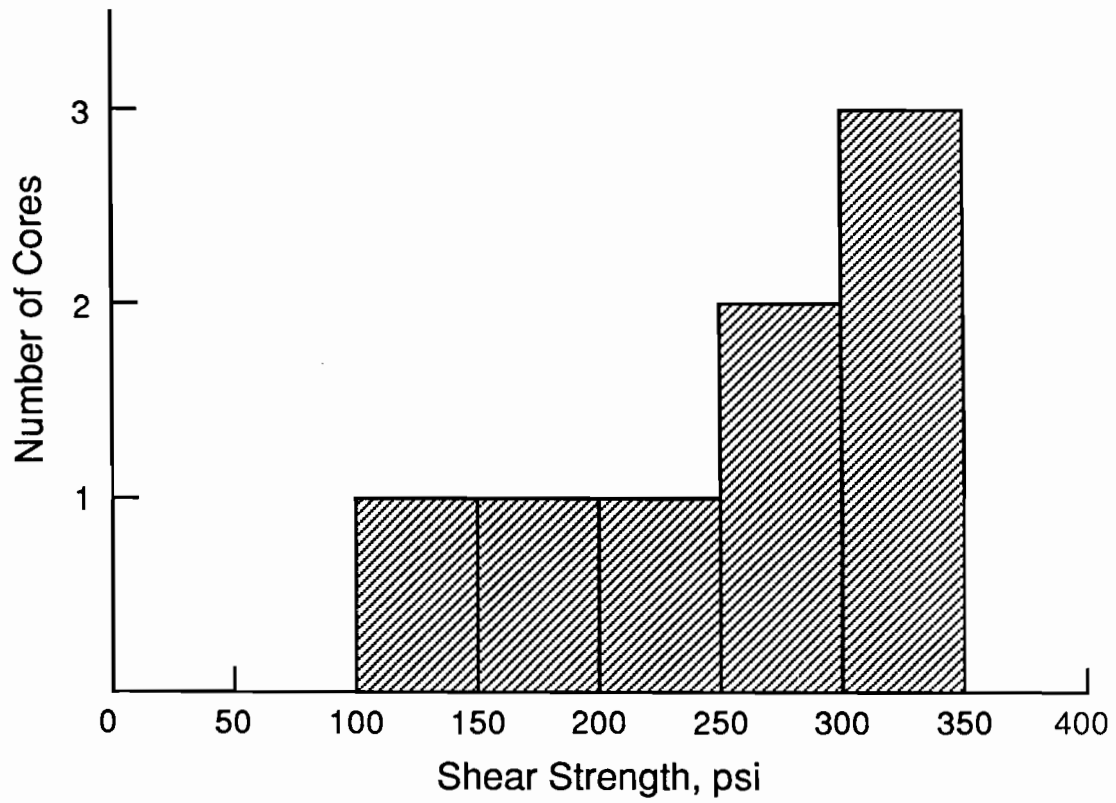
Fig 4.20. Shear strength at interface of Slab No. 2.

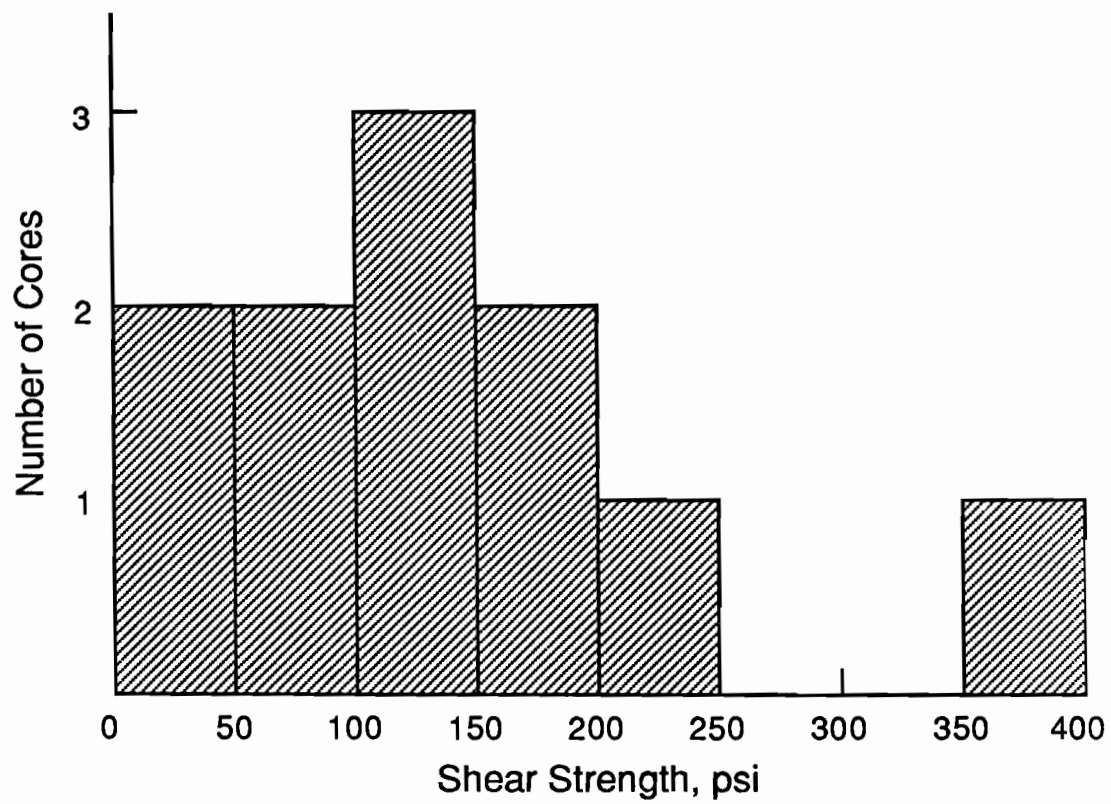
Fig 4.21. Shear strength at interface of Slab No. 3.

Slab No. 3 (Fig 4.21) had an average shear strength of 139 psi and a standard deviation of 102 psi. These numbers include 2 cores out of the 11 taken (Figs 4.22 and 4.23) that had zero shear strength. Delamination in Slab No. 3 had occurred directly beneath the loading plate and at one of the corners of the slab.

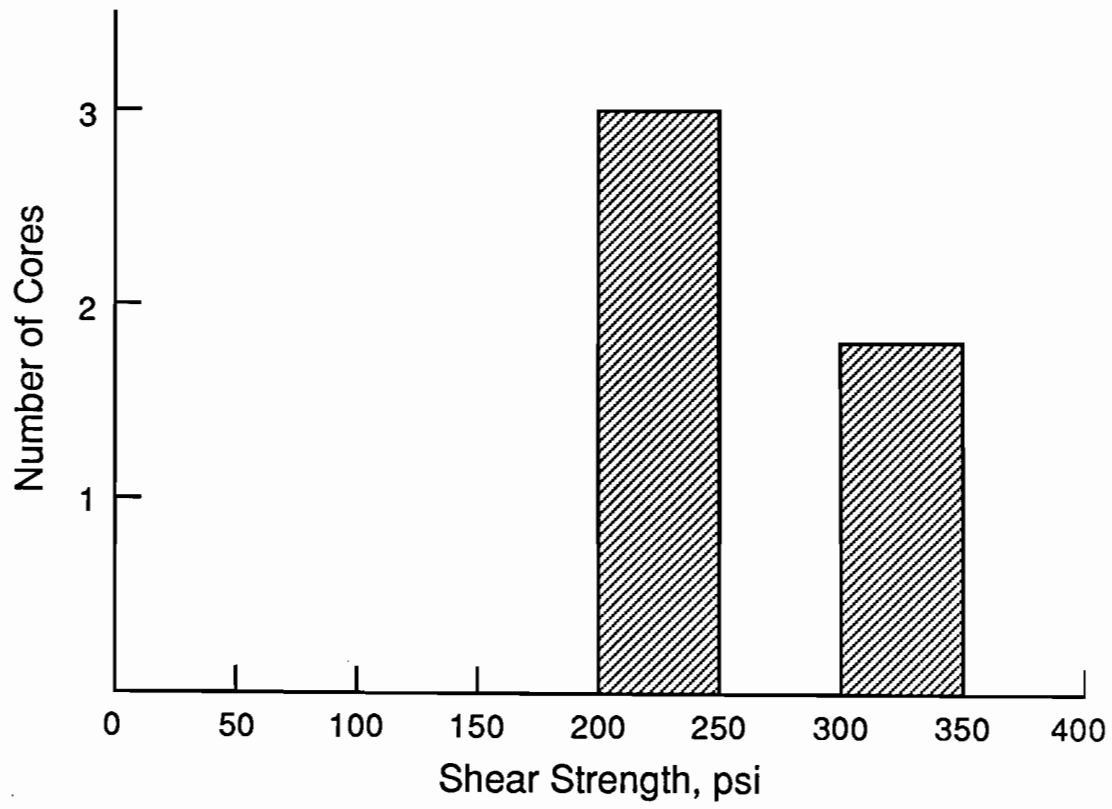
Fig 4.24. Shear strength at interface of Slab No. 4.

Slab No. 4 (Fig 4.24) had an average shear strength of 270 psi and a standard deviation of 62 psi. There were no signs of delamination in Slab No. 4.

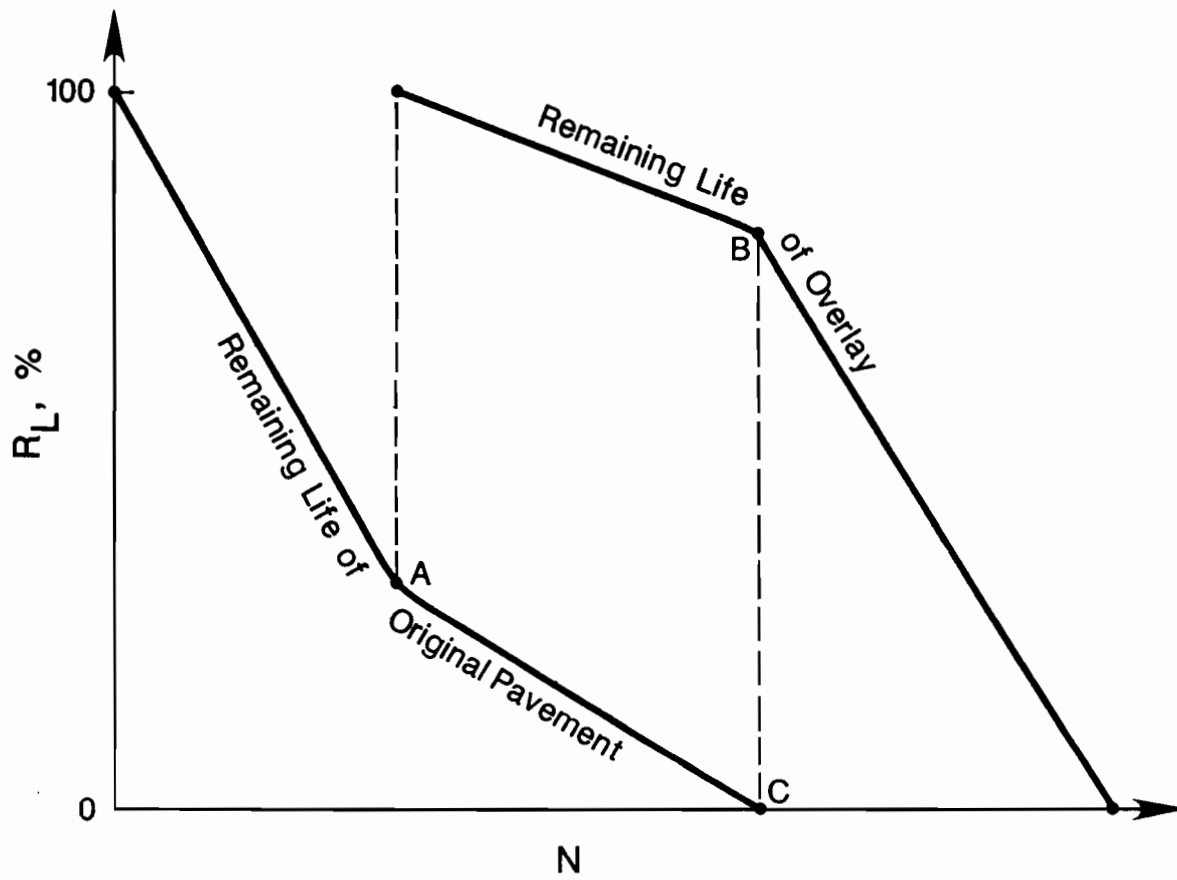
Fig 5.1. Remaining life (R_L) as a function of load repetitions (N).

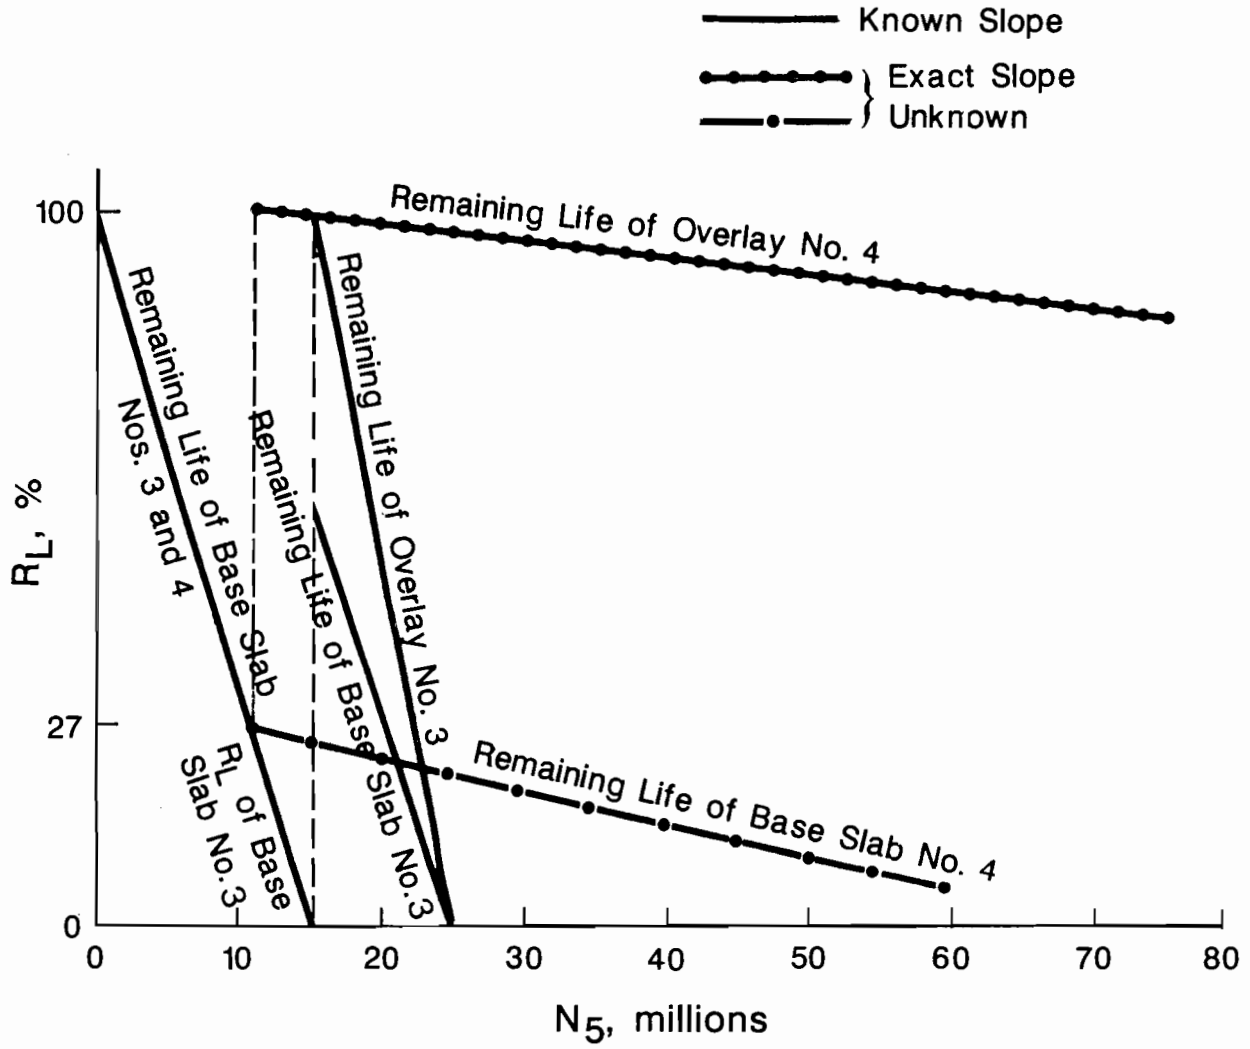
Fig 5.6. Remaining life of Slab Nos. 3 and 4.

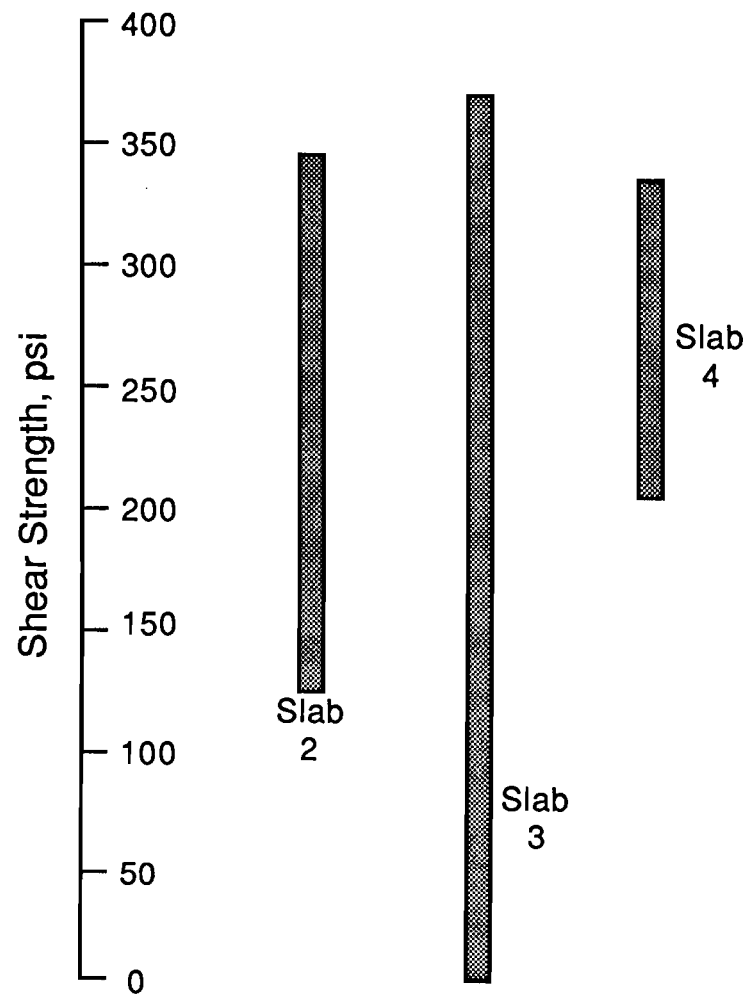
Fig 6.1. Range of interface shear strength of slabs 2, 3, and 4.

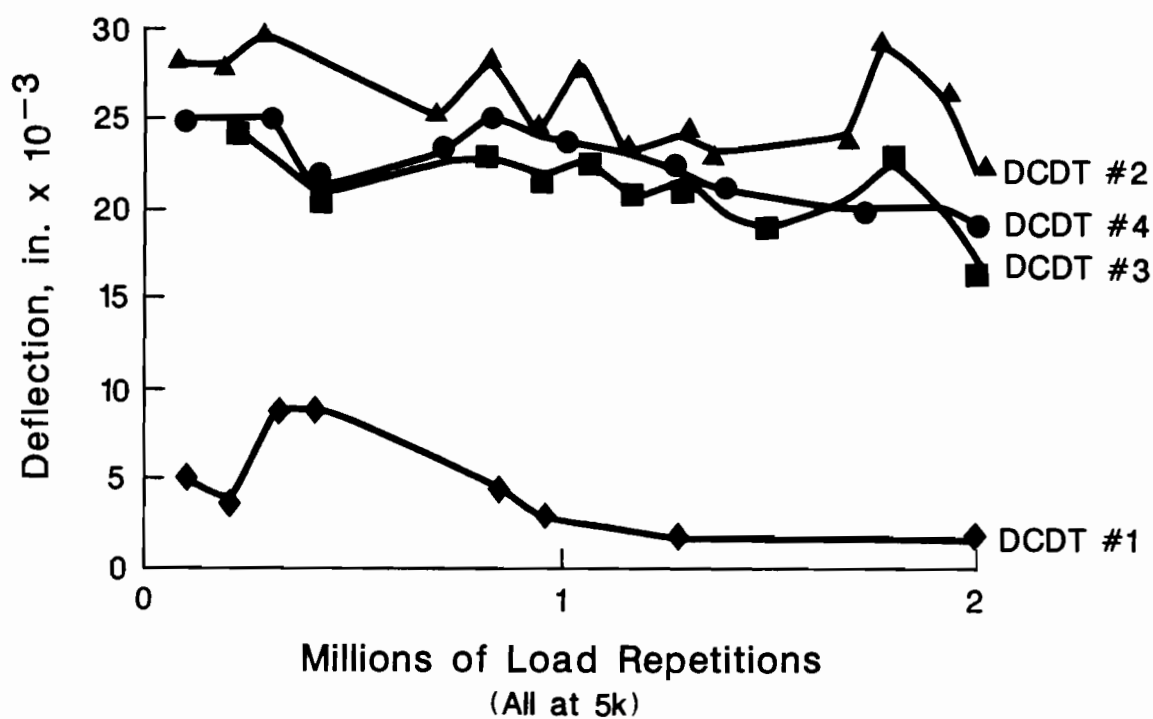
Fig A.1. Deflections of Base Slab No. 1.

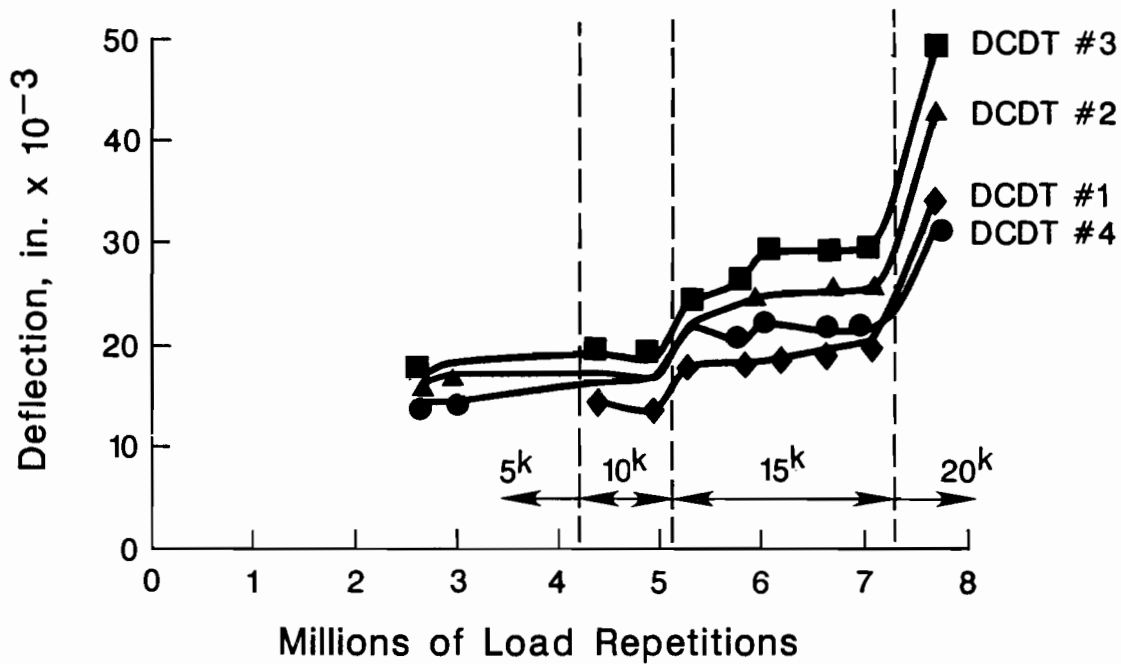
Fig A.3. Deflections of Base Slab No. 2.

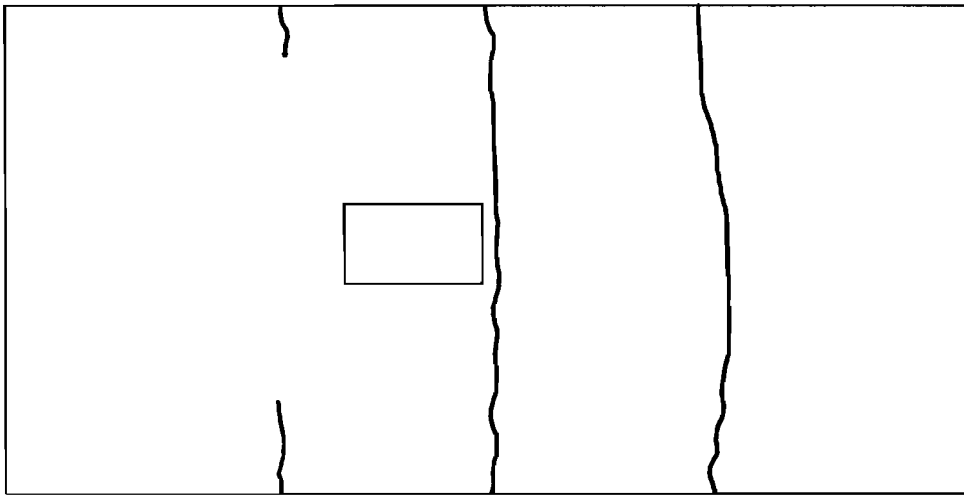
Fig B.1. Base Slab No. 1 after 100,000 load repetitions.

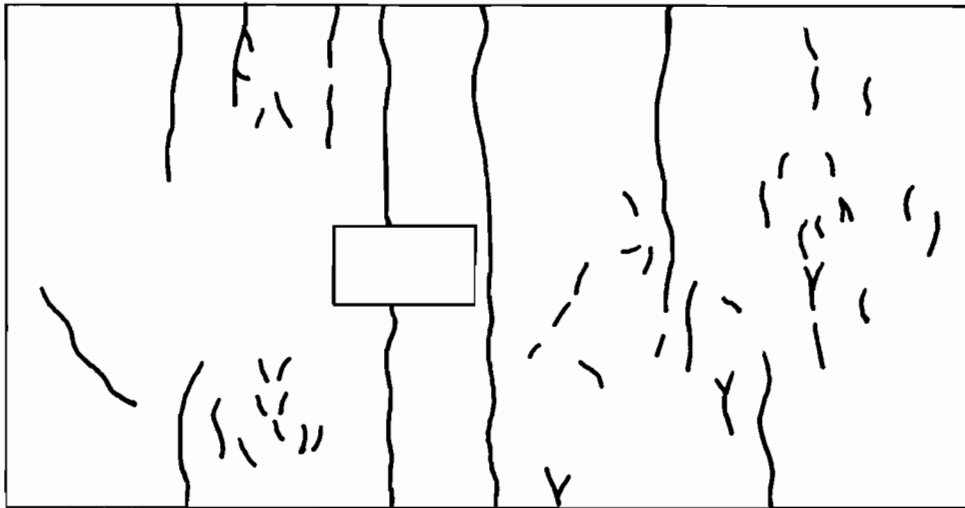
Fig B.8. Base Slab No. 2 after 800,000 load repetitions.
