| <b>4. Title and Subtitle</b><br>AN EXPLORATORY INVESTIGATION OF SHEAR FATIGUE BEHAVIOR OF PRESTRESSED CONCRETE GIRDERS | | <b>5. Report Date</b><br>June 1987 | <b>6. Performing Organization Code</b> |
| <b>7. Author(s)</b><br>Patrick M. Bachman, Michael E. Kreger, and John E. Breen | | <b>8. Performing Organization Report No.</b><br>Research Report 465-1 | |

Research Report 465-1

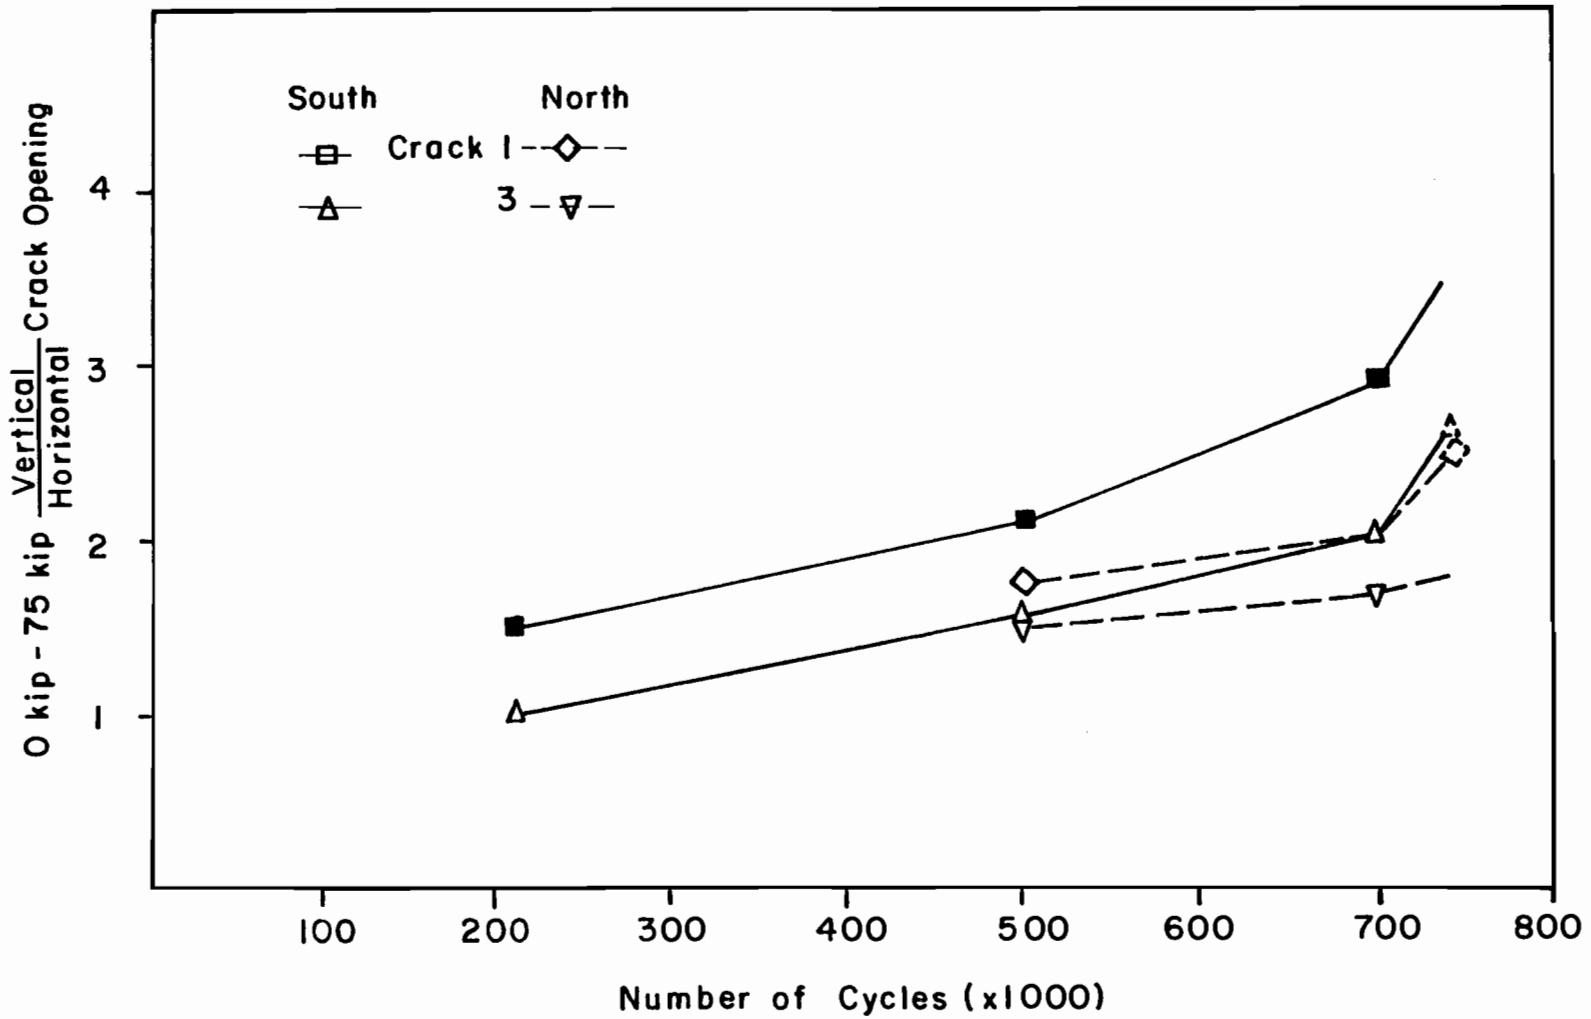
Fig. 4.21 Beam 2, relationship between horizontal and vertical crack opening with progressive load cycles

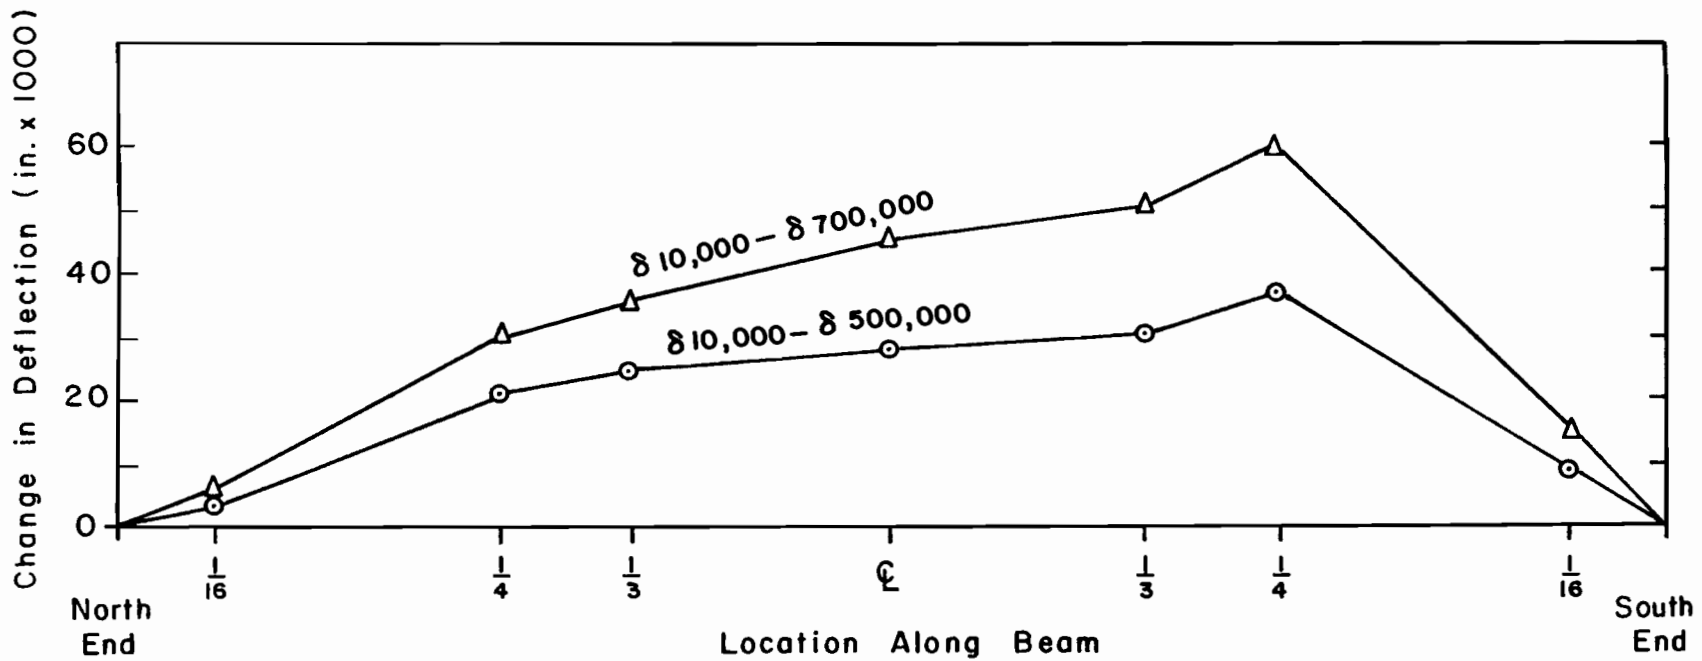
Fig. 4.26 Change in deflection along Beam 2 from 10,000 to 500,000 cycles and from 10,000 to 700,000 cycles

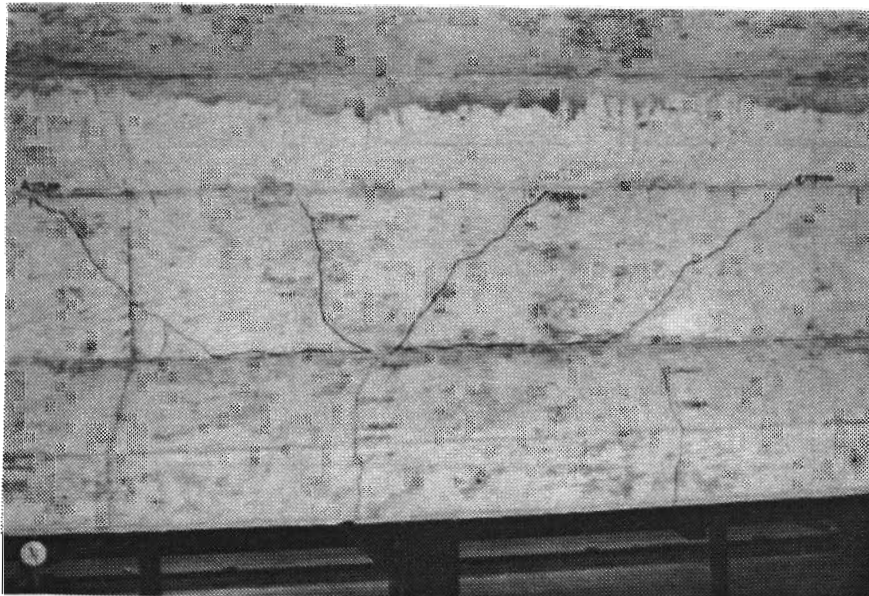
Fig. 4.38 East side (top) and west side (bottom) torsional cracking observed in the flexural failure zone

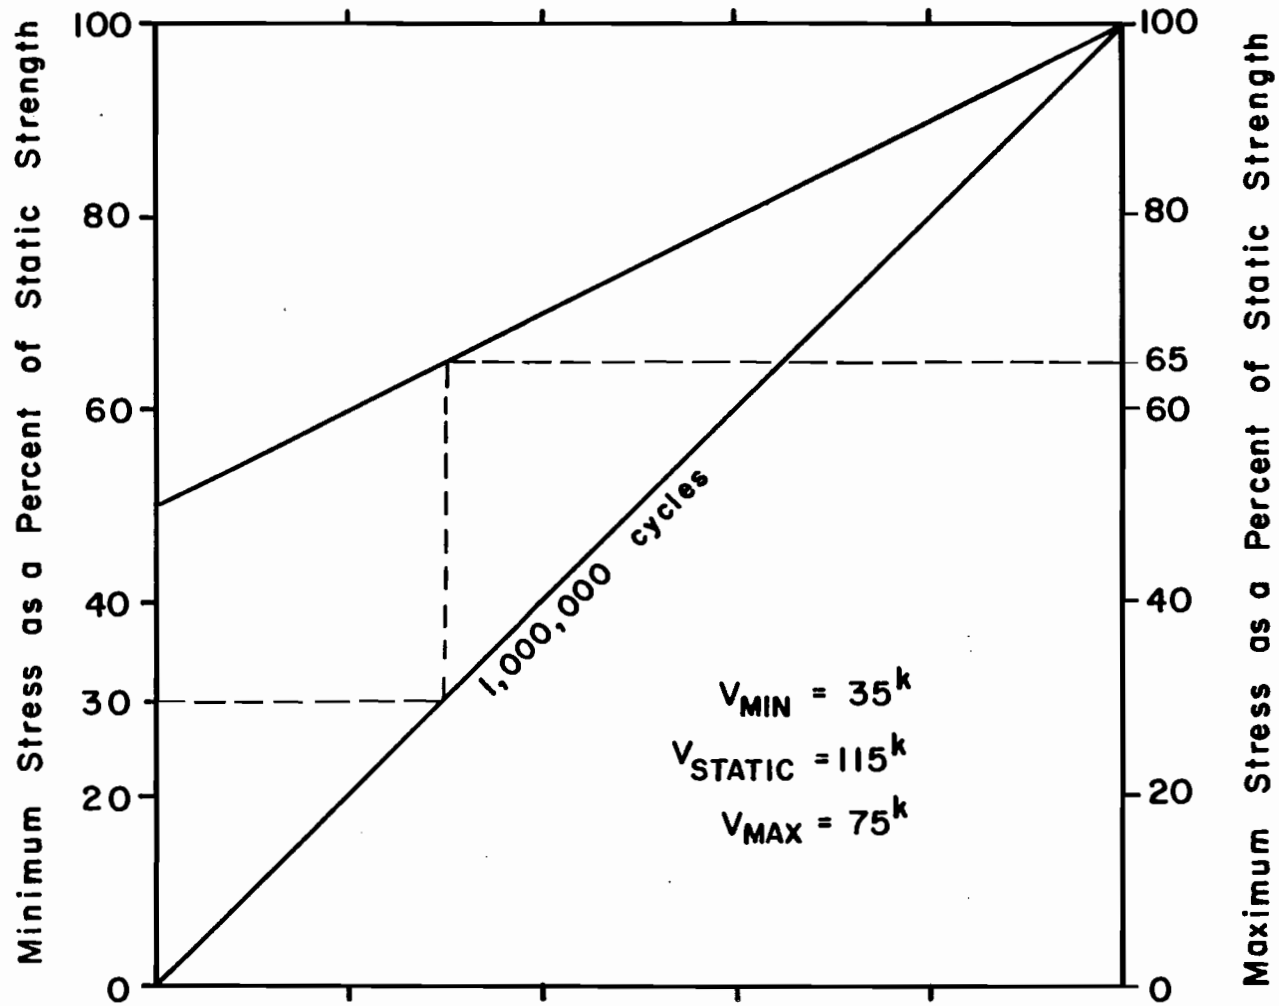
Fig. 5.15 Fatigue strength of plain concrete in tension, compression, or flexure; dashed line indicates value for test specimens (from Ref. 4)
