**"EXPERIMENTAL THIN-BONDED OVERLAY
PAVEMENT IN HOUSTON, TEXAS"**

**Project 561 Initial
(DTFH71-83-3952-TX-15)**

**Prepared by
Steven Golding
Senior Research Engineer
D-10 Research
Texas State Department of Highways & Public Transportation**

INITIAL CONSTRUCTION REPORT: EXPERIMENTAL
THIN-BONDED CONCRETE OVERLAY PAVEMENT IN HOUSTON, TEXAS

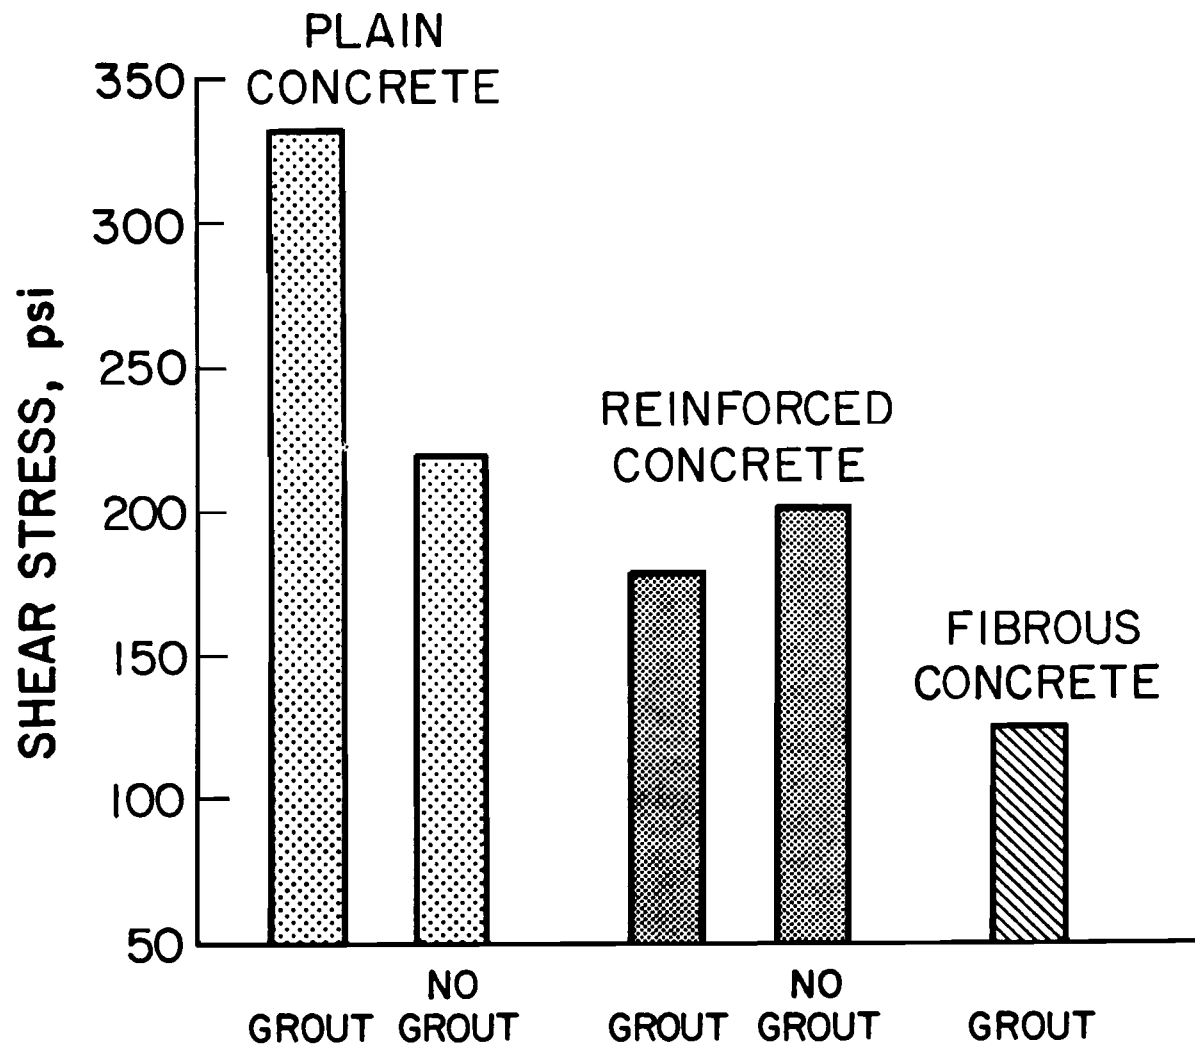
Fig 2 Field cores.

A month after the overlays were placed, field cores were obtained by random sampling. Direct shear tests were performed on 29 cores. Field core shear strength results are shown in Table 8.³ Since the cores from the inner lane had a mean strength of 186 psi and those obtained from outer lanes had a mean strength of 220 psi, it could be concluded that lane location does not have a significant effect on the shear strength at the interface. Figure 2 shows the mean shear stress obtained under the different conditions.³

Since the cores with grout and Daraweld-C as a bonding agent had a mean shear strength of 135 psi, and those with no grout at the interface had a strength of 213 psi, it may be concluded that the dry surface without grout during dry weather conditions results in higher shear strength at the interface. This result agrees with the laboratory findings that the dry surface with no grout at the interface gave rise to higher shear strength at the interface.

The lowest shear strength obtained was 79 psi, compared with 24 psi, the highest shear stress expected at the interface, giving a factor of safety greater than 3.³

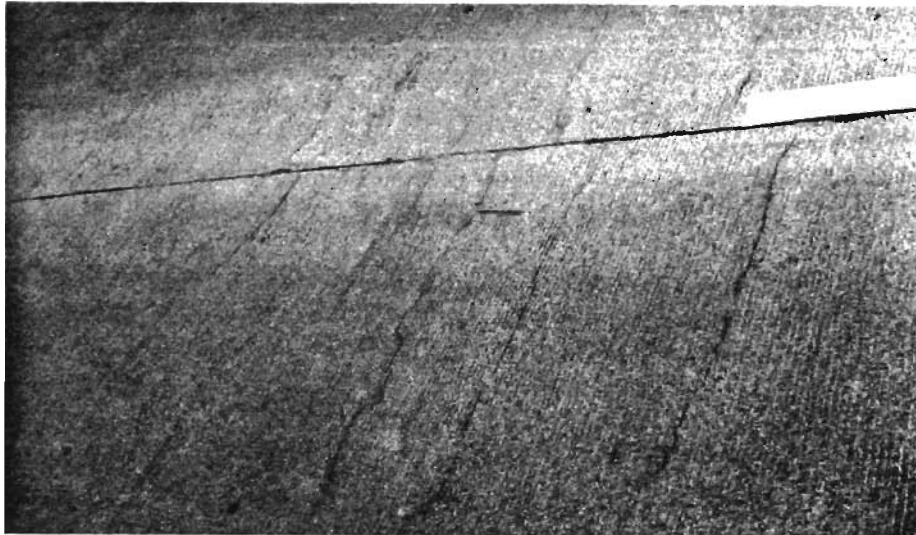
A portion of the IH-610 thin bonded overlay test section with evident lateral cracks.

From Table 1, it can be seen that construction of the thin bonded overlay resulted in a large reduction in the number of cracks.¹ Average crack width was also reduced. Table 2 shows that spalling, which was widespread before the overlay, did not occur after construction of the overlay.¹ No maintenance on the thin bonded overlay has been performed to date.
