**FINAL CONSTRUCTION REPORT:
EXPERIMENTAL THIN BONDED CONCRETE
OVERLAY PAVEMENT IN HOUSTON, TEXAS**

Demonstration Project 561

FINAL CONSTRUCTION REPORT

**Project 561
(DTFH71-83-3952-TX-15)**

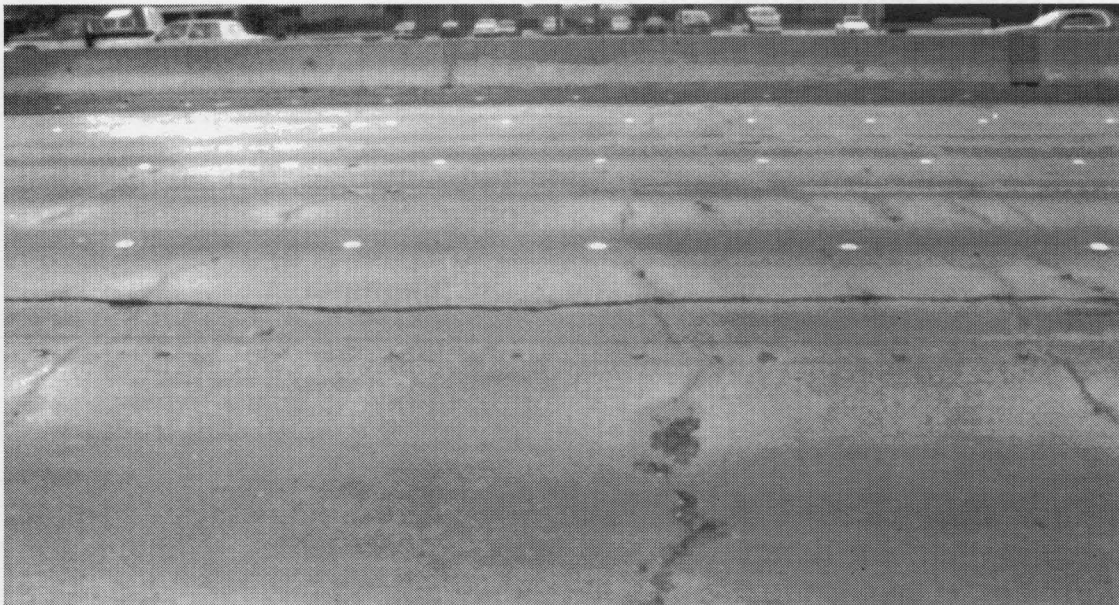
Figure 1. Loop 610 before overlay. Note longitudinal cracking and surface spalling.

Defects in the original CRCP surface consisted primarily of spalled transverse cracks, longitudinal cracks and punchouts of varying dimensions. Although these defects were not considered an immediate threat to the life and load carrying capacity of the structure, they required increasing amounts of maintenance and caused increasing disruptions and inconveniences to heavy traffic. When it became obvious that something had to be done and that some form of rehabilitation would be necessary in the near future, the decision was made to place an experimental thin bonded concrete overlay on the structure.
