1. Report No. TX-95+987-3		2. Government Accession No.		3. Recipient's Catalog #	
4. Title and Subtitle CONSTRUCTION OF REHABILITATION TEST SECTIONS ON US 59 IN THE LUFKIN DISTRICT				5. Report Date August 1994

**CONSTRUCTION OF REHABILITATION TEST SECTIONS ON US 59
IN THE LUFKIN DISTRICT**

Research Report 987-3

A Long-Range Plan for the Rehabilitation of US 59 in District 11

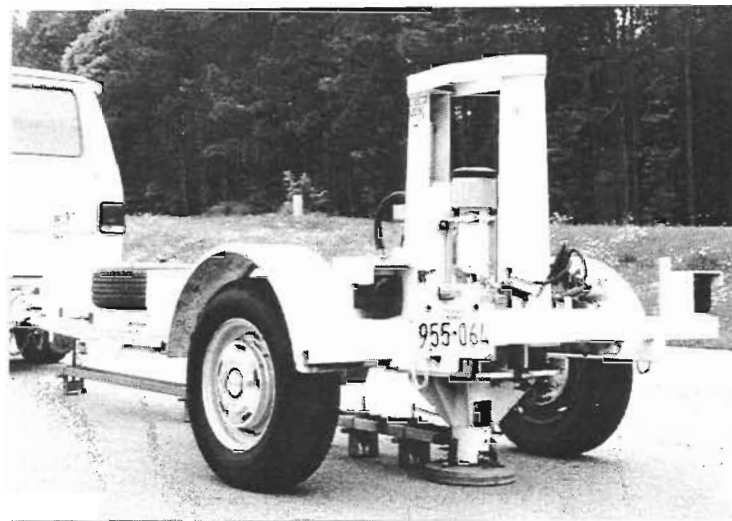
Figure 2.1. The FWD operating within the flexible sections

Falling weight deflectometer (FWD) measurements were taken prior to construction every 50 feet on both the rigid and flexible sections. The FWD documents the condition of the pavement below the surface layer by measuring deflections that may be used to estimate the load transfer characteristics. Figure 2.1 shows the FWD recording the condition of the pavement at the future rigid test section site.

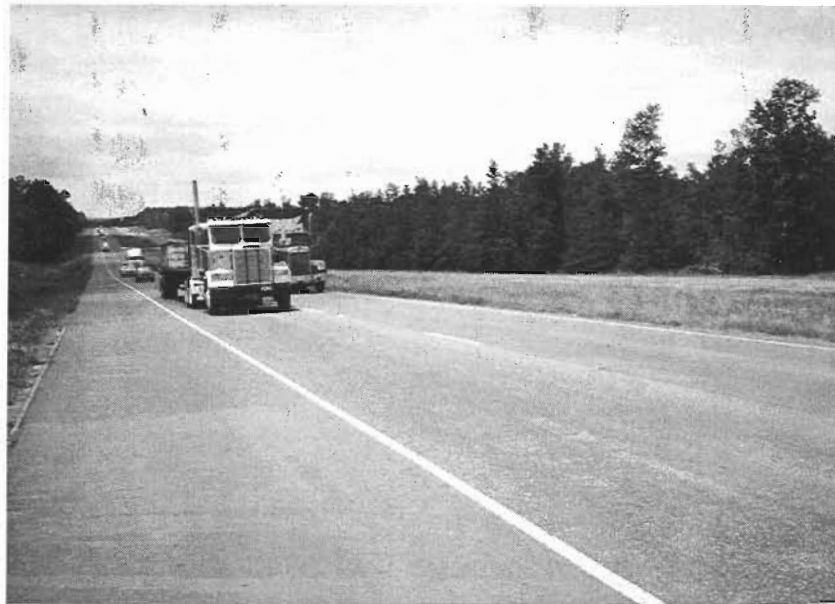
Figure 2.2. Truck traffic in the flexible sections

Traffic data were collected by Lufkin District personnel from D-10. This traffic data included both the history of traffic and a future projection of what traffic numbers will likely be in the years to come. The future traffic predictions were derived from past trends and the expected growth of industry and population. US 59 within the Lufkin District includes a high percentage of truck traffic. US 59 offers a direct north route from the Port of Houston and is also used by the large logging industry within the district. Figure 2.2 shows a typical logging truck, a common site, traveling on US 59. The heavy truck traffic, which comprises over 20 percent of the overall traffic in the Lufkin District, is a major contributor to the number of failures that have occurred on US 59

in the Lufkin District in the past. These failures were documented in the set of detailed condition surveys conducted by CTR personnel.

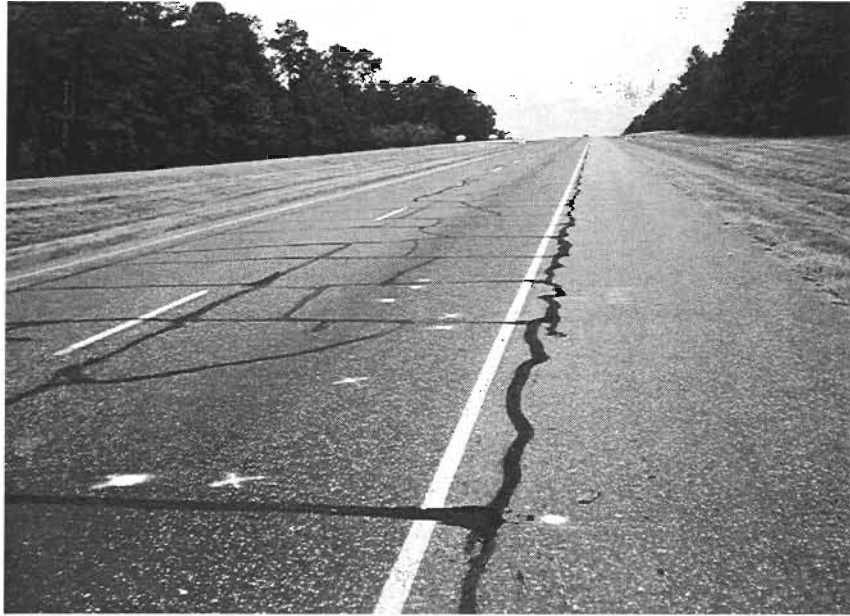
Figure 2.3. Rigid sections prior to rehabilitation

Photographs and video were taken in conjunction with the condition survey to document the surface condition of the pavement. Figure 2.3 shows the general condition of the rigid pavement site prior to the start of rehabilitation, as documented in photographs and video.

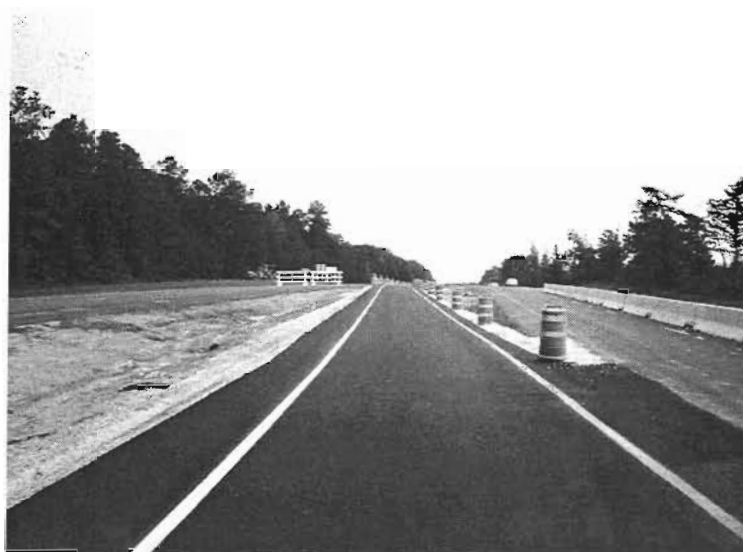
Figure 3.3. Finished view of Detour #4

Placement then included 20.32 cm (8 inches) of cement-treated foundation and a one-course surface treatment, followed by 25.4 cm (10 inches) of Type A flexible base material with a prime coat and one-course surface treatment. Finally, a 5.08-cm (2-inch) Type C asphalt base was placed on the detour surfaces. All asphalt was supplied by East Texas Asphalt located in Lufkin, Texas, approximately 32.19 km (20 miles) from the rigid section sites. Concrete barriers were placed in the northbound lanes to separate the bidirectional traffic. The detours were finished and ready for traffic by August 28; traffic was diverted that afternoon (Fig 3.3). Figure 3.4 illustrates the traffic handling plan and shows the layout of the test sections.

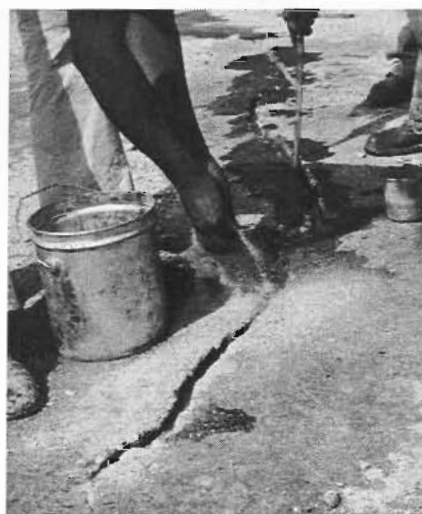
Figure 3.6. Placement of HMWM and sand

On August 30, 1991, the surface material was once again milled off, exposing the JCP. All cracks and joints were water blasted and then air blasted. After the cracks and joints were cleaned, a thin layer of black tar was applied in the joints to act as a sealer. Sand followed by HMWM was once again applied to the cracks. In this process 189.27 L (50 gallons) of HMWM were used, along with over 453.59 kg (1,000 pounds) of sand. All the exposed joints were sealed and the exposed cracks were treated with the HMWM. A detailed condition survey of Section R1 was conducted in order to monitor the success of the joint and crack repairs (Appendix B). Cores were taken over the treated cracks and joints to confirm the strength of the bond. Figure 3.6 shows the placement of the HMWM and sand, while Figure 3.7 shows the subsequent cores.

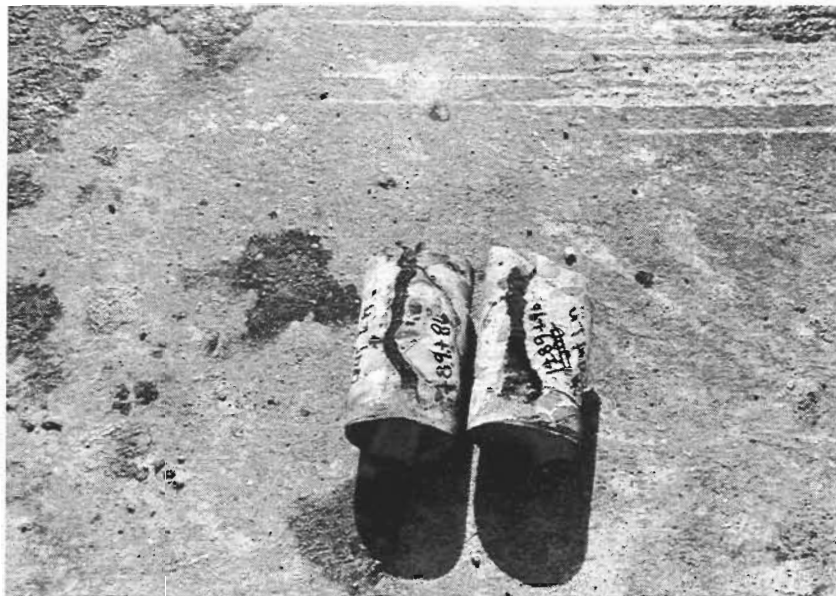
Figure 3.7. Cores taken from Monomer repair

FWD deflection measurements were also taken again to estimate the load transfer. Both the cores and FWD data confirmed that the integrity of the slabs and joints had been restored. The inside shoulder was then removed and excavated in preparation for shoulder extension (Fig 3.8).

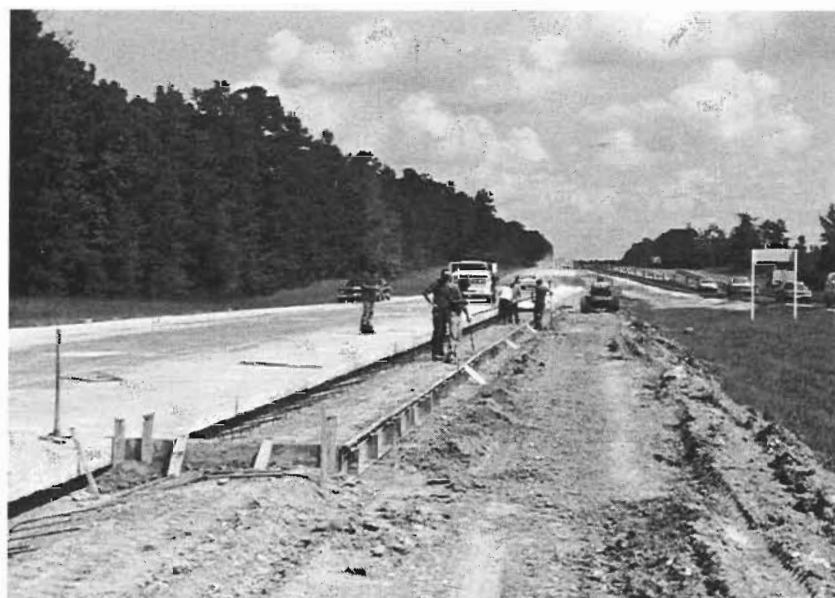
Figure 3.8. Excavation and preparation for shoulder extension

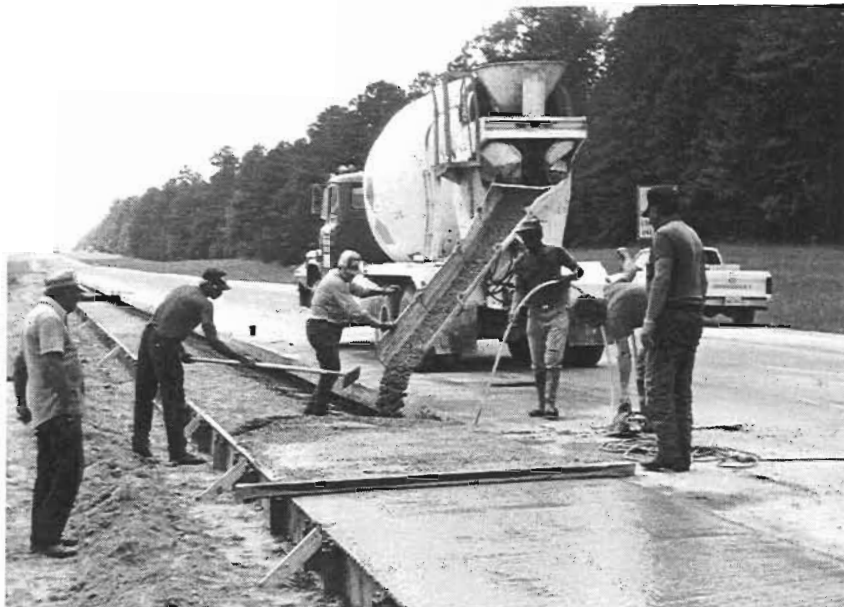
Figure 3.10. Placement of extended shoulder

Figure 3.9 shows the design plan for the shoulder extension. The inside shoulder of the jointed concrete pavement was extended 1.98 m (78 inches) using 22.86 cm (9 inches) of portland cement concrete (Fig 3.10).

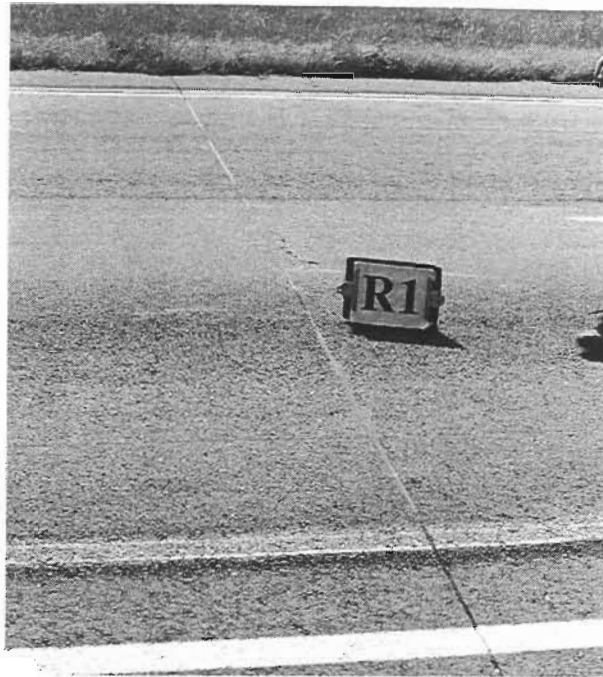
Figure 3.11. Saw cut over joint in R1

After all repairs were made and after the shoulder was extended, a one-coarse surface treatment was applied over the 304.8-m (1,000-foot) section, followed by 6.35 cm (2.5 inches) of Type C base. The base was then followed by a 3.81-cm (1.5-inch) Type C surface material. After the placement of all the roadway material, a pavement saw was used to make 34 saw cuts over the joints in an attempt to control cracking. The saw cut was set at a 1.91 cm (3/4 inch) depth (approximately). The cuts started at 79.25 m (260 feet) into the section and were placed every 4.57 m (15 feet) to match the joint spacing. The cuts ended 234.70 m (770 feet) into the section. This

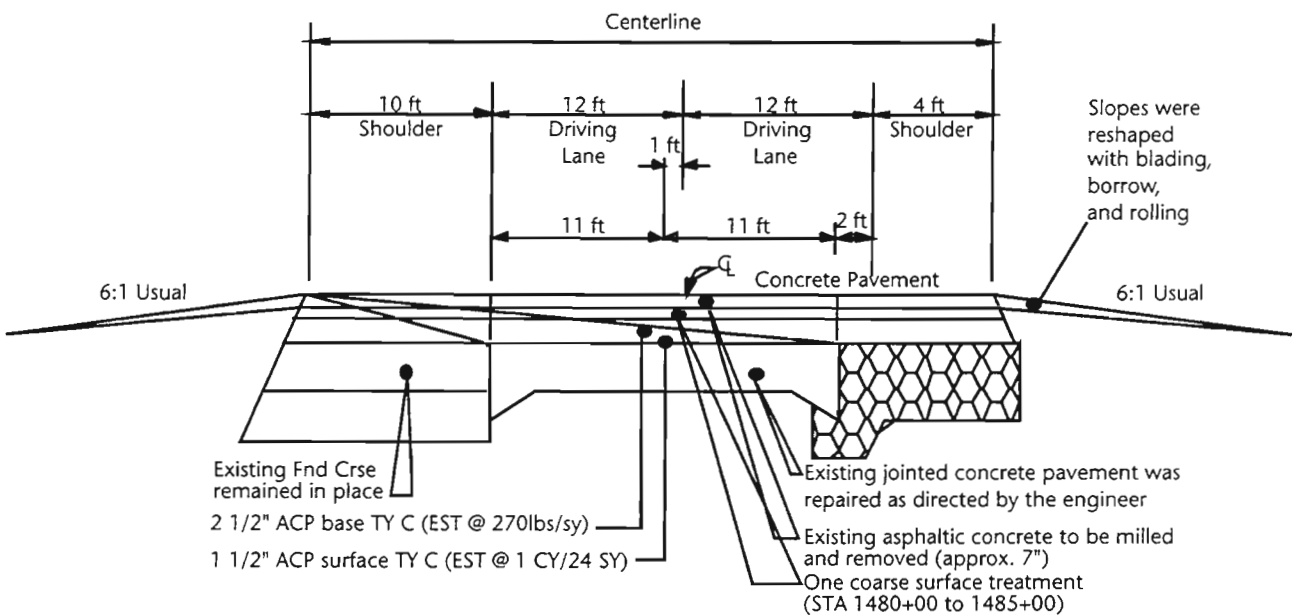
Figure 3.12. Post-construction cross section of R1

completed the construction of Test Section R1. Figure 3.12 shows the post-construction cross section now in place in Section R1.

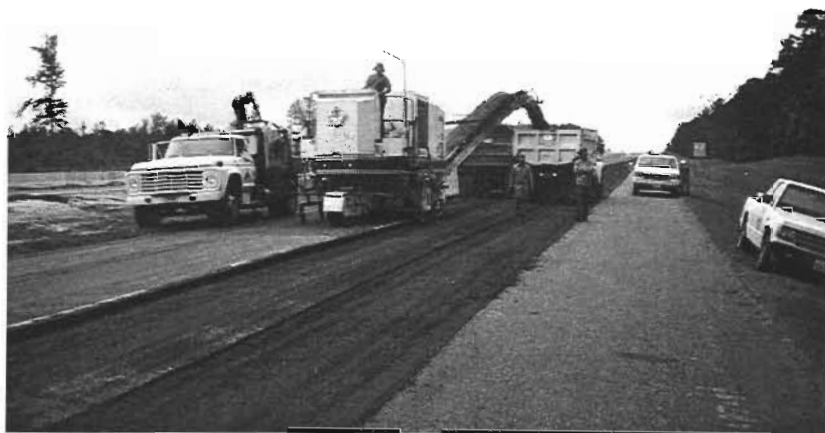
Figure 3.13. Roto-milling of Section R2

In Section R2, the existing asphalt was milled and removed on September 4. After the exposed surface was cleaned (on the morning of September 10), the crack and seat operation began on Research Test Section R-2A and R-2B. The roto-milling operation went very smoothly, and the exposed jointed-concrete pavement was very clean, which would suggest that a tack coat was never used on the pavement prior to the first overlay (Fig 3.13). There was some evidence along the jointed-concrete pavement of extensive joint repair that had affected the surface of the concrete. The crack and seat was performed by a Houston subcontractor. The equipment used for the crack and seat operation was a Woergten hammer and a 45,359-kg (50-ton), rubber-tired roller pulled by a front-end loader.

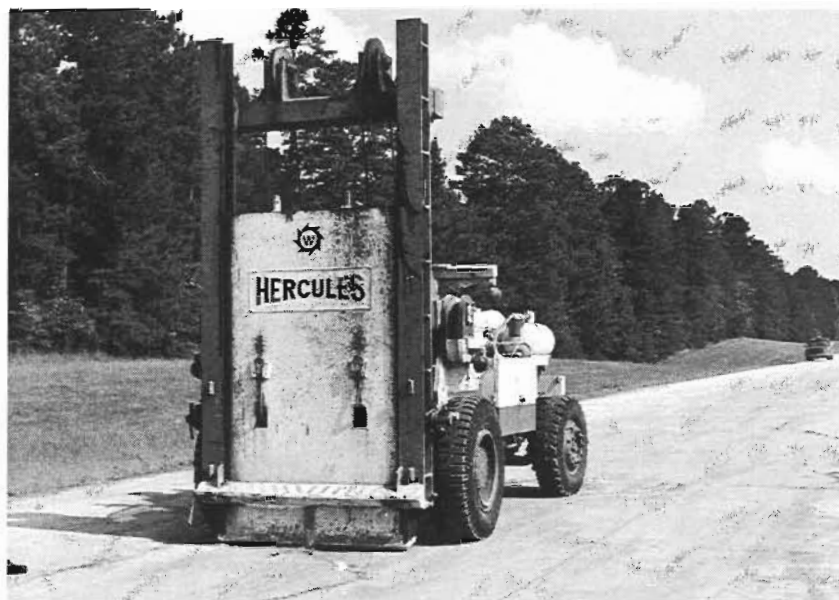
Figure 3.14. Woergten drop hammer

The Woergten drop hammer, capable of dropping a 5896.7-kg (13,000-pound) load at a height of 1.83 m (6 feet), can crack pavements that are 33.02 to 38.1 cm (13 to 15 inches) thick. However, because of the relative thinness of the pavement on US 59 in Lufkin (a 9-7-9 jointed-concrete pavement), the hammer was operated at a drop height of only 30.48 cm (12 inches) to 45.72 cm (18 inches). The target nominal crack spacing was 60.96 cm (24 inches). To achieve this 60.96-cm (24-inch) nominal crack-spacing, the hammer was initially set to drop every 60.96 cm (24 inches). Since the jointed-concrete pavement was 3.35 m (11 feet) wide, it was initially envisioned that one pass of the hammer would achieve a random 60.96-cm (24-inch) crack-spacing across the entire pavement width. However, once the cracking operation had begun, it became obvious that more than one pass would be necessary. Therefore, the hammer was shifted to within 20.32 cm (8 inches) of the pavement edge of the left-hand shoulder. The first pass produced the desired crack spacing. After the first pass along this section, the hammer was placed

on the right-hand side of the pavement 8 inches from the edge. To complete the cracking operation, a third pass was made down the center of the jointed-concrete pavement spanning the longitudinal joint. This method appeared to give the desired uniform 60.96-cm (24-inch) nominal crack-spacing using the Woergten drop hammer (Figs 3.14 and 3.15).

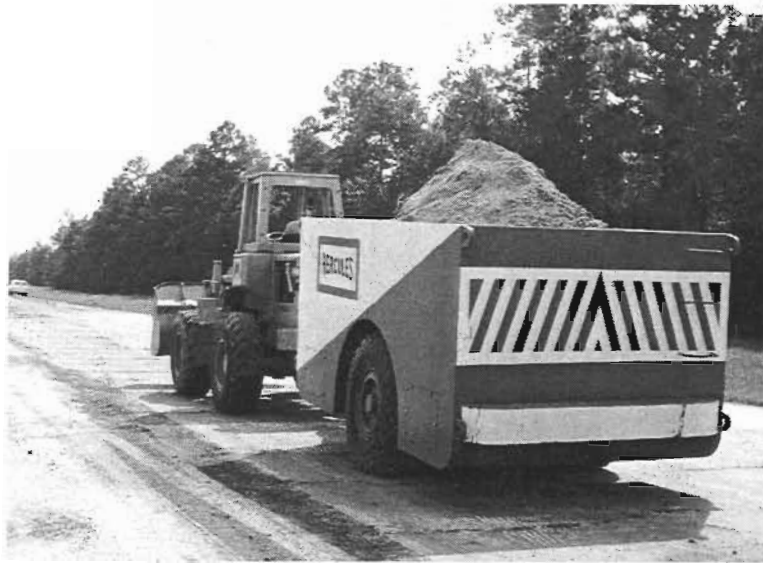
Figure 3.16. Seating roller

To seat the newly-cracked concrete pavement, a 31,751-kg (35-ton) proof roller, towed by a medium-sized, front-end loader, was used. The ballast used in the roller was 1.37 m³ (18 cubic yards) of bank sand. The roller made five passes across each section of the pavement, with the entire operation taking approximately 1.5 hours. As the 31,751-kg (35-ton) roller was moving across the pavement section, very little movement in the cracked pieces of concrete was evident. It seemed that the structural integrity of the pavement was very high despite the extensive cracks in the pavement. However, some slight movements were noticed around some of the more deteriorated joints.

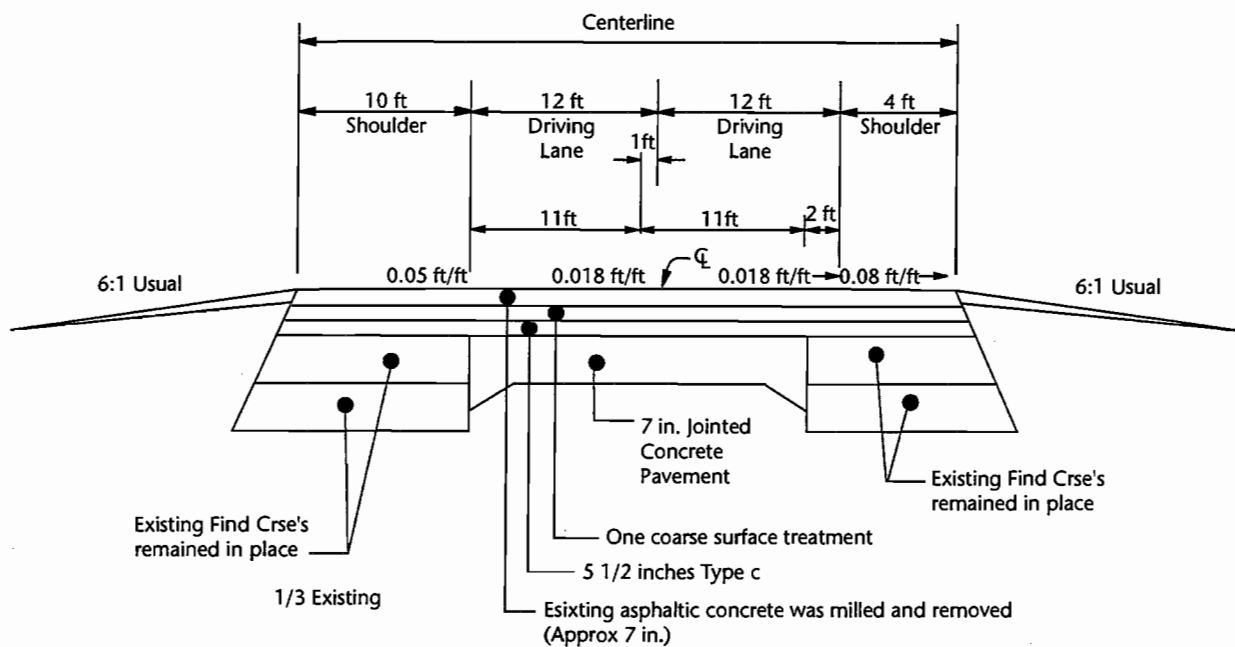
Figure 3.18. Post-construction cross section of R2B

Following the crack-and-seat operation, a one-course surface treatment was applied to the entire test section. Then 6.35 cm (2.5 inches) of Type C base was placed, followed by 3.81 cm (1.5 inches) of Type C surface material on the first 152.4 m (500 feet) of the section. Following that, 10.16 cm (4 inches) of Type C base were placed on the second 152.4 m (500 feet) in two lifts, followed by a lift of 3.81 cm (1.5 inches) of Type C surface material. This completed the construction of Test Section R2 (Figs 3.17 and 3.18).

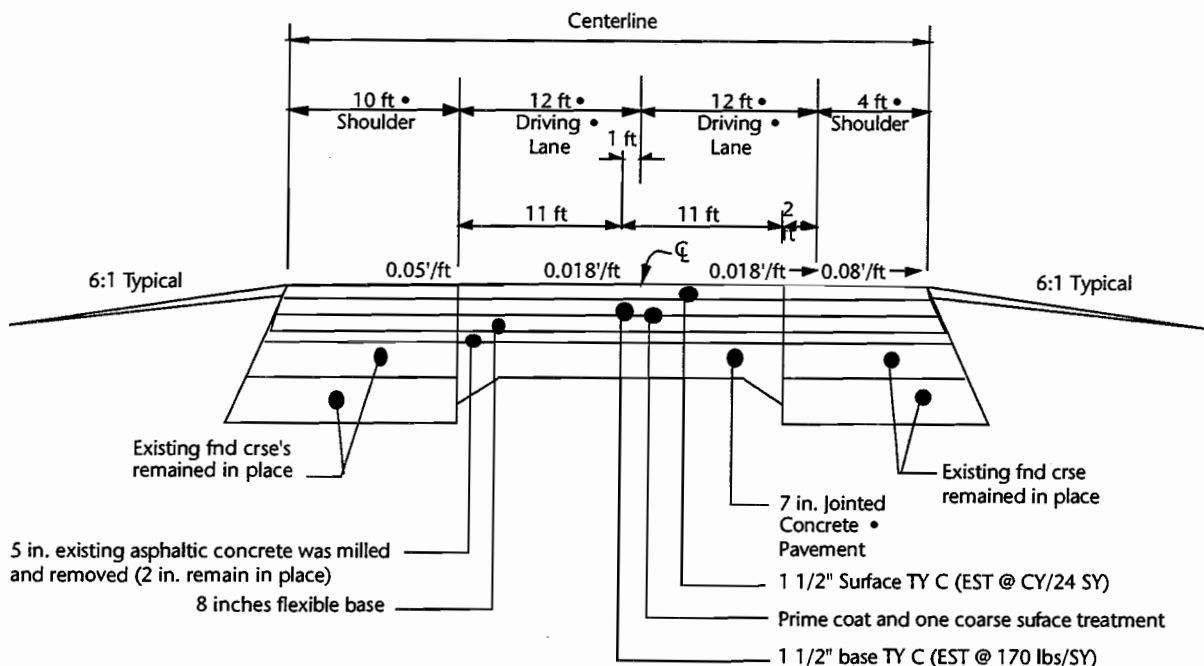
Figure 3.19. Post-construction cross section of R3

In Test Section R3, 5 of the existing 17.78 cm (7 inches) of asphalt concrete were milled and removed. Next, 20.3 cm (8 inches) of flexible base were placed over the remaining 5.08 cm (2 inches) of asphalt concrete. The flexible base was brought in from the maintenance yard in Corrigan (rather than from East Texas Asphalt in Lufkin). A prime coat and one-course surface treatment was then applied over the flexible base. Then, 3.81 cm (1.5 inches) of Type C base and 3.81 cm (1.5 inches) of Type C surface were placed over the entire test section in two lifts, completing construction of Test Section R3 (Fig 3.19).

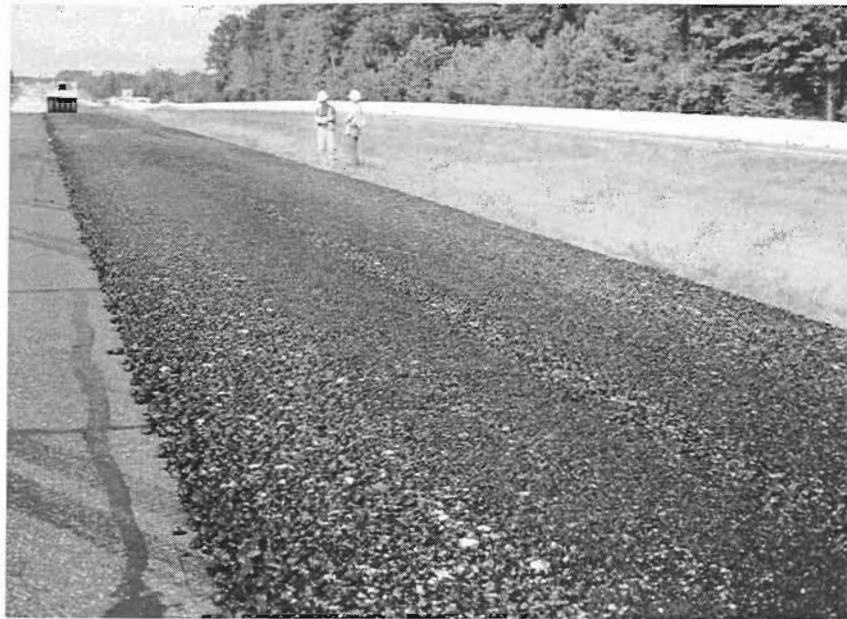
Figure 3.20. Placement of Type G material in R4

In Test Section R4, the existing pavement was not disturbed. A 8.89-cm (3.5-inch) open graded Type G asphalt base with an unusually large coarse aggregate was placed over the existing surface. During placement of the Type G aggregate, some segregation became apparent: The large aggregate was separating from the small aggregate in the auger. The auger appeared to leave the smaller aggregate in the center of the lane and push only the larger aggregate to the outside of the lane. Although adjustments were made to the auger, the segregation was not much affected. The Type G material was followed by 7.62 cm (3 inches) of Type B base and 3.81 cm (1.5 inches) of Type C surface material. Figure 3.20 shows the placement of the Type G material. Figure 3.21 shows the final cross section of R4. Before the overlay process began, an under-drain was installed to collect the water and drain it into the outfalls. The Type G material that was placed between the surface material and the existing overlay — less dense than the other layers — allowed water to move through the material. The under-drain was constructed of a 2.54-cm (1-inch) thick piece of rigid corrugated plastic surrounded by a fine mesh filter. This filter was attached at the bottom to a PVC pipe with small holes to collect the water. The special material surrounding the rigid plastic and the PVC pipe would allow water into the pipe, but filter out any other elements. The under-drain seemed to be functioning properly after the R4 test section was completed.

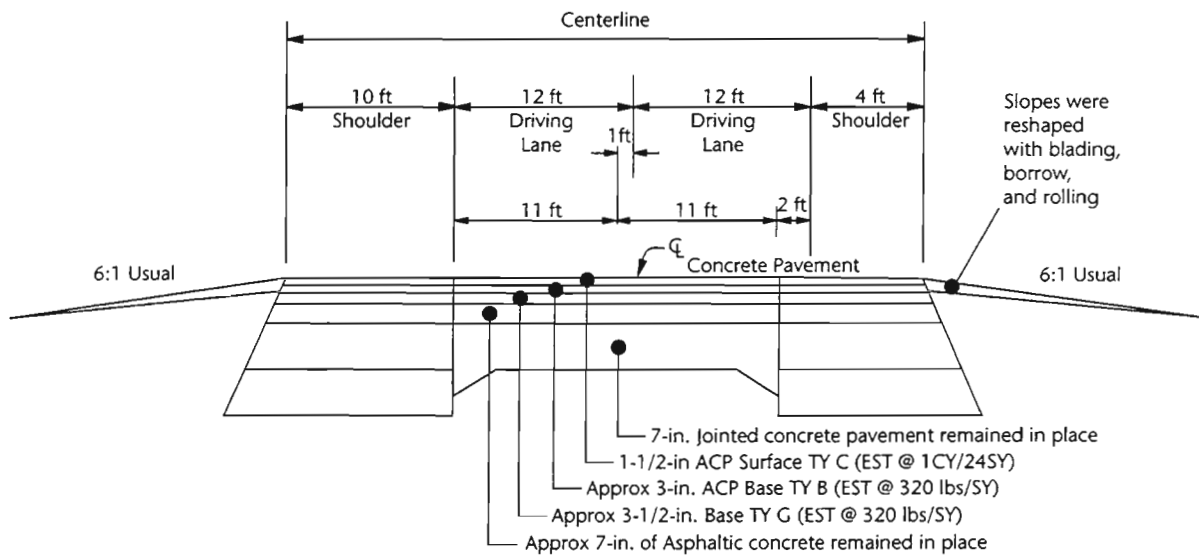
Figure 3.21. Post-construction cross section of R4

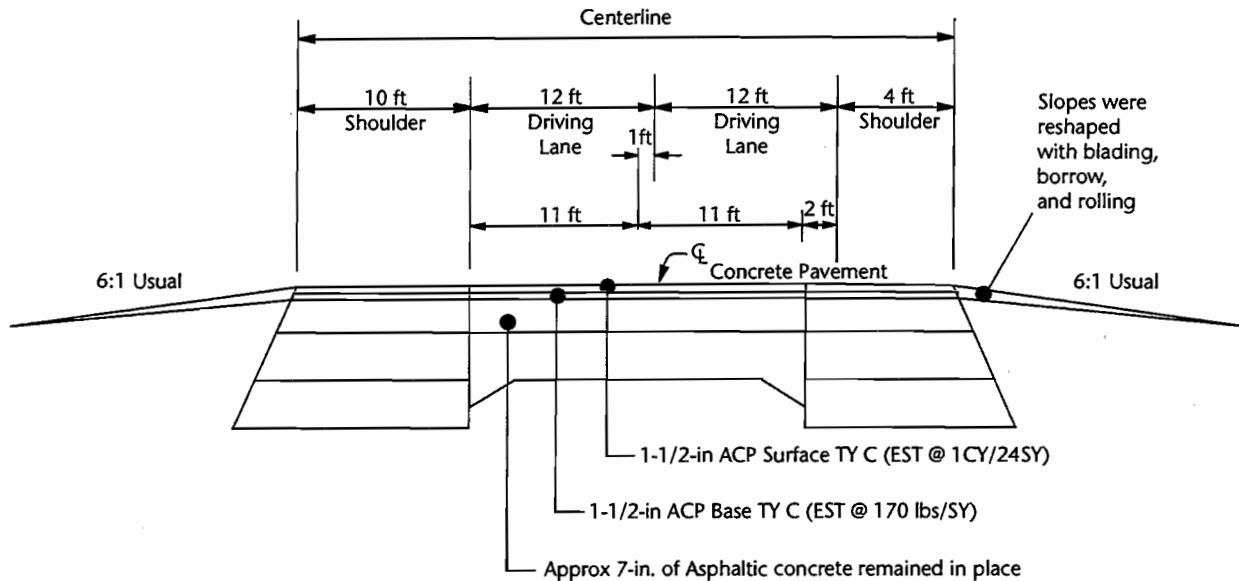
Figure 3.24. Post-construction cross section of R0

Test Section R0 is the control section and had received the typical treatment used by the district in the past. A standard Type-D surface material was placed over the existing asphalt. This allows for comparison between the performance of the six alternate design test sections and the conventional rehabilitation technique used on this highway. The weight-in-motion traffic system (WIM) was installed in Section R0 prior to the sections being opened to traffic. Figure 3.24 is the post-construction cross section of R0.

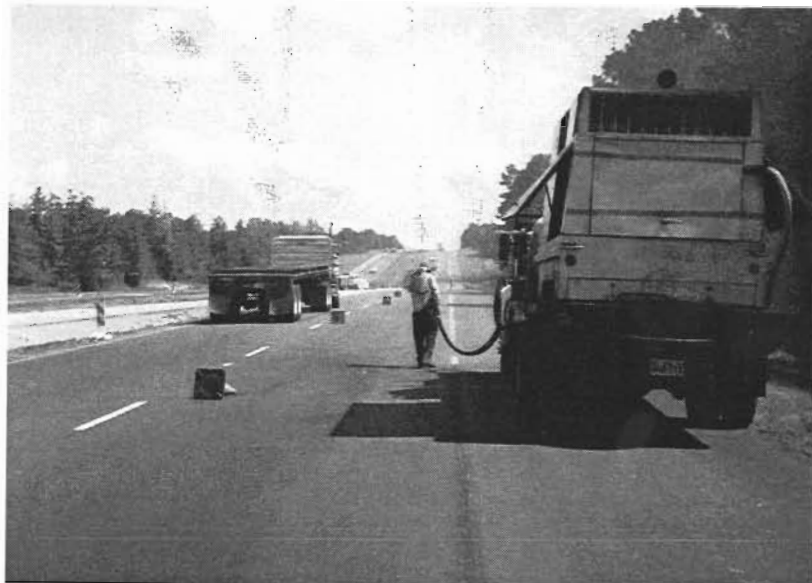
Figure 3.25. Sandblaster removing striping

system. In April 1993, we determined that the striping should be moved 45.72 cm (18 inches) over towards the outside shoulder, as shown in Figure 3.26.. Figure 3.25 shows the striping being removed by a sandblaster. The effect of moving the striping on performance and testing will be documented in Report 987-4.

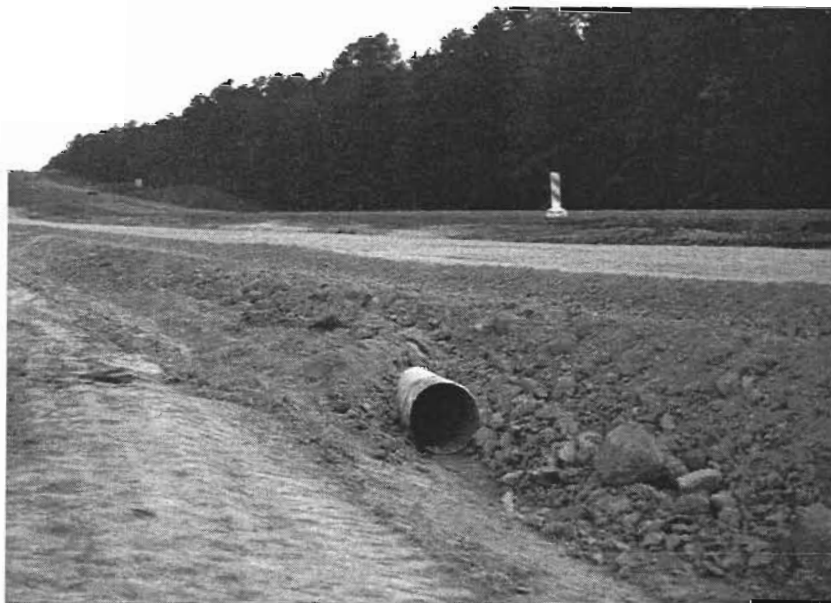
Figure 4.2. Pipe placement in Detour #2

The new detour was being constructed on an incline. To avoid problems created by water build up behind the detour, a pipe was placed to allow rainwater to flow through the detour (Fig 4.2). The new detour was not in place until late May 1992. Traffic was moved from the southbound lanes onto the detour on May 26. Within 4 hours of the traffic move, the detour experienced dramatic failure. During the months of construction, the base and underlying soil of the detour had become extremely saturated. By moving the heavy traffic (mostly trucks), the base of the detour began to slide out, causing the surface to collapse. Figure 4.3 shows Detour #2 experiencing failure caused by traffic. Repair attempts were considered, but it was determined that total reconstruction would be necessary to restore detour functioning. Because of time and cost constraints, we decided to complete the construction of the flexible sections by rehabilitating one lane at a time, while leaving the second lane open to traffic. The outside lane was to be constructed first from end to end, followed by the inside lane. Detour #1 and the failed detour were both removed during the first two weeks in June.

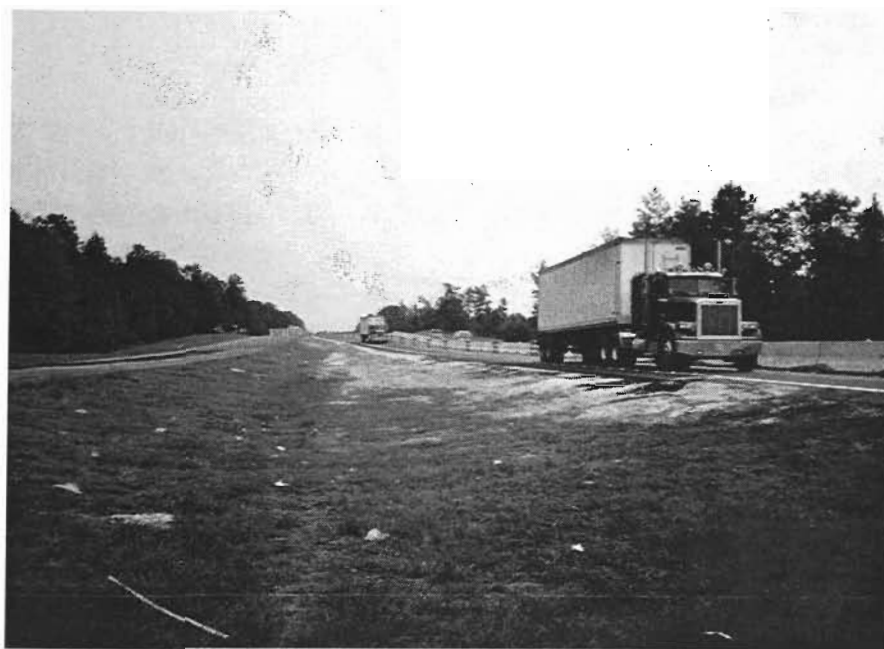
Figure 4.3. Failing detour under traffic

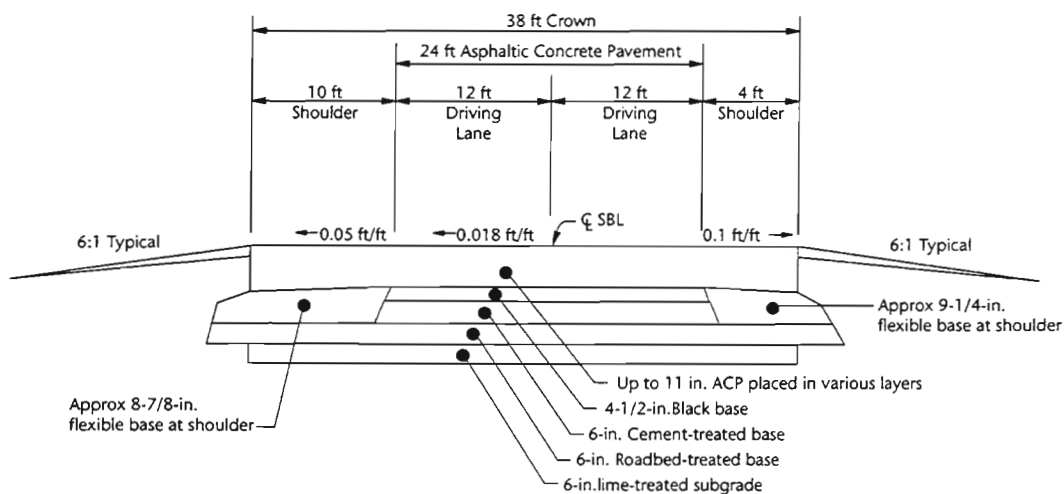
Figure 4.4. Existing typical cross section in flexible test sites (1 ft=0.304 m, 1 in.=2.54 cm)

Each of the six test sections and the control section are approximately 304.8 m (1,000 feet) long. The current typical cross section of the flexible pavement consists of 15.24 cm (6 inches) of lime-treated subgrade, followed by 15.24 cm (6 inches) of roadbed-treated base (Fig 4.4). Next there is 15.24 cm (6 inches) of cement-treated base, followed by 11.43 cm (4.5 inches) of black base. In total, 27.94 cm (11 inches) of asphalt have been placed in various layers over time.

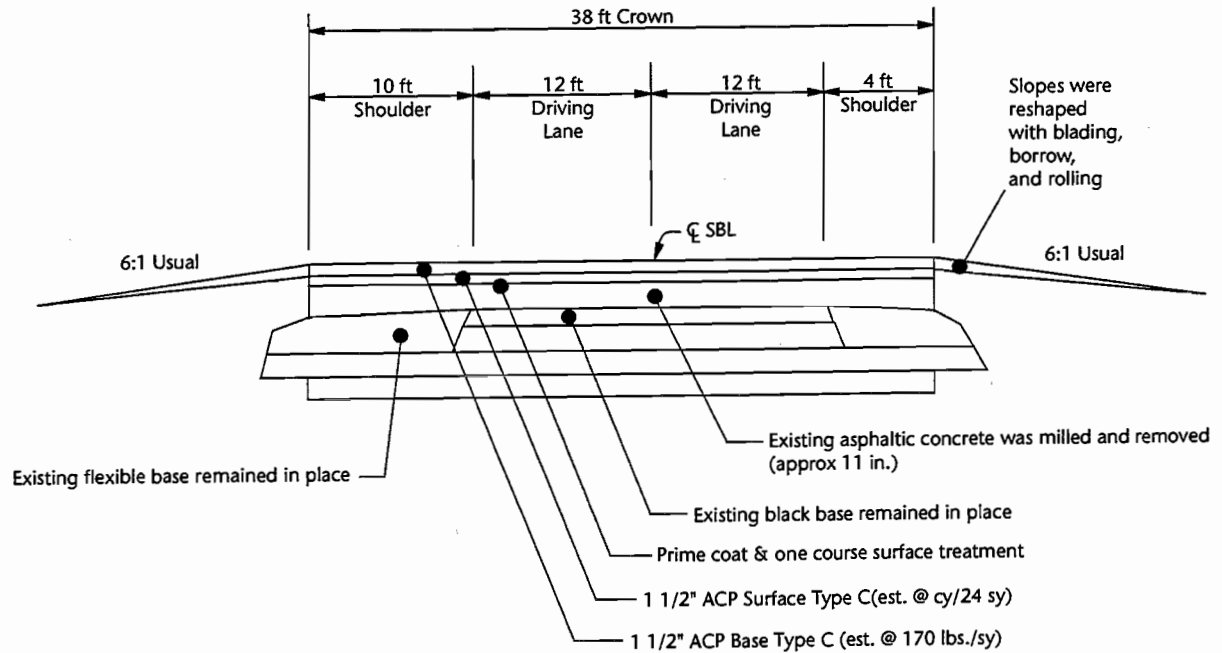
Figure 4.9. Post-construction cross section of F5 (1 ft=0.304 m, 1 in.=2.54 cm)

In Test Section F5, the existing 27.94 cm (11 inches) of asphalt were milled and removed. About 25.4 cm (10 inches) of flexible base were then placed over the exposed black base. A prime coat and a one-course surface treatment were then applied to the flexible base, followed by 7.62 cm (3 inches) of Type C asphalt placed in two lifts. Figure 4.9 shows the post-construction cross section of F5.

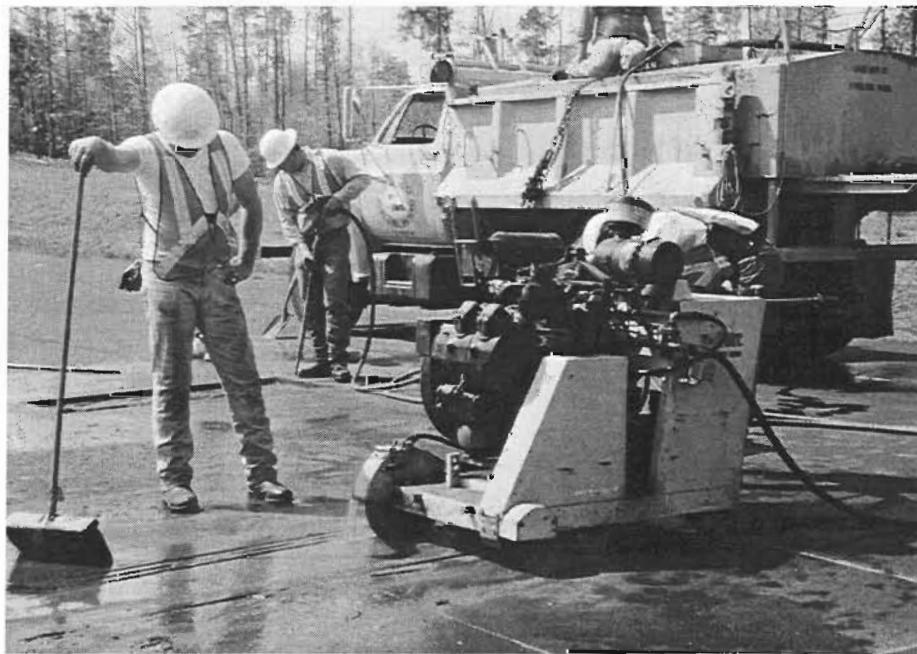
Figure 5.2. Concrete saw used to remove overlay at WIM site

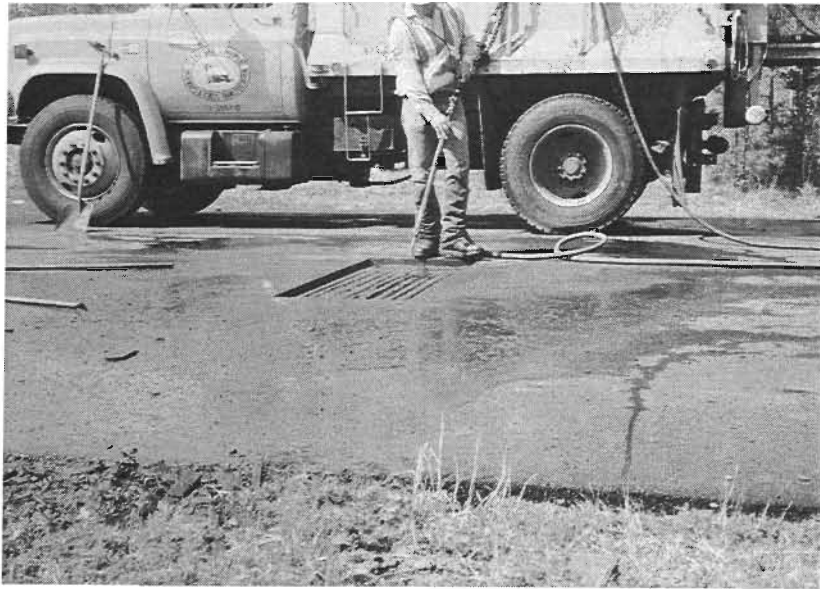
Figure 5.3. Sandblaster preparing WIM pad site

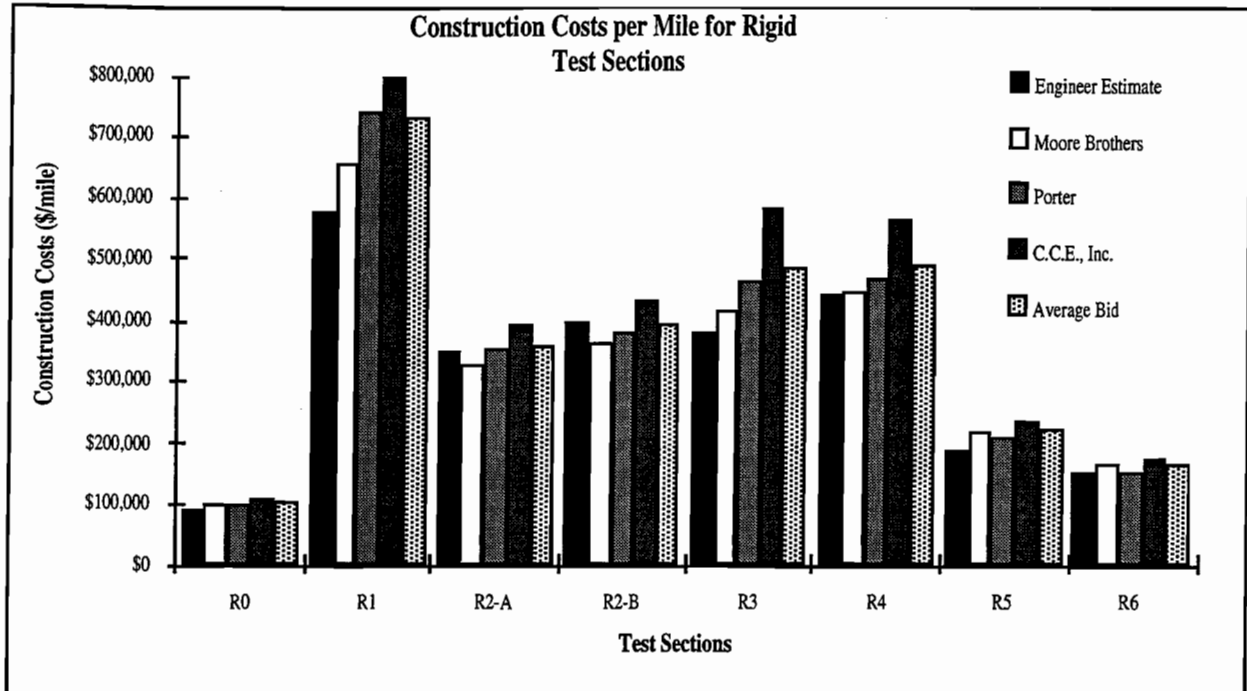
Figure 6.1. Contractor bids for rigid section by mile

contractor, i.e., R0 is the smallest and R1 is the highest. There is an exception of some position shifting on R3 and R4, since the costs for both test sections are relatively equal for a given contractor.

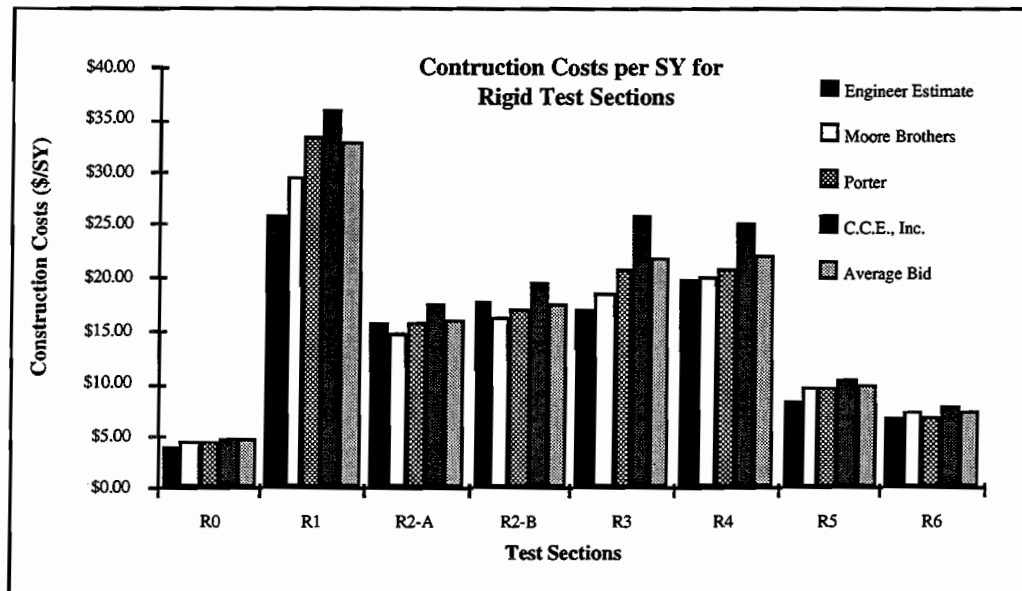
Figure 6.2. Contractor bids for rigid section by square yard

Figure 6.2 presents the total costs for each of the test section alternatives. In this case, there is a grouping on a test section by contractor to present the relative distribution. In terms of total costs, R1 has the largest variation bid between the prices between the contractors, though, percentage-wise, the others are also large.

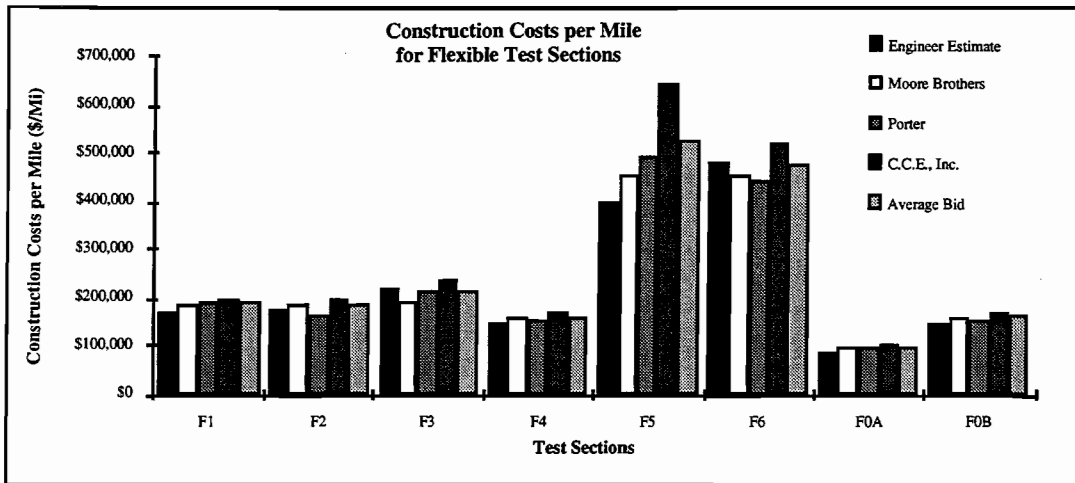
Figure 6.4. Cost of construction on a two-lane-mile basis

Tables 6.4 and 6.5 present the cost of construction on a two-lane mile and square-yard basis for each test section. Test Sections F5 and F6, the largest on a unit-cost basis, represent a 5-to-1 ratio. In this case, the engineer's estimate is much closer to the average bid price. This is to be expected, since there were more known facts about each item based on previous experience. Again, the spread between contractors is small. Figures 6.4 and 6.5 summarize or plot the data found in Tables 6.4 and 6.5.
