1. Report No. TX-95+987-4		2. Government Accession No.		3. Recipient's Catalog No.	
4. Title and Subtitle Initial Performance of Asphalt Overlays on Overlaid Jointed Concrete Pavement (JCP) and on Flexible Pavements in Field Test Sections in Lufkin, Texas				5. Report Date January 1995

**INITIAL PERFORMANCE OF ASPHALT OVERLAYS ON OVERLAID JOINTED
CONCRETE PAVEMENT (JCP) AND ON FLEXIBLE PAVEMENTS IN FIELD TEST
SECTIONS IN LUFKIN, TEXAS**

Research Report Number 987-4

A Long-Range Plan for the Rehabilitation of US 59 in District 11

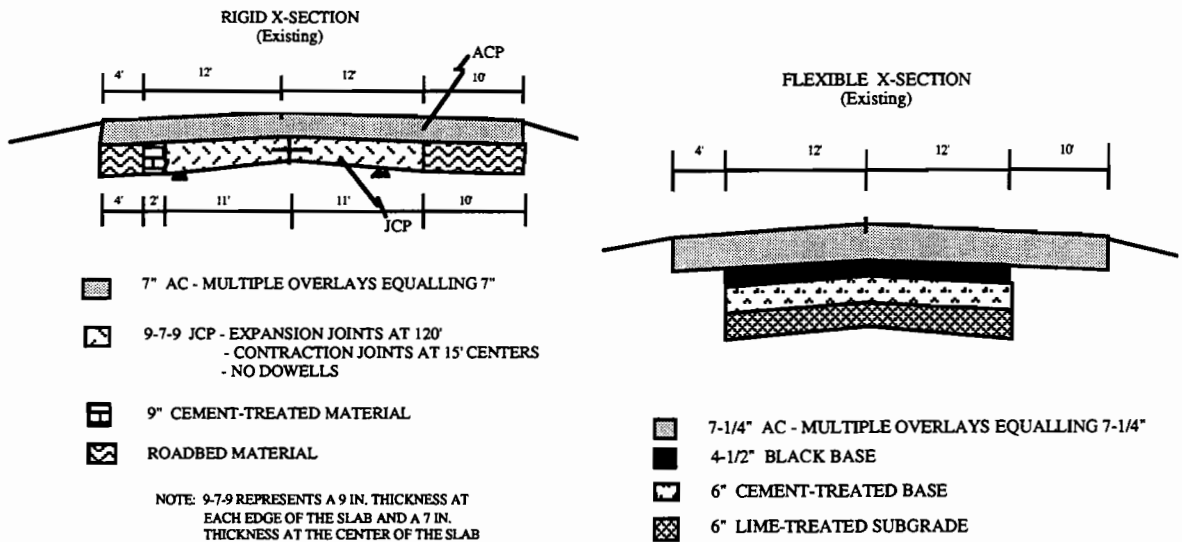
*Figure 2.1 Typical plane section of the test section before construction
(1 inch=2.54 cm; 1 foot=0.304 m)*

The flexible test section was built in 1966 with 3.81 cm (1.5 in.) of asphalt concrete on 15.24 cm (6 in.) of cement treated base, with 15.24 cm (6 in.) of lime-treated subgrade. Since the construction, three thin asphalt overlays have been placed. Longitudinal and transverse cracking are found throughout the test section, and water-related problems (e.g., stripings) were observed. The cross section before construction is shown in Figure 2.1.

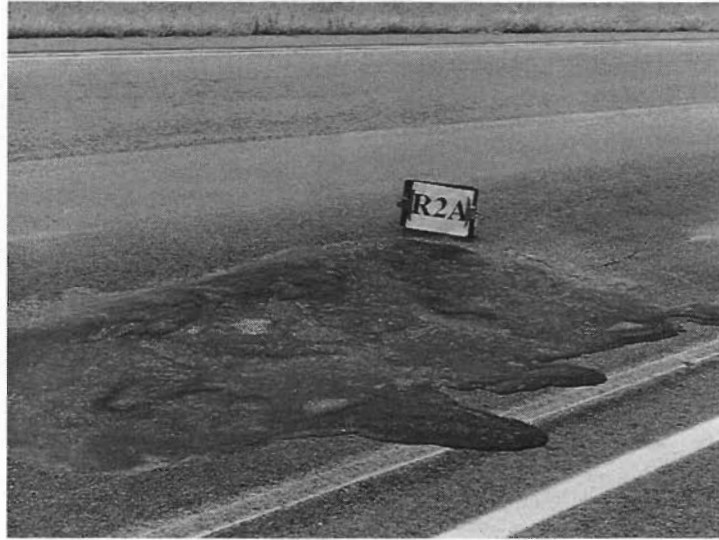
Figure 2.4 Example of failure in R2A

Several of the test sections performed poorly and cracked extensively after they were opened to traffic. Sections R2A and F5 especially exhibited poor performance, as indicated in Figures 2.4 and 2.5. Severe cracks and areas of pumping were repaired by the district.

In section R2A, a large pothole and some additional fine alligator cracking were repaired by patching in January 1993. The pothole was approximately 0.6 m (2 feet) wide and 3 m (10 feet) long; the alligator cracking was observed 4.572 m (15 feet) in each direction from the pothole. Moderate pumping was also observed in the pothole. This section also had patches applied in three places in November 1993.

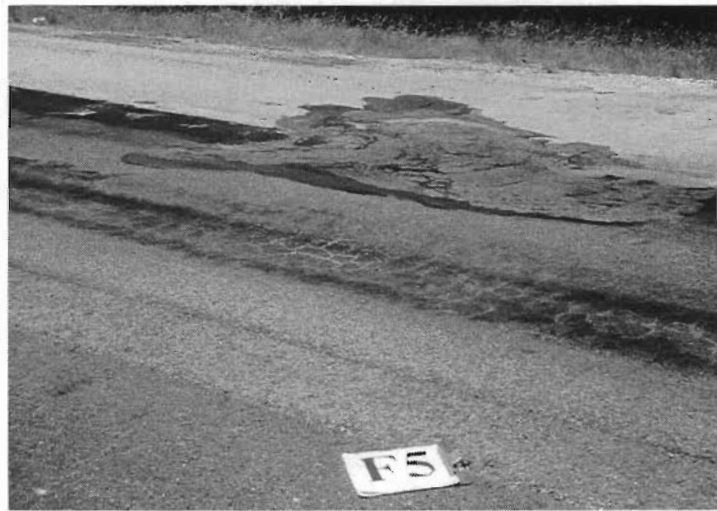
Figure 2.5 Example of failure in F5

The flexible base section F5 exhibited base failure, with rutting, severe alligator cracking, and raveling appearing on the outside wheel path for the right lane from station 1009+70 to 1008+90, which was located at the crest of a vertical curve. For the forensic analysis, seven cores were taken from the site and vacuum extraction was performed by the district. According to maintenance records available at the district, the AC base and surface seem to be a very porous mix, with air voids ranging from 8 to 10 percent. Because water was observed migrating through the ACP and along the coarse surface treatment, two samples of the flexible base (taken from the top and bottom of the layer) were checked for moisture content. The bottom sample presented a higher water content of 8.5 percent, while the top sample presented a water content of 7.5

percent. After confirming that the failure mode of the pavement structure was associated with base failure, the district, in conjunction with CTR staff, decided to remove the distressed area and replace it with a cement-treated patching material 33 cm (13 in.) thick, a commonly used corrective procedure for this type of failure. After subsequent rainfall, additional distressed areas were observed in the outside wheel path. The distressed areas underwent the same type of treatment described previously. To prevent further rapid deterioration, a seal coat was applied in March 1993 to the areas showing distress.

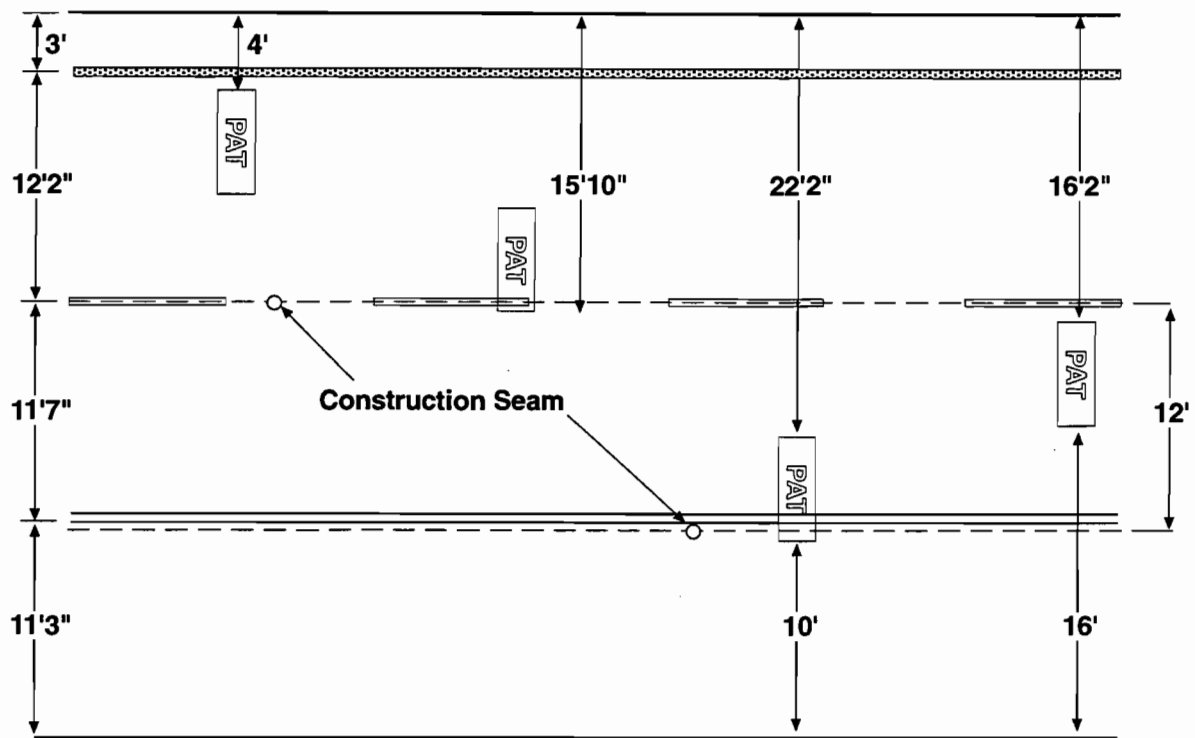
Figure 3.1 Incorrect lateral striping location (1 inch=2.54 cm; 1 foot=0.304 m)

In March 1992, the weighpads of the WIM station were installed on the control section of the rigid test sections; after installation, the rigid test section was open to traffic. Unfortunately, the longitudinal traffic stripes were found to be misplaced on the rigid section during a routine survey carried out in July 1992 by CTR staff. Because this problem affected the data collected for lateral displacement, it will be discussed later in this report. After reviewing the longitudinal stripes after overlay, a contractor sandblasted the paint stripes off the pavement, about 6,096 m (20,000 feet) in length; the stripes were then relocated in June 1993. Figure 3.1 shows the improper location of the longitudinal stripes on the rigid section; the corrected positions of the longitudinal stripes are depicted in Figure 3.2. The WIM station for the flexible section was installed in July 1992; these sections were open to traffic once installation was completed.

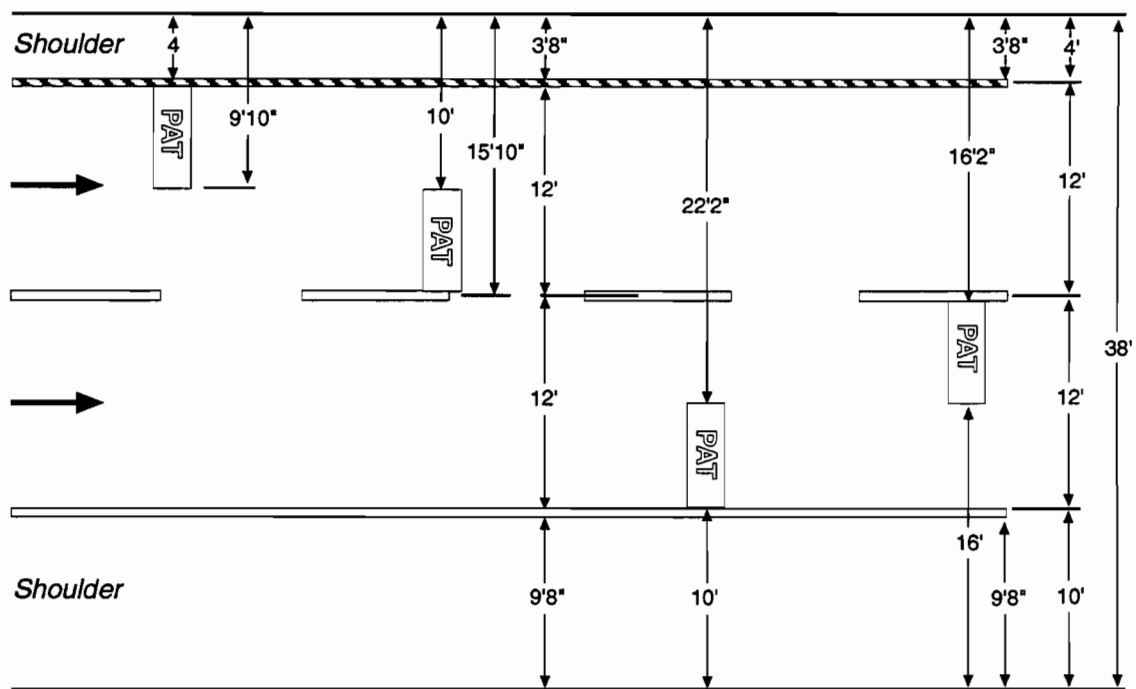
Figure 3.2 Current striping location (1 inch=2.54 cm; 1 foot=0.304 m)

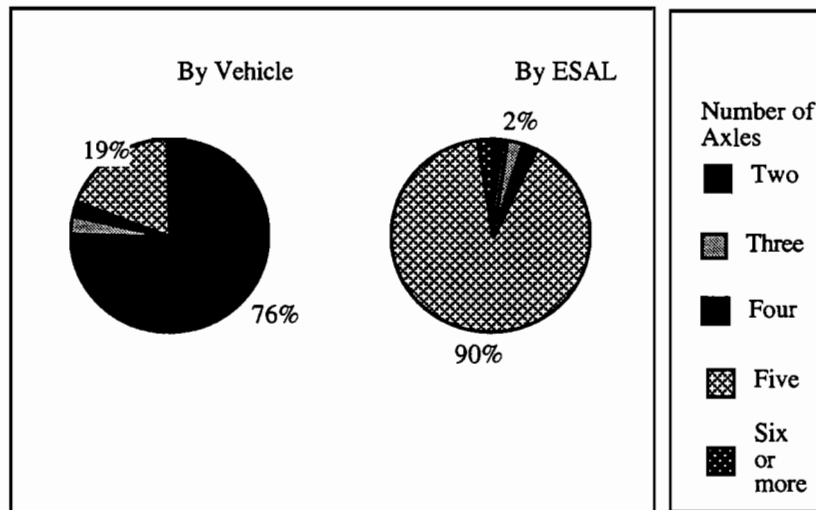
Figure 3.5 Vehicle classification in the right lane

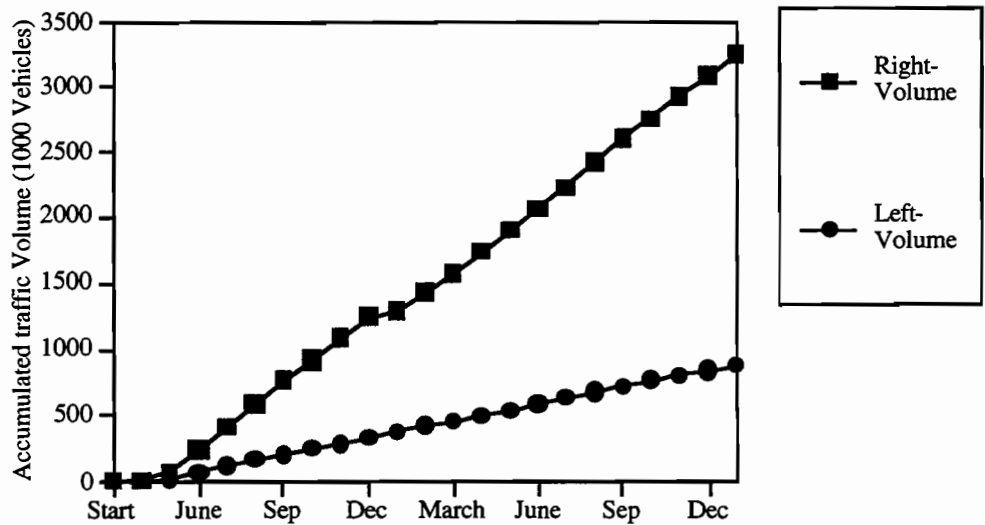
Figure 3.7 Accumulated traffic volume

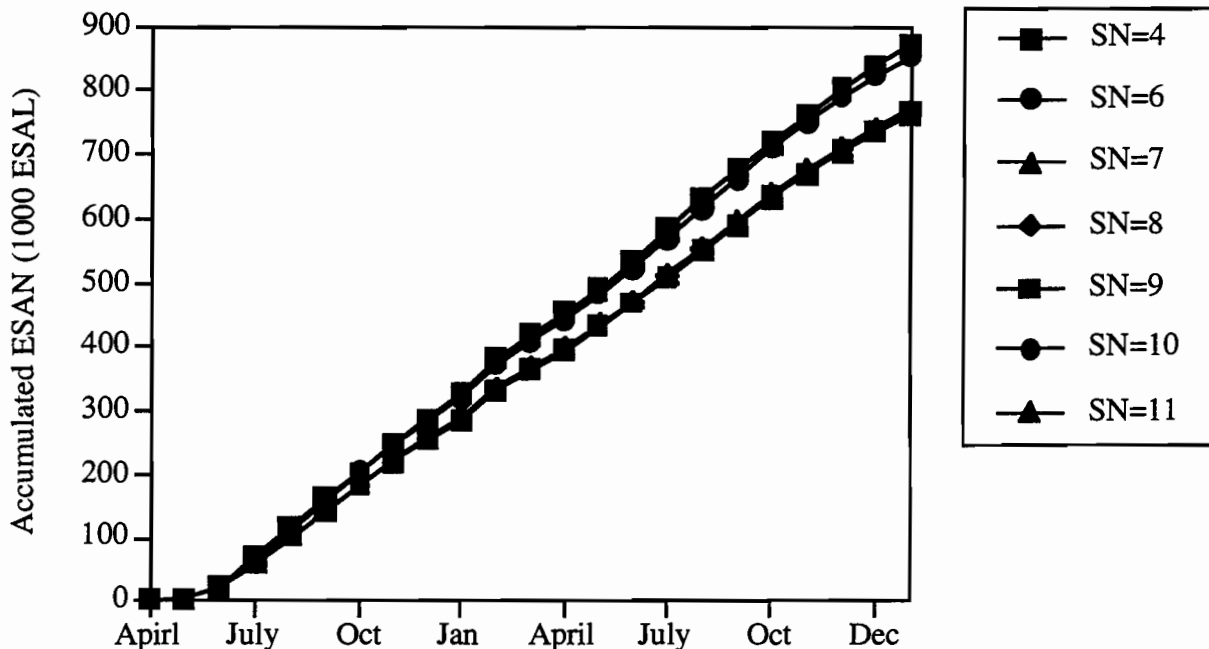
Figure 3.9 Accumulated ESAL variation under different SN

Usually the pavement design process requires at least 20 years of traffic estimation obtained either by simple extrapolation of the available traffic data, or through more complex traffic modeling. Many pavement engineers rely on simple curve fitting to obtain design traffic information for a 20-year period.

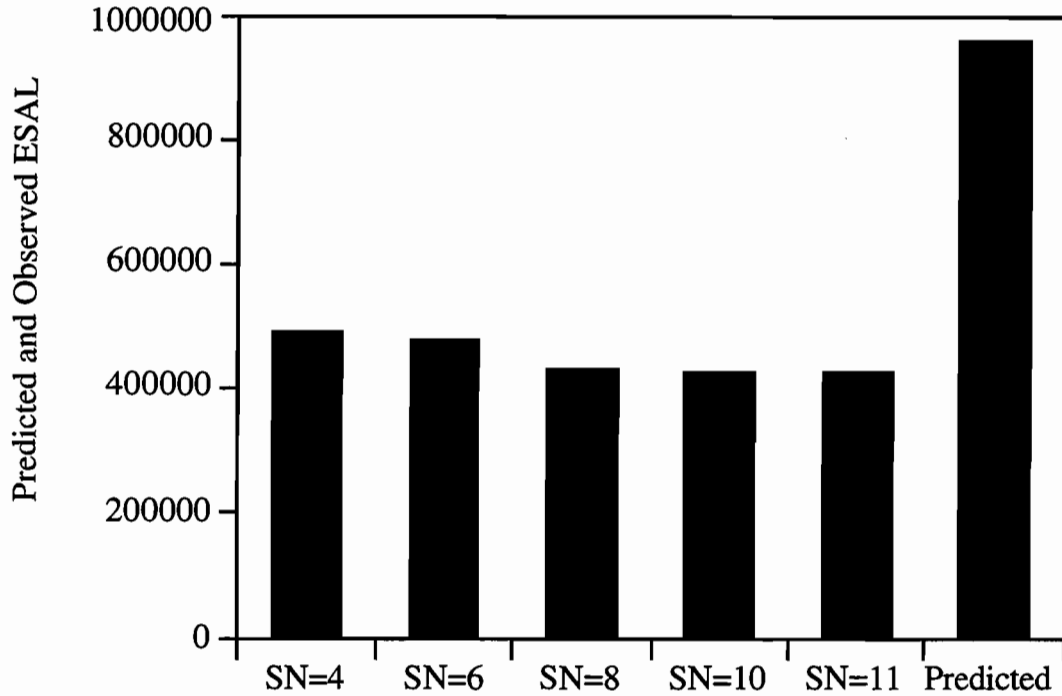
Figure 3.10 Comparison between predicted and observed ESALs in rigid section in 1993

The test section design was also based on an extrapolation of ESALs (Ref 2). The comparison between observed ESALs obtained from the WIM station and the results of the prediction used in the design permits the study of the reliability of the ESAL predictions used in the design of the pavement test section. Figure 3.10 shows that the design-predicted ESALs were 2 times larger than the ESALs calculated using the WIM station information, meaning that the design led to a more conservative design thickness.

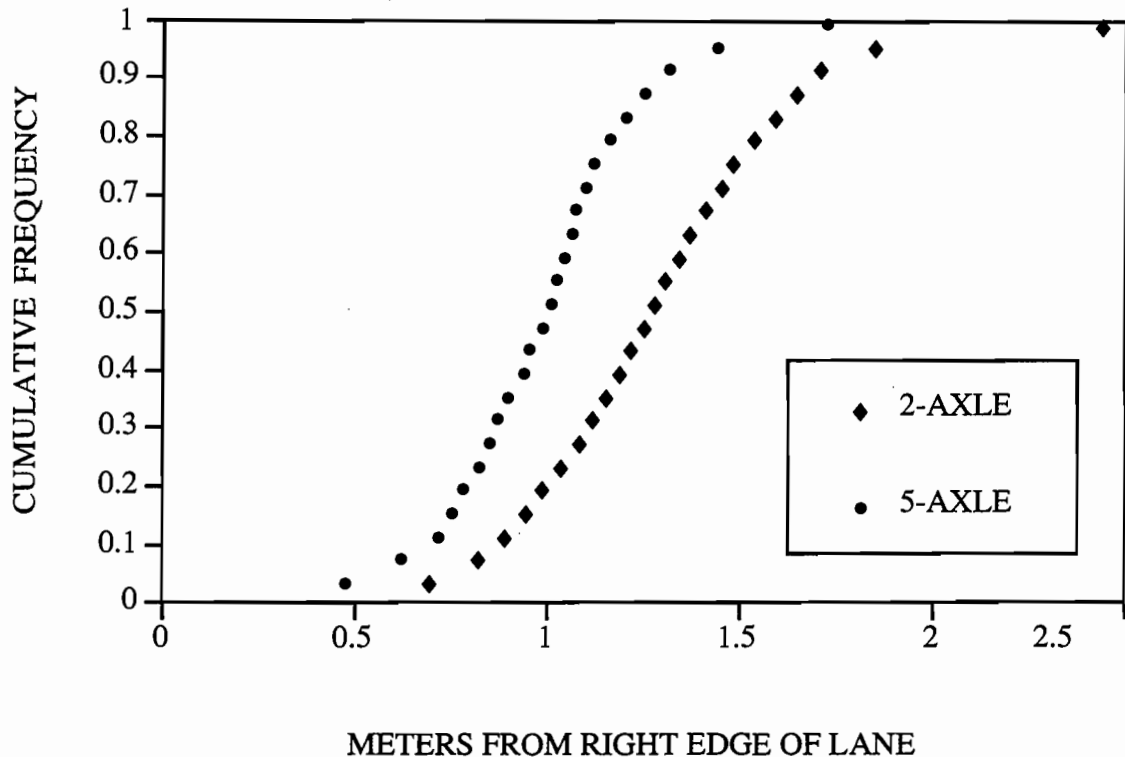
Figure 3.11 Accumulative lateral distribution of two- and five-axle vehicles (1 m=0.304 ft)

The lateral distribution of traffic loading is important in the estimation of test section pavement performance. Beginning with the plate theory of the 1930s, the importance of the traffic loading position on the pavement has been recognized. Using infrared sensors, the lateral distribution of each lane has been calculated. This will demonstrate the exact pavement behavior under traffic loading through three-dimensional pavement analysis, and will offer a possible explanation of distress growth in the test section. The distance from the outside wheel of a vehicle to the pavement shoulder was measured; Figure 3-10 shows the lateral distribution of two- and five-axle vehicles in the right lane of the test section. The mean value of two-axle vehicles was 1.31 m (4.3 feet) from the edge of the right shoulder, and .91 m (3.0 feet). The figure also shows that the vehicle loading position on the pavement varies from less than .30 m (1 foot), to more than 1.82 m (6 feet).

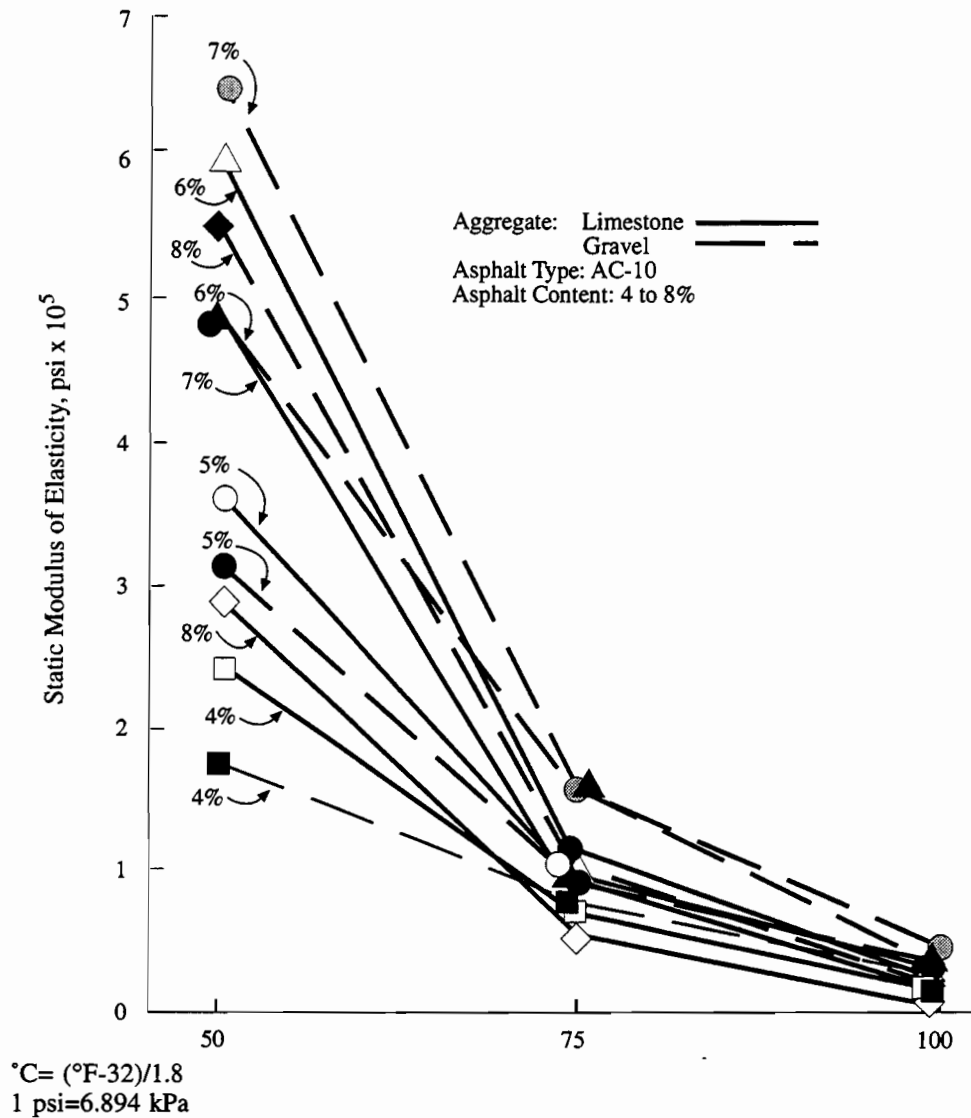
Figure 3.12 Asphalt stiffness variation on temperature

The stiffness of the asphalt also depends on the temperature, such that the higher the temperature, the lower the stiffness (Refs 9, 10). Thus, in the summer, the stiffness of the asphalt will decrease. This is illustrated in Figure 3.12, a summary of indirect tensile tests of the asphalt mix in the laboratory (Ref 10). These test results verify that thermal cracks develop primarily during the winter, and that rutting develops primarily during the summer.

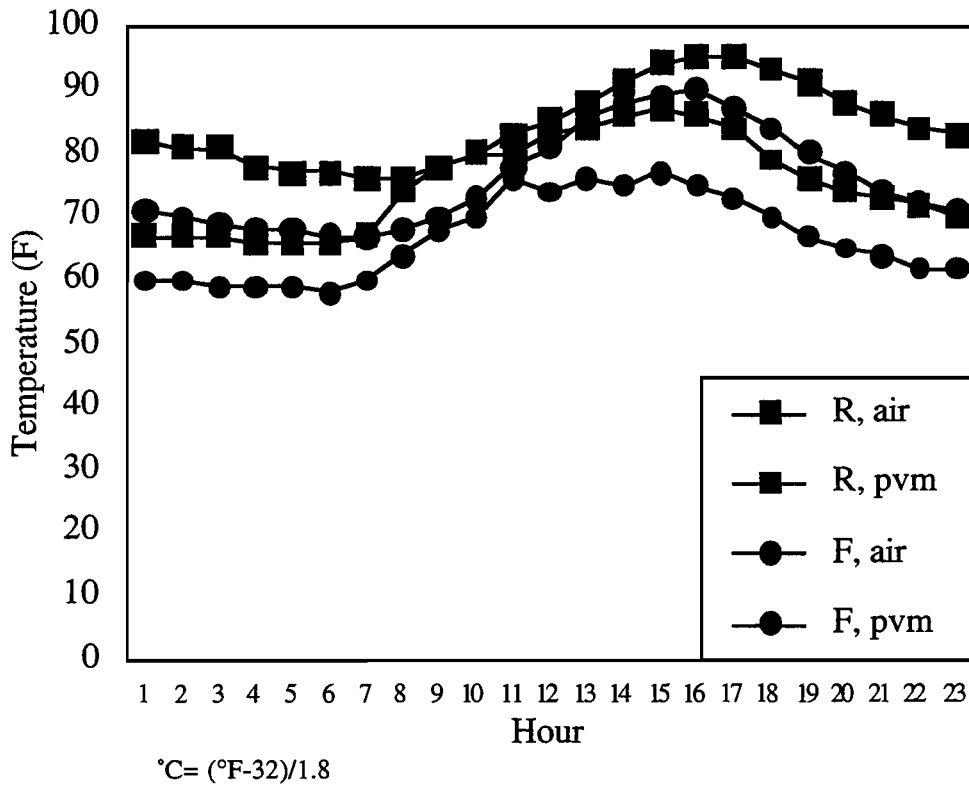
Figure 3.13 Hourly distribution of temperature in test section — Spring (May 1993)

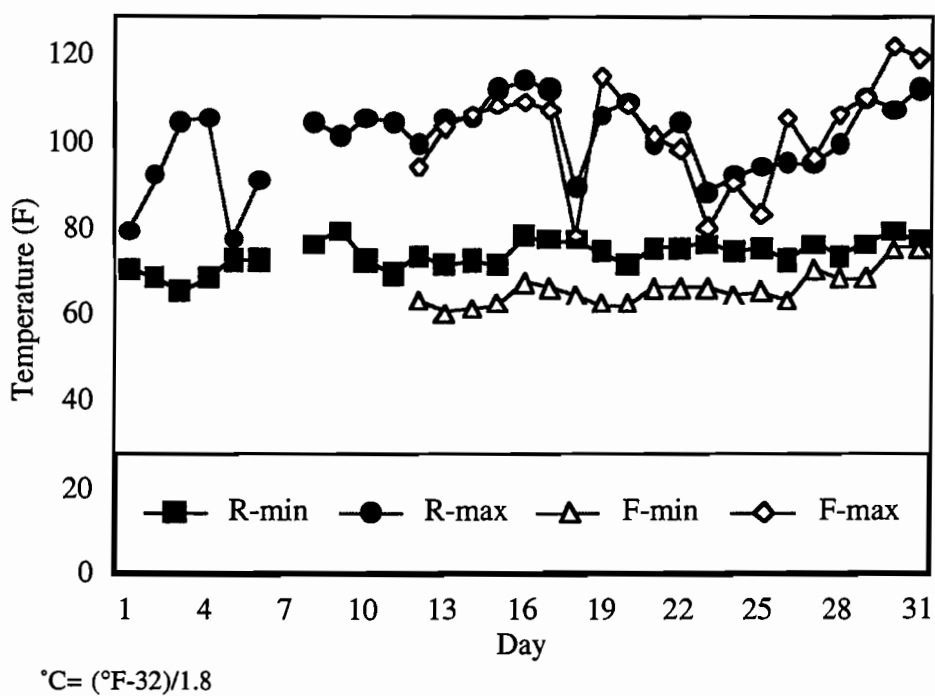
Figure 3.17 Daily variation of temperature in the test sections — Spring (May 1993)

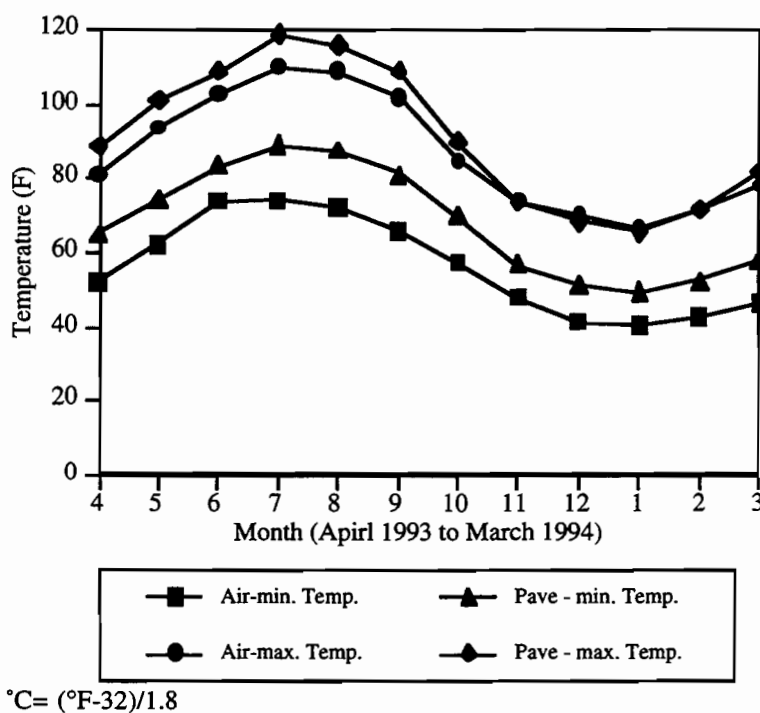
Figure 3.21 Monthly variation of average min. and max. temperature in the rigid section

The monthly temperature variations for both the rigid and flexible test sections were also summarized. The average minimum and maximum temperatures of the month are depicted in Figures 3.21 and 3.22. The curves show a sinusoidal function form for the air and pavement temperature distributions. The maximum pavement temperature in the rigid section was 53.8° C (129° F) in July 1993, while the minimum was 2.78° C (37° F) in January 1994. The flexible section experienced a slightly higher pavement temperature; the maximum temperature was observed in July, while the minimum temperature was observed in December.

Both minimum and maximum temperatures for the test sections are usually above the air temperature, probably because both sections have a black asphalt overlay with a surface absorptivity of almost 0.90. The temperatures measured in the flexible section also show that the pavement temperature at 2.54 cm (1 inch) depth is always higher than the air temperature. The difference is 5.56° C (10° F) on average, suggesting that careful modeling is needed when calculating pavement temperatures based on air temperature.

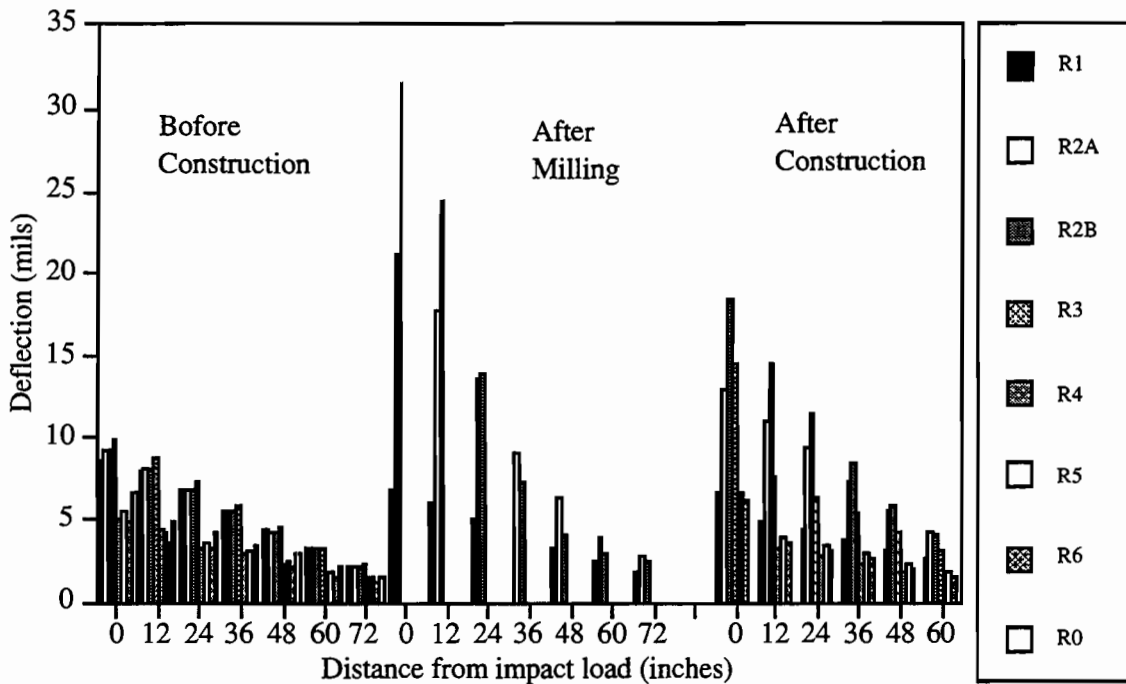
Figure 4.8 Deflection variation of three stage of construction, left lane (March 1992)
 (1 inch=2.54 cm, 1 mil=0.025 mm)

The remaining test sections, which were not milled, presented almost the same deflection basin after the new overlay was applied. Owing to interlayer effect, the slope between the first and second sensors observed after overlay was comparable to that observed before overlay.

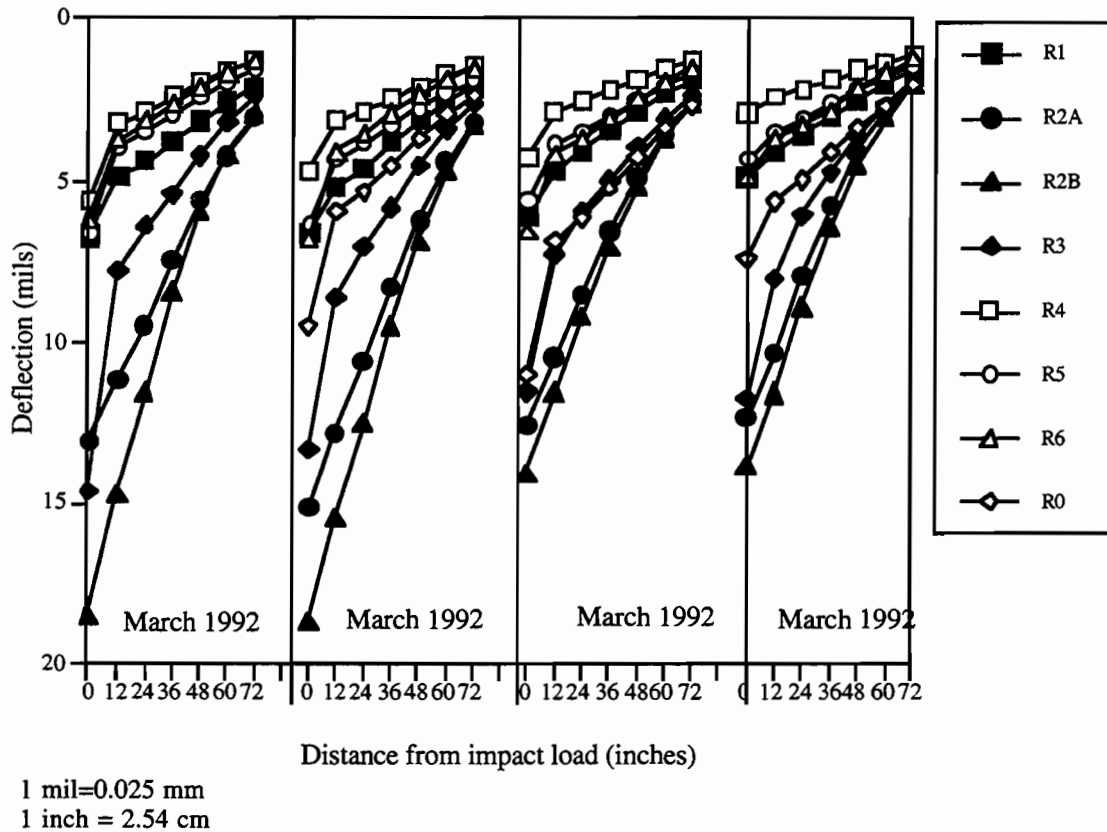
Figure 4.10 Variation of average deflection of the left lane of the rigid section

The first three charts in Figures 4.10 and 4.11 show the trend of the deflections over time for both lanes. These charts show that the average deflection has generally increased for almost all sections since the beginning of construction (sections R2A, R2B, and the left lane of section R3 showed decreasing deflections). These results contradict the commonly held assumption (Ref 15) that pavement deflections will increase over time and traffic loadings. A possible explanation for the conflicting results observed in the evolution of the deflections over time is the densification of the sublayer owing to the application of traffic loadings. Construction compacting is designed to achieve minimum air percentage in the asphalt concrete, with such design meant to ensure the kind of elastic material behavior that protects the pavement from rutting problems. However, if substandard compacting occurs during construction on a weaker flexible base section, the remaining compaction will occur as a result of the application of the traffic loadings. While this action translates into an increase in deflections during the early life of the overlay, the deflections will stabilize once the layers reach maximum compaction. On the other hand, the discrepancies may be a result of AC layer aging, or of ambient temperature.

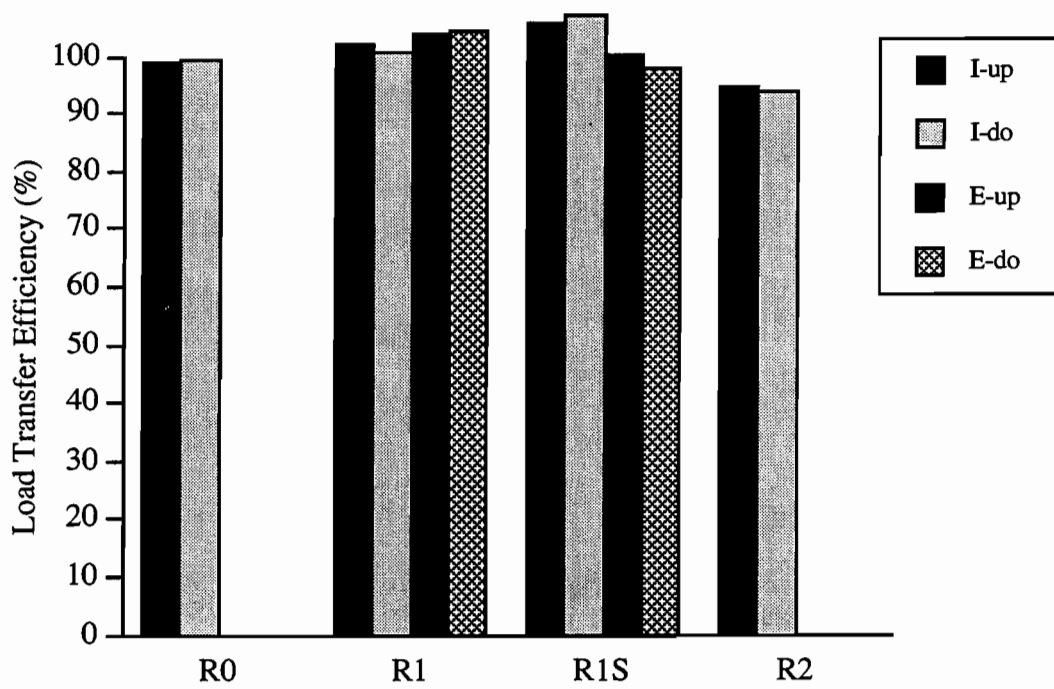
Figure 4.14 Load transfer efficiency at transverse cracks using the Ricci procedure

Figures 4.14 and 4.15 present the December 1993 results of LTE for the rigid test sections. Three test sections — R1, R2, and control section R0 — were selected. Within section R1, the subsection that had sawcuts was segregated and referred to as “R1S” for identification purposes. The LTE, using the Teller method, gives a slightly higher value than the LTE calculated using the Ricci method, as was also noted by previous CTR studies (Ref 19). The charts also show that there is no significant difference between downstream and upstream LTE results. All the test sections show over 95 percent LTE either upstream or downstream. Among the test sections, sections R1 and R0 have better LTE than R2. The R2 test section, which was built using a break and seat method, presented the lowest value for LTE, a situation that may lead to reflective cracking through traffic loadings. Test section R1S, which had the highest LTE among the test sections, will consequently not be prone to reflective cracking caused by traffic loadings.

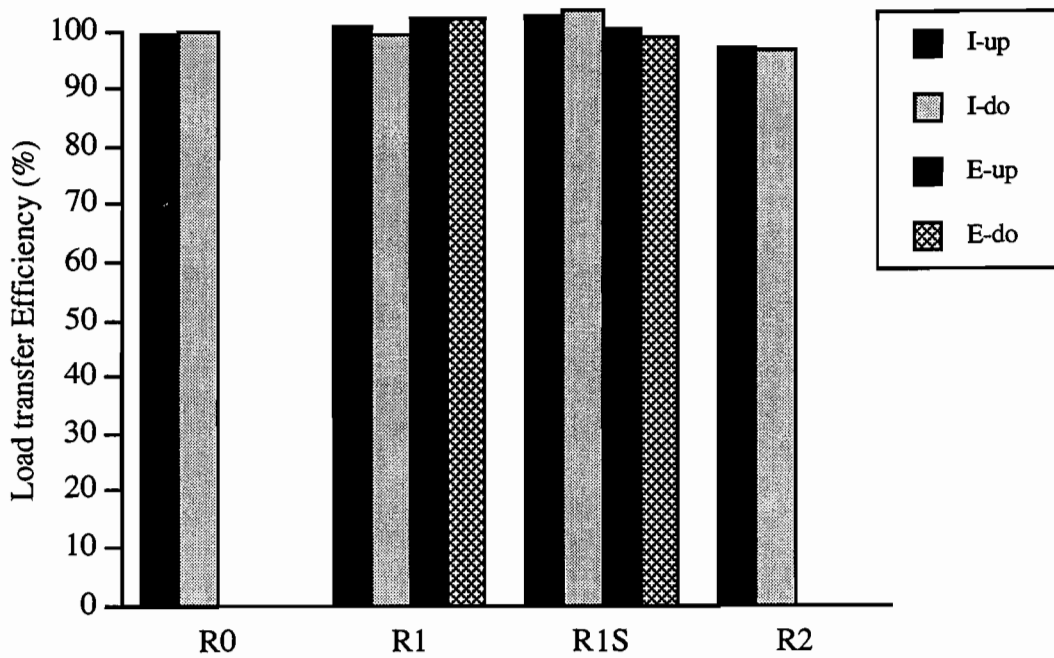
Figure 4.15 Load transfer efficiency at transverse cracks using the Teller procedure

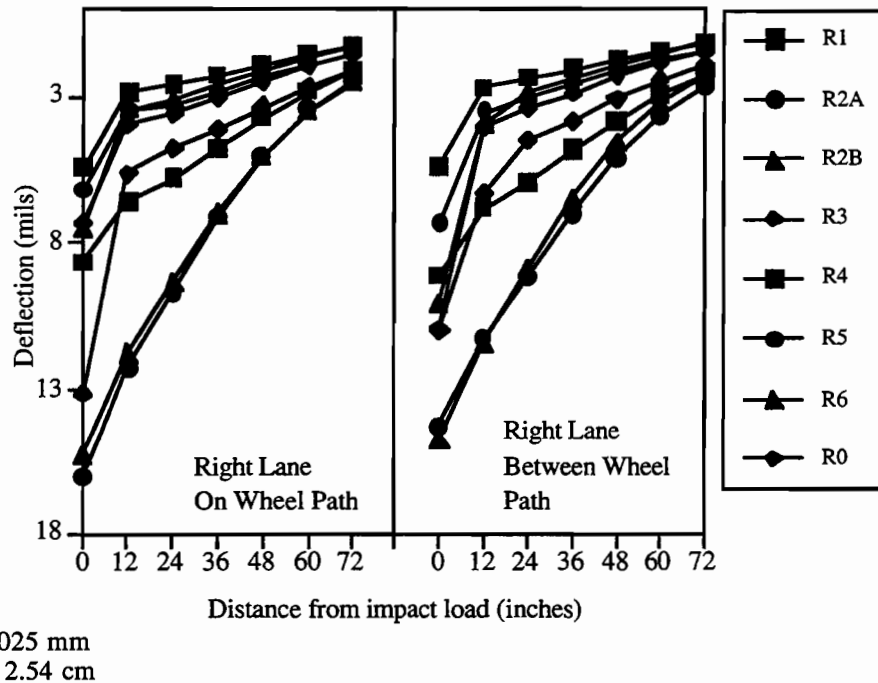
Figure 4.16 Deflection variations at rigid section — March 1994

A comparison of the deflections between these conditions shows the effect of the traffic loadings applied on the pavement structure after construction. Even though some variation is observed for each section, the general trend shows that the deflection between the wheel paths is smaller than the deflections on the wheel path. The sections that had the largest deflection on the wheel path were R3 and R2A, while the smallest deflections on the wheel path were observed for sections R0, R5, and R6. Only sections R3 and R2A experienced severe failures (discussed in Chapter 7) and low stiffness sections. Between these failed sections, the R3 section presented the largest variation between measurements taken on the wheel path and between wheel paths.

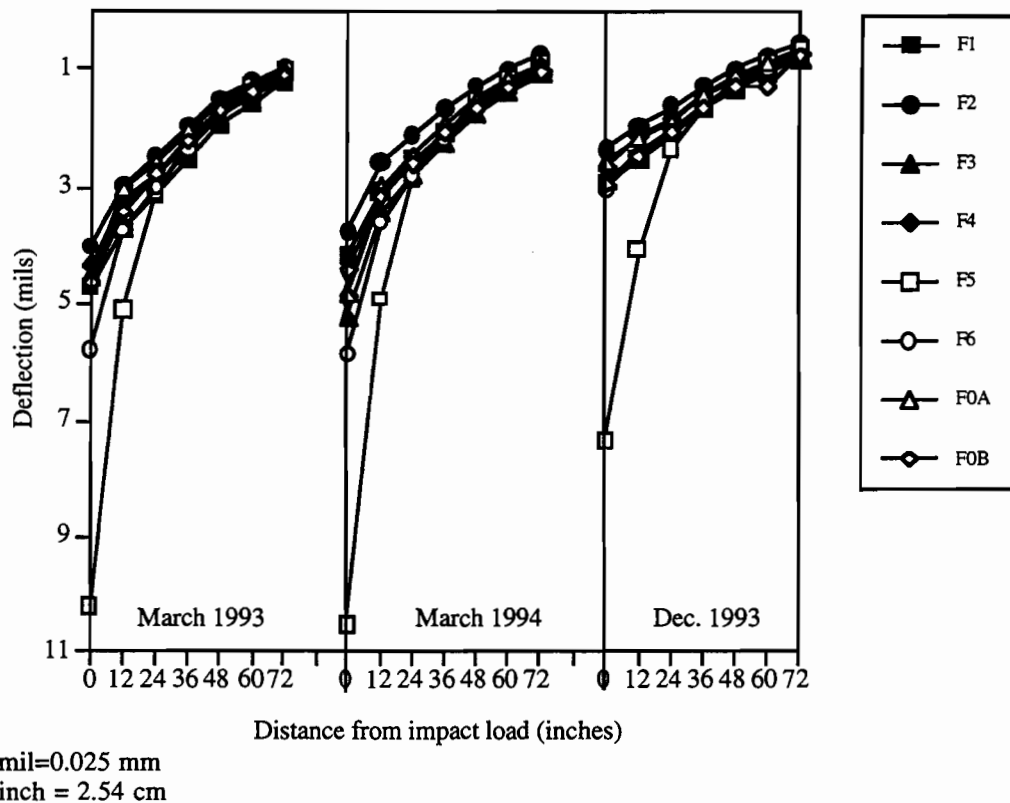
Figure 4.17 Variation of average deflection of the left lane of the flexible section

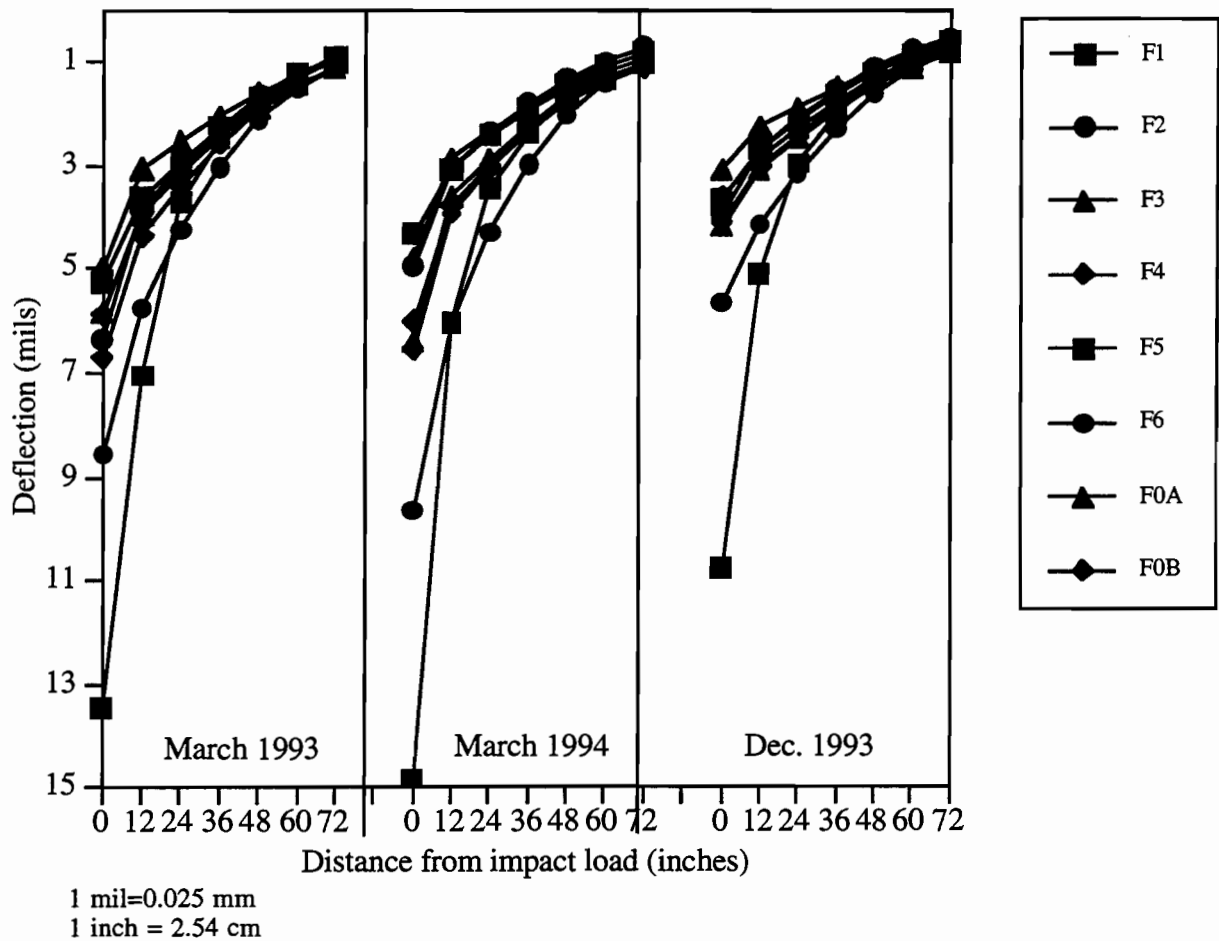
Figure 4.18 Variation of average deflection of the right lane of the flexible section

traffic was analyzed by comparing the first two charts in Figures 4.18 and 4.19, which summarize the available deflection information for March 1993 and March 1994. The effect of temperature was analyzed by comparing the deflection measurements for two different seasons, which are represented by the summaries of the deflection measurements taken in December 1993 (winter) and March 1994 (spring). As expected, the deflection generally increases as the number of traffic loading applications increases. Two test sections presented relatively larger deflections than the other sections; section F5, which has a flexible base, had the largest deflections and the largest SCI values. This section also experienced significant rutting problems, showing that SCI is a good indicator of rutting problems. Section F6 also presented a large SCI, indicating a possible susceptibility to rutting. Structurally, the remaining sections are relatively stable, considering the deflection results. Deflections between the left and right lane for test sections F5 and F6 differ significantly. The right lane for test section F5 presented in March 1994 about 0.375 mm (15 mil) while 0.25 mm (10 mil) were observed for the left lane. This was also observed for test section F6, which had higher values for the deflections being monitored on the right lane. These findings could be the result of traffic loadings, swelling, or insufficient drainage. Among these causes, the heavier traffic may be the main reason for the difference in structural-bearing capacity between the left and the right lanes.

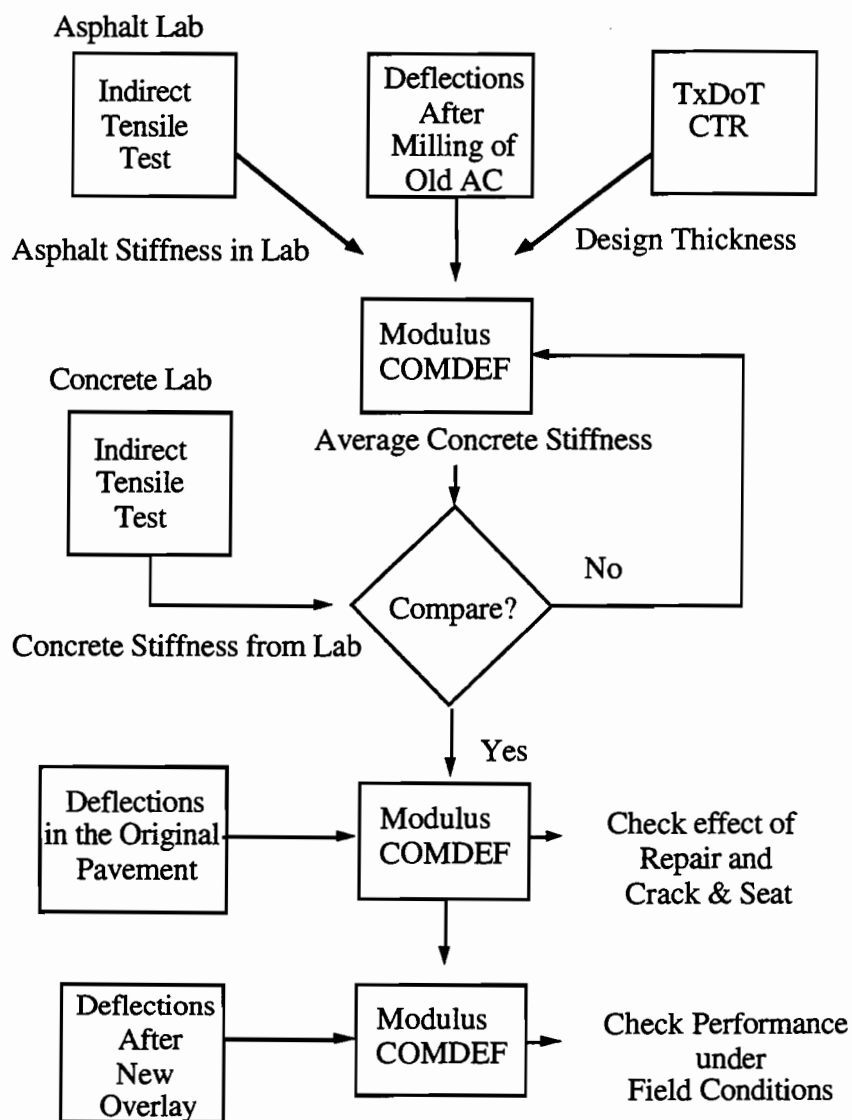
Figure 5.1 Backcalculation procedure adopted in the research

because laboratory test results on cores extracted from the pavement at the different stages were also available, the procedure summarized by Figure 5.1 was developed to implement the backcalculation procedure.

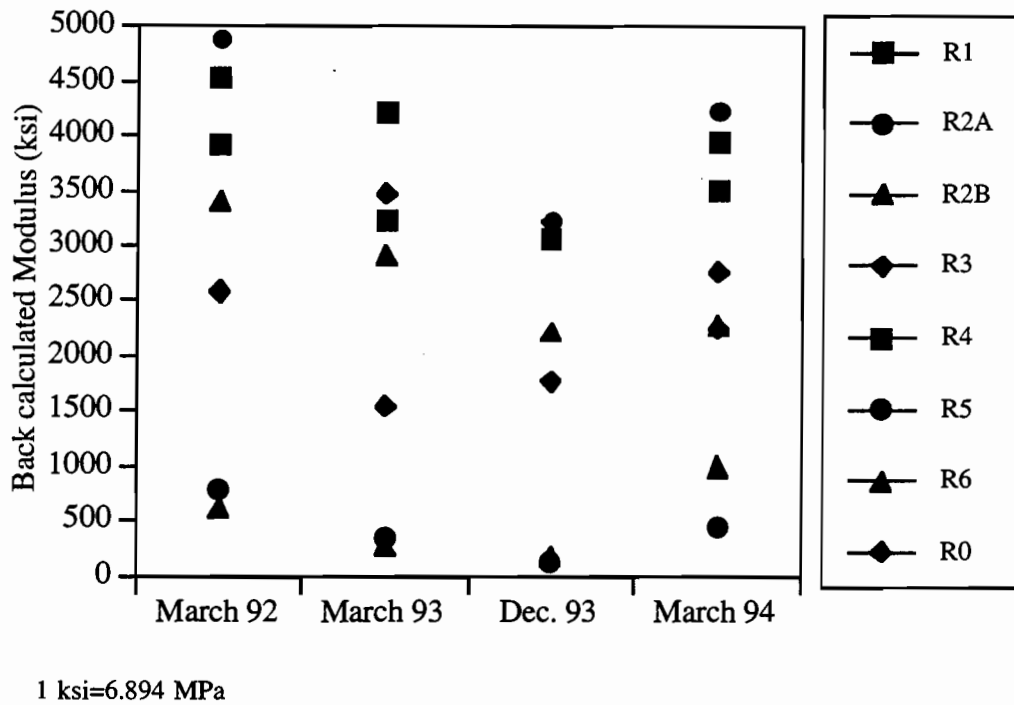
Figure 5.10 Stiffness variation of concrete in the right lane

The stiffness results for the right lane in December 1993 show a relatively low stiffness for some sections (e.g., R4, R5, and R6) that have thicker asphalt overlays (including old asphalt overlays). Considering the stiffness of the next measurement, taken in March 1994, the backcalculation value of the concrete stiffness could be affected either by a large thickness of asphalt overlay, which was stiffer during winter, or by limitations in the backcalculation process, which had to assume a fixed stiffness for the old asphalt overlay.

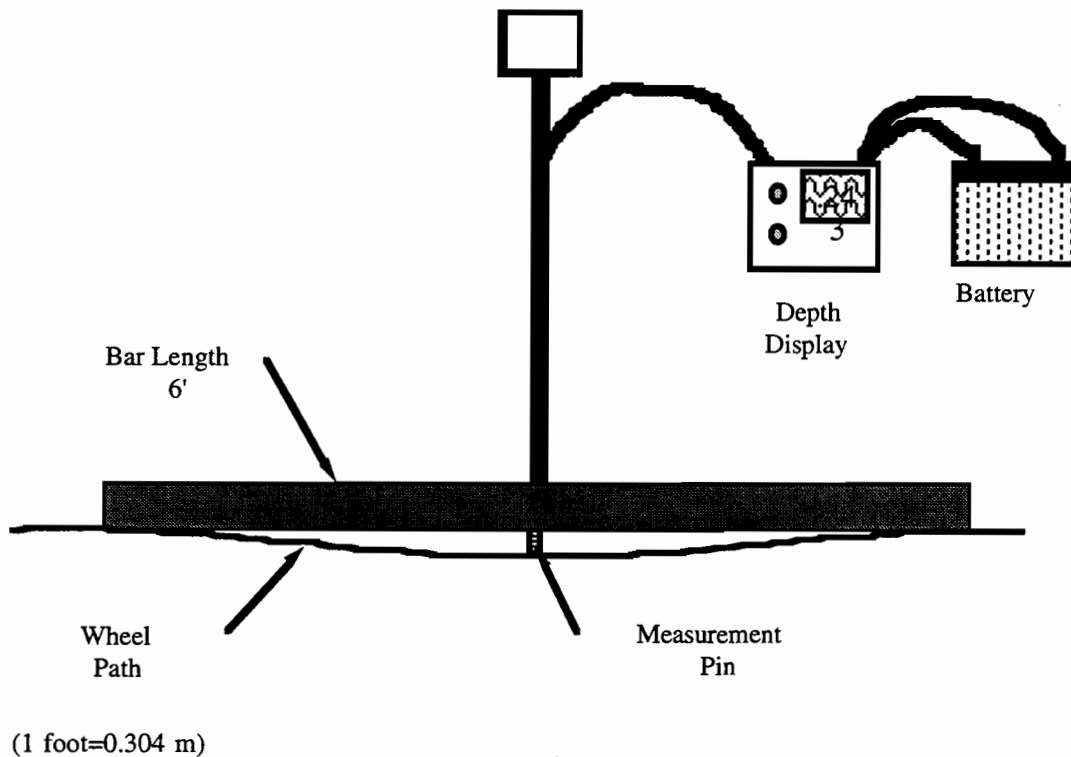
Figure 6.3 Rut depth measurement equipment

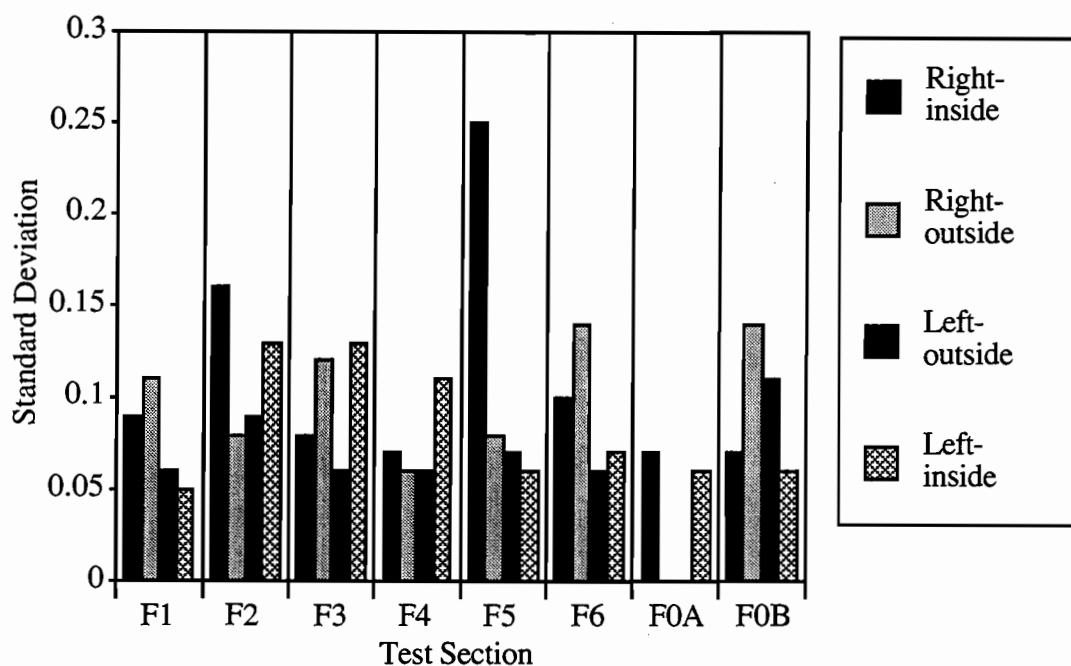
Figure 6.7 Standard deviation of rut depth for the flexible test sections — Before construction
