1. Report No. TX-95+987-4		2. Government Accession No.		3. Recipient's Catalog No.	
4. Title and Subtitle Initial Performance of Asphalt Overlays on Overlaid Jointed Concrete Pavement (JCP) and on Flexible Pavements in Field Test Sections in Lufkin, Texas				5. Report Date January 1995

**INITIAL PERFORMANCE OF ASPHALT OVERLAYS ON OVERLAID JOINTED
CONCRETE PAVEMENT (JCP) AND ON FLEXIBLE PAVEMENTS IN FIELD TEST
SECTIONS IN LUFKIN, TEXAS**

Research Report Number 987-4

A Long-Range Plan for the Rehabilitation of US 59 in District 11

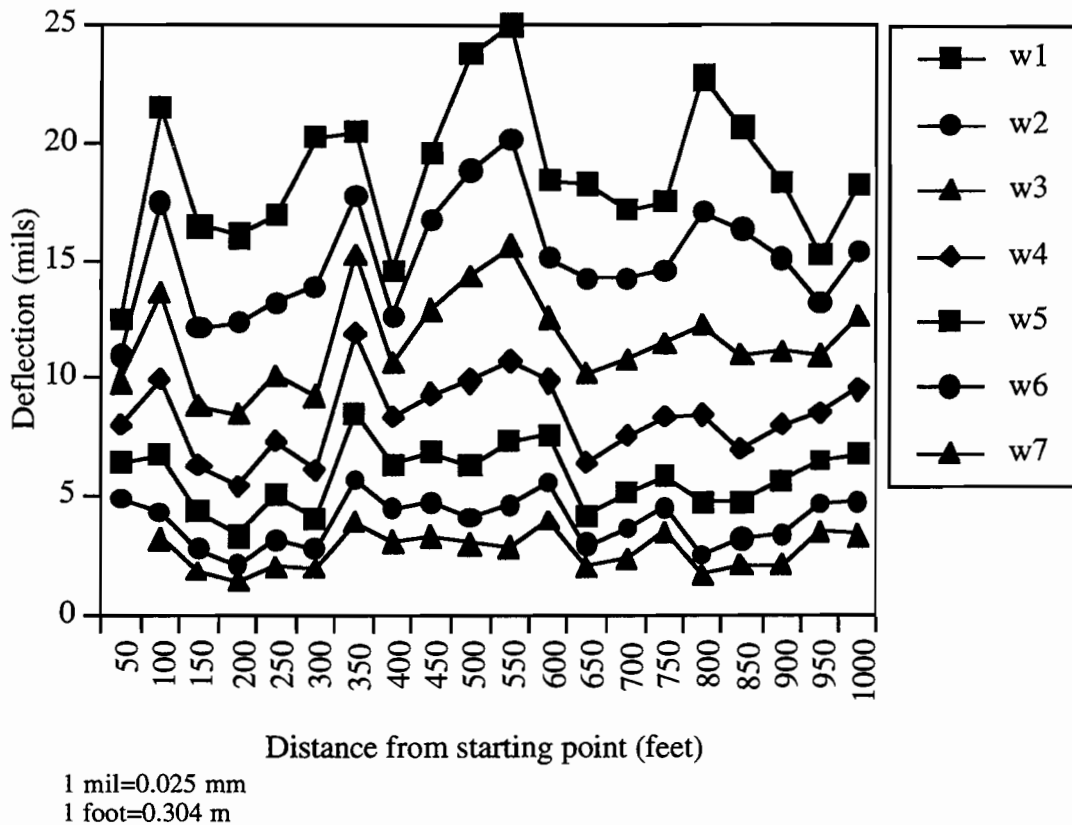
Figure 6.22 Deflection variation along the right lane of R3 in March 1993 — Second drop height

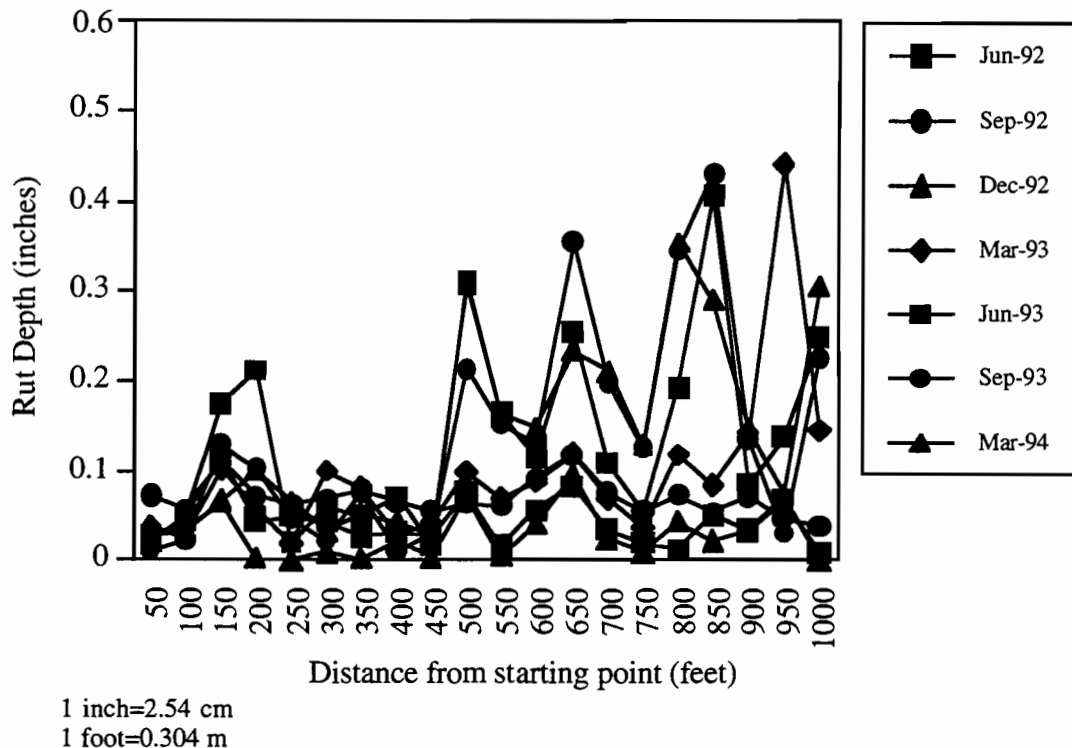
Figure 6.25 Rut depth variation along outside wheel path in right lane — F5

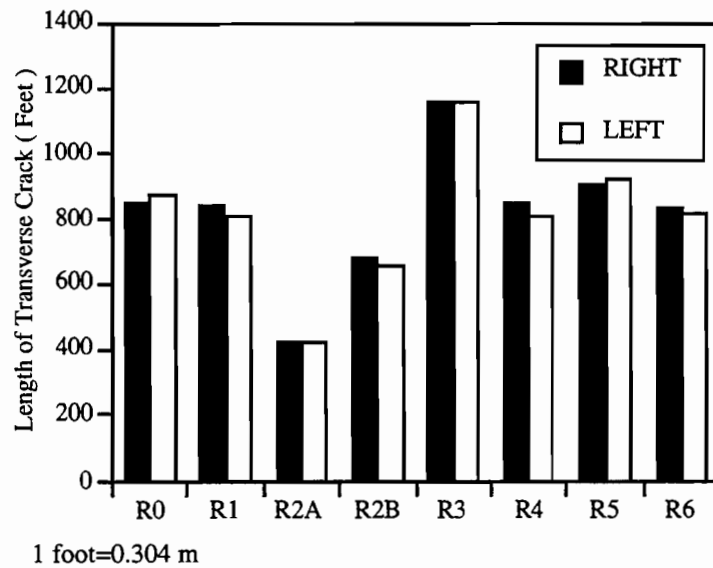
Figure 7.1 Transverse crack in the rigid sections — Before construction

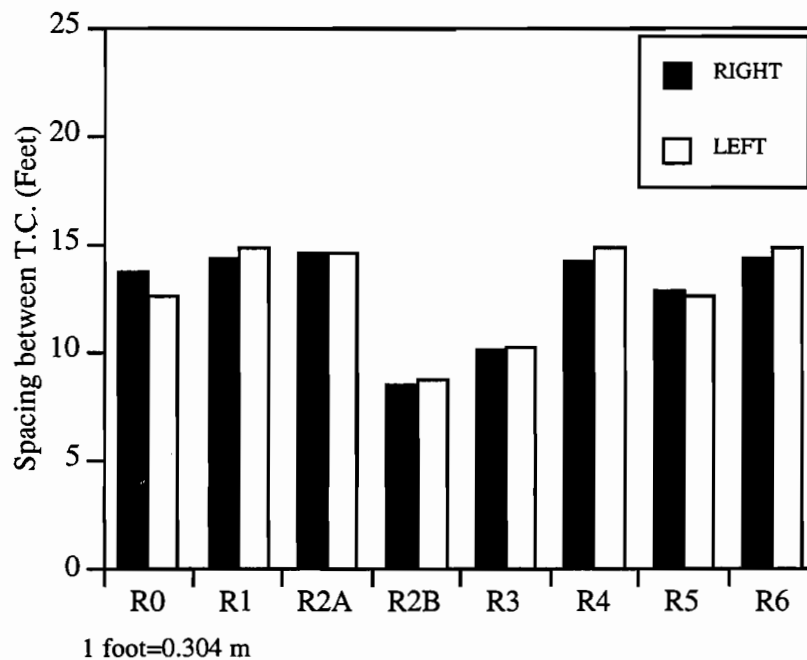
Figure 7.2 Transverse crack spacing in the rigid sections — Before construction

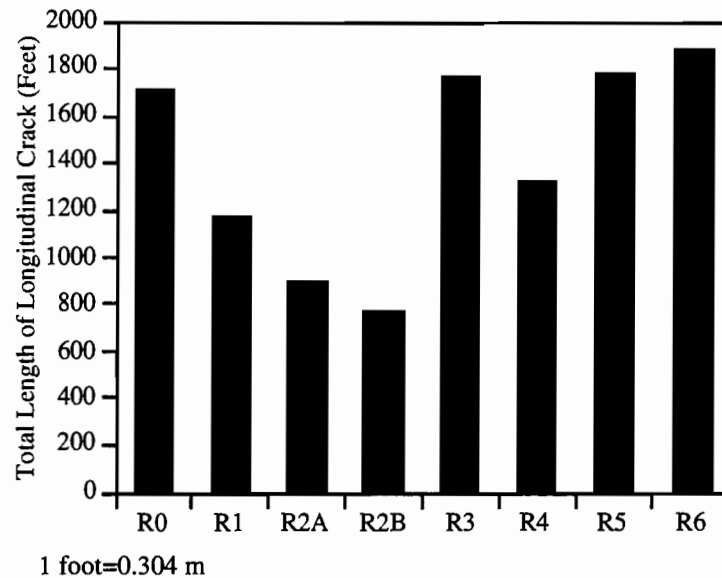
Figure 7.3 Total length of longitudinal crack in rigid section — Before construction

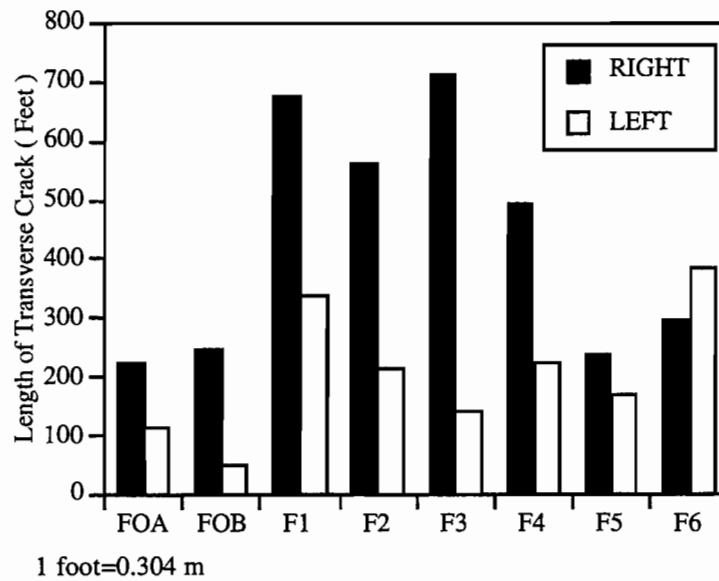
Figure 7.4 Transverse cracking in the flexible sections — Before construction

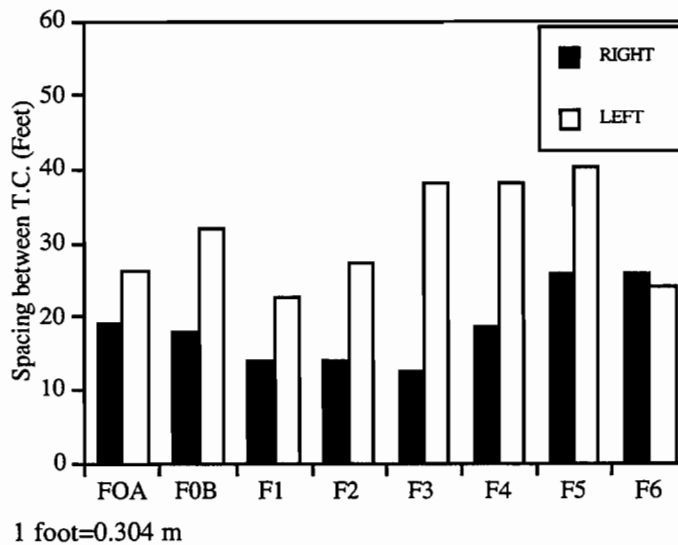
Figure 7.5 Transverse cracking spacing in the flexible sections — Before construction

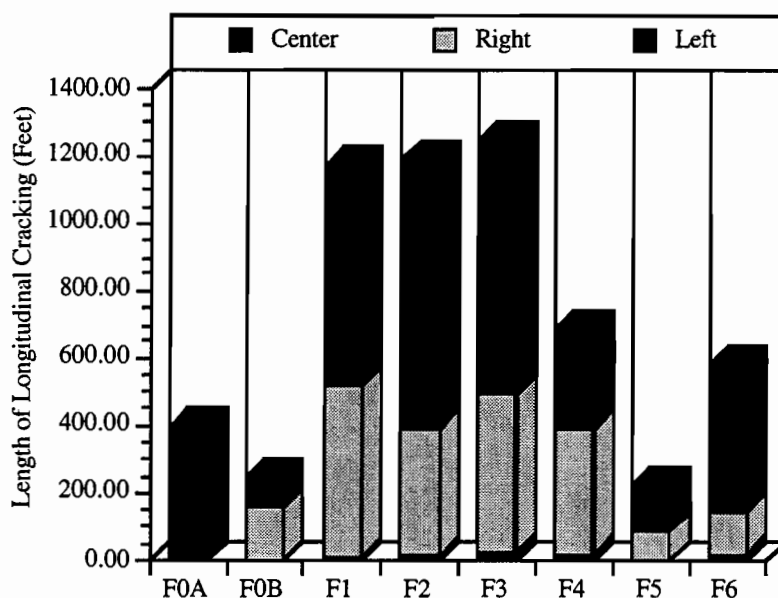
Figure 7.6 Longitudinal crack in the flexible sections — Before construction

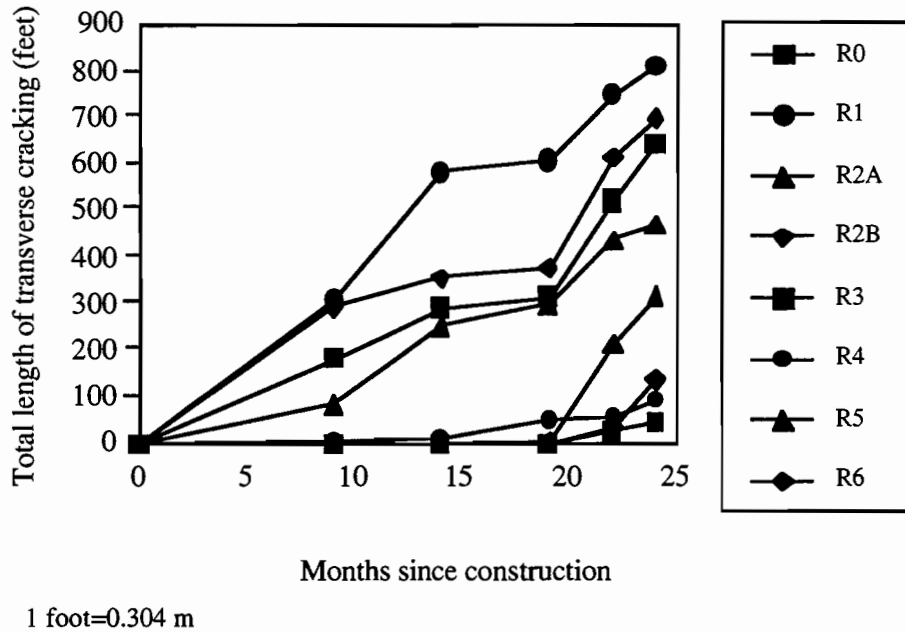
Figure 7.7 Total length of transverse cracking for the right lane for the rigid section

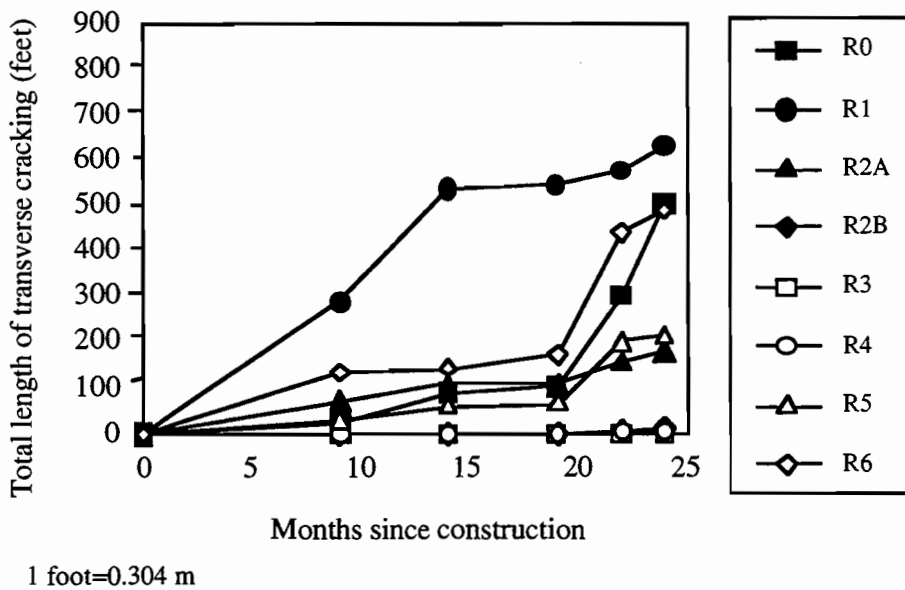
Figure 7.8 Total length of transverse cracking for the left lane for the rigid section

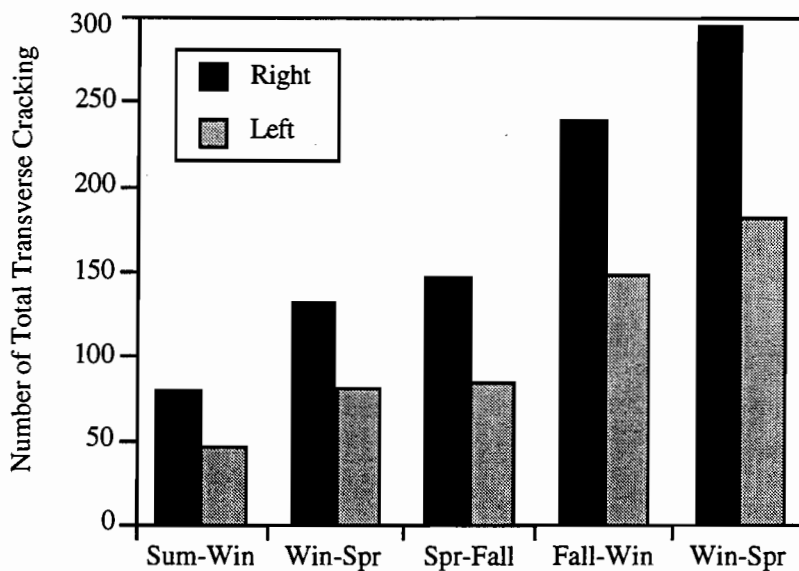
Figure 7.9 Total number of transverse cracks by season for the rigid test sections

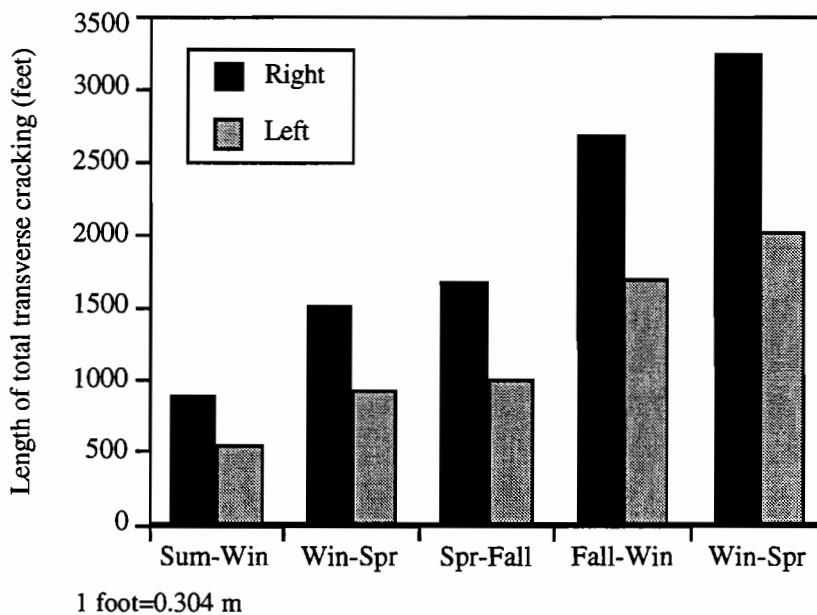
Figure 7.10 Total length of transverse cracks by season for the rigid test sections

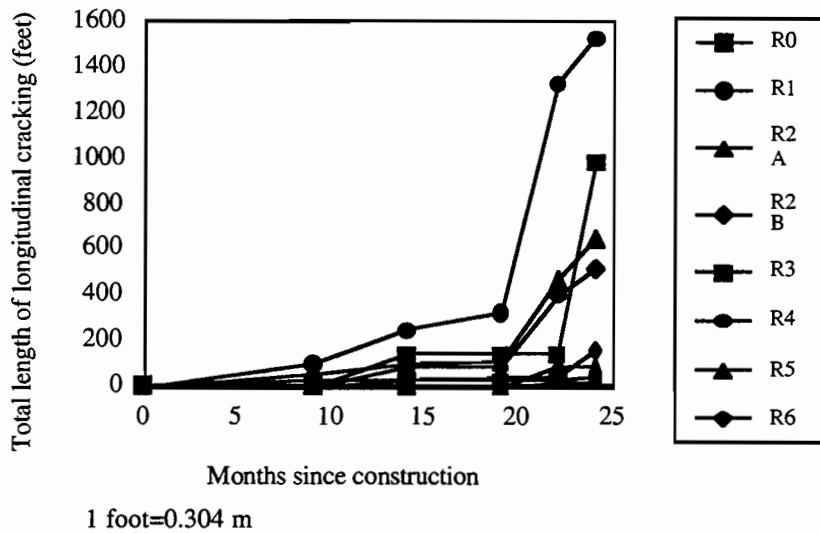
Figure 7.13 Total length of longitudinal cracking for the rigid sections

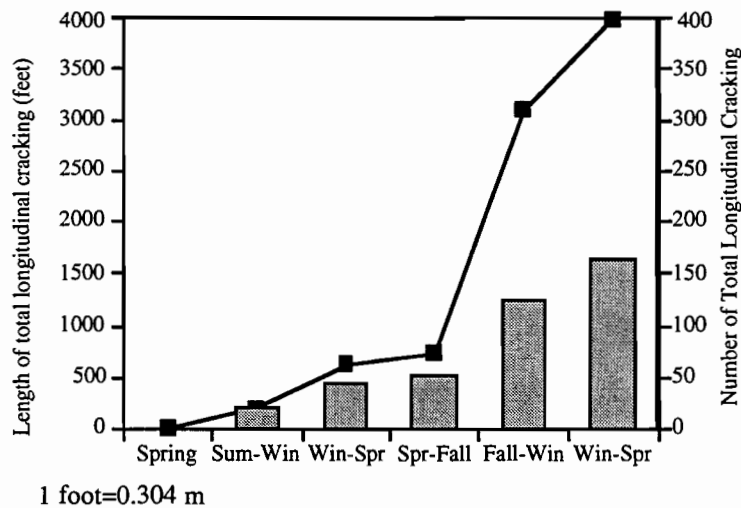
Figure 7.14 The trend of total length of longitudinal cracking in rigid section

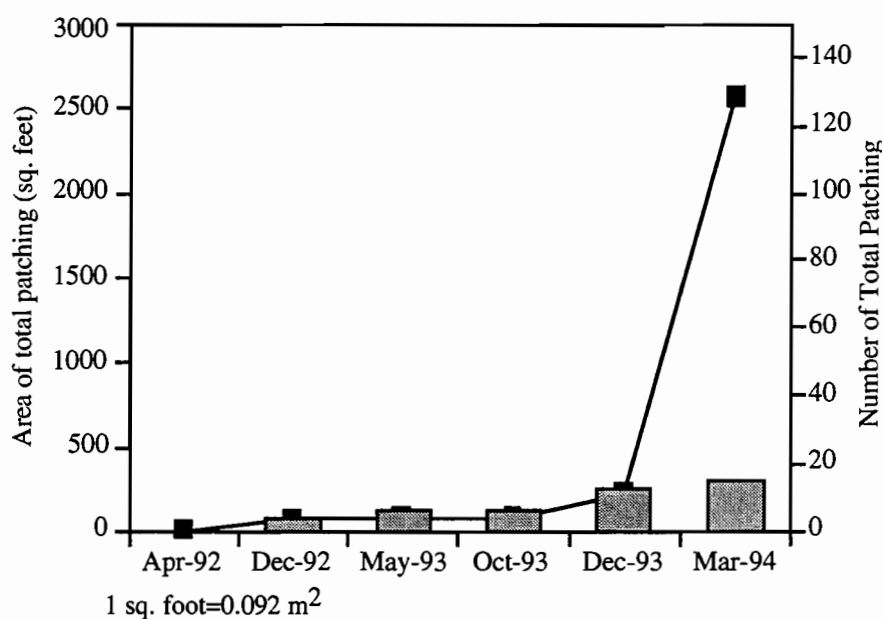
Figure 7.15 Total area of patching versus time in the rigid

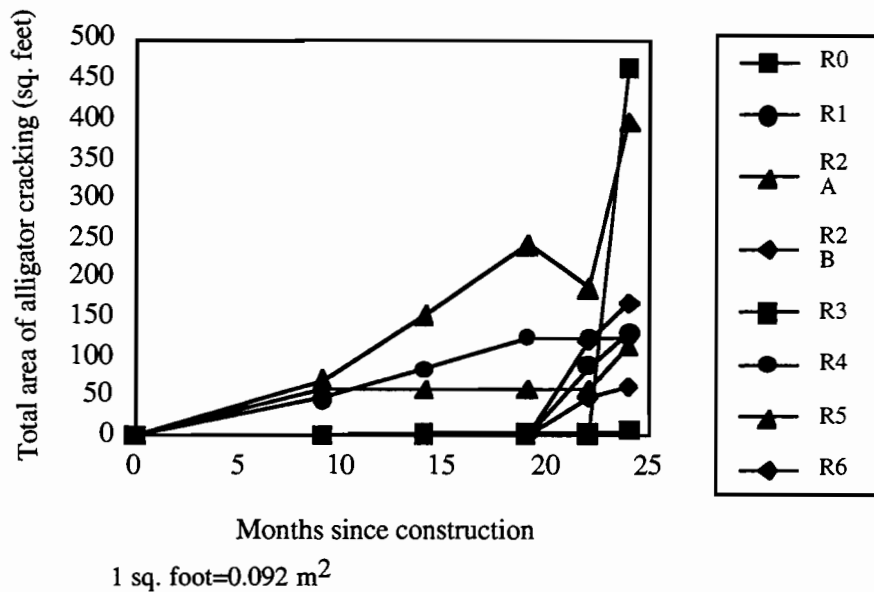
Figure 7.16 Total area of alligator cracking

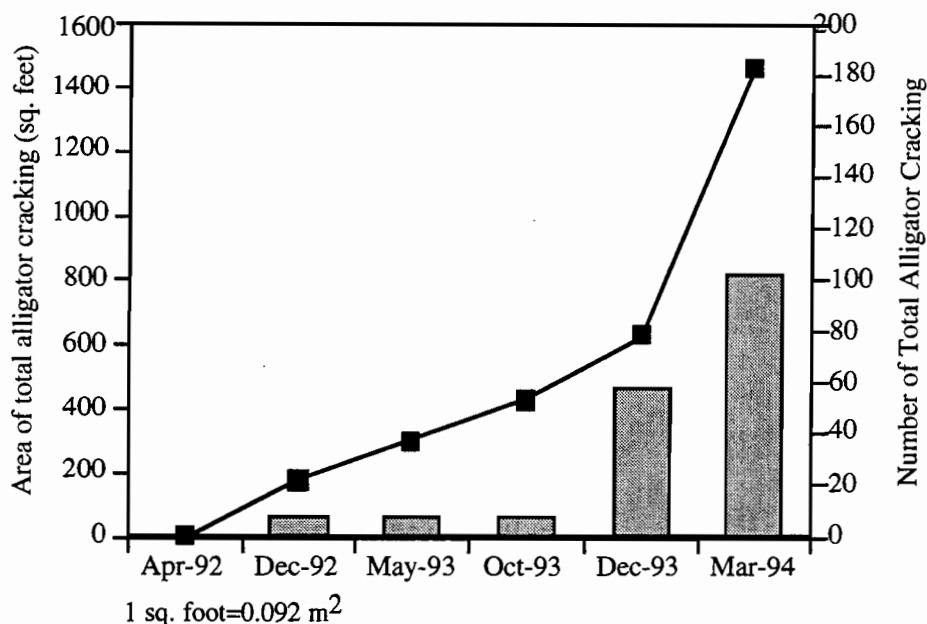
Figure 7.17 The trend of alligator cracking in test section

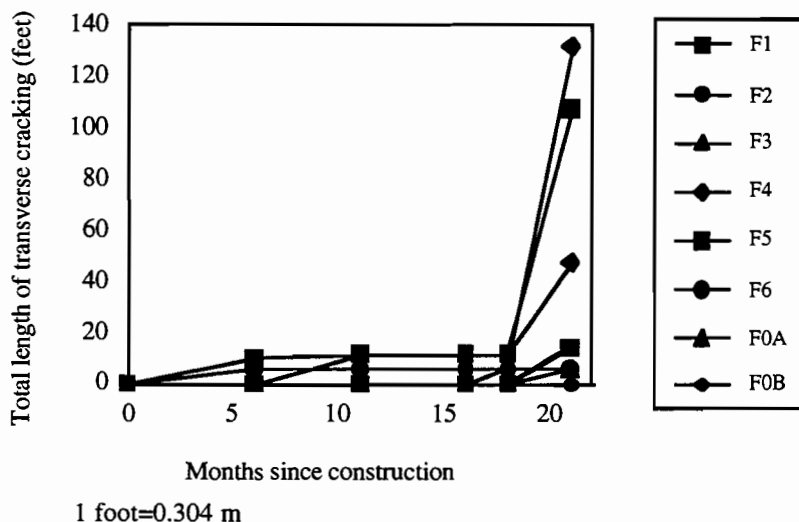
Figure 7.18 Total length of transverse cracking in right lane

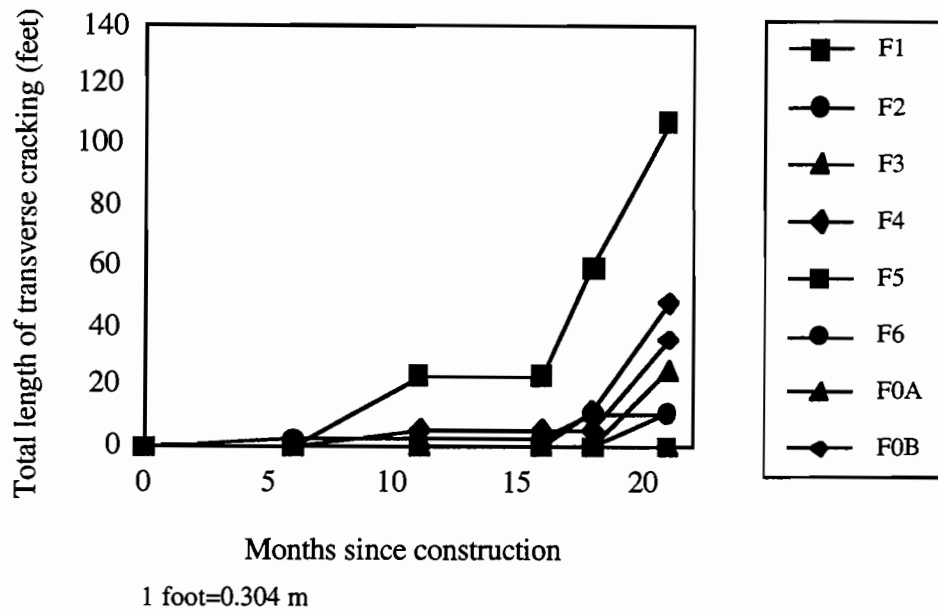
Figure 7.19 Total length of transverse cracking in left lane

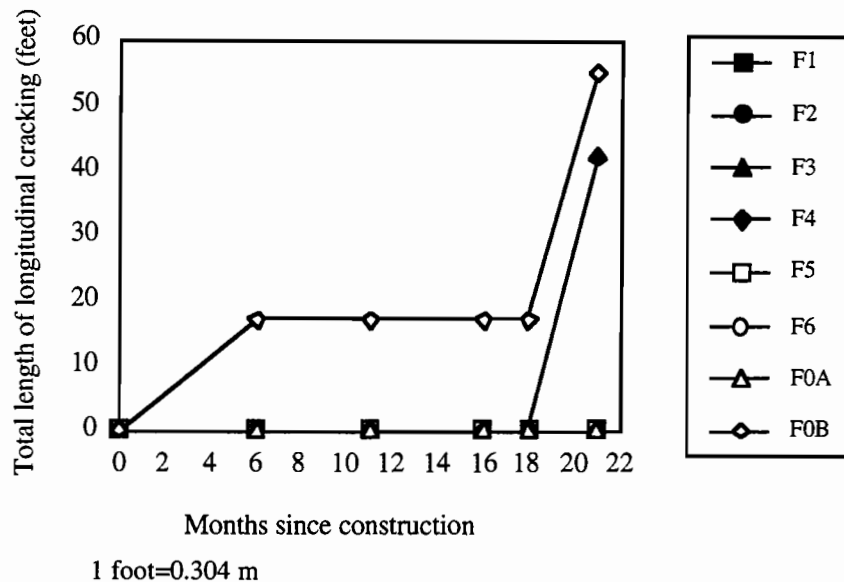
Figure 7.20 Total length of longitudinal length

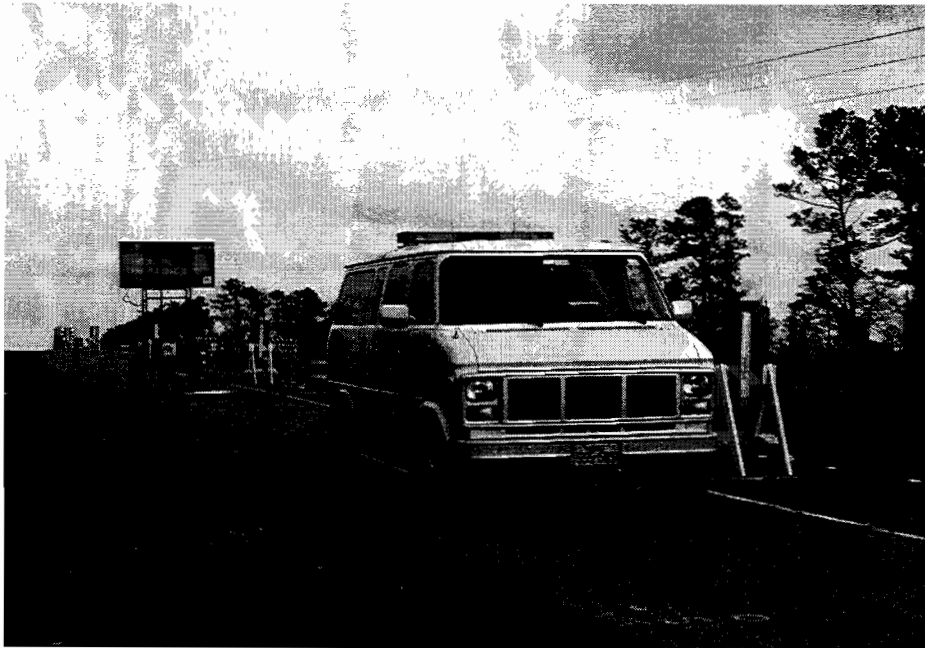
Figure 8.1 The Surface Dynamics Profilometer (SDP)

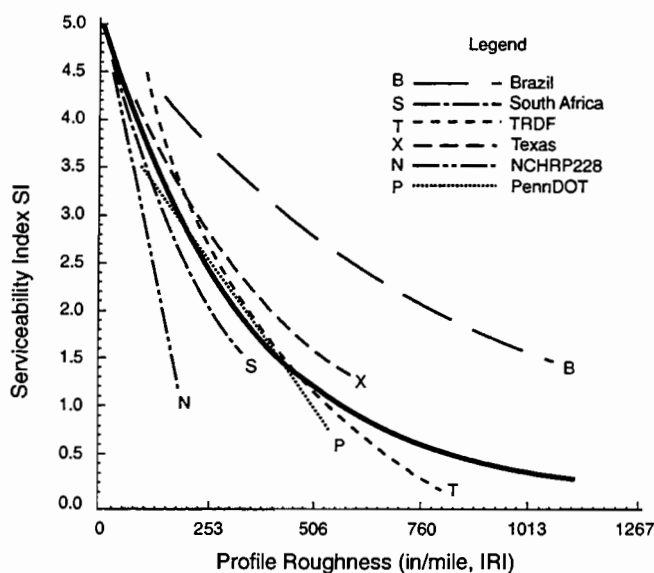
Figure 8.2 Approximate relationship between AASHO serviceability index and IRI

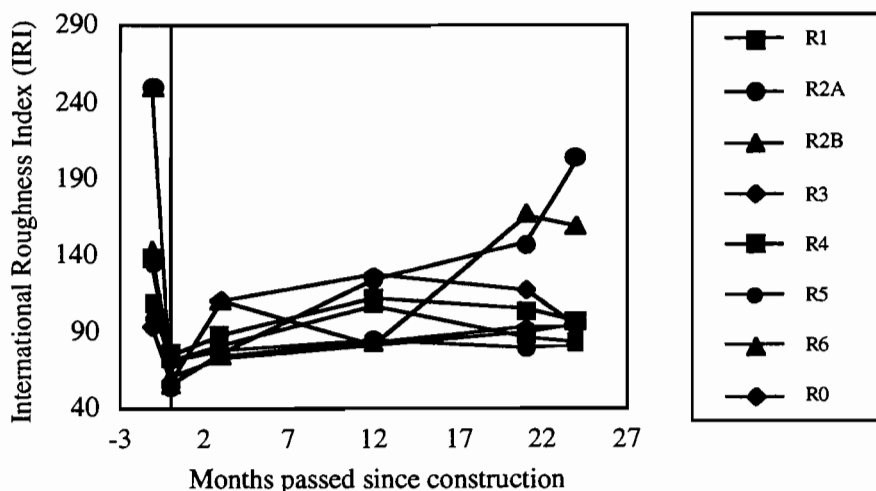
Figure 8.9 IRI versus time at outside wheel path of right lane — Rigid section

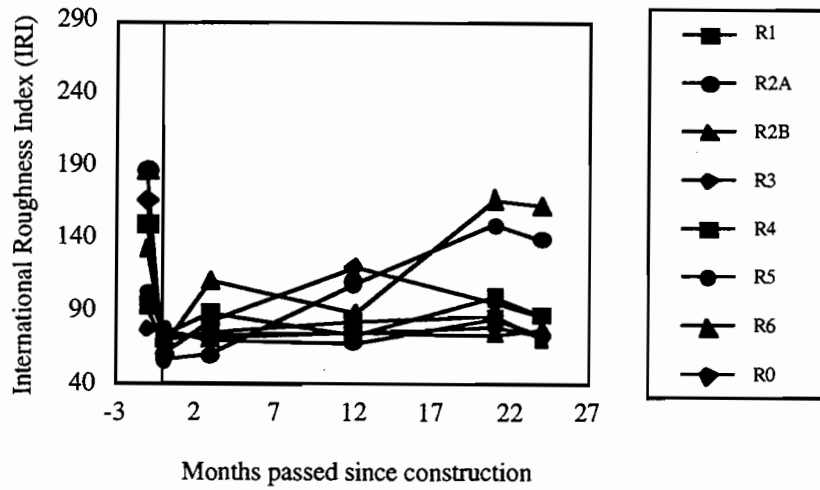
Figure 8.10 IRI versus time at inside wheel path of right lane — Rigid section

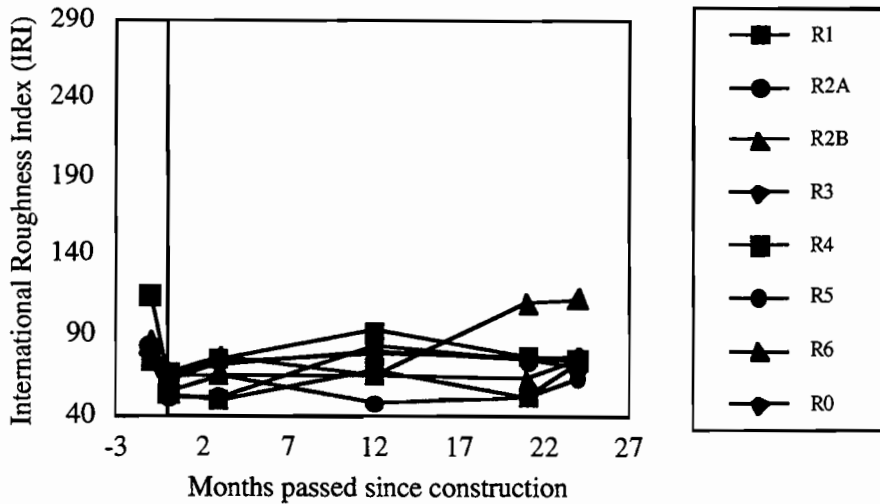
Figure 8.11 IRI versus time at inside wheel path of left lane — Rigid section

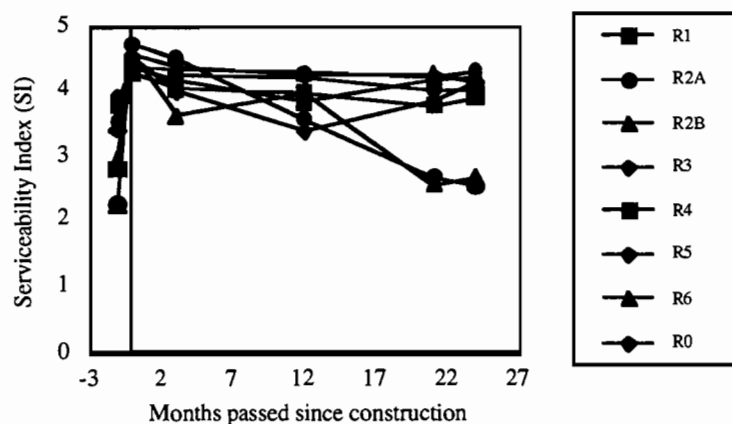
Figure 8.13 PSI variation of the right lane — Rigid section

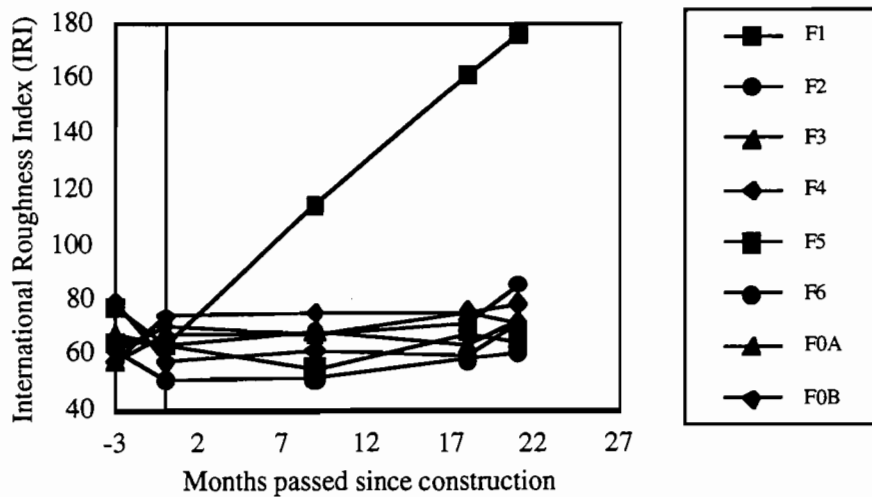
Figure 8.15 IRI versus time at outside wheel path of right lane — Flexible section

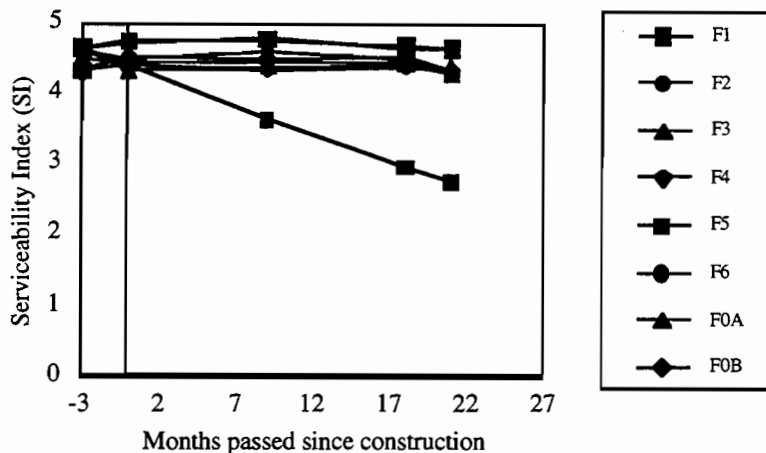
Figure 8.19 PSI variation of right lane — Flexible
