**ACCELERATED TRIALS OF  
GLASS FIBER REINFORCED RIGID PAVEMENTS**

by: Ernest L. Buckley, P.E., Ph.D.

April 12, 1974

Published by  
The Construction Research Center  
College of Engineering  
University of Texas at Arlington  
Arlington, Texas 76019

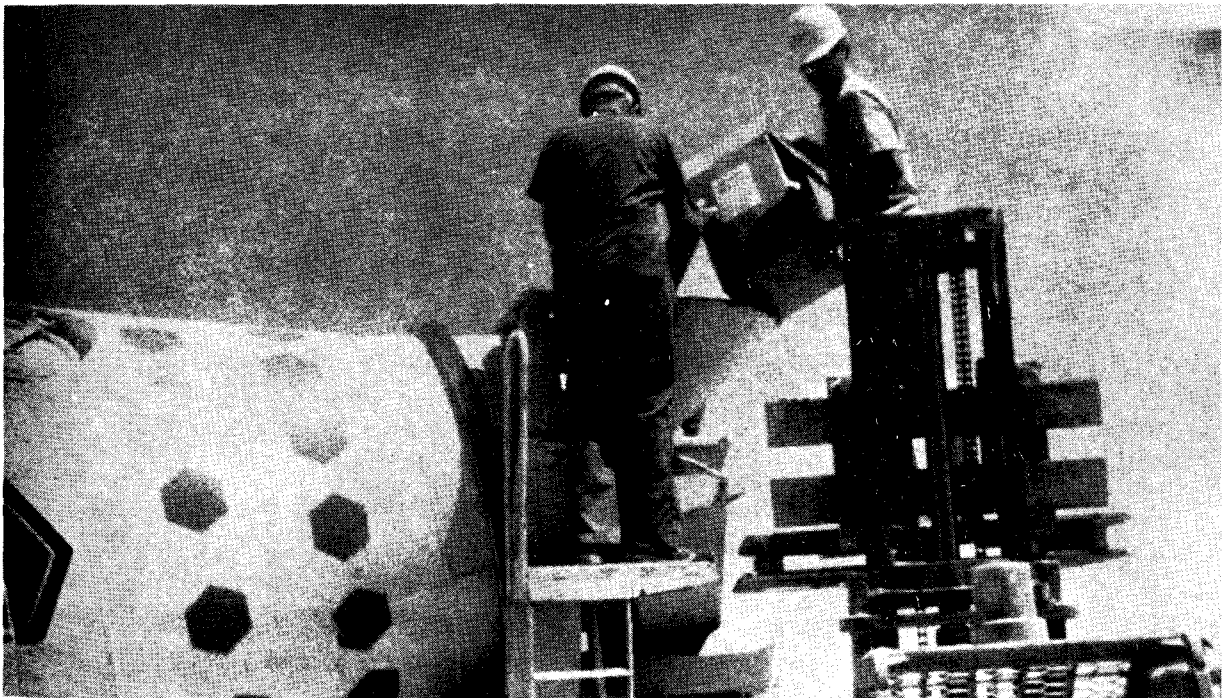
Figure 5: GLASS RIBERS ADDED TO READY-MIX AT THE JOB SITE

In future work of this kind, a mix with an increased amount of cement is recommended. The glass fibers could probably be chopped and added at the transit mixer, using an electric or pneumatic chopper, with less manual effort. For this test the fibers were pre-chopped and

dumped into the mixer by hand, directly from the 50 pound cardboard shipping containers.

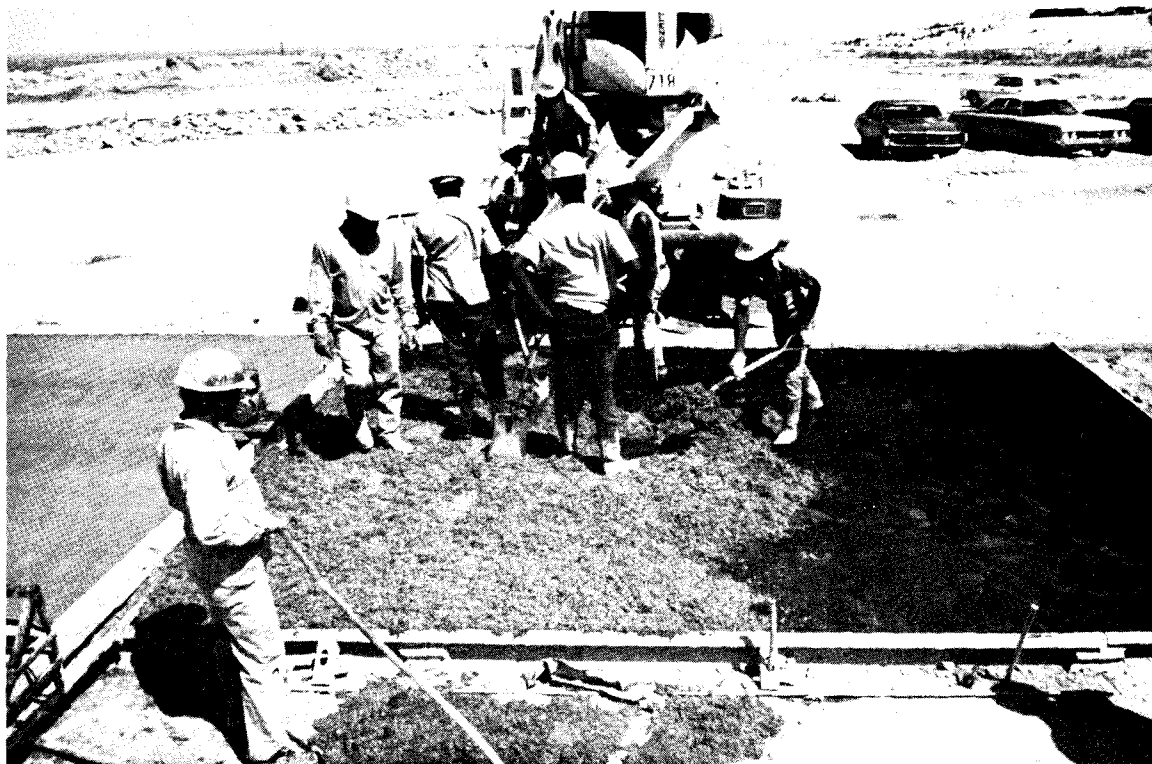
Figure 6: LOW SLUMP FIBER REINFORCED CONCRETE  
(AT  $\frac{V_r}{V} = 1.34\%$ ) REQUIRED EXTRA EFFORT IN PLACEMENT

The low-slump characteristic of the glass fiber and concrete mix requires vibration during placement. An adequate number of high-energy, high frequency vibrators should be available for any future work.

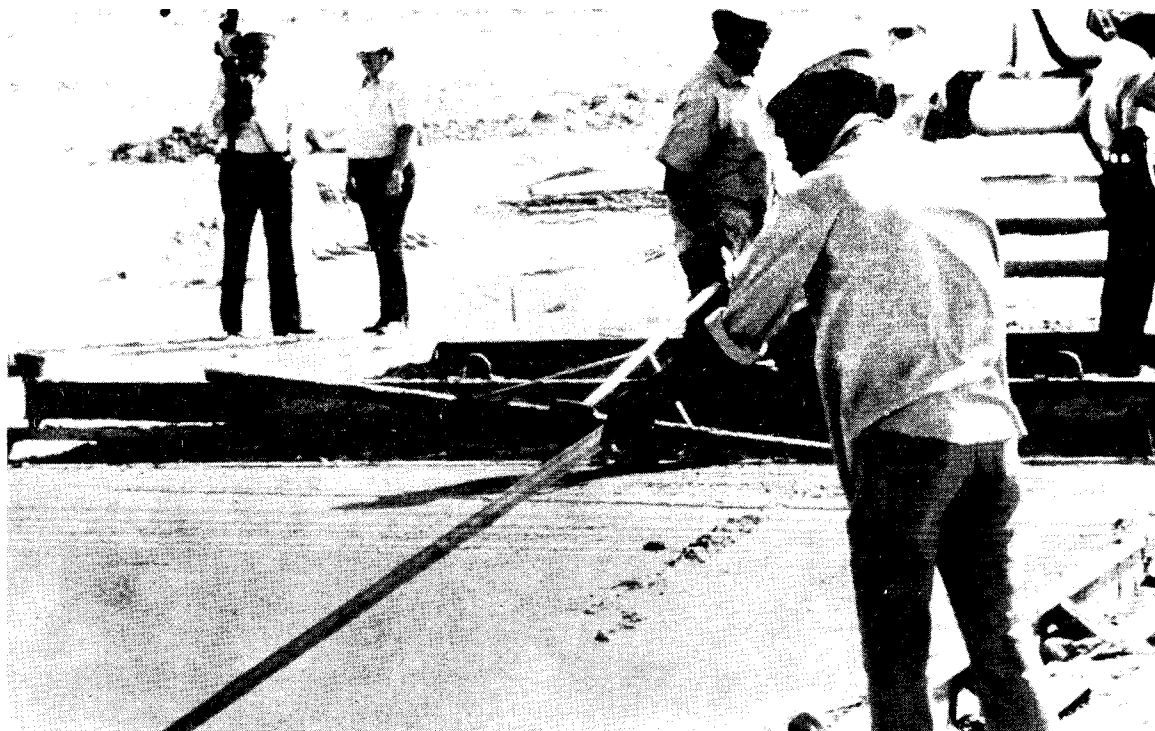
Figure 7: PLACEMENT AND FINISHING WERE RELATIVELY  
EASIER AT  $\frac{V_r}{V} = 0.97\%$

The finishing of slabs 2, 3 and 4 proved to be no problem. See Figure 7. A normal surface of texture that would provide standard skid resistance was provided.

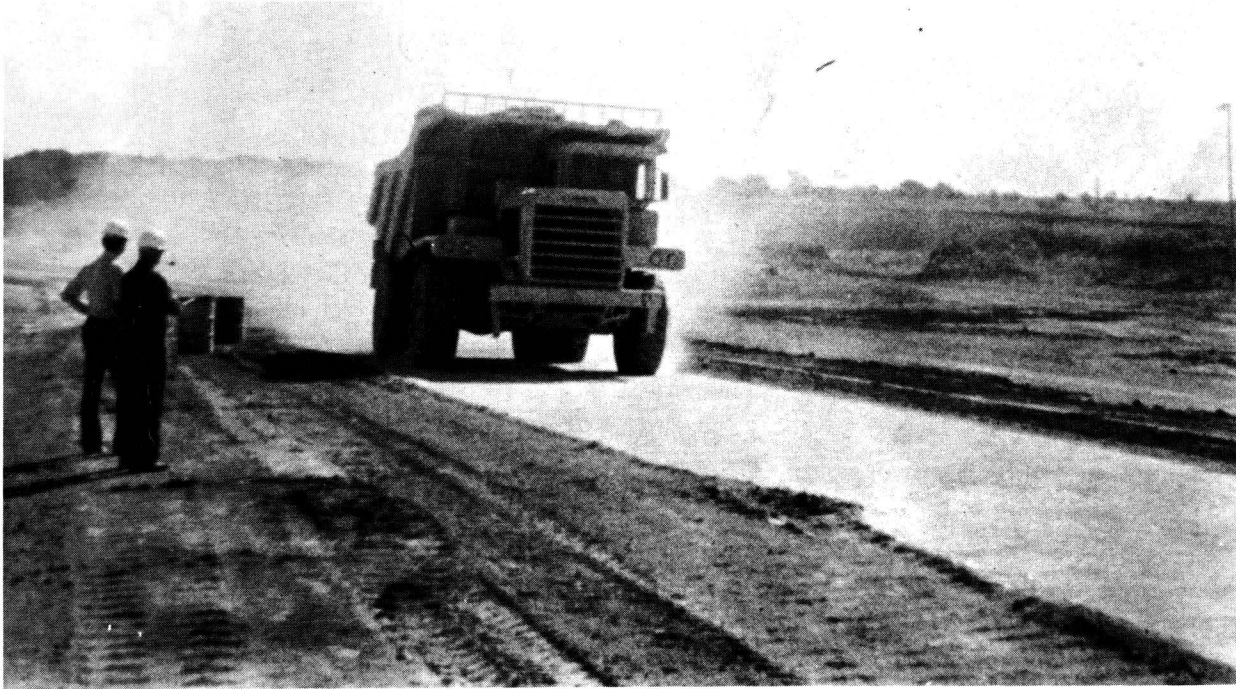
Figure 11: FIRST TEST LOAD APPLIED

The application of loads to the test pavement slabs was begun on August 7, 1973, as shown by Figure 11, and continued with periodic observations made through March 15, 1974. For observing and recording the developing crack pattern, the pavement surface was swept clean (see Figure 12). Extension of cracking was carefully mapped.

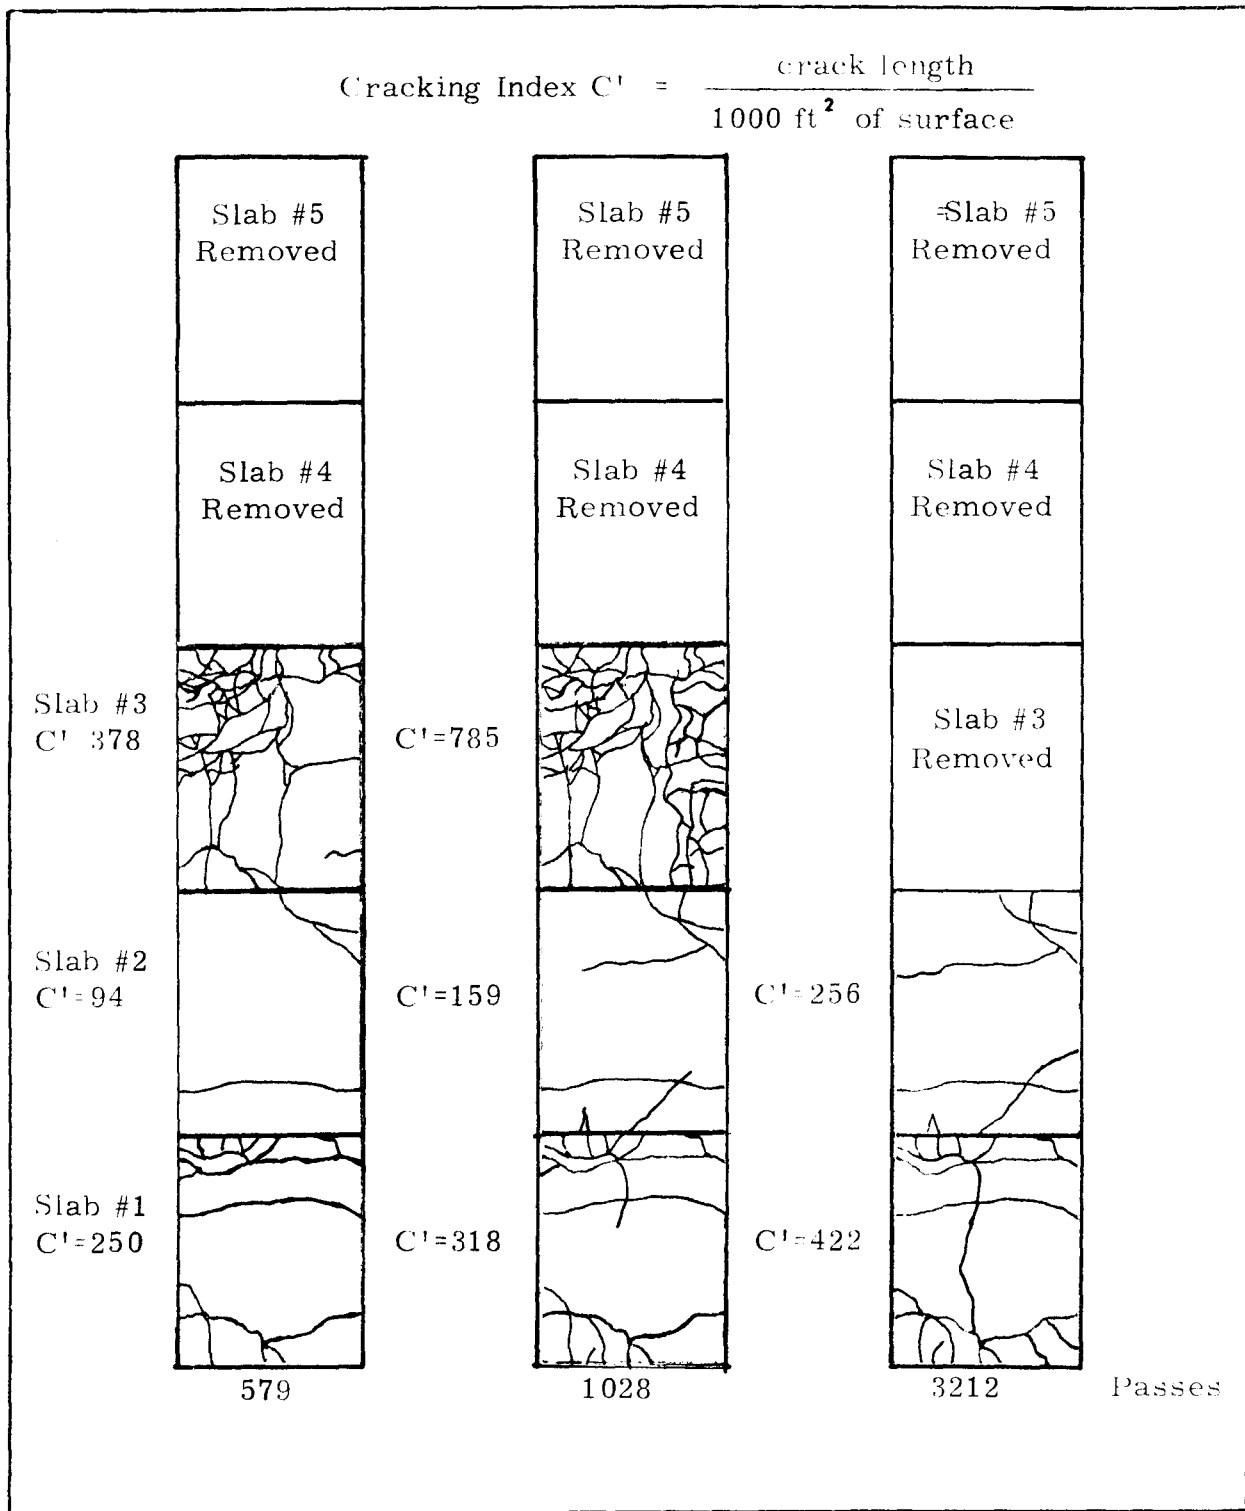
Figure 13: CRACK DEVELOPMENT UNDER 85 KIP SINGLE AXLE TEST LOADS

After removal of Slab #5, routine loading was resumed. The results of periodic mapping of cracks are tabulated in Table 5-1. Crack growth proceeded rapidly in Slab #4. It was determined that the failure of the Northeast corner of Slab #4 was due, in part, to the deposition of the residue from Slab #5 batch at the time of initial pouring. In any case,

the 4-inch, glass fiber reinforced Slab #4 had reached a terminal condition 116 load repetitions. It was also noted that, at this point, Slab #3 had developed the same amount of cracking as the control slab. In other words, up to this point, the 6-inch glass fiber reinforced slab had performed better than the conventional steel reinforced Slab #1.

Slab No.	Load Repetitions - 85 kip Axle Load								
	13	20	116	179	316	578	678	1028	3212
1	17	20	35	68	70	80	90	102	135
2				30	30	30	30	53	82
3		15	35	50	50	121	150	250	Terminated
4	72	108	193	Terminated					
5	250	Terminated
