TECHNICAL MEMORANDUM 505-9S

Texas Transportation Institute
Texas A&M Research Foundation

EVALUATION OF CRASH CUSHIONS
CONSTRUCTION OF LIGHTWEIGHT CELLULAR CONCRETE

A Tentative Progress Memorandum on Contract No. CPR-11-5851

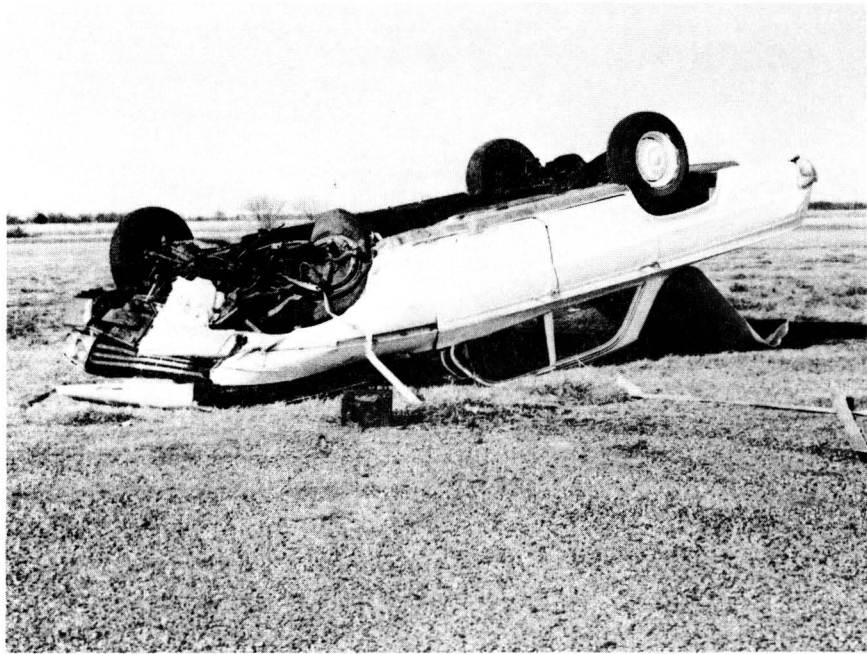
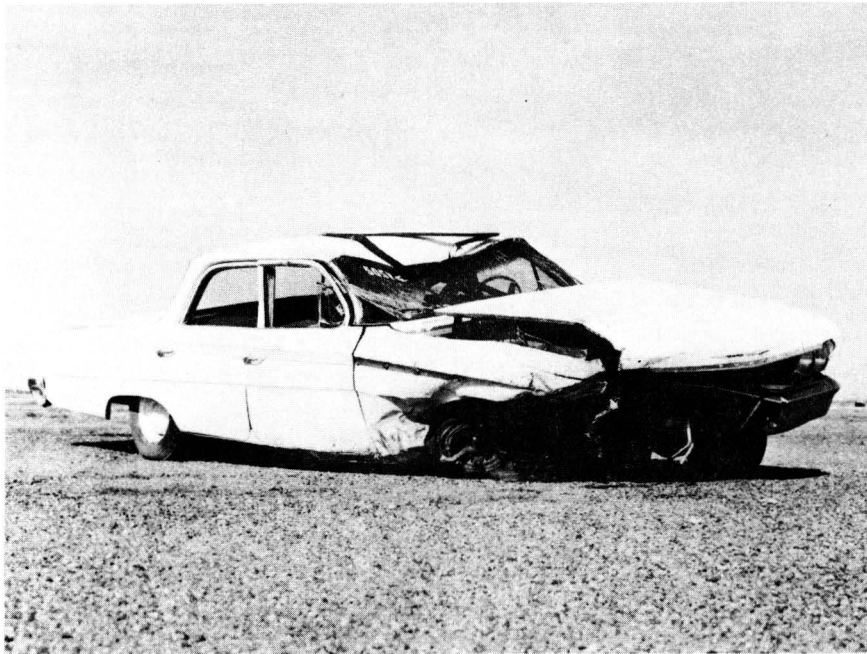
Figure 12, Vehicle After Test E.

Final Position

After Righting

This test was a 20° side angle impact on the Mod III barrier using a 1962 Chevrolet weighing 3820 lbs. The point of contact was 16 ft in advance of the rigid backup wall. The impact speed was 59.7 mph and speed of the vehicle at loss of contact with the barrier was 29.3 mph. This represented an average deceleration of 5.6 g's in the longitudinal direction. The vehicle was in contact with the cushion for approximately 16 ft. Photographs of this test are shown in Figures 10 through 15. As the vehicle made contact and slid down the side of the cushion, a slight ramping tendency was observed. This interaction finally culminated in the generation of a high roll-initiating force as the vehicle reached the end of the cushion. The vehicle rolled in a counterclockwise direction, when viewed in the direction of vehicle travel; ramped on the rear end of the cushion near the end of the backup wall; traveled beyond the cushion installation, skidding on its left side; rolled clockwise to an upright position; and continued to roll over onto its top. It came to rest approximately 80 ft past the barrier. Although the decelerations which were imparted to the vehicle during its interaction with the cushion were within the range of human tolerance, the roll condition which occurred after the vehicle left the cushion is a very undesirable reaction and is unacceptable from a passenger safety viewpoint.

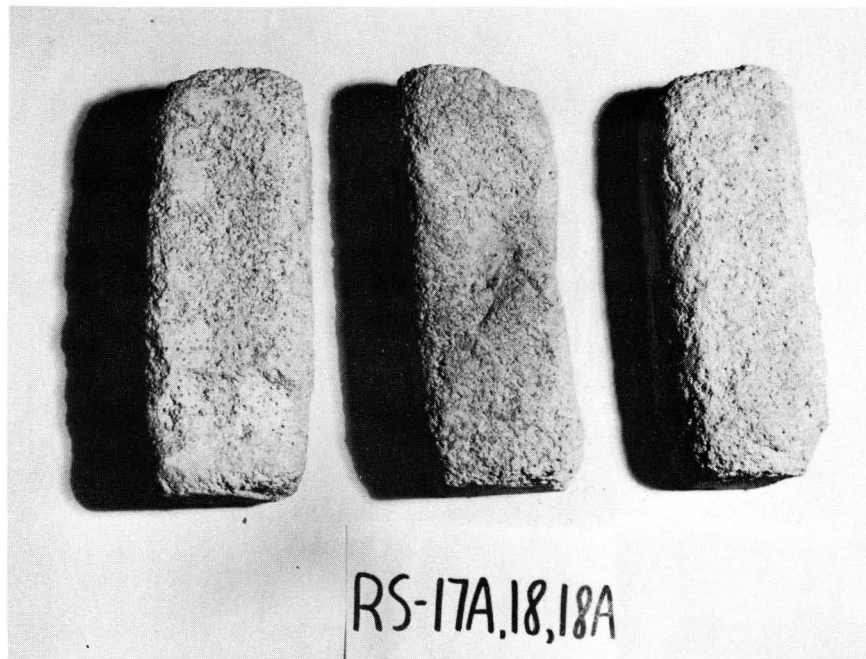
Figure C2 Conditions of specimens RS-17A, 18, 18A after 11 cycles of freezing and thawing.

Figures C1 through C29 are photographs of the specimens illustrating their condition at the listed number of cycles. The uncoated specimens suffered progressive attrition of the surface without "structural" cracking. The most effective treatment investigated was obtained by soaking the specimens in linseed oil for 24 hours. The two flexible epoxy coating treatments were applied by Perlite Industries Inc. of Midland, Texas.

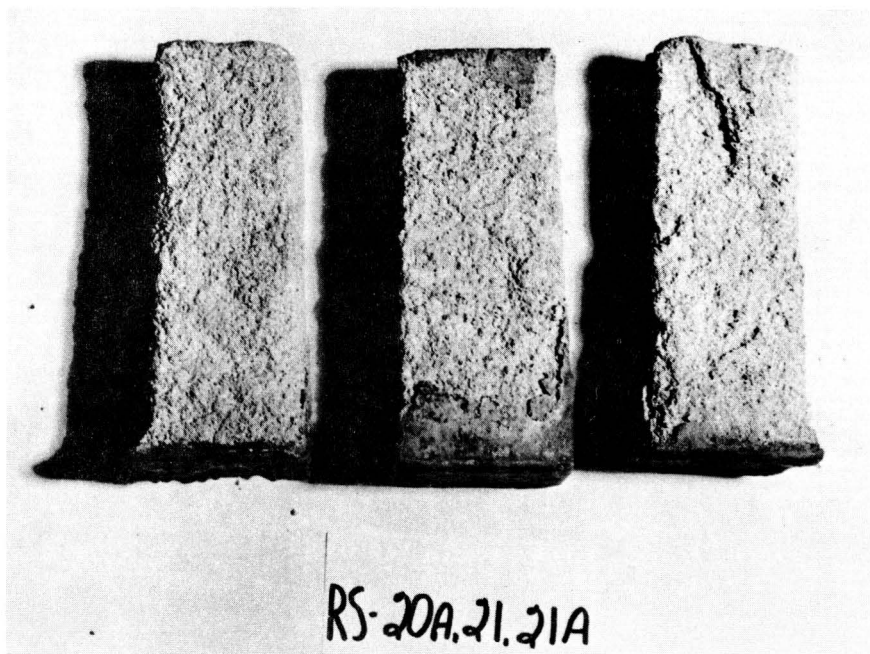
Figure C4 Conditions of specimens RS-20A, 21, 21A after eight cycles of freezing and thawing.

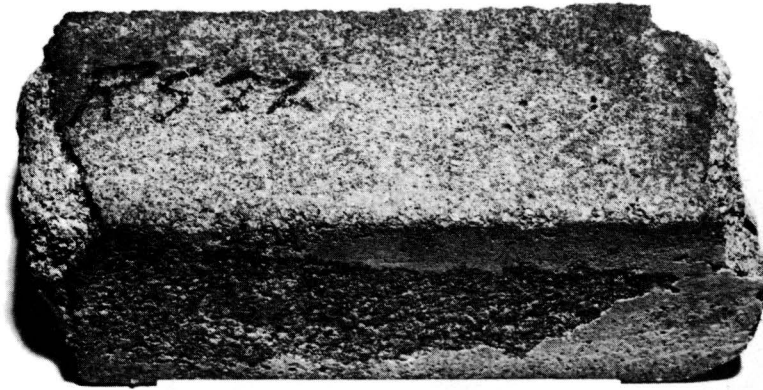
Figure C5 Condition of specimen RS-22 after 44 cycles of freezing and thawing.

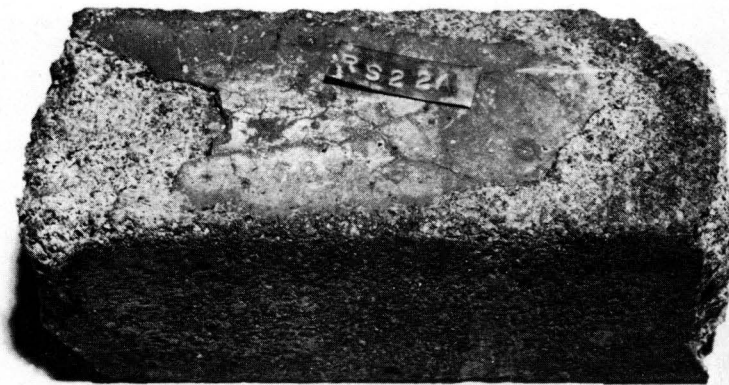
Figure C6 Condition of specimen RS-22A after 44 cycles of freezing and thawing.

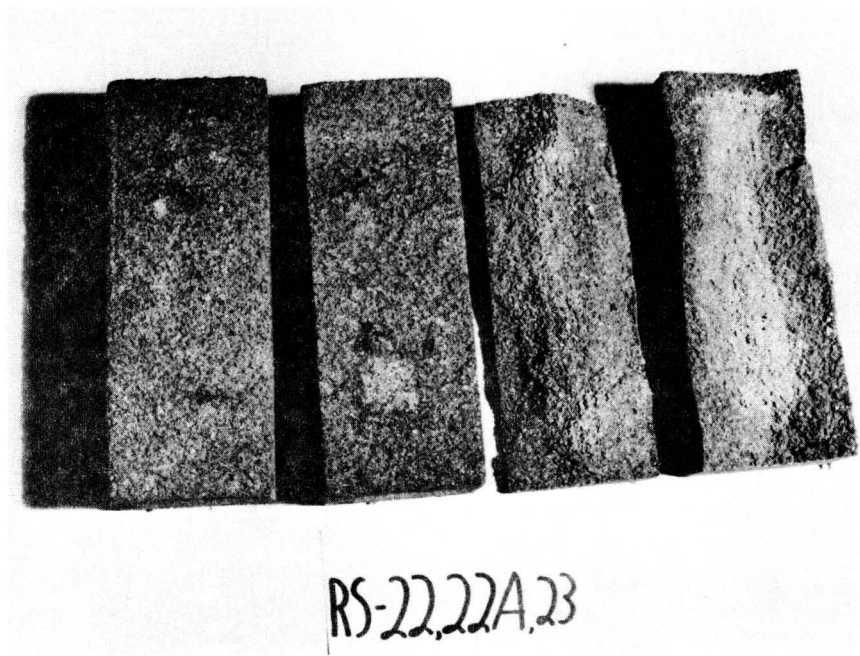
Figure C7 Conditions of specimens RS-22, 22A after 27 cycles, and RS-23 after 4 cycles of freezing and thawing.

Specimen RS 23, one of the group soaked in linseed oil for 24 hours prior to freezing and thawing, failed after only four cycles. A single crack formed in the longitudinal direction of the specimen and it separated into two pieces as illustrated in Figure C7. The reason for early failure of this specimen is questioned. The failure was not a classical freeze-thaw type failure and no deterioration other than the single crack was experienced.

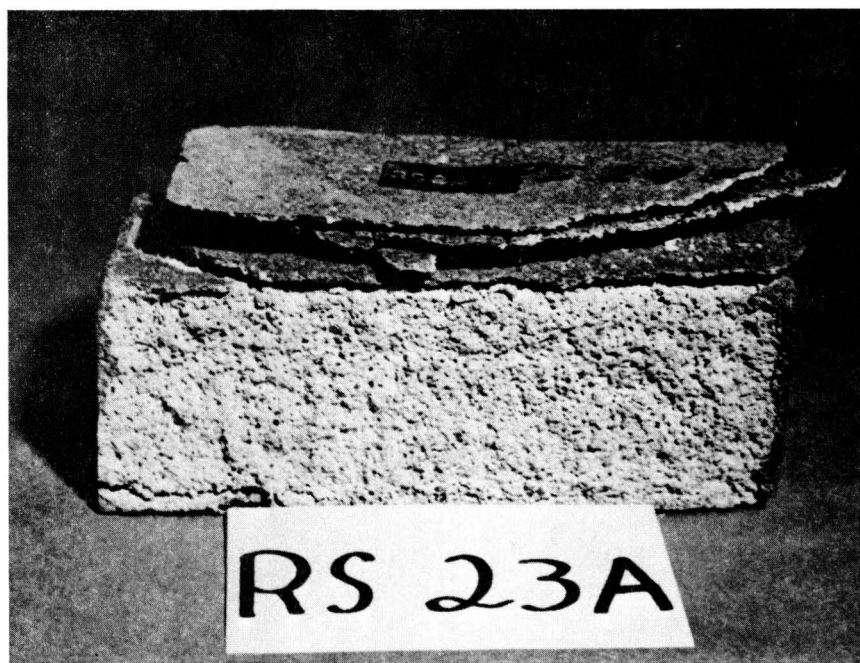
Figure C8 Condition of specimen RS-23A after 19 cycles of freezing and thawing.

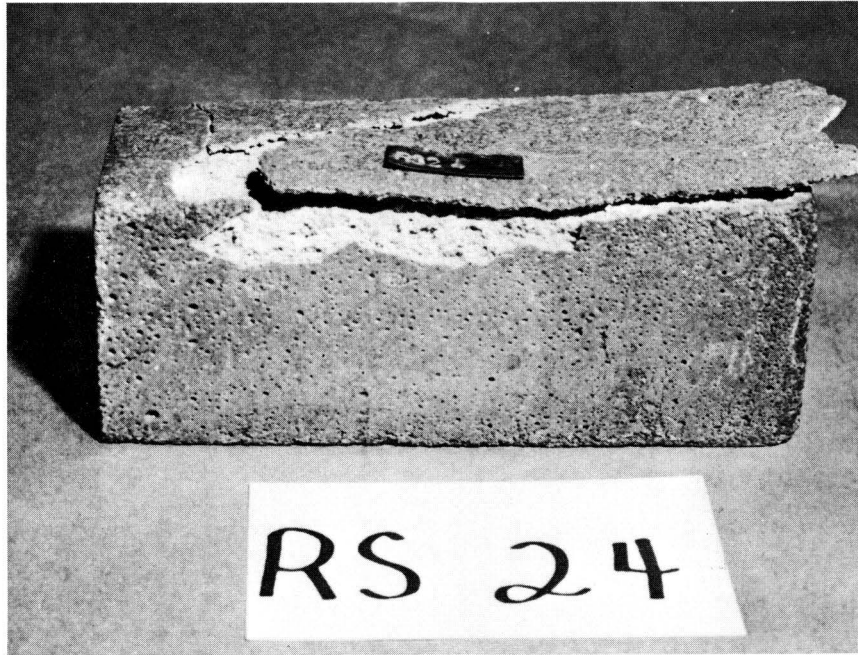
Figure C9 Condition of specimen RS-24 after 14 cycles of freezing and thawing.

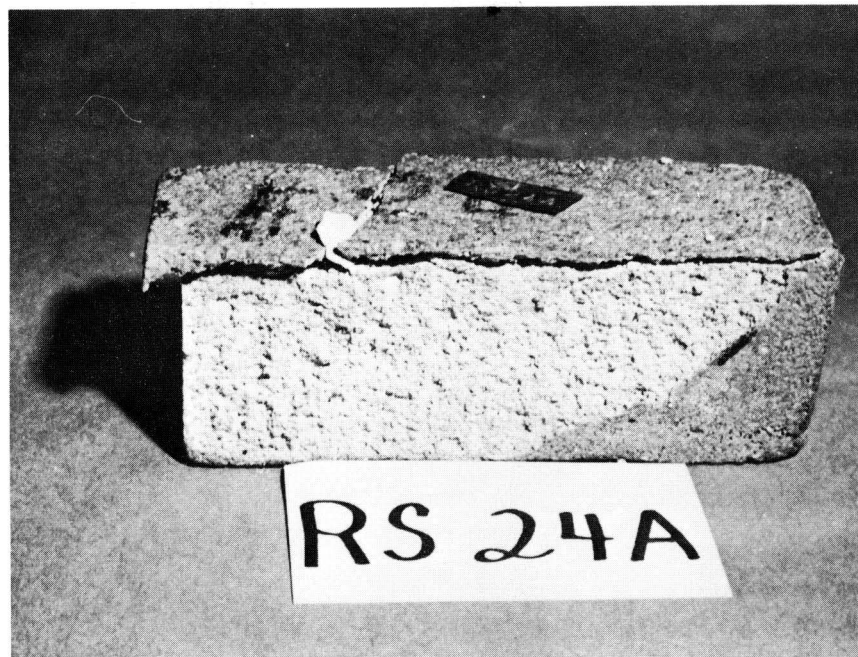
Figure C10 Condition of specimen RS-24A after 16 cycles of freezing and thawing.

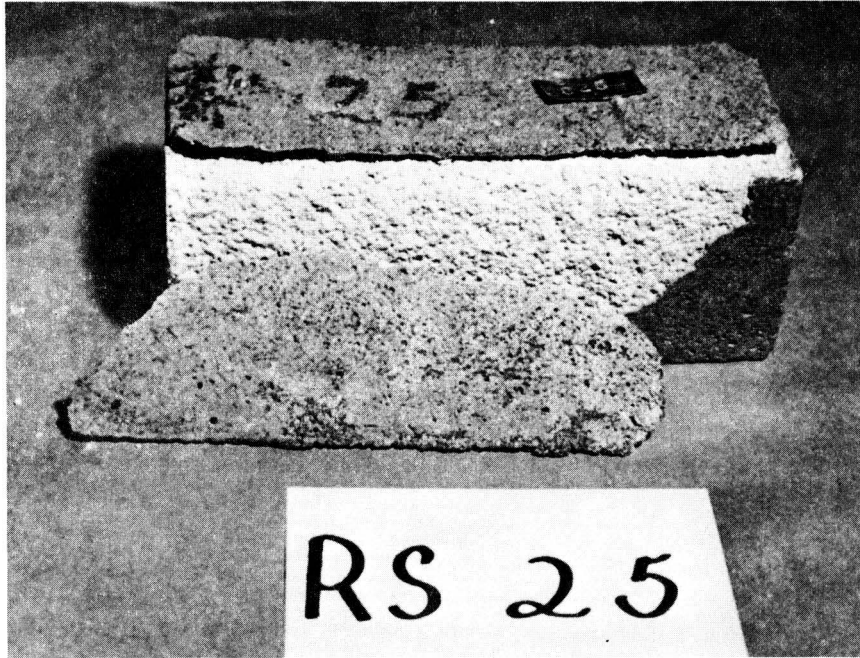
Figure C11 Condition of specimen RS-25 after 8 cycles of freezing and thawing.

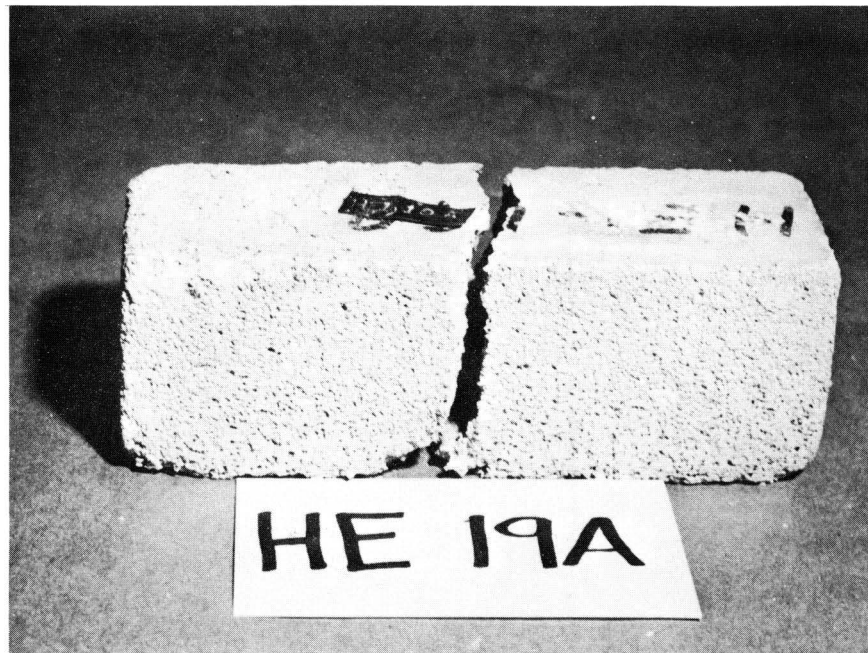
Figure C13 Condition of specimen HE1-19A after 24 cycles of freezing and thawing.

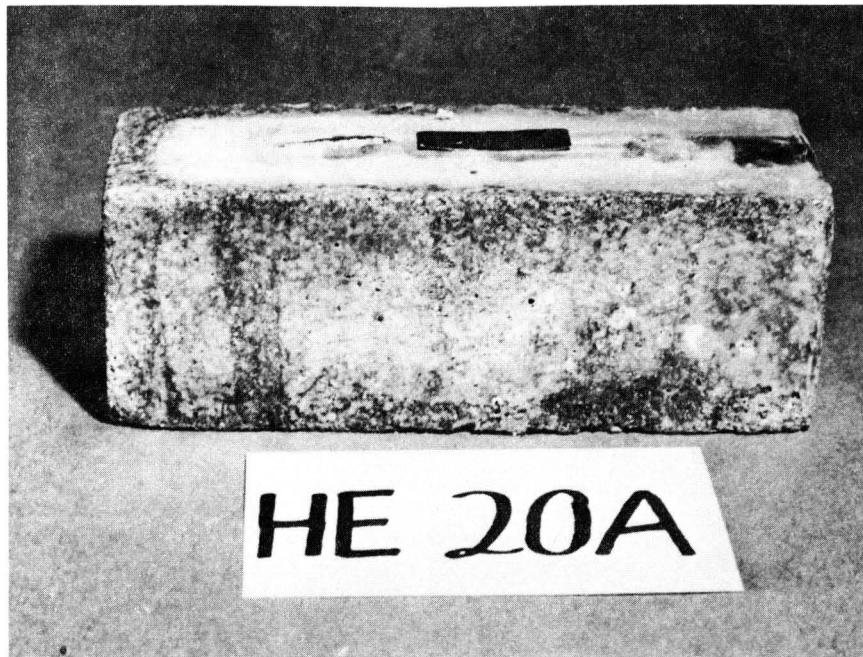
Figure C15 Condition of specimen HE1-20A after 16 cycles of freezing and thawing.

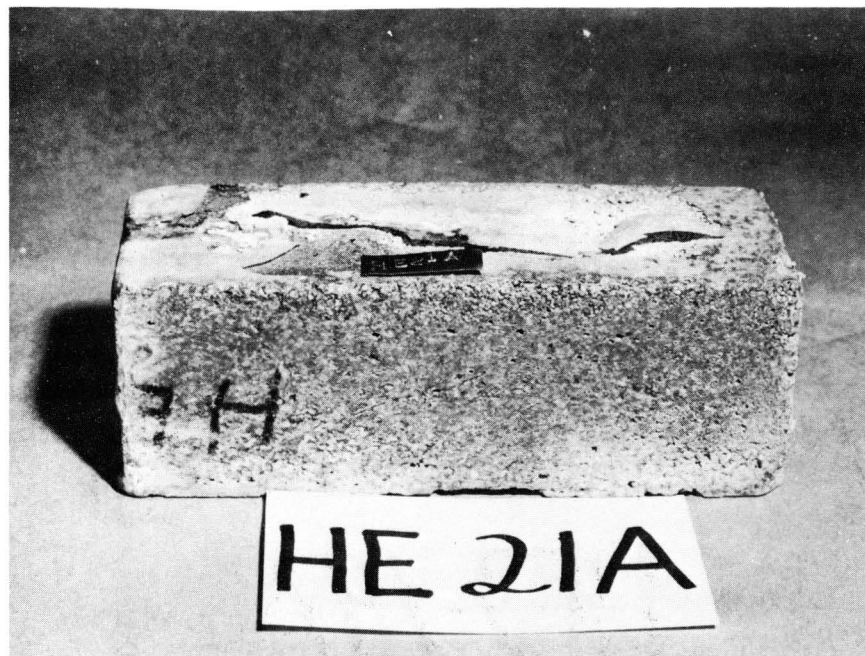
Figure C17 Condition of specimen HE1-21A after 16 cycles of freezing and thawing.

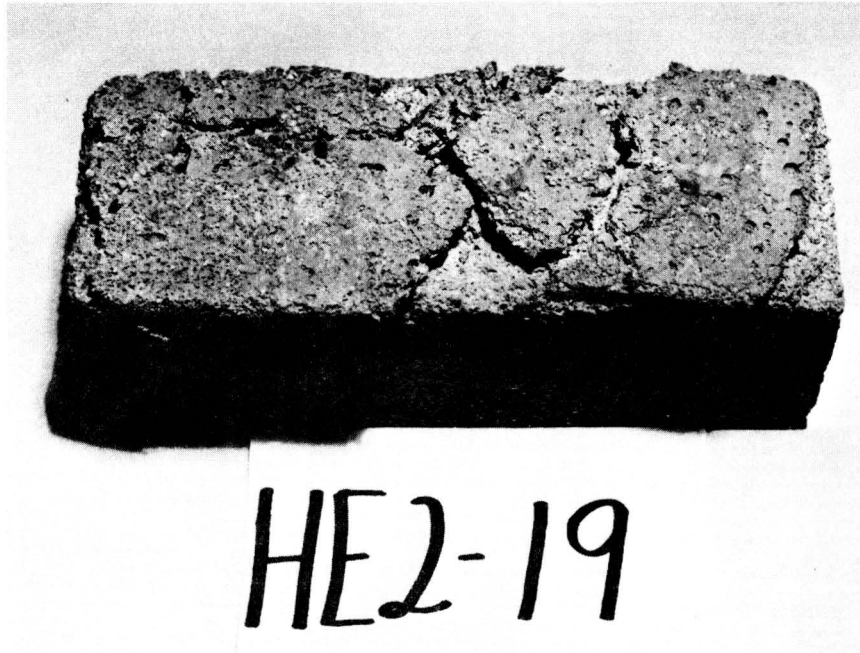
Figure C18 Condition of specimen HE2-19 after 23 cycles of freezing and thawing.

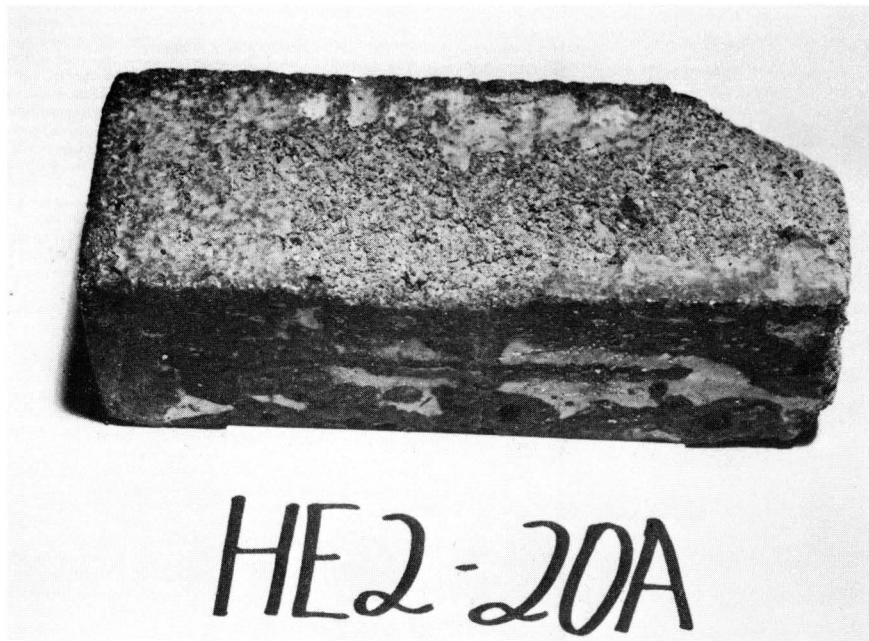
Figure C21 Condition of specimen HE2-20A after 36 cycles of freezing and thawing.

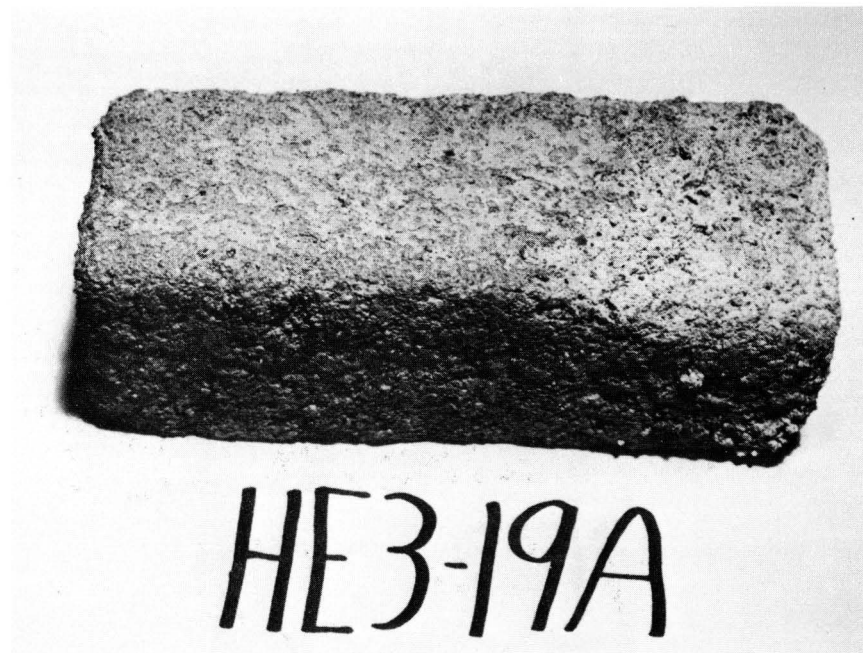
Figure C25 Condition of specimen HE3-19A after 37 cycles of freezing and thawing.

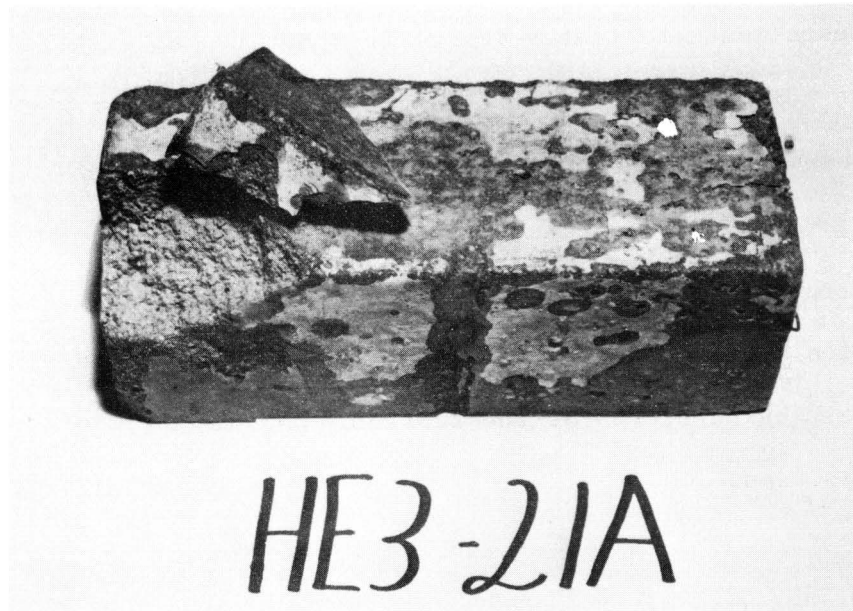
Figure C29 Condition of specimen HE3-21A after 38 cycles of freezing and thawing.
