THE DEVELOPMENT OF A
LONG-RANGE REHABILITATION PLAN
FOR US-59 IN DISTRICT 11—
PRELIMINARY REPORT

RESEARCH REPORT 987-1

PROJECT 3-11D-89/1-987

CENTER FOR TRANSPORTATION RESEARCH

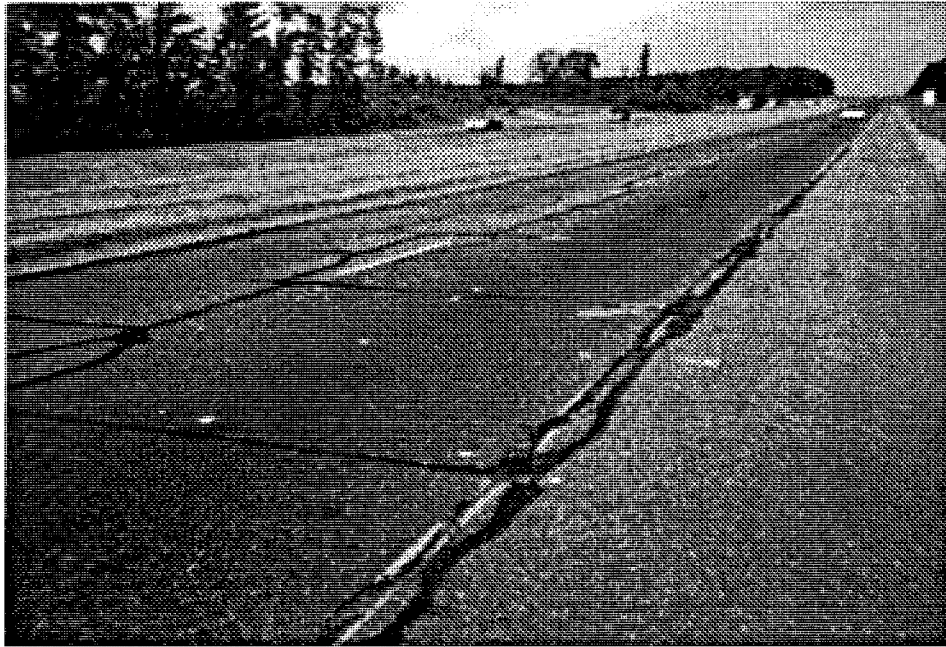
Figure 2.6 Repair location

The repair site was located just south of the intersection of FM 357 with US-59 in the southbound lanes. Repairs were made between stations 1488 and 1490 on the 9-7-9 jointed concrete pavement following the milling of approximately 7 inches of asphalt concrete. Figure 2.6 shows the repair location before repairs.

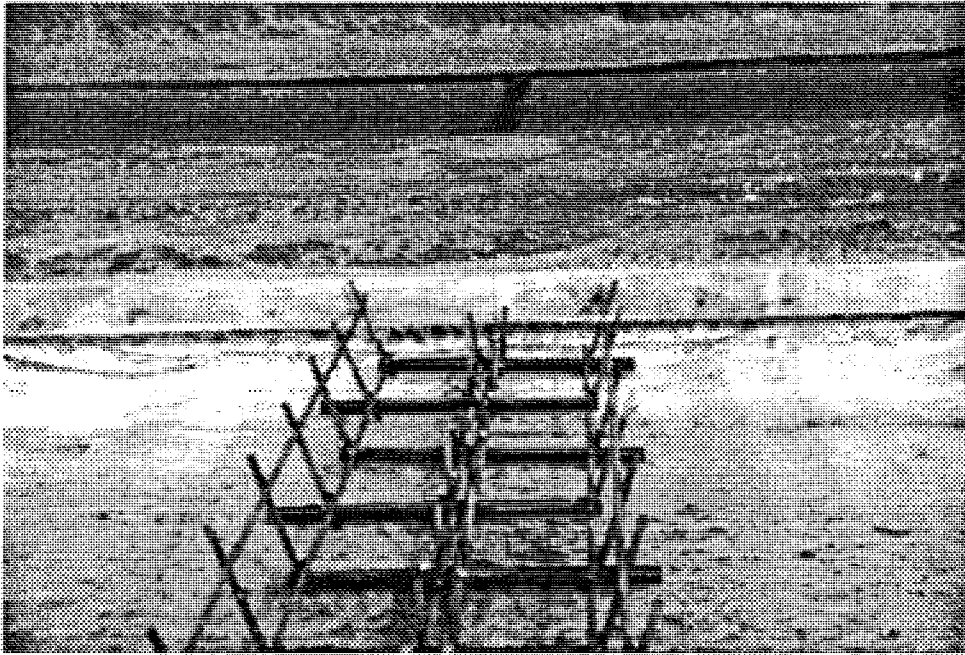
Figure 2.8 Milled joint and dowel basket assembly

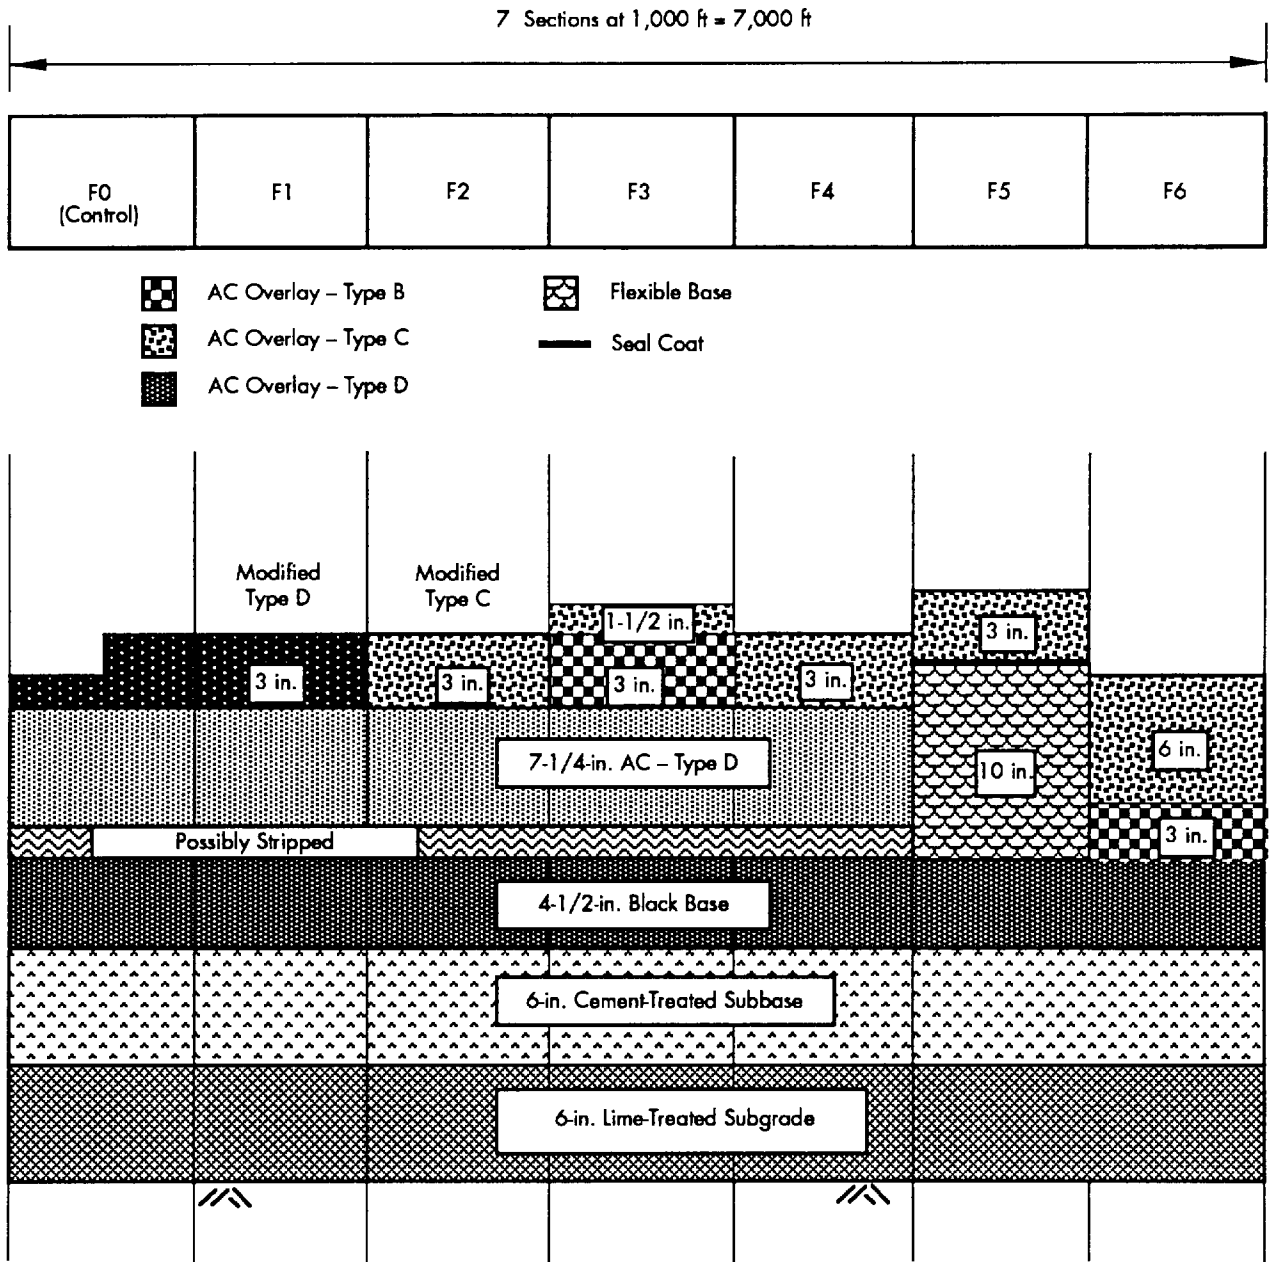
- F0 – AC Overlay – Type D (Control)
- F1 – SBS Modified AC Overlay – Type D
- F2 – SBS Modified AC Overlay – Type C
- F3 – AC Overlay – Type C
- F4 – AC Overlay – Type C
- F5 – Remove Stripped Layer – Flexible Base
- F6 – Remove Stripped Layer

Figure 4.2 Flexible site — rehabilitation plan and profile

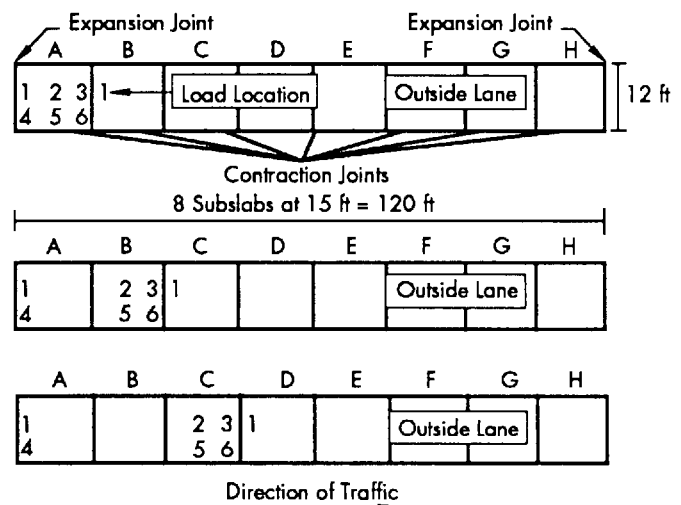
Location	Description
1	Immediately downstream from the expansion joint
2*	Between the contraction joints (or between the expansion and contraction joints) away from any midspan cracks
3*	Upstream from the contraction joint
4	Adjacent to the expansion joint near outside shoulder
5*	Near pavement edge adjacent to Location 2
6*	Near pavement edge adjacent to Location 3
1*	Downstream from Location 3 on the opposite side of the contraction joint

- Readings at locations 2, 3, 1, 5, and 6 alternated between areas A, B, C, D, E, F, G, and H in successive slabs (i.e., readings were taken in area A in the first slab, in area B in the second slab, etc.).
- NOTE: In this context, a slab is defined as the rigid pavement between successive expansion joints.

Figure 4.4 Rigid FWD measurement pattern
