# ANALYSIS OF REMAINING LIFE FOR RUNWAY 17R-35L AND TAXIWAY L AT DALLAS/FORT WORTH INTERNATIONAL AIRPORT

Research Report Number ARC-702 **FOR LOAN ONLY CTR**

VOLUME I EXECUTIVE SUMMARY

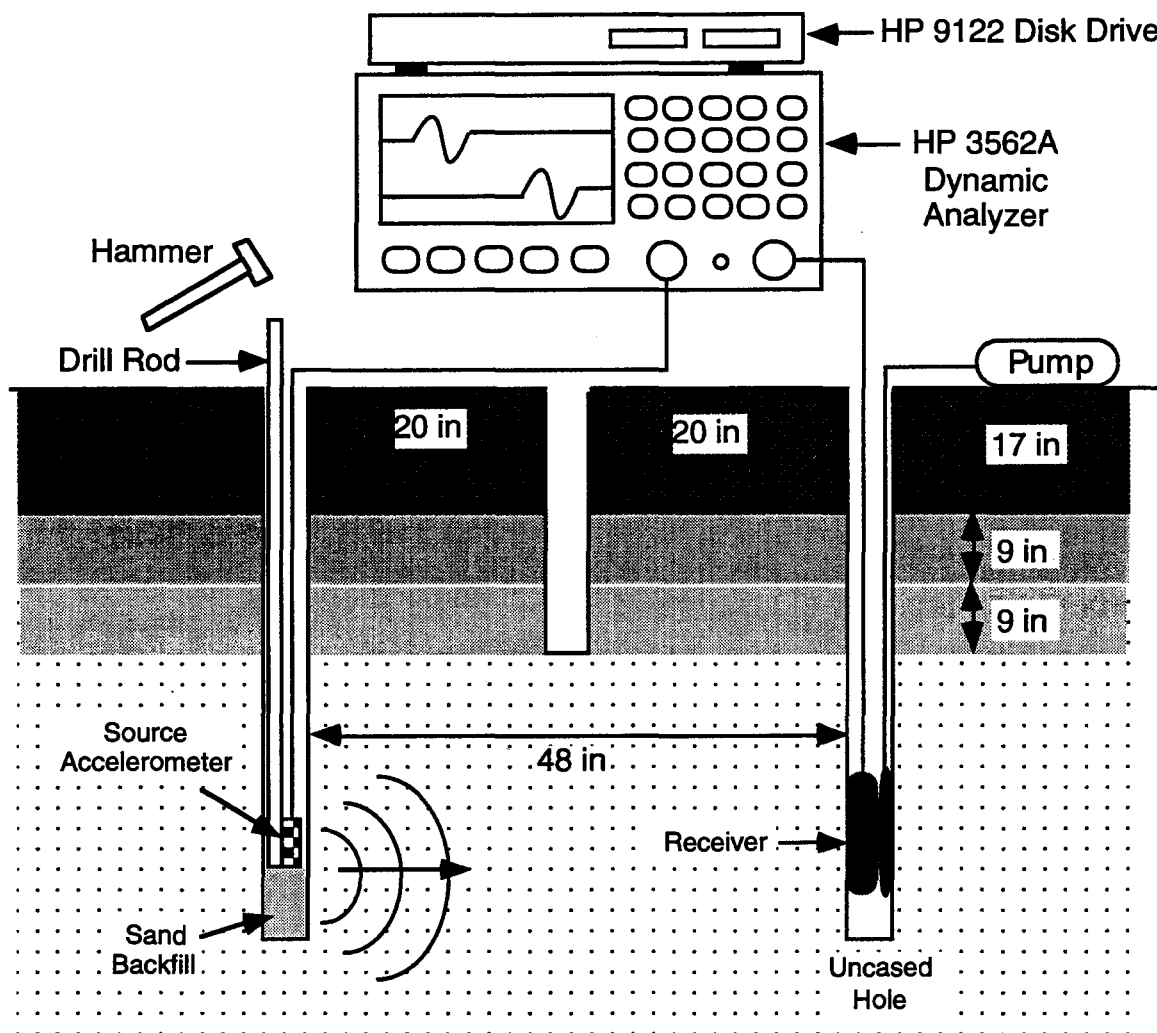
*Figure 1. Cross-hole Seismic Test*

**Cross-hole Seismic Testing.** Cross-hole seismic testing was performed at four locations on Runway 17R/35L and at eight locations on Taxiway L. At each of these locations, a pattern with 3 to 9 core holes was drilled into the pavement system to depths ranging from 3 to 9 feet. A typical pattern with three core holes is shown in Figure 1.

Generally, horizontal spacing between core holes ranged from 3.5 to 7 feet. Testing was performed by initiating stress waves in one core hole and monitoring their arrivals in the adjacent core holes. The purpose of these tests was to evaluate the stiffness of each component of the pavement system independently and in-place.

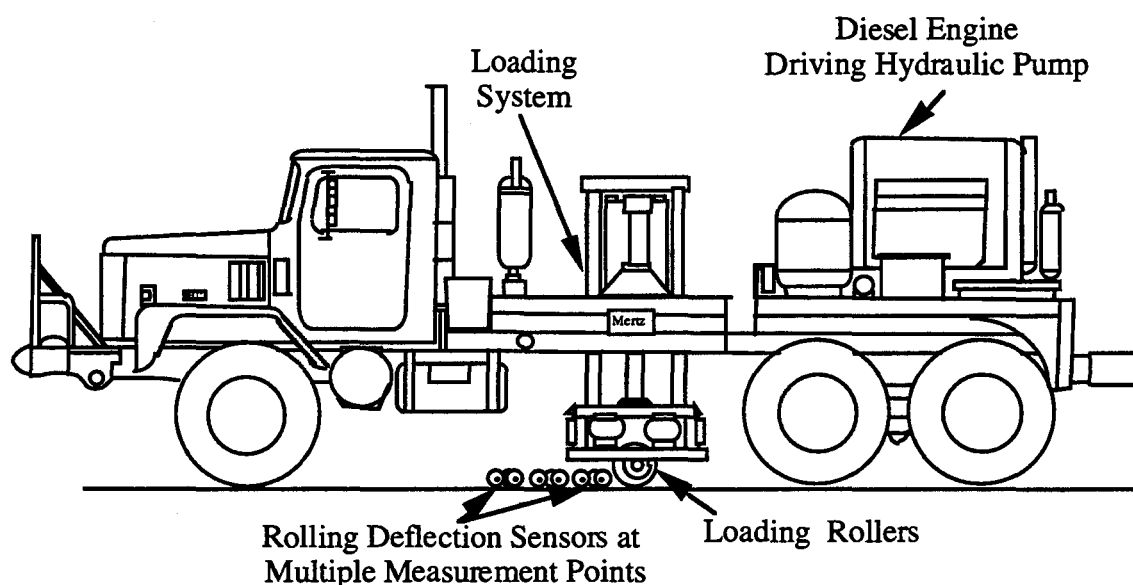
***Figure 2. General Configuration of the Rolling Dynamic Deflectometer (RDD)***

***Description of the Rolling Dynamic Deflectometer (RDD).*** The Rolling Dynamic Deflectometer (RDD) is a truck mounted device that measures continuous deflection profiles of pavements. A drawing of the RDD is shown in Figure 2. The device consists of a large truck with a gross weight of about 195 kN (44,000 lb) on which a servo-hydraulic vibrator is mounted. The vibrator has a 33-kN (7,500-lb) reaction mass which is used to generate vertical dynamic forces as large as 310 kN peak-to-peak (70,000 lb peak-to-peak) over a frequency range of about 10 to 100 Hz. Simultaneously, the hydraulic system generates a constant hold-down force ranging from 65 to 180 kN (15,000 to 40,000 lb). The static and superimposed dynamic forces are transferred to the pavement through two loading rollers as shown in Figure 3.

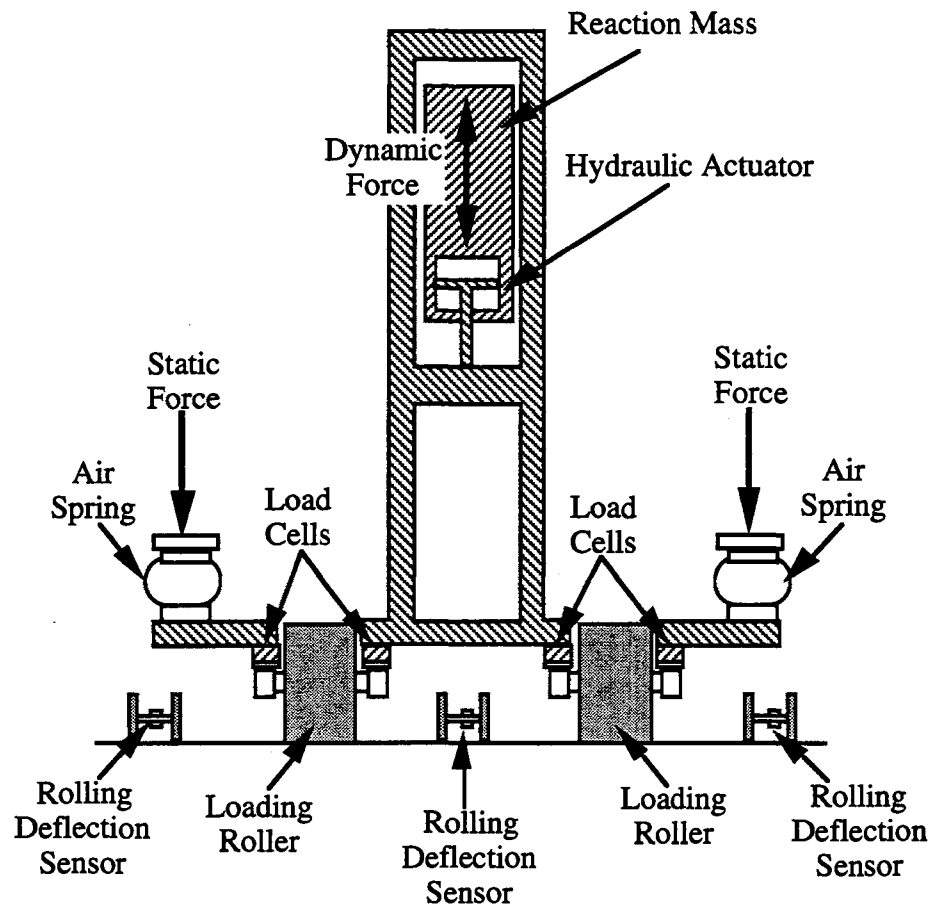
**Figure 3. Front Cross-Sectional View of the RDD Loading and Measurement Systems**

As the RDD slowly rolls over a pavement, it applies a cyclic load to the pavement surface through the loading rollers. Dynamic displacements are measured with four rolling sensors. By measuring the applied forces and the resulting deflections, a continuous deflection profile for the pavement is determined, with soft regions of the pavement exhibiting large deflections and stiff regions lower deflections.

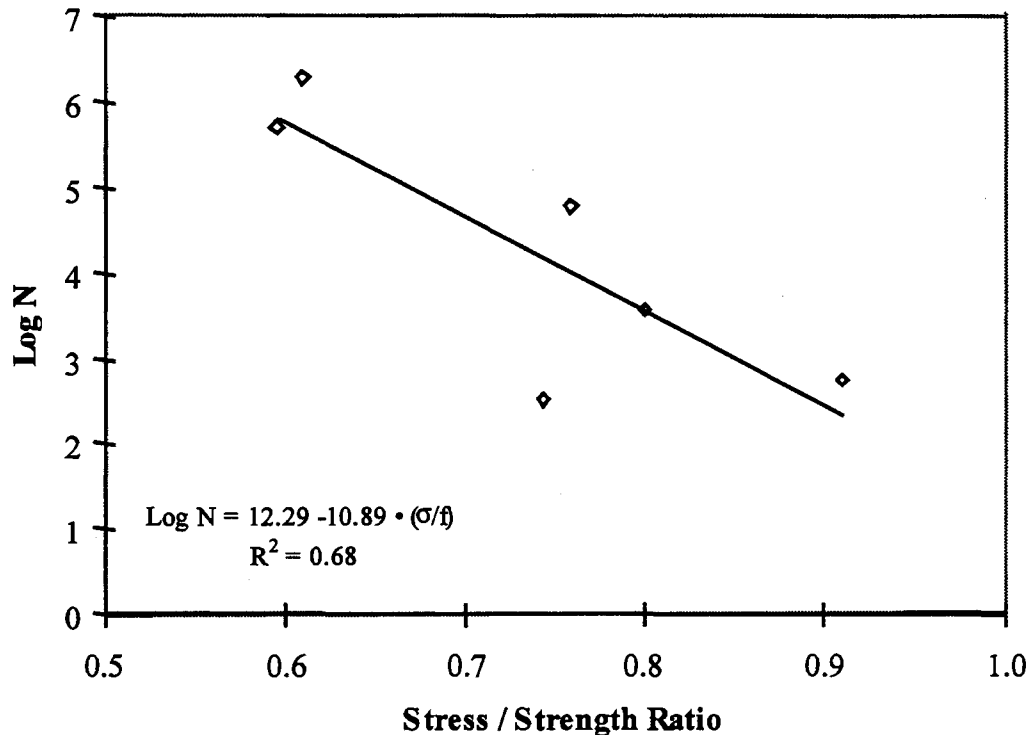
**Figure 4. Fatigue Curve for RW 17R/35L and TW L Concrete Cores**

fatigue life of the concrete, decreases with increasing stress to strength ratio as shown in Figure 4.

In this figure, the cycles to failure is the number of load applications that each sample supported before failing in tension. The stress/strength ratio is the relationship between the tensile strength of the concrete and the tensile stress applied. The vertical axis is shown in the logarithm of the number of loads to failure for clarity.

The slope of the fatigue curve in the figure is -10.89, which is comparable to the slope of -20.224 obtained by Yimprasert and McCullough in CTR Report 123-16 *Fatigue and Stress Analysis for Modifying the Rigid Pavement Design System*. The curve represents the number of allowable cycles that the pavement can withstand before failing. In most of the samples in the figure, the allowable cycles to failure is measured on concrete that has already been exposed to many thousands of loads and this accounts for the slope of the fatigue curve in Figure 4 being only about half of that in Report 123-16. The concrete slabs from which the cores were taken have in fact been exposed to as many as 730,000 equivalent B-727 aircraft departures since construction. The results of the fatigue analysis will thus allow a prediction of remaining life based on the previous number of equivalent B-727 departures and the magnitude of the stress induced by those aircraft. The remaining life will be estimated by taking the difference between the previous and ultimate

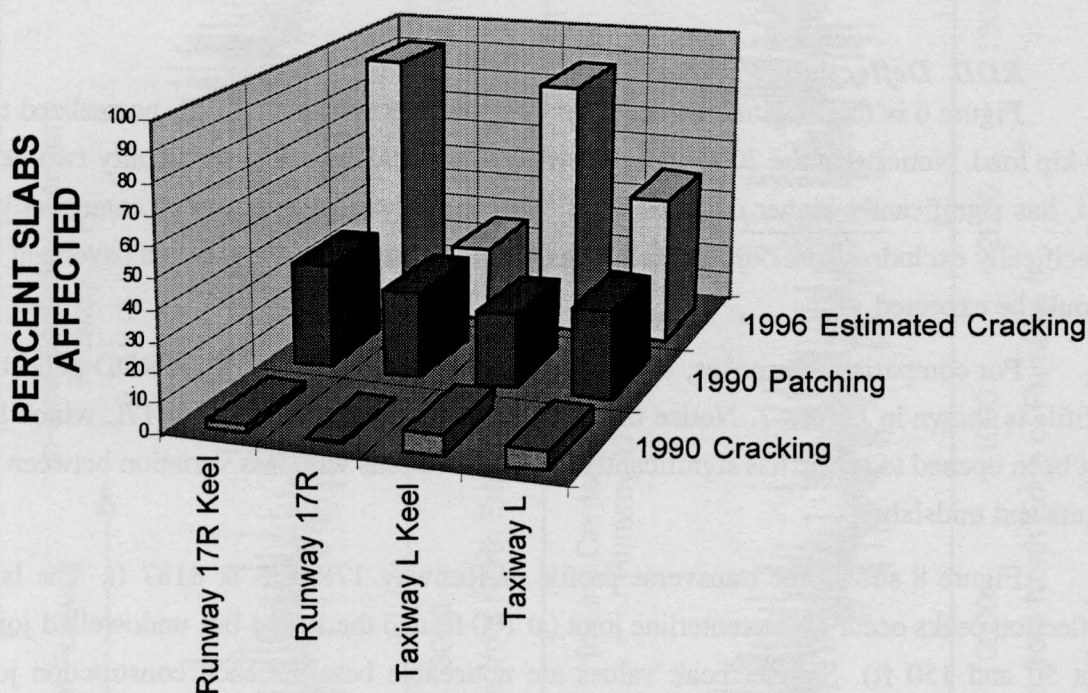
*Figure 5. Percent of Slabs Affected by Cracking*

The cracking observed from the CTR partial inspection on the runway and taxiway is primarily a load related phenomenon. As shown in Figure 5, the cracking for the most part was not observed or reported in much detail in the Harding Lawson Associates report. Using the official PCI inspection guidelines, the cracking pattern observed would only be classified as low-severity shrinkage cracking, which is generally not assessed as a threat to remaining life but only as a cosmetic problem and as a possible foreign object problem. The cracking observed by CTR personnel was in fact fatigue cracking which is a much more

serious threat to remaining life. For this study, a special visual inspection was conducted in nine different areas of the runway and taxiway using an more descriptive reporting procedure to identify the level of fatigue cracking. The fatigue cracking is a serious concern and fatigue of concrete is the most important potential mode of failure for Runway 17R/35L and Taxiway L.

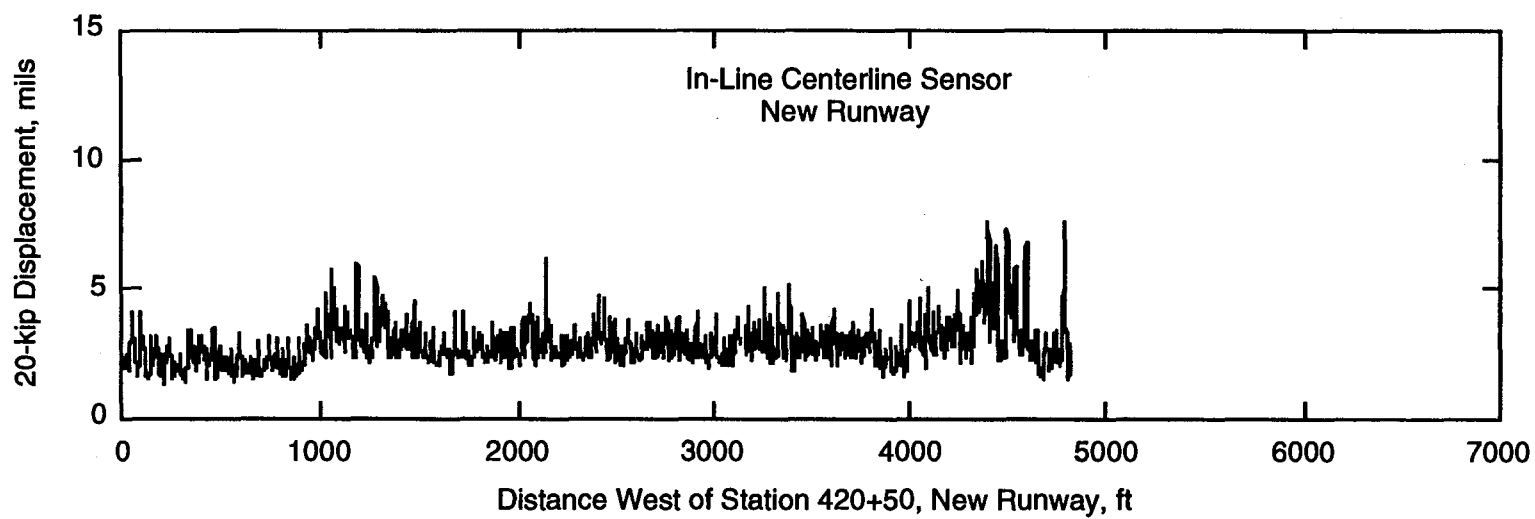
*Figure 7. Partial RDD deflection profile of Runway 17L.*

For comparison purposes, a selected portion of Runway 17L/35R RDD deflection profile is shown in Figure 7. Notice that the deflection profile of Runway 17L which had not been opened to traffic has significantly lower deflections with less variation between the joints and midslabs.

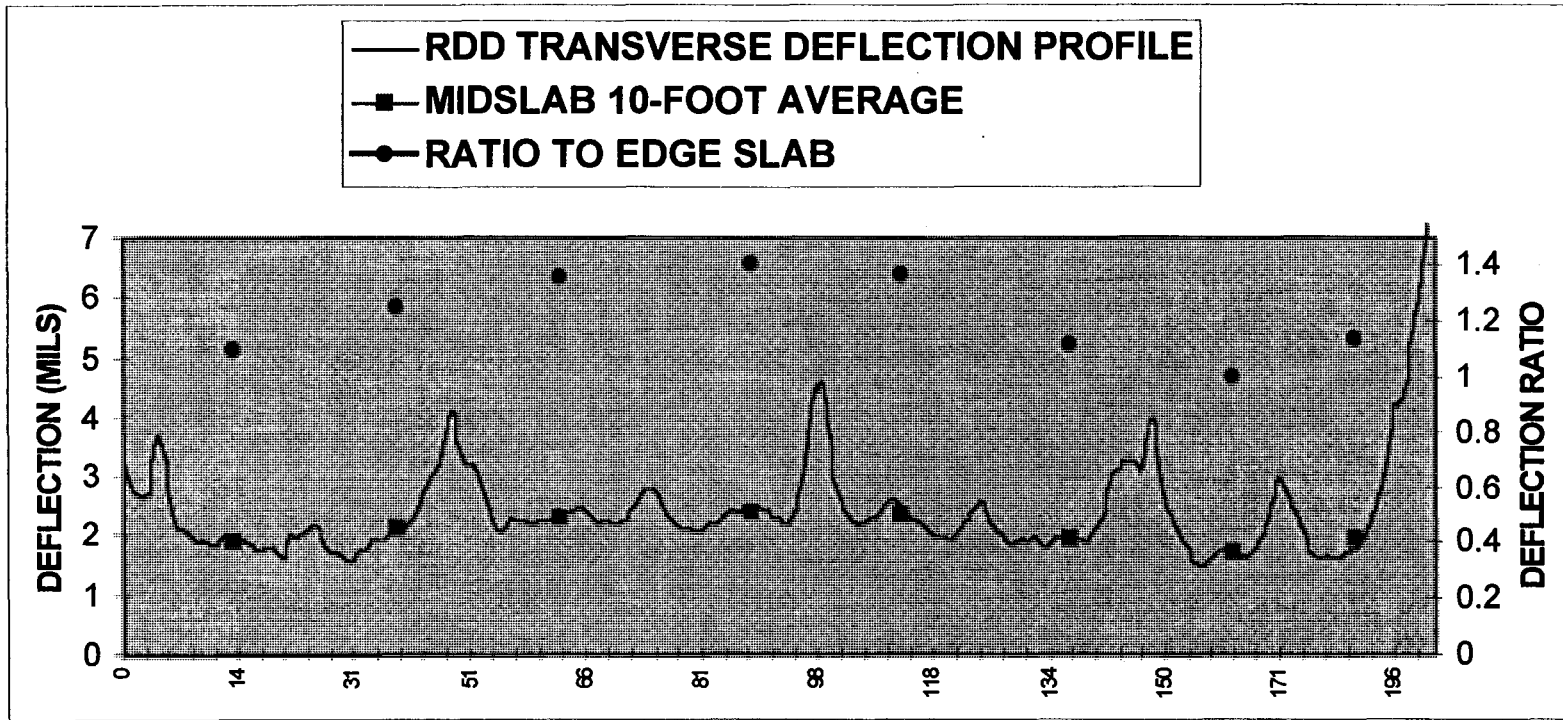
*Figure 8. Runway 17R/35L Transverse Deflection Profile*

Figure 8 shows the transverse profile of Runway 17R/35L at 8187 ft. The large deflection peaks occur at the centerline joint (at 100 ft) and the keyed but undoweled joints ( at 50 and 150 ft). Smaller peak values are noticeable between each construction joint where the sawed reinforced joints are located. The poor performance of the doweled joints is evident on all the profiles. All longitudinal RDD profiles are provided in the data appendices in Volume III and their locations are depicted in reference to the slabs on the delivered MicroStation design file.

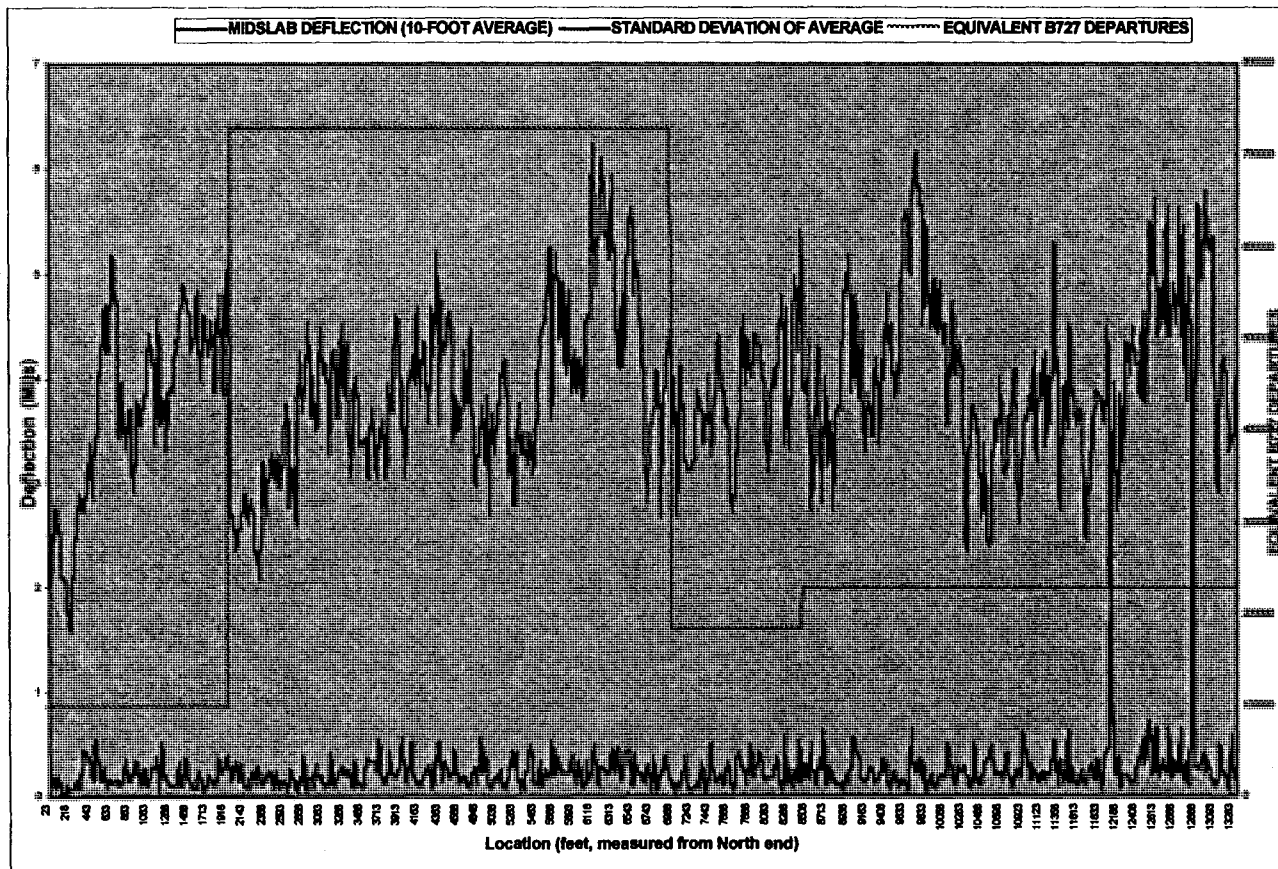
*Figure 10. Runway 17R/35L Midslab RDD Deflections*

Figure 10 shows the longitudinal plot of the average and standard deviation of the midslab deflections over 10 feet for the entire length of Runway 17R/35L. The areas of highest deflection are the areas of greatest concern for future performance under traffic. Those areas which receive heavy traffic and have high deflections are most likely to show load related distress sooner.

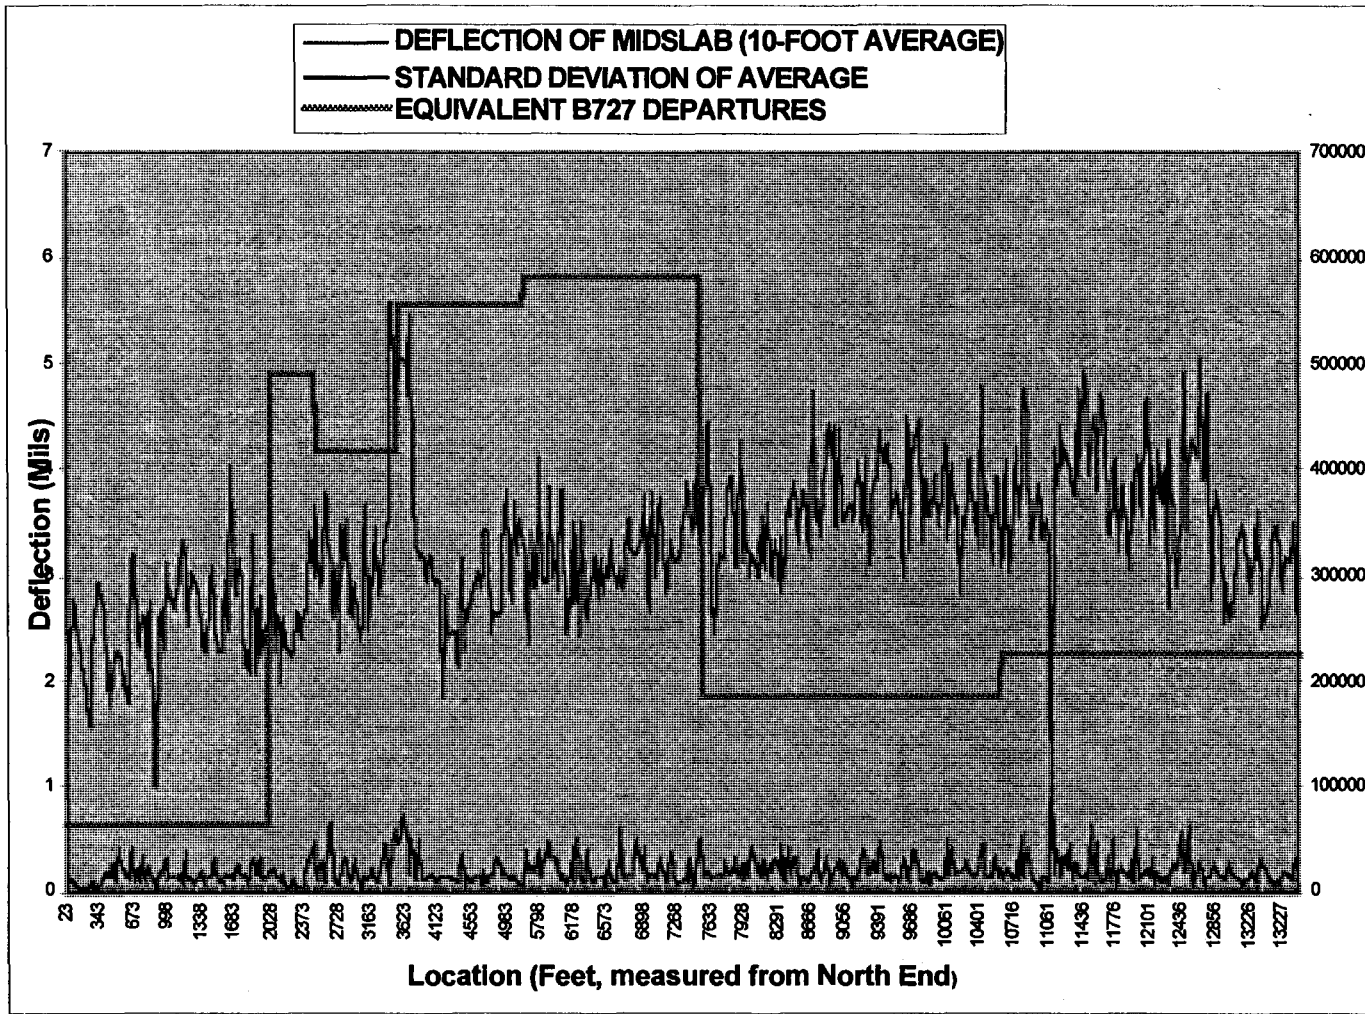
Figure 11. Taxiway L Midslab RDD Deflections

In Figure 11, the plot of midspan average deflections is shown for Taxiway L. The taxiway generally has lower average midspan deflections under a 20 kip load than the runway. Notice in Figure 11 that there appears to be an abnormally high deflection (5 mils) around the 3600-foot location. When this taxiway was tested, preparation for slab replacements were started and those slabs had already been saw cut into smaller free slabs. This higher deflection would indicate a worst case limit for pavement performance.

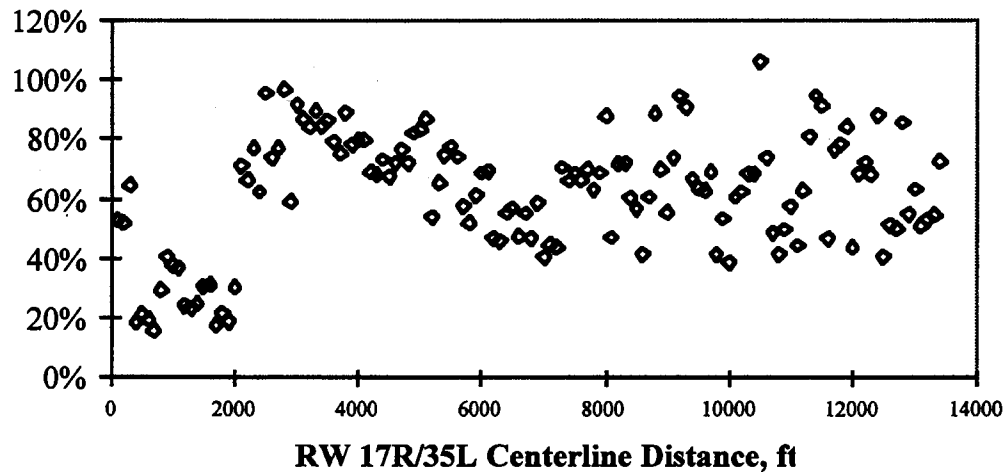
***Figure 12. Load Transfer Efficiency Along Length of Runway 17R .***

The analysis to estimate the performance of the joints uses the results of the Rolling Dynamic Deflectometer to calculate the load transfer efficiency (LTE) of the joint. In Figure 12, the load transfer is very low for the centerline doweled joint in the first 2000 feet. This section is the extension of the runway which was constructed only a few years ago. This general trend indicates that the performance of the joint was already poor immediately after construction since the LTE of the joint after 2000 feet is much better and this section has been in service for over 20 years.

determine proper rehabilitation action. It must be noted, though, that the measurement shown in Figure 12 is for the centerline joint only, and an evaluation of the other joints should be made before implementing any rehabilitation strategy. In addition, the centerline joint between 2000 and 8000 feet from the north end should be reevaluated in approximately 5 years to estimate the rate of deterioration of the joint's performance. If, at that time, the joint performance has deteriorated significantly, a rehabilitation plan should be prepared to correct the problem, and to prevent further deterioration of the joint.

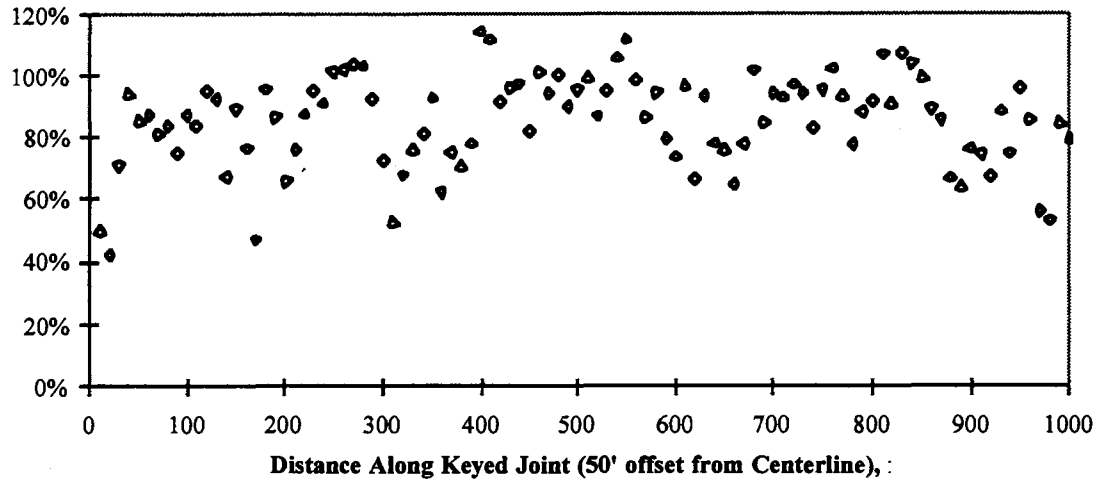
**Figure 13. Load Transfer Efficiency of Keyed Joint, North End.**

Figures 13 and 14 show the LTE of the keyed joint which is offset 50 feet from the centerline joint. The location of the measurements in Figure 13 is at 2000 ft from the north end, or the threshold of the original runway. The LTE ranges from about 60% to 100%. Figure 14 shows the same joint at a location of 7300 to 8300 feet from the original runway threshold. The range of LTE in this section of the runway is from about 40% to 90%.

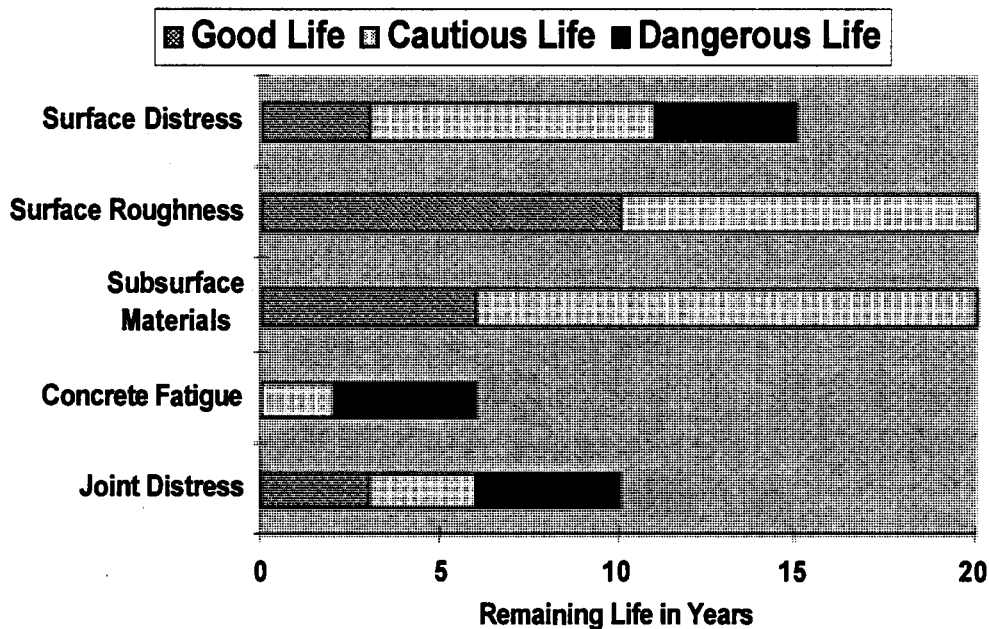
*Figure 15. Remaining Life of Runway 17R/35L in years*

1. The prediction of remaining life of Runway 17R/35L and Taxiway L are shown in Figure 15 for five different modes of failure. The most severe mode of potential failure is due to concrete fatigue. It is in the caution zone already as evidenced by the high degree of fatigue cracking on the north end of the runway and taxiway. It is predicted that concrete fatigue will become a dangerous problem in 2 to 3 years at the north ends of both the runway and taxiway. As the fatigue continues, surface distress will become a problem as the longitudinal fatigue cracking observed becomes closer together and transverse cracking leads to block cracking and eventually punchouts.
