ANALYSIS OF REMAINING LIFE FOR RUNWAY 17R-35L AND TAXIWAY L AT DALLAS/FORT WORTH INTERNATIONAL AIRPORT

Research Report Number ARC-702

VOLUME II FINAL REPORT

August 1997

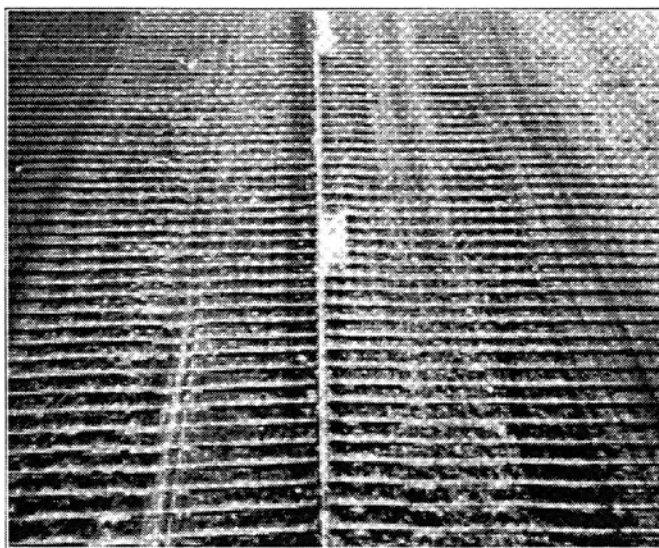
At the DFW airport there is a considerable amount of spalling along the longitudinal joints. Most of this distress was observed to be less than 2 ft. in length and very shallow. The typical maintenance repair procedure is to saw out a 2 ft. by 3-inch area a few inches deep and replace with patching materials as shown in Figure 2.1.

Figure 2.1 Patching of Joint Spalling

The FAA Advisory Circular AC150/5380-6 and ASTM D5340-93 both indicate that joint spalls of under 2 ft. in length are not counted as distress if the spall is not broken into pieces. If the broken pieces are removed leaving frayed edges less than 2 ft. in length, according to the PCI method there is no distress. If the pieces are still in place or the spall is greater than 2 ft. in length, it is counted as a joint spall.

However, if the joint spall is repaired with a patch, it becomes patching distress, even if it is less than 2 ft. in length. This leads to an anomaly in the PCI method, whereby a good

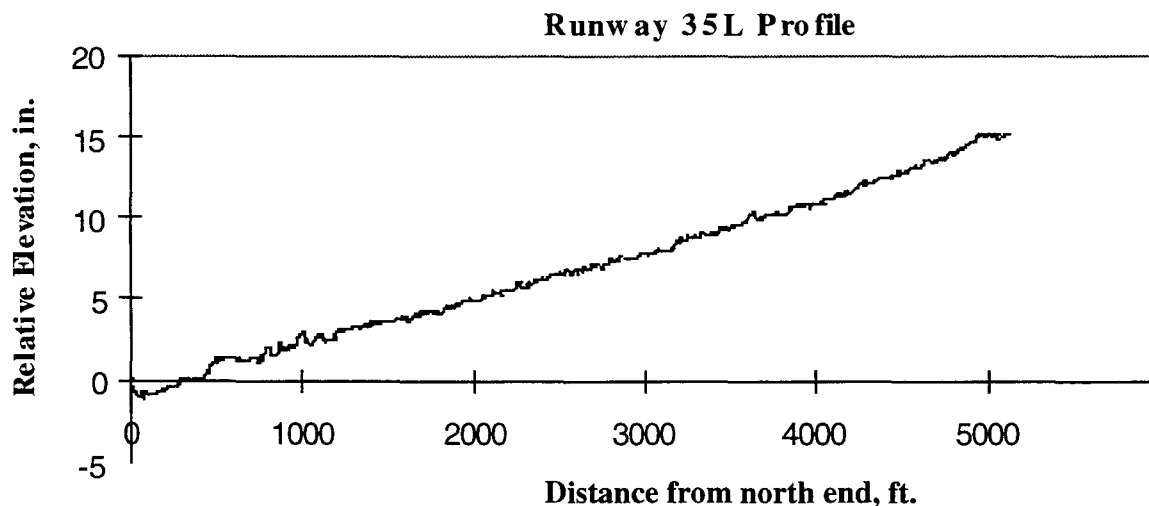
Consultants is given in Appendix E. An example of the profile data obtained is presented in Figure 4.1.

Figure 4.1. Example of Runway 35L profile data.

Since aircraft have very long wheelbases, i.e., distance between the main gear and the nose gear, and because aircraft travel at high speeds across the pavement, only long wavelengths in the profile will affect the pavement performance. For the same reasons, since localized roughness will not affect aircraft operations, the profile was taken only along the centerlines of the runway and taxiway.

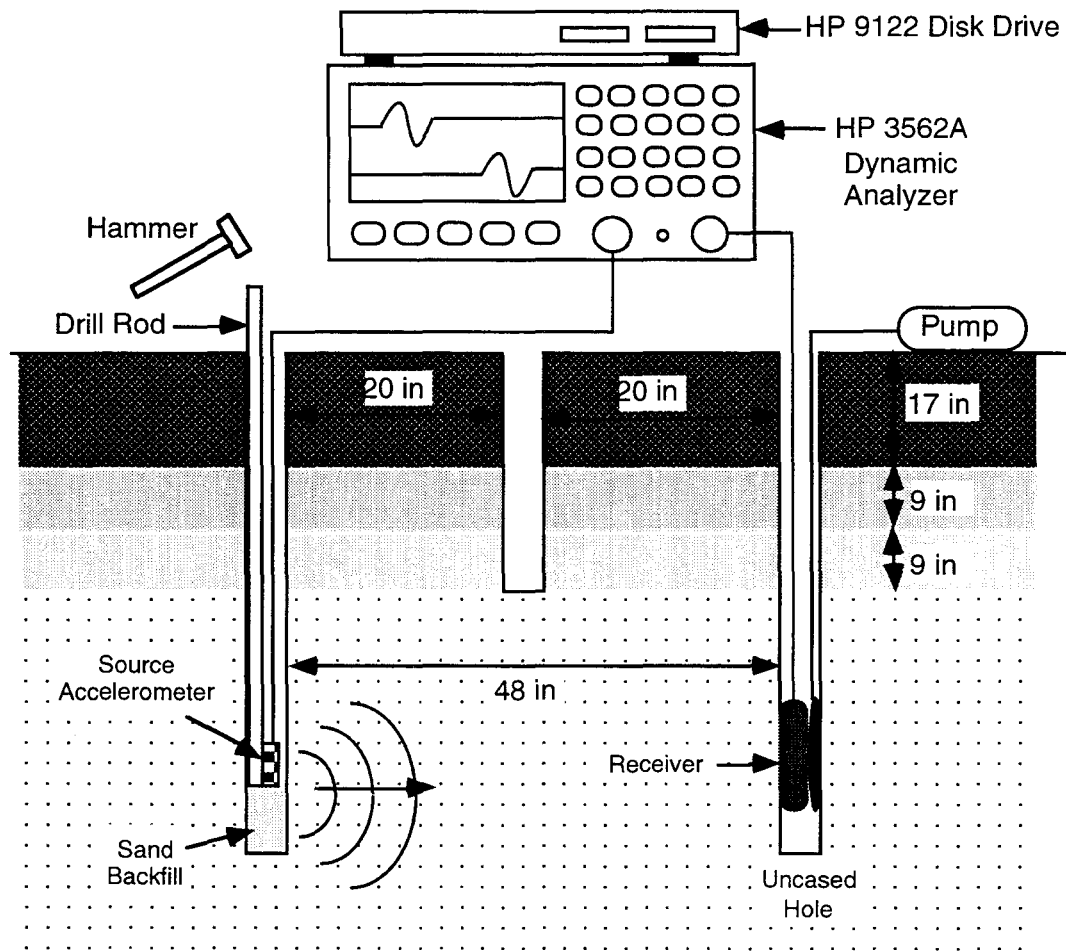
Figure 4.2. Example Cross-hole Seismic Test

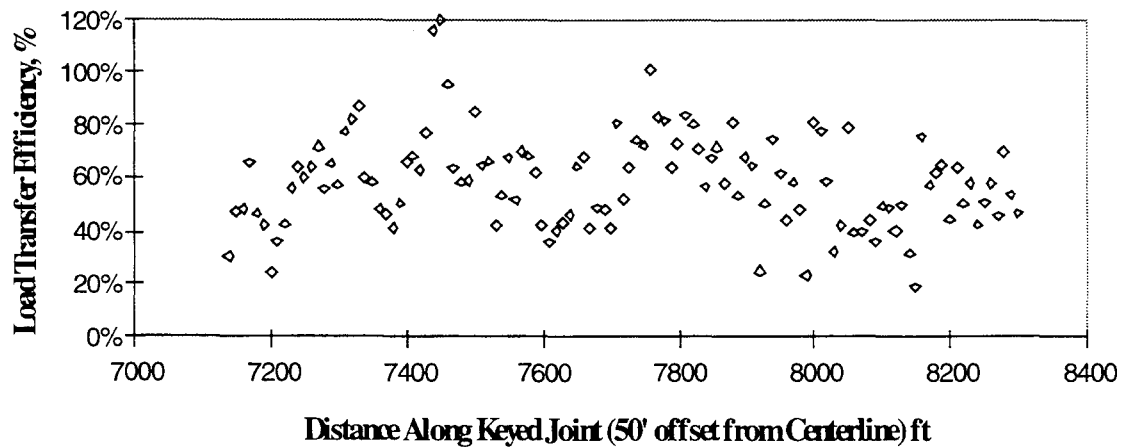
Figure 4.7. Load Transfer Efficiency of Keyed Joint (North End).

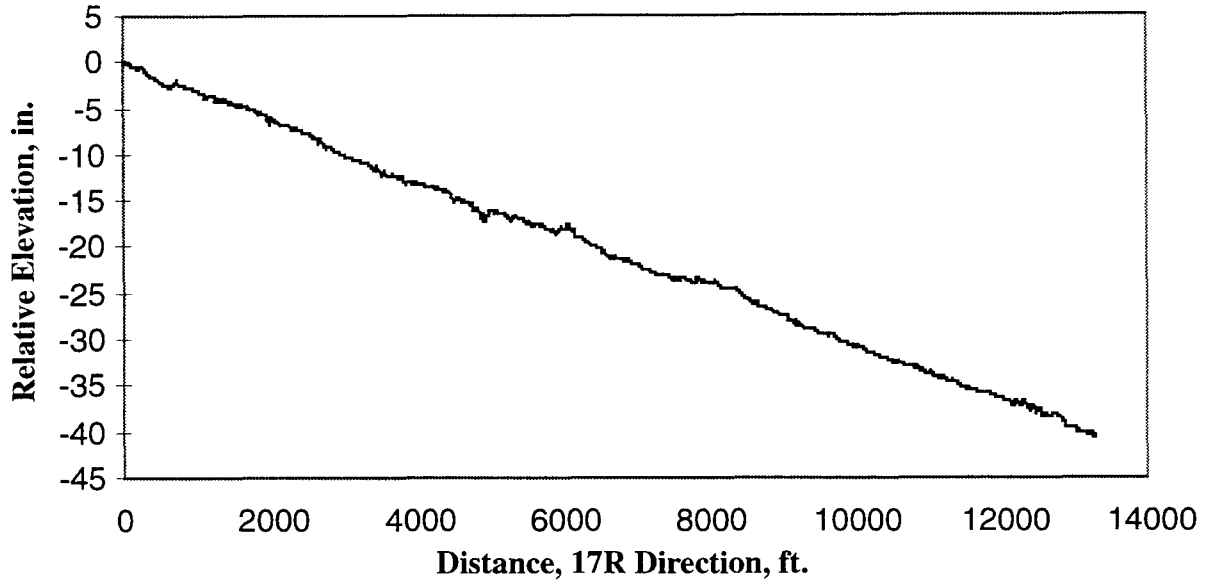
Figure 5.1. Profile of Runway 17R/35L, moving South on RW17.

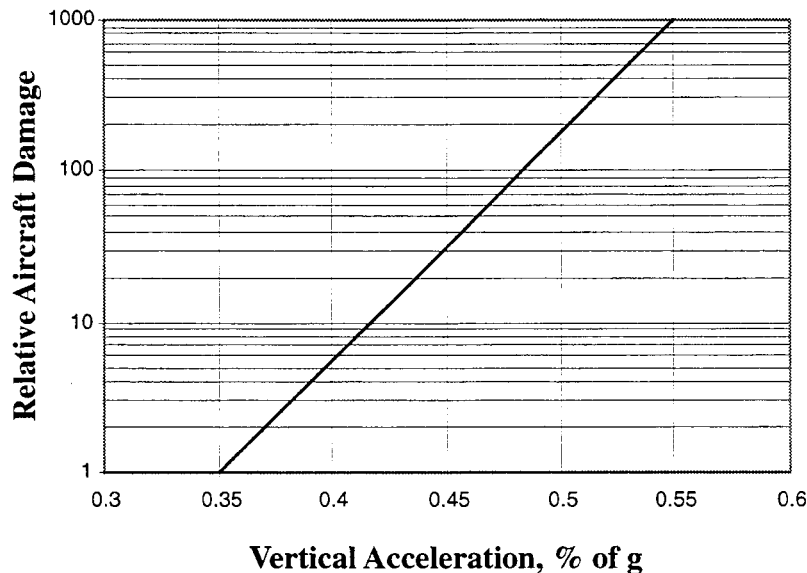
The Boeing Corporation has performed detailed studies that produced a correlation between vertical accelerations and relative fatigue damage to aircraft (Ref. 1). Figure 5.3 presents a curve that indicates how vertical accelerations affect the fatigue life of an aircraft. The graph shows relative damage, based on a 0.35g (or 0.35 times the acceleration of gravity) vertical acceleration. For example, a vertical acceleration of 0.45g would cause over 30 times as much damage relative to a 0.35g acceleration, i.e. a 30% increase in acceleration increases damage 3000%. An acceleration of 0.55g would cause 1000 times

more damage as a 0.35g acceleration. Another way to look at this effect is to say that runway roughness that causes a 0.45g vertical acceleration during a takeoff or landing operation would cause as much damage to the aircraft as 30 operations on a smooth runway which produces an acceleration of only 0.35g. At a vertical acceleration level of 0.4g, or 0.4 times greater than the acceleration of gravity, the effects on aircraft can become detrimental. In addition, vertical accelerations of this magnitude begin to have adverse effects on pilots and passengers.

Figure 5.3. Relative Aircraft Damage Due to Vertical Accelerations (Ref. 1).

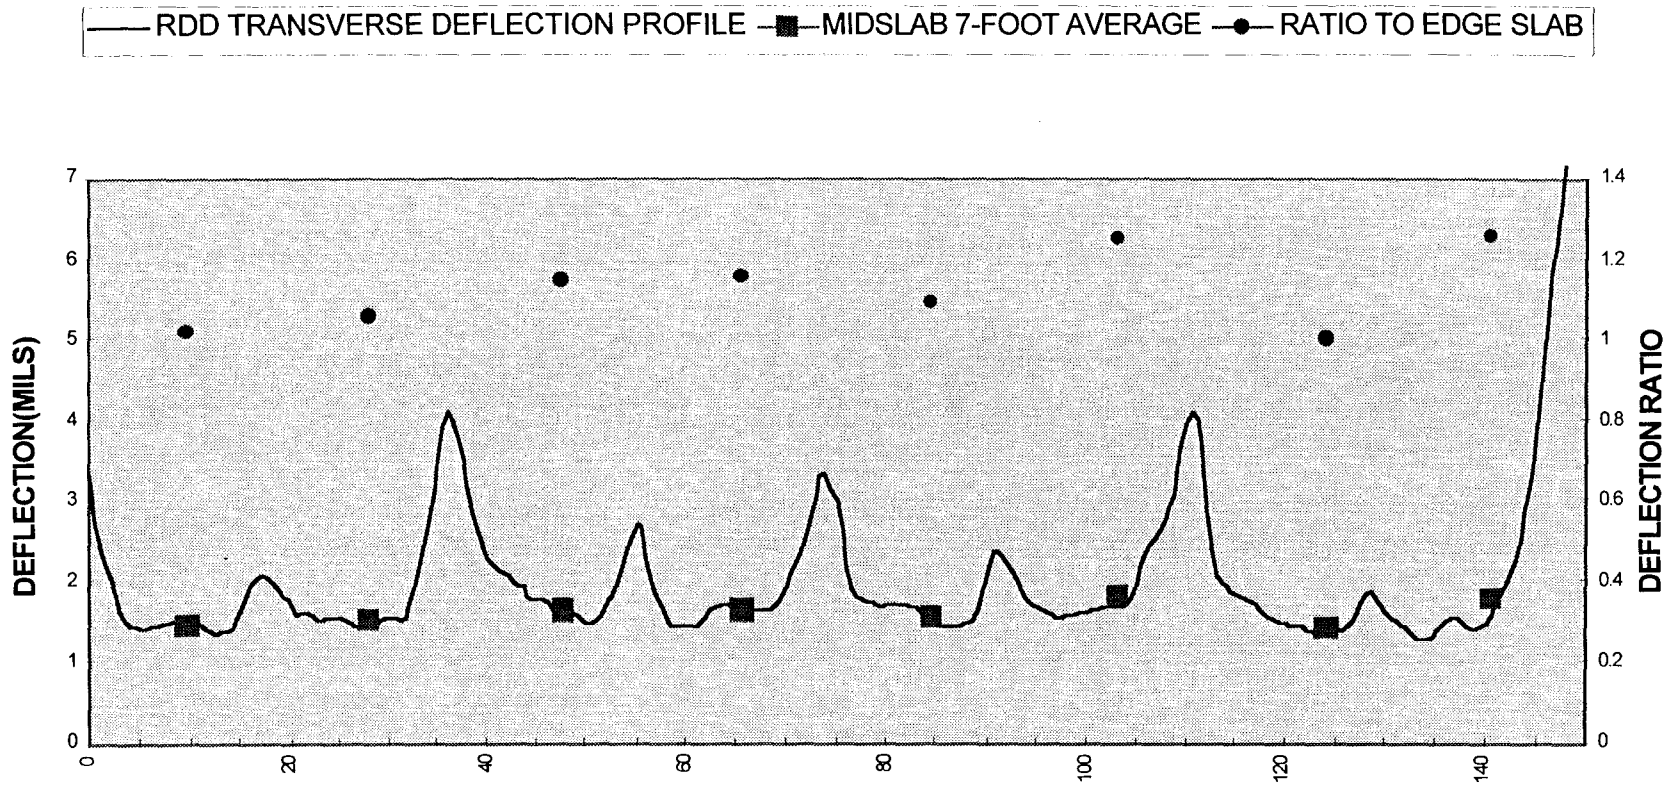
Figure 5.10. Runway 17L/35R Transverse Deflection Profile.

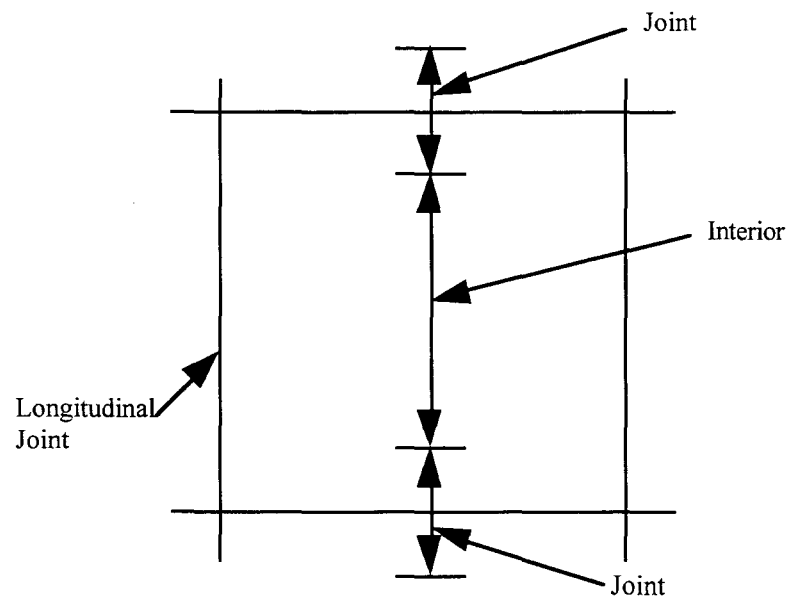
Figure 5.16. Definition of Interior and Joint Locations on Slabs.

The definition of interior or joint on a slab will depend on its deflection characteristics. Since slabs have greater deflection at the joint than at the interior of the slab, which is not due to fatigue, but to support and to load transfer at the joint, the point at which the deflection begins to increase near a joint is called the zone of influence. The zone of influence of the joint may be larger in some slabs that have lost subbase support near the joint, or that have lost load transfer efficiency. A more direct definition of the zone of influence is given in Figure 5.17.

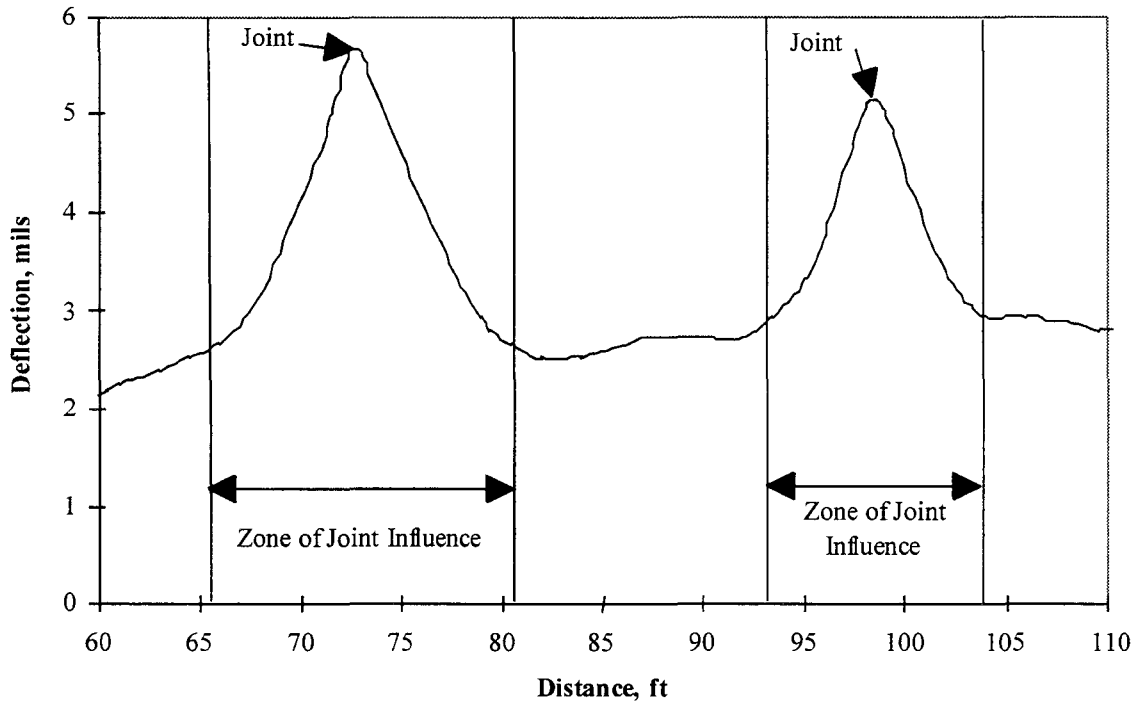
Figure 5.17. Joint Zone of Influence Based on Deflection Measured by RDD.

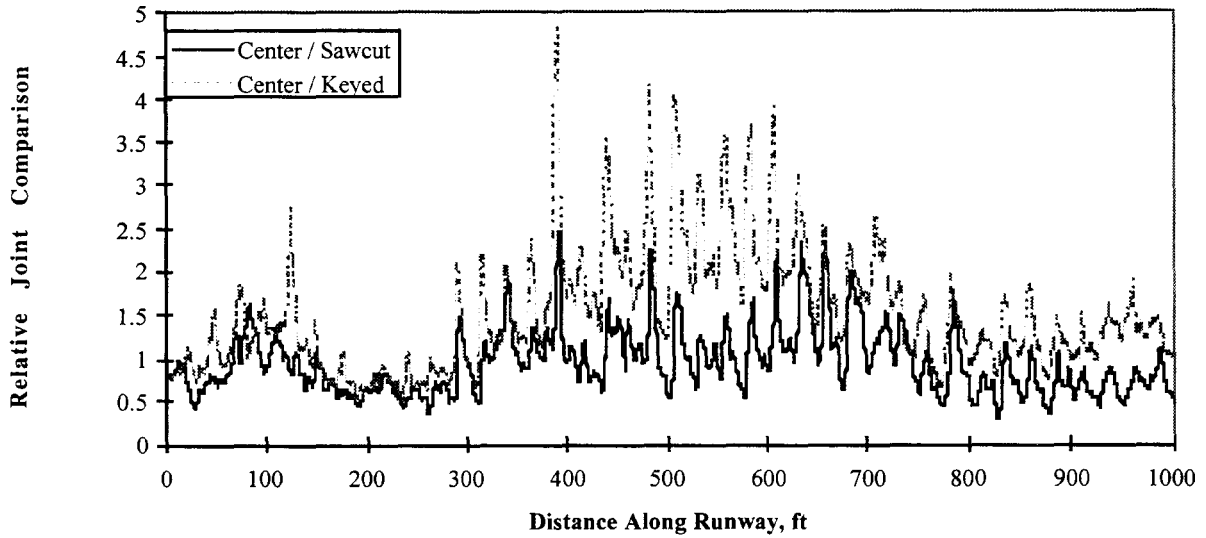
In Equation 5.6, the joints are said to be performing well if the deflections at both joints are equal. If this is the case, the ratio of the deflections will be equal to or near 1.0. This statement assumes that the joint at 50 ft. from centerline, which is being used as a basis, is in good condition, and that its performance is not affected by other circumstances. If the deflections noted in Equation 5.6 are not equal, the most likely case is that the deflections at Joint A will be greater, causing the ratio to be greater than 1.0, and indicating that the joint may be approaching the limit indicated in Figure 5.9. Using the RDD to provide a continuous measure of deflection, airport maintenance staff can prioritize and schedule maintenance activities to focus attention on those locations which are exhibiting the most fatigue damage or are closest to failure. The data described in this section are presented in Figures 5.18 and 5.19.

Figure 5.18. Relative Longitudinal Joint Deflection, Runway 17R/35L.

As can be seen in the previous two figures, the relative joint comparison shows where the deflections of two joints offset from centerline are greater or smaller than those at the same longitudinal location on the centerline joint. Where the values in the figures are greater than one, the centerline joint is deflecting more than the other joints. In the Figure 5.18, the relative differences are generally between 0.5 and 2.5, as there also are in Figure 5.19 from section 7100

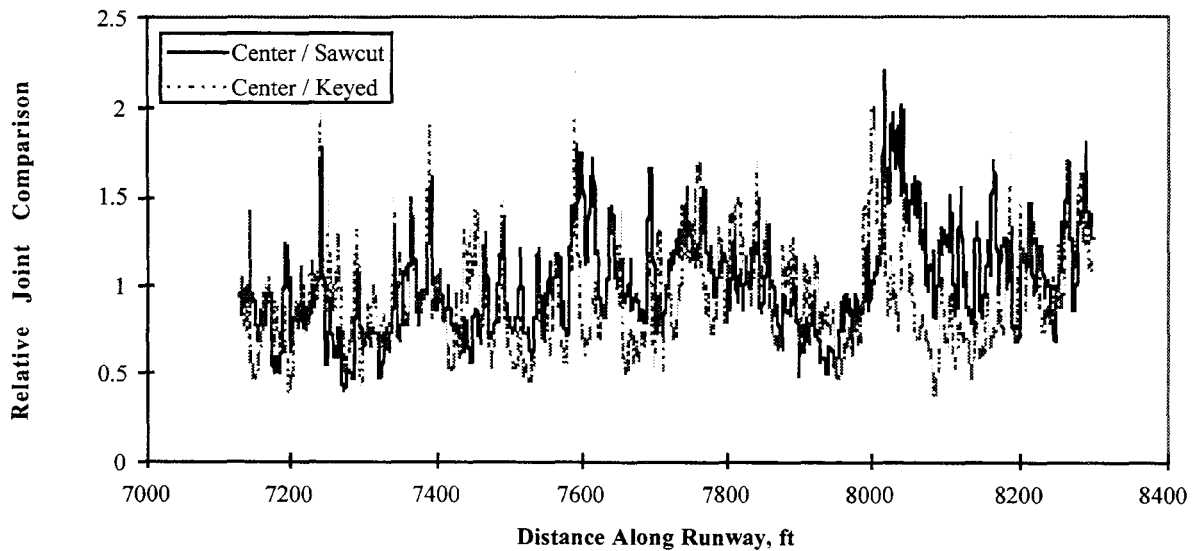
Figure 5.19. Relative Longitudinal Joint Deflection, Runway 17R/35L.

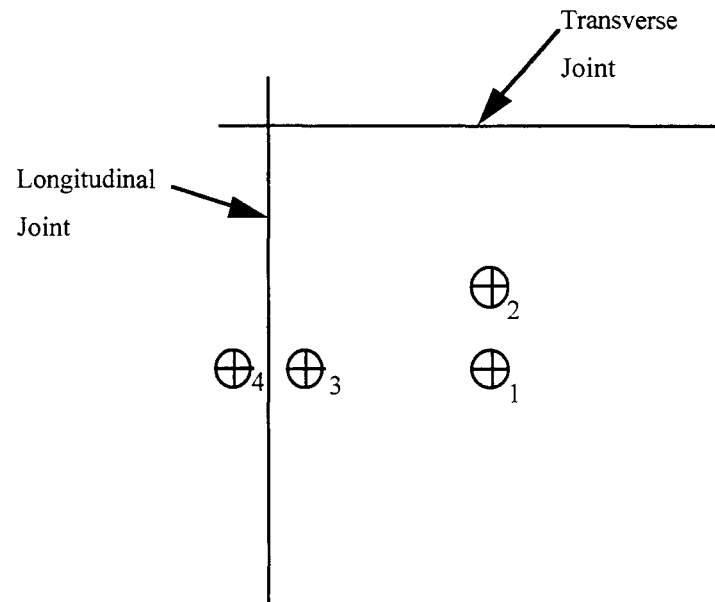
Figure 5.20. RDD sensor configuration for joint comparison and analysis.

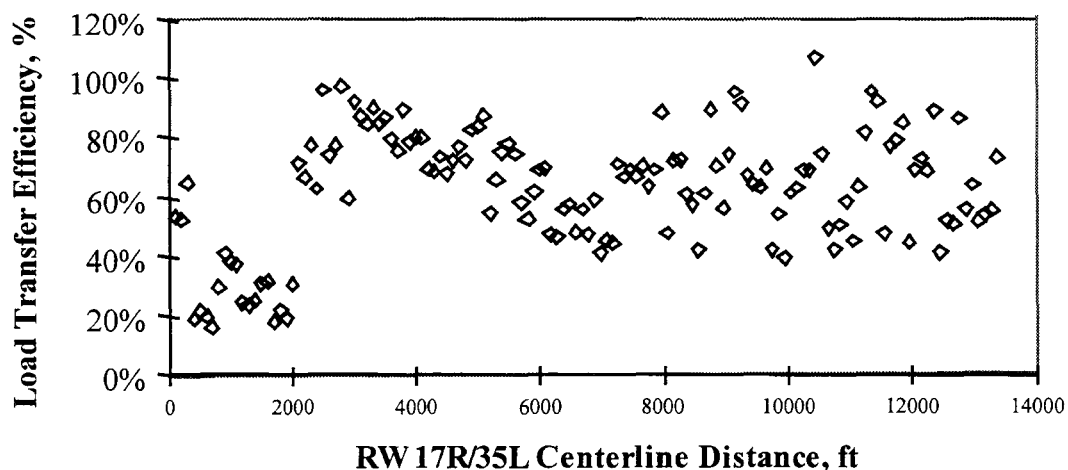
The next type of comparison of longitudinal joints involves estimating the stresses induced in the concrete slabs by aircraft loading. A relative comparison can be made by again taking a ratio of deflections at any two joints for comparison. The ratio of the deflection at sensors 3 and 4 (from Figure 5.15) is found, by taking measurements across the joint. This configuration is shown in Figure 5.20. The purpose of this configuration is to determine how much a slab deflects when a load is placed on an adjacent slab. In an ideal situation, the joint would transfer half of the load to the adjacent slab, and both would deflect the same amount, thus the load transfer ratio should equal 1.0, or a Load Transfer Efficiency of 100 percent. Figure 5.21 shows the load transfer ratio for the entire distance of the centerline joint of Runway 17R.

Figure 5.21. Load Transfer Efficiency of Centerline Joint, Runway 17R/35L.

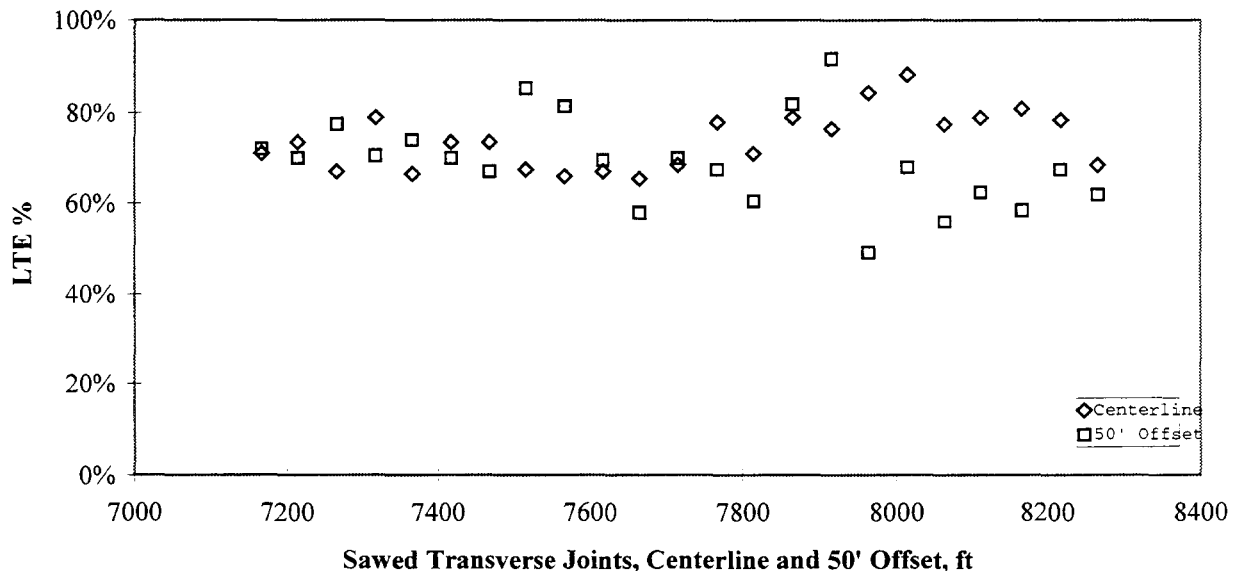
Another comparison available is the difference in deflection ratios for the same joint type, or the same individual joint, but comparing the joints at the A and C slabs. In this manner, the fatigue effects of aircraft loading on the pavement can be compared for the same joints. This can be done since Joint A has experienced many more load repetitions than Joint C. Figures 5.22 through 5.25 show the results of the analysis described above.

Figure 5.22. LTE of Sawed Transverse Joints at Centerline and at 50 ft. Offset.

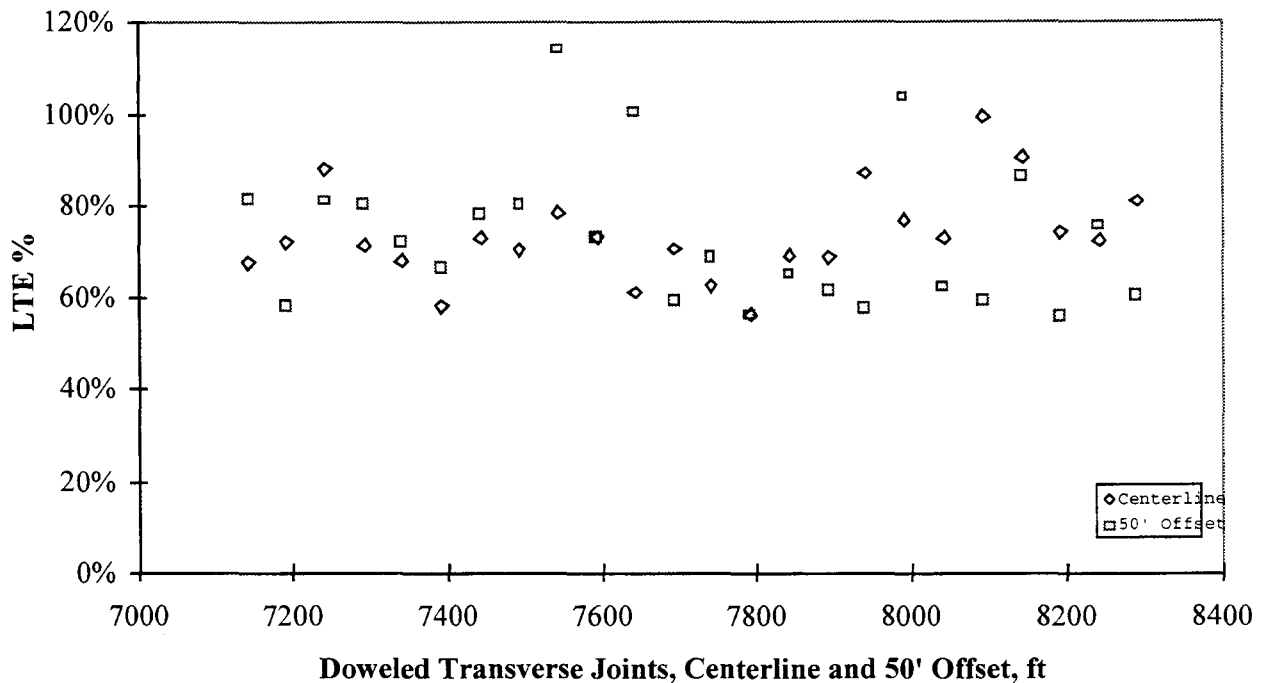
Figure 5.25. LTE of Doweled Transverse Joints, Centerline and 50 ft. Offset.
