DETERMINATION OF
ACCURACIES IN EARTHWORK
QUANTITIES FROM
PHOTOGRAMMETRICALLY
MADE SURVEYS

TEXAS HIGHWAY DEPARTMENT

Research Report Number 38-1F

May 1968

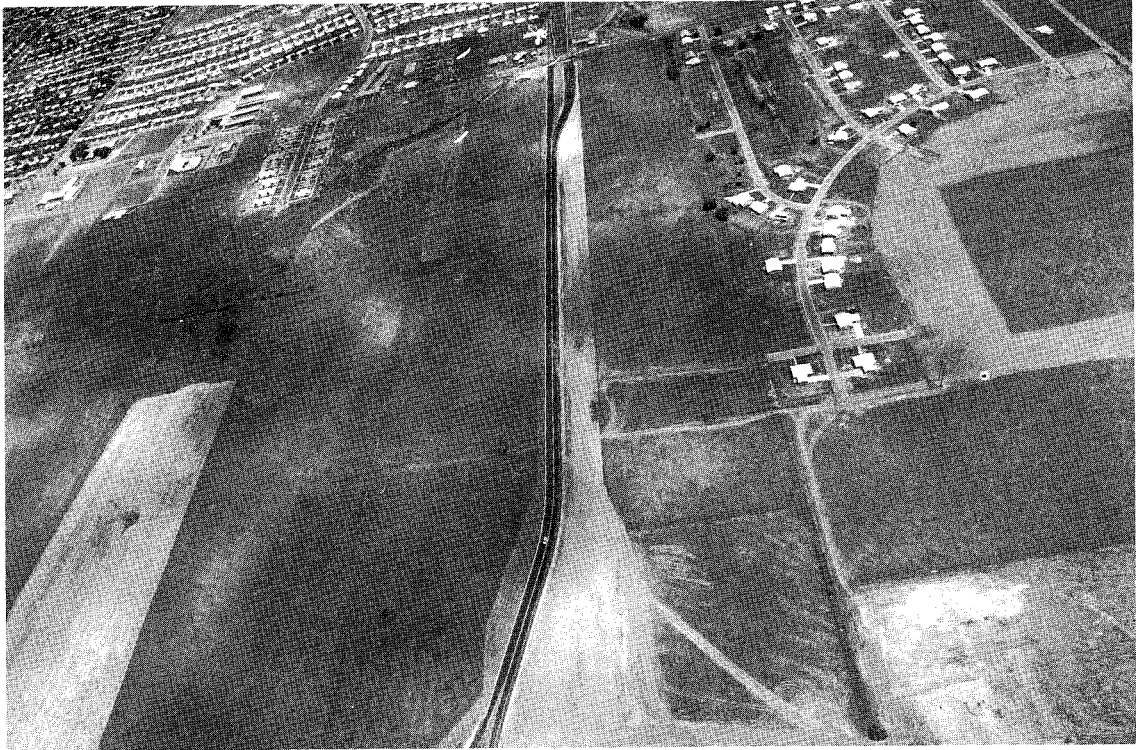
FIGURE 3. S.H. 360, TARRANT COUNTY

Figure 3, Page 8, is an oblique photograph of this entire test section. The section is approximately 1/2 mile long and traverses gently rolling terrain. This short project was chosen to reflect light volumetric earthwork quantities.

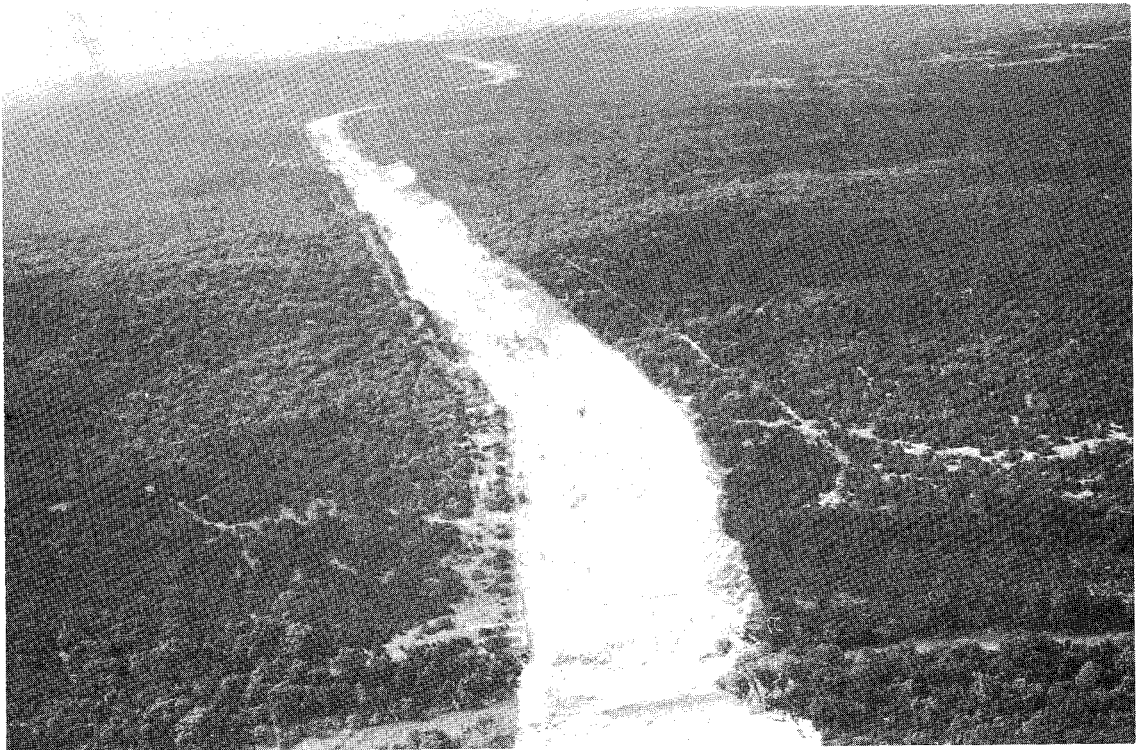
FIGURE 4. LOOP 360, TRAVIS COUNTY

This 3-1/2 mile section in Travis County, which is shown in Figure 4, Page 8, is part of a loop around the City of Austin and traverses rough terrain in the central Texas geological uplift area.
