A Cost-Benefit Analysis of the Use of Local Materials by the Texas Department of Transportation

DHT-43

A COST-BENEFIT ANALYSIS OF THE USE OF LOCAL MATERIALS BY THE TEXAS DEPARTMENT OF TRANSPORTATION

JUNE 1998

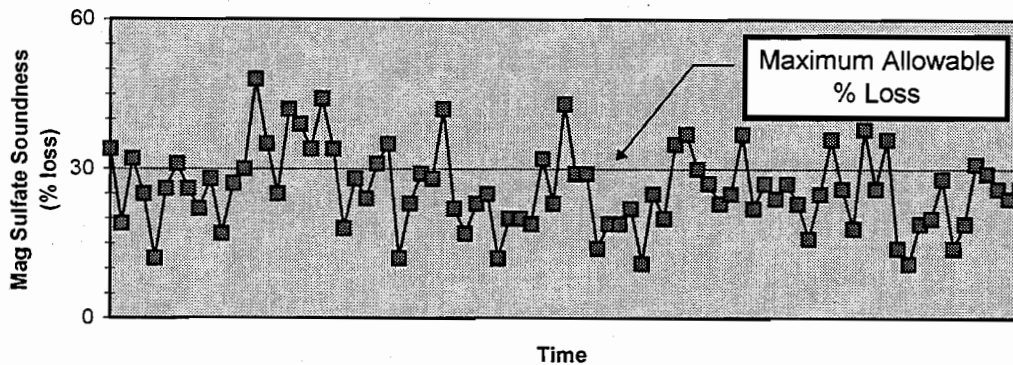
FIGURE 3

Soundness Test Result History
Central Texas Limestone Source #2

A wide range in quality can also be found between sources of the same mineralogy. For instance, some limestone sources provide aggregates which are many times stronger and more durable than limestone aggregates from other sources. Some siliceous aggregates are chemically reactive with elements in portland cement, potentially causing severe damage to the involved structure, while other siliceous aggregates do not react in this manner.

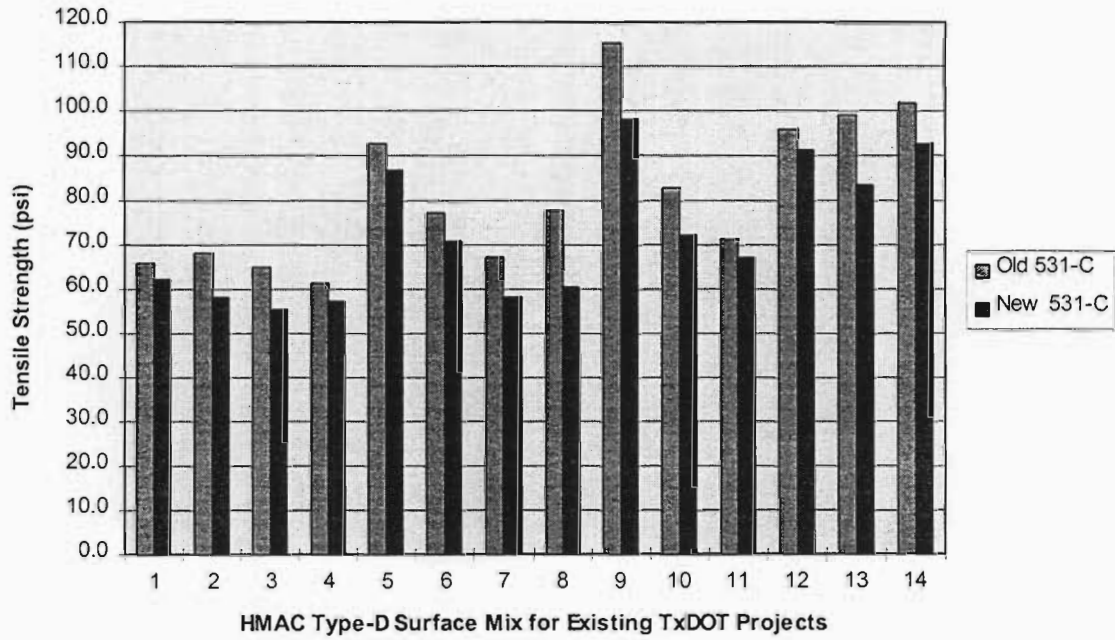
531-C Test Method Evaluation

This procedure was modified in April 1997. Work coordinated by the Materials and Tests Division showed limited relationship between saturation level and TSR for some aggregates, while some aggregates with a history of stripping showed a higher probability of failing the test when the specimens were subjected to higher saturation percentages. Thus, a higher saturation was adopted to increase the likelihood that poor performing mixtures would be identified. This change also eliminated a time-consuming step from the test method, which is already very lengthy, around 3-4 days in duration.

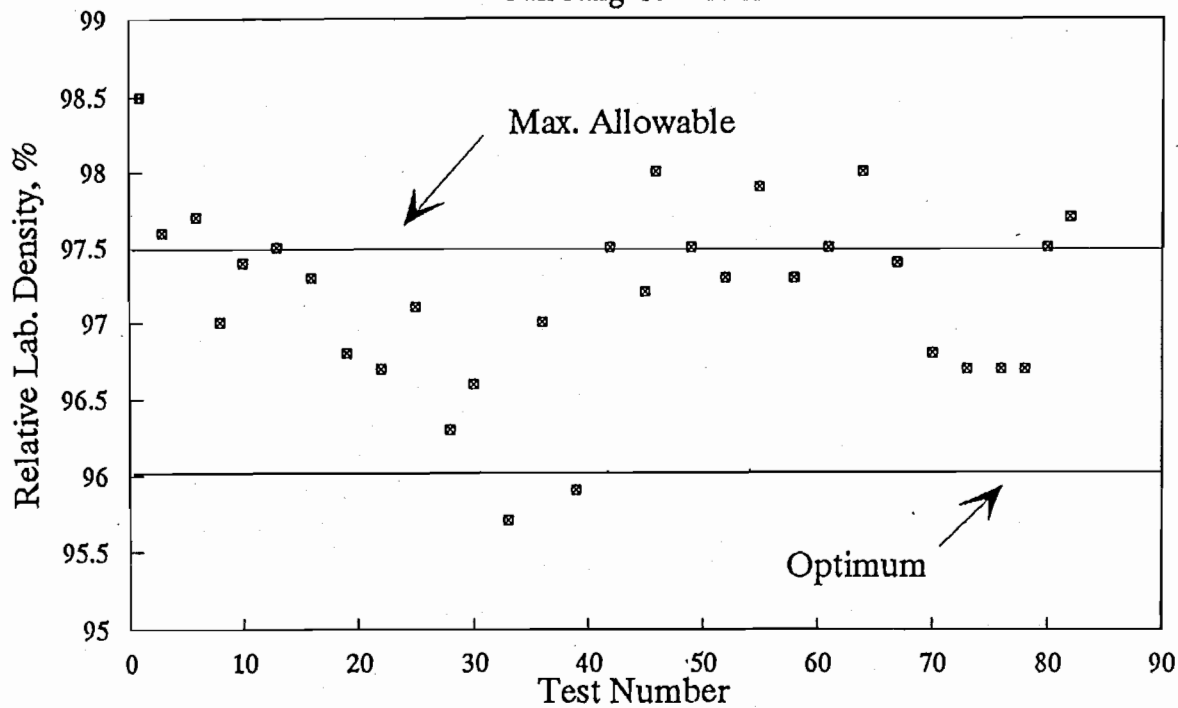
Figure 1. Variations in Relative Lab. Density

IH-10, Crocket County

San Angelo District

2. In 1994, a project on IH 10 had a problem with flushing and rutting. These were caused by high laboratory densities, which in turn were attributed to excessive amounts of very fine dust in the mixture. The excessive amount of dust was apparently generated by degradation of coarse aggregate during the plant mixing process. Magnesium sulfate soundness test results on the most common coarse aggregate size ranged from 27.0 to 28.0 percent. Stockpiles of smaller coarse aggregates tested in the low to mid 40s. (See Appendix D.)

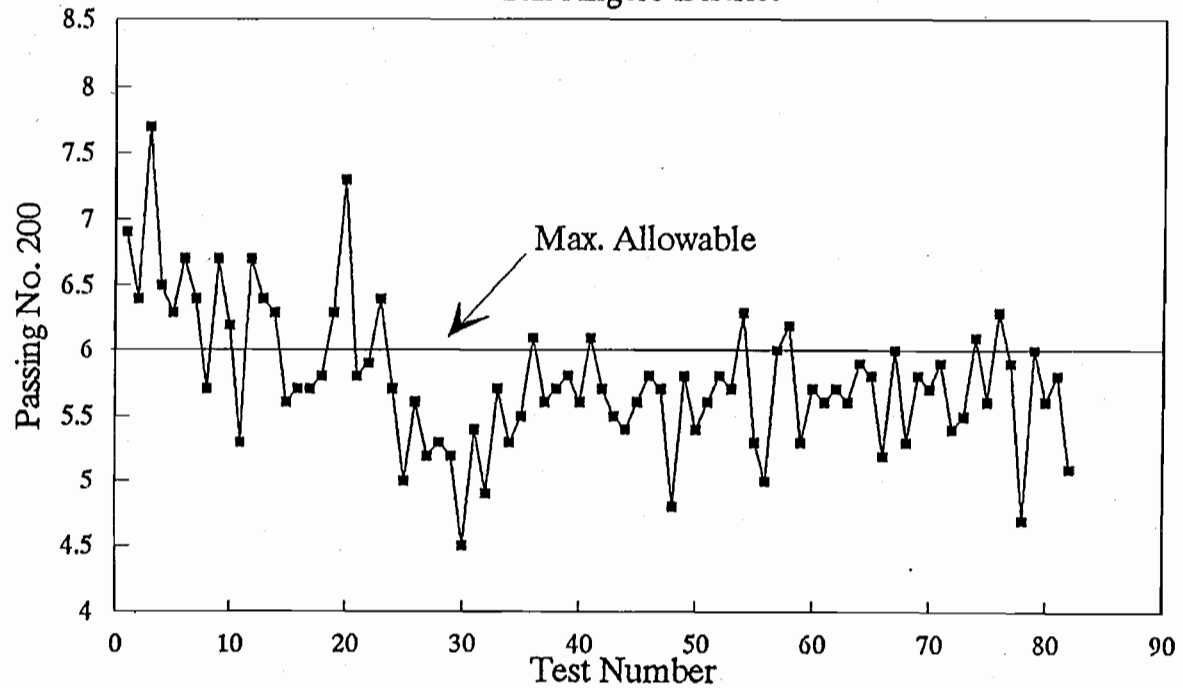
Figure 2. Variations in Percent Passing No. 200 Sieve

IH-10, Crocket County

San Angelo District

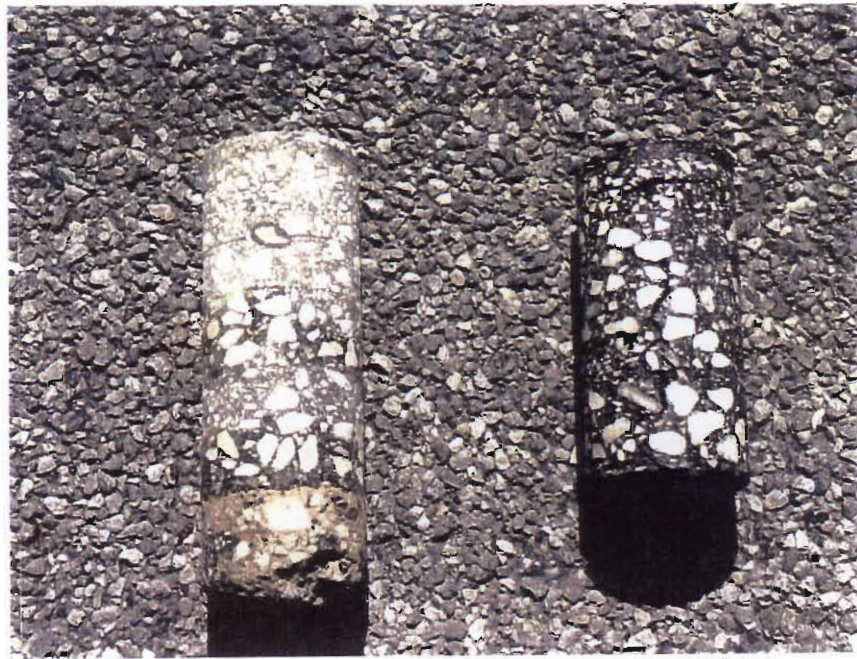
CSJ: 10Z-4-67 Highway: US 77

Limestone not stripped
even at cracked areas.

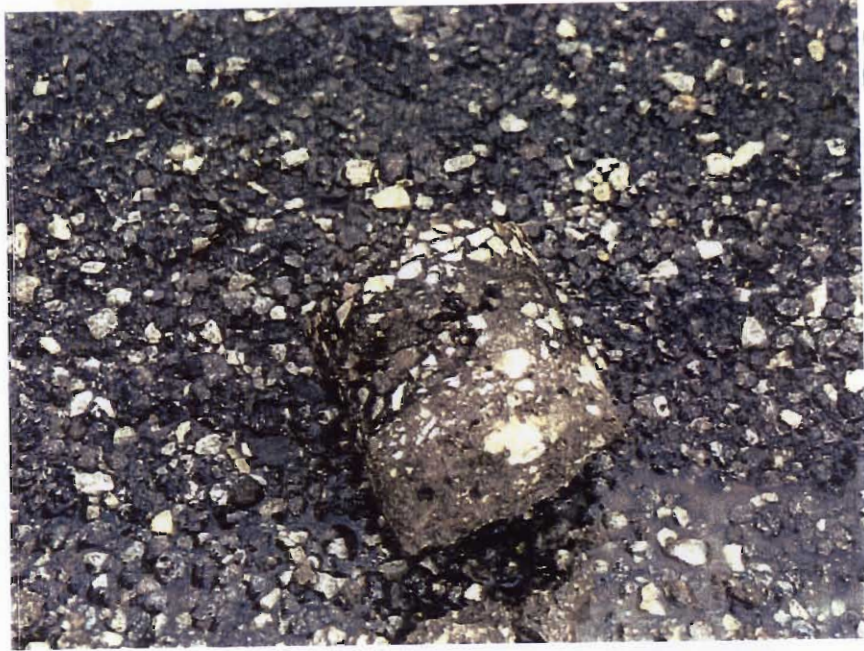
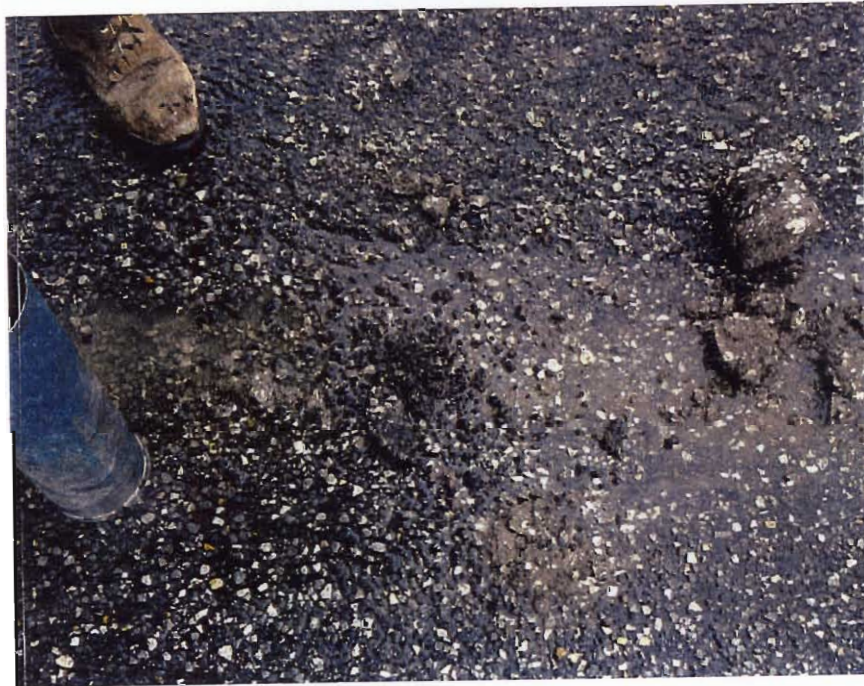
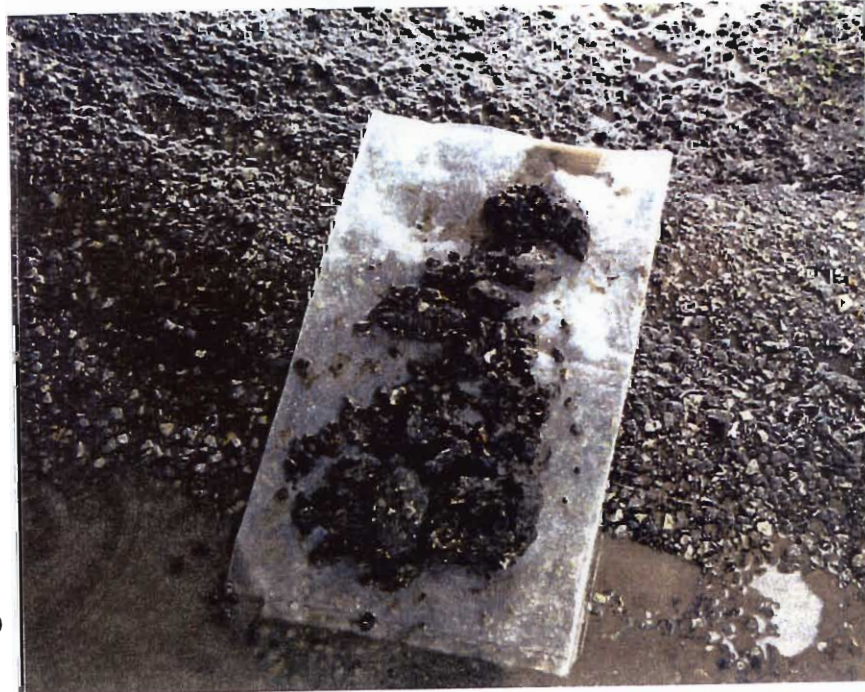
CSJ: 2343-1-19 Highway: FM 2444

Slight stripping of
gravel. LRA seal coat
on top.

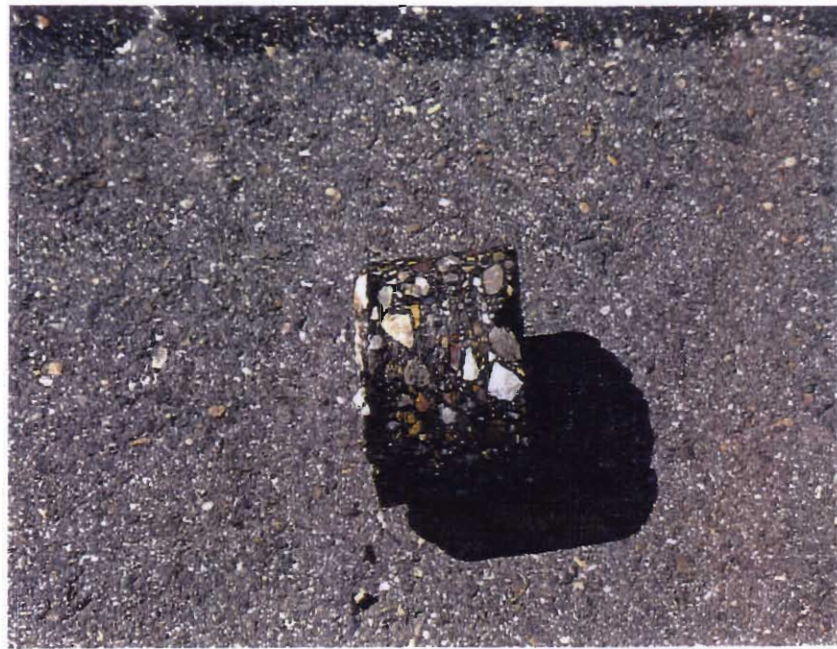
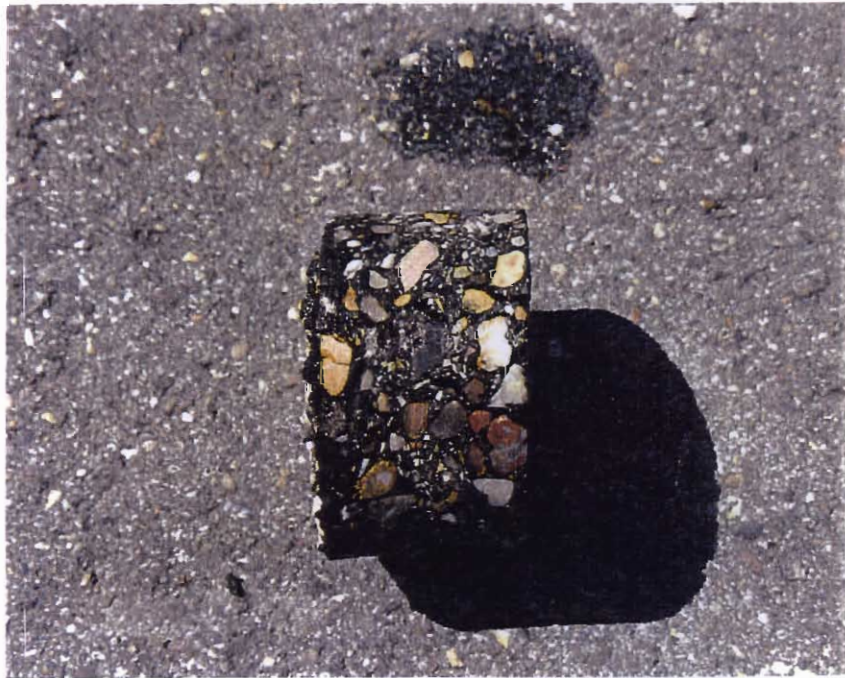
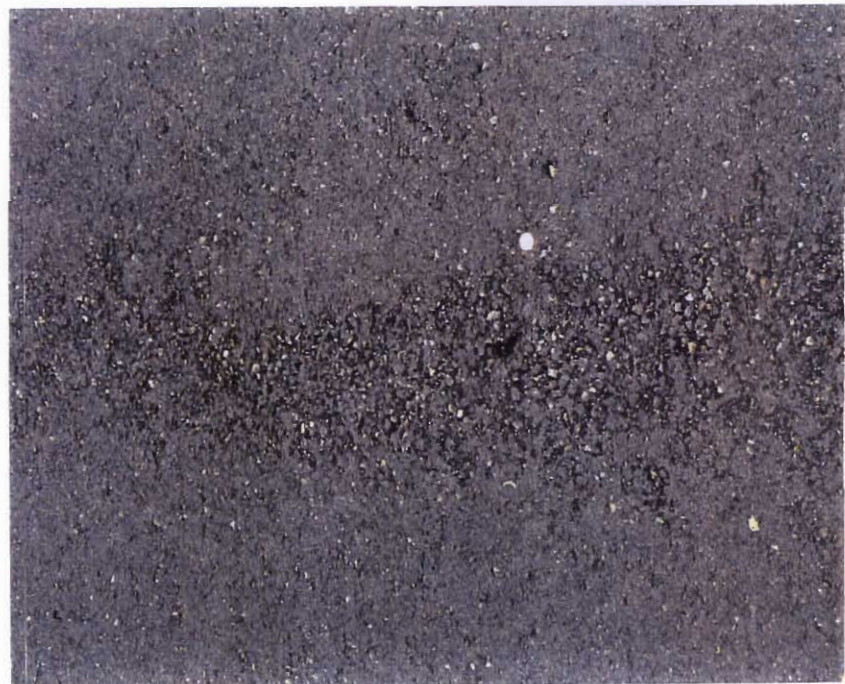
CSJ: 2343-123 Highway: FM 2444

No stripping of new
pavement. Surface
showed some ravelling

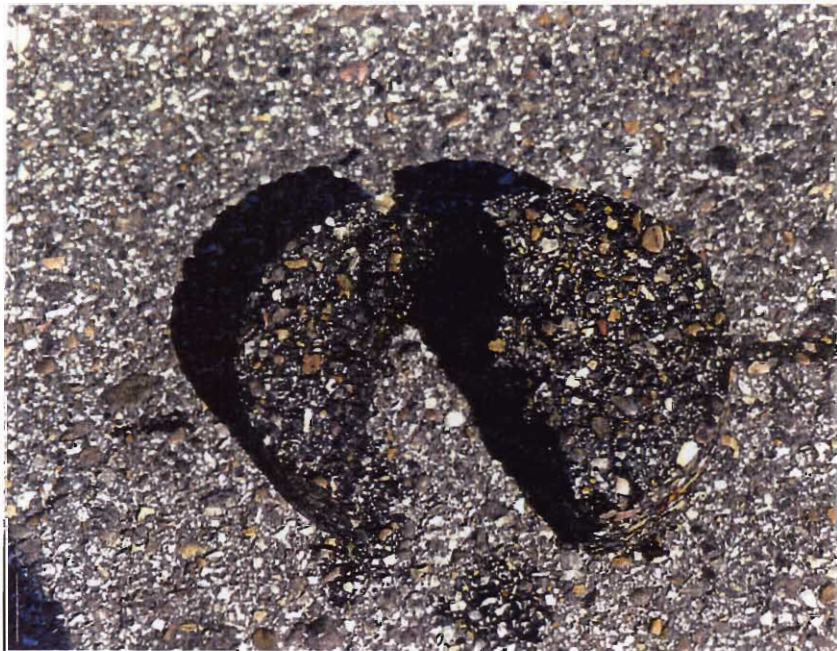
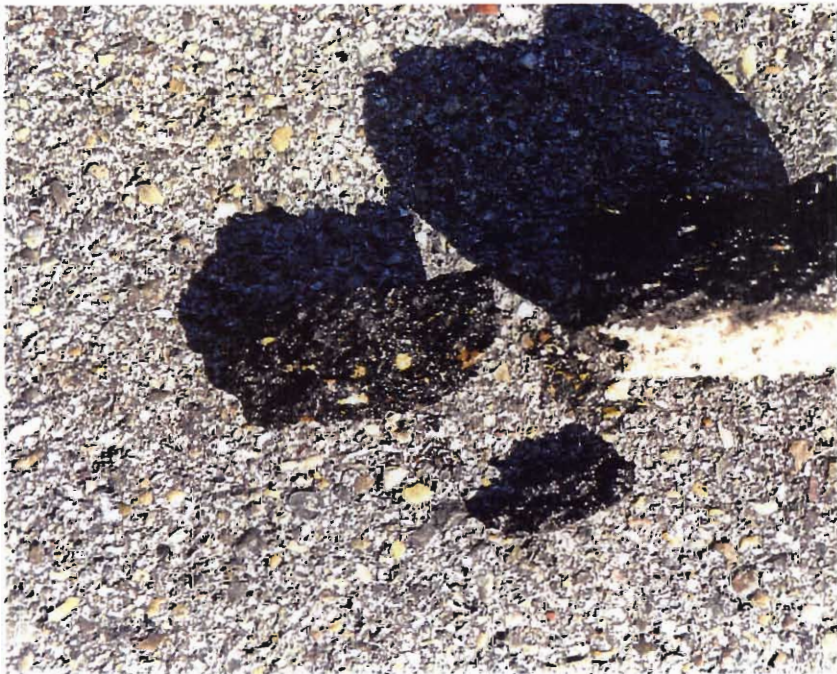
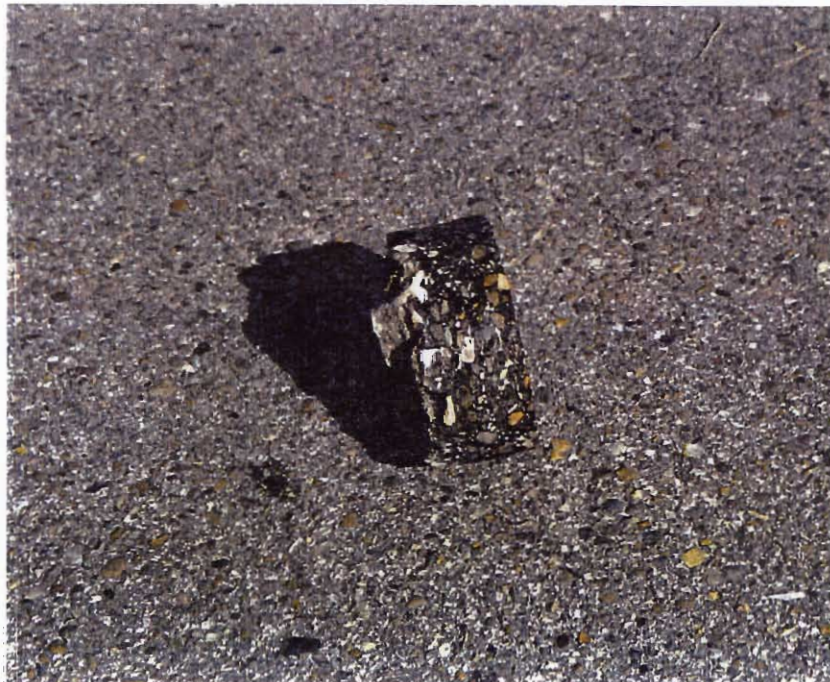
CSJ: 1052-2-60 Highway: FM 665

Slight stripping of
gravel near pavement
cracks.

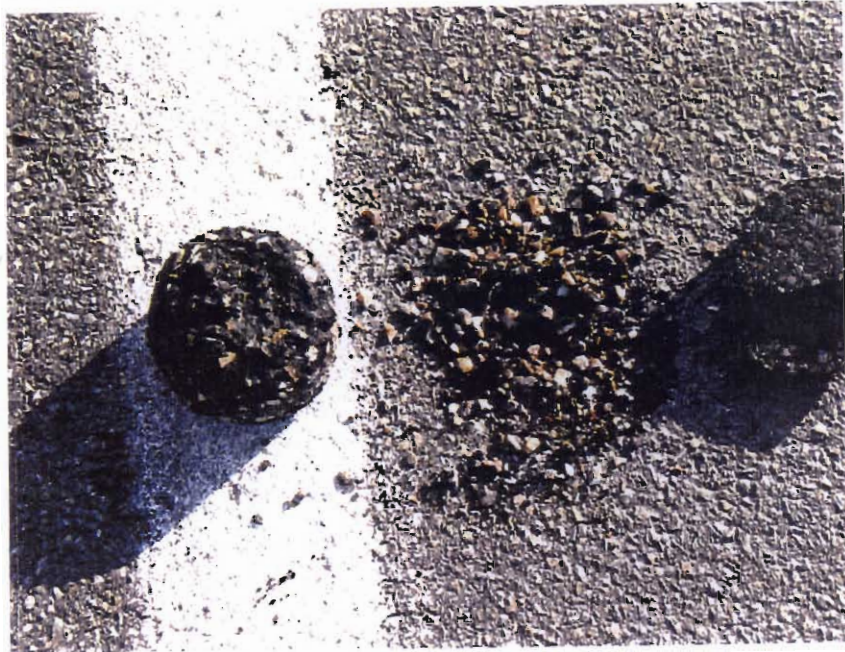
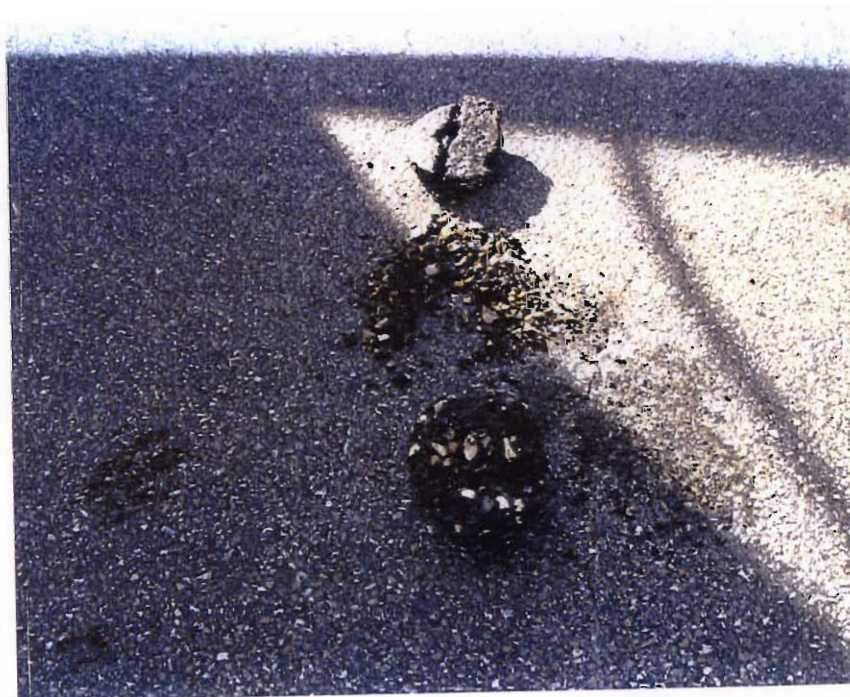
CSJ: 102-3-65 Highway: US77

middle layer of
gravel completely
stripped.

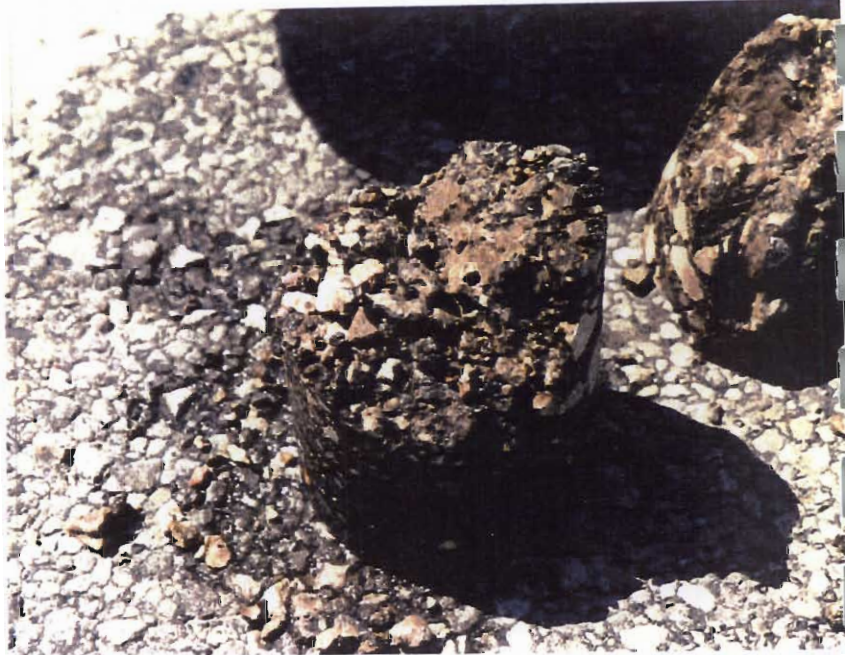
CSJ: 373-2.69 Highway: SH 44

LRA (seal coat)
Gravel layer stripped
severely in some
sections.

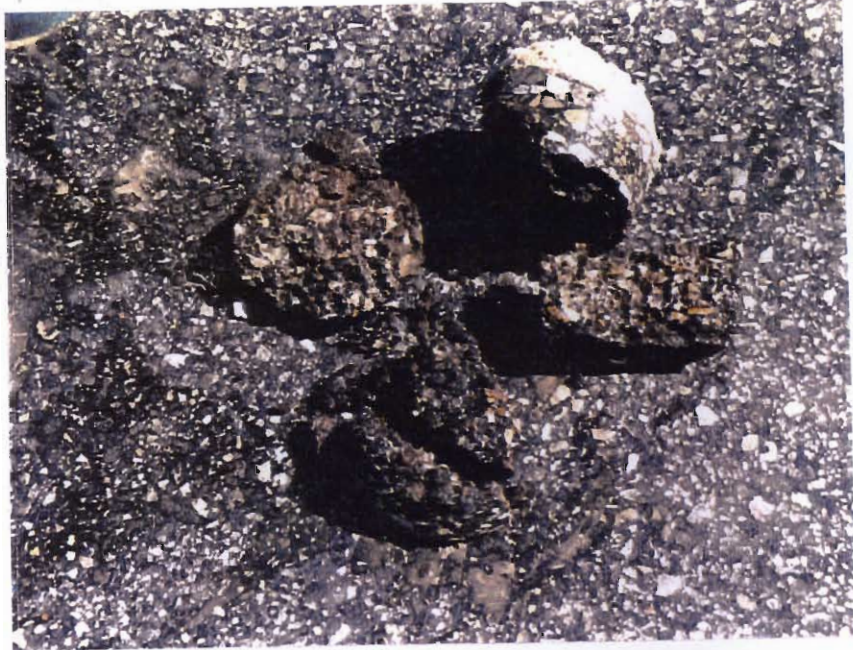
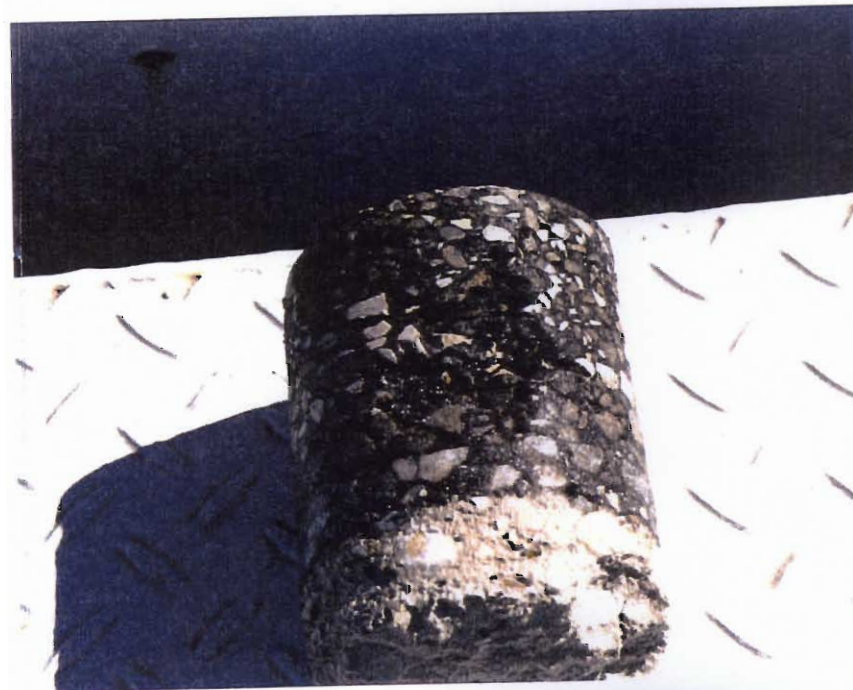
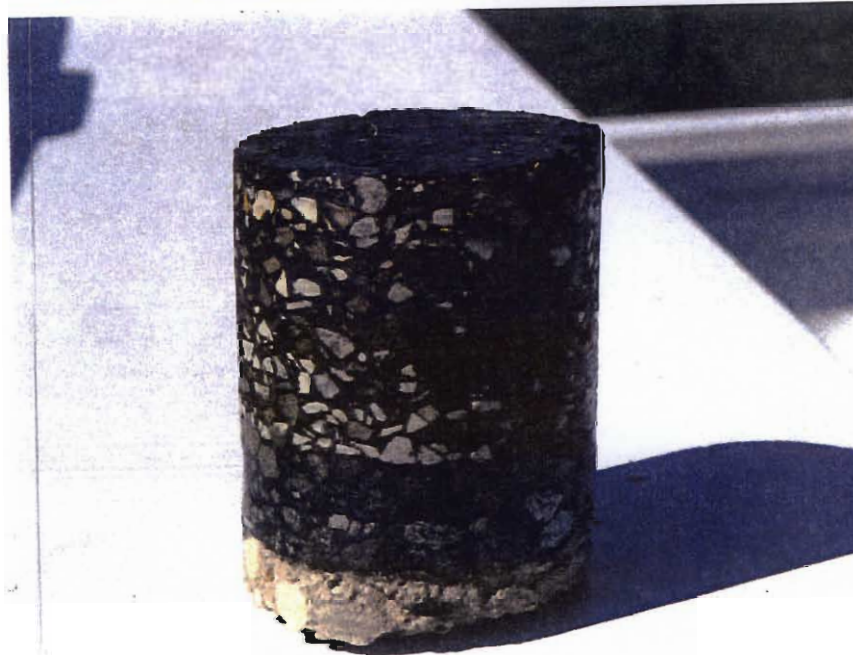
CSJ: 254-1-106 Highway: US 281

Cores taken in a section with slight rutting. Stripped aggregate varied from none to moderate.
