EXPERIMENTAL PROJECTS

PRECOATED LIGHTWEIGHT AGGREGATE

Report Number 605-2

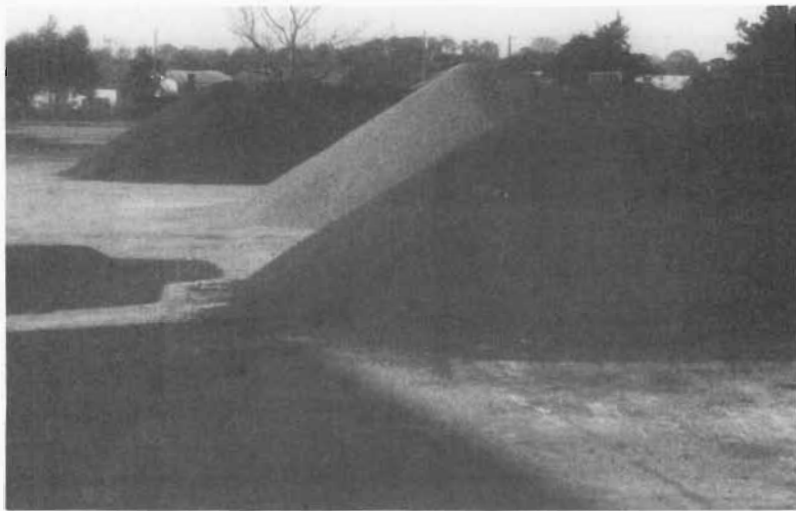
FIGURE 1 - STOCKPILED AGGREGATE

After precoating, the material was immediately hauled to the South Tyler maintenance yard and stockpiled in three separate piles. Upon observing the material after stockpiling, it was evident that the lightweight aggregate had absorbed a portion of the precoat oil and it was noted that the 1.6% rate, which appeared to be right at the time of precoating, appeared too dry in the stockpile. Likewise, the 1.8% rate, which appeared too high at the time of precoating, appeared to be right in the stockpile. This observation may be noted in the photograph in Figure 1.

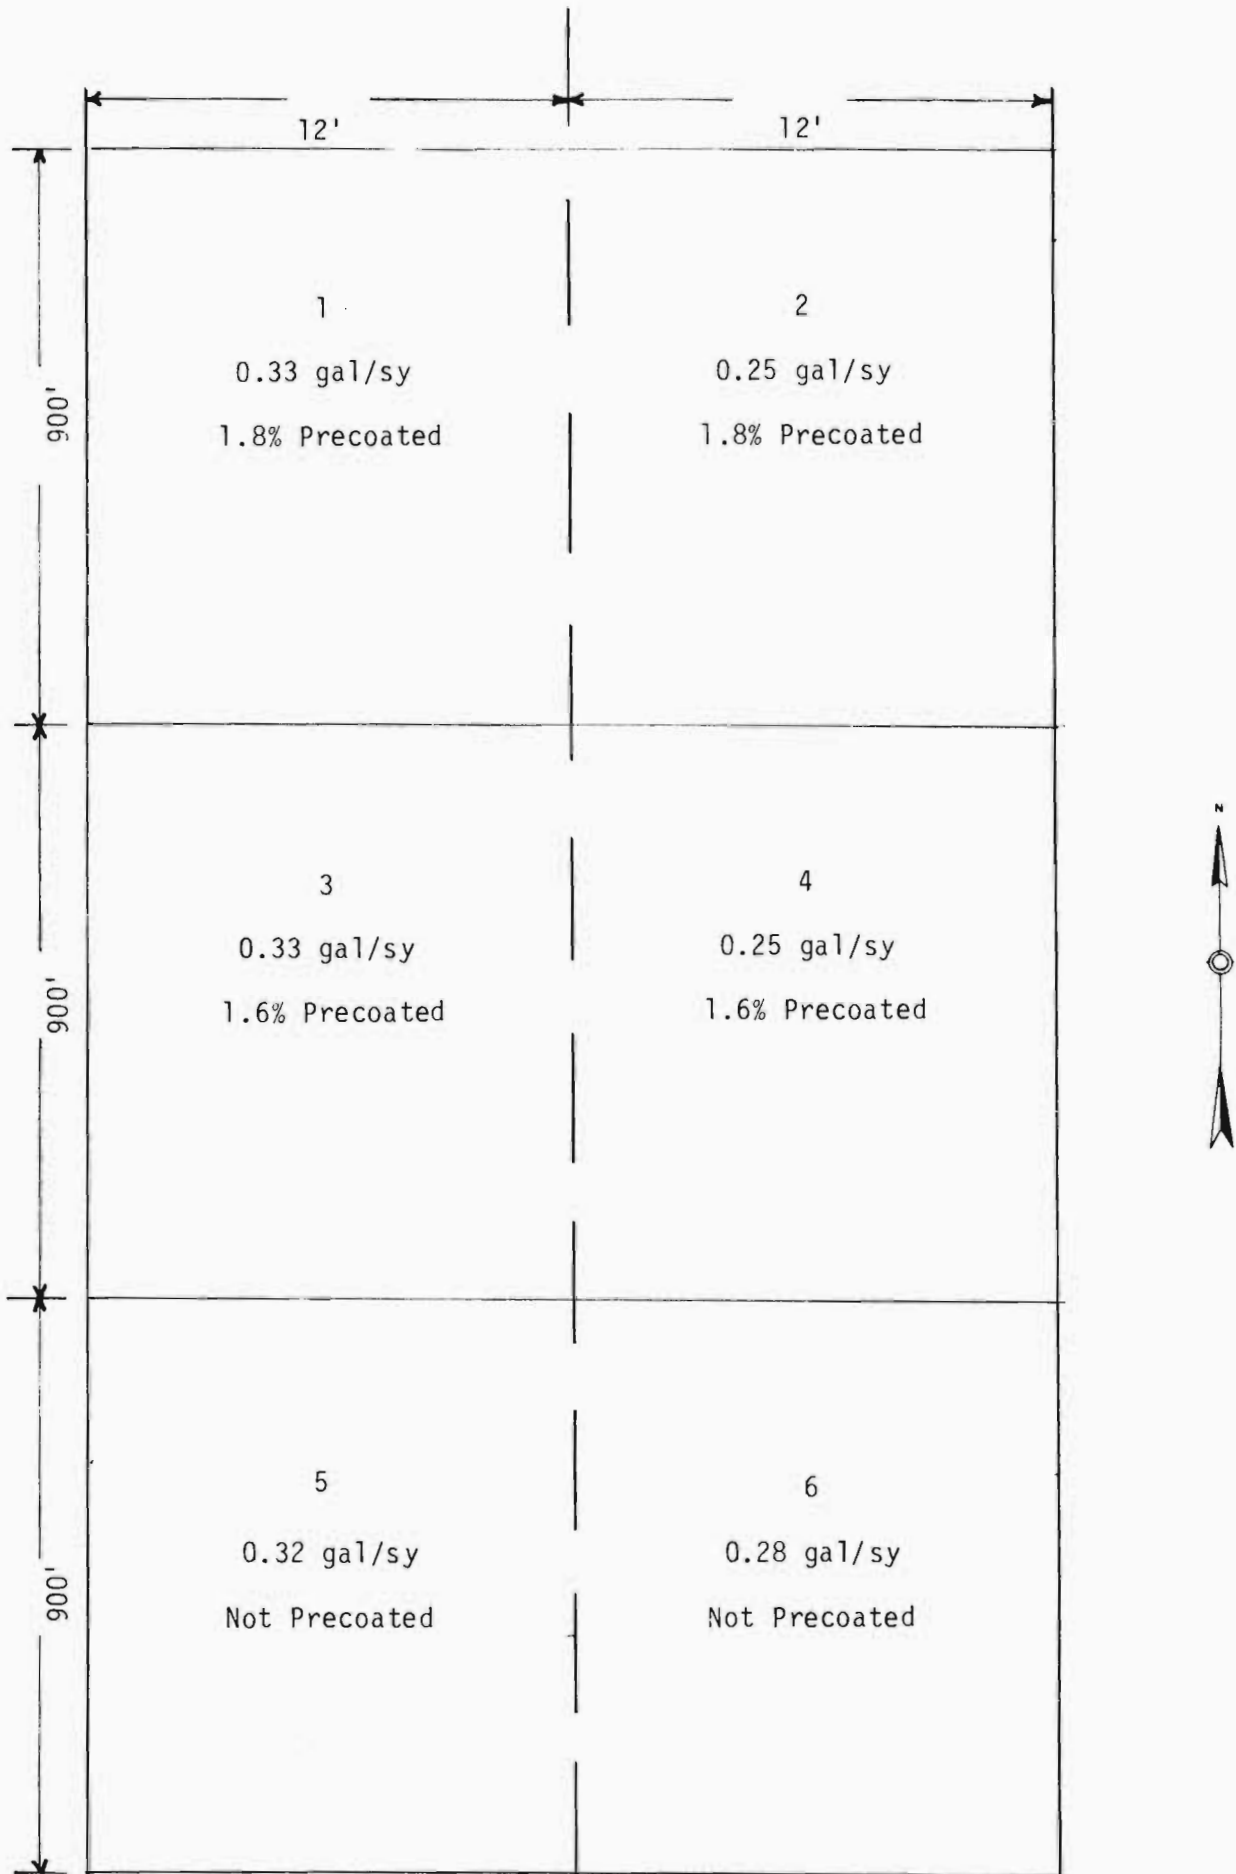
FIGURE 2 - SCHEMATIC OF EXPERIMENTAL SECTIONS

Six sections, each 12' wide and 900' long, were selected as follows (see Figure 2):

On Sections #1 and #2, 1.8% precoated lightweight aggregate was applied at a rate of 1 CY to 120 SY. The asphalt rate was .33 gal/SY on Section #1 and .25 gal/SY on Section #2.

On Sections #3 and #4, 1.6% precoated lightweight aggregate was applied at a rate of 1 CY to 120 SY. The asphalt rate was .33 gal/SY on Section #3 and .25 gal/SY on Section #4.

On Sections #5 and #6, uncoated lightweight aggregate was applied at a rate of 1 CY to 120 SY. The asphalt rate was .32 gal/SY on Section #5 and .28 gal/SY on Section #6.

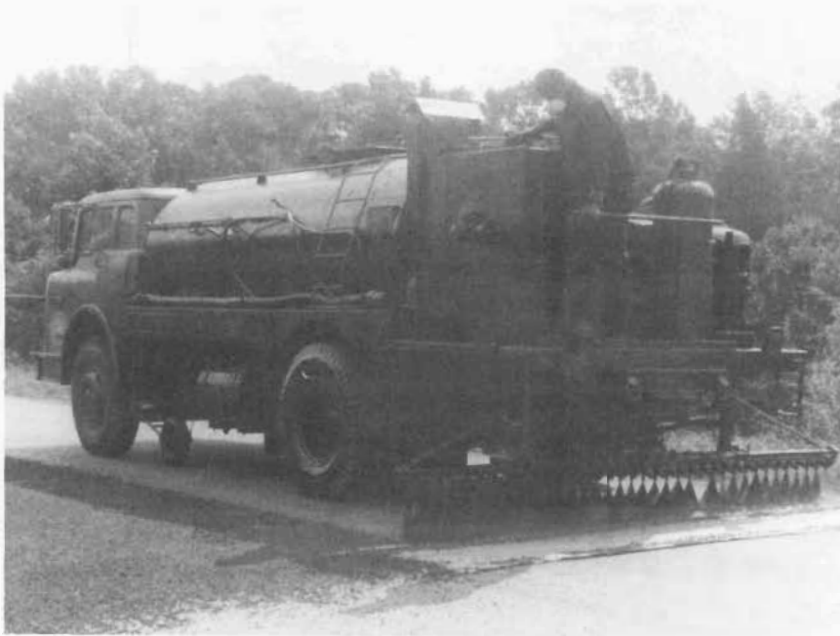
FIGURE 3
DISTRIBUTOR
USED

The construction work was done by State Maintenance forces. The AC-10 was applied with a Rosco Distributor. The aggregate was placed with a self-propelled spreader and rolling followed immediately utilizing a SB-3000 pneumatic roller. Figures 3 to 5 show views of the construction equipment and operations. Generally the construction operations progressed very well and a good seal coat was obtained.

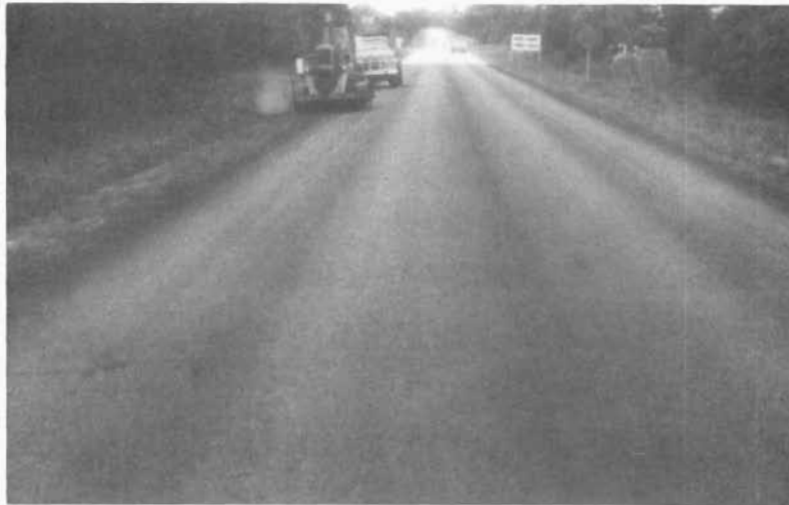
FIGURE 6 - GENERAL VIEW OF SECTIONS 1 AND 2

The following morning the sections were broomed to remove any excess aggregate. It was noted that there was no loose aggregate except a minor amount along the extreme outside edge of the pavement. Figures 6 through 8 show photographs of the completed sections and the brooming operations.

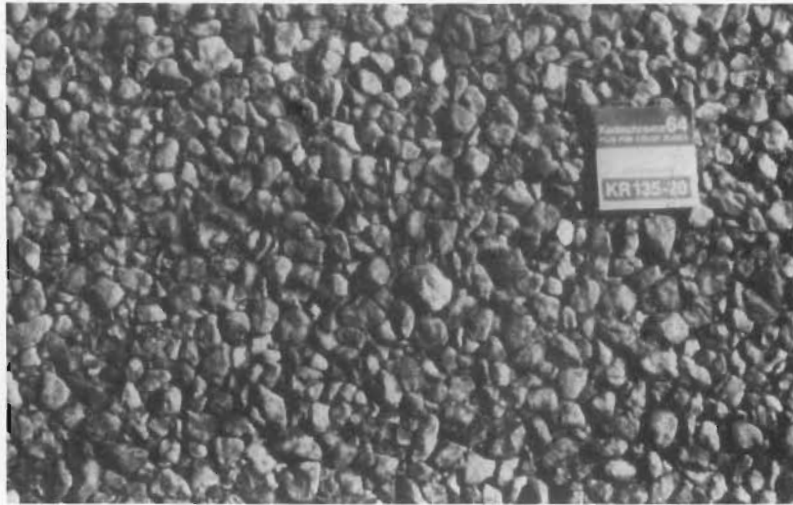
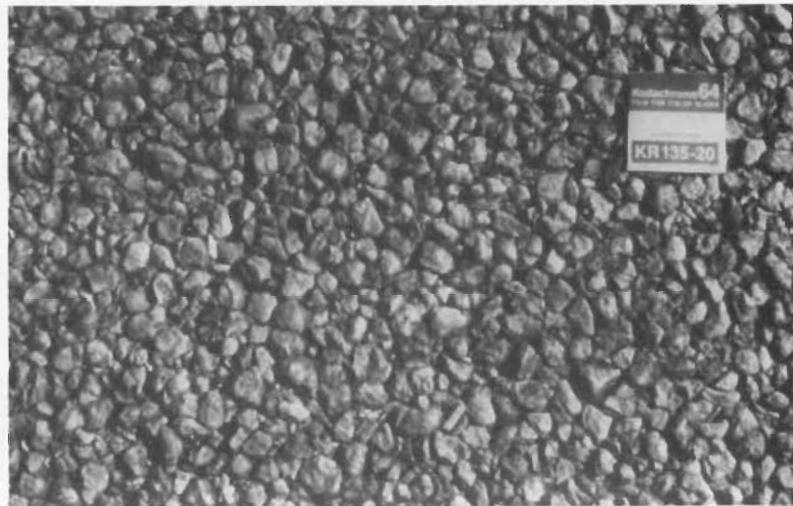
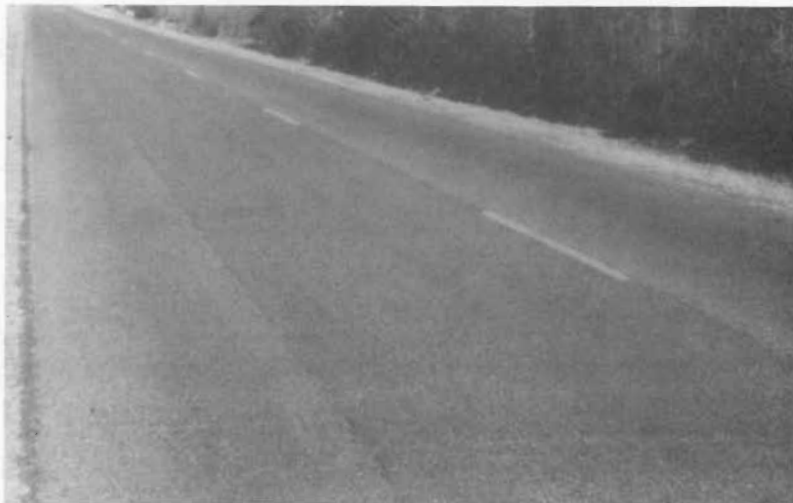
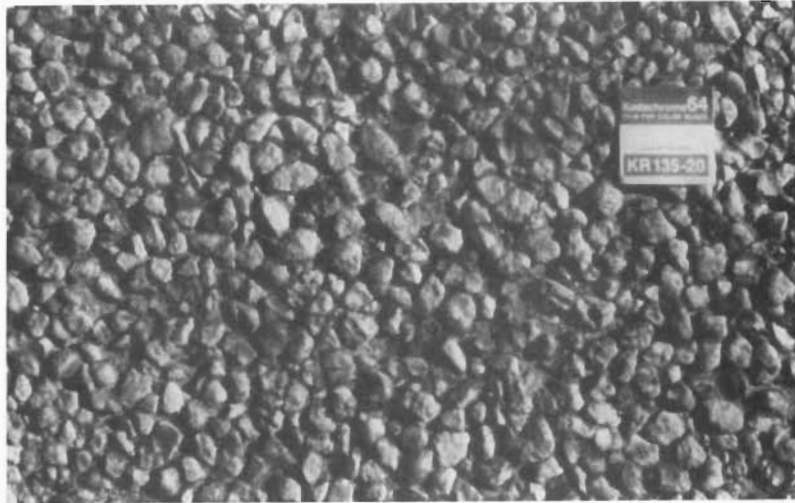
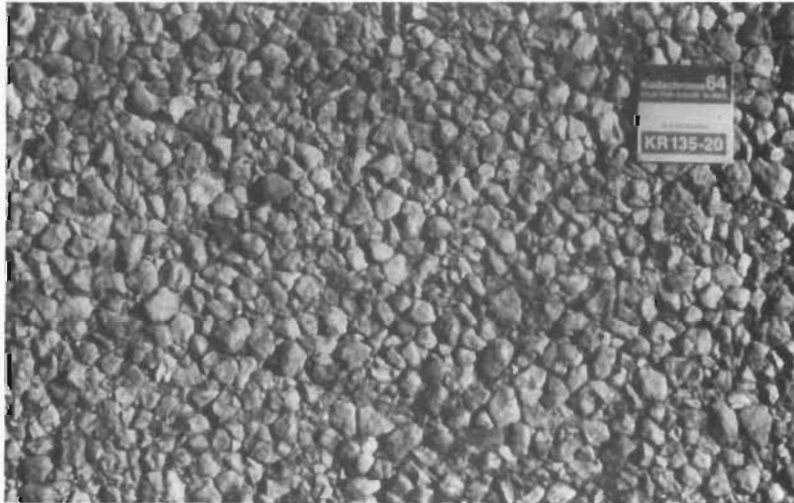
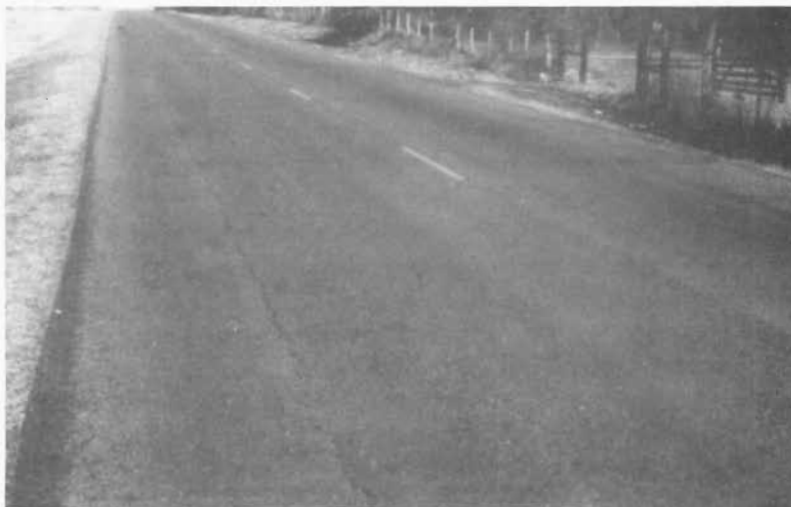
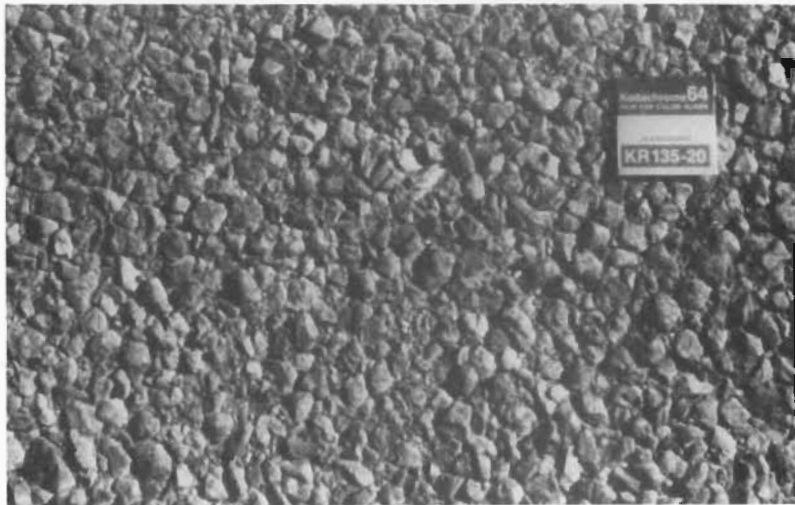
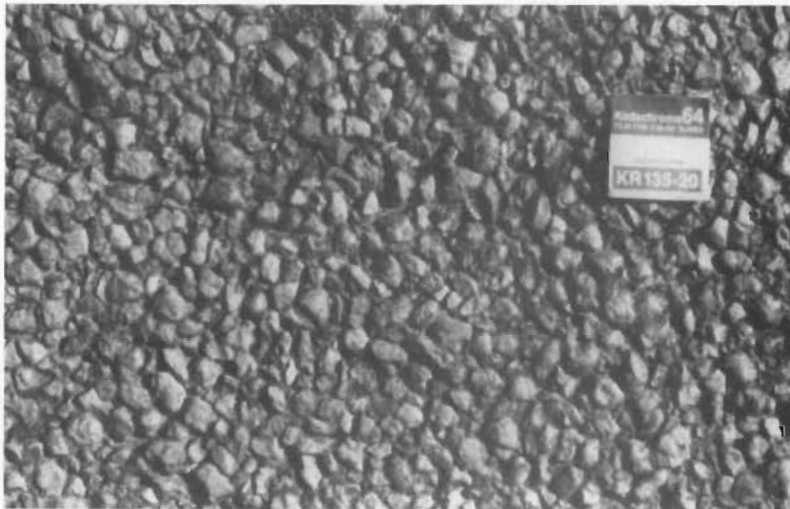
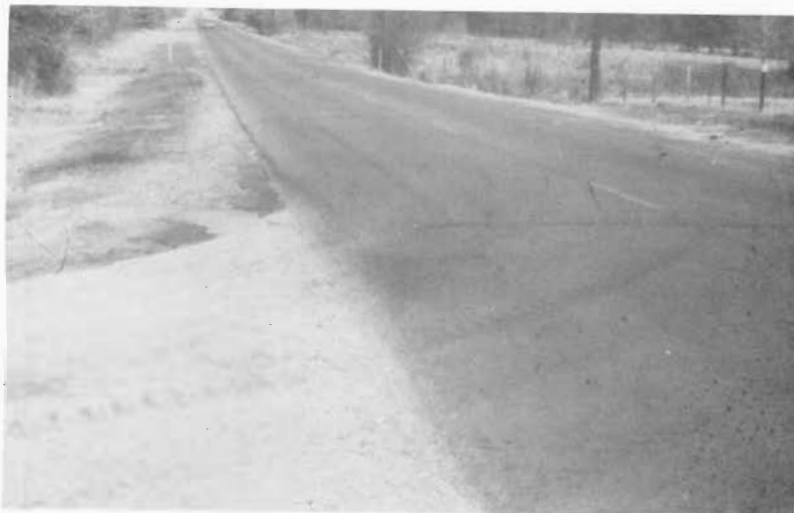
The team rating was performed at approximate six month intervals and a summary of the data collected may be found in Table I. An example of the data collected has been included in Appendix C. Figures 9 through 17 show photographs of the sections taken at rating time during the first winter. Note little raveling, flushing or aggregate degradation have been found to date and the overall appearance and performance has been very good.

All experimental sections are performing well and it was concluded that precoating synthetic lightweight aggregate was successful and beneficial. Based on the results of this information, some 51 lane miles of highways in District 10 were sealed with a precoated lightweight aggregate during the 1981 asphalt season. At the present time, this construction is performing very well. Flushing, as would be expected, may be found in areas where previous patching occurred, but little flushing, aggregate loss or aggregate degradation developed or is evident.
